Forman Inspection Services, LLC

Property Inspection Report

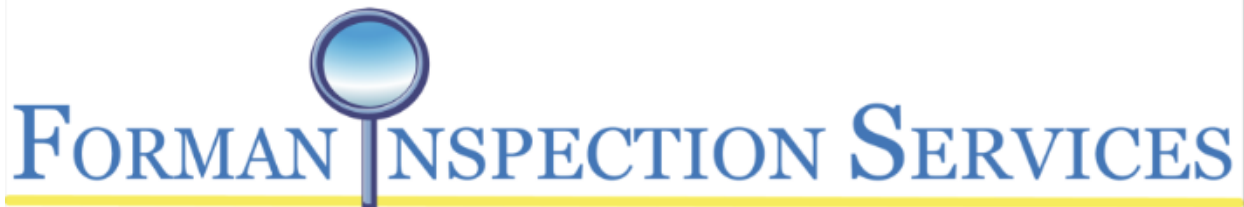
Email: cforman61@gmail.com

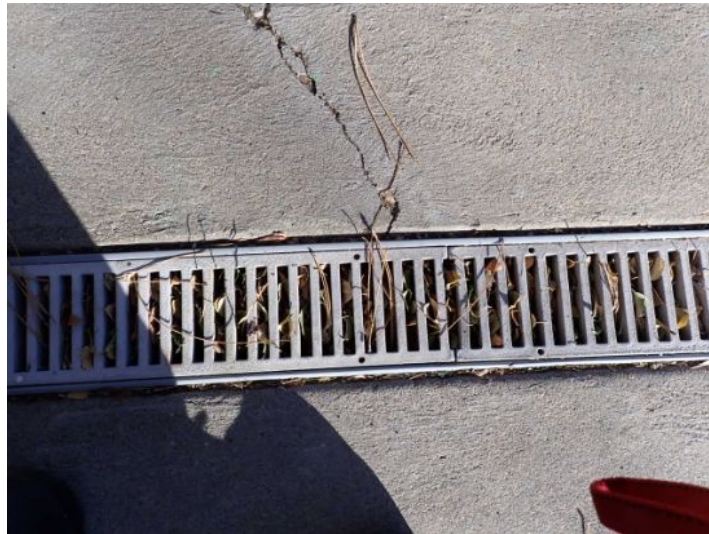
Drainage systems blocked by debris in areas. Recommend repairs.

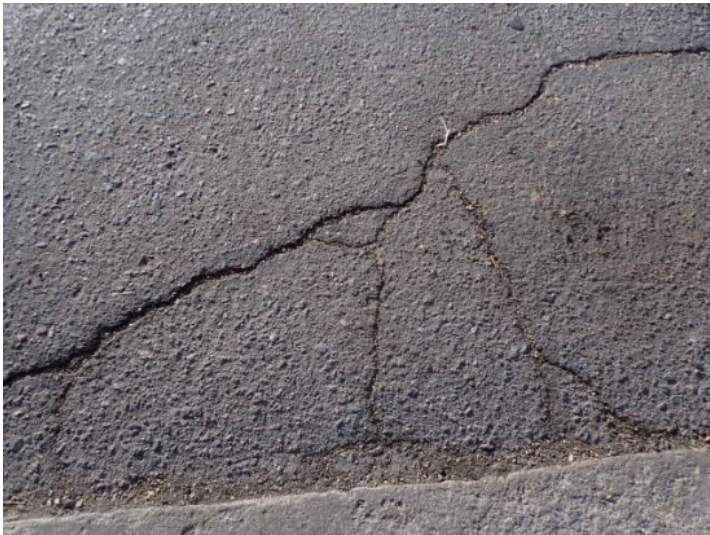
Recommend crack filling to aid in extending the life of the existing asphalt surface. Recommend repairs by a licensed contractor.

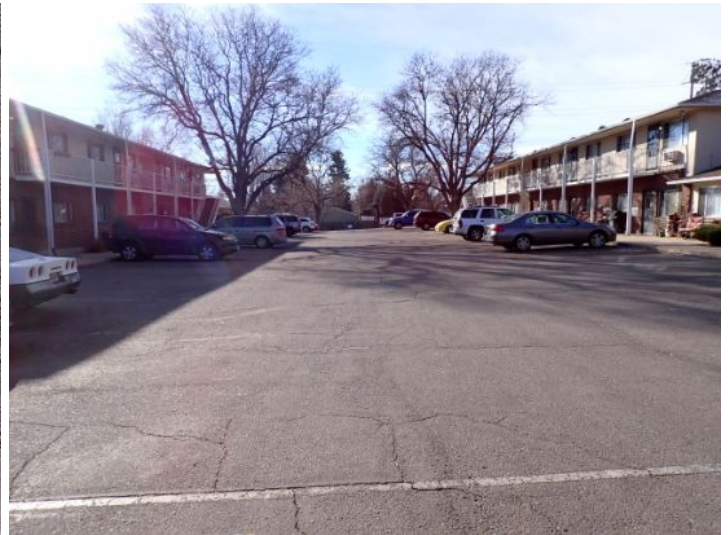
The parking lot surface was in fair condition at the time of the inspection.

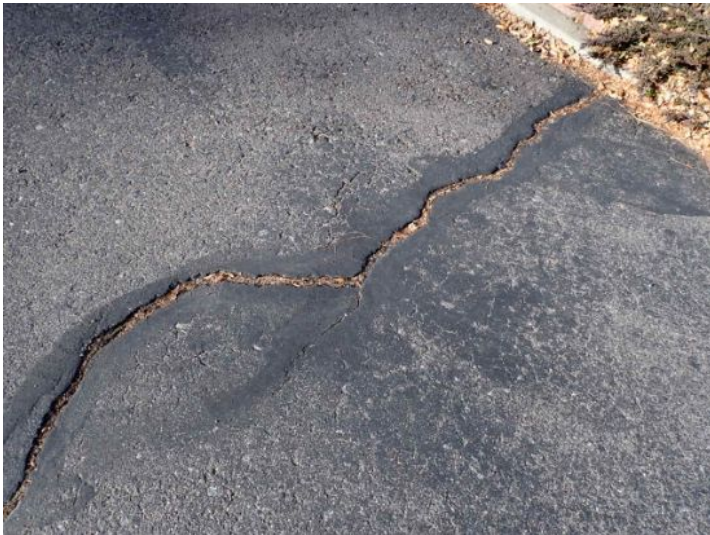
Recommend crack filling to aid in extending the life of the existing asphalt surface. Recommend repairs by a licensed contractor.

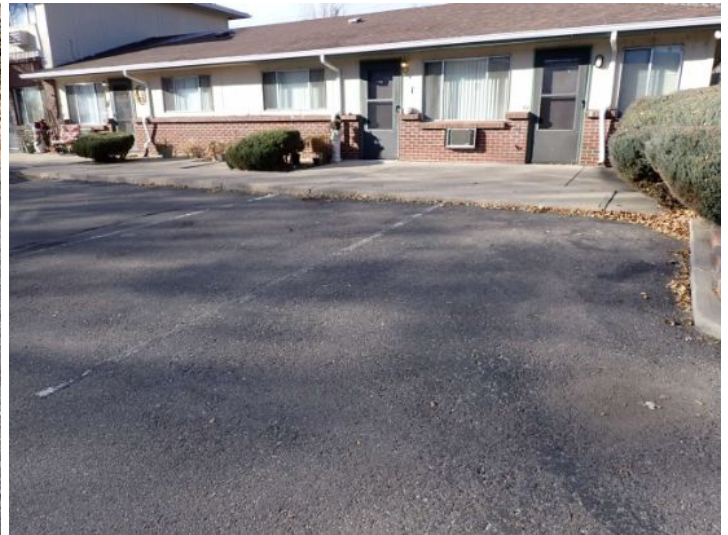
The parking lot surface was in fair condition at the time of the inspection.

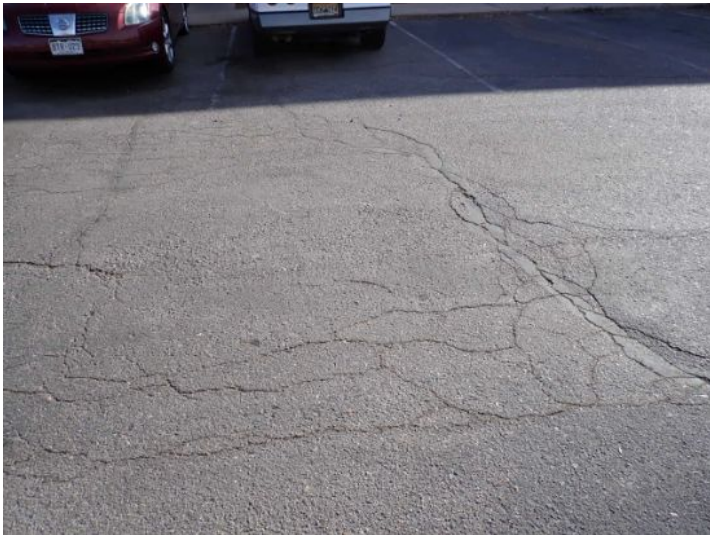
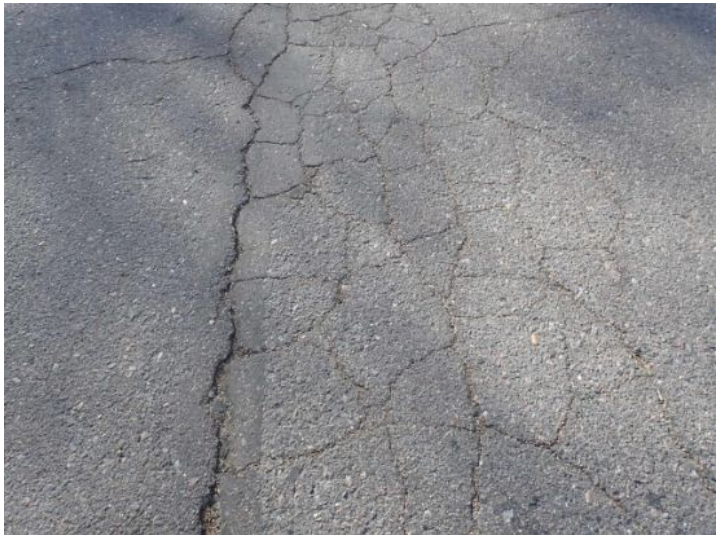
Alligatoring noted in areas of the parking lot at the time of the inspection. This is generally caused by heavy trucks/equipment and is indicative of sub surface failure. Recommend monitoring of the areas for repair/resurfacing within the next several years.

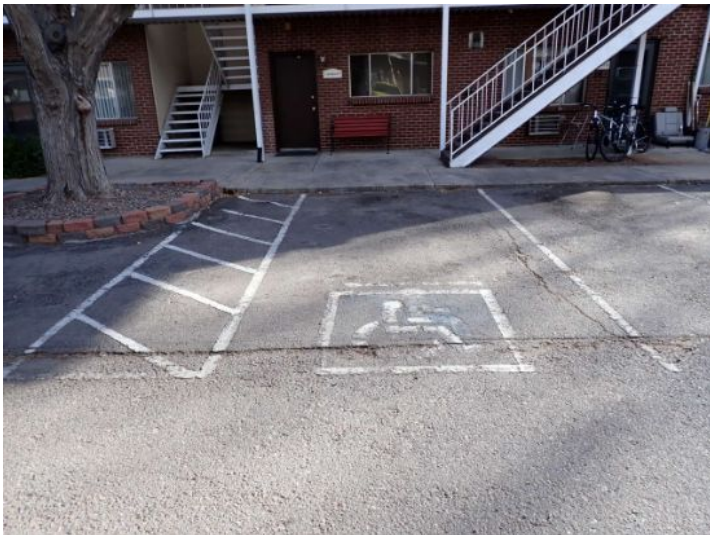
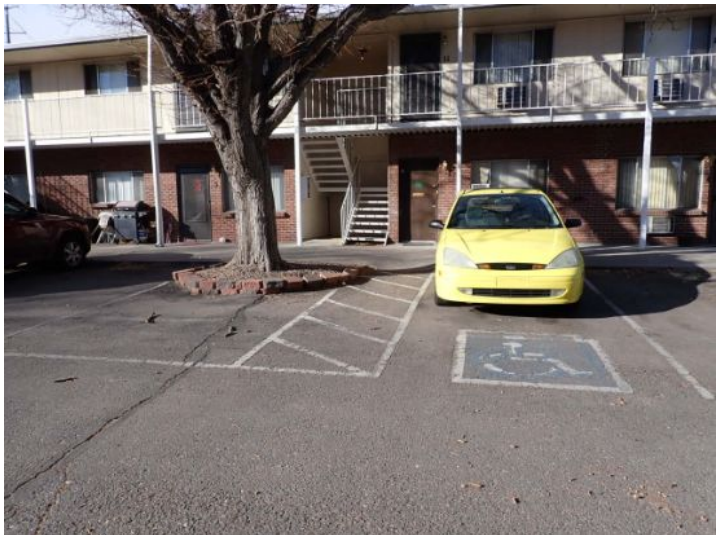
ADA parking was clearly marked at the time of the inspection.

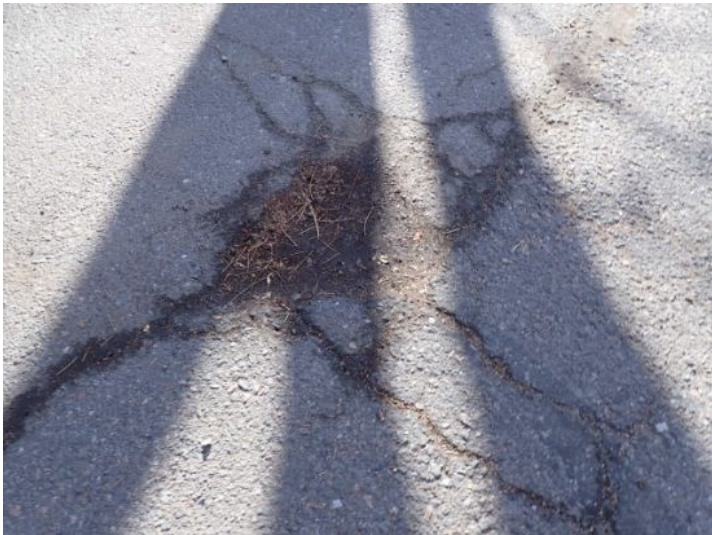
Significant deterioration noted in areas of the parking lots surface. Recommend repairs by a licensed contractor.

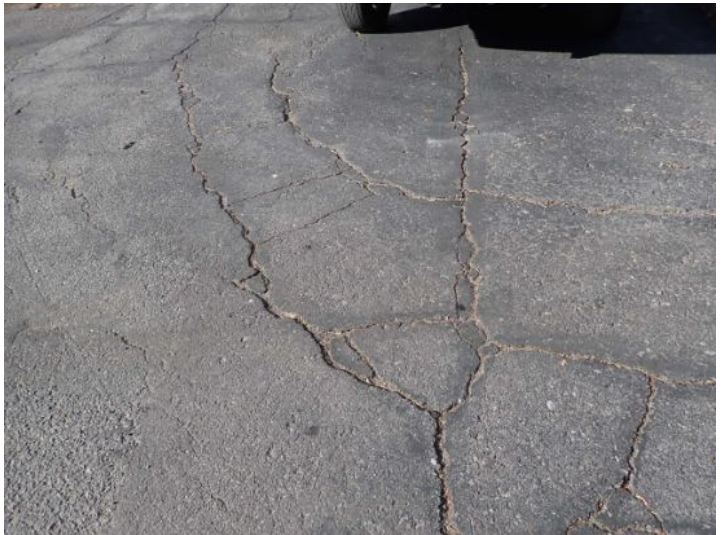
Recommend crack filling to aid in extending the life of the existing asphalt surface. Recommend repairs by a licensed contractor.

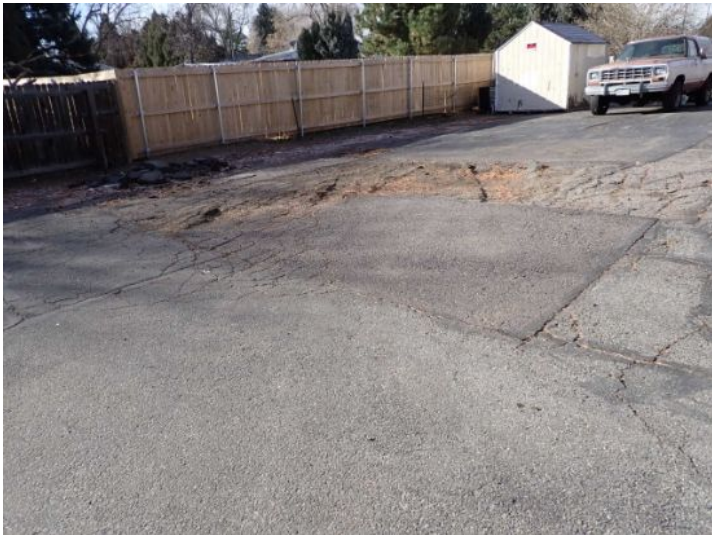
Significant deterioration noted in areas of the parking lots surface. Recommend repairs by a licensed contractor.

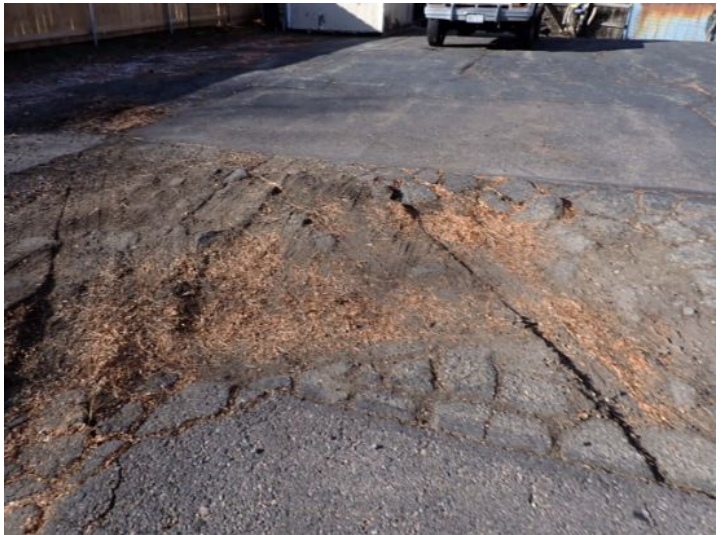
Significant deterioration noted in areas of the parking lots surface. Recommend repairs by a licensed contractor.

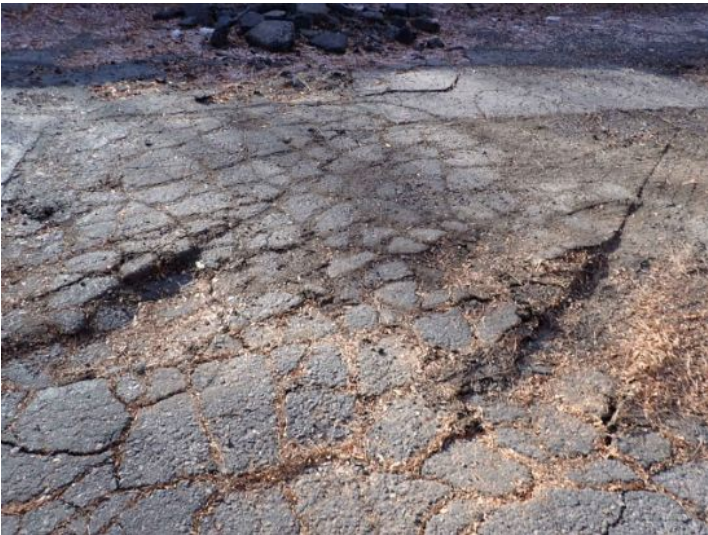
Significant deterioration noted in areas of the parking lots surface. Recommend repairs by a licensed contractor.

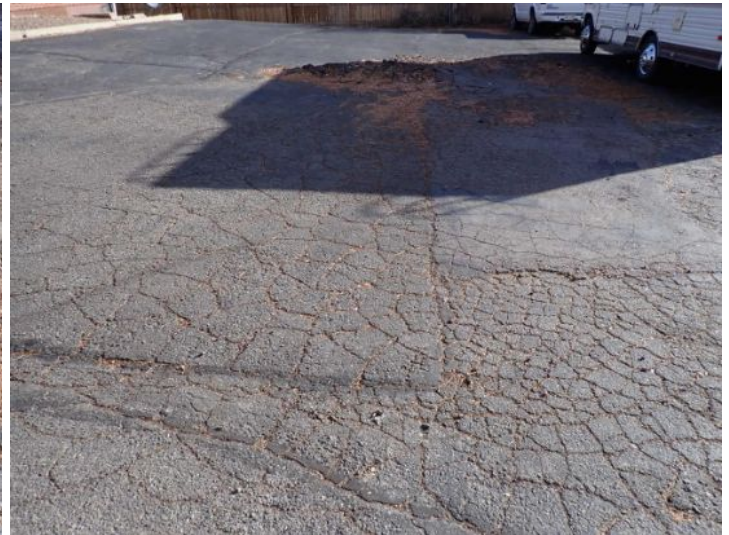
Alligatoring noted in areas of the parking lot at the time of the inspection. This is generally caused by heavy trucks/equipment and is indicative of sub surface failure. Recommend monitoring of the areas for repair/resurfacing within the next several years.

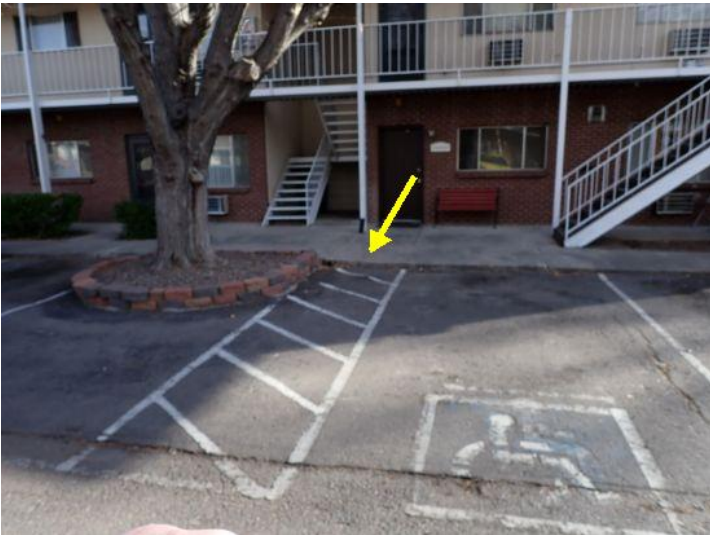
No ADA ramp system installed at the ADA parking area on the east side structure at the time of the inspection.

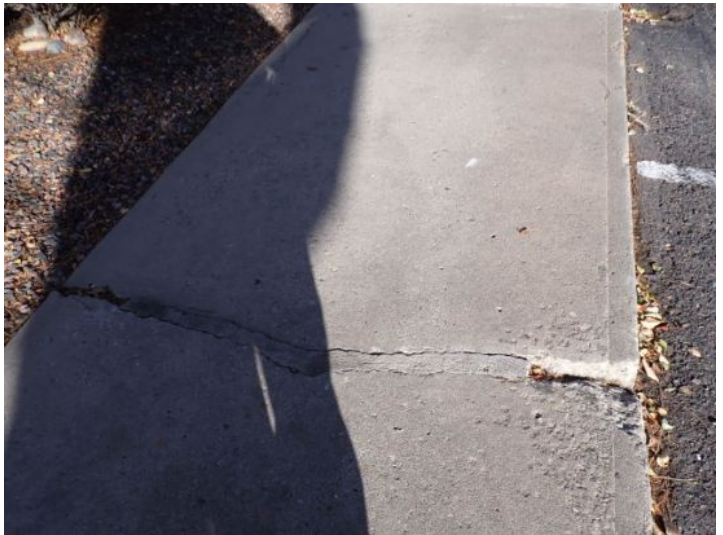
Trip hazards noted. Recommend repairs.

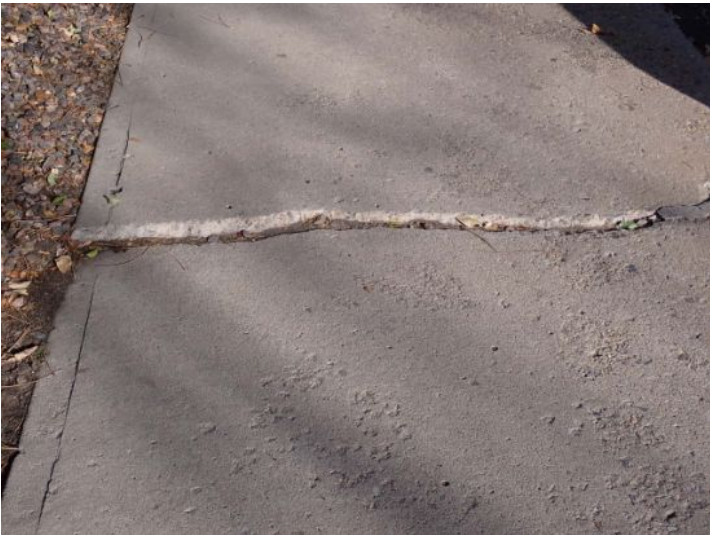
Significant cracking noted at the time of the inspection. Recommend repairs.

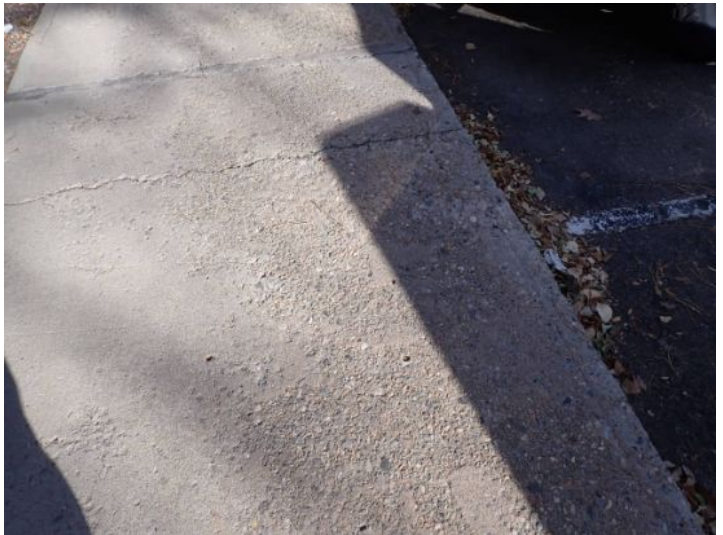
Significant spalling noted in areas of the flatwork at the time of the inspection. Recommend repairs by a licensed contractor.

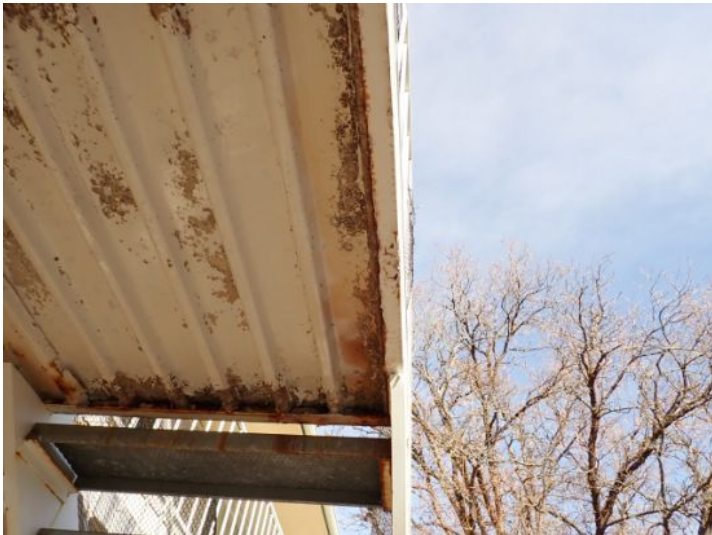
Pan rusting and deterioration noted below the upper level walkways and landings at the time of the inspection. Recommend repairs by a licensed contractor prior to taking possession of the property.

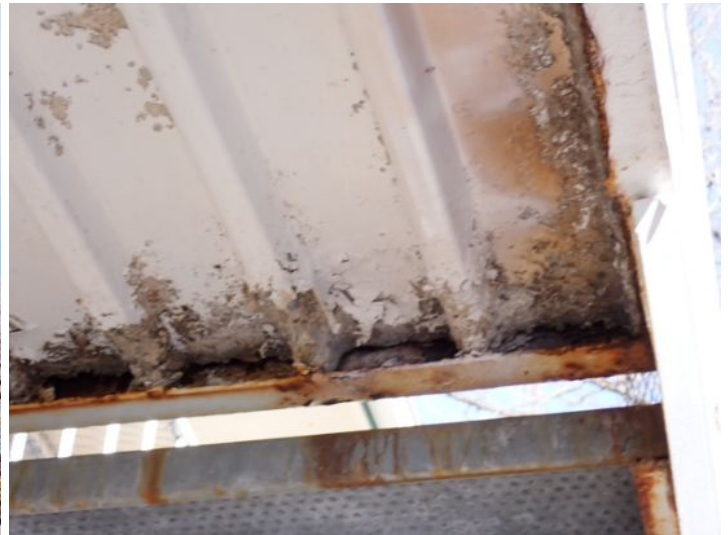
Pan rusting and deterioration noted below the upper level walkways and landings at the time of the inspection. Recommend repairs by a licensed contractor prior to taking possession of the property.

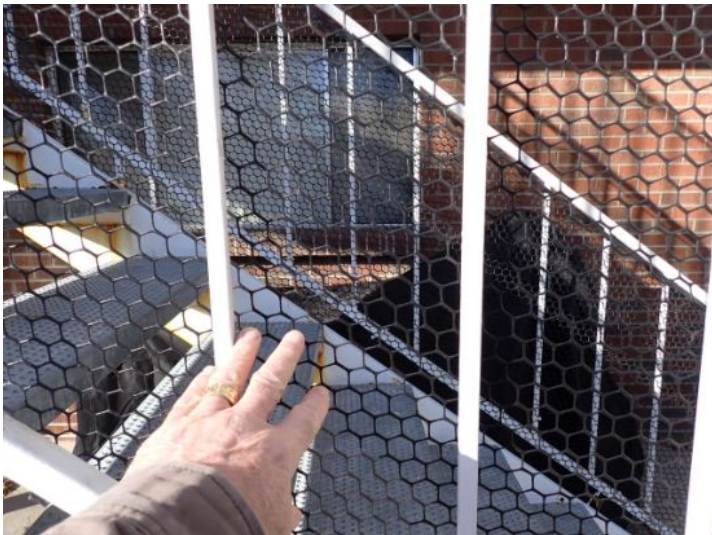
Balustrade openings too wide on the stairs and upper level railing systems at the time of the inspection. Opening should not exceed 4". Recommend repairs by a licensed contractor.

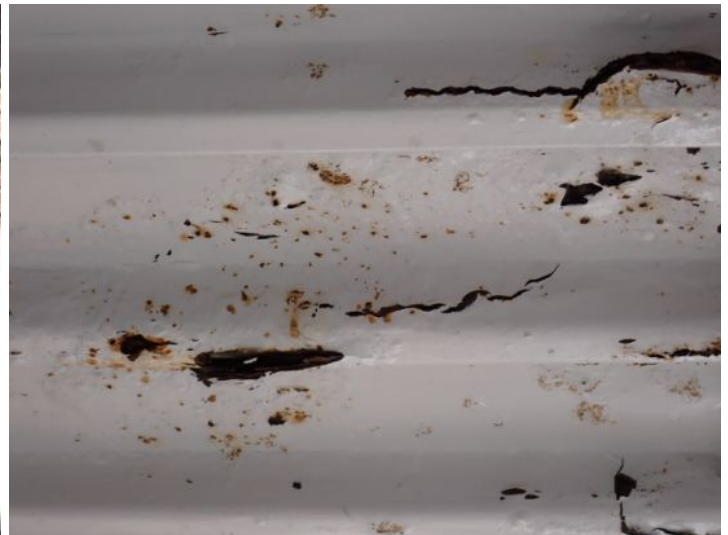
Pan rusting and deterioration noted below the upper level walkways and landings at the time of the inspection. Recommend repairs by a licensed contractor prior to taking possession of the property.

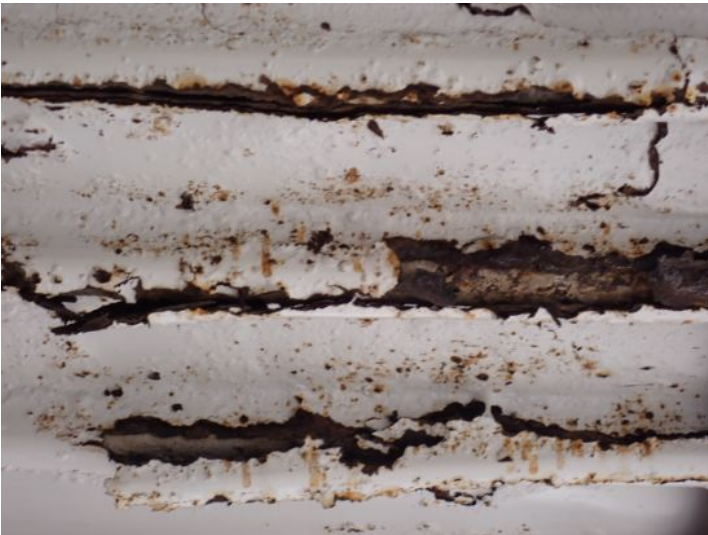
Pan rusting and deterioration noted below the upper level walkways and landings at the time of the inspection. Recommend repairs by a licensed contractor prior to taking possession of the property.

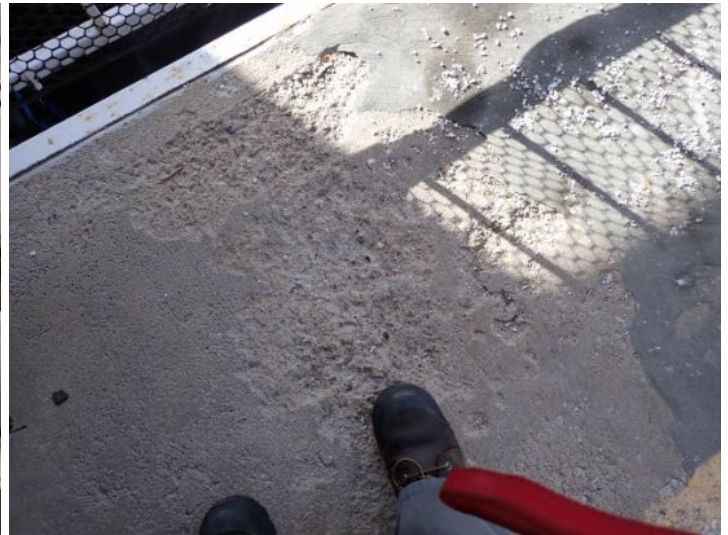
Signifiicant spalling noted in areas of the flatwork at the time of the inspection. Recommend repairs by a licensed contractor.

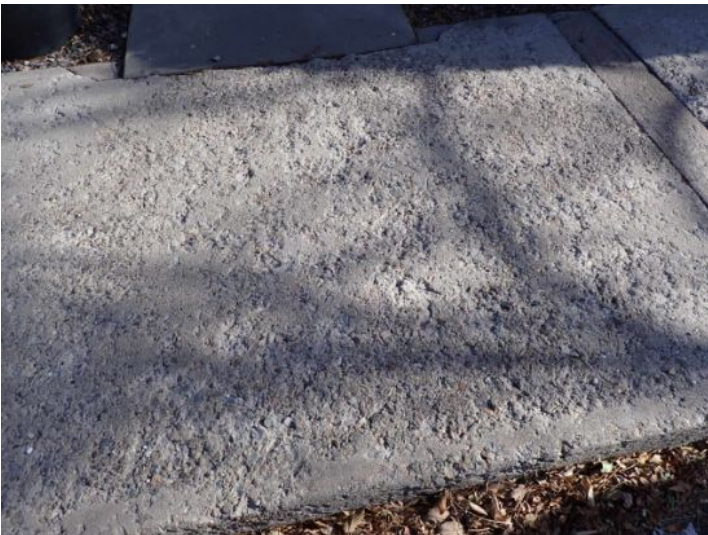
Significant spalling noted in areas of the flatwork at the time of the inspection. Recommend repairs by a licensed contractor.

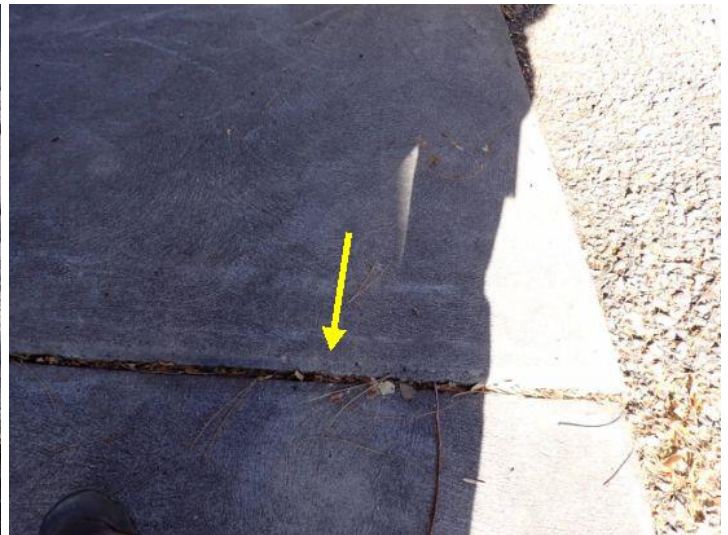
Trip hazards noted. Recommend repairs.

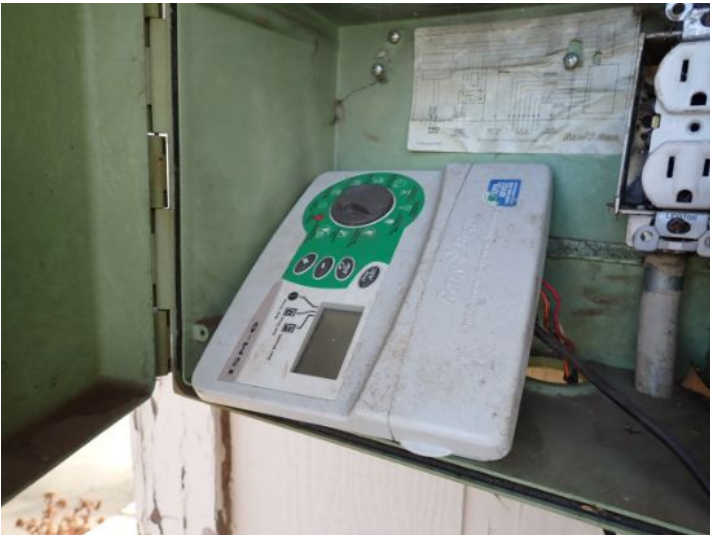
The property had an irrigation system at the time of the inspection.

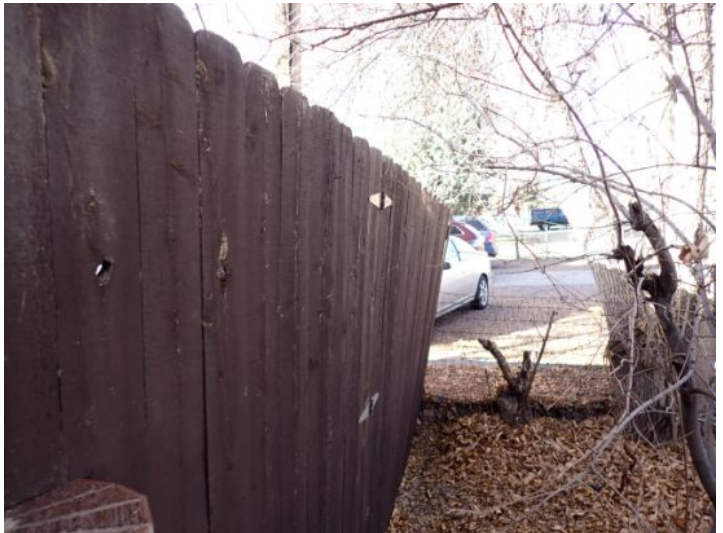
Fencing damage noted around the property at the time of the inspection. Recommend repairs by a licensed contractor.

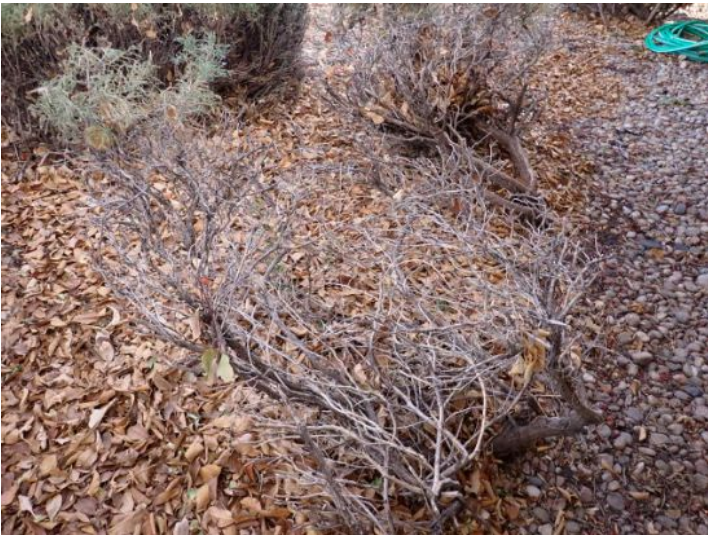
Foliage in contact with structure at time of inspection. Recommend trimming/removal.

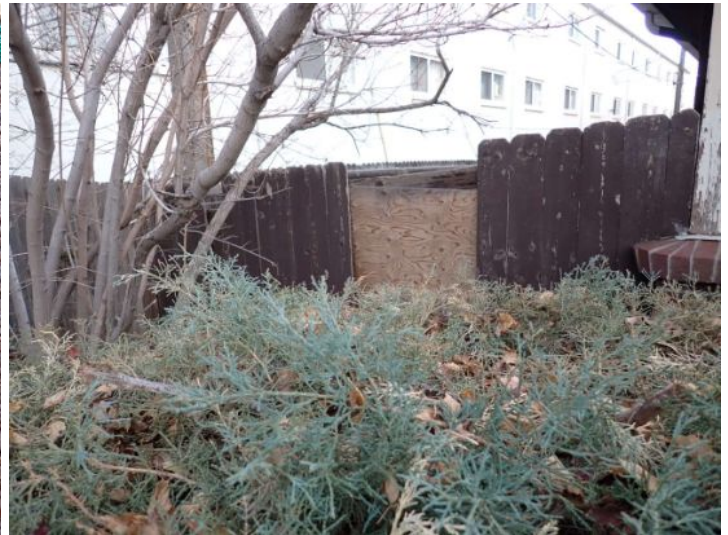
Fencing damage noted around the property at the time of the inspection. Recommend repairs by a licensed contractor.

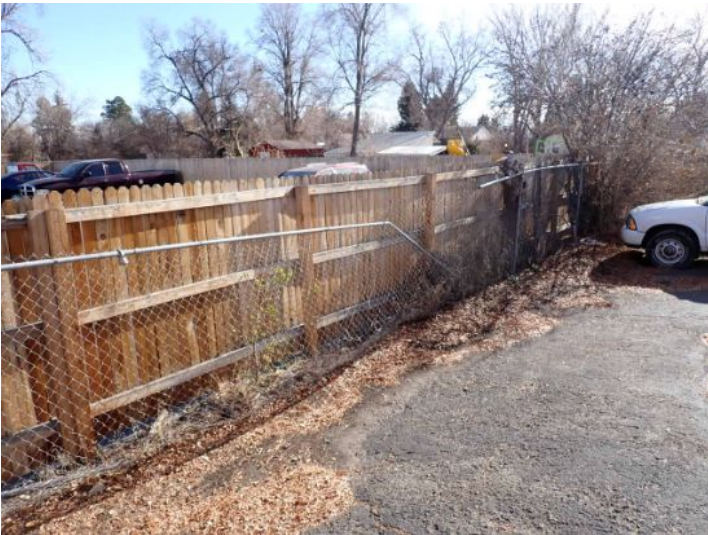
Fencing damage noted around the property at the time of the inspection. Recommend repairs by a licensed contractor.

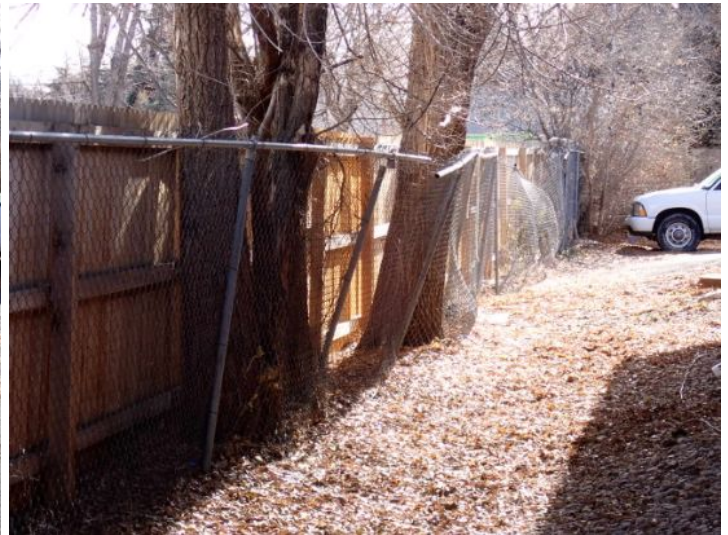
Fencing damage noted around the property at the time of the inspection. Recommend repairs by a licensed contractor.

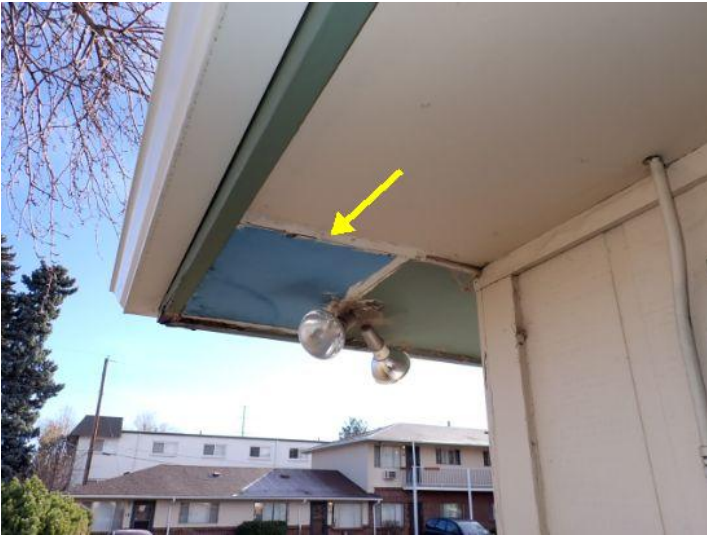
Moisture damaged soffit/eave material noted in areas around both of the structures at the time of the inspection. This was most likely caused by ice damming which was caused by inadequate attic insulation and ventilation. Recommend repairs as needed by a licensed contractor.

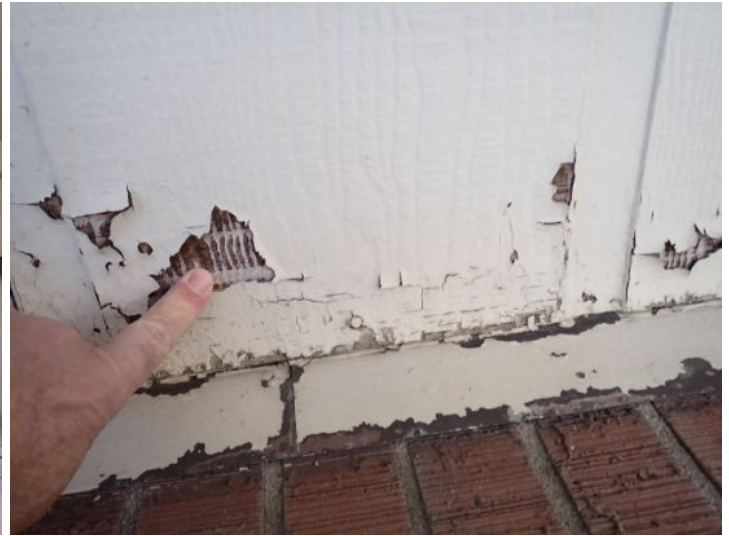
Wood rot/deterioration noted on the wood/composition siding in areas on both structures at the time of the inspection. Recommend repairs by a licensed contractor.

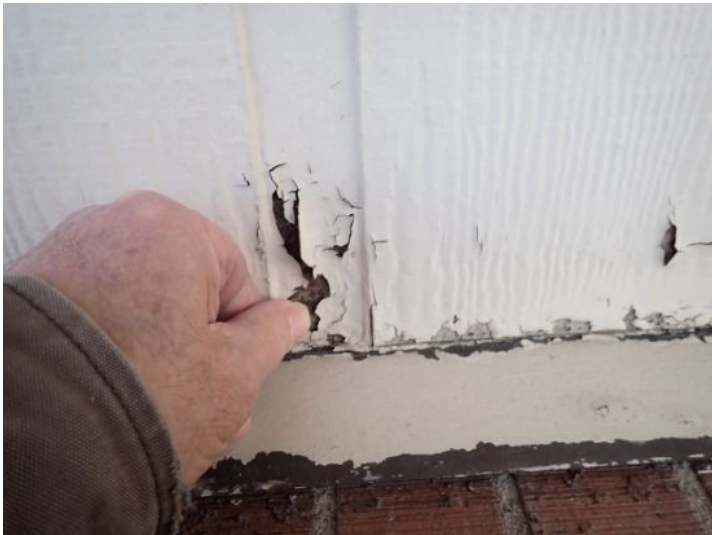
Wood rot/deterioration noted on the wood/composition siding in areas on both structures at the time of the inspection. Recommend repairs by a licensed contractor.

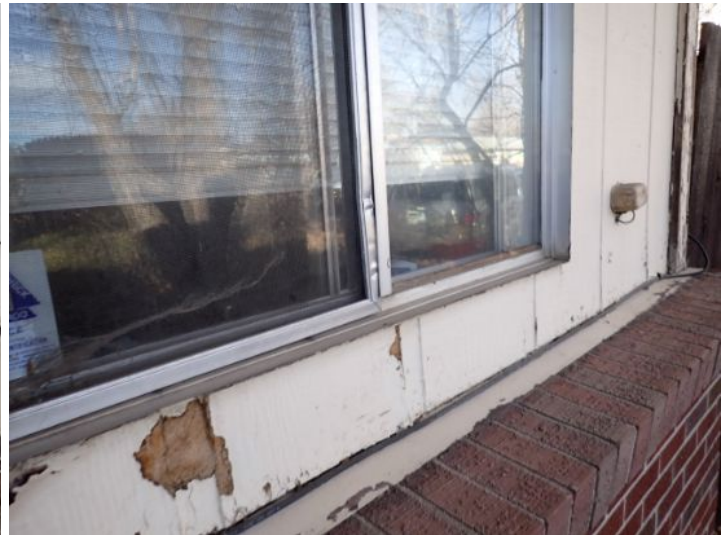
Peeling paint noted on the wood/composition siding material on both structures. Recommend repairs by a licensed contractor.

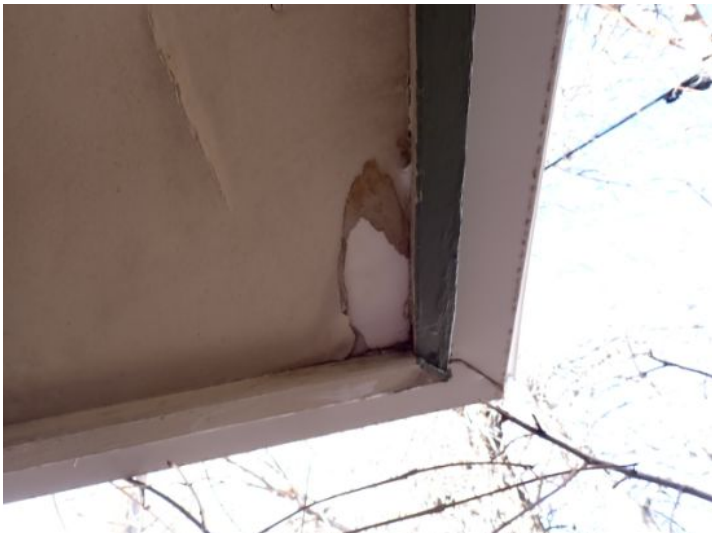
Moisture damaged soffit/eave material noted in areas around both of the structures at the time of the inspection. This was most likely caused by ice damming which was caused by inadequate attic insulation and ventilation. Recommend repairs as needed by a licensed contractor.

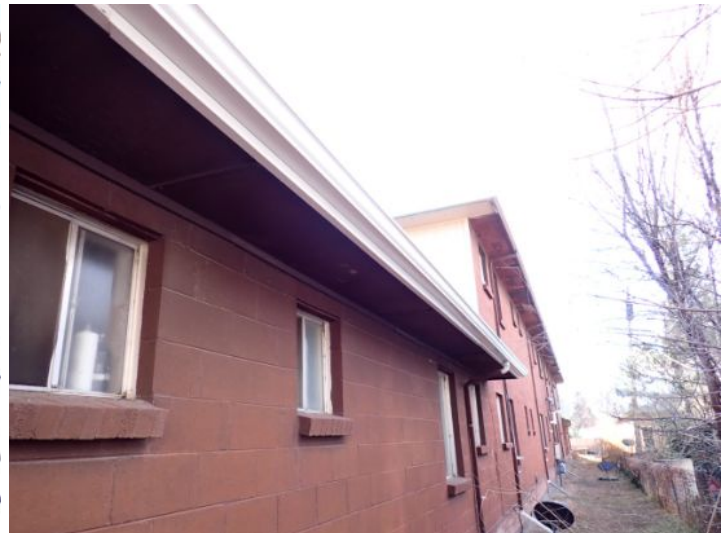
The majority of the exterior envelopes of the structures appeared to be in fair condition at the time of the inspection.

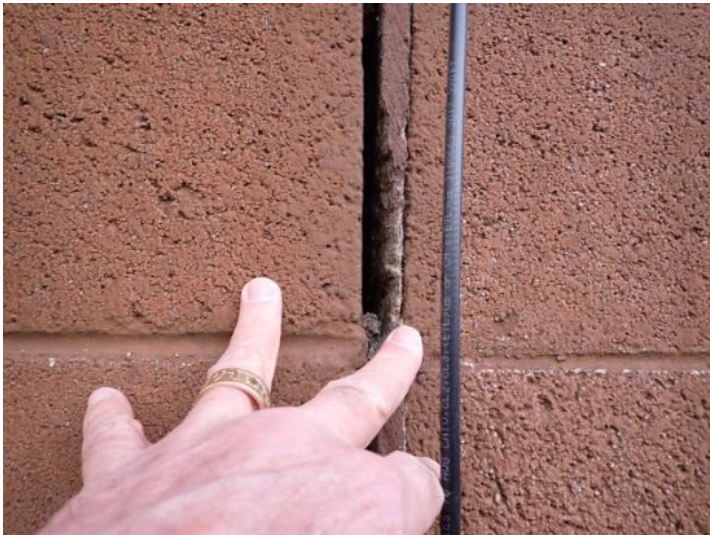
Expansion joint sealant repairs required in areas. Recommend repairs by a licensed contractor.

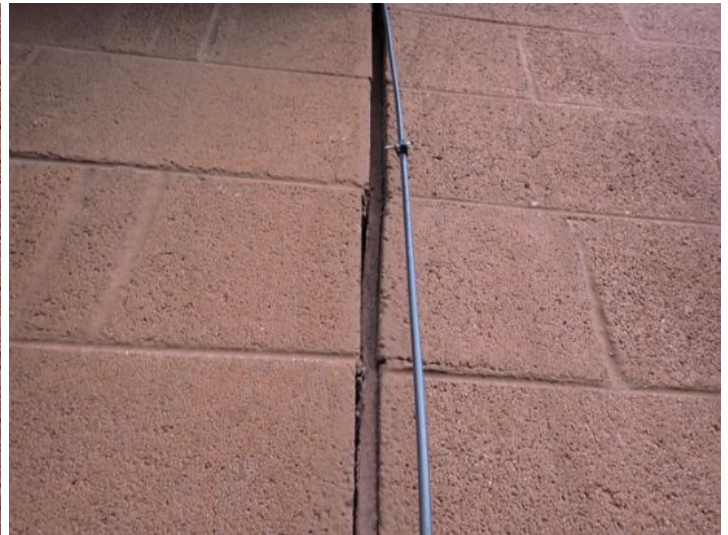
Expansion joint sealant repairs required in areas. Recommend repairs by a licensed contractor.

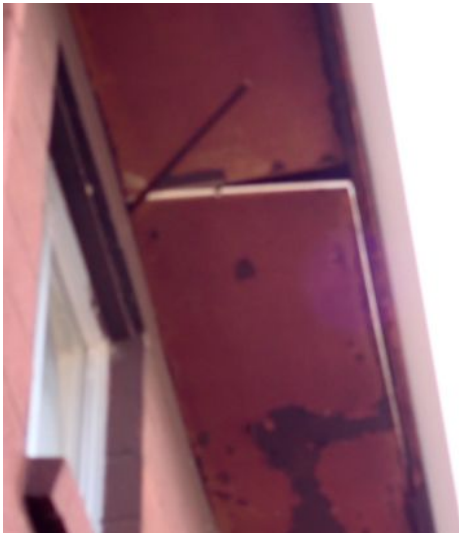
Moisture damaged soffit/eave material noted in areas around both of the structures at the time of the inspection. This was most likely caused by ice damming which was caused by inadequate attic insulation and ventilation. Recommend repairs as needed by a licensed contractor.

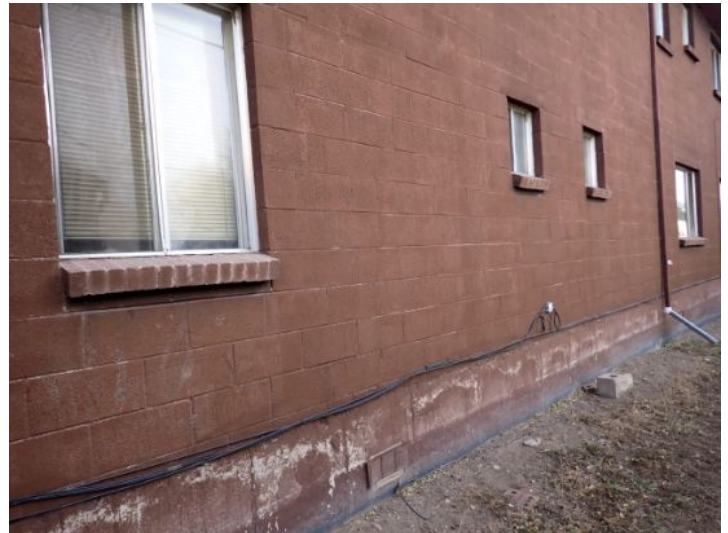
The majority of the exterior envelopes of the structures appeared to be in fair condition at the time of the inspection.

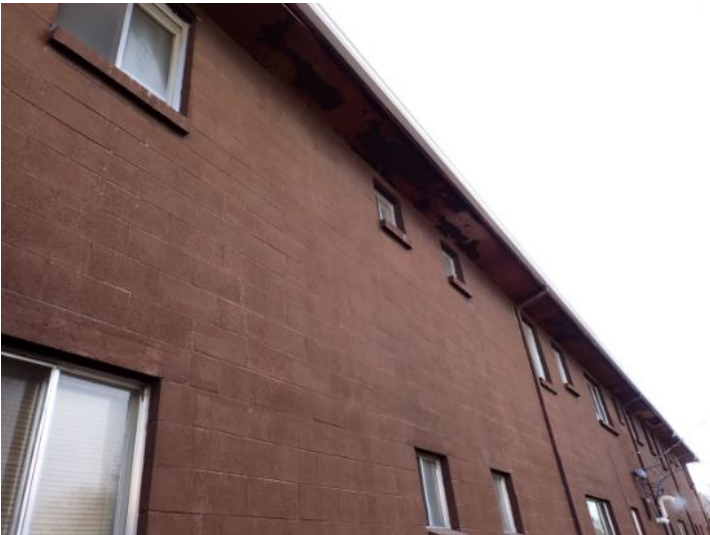
The majority of the exterior envelopes of the structures appeared to be in fair condition at the time of the inspection.

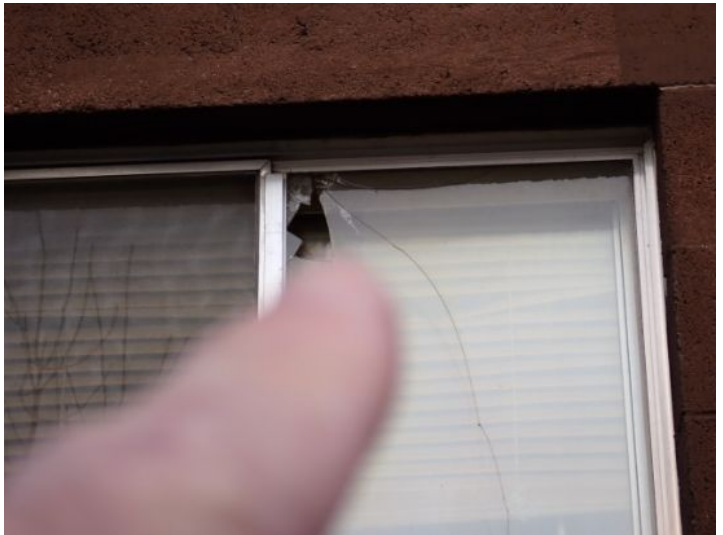
Cracked/broken window glass noted in areas. Recommend repairs by a licensed contractor.

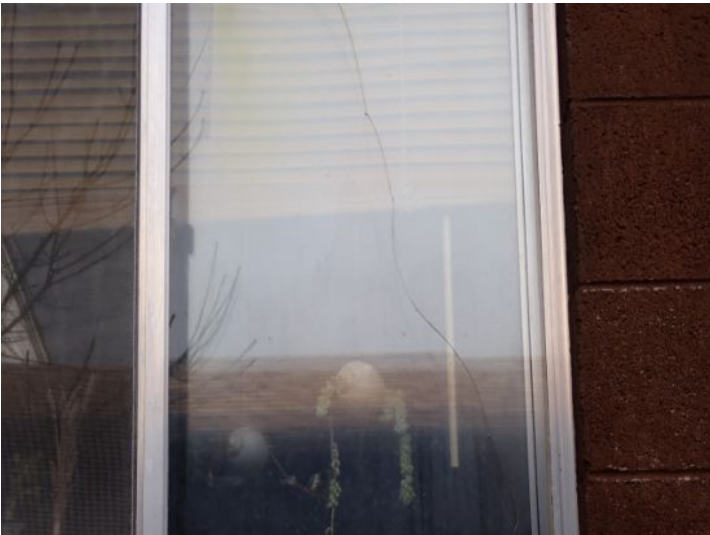
Cracked/broken window glass noted in areas. Recommend repairs by a licensed contractor.

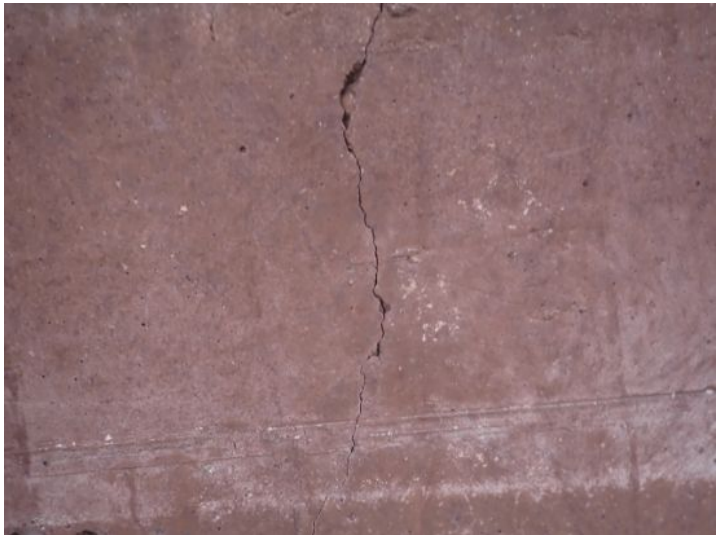
Minor foundation wall cracking noted in areas. Recommend monitoring for future repairs.

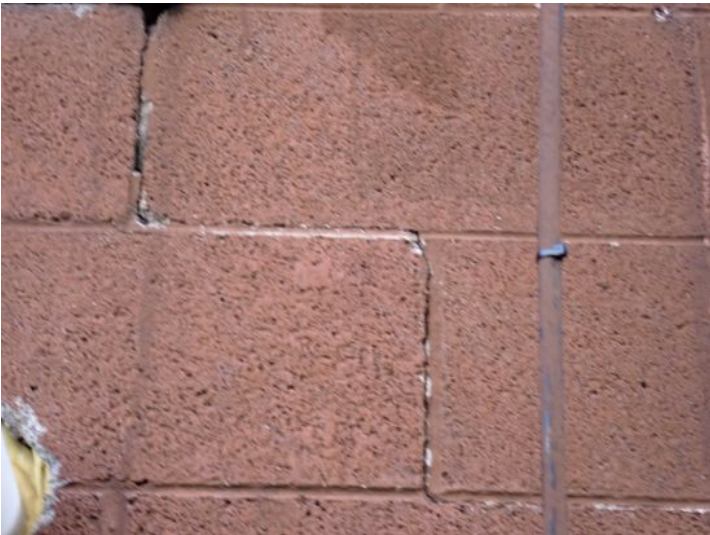
Cracked mortar noted in areas. Recommend tuck pointing repairs by a licensed contractor.

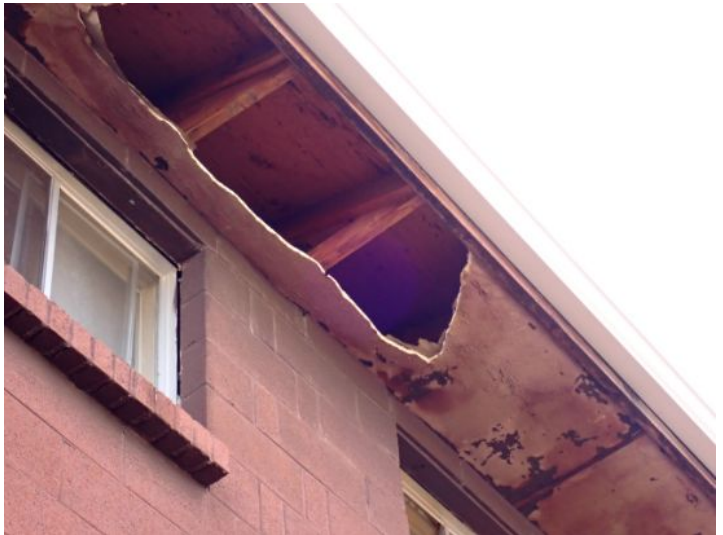
Moisture damaged soffit/eave material noted in areas around both of the structures at the time of the inspection. This was most likely caused by ice damming which was caused by inadequate attic insulation and ventilation. Recommend repairs as needed by a licensed contractor.

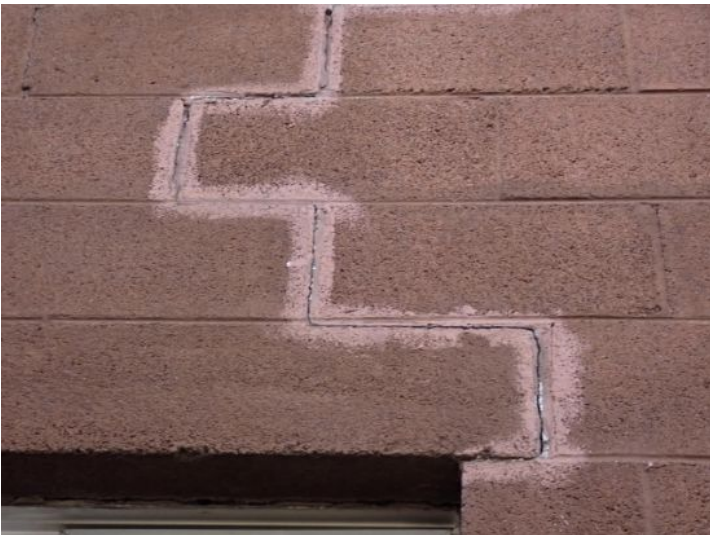
Cracked mortar noted in areas. Recommend tuck pointing repairs by a licensed contractor.

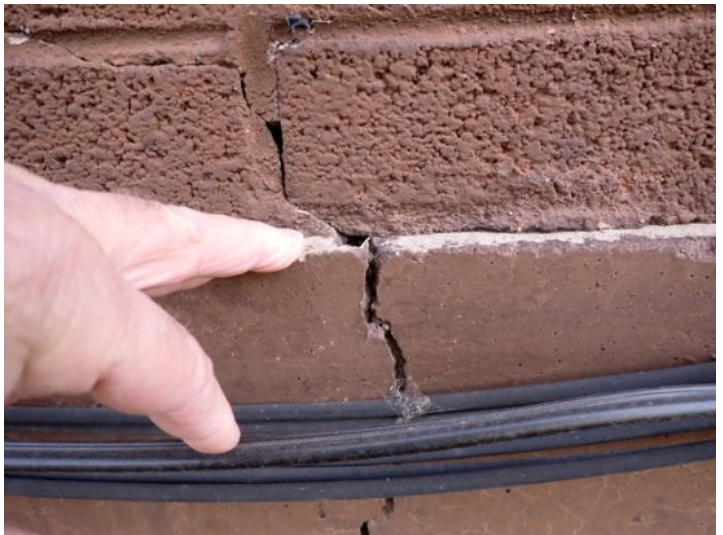
Significant foundation wall cracking noted on both structures at the time of the inspection. Recommend repairs by a licensed contractor.

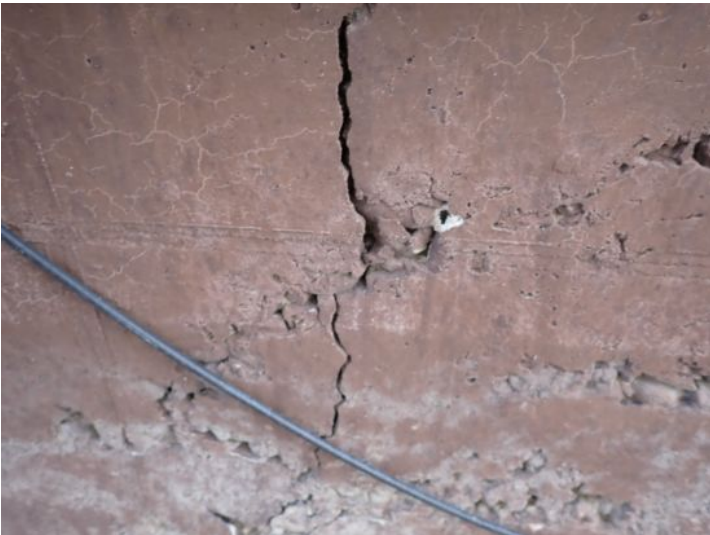
Significant foundation wall cracking noted on both structures at the time of the inspection. Recommend repairs by a licensed contractor.

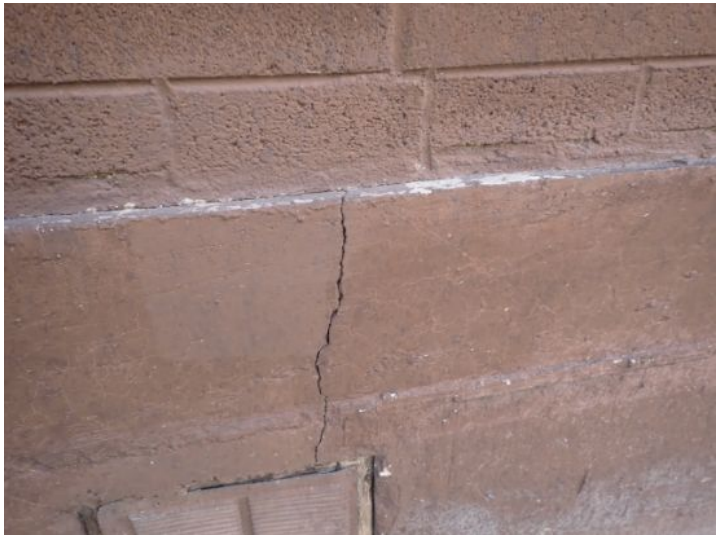
Minor foundation wall cracking noted in areas. Recommend monitoring for future repairs.

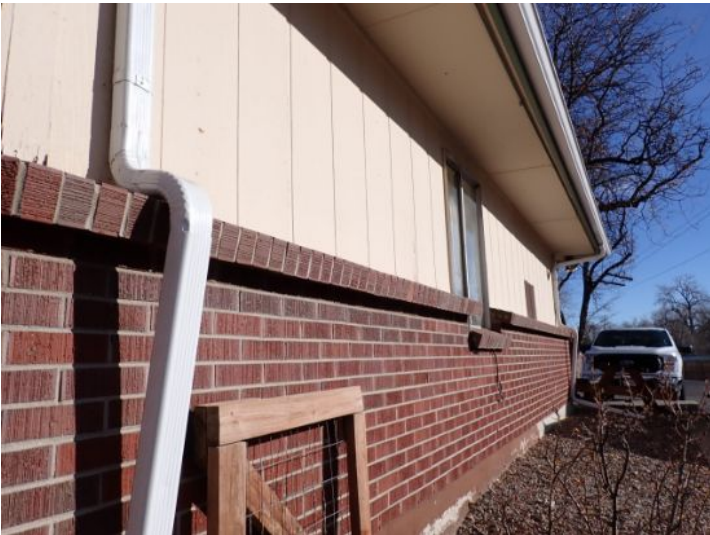
The majority of the exterior envelopes of the structures appeared to be in fair condition at the time of the inspection.

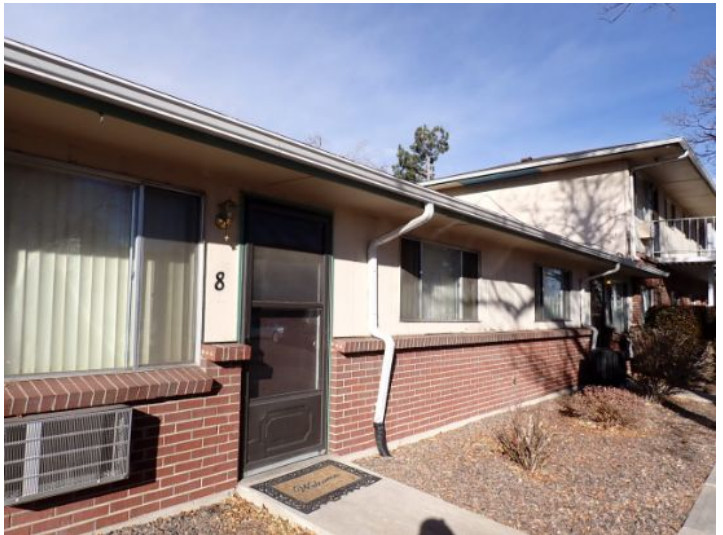
The majority of the exterior envelopes of the structures appeared to be in fair condition at the time of the inspection.
