Forman Inspection Services, LLC

Property Inspection Report

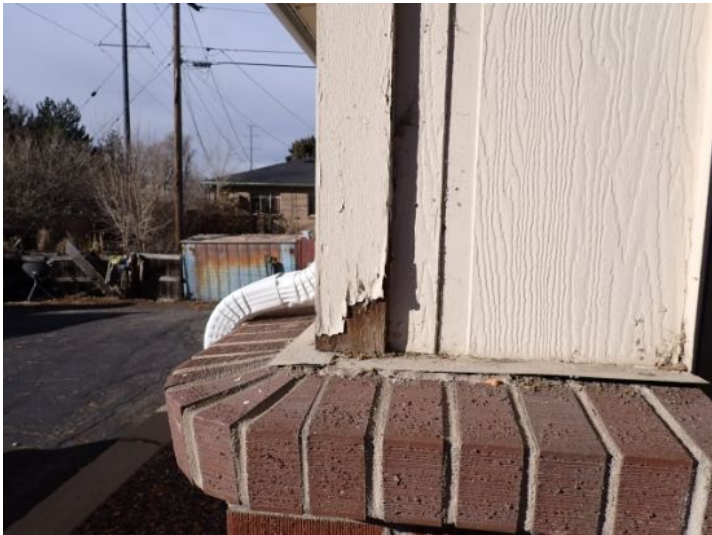
Peeling paint noted on the wood/composition siding material on both structures. Recommend repairs by a licensed contractor.

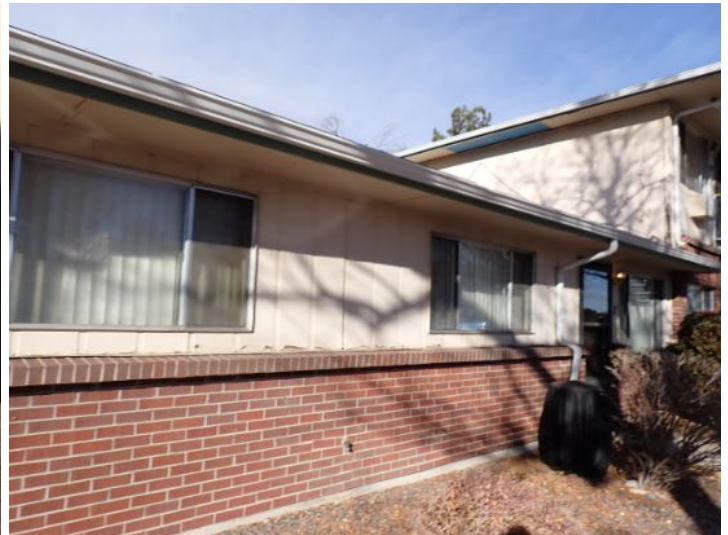
The majority of the exterior envelopes of the structures appeared to be in fair condition at the time of the inspection.

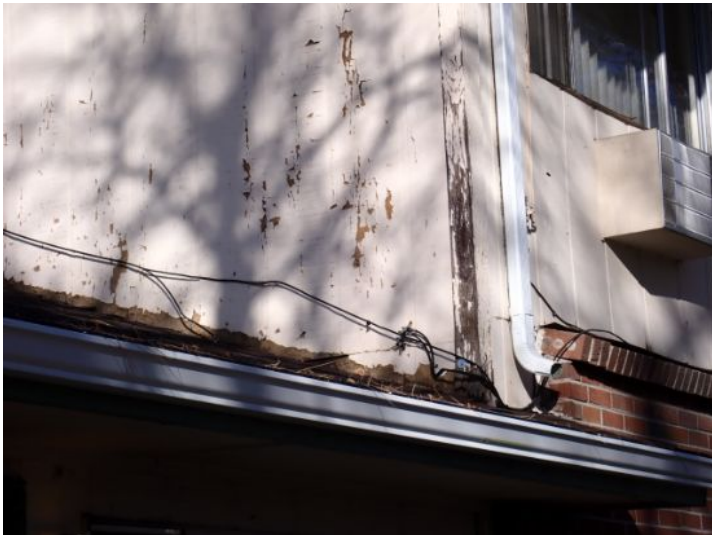
Peeling paint noted on the wood/composition siding material on both structures. Recommend repairs by a licensed contractor.

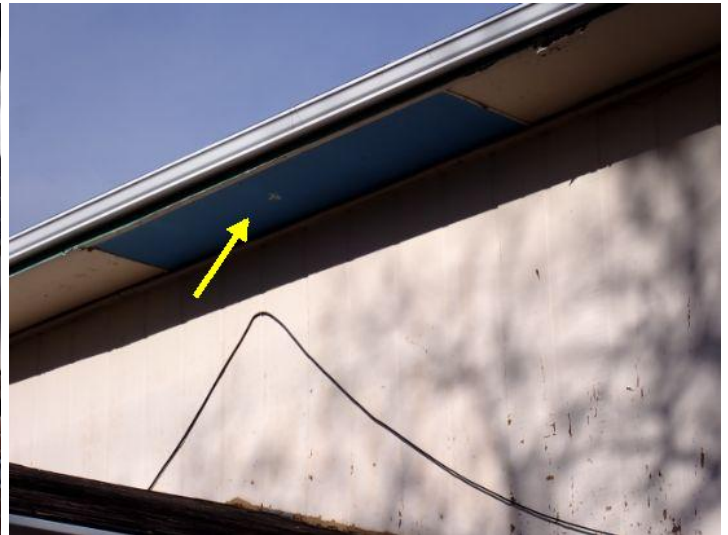
Moisture damaged soffit/eave material noted in areas around both of the structures at the time of the inspection. This was most likely caused by ice damming which was caused by inadequate attic insulation and ventilation. Recommend repairs as needed by a licensed contractor.

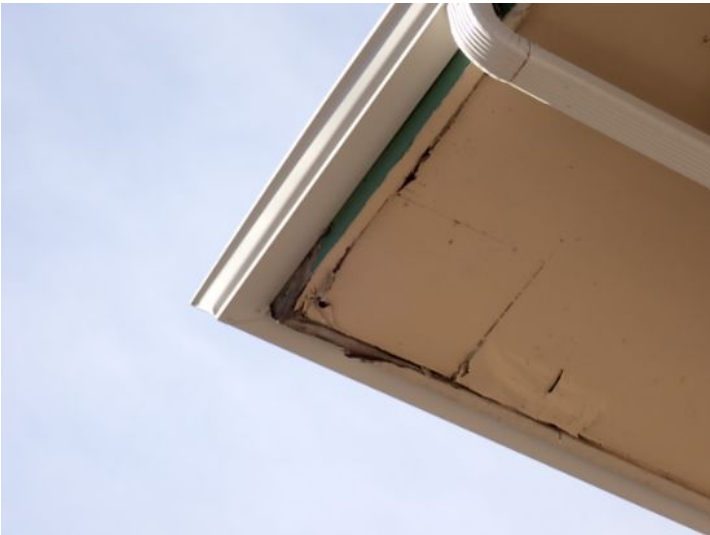
Moisture damaged soffit/eave material noted in areas around both of the structures at the time of the inspection. This was most likely caused by ice damming which was caused by inadequate attic insulation and ventilation. Recommend repairs as needed by a licensed contractor.

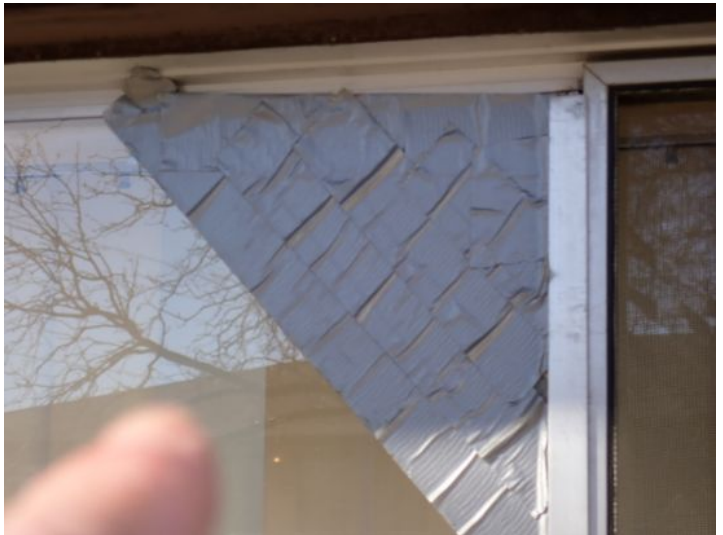
Cracked/broken window glass noted in areas. Recommend repairs by a licensed contractor.

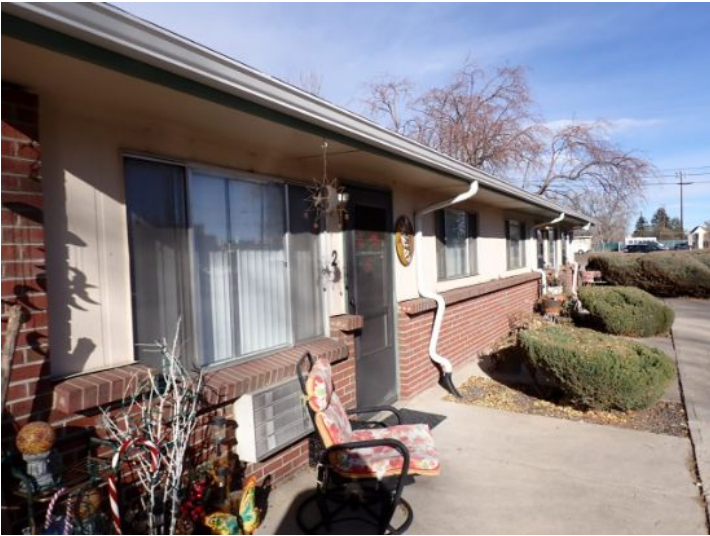
The majority of the exterior envelopes of the structures appeared to be in fair condition at the time of the inspection.

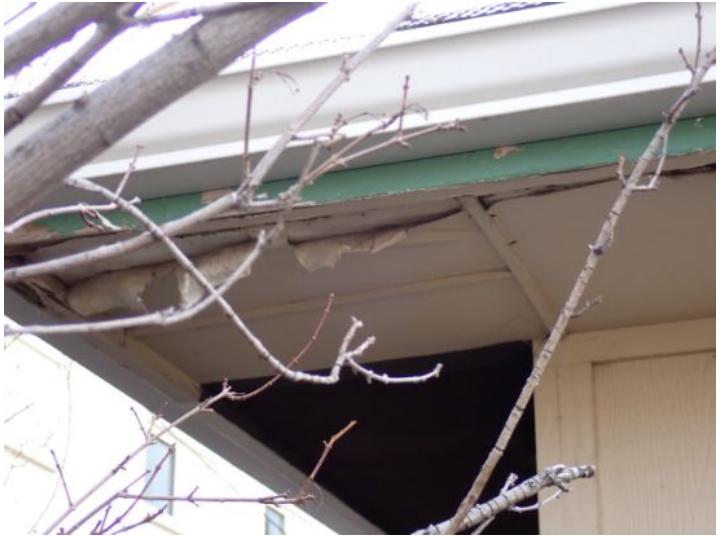
Moisture damaged soffit/eave material noted in areas around both of the structures at the time of the inspection. This was most likely caused by ice damming which was caused by inadequate attic insulation and ventilation. Recommend repairs as needed by a licensed contractor.

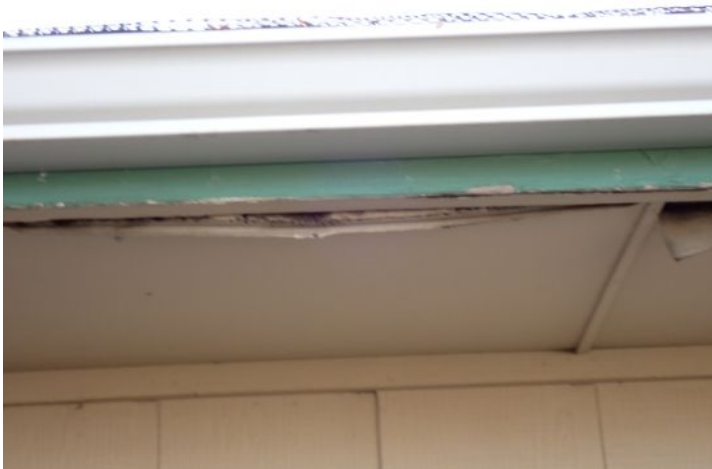
Moisture damaged soffit/eave material noted in areas around both of the structures at the time of the inspection. This was most likely caused by ice damming which was caused by inadequate attic insulation and ventilation. Recommend repairs as needed by a licensed contractor.

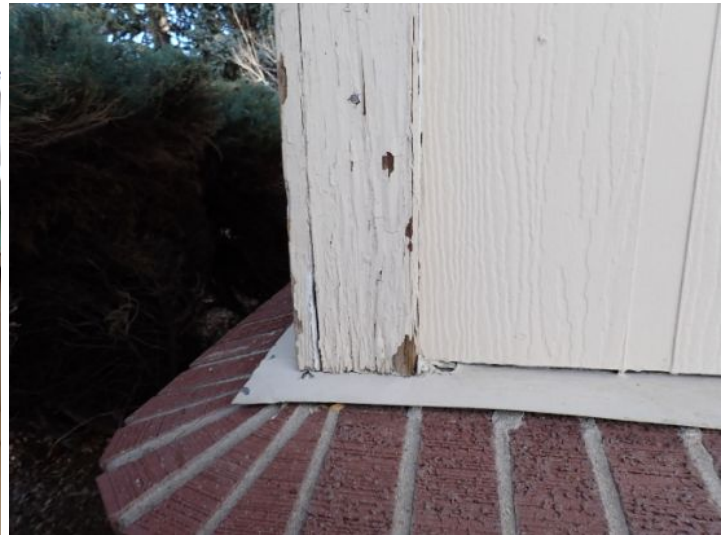
Peeling paint noted on the wood/composition siding material on both structures. Recommend repairs by a licensed contractor.

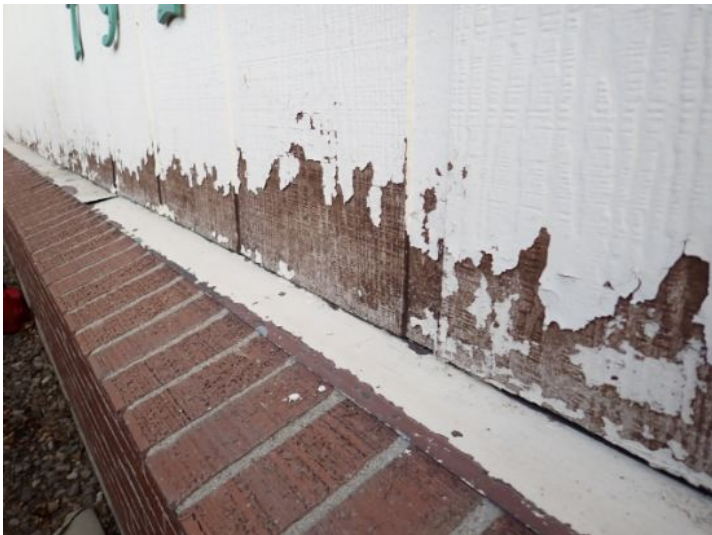
Peeling paint noted on the wood/composition siding material on both structures. Recommend repairs by a licensed contractor.

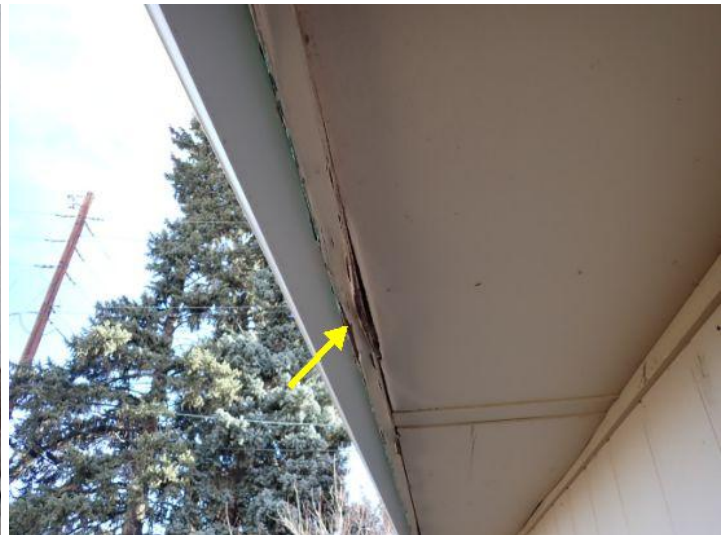
Moisture damaged fascia noted in areas. Recommend repairs by a licensed contractor.

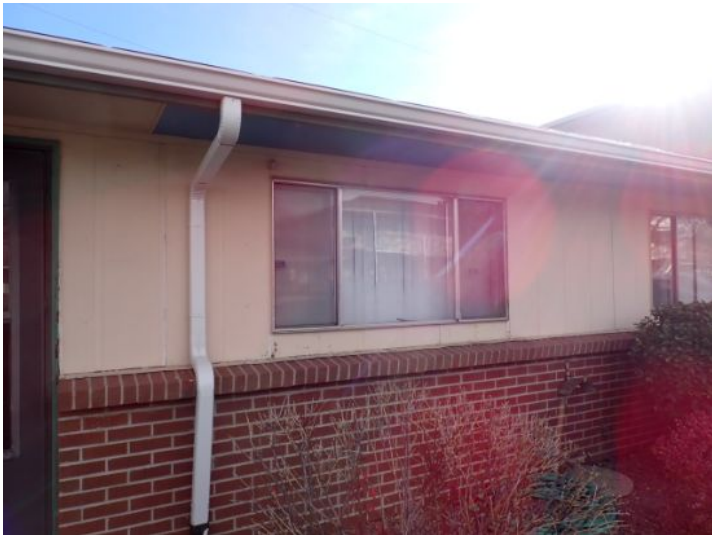
The majority of the exterior envelopes of the structures appeared to be in fair condition at the time of the inspection.

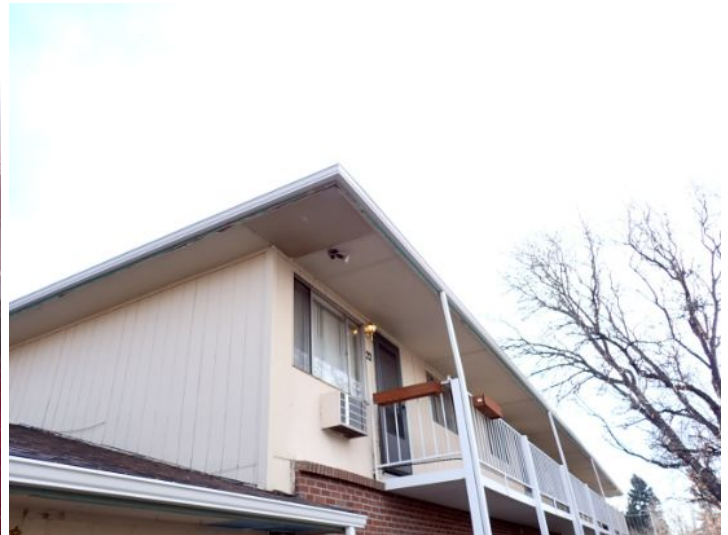
The majority of the exterior envelopes of the structures appeared to be in fair condition at the time of the inspection.

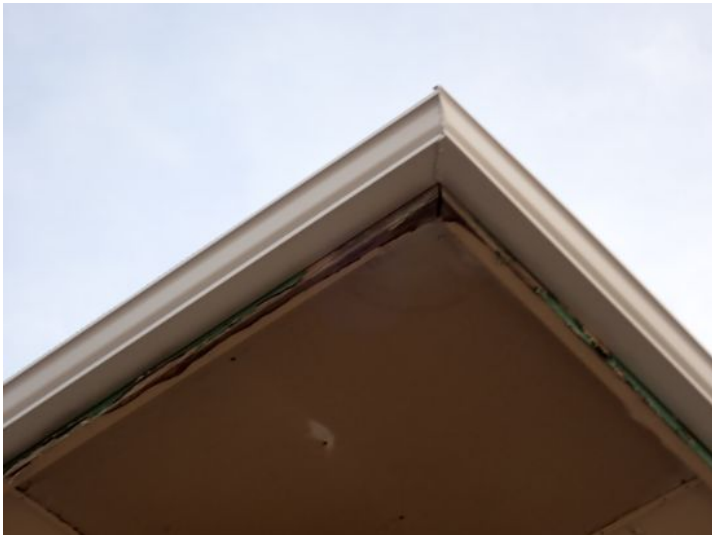
Moisture damaged fascia noted in areas. Recommend repairs by a licensed contractor.

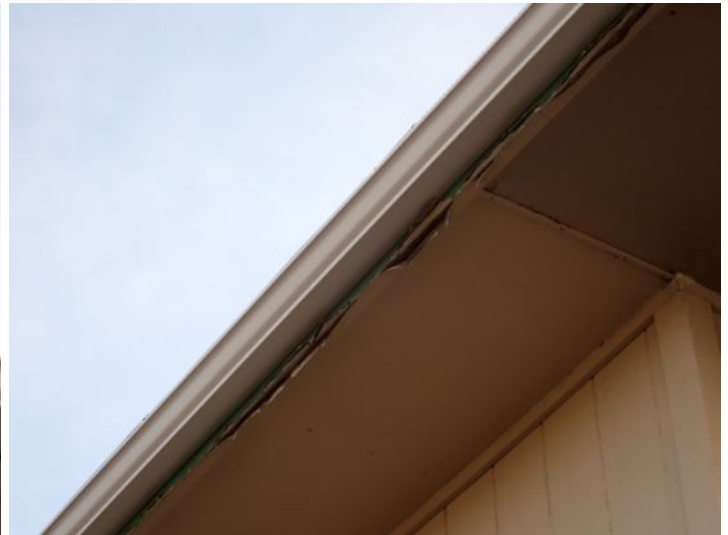
Moisture damaged fascia noted in areas. Recommend repairs by a licensed contractor.

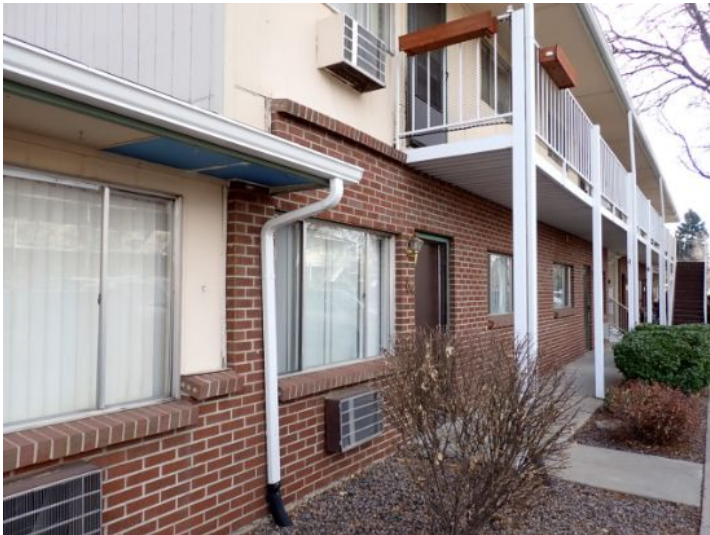
The majority of the exterior envelopes of the structures appeared to be in fair condition at the time of the inspection.

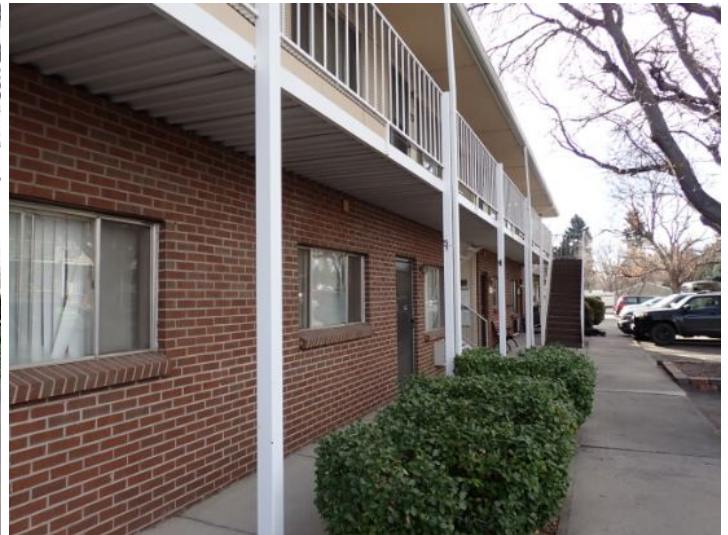
The majority of the exterior envelopes of the structures appeared to be in fair condition at the time of the inspection.

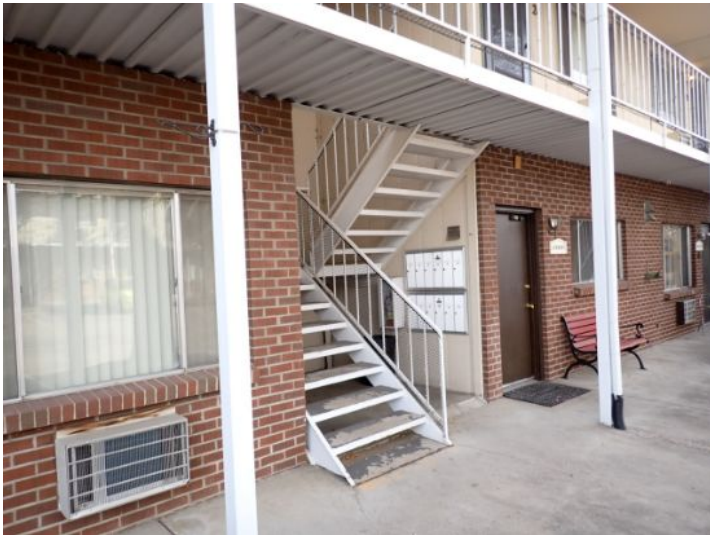
The majority of the exterior envelopes of the structures appeared to be in fair condition at the time of the inspection.

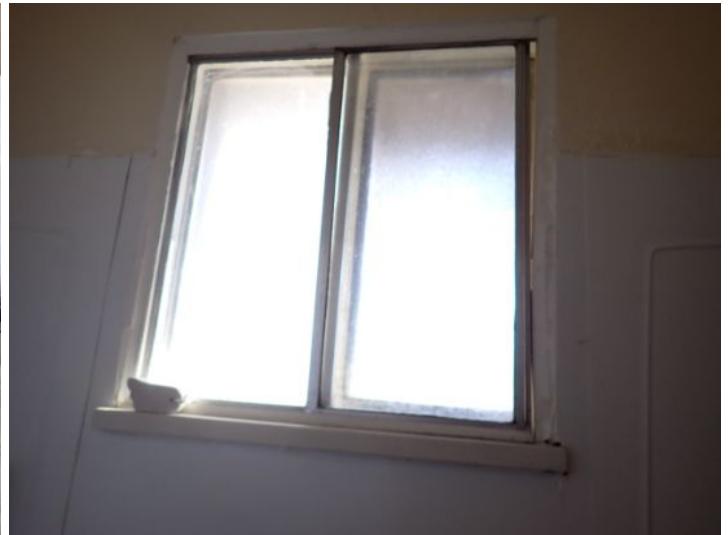
Missing safety stamps noted on the bathroom windows at the time of the inspection. While not required at the time of construction today's standards require any window located within 3 feet of a tub/shower surround be glazed with safety glass. Recommend repairs as needed by a licensed contractor.

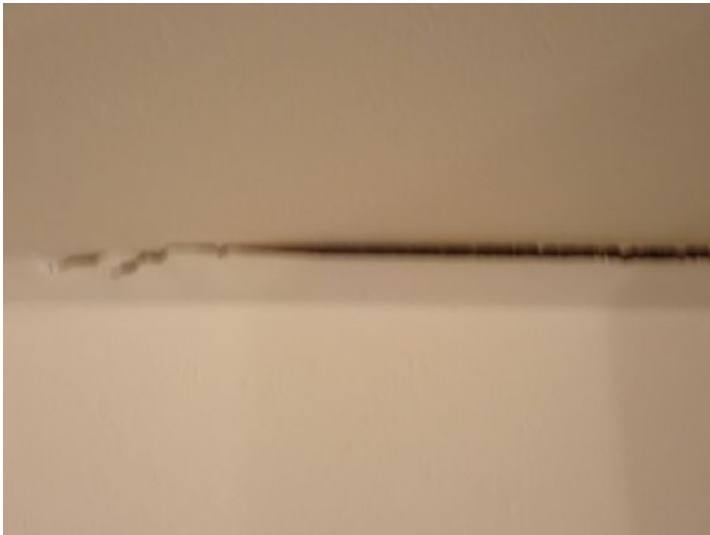
Due to the amount of structural movement, flooring deflection as well as improper/inadequate past repairs we recommend that both of the structures be evaluated by a licensed structural contractor prior to taking possession of the property.

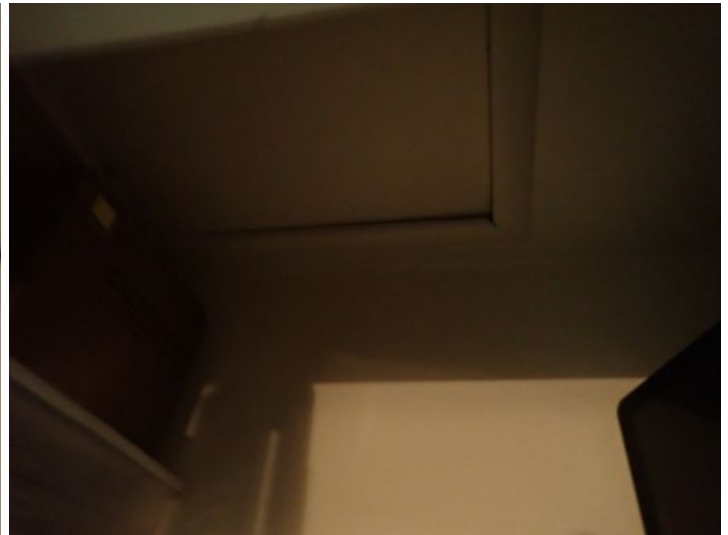
Some attic areas were not able to be viewed due to either the hatch systems being sealed shut or the inspector not being able to open the hatches for some reason.

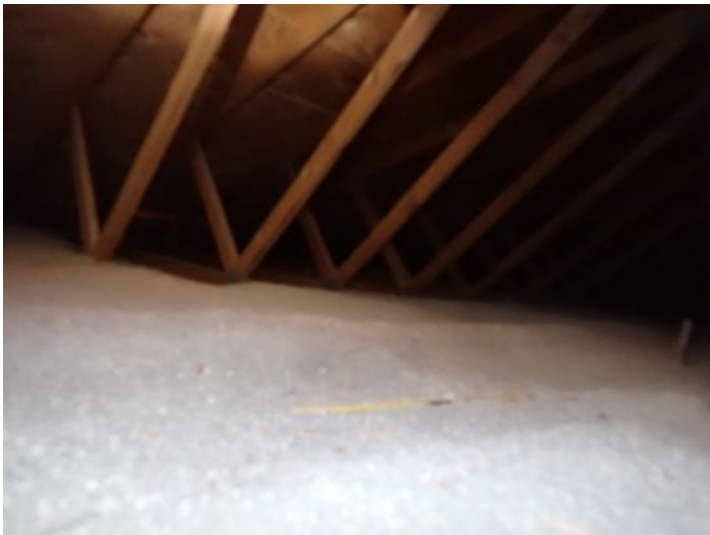
Inadequate attic insulation noted at the time of the inspection. In this part of the country, based on recommendations by the U.S. Department of Energy (DOE) and the International Energy Conservation Code (IECC), the insulating R-value in an attic should be between R38 to R60 dependent upon the type of heating systems used within the structure.

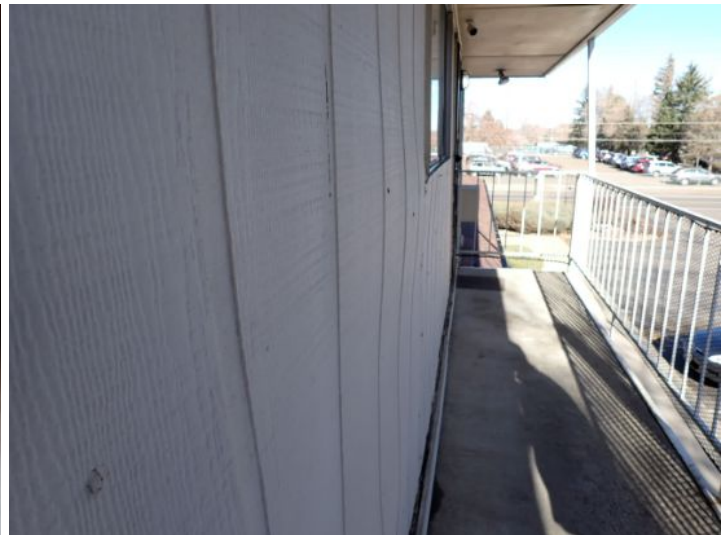
Warped siding material noted on upper level east side of west building. Recommend repairs by a licensed contractor.

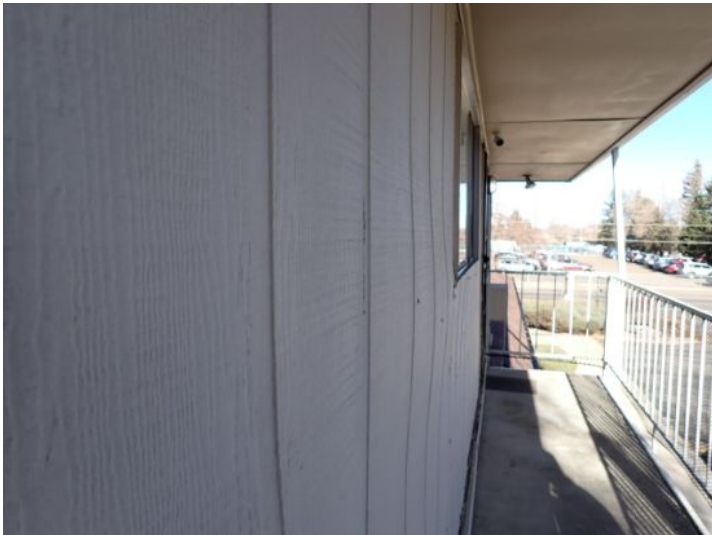
Warped siding material noted on upper level east side of west building. Recommend repairs by a licensed contractor.

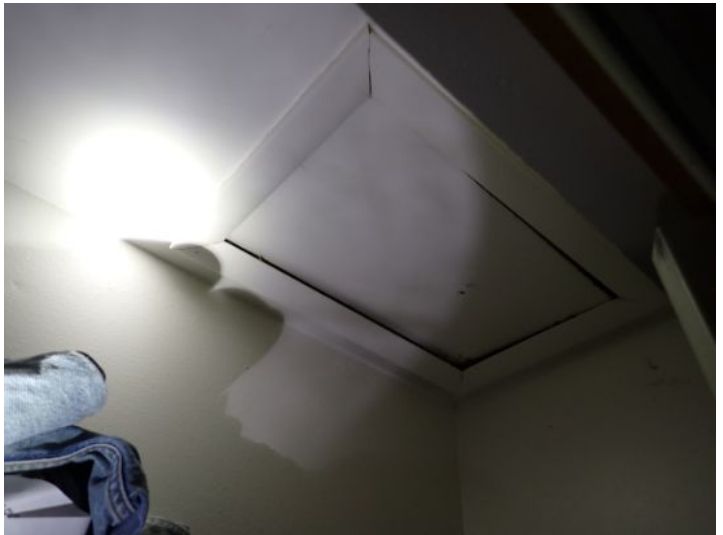
Some attic areas were not able to be viewed due to either the hatch systems being sealed shut or the inspector not being able to open the hatches for some reason.

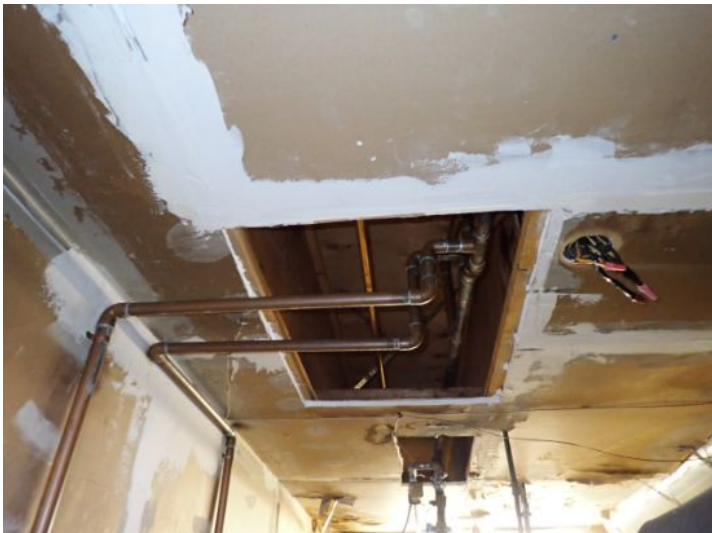
Damaged ceilings noted in boiler rooms at the time of the inspection. Fire Hazard. Recommend repairs by a licensed contractor.

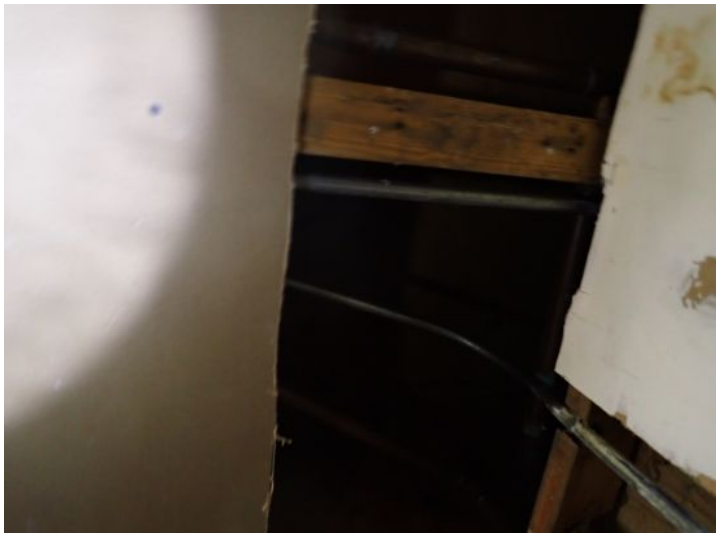
Damaged ceilings noted in boiler rooms at the time of the inspection. Fire Hazard. Recommend repairs by a licensed contractor.

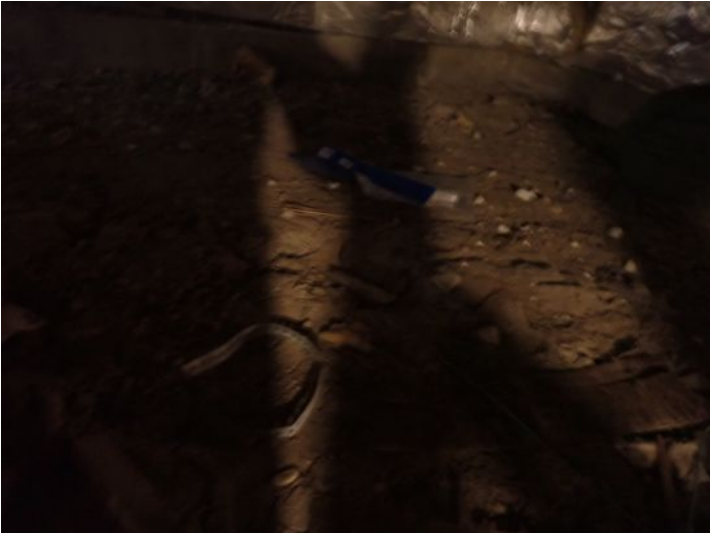
No vapor barrier noted in crawl spaces at the time of the inspection. Recommend repairs by a licensed contractor.

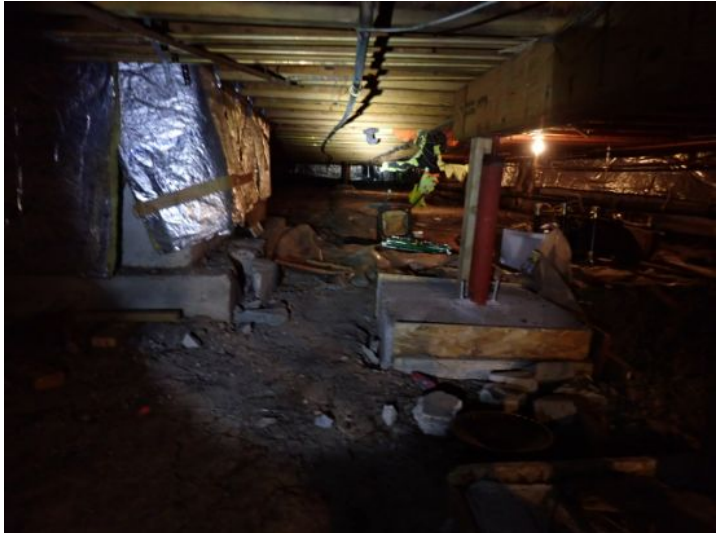
Due to the amount of structural movement, flooring deflection as well as improper/inadequate past repairs we recommend that both of the structures be evaluated by a licensed structural contractor prior to taking possession of the property.

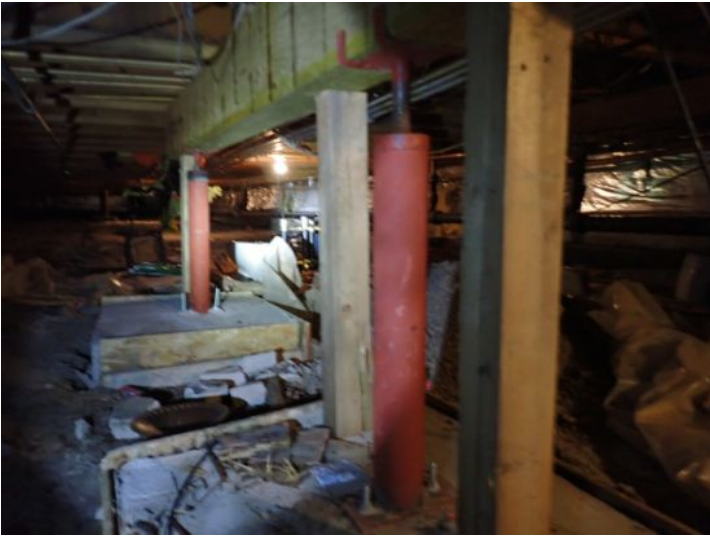
Due to the amount of structural movement, flooring deflection as well as improper/inadequate past repairs we recommend that both of the structures be evaluated by a licensed structural contractor prior to taking possession of the property.

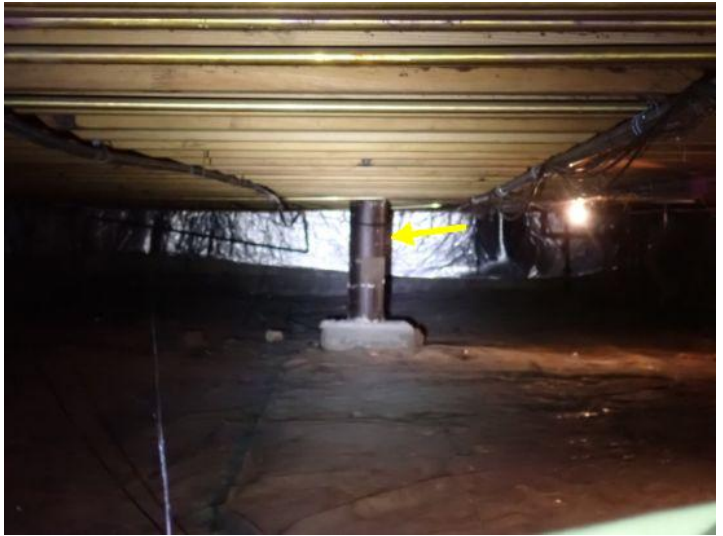
Leaning support posts noted in areas below the structures at the time of the inspection. Recommend repairs by a licensed contractor.

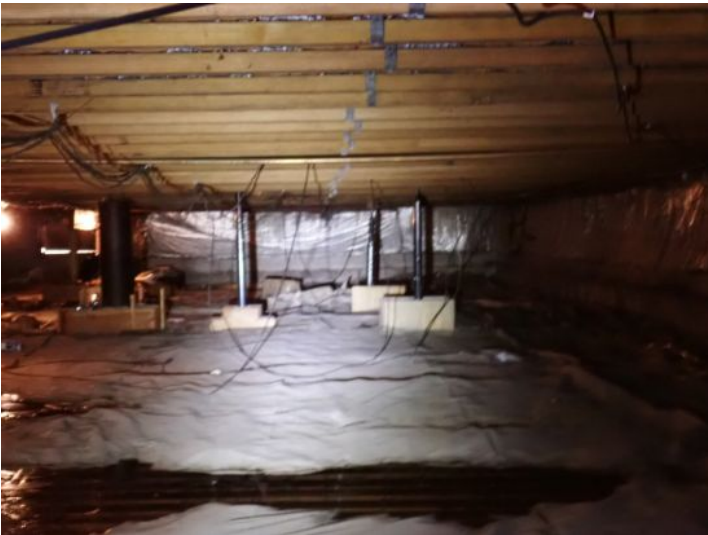
Due to the amount of structural movement, flooring deflection as well as improper/inadequate past repairs we recommend that both of the structures be evaluated by a licensed structural contractor prior to taking possession of the property.

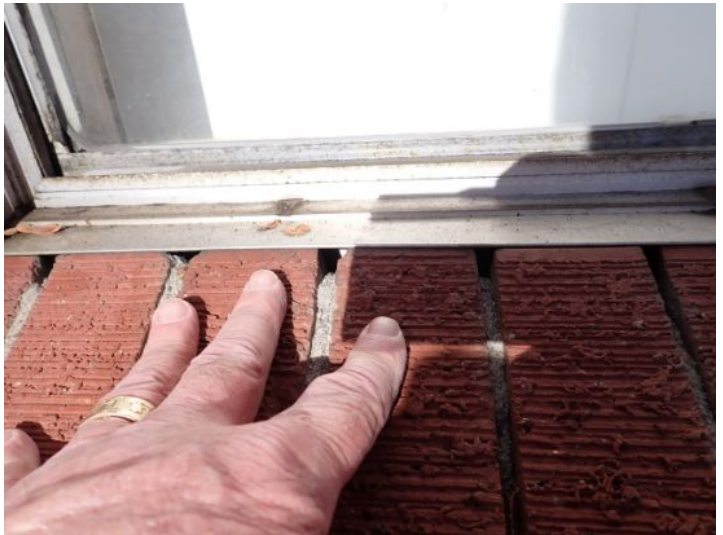
Tuck pointing required in areas. Recommend repairs by a licensed contractor.

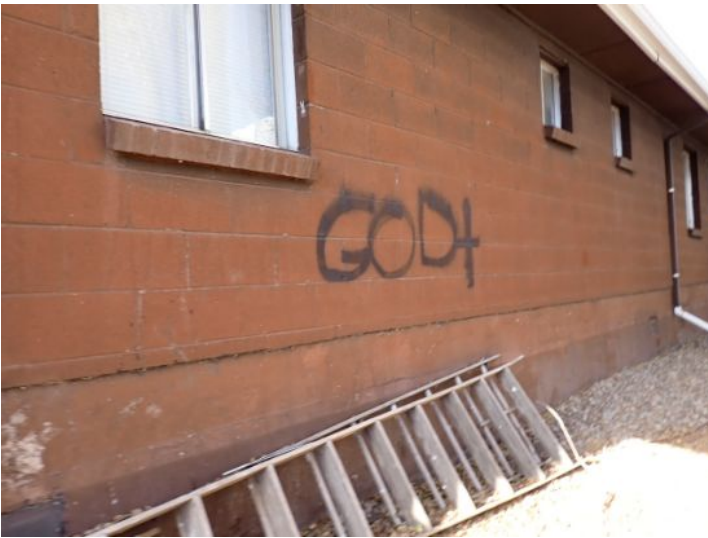
The majority of the exterior envelopes of the structures appeared to be in fair condition at the time of the inspection.

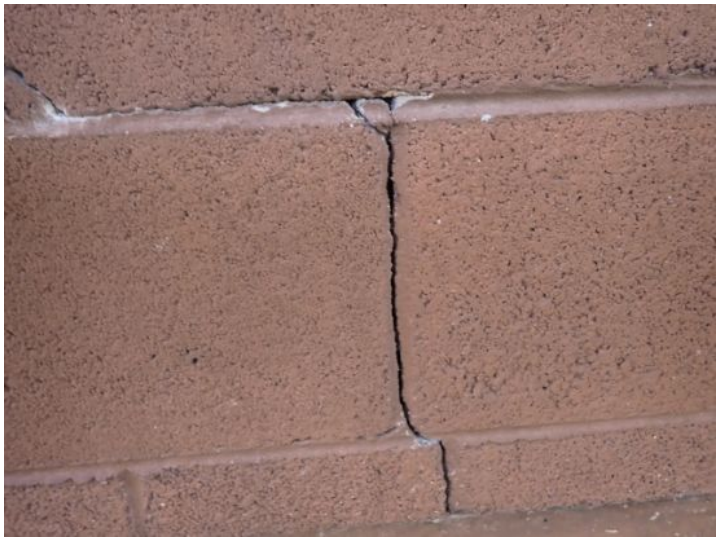
Cracked mortar noted in areas. Recommend tuck pointing repairs by a licensed contractor.

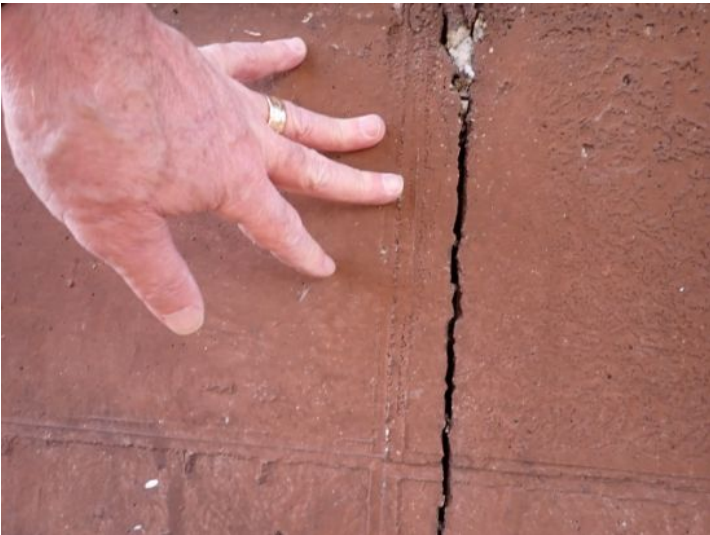
Significant foundation wall cracking noted on both structures at the time of the inspection. Recommend repairs by a licensed contractor.

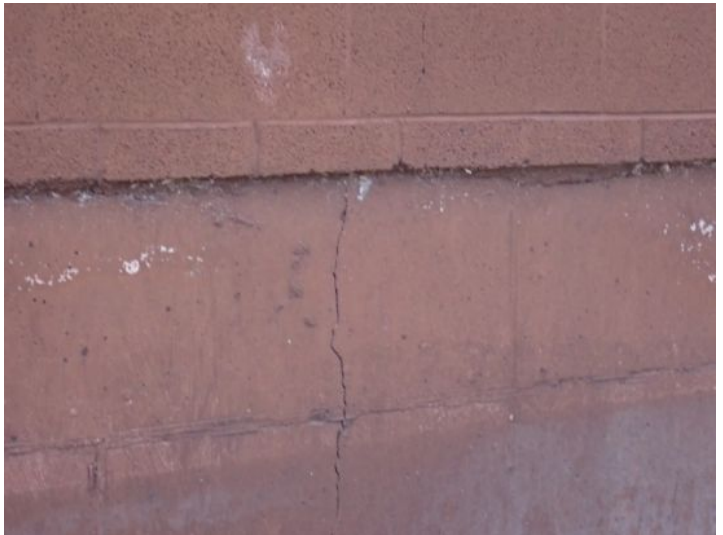
Minor foundation wall cracking noted in areas. Recommend monitoring for future repairs.

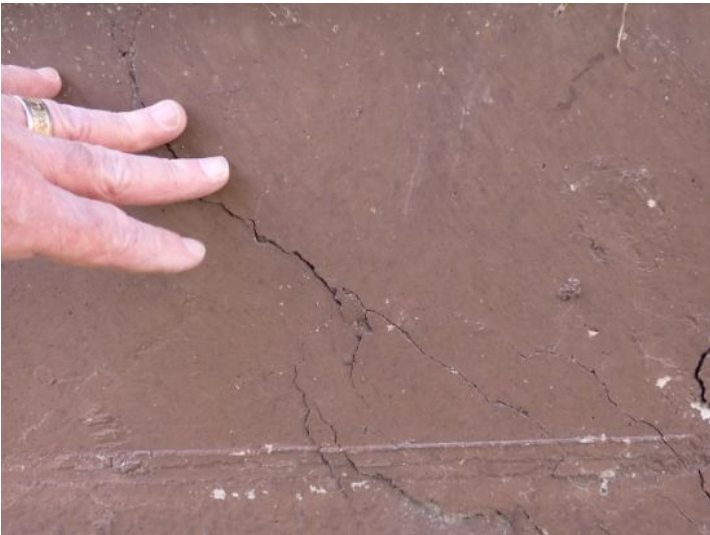
Minor foundation wall cracking noted in areas. Recommend monitoring for future repairs.

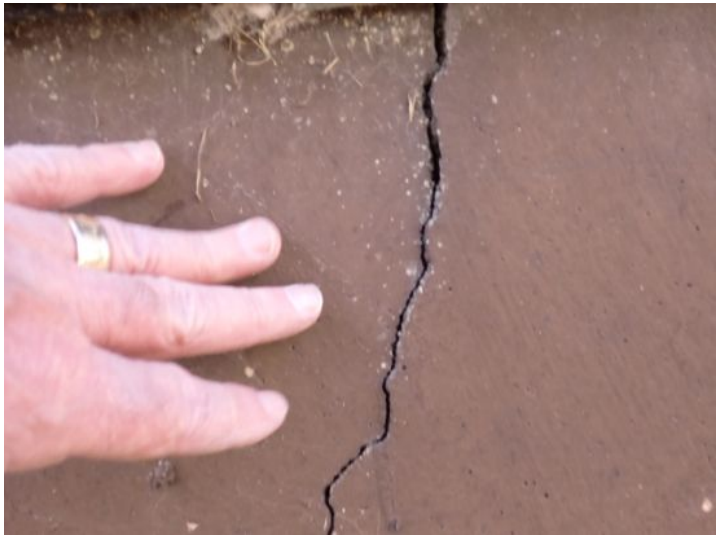
Significant foundation wall cracking noted on both structures at the time of the inspection. Recommend repairs by a licensed contractor.

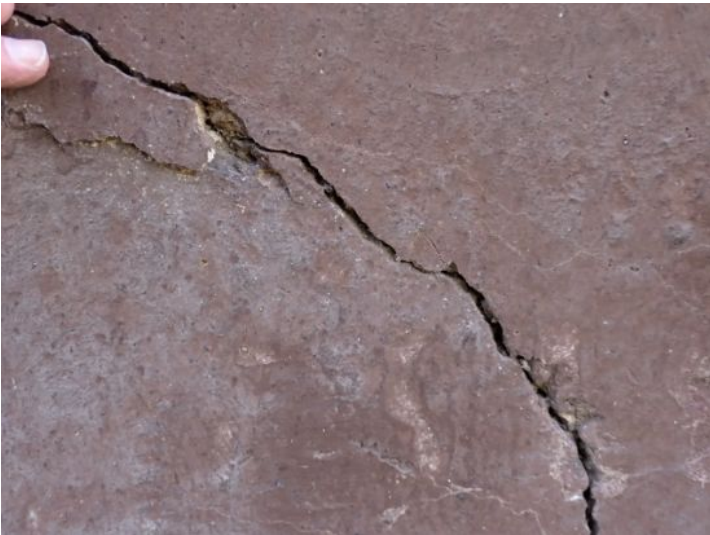
Significant foundation wall cracking noted on both structures at the time of the inspection. Recommend repairs by a licensed contractor.

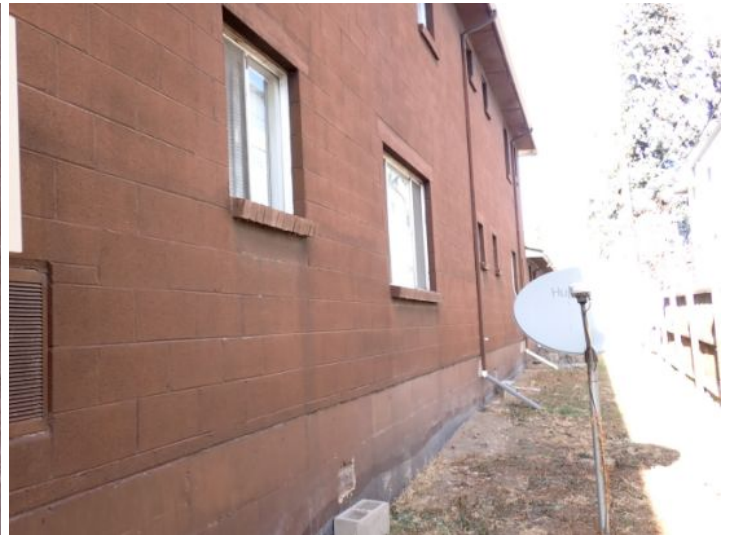
The majority of the exterior envelopes of the structures appeared to be in fair condition at the time of the inspection.

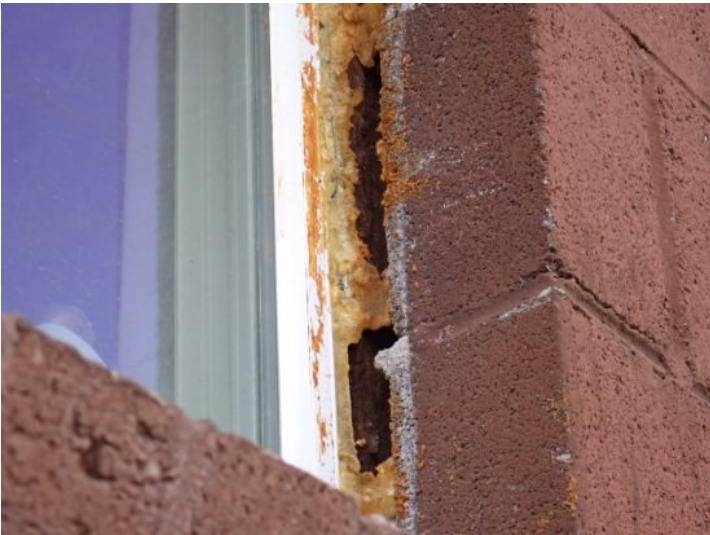
Recommend assuring that any area where 2 separate substrates meet should be properly caulked/sealed. Recommend repairs by a licensed contractor.

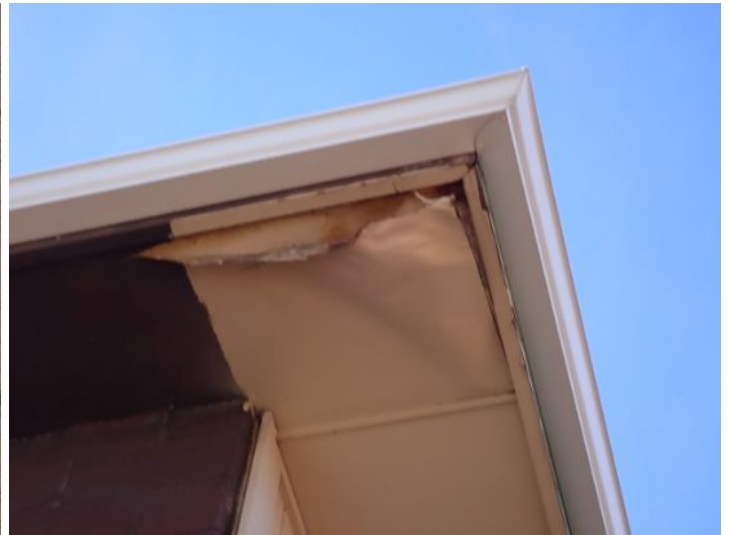
Moisture damaged soffit/eave material noted in areas around both of the structures at the time of the inspection. This was most likely caused by ice damming which was caused by inadequate attic insulation and ventilation. Recommend repairs as needed by a licensed contractor.

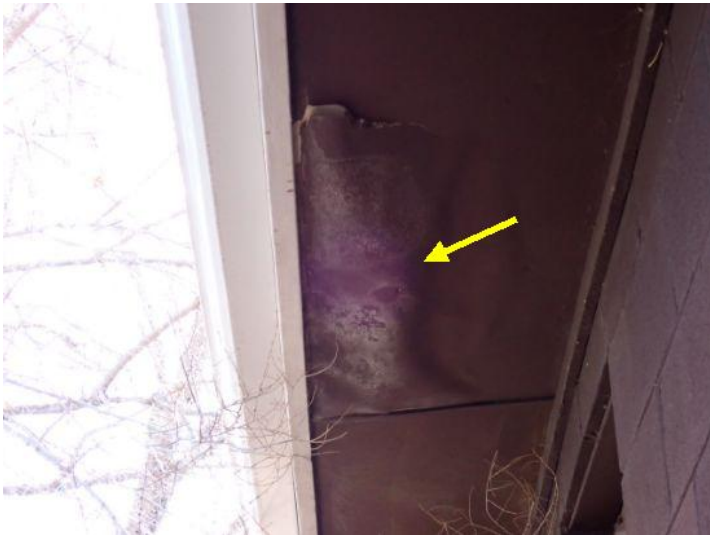
Moisture damaged soffit/eave material noted in areas around both of the structures at the time of the inspection. This was most likely caused by ice damming which was caused by inadequate attic insulation and ventilation. Recommend repairs as needed by a licensed contractor.

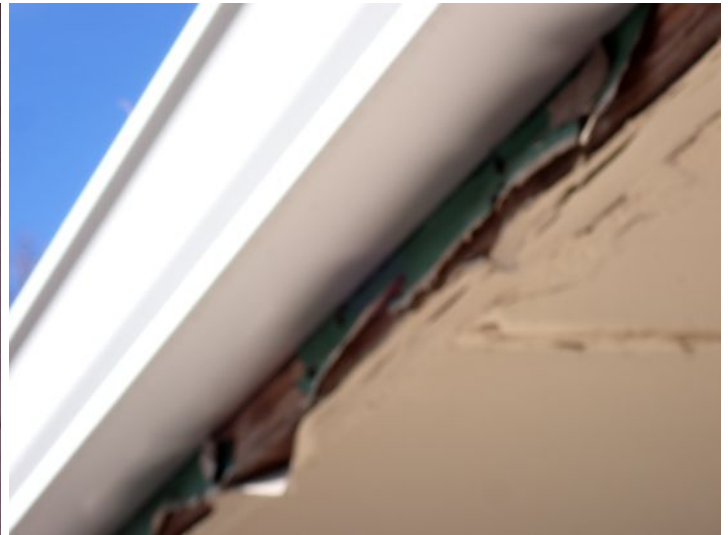
Moisture damaged fascia noted in areas. Recommend repairs by a licensed contractor.

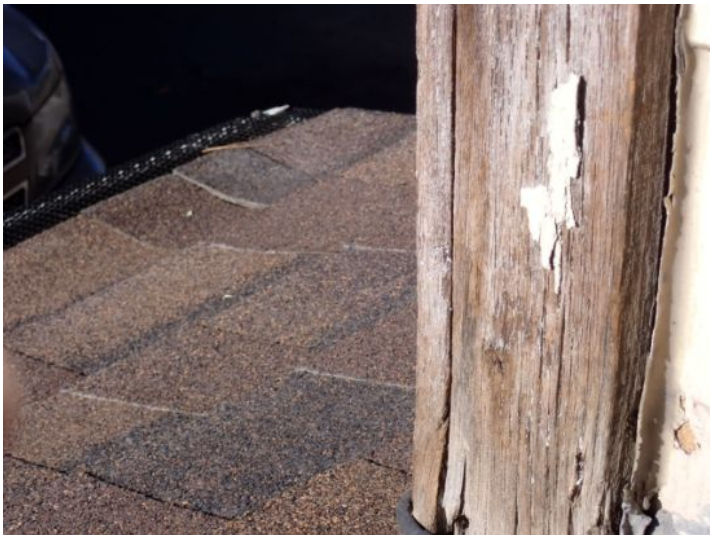
Missing/rotted/deteriorated wood trim noted in areas at the time of the inspection. Recommend repairs by a licensed contractor.

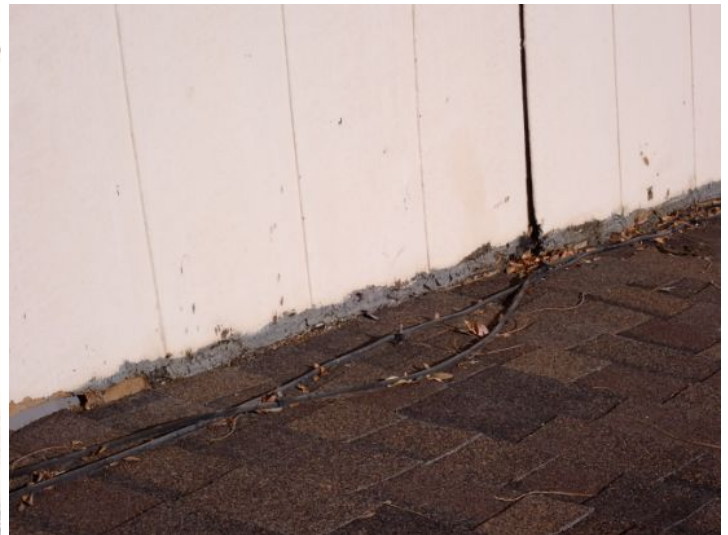
Siding material touching the roofing material in areas at the time of the inspection. Recommend repairs by a licensed contractor.

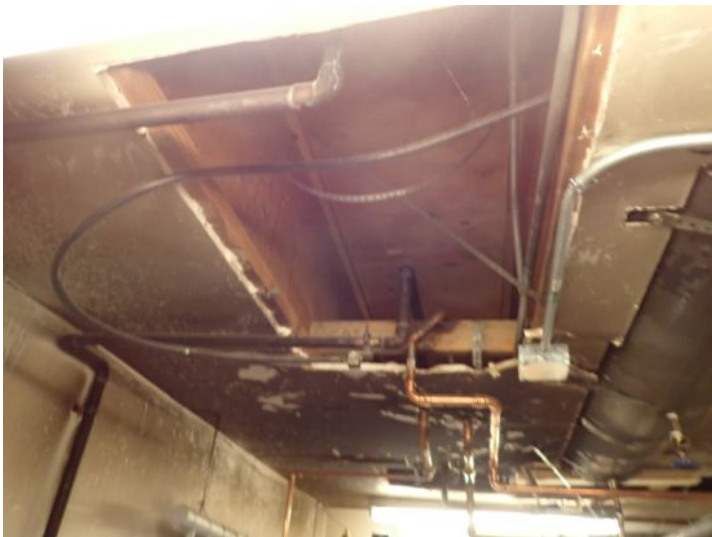
Damaged ceilings noted in boiler rooms at the time of the inspection. Fire Hazard. Recommend repairs by a licensed contractor.

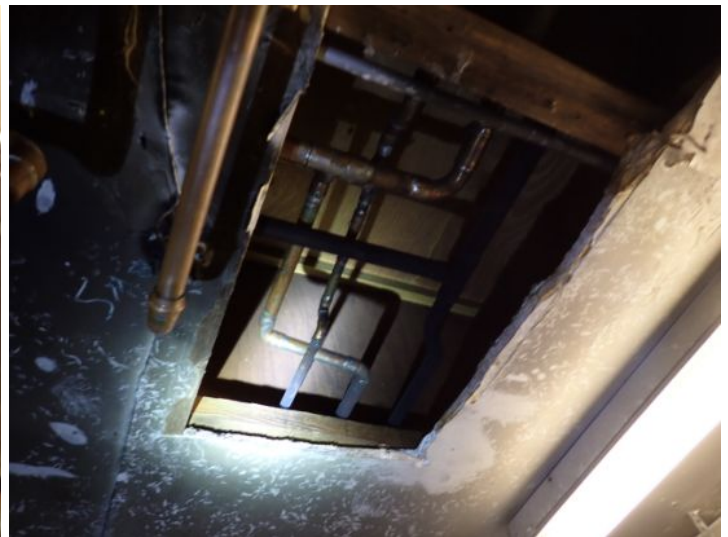
Damaged ceilings noted in boiler rooms at the time of the inspection. Fire Hazard. Recommend repairs by a licensed contractor.

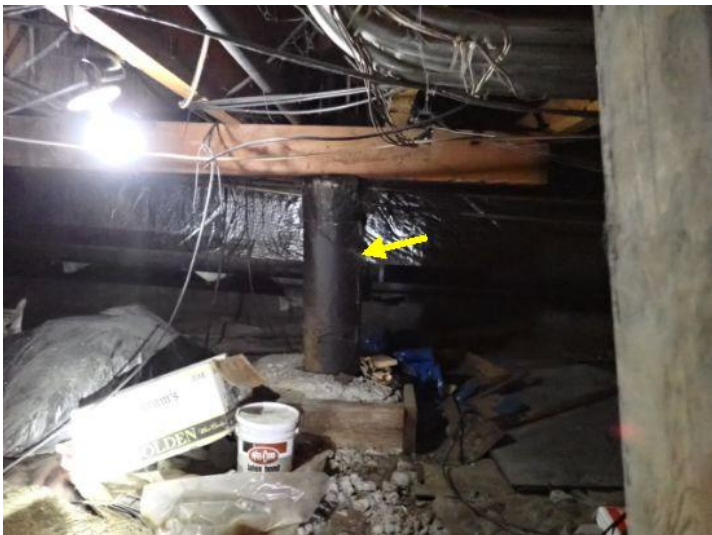
Leaning support posts noted in areas below the structures at the time of the inspection. Recommend repairs by a licensed contractor.

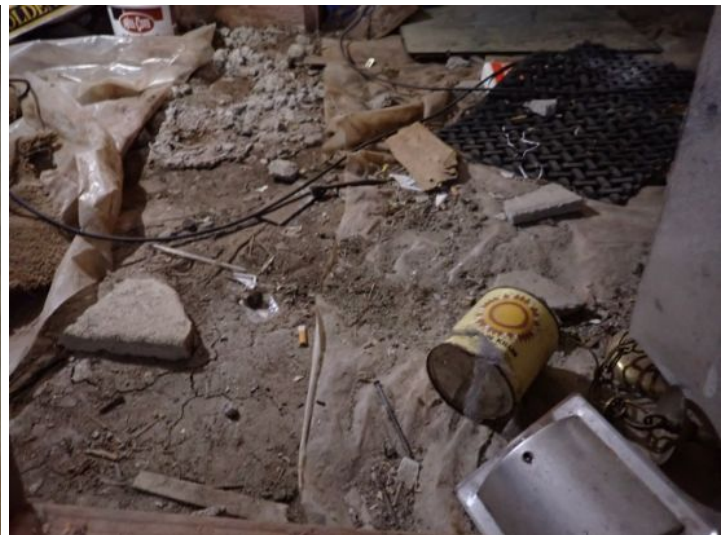
No vapor barrier noted in crawl spaces at the time of the inspection. Recommend repairs by a licensed contractor.

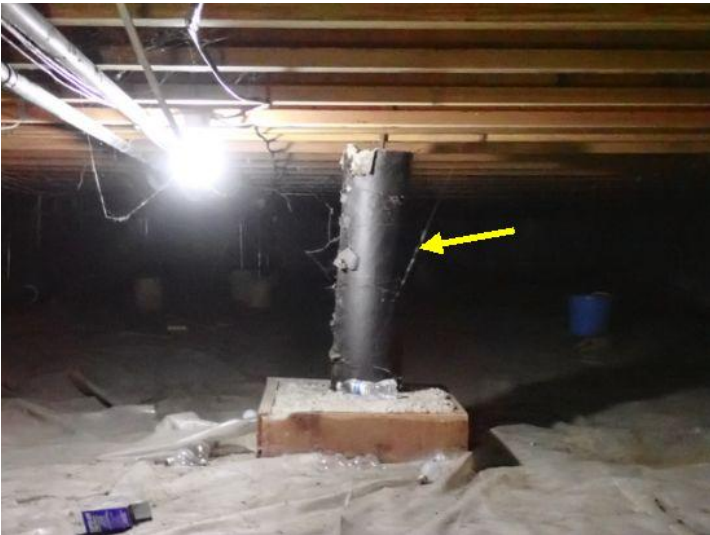
Leaning support posts noted in areas below the structures at the time of the inspection. Recommend repairs by a licensed contractor.

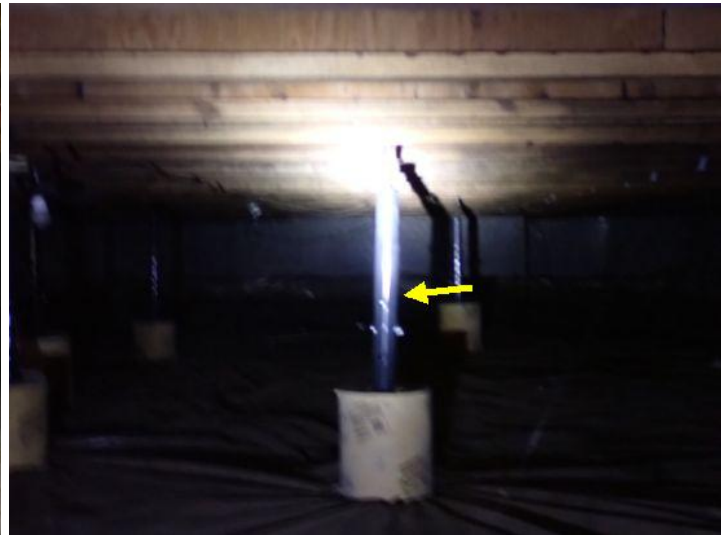
Leaning support posts noted in areas below the structures at the time of the inspection. Recommend repairs by a licensed contractor.
