Forman Inspection Services, LLC

Property Inspection Report

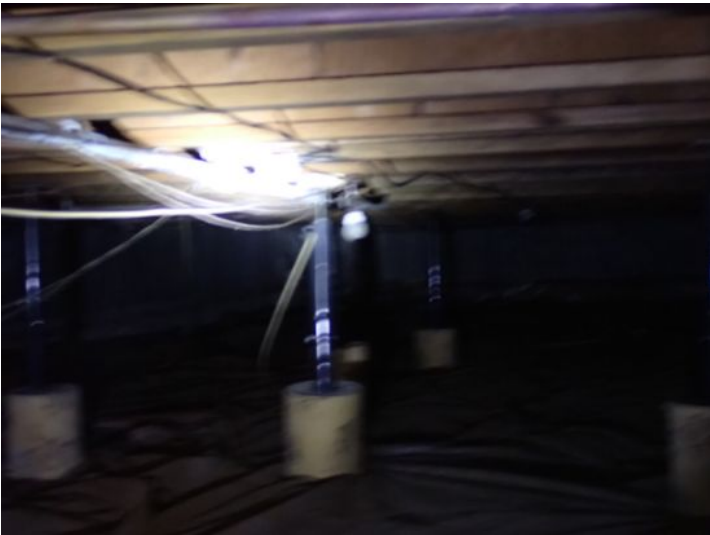
Due to the amount of structural movement, flooring deflection as well as improper/inadequate past repairs we recommend that both of the structures be evaluated by a licensed structural contractor prior to taking possession of the property.

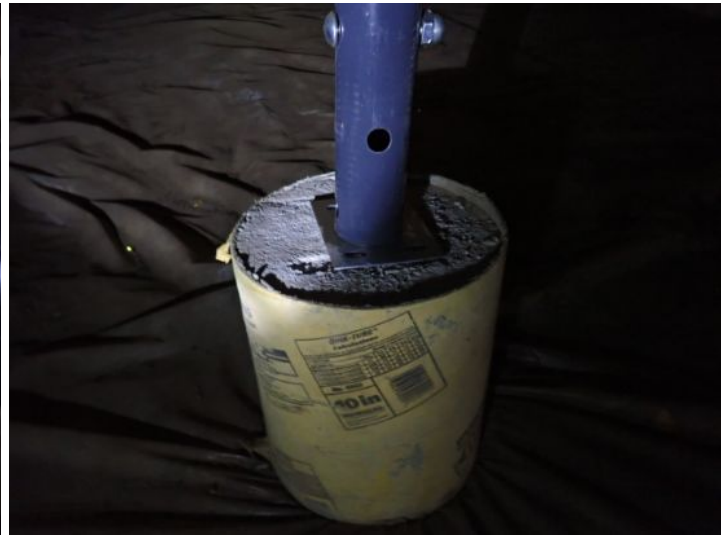
Due to the amount of structural movement, flooring deflection as well as improper/inadequate past repairs we recommend that both of the structures be evaluated by a licensed structural contractor prior to taking possession of the property.

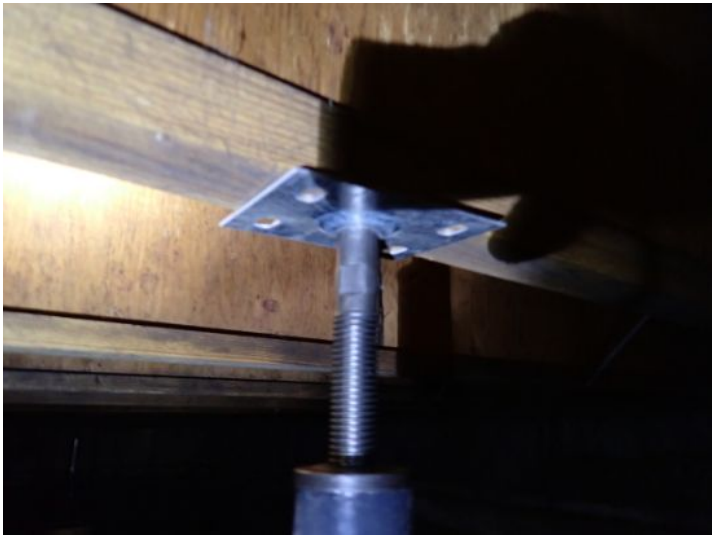
Due to the amount of structural movement, flooring deflection as well as improper/inadequate past repairs we recommend that both of the structures be evaluated by a licensed structural contractor prior to taking possession of the property.

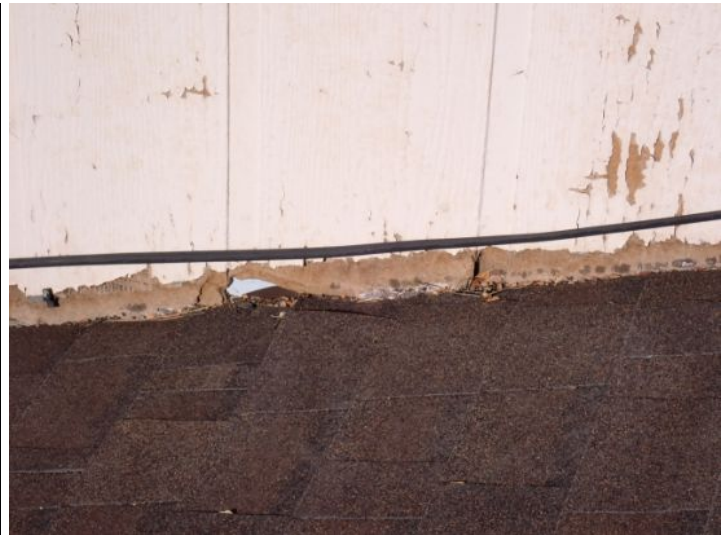
Siding material touching the roofing material in areas at the time of the inspection. Recommend repairs by a licensed contractor.

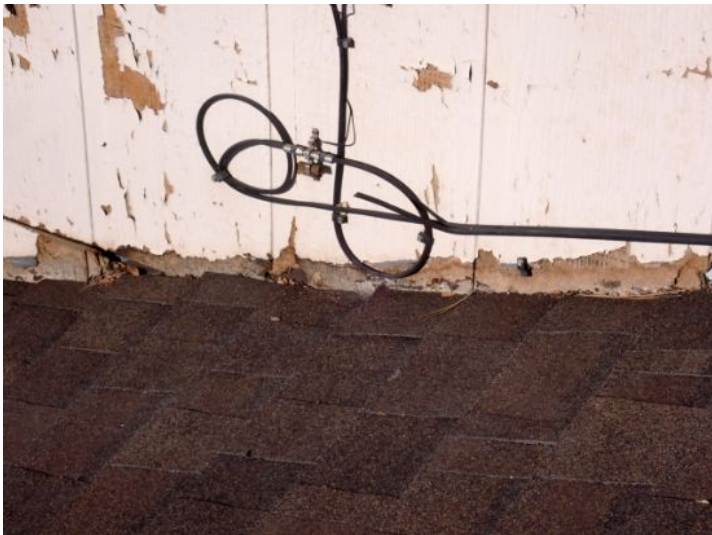
Wood rot/deterioration noted on the wood/composition siding in areas on both structures at the time of the inspection. Recommend repairs by a licensed contractor.

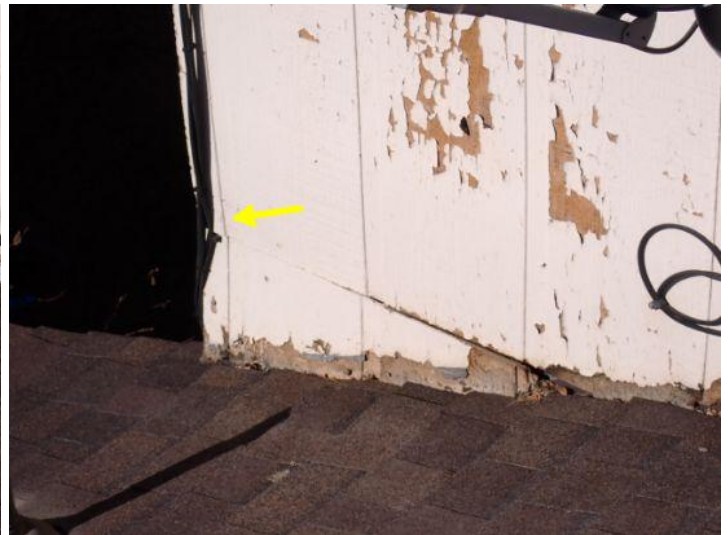
Missing/rotted/deteriorated wood trim noted in areas at the time of the inspection. Recommend repairs by a licensed contractor.

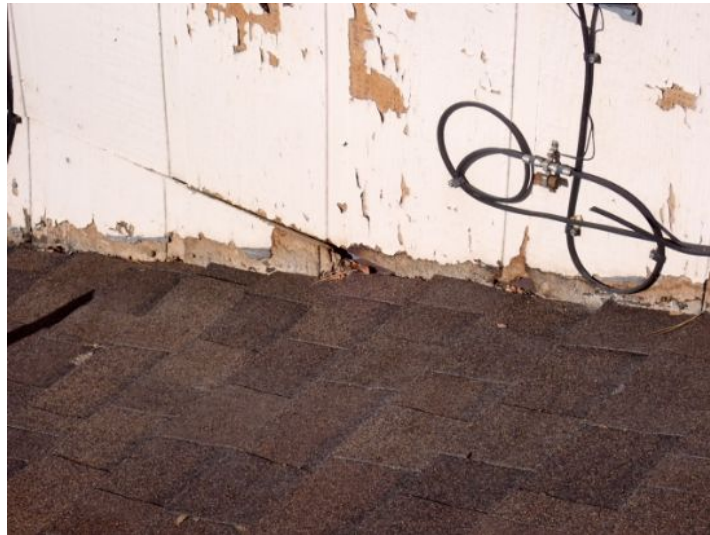
Wood rot/deterioration noted on the wood/composition siding in areas on both structures at the time of the inspection. Recommend repairs by a licensed contractor.

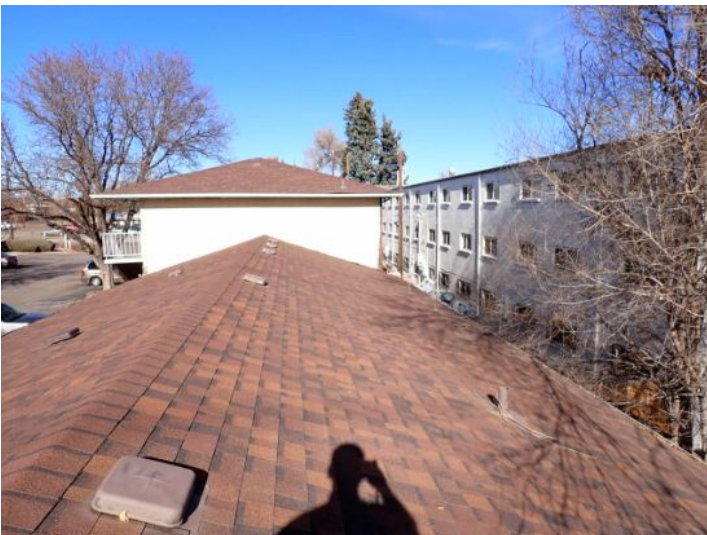
The majority of the roofing systems appeared to be in fair condition at the time of the inspection.

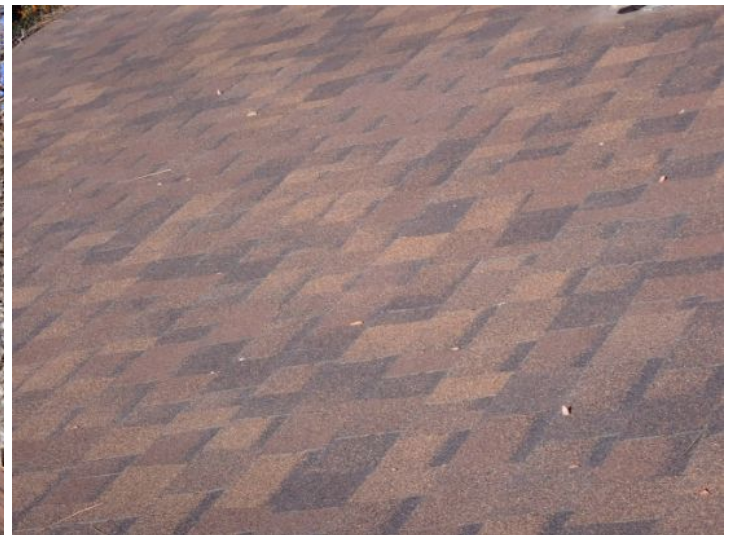
The majority of the roofing systems appeared to be in fair condition at the time of the inspection.

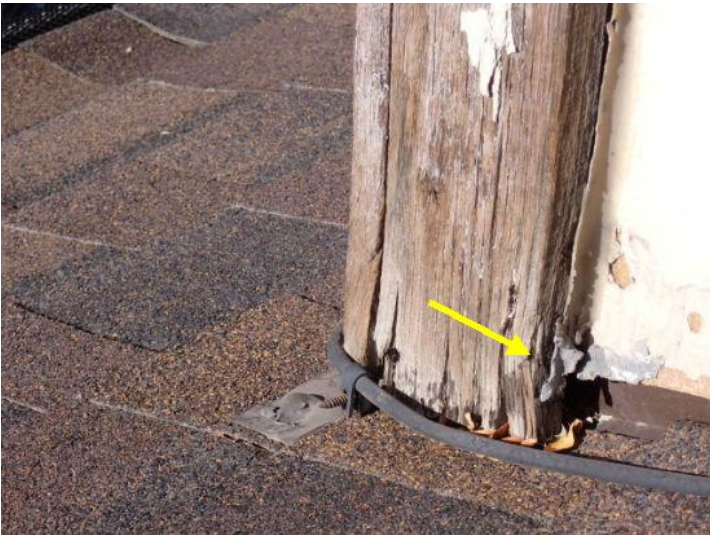
Missing kickout flashing noted in areas on the lower level roofing systems. Recommend repairs by a licensed contractor.

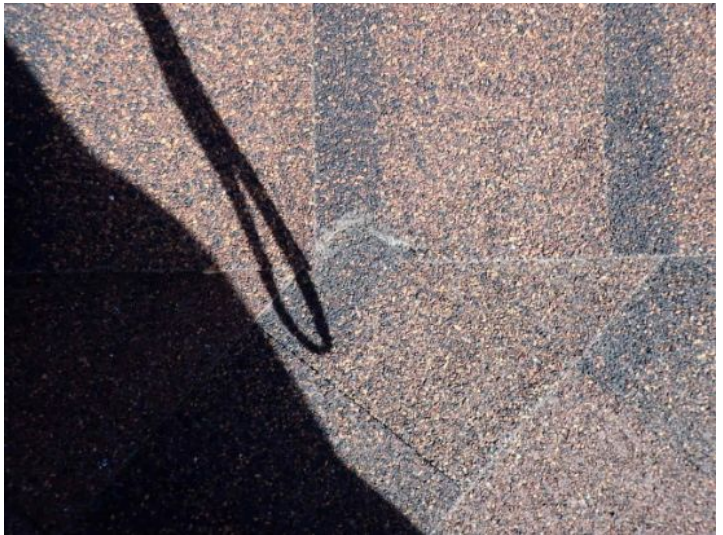
Minor shingle damaged noted in areas at the time of the inspection. Recommend monitoring for future repairs.

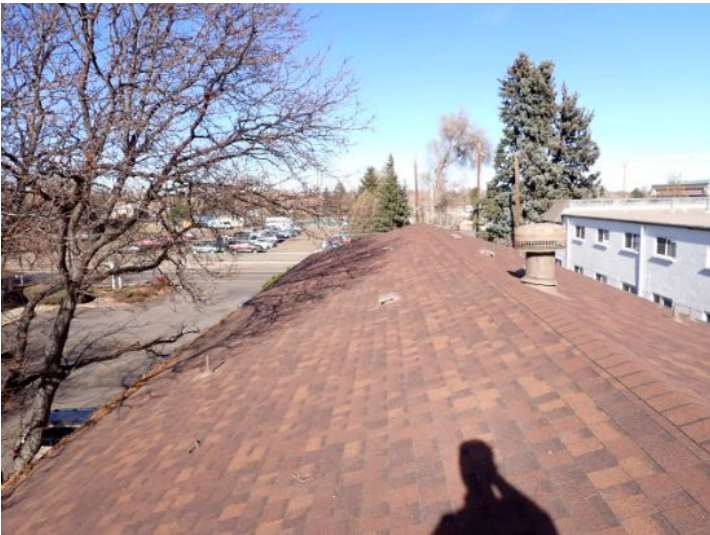
The majority of the roofing systems appeared to be in fair condition at the time of the inspection.

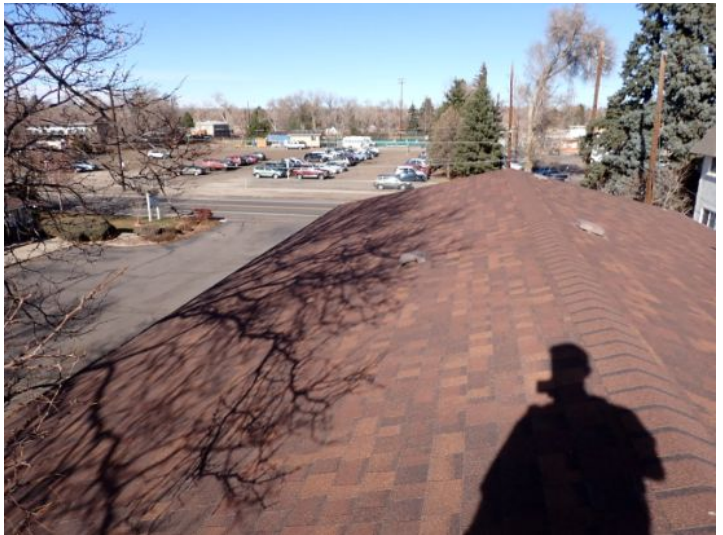
The majority of the roofing systems appeared to be in fair condition at the time of the inspection.

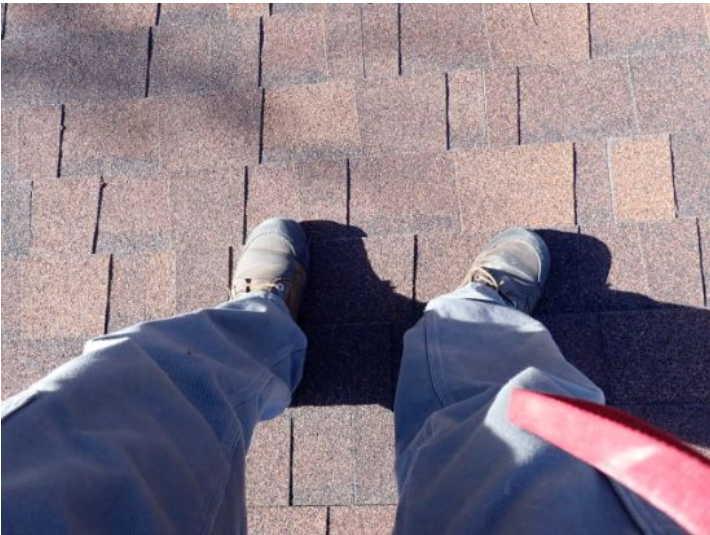
Spongy/weak decking noted under foot on both roofing systems at the time of the inspection. Recommend monitoring for future repairs.

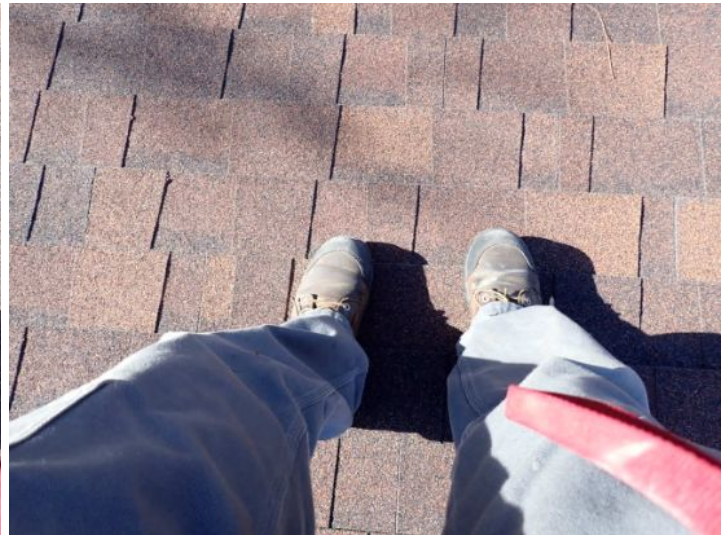
Spongy/weak decking noted under foot on both roofing systems at the time of the inspection. Recommend monitoring for future repairs.

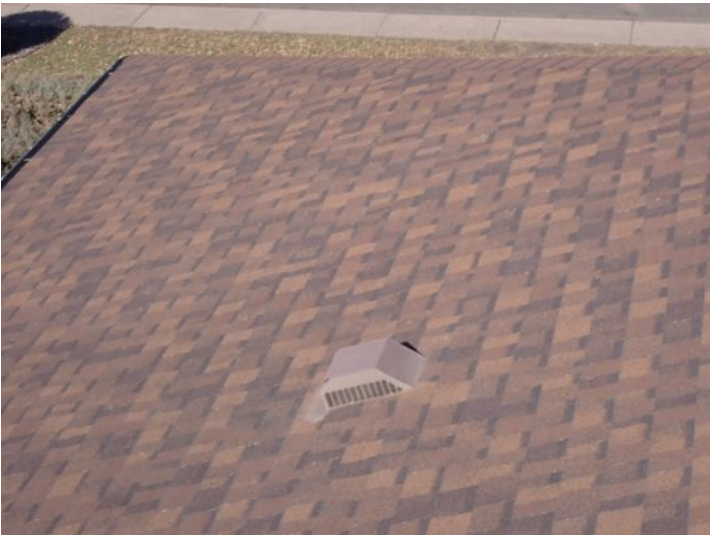
The majority of the roofing systems appeared to be in fair condition at the time of the inspection.

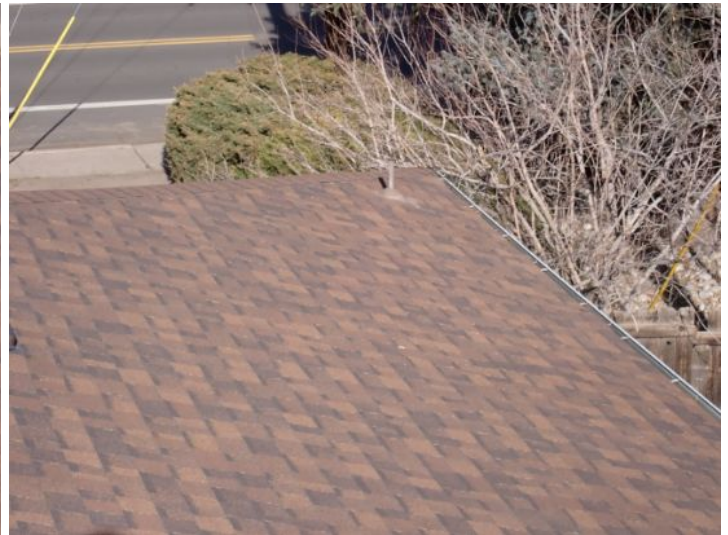
The majority of the roofing systems appeared to be in fair condition at the time of the inspection.

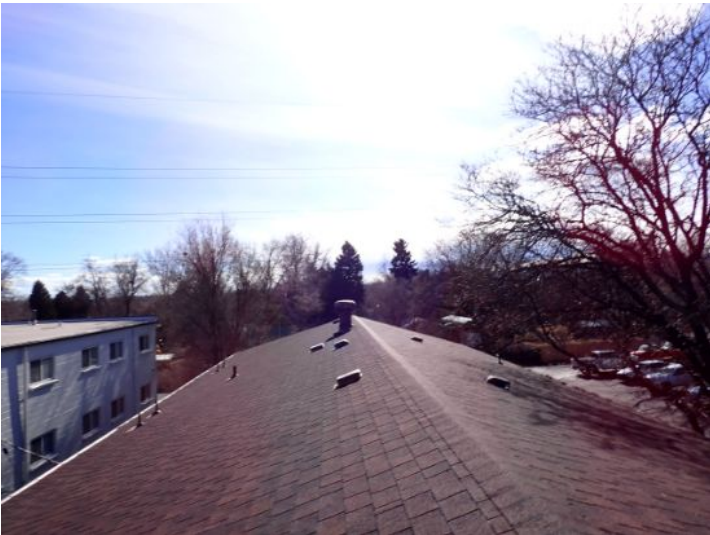
The majority of the roofing systems appeared to be in fair condition at the time of the inspection.

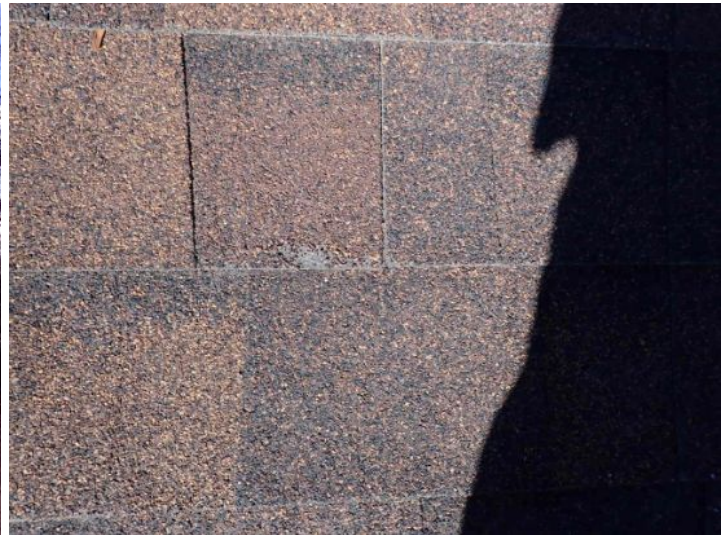
Minor shingle damaged noted in areas at the time of the inspection. Recommend monitoring for future repairs.

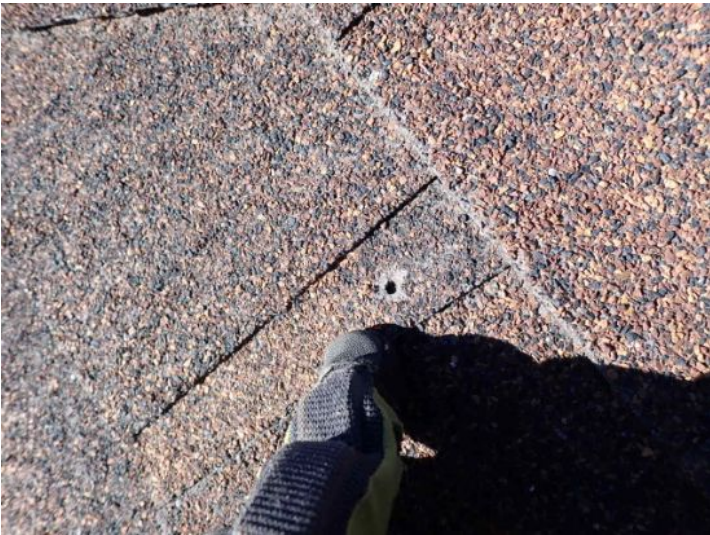
Minor shingle damaged noted in areas at the time of the inspection. Recommend monitoring for future repairs.

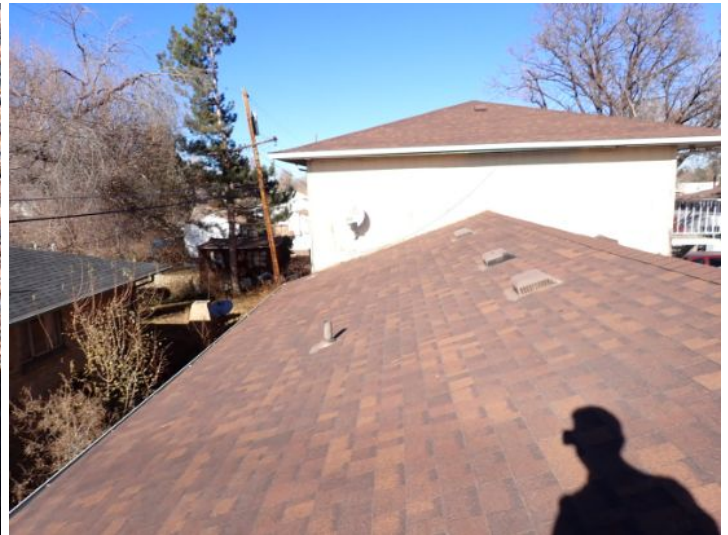
The majority of the roofing systems appeared to be in fair condition at the time of the inspection.

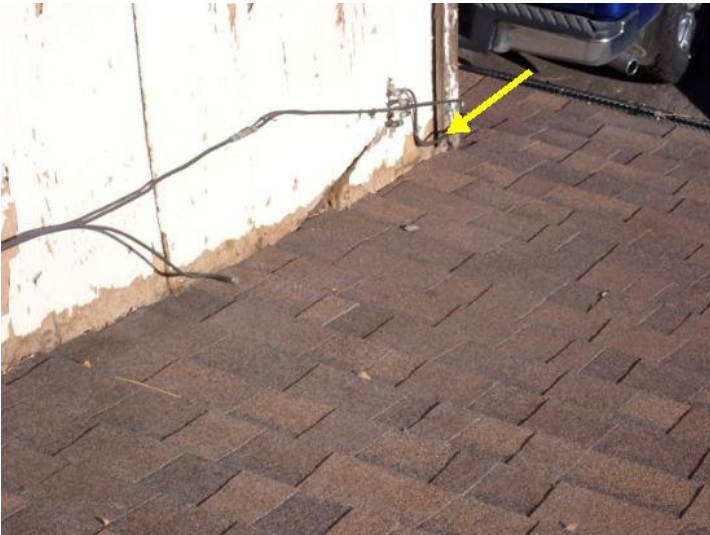
Missing kickout flashing noted in areas on the lower level roofing systems. Recommend repairs by a licensed contractor.

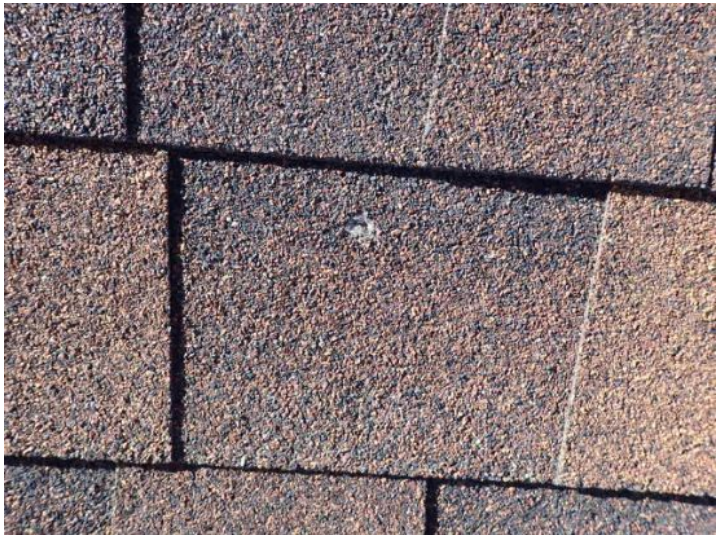
Minor shingle damaged noted in areas at the time of the inspection. Recommend monitoring for future repairs.

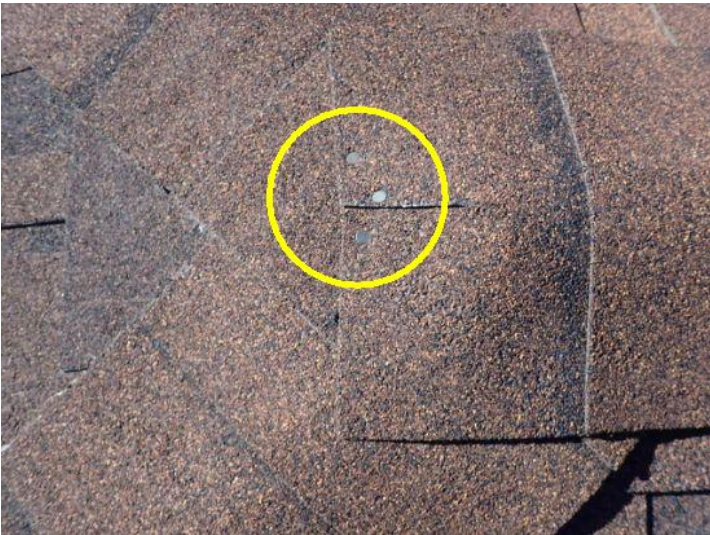
Missing sealant on exposed ridge row nails noted on the west side structures roof at the time of the inspection. Recommend repairs by a licensed contractor.

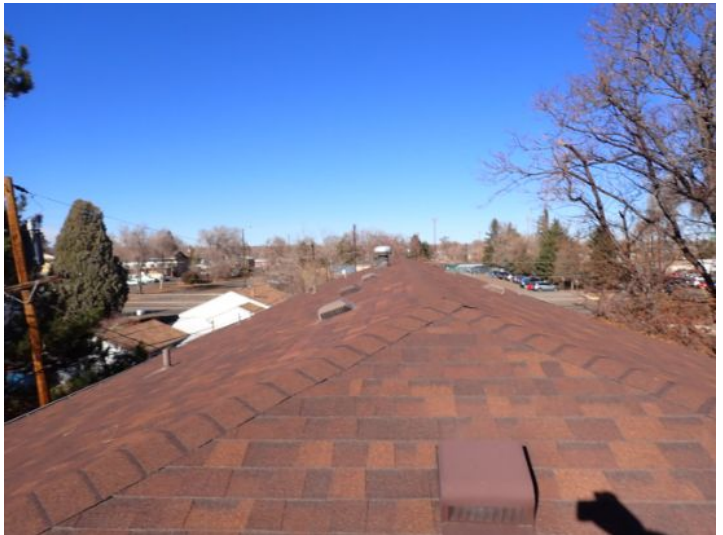
The majority of the roofing systems appeared to be in fair condition at the time of the inspection.

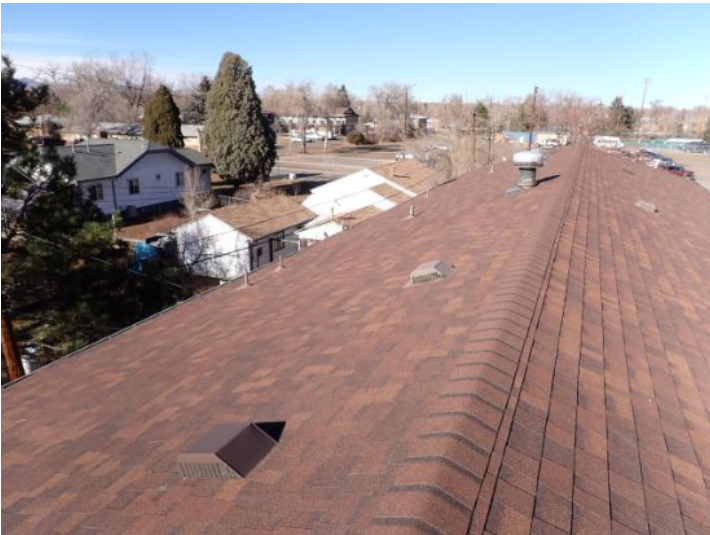
The majority of the roofing systems appeared to be in fair condition at the time of the inspection.

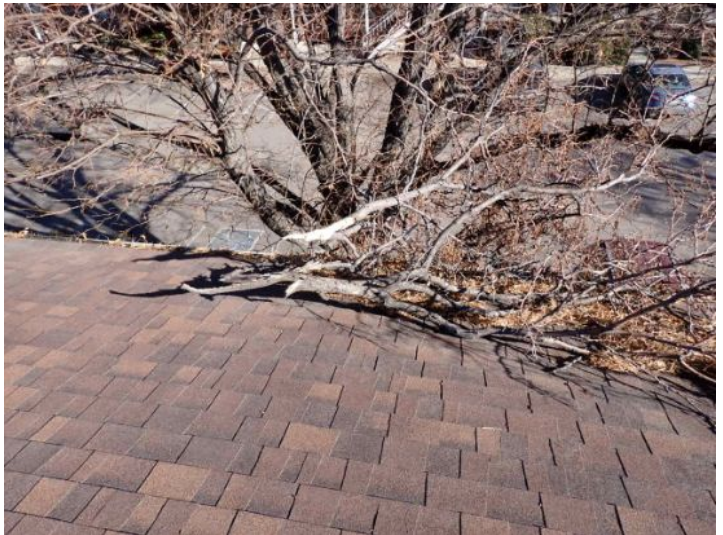
Tree touching roof on the upper west side structure. Recommend removal and roof evaluation in this area prior to taking possession of the property.

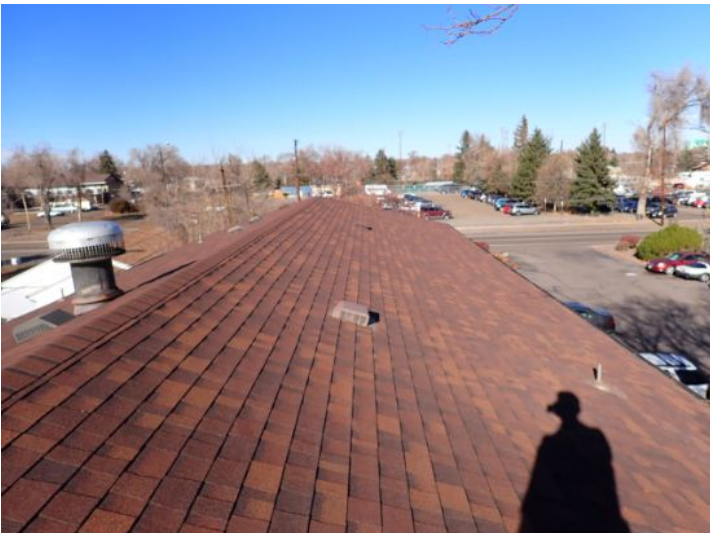
The majority of the roofing systems appeared to be in fair condition at the time of the inspection.

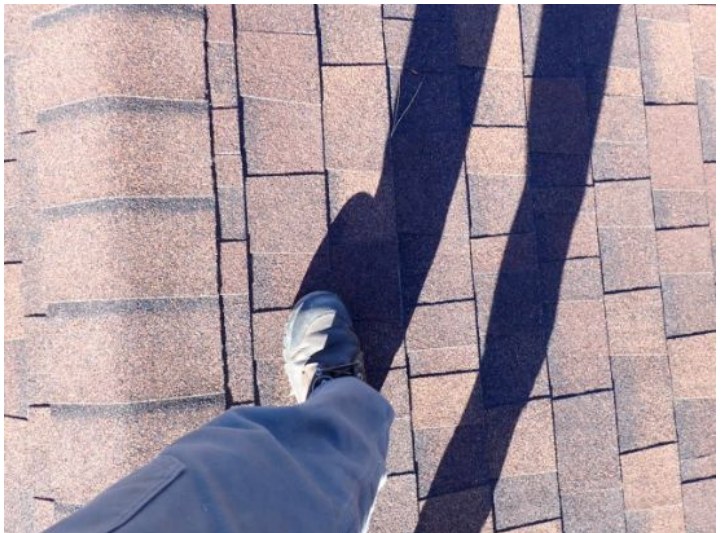
Spongy/weak decking noted under foot on both roofing systems at the time of the inspection. Recommend monitoring for future repairs.

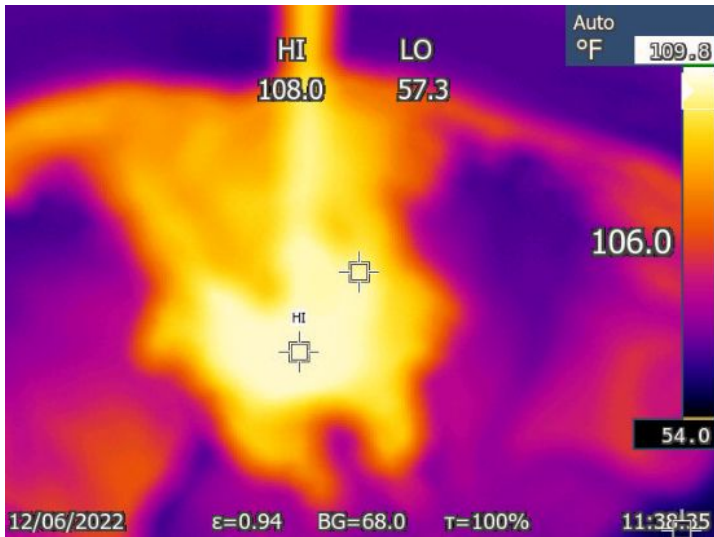
Domestic hot water systems functional at the time of the inspection.

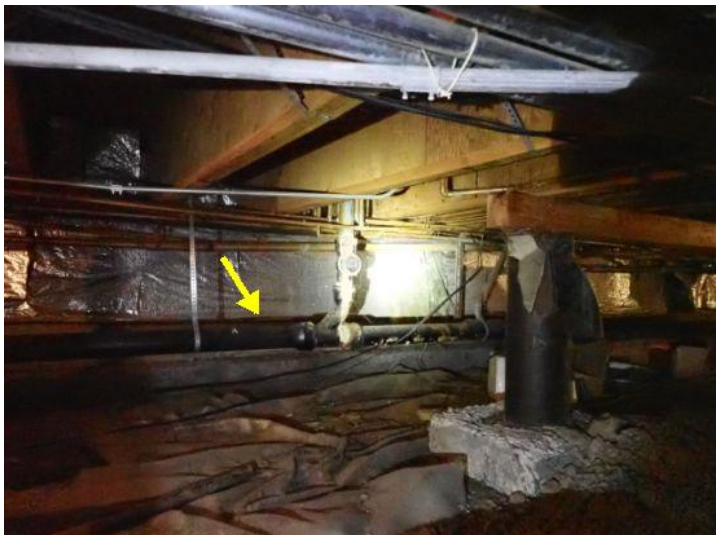
Improper slope noted in the sewer line below the east side structure at the time of the inspection. Recommend repairs as needed by a licensed contractor.

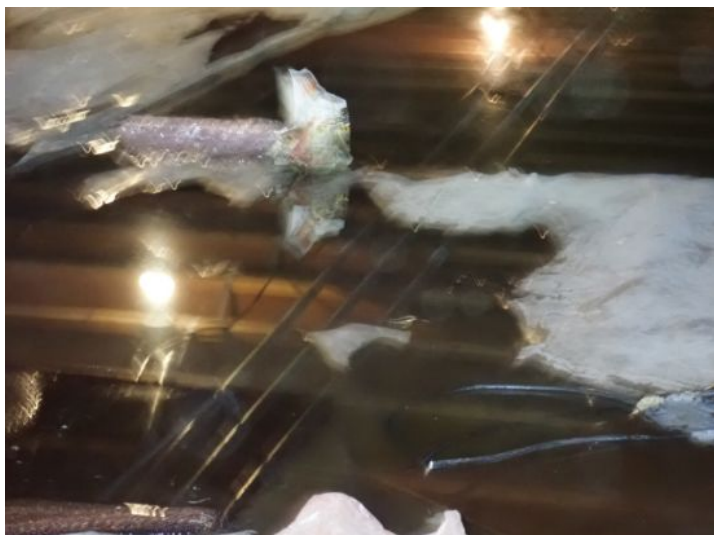
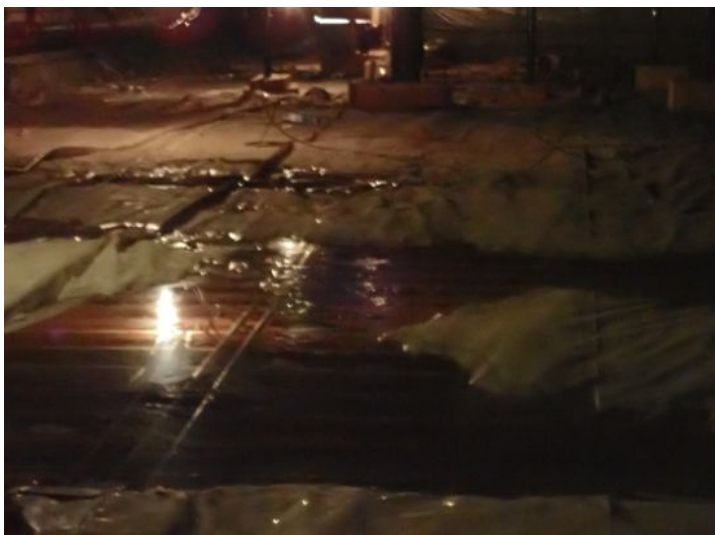
Active sewer leak noted below the east side structure at the time of the inspection causing flooding of the crawl space area. Recommend repairs and cleanup by a licensed contractor prior to taking possession of the property.

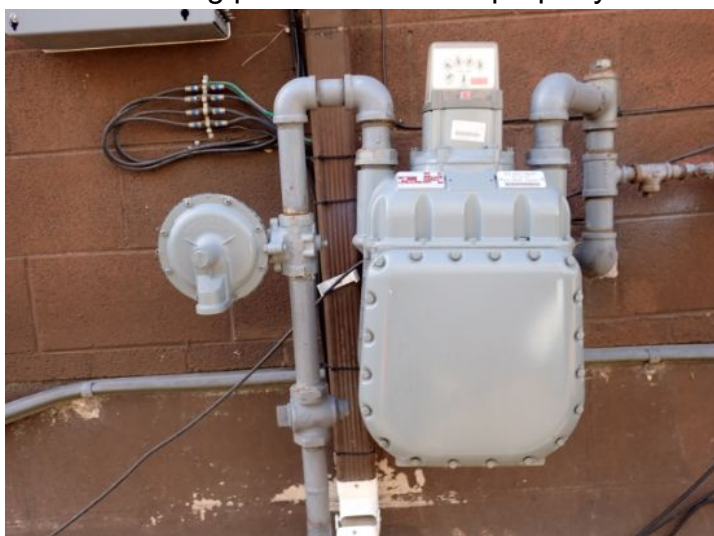
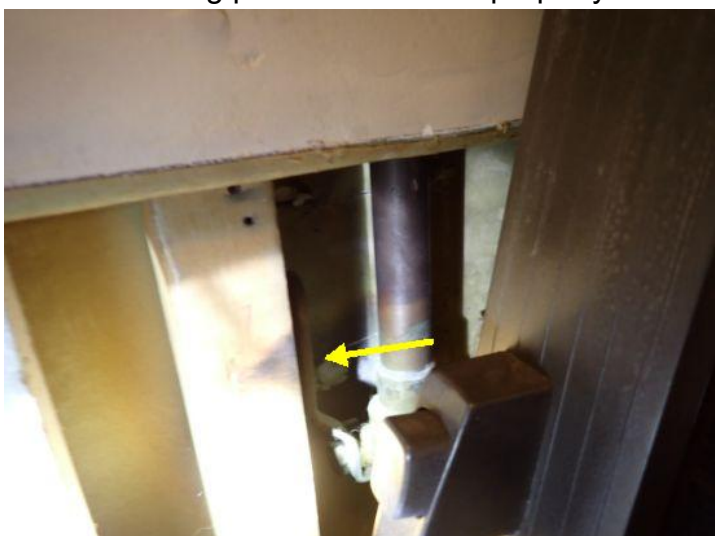
The main gas shutoff valve(s) was/were functional at the time of the inspection

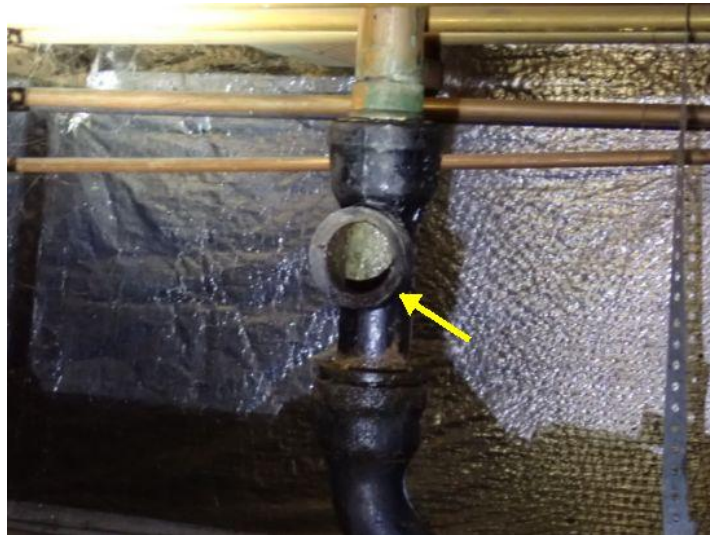
Minor sewer leak caused by missing cap noted below the west side structure at the time of the inspection. Recommend repairs by a licensed contractor.

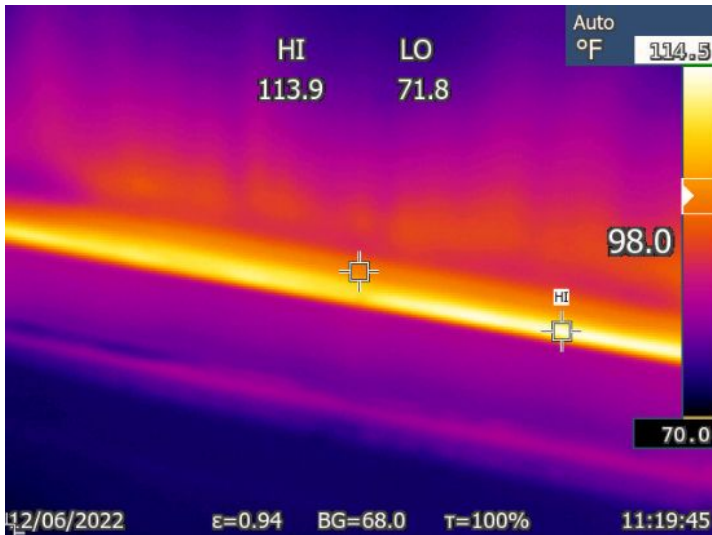
The heating system(s) were tested and functional at the time of the inspection.

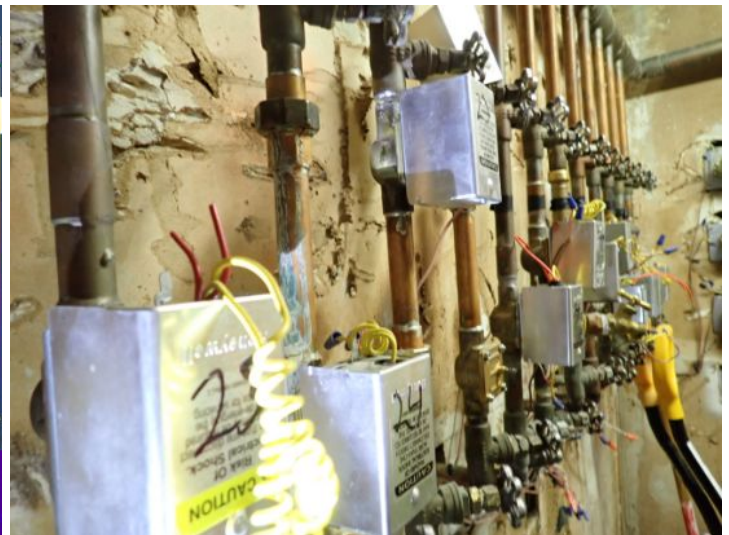
One or more zone valves did not appear to be functioning properly at the time of the inspection. Recommend repairs as needed by a licensed contractor.

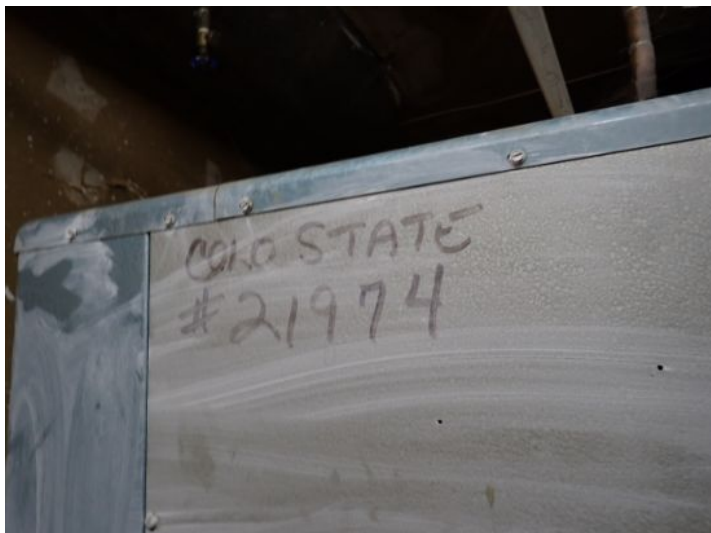
East Bldg. Boiler: Inspector could not locate a data plate for this boiler at the time of the inspection. The boiler was functional but in poor condition and appeared to have reached the end of its serviceable life expectancy. The nominal serviceable life expectancy of a hot water cast iron boiler system is 35 years. Recommend replacement by a licensed contractor prior to taking possession of the property.

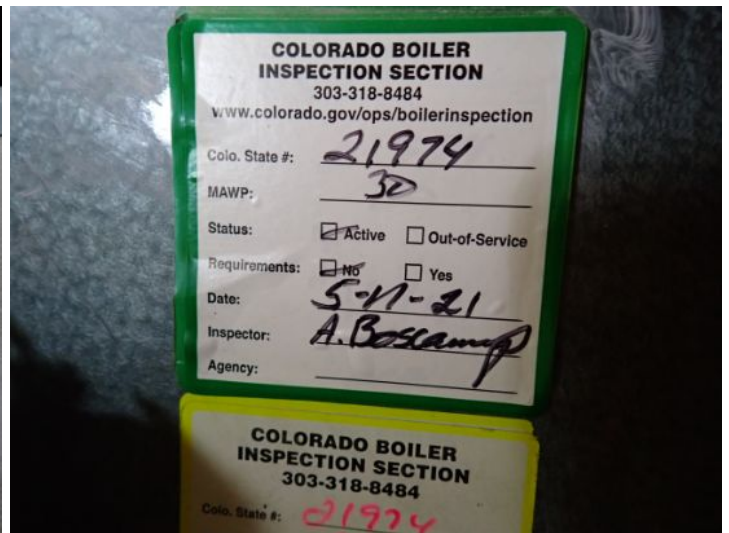
East Bldg. Boiler: Brand ? M/N ? S/N ? Colorado Boiler # 21974. Last date of inspection/certification 5/21.

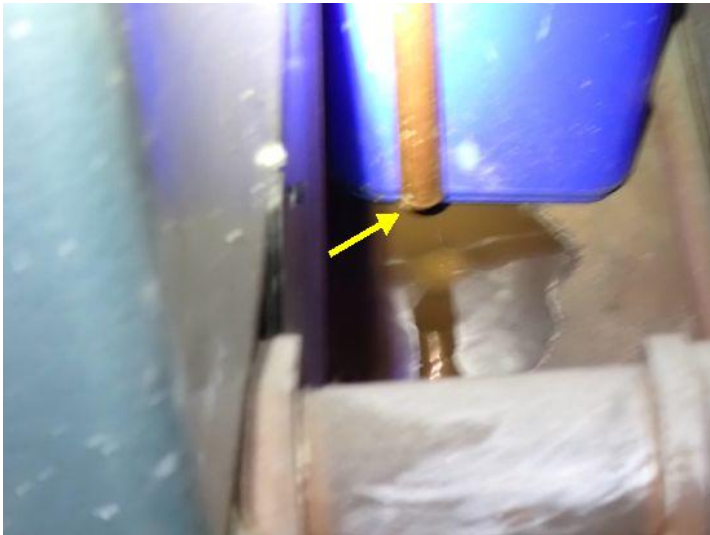
East Bldg. Boiler: The TPRV for the boiler was leaking at the time of the inspection. Recommend repairs by a licensed contractor.

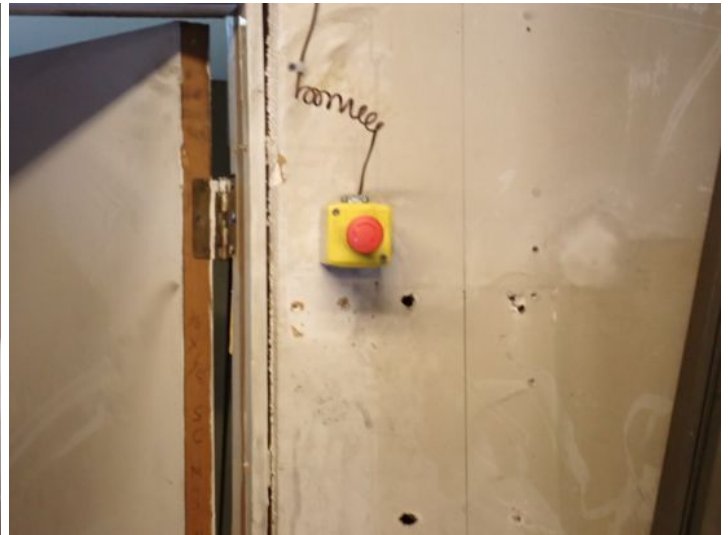
The emergency shutdown switches for the boiler systems were in place and appeared functional at the time of the inspection.

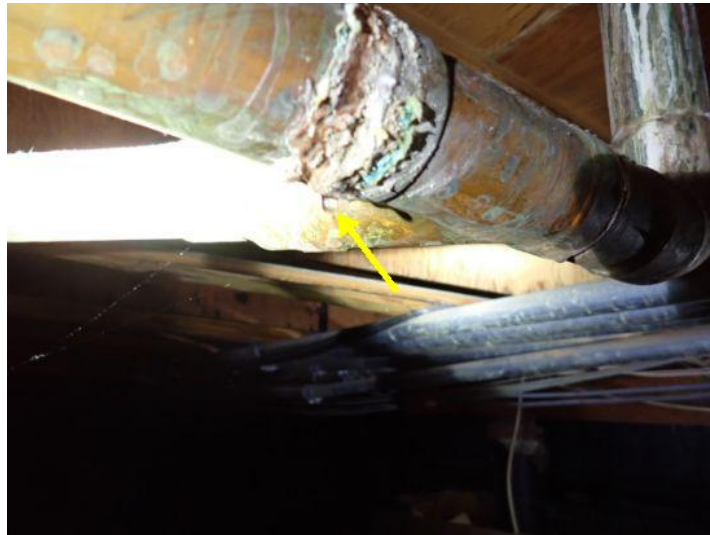
Minor leak noted on boiler piping in west side crawl space. Recommend repairs by a licensed contractor.

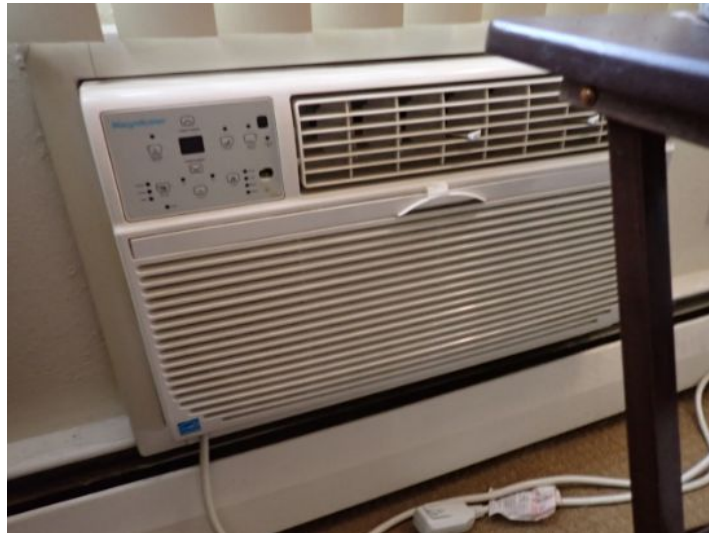
The air conditioning systems were visually inspected and no abnormalities were noted at the time of the inspection.

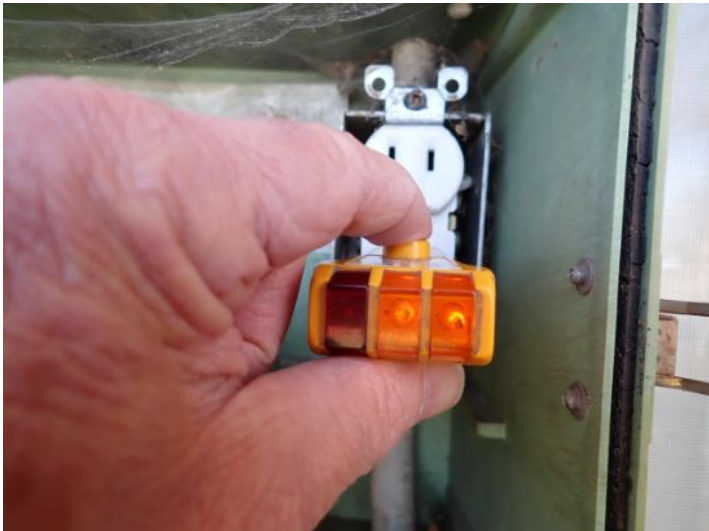
Exterior GFCI outlets were tested and failed at the time of the inspection. Recommend repairs by a licensed electrician

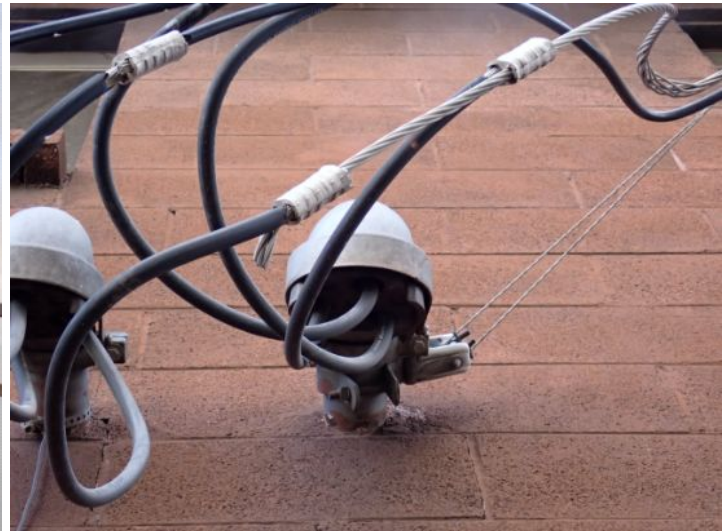
The main electrical system was a 1 phase 3 wire system

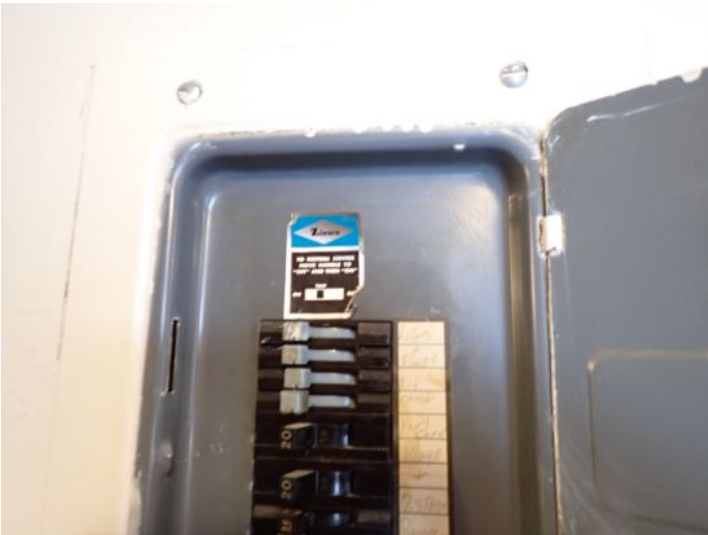
Zinsco panels were noted in the tenant units and main electrical rooms at the time of the inspection. These systems have been considered a fire/safety hazard. Recommend replacement of all Zinsco panels and breakers prior to taking possession of the property. Recommend repairs by a licensed contractor.

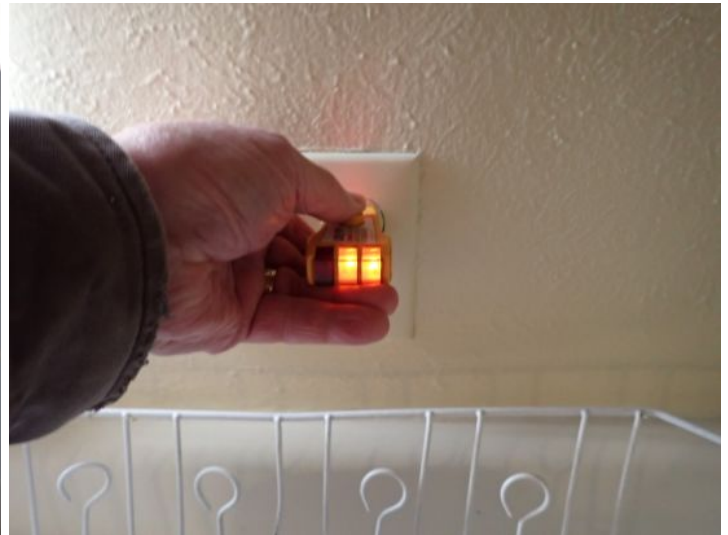
No GFCI protection for the majority of the restrooms and kitchens at the time of the inspection. Recommend repairs by a licensed electrician.

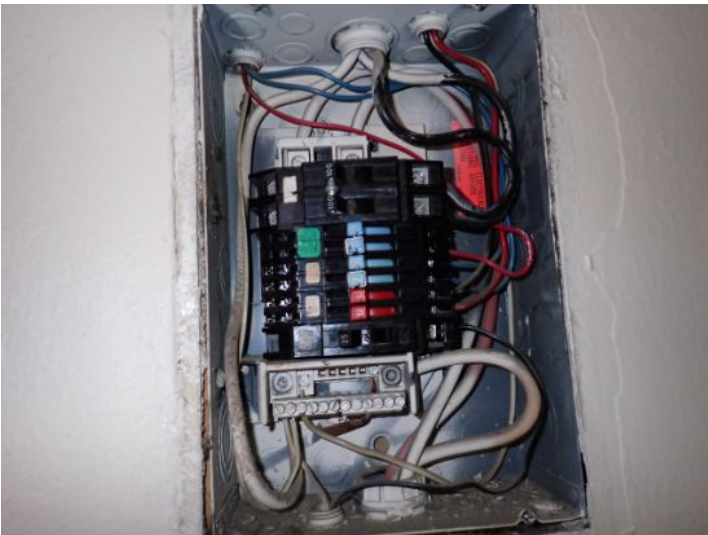
Zinsco panels were noted in the tenant units and main electrical rooms at the time of the inspection. These systems have been considered a fire/safety hazard. Recommend replacement of all Zinsco panels and breakers prior to taking possession of the property. Recommend repairs by a licensed contractor.

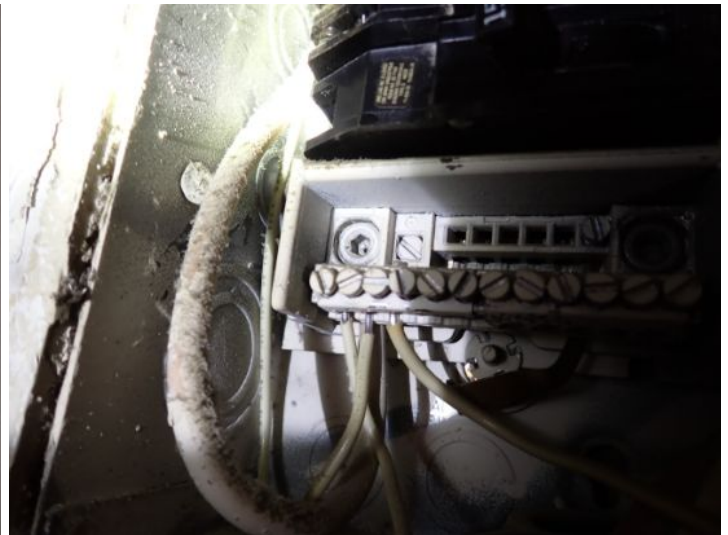
Aluminum wiring noted within the buildings at the time of the inspection. Recommend pig tailing of all aluminum wire connections within the structures. Recommend repairs by a licensed electrician.

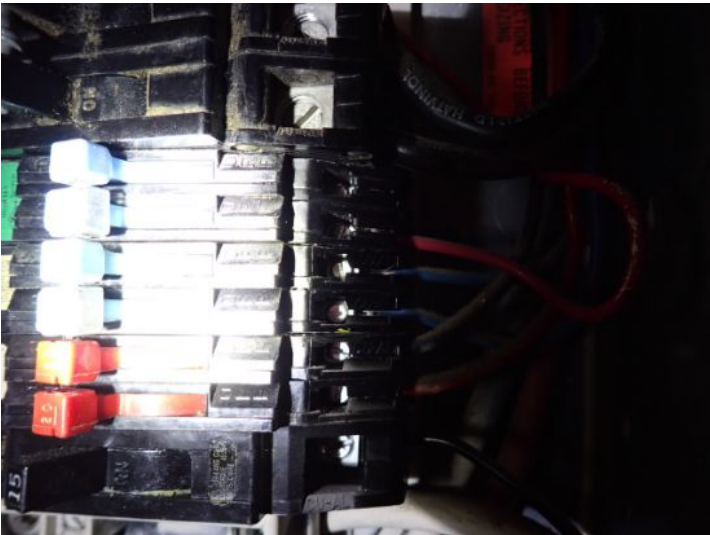
Aluminum wiring noted within the buildings at the time of the inspection. Recommend pig tailing of all aluminum wire connections within the structures. Recommend repairs by a licensed electrician.

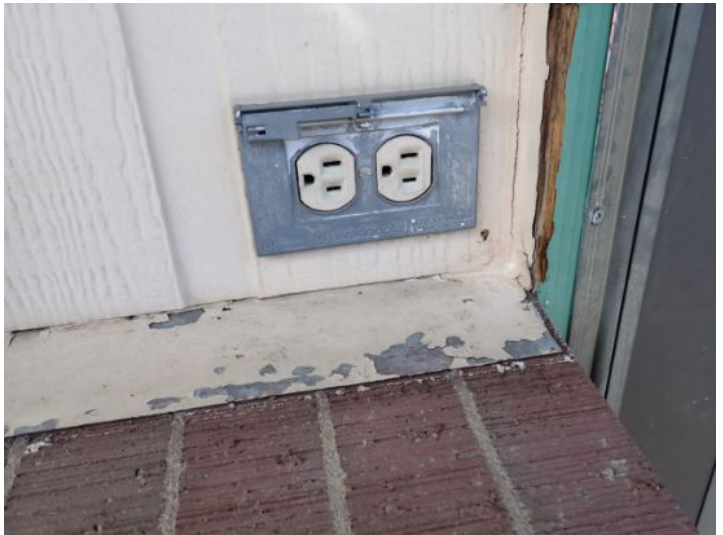
Exterior outlet missing weather cover. Recommend repairs.

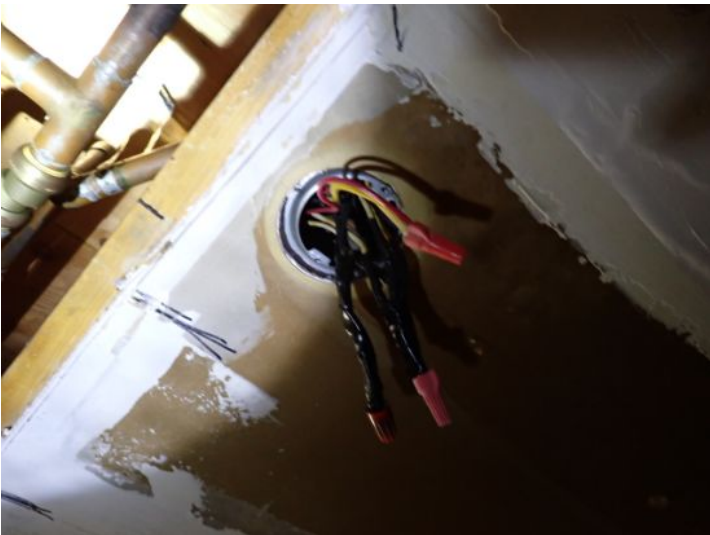
Exposed electrical wiring noted in areas. Recommend repairs by a licensed electrician.

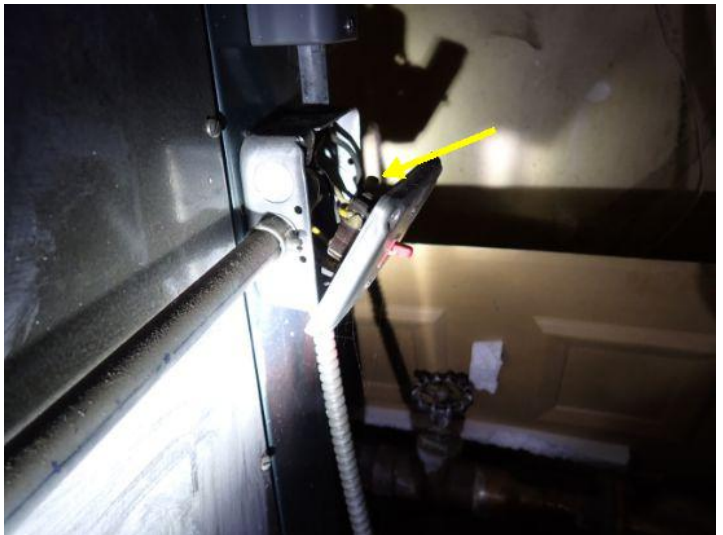
Exposed electrical wiring noted in areas. Recommend repairs by a licensed electrician.

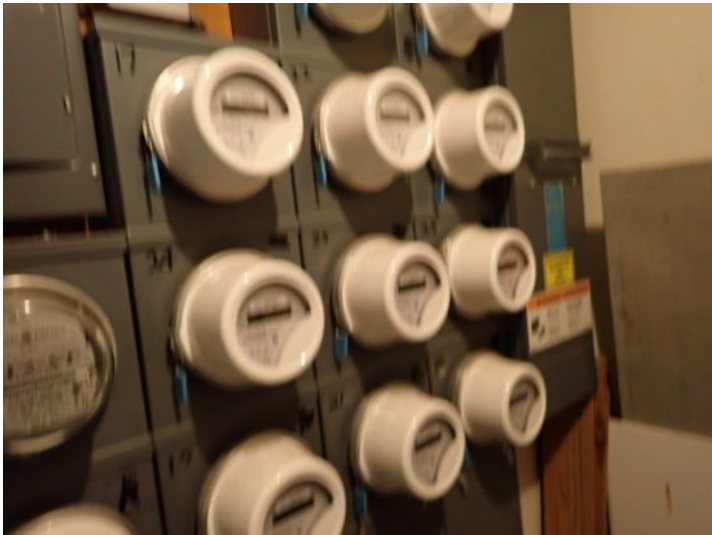
The tenant units were individually metered for electricity at the time of the inspection.
