Forman Inspection Services, LLC

Property Inspection Report

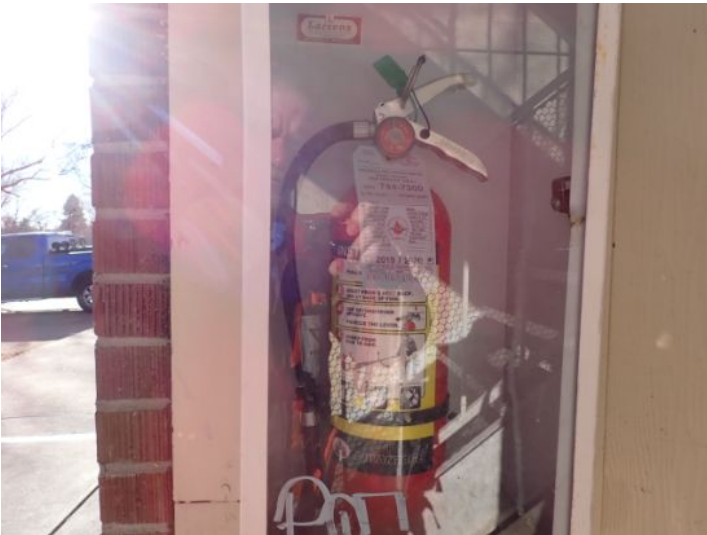
There were fire extinguishers located within the common areas of the structure

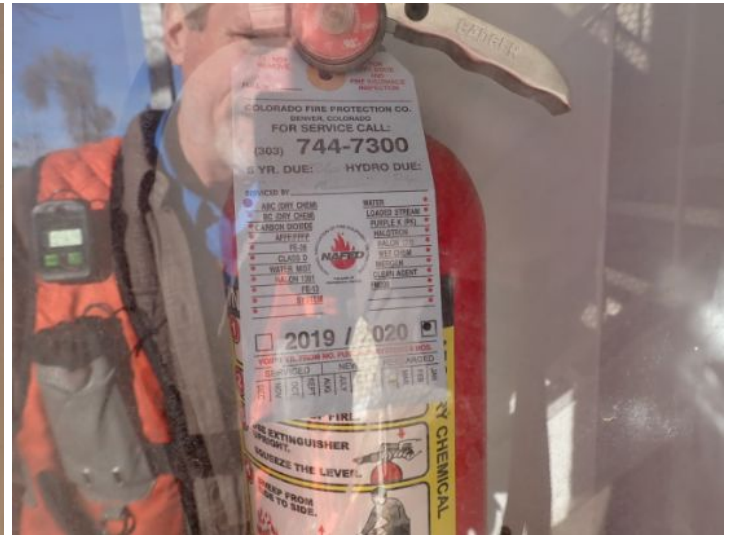
Last date of inspection/certification for the fire extinguishers was 4/20. These systems are required to be inspected/certified annually. Recommend repairs by a licensed contractor.

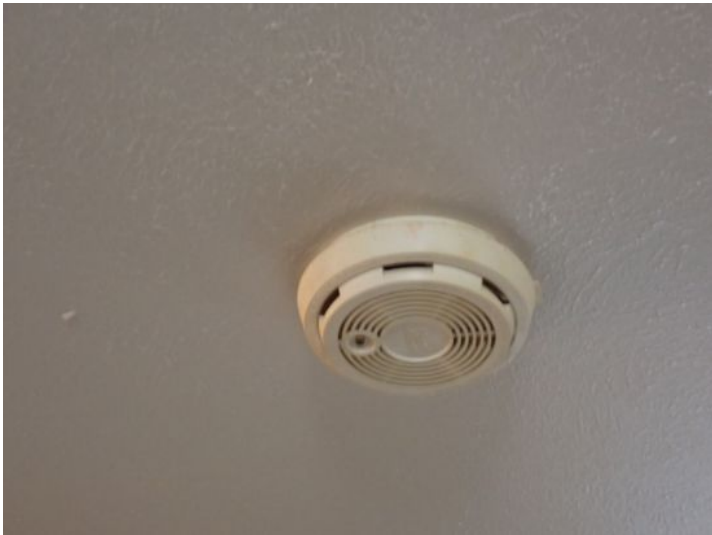
Recommend replacement of any/all smoke alarms and carbon monoxide detectors 10 years of age or older.

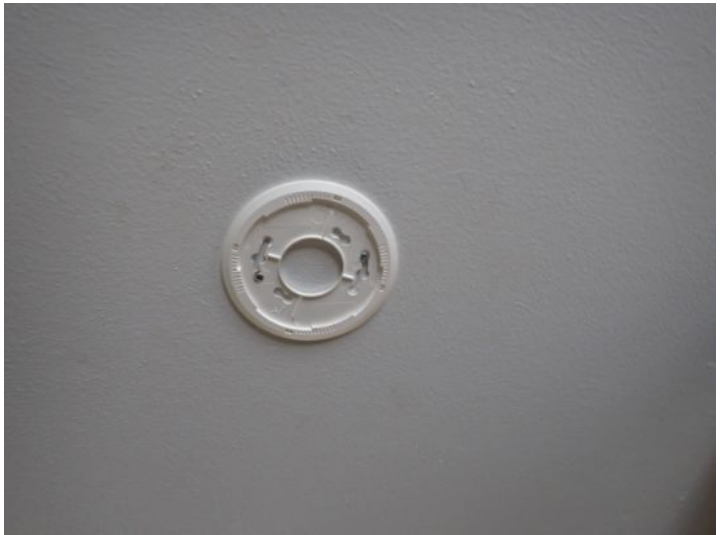
One or more smoke alarms or carbon monoxide detectors missing at the time of the inspection. Recommend repairs by a licensed contractor,

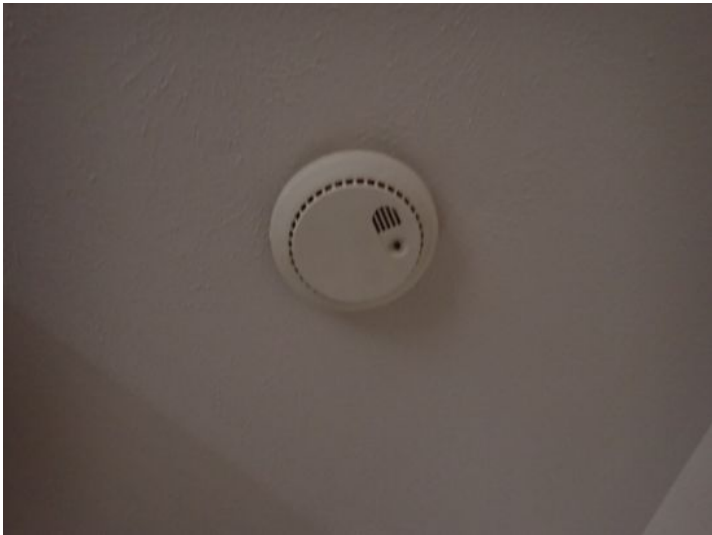
Recommend replacement of any/all smoke alarms and carbon monoxide detectors 10 years of age or older.

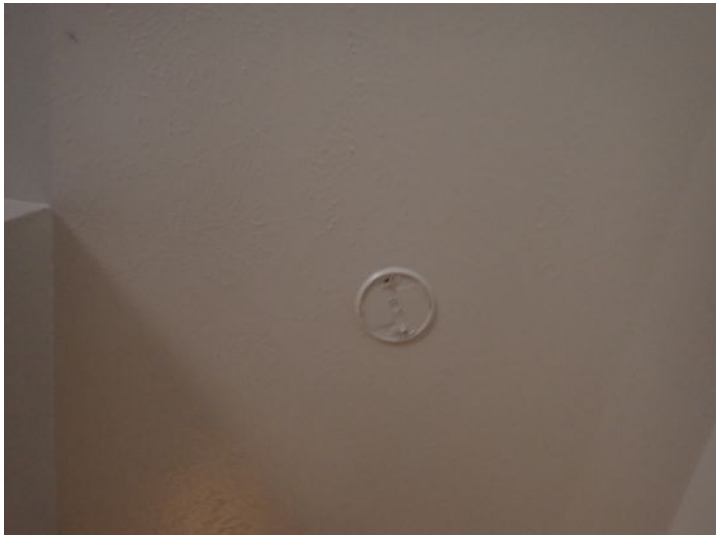
One or more smoke alarms or carbon monoxide detectors missing at the time of the inspection. Recommend repairs by a licensed contractor,

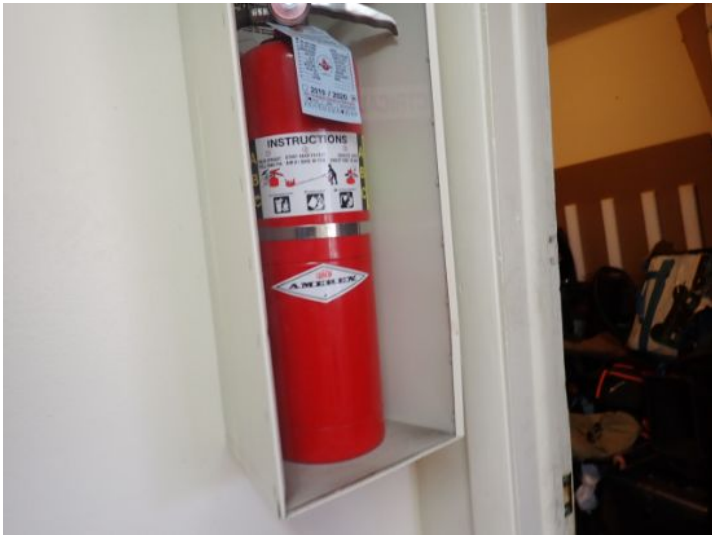
There were fire extinguishers located within the common areas of the structure

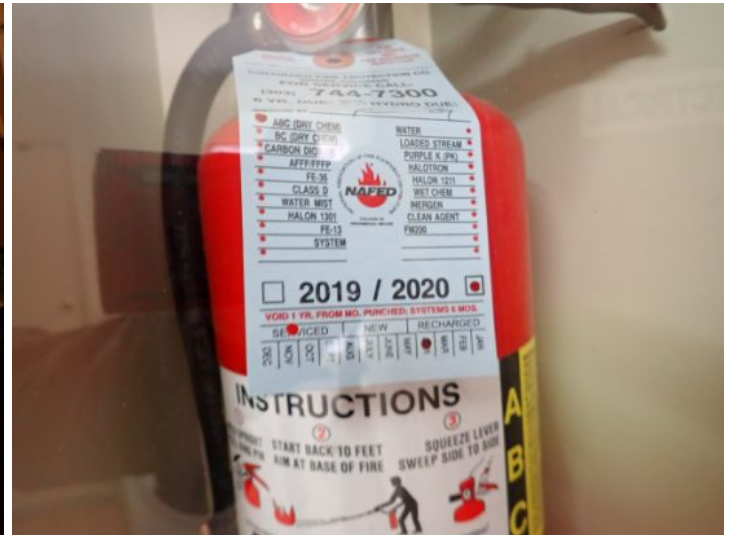
Last date of inspection/certification for the fire extinguishers was 4/20. These systems are required to be inspected/certified annually. Recommend repairs by a licensed contractor.

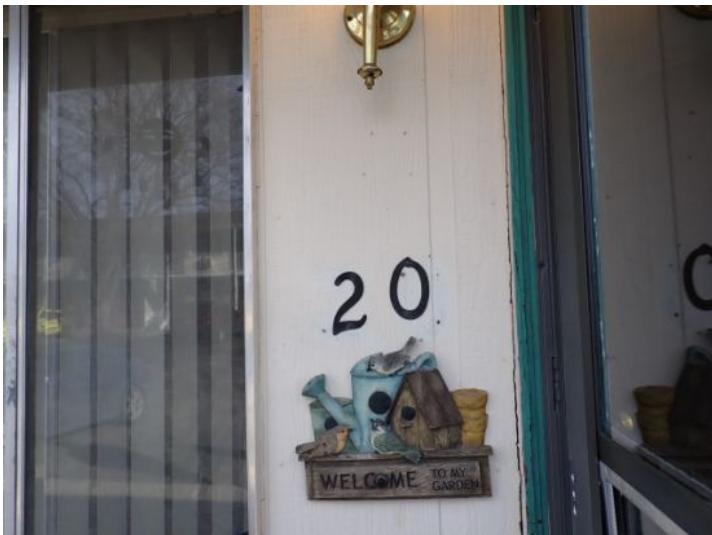
Unit 20: Damaged radiator system noted. Significant flooring deflection noted. Tub finish in poor condition. Significant wall movement noted. Recommend repairs.

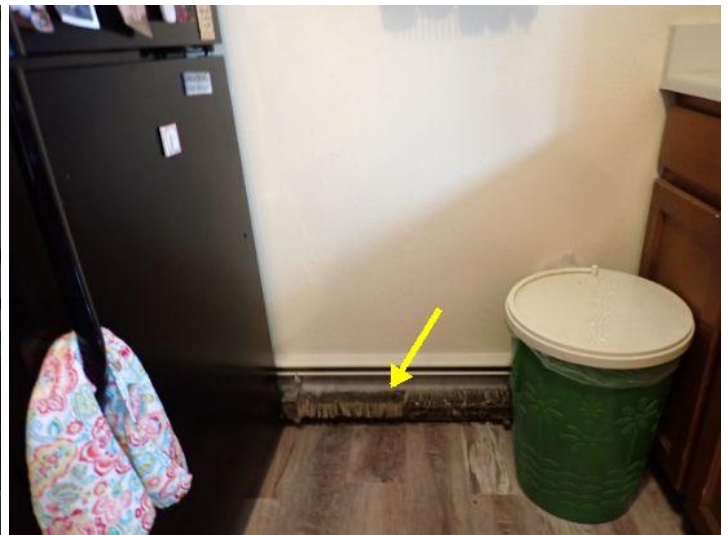
Unit 20: Damaged radiator system noted. Significant flooring deflection noted. Tub finish in poor condition. Significant wall movement noted. Recommend repairs.

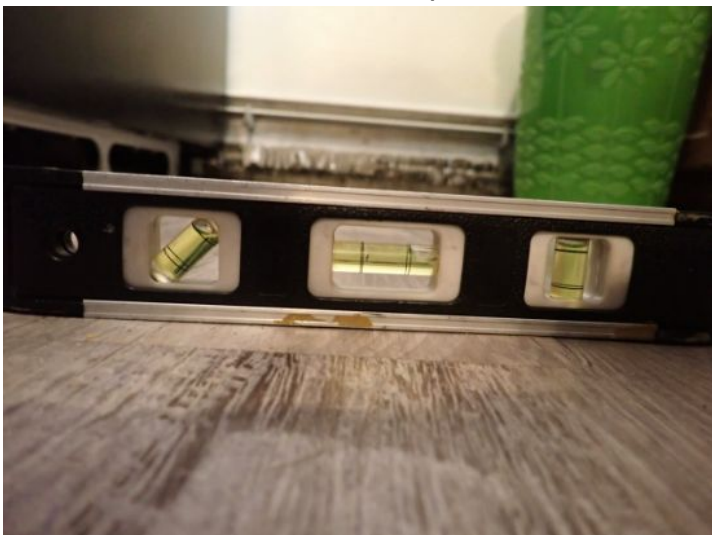
Unit 20: Damaged radiator system noted. Significant flooring deflection noted. Tub finish in poor condition. Significant wall movement noted. Recommend repairs.

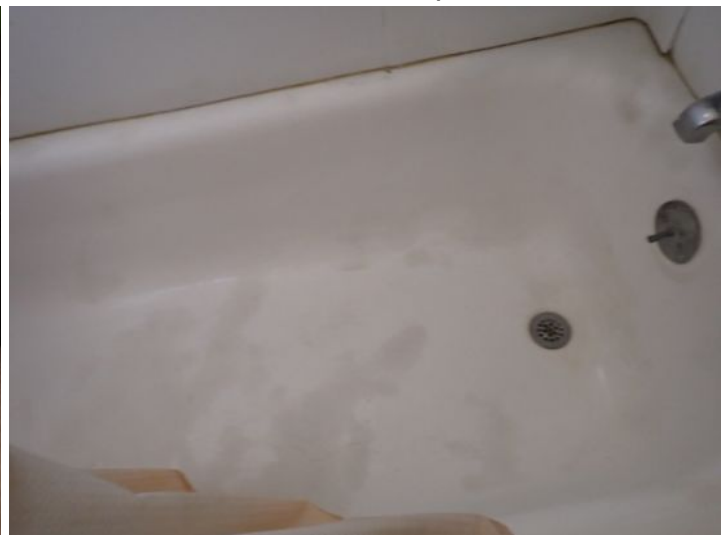
Unit 20: Damaged radiator system noted. Significant flooring deflection noted. Tub finish in poor condition. Significant wall movement noted. Recommend repairs.

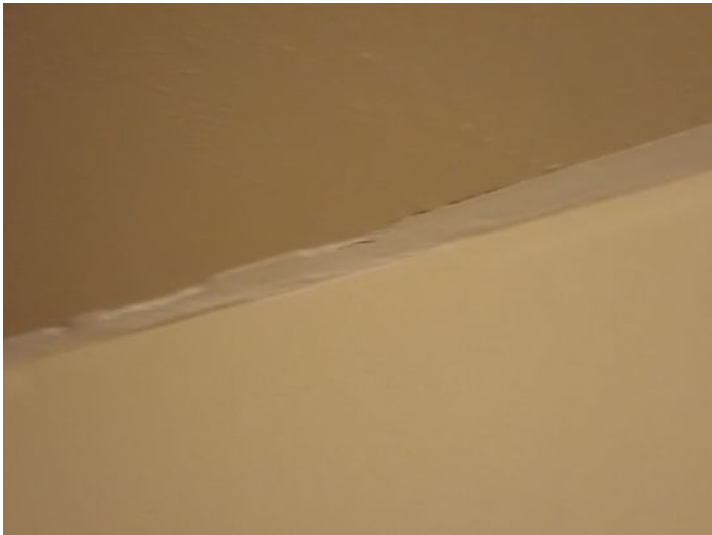
Unit 20: Damaged radiator system noted. Significant flooring deflection noted. Tub finish in poor condition. Significant wall movement noted. Recommend repairs.

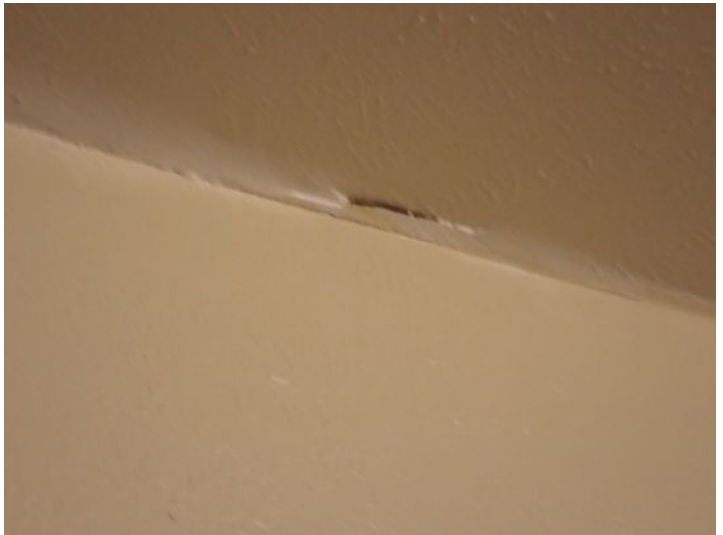
Unit 20: Damaged radiator system noted. Significant flooring deflection noted. Tub finish in poor condition. Significant wall movement noted. Recommend repairs.

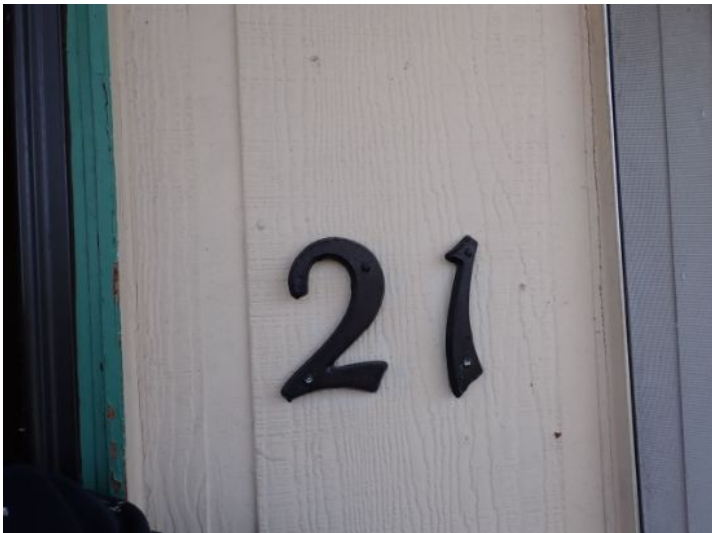
Unit 21: Missing cover plate noted on electrical panel. Wall damage noted in bathroom. Flooring damage noted. Tub spigot missing. Recommend repairs.

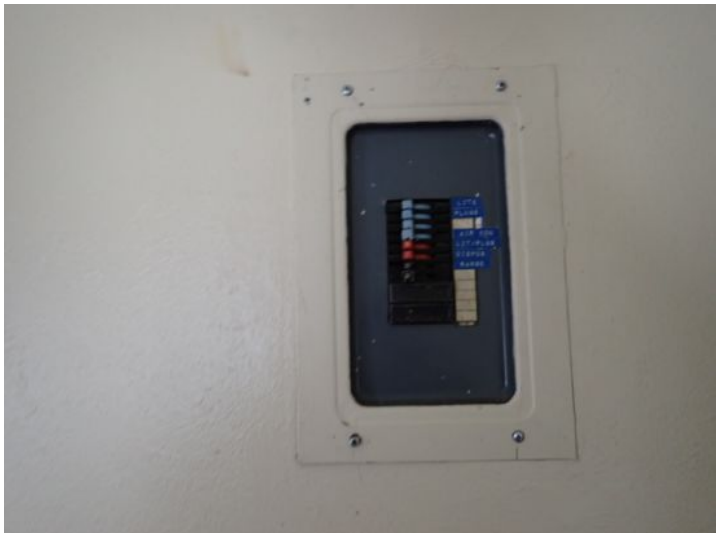
Unit 21: Missing cover plate noted on electrical panel. Wall damage noted in bathroom. Flooring damage noted. Tub spigot missing. Recommend repairs.

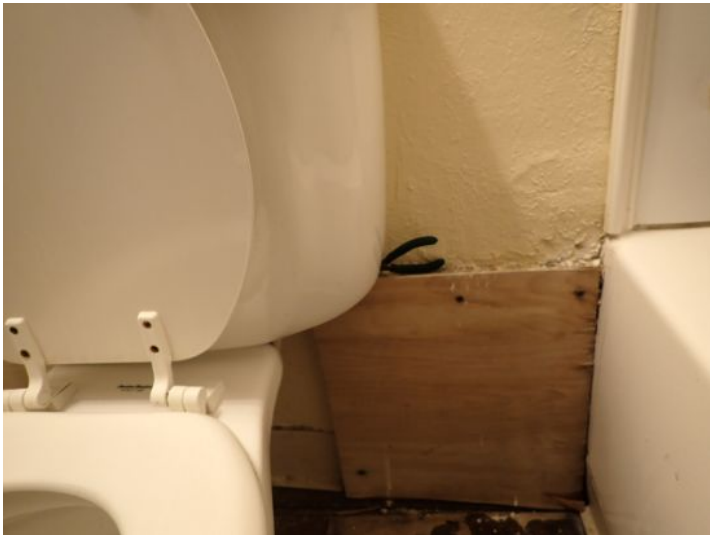
Unit 21: Missing cover plate noted on electrical panel. Wall damage noted in bathroom. Flooring damage noted. Tub spigot missing. Recommend repairs.

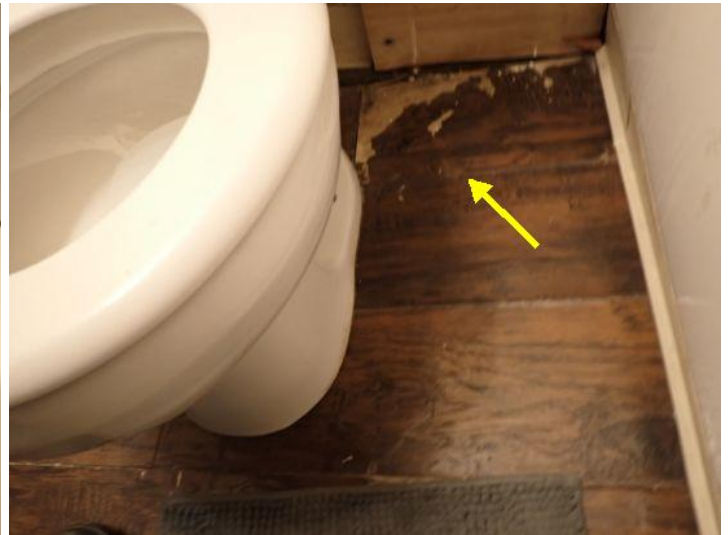
Unit 21: Missing cover plate noted on electrical panel. Wall damage noted in bathroom. Flooring damage noted. Tub spigot missing. Recommend repairs.

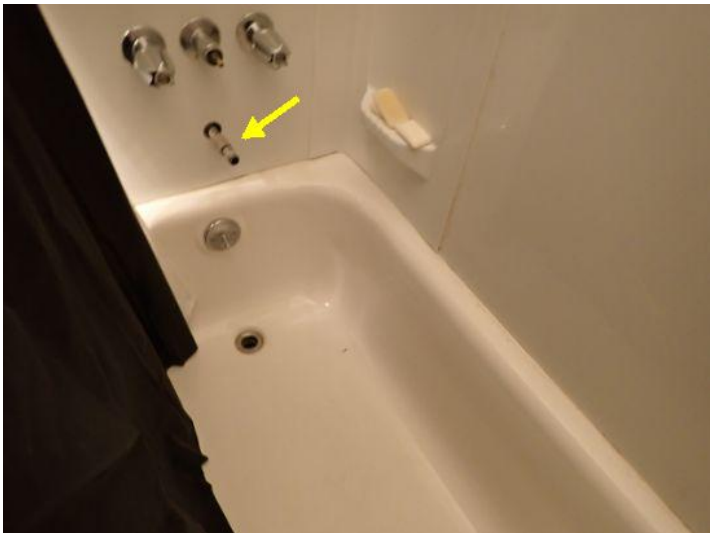
Unit 21: Missing cover plate noted on electrical panel. Wall damage noted in bathroom. Flooring damage noted. Tub spigot missing. Recommend repairs.

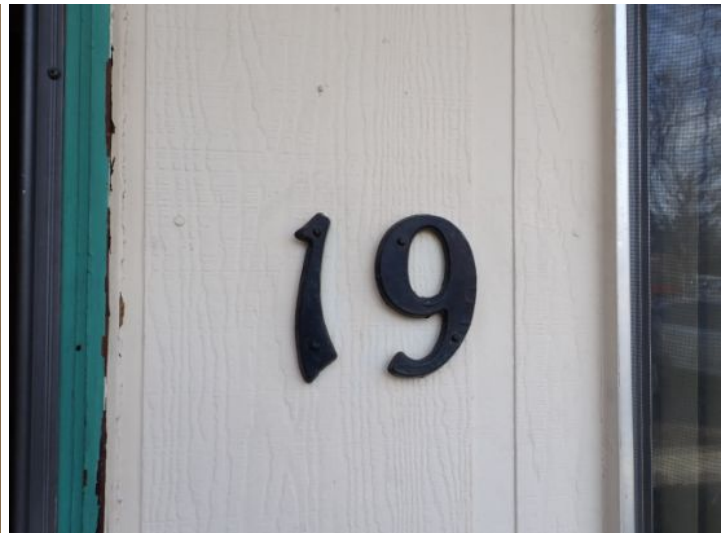
Unit 19: Significant wall movement and ceiling cracking noted. Recommend repairs.

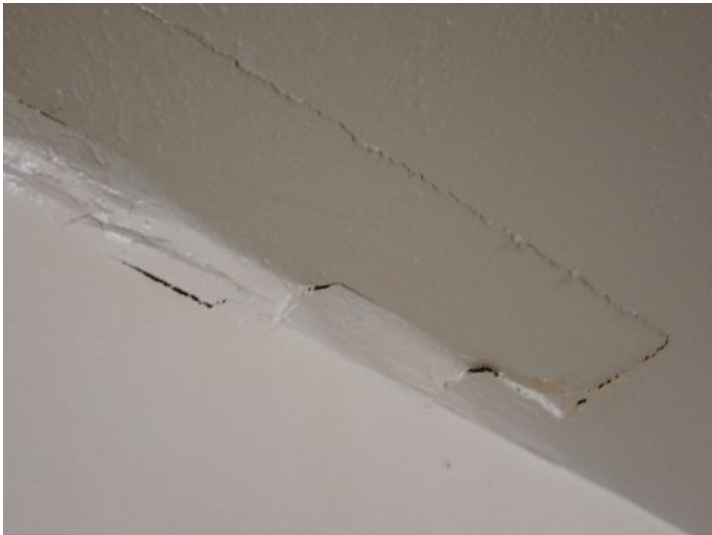
Unit 19: Significant wall movement and ceiling cracking noted. Recommend repairs.

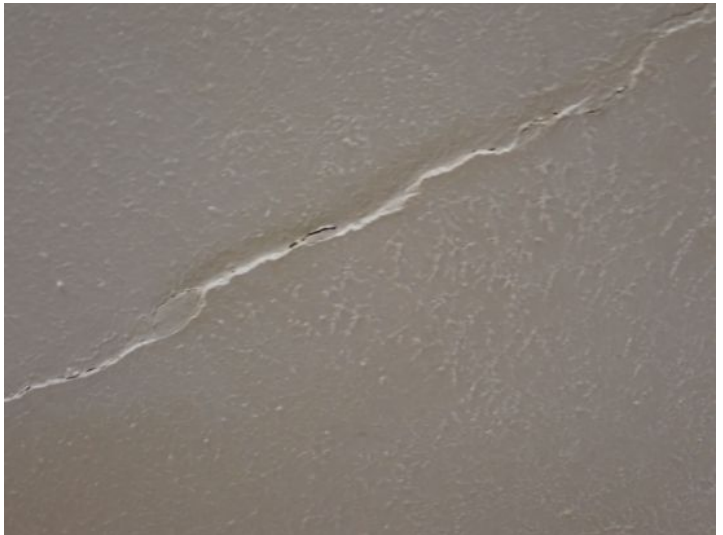
Unit 19: Significant wall movement and ceiling cracking noted. Recommend repairs.

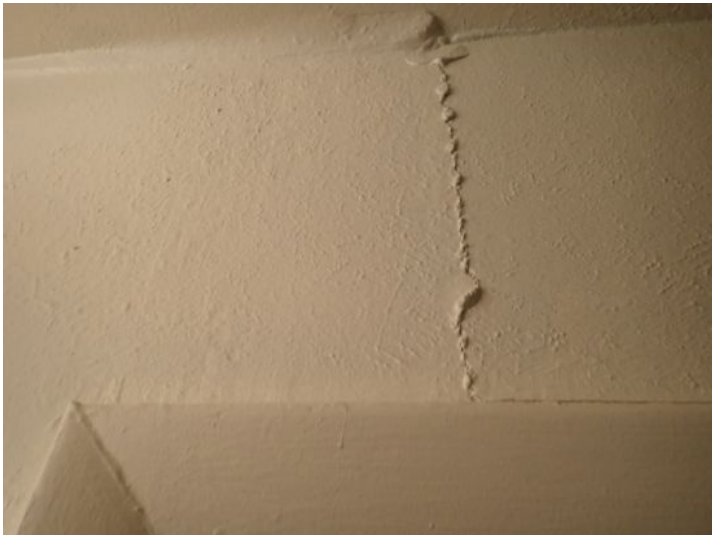
Unit 19: Significant wall movement and ceiling cracking noted. Recommend repairs.

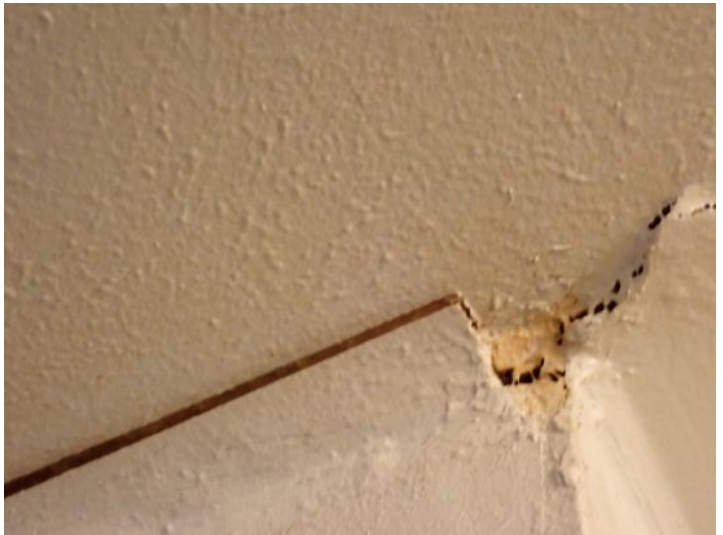
Unit 19: Significant wall movement and ceiling cracking noted. Recommend repairs.

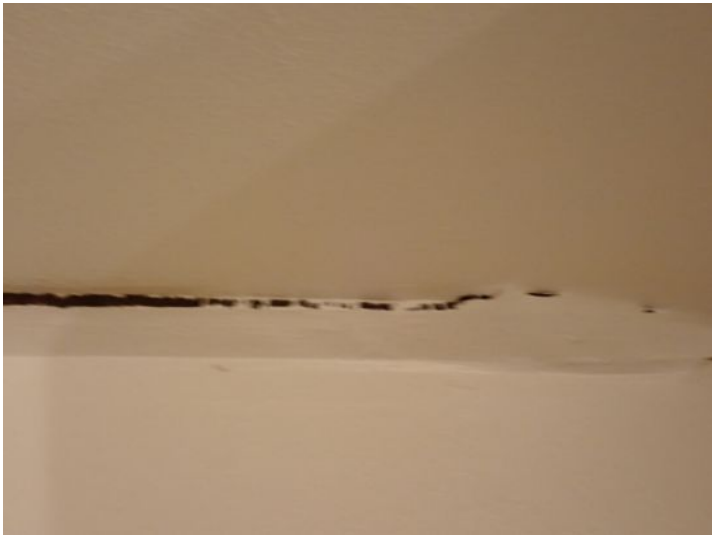
Unit 19: Significant wall movement and ceiling cracking noted. Recommend repairs.

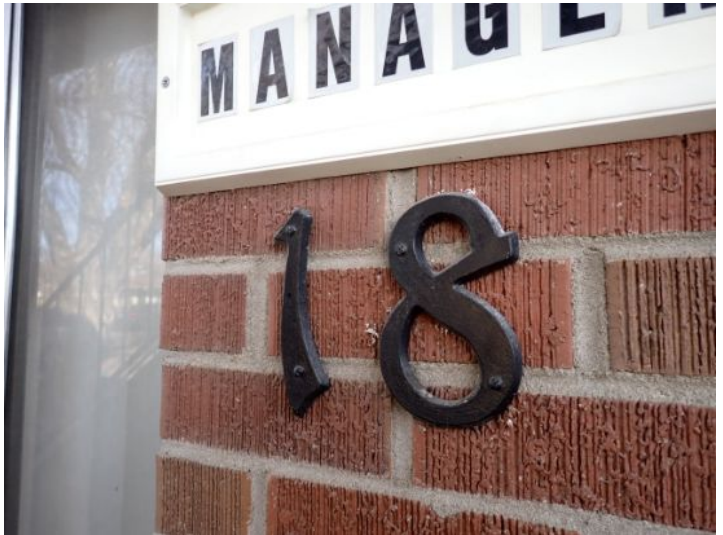
Unit 18: Carpet damage noted. Tub/shower surround requires caulk/grout repairs. Significant flooring deflection noted. Recommend repairs.

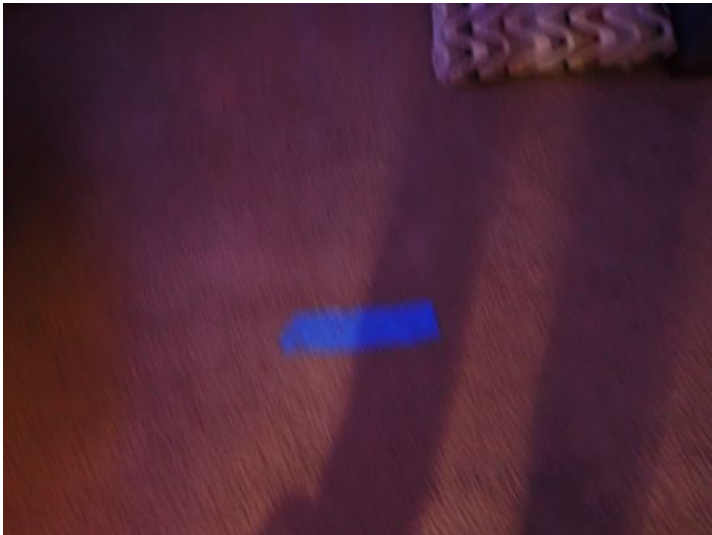
Unit 18: Carpet damage noted. Tub/shower surround requires caulk/grout repairs. Significant flooring deflection noted. Recommend repairs.

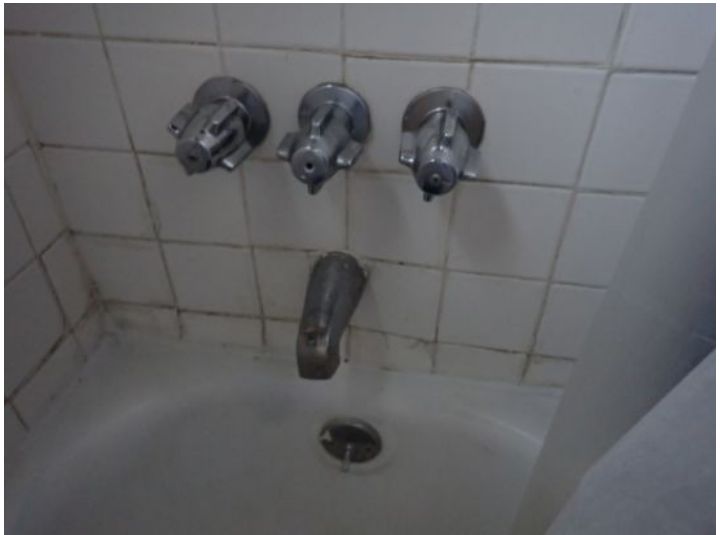
Unit 18: Carpet damage noted. Tub/shower surround requires caulk/grout repairs. Significant flooring deflection noted. Recommend repairs.

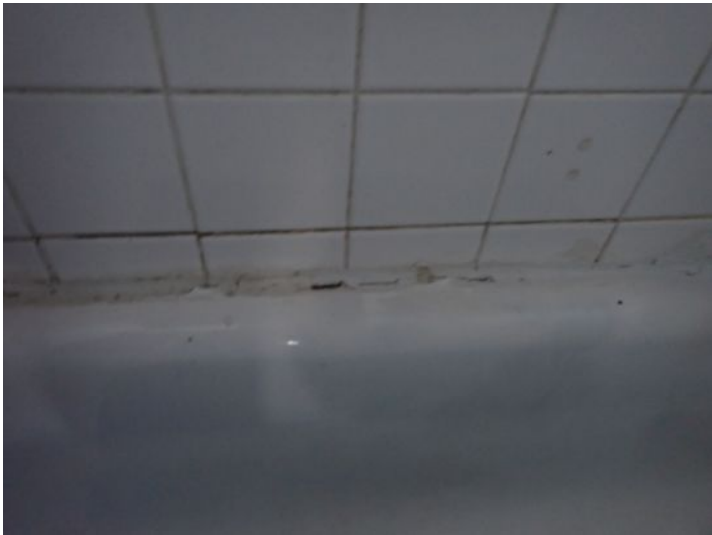
Unit 18: Carpet damage noted. Tub/shower surround requires caulk/grout repairs. Significant flooring deflection noted. Recommend repairs.

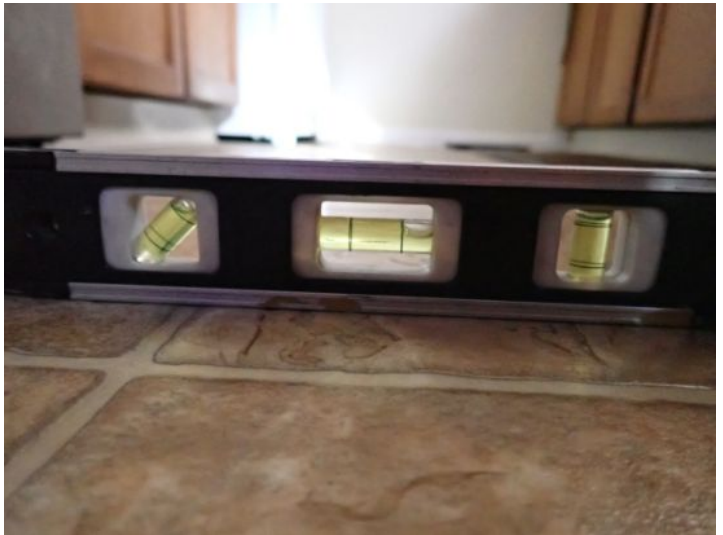
Unit 18: Carpet damage noted. Tub/shower surround requires caulk/grout repairs. Significant flooring deflection noted. Recommend repairs.

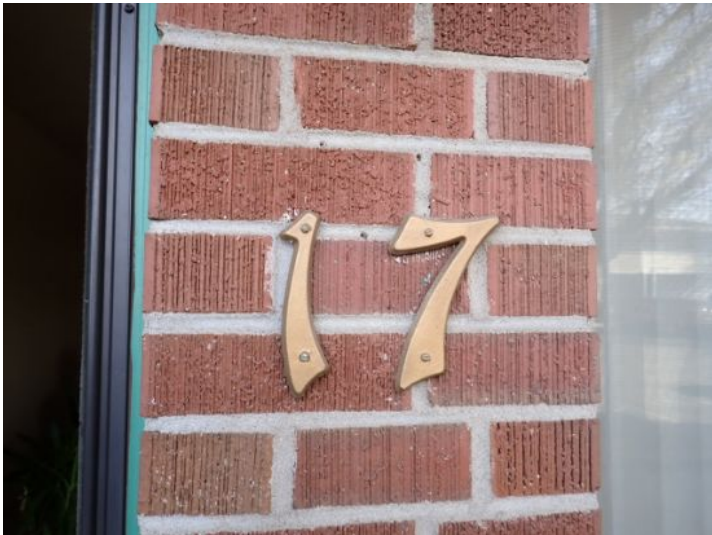
Unit 17: Tub/shower surround damage noted. Tub faucet damage. Recommend repairs.

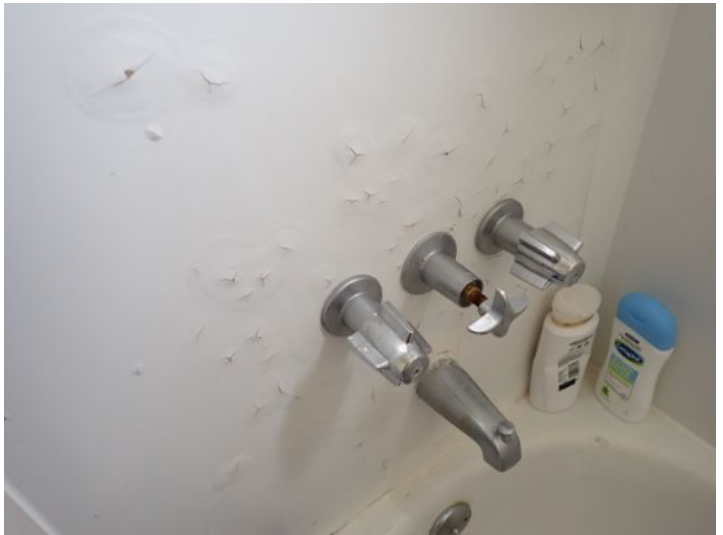
Unit 17: Tub/shower surround damage noted. Tub faucet damage. Recommend repairs.

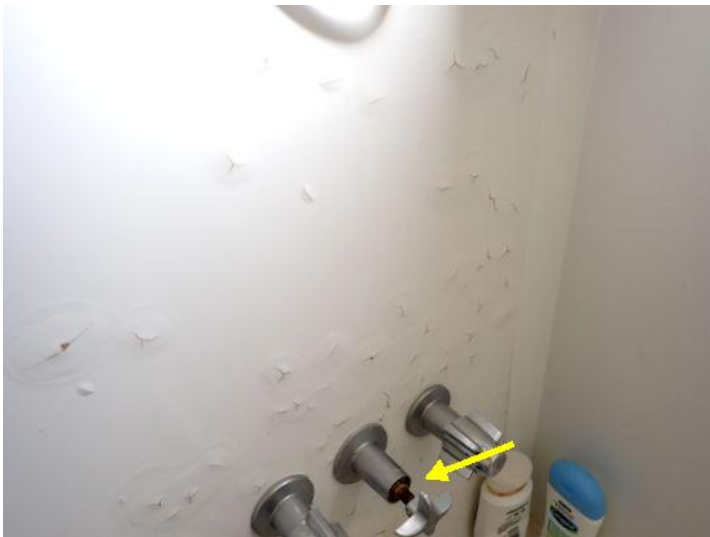
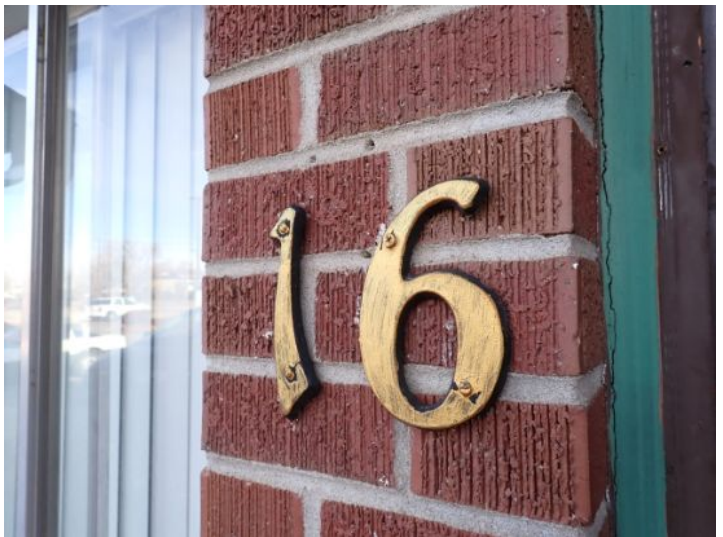
Unit 17: Tub/shower surround damage noted. Tub faucet damage. Recommend repairs.

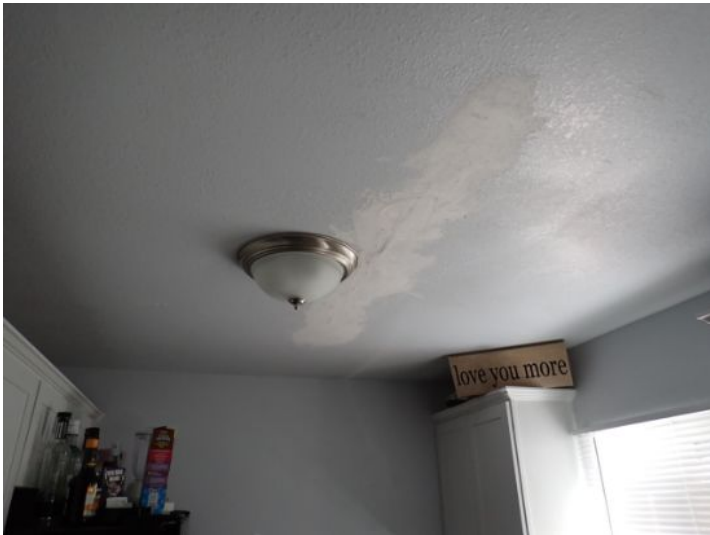
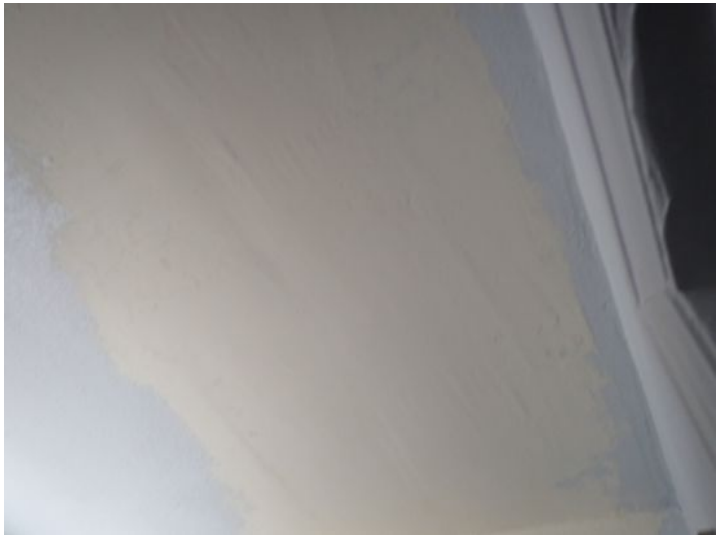
Unit 16: Kitchen ceiling cracking. Bathroom ceiling damage. Wall damage noted. Door trim missing. Recommend repairs.

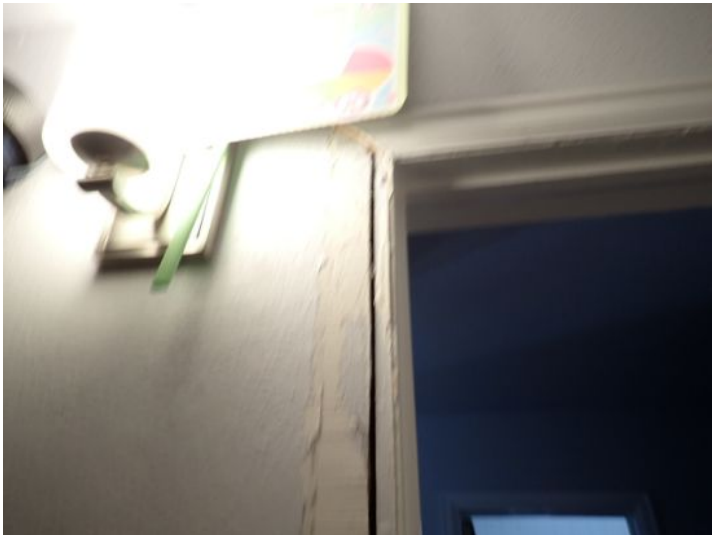
Unit 16: Kitchen ceiling cracking. Bathroom ceiling damage. Wall damage noted. Door trim missing. Recommend repairs.

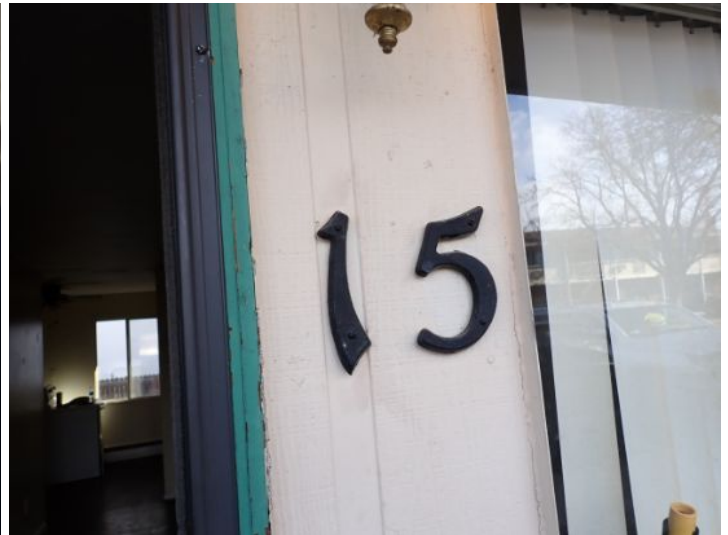
Unit 15: Unit being turned at the time of the inspection.

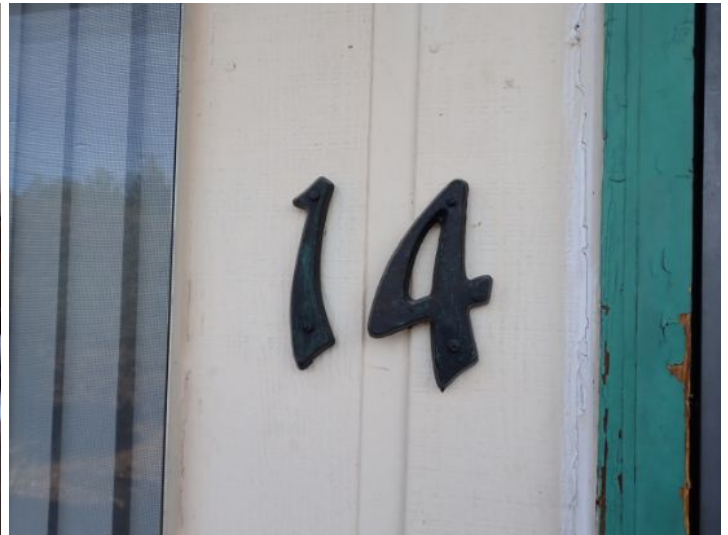
Unit 14: No significant findings noted at the time of the inspection.

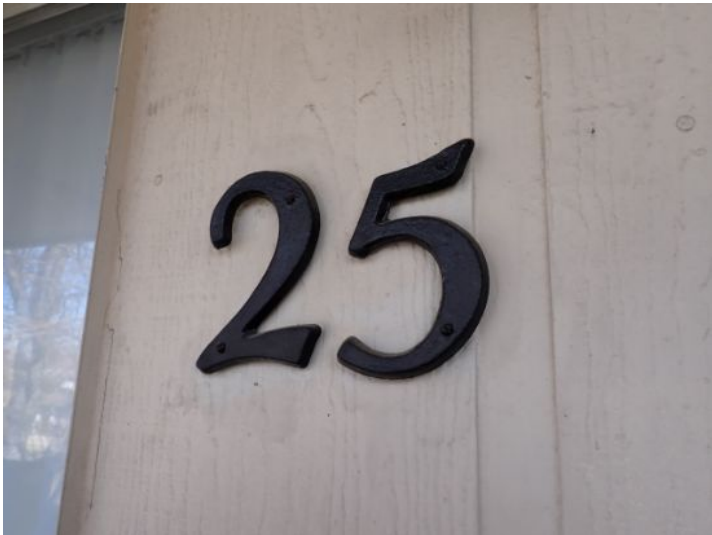
Unit 25: No significant findings noted at the time of the inspection.

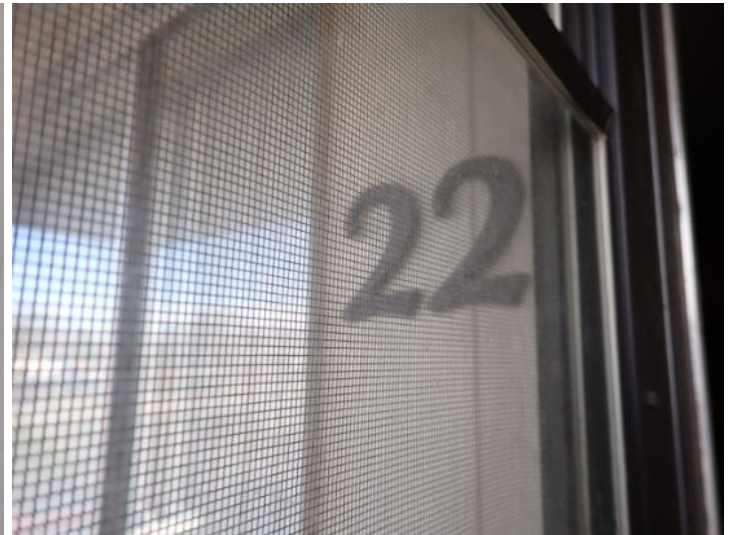
Unit 22: Carpeting in poor condition. Vinyl flooring damage noted. Missing dead cover on electrical panel. Wall damage noted in bathroom. Cracked mirror on closet door. Recommend repairs.

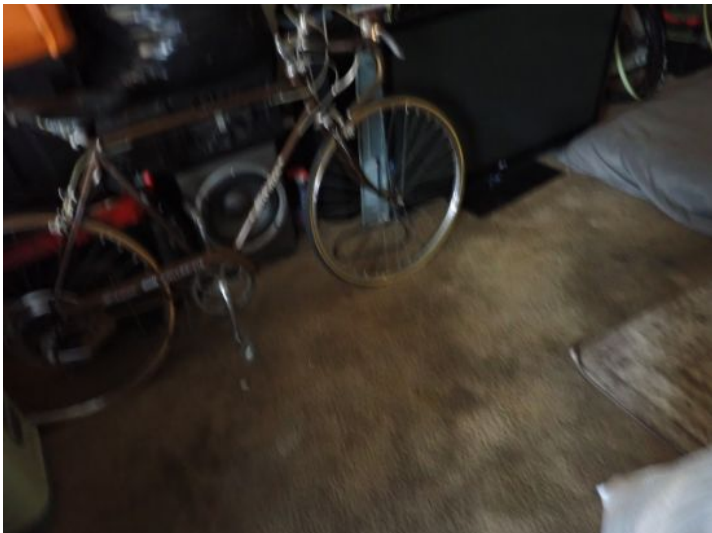
Unit 22: Carpeting in poor condition. Vinyl flooring damage noted. Missing dead cover on electrical panel. Wall damage noted in bathroom. Cracked mirror on closet door. Recommend repairs.

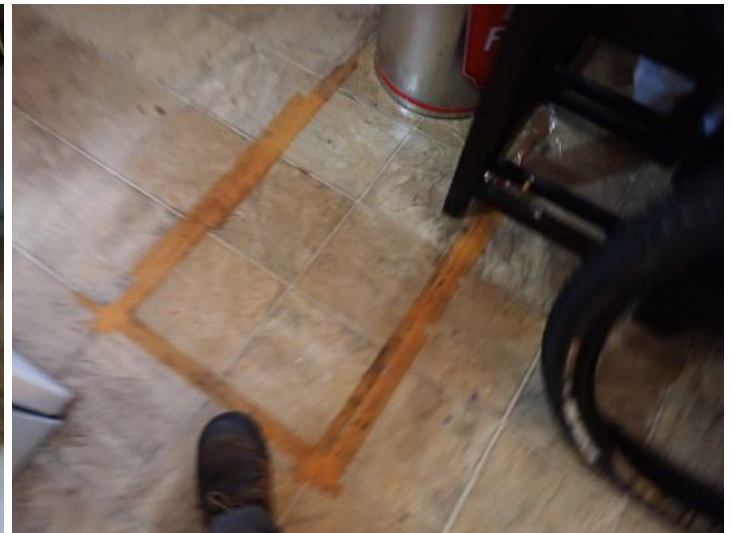
Unit 22: Carpeting in poor condition. Vinyl flooring damage noted. Missing dead cover on electrical panel. Wall damage noted in bathroom. Cracked mirror on closet door. Recommend repairs.

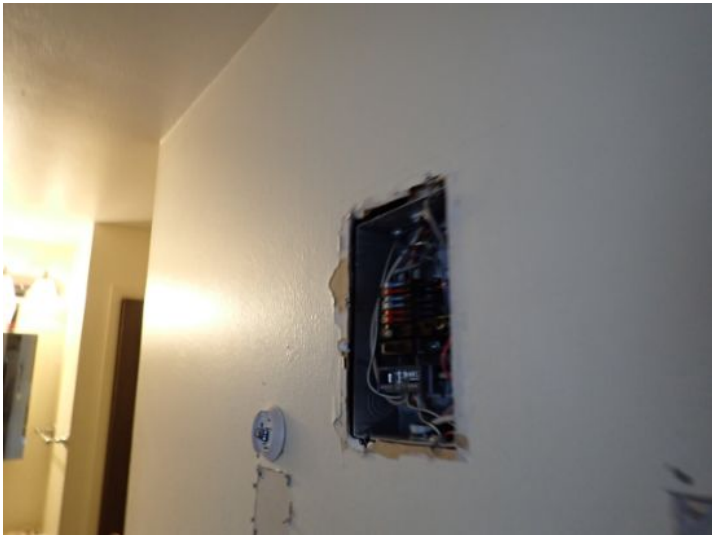
Unit 22: Carpeting in poor condition. Vinyl flooring damage noted. Missing dead cover on electrical panel. Wall damage noted in bathroom. Cracked mirror on closet door. Recommend repairs.

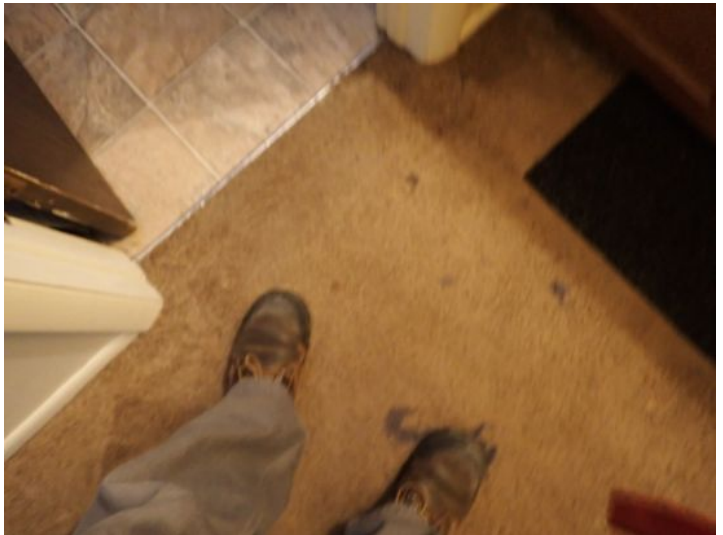
Unit 22: Carpeting in poor condition. Vinyl flooring damage noted. Missing dead cover on electrical panel. Wall damage noted in bathroom. Cracked mirror on closet door. Recommend repairs.

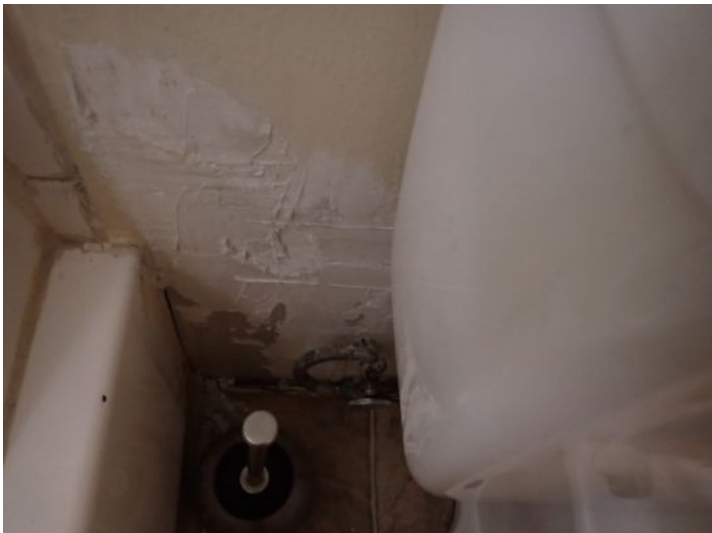
Unit 22: Carpeting in poor condition. Vinyl flooring damage noted. Missing dead cover on electrical panel. Wall damage noted in bathroom. Cracked mirror on closet door. Recommend repairs.

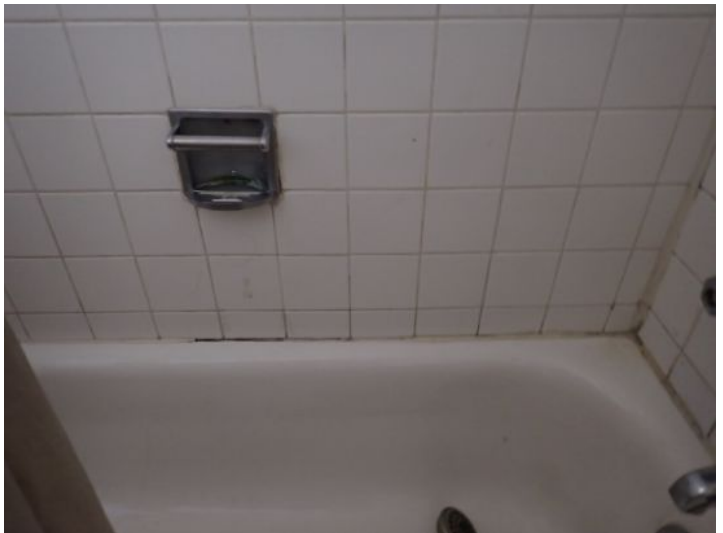
Unit 22: Carpeting in poor condition. Vinyl flooring damage noted. Missing dead cover on electrical panel. Wall damage noted in bathroom. Cracked mirror on closet door. Recommend repairs.

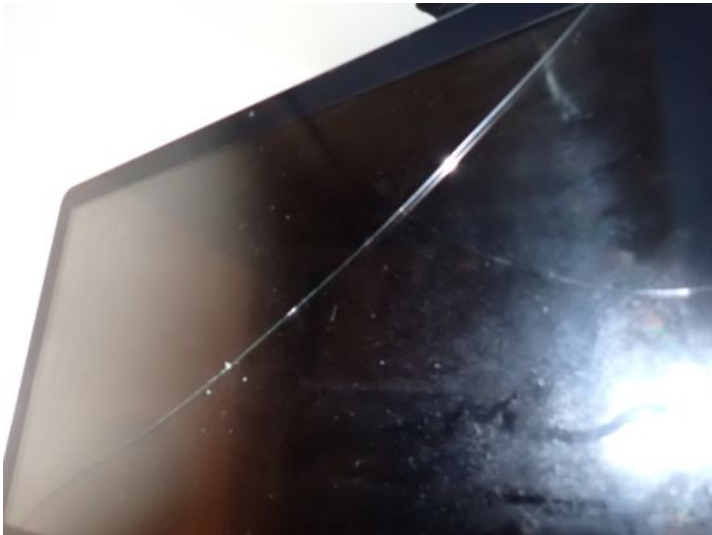
Unit 22: Carpeting in poor condition. Vinyl flooring damage noted. Missing dead cover on electrical panel. Wall damage noted in bathroom. Cracked mirror on closet door. Recommend repairs.

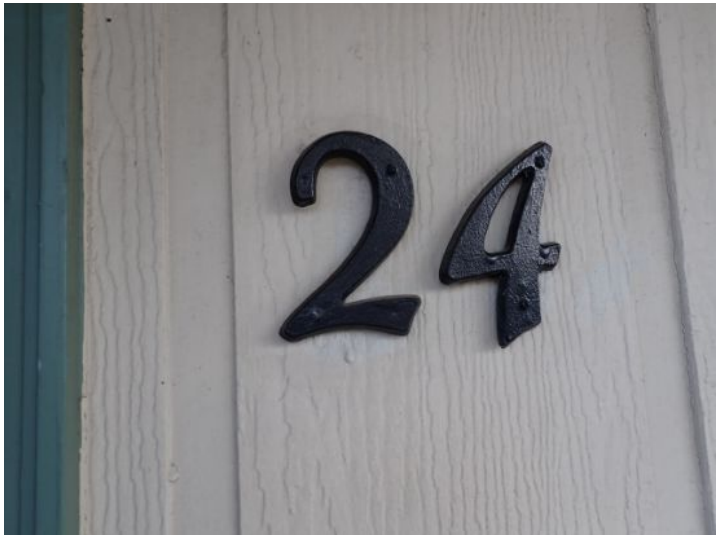
Unit 24: Carpet in poor condition. Ceiling/wall junction cracking. Vinyl floor damage. Wall damage noted below kitchen sink. Recommend repairs.

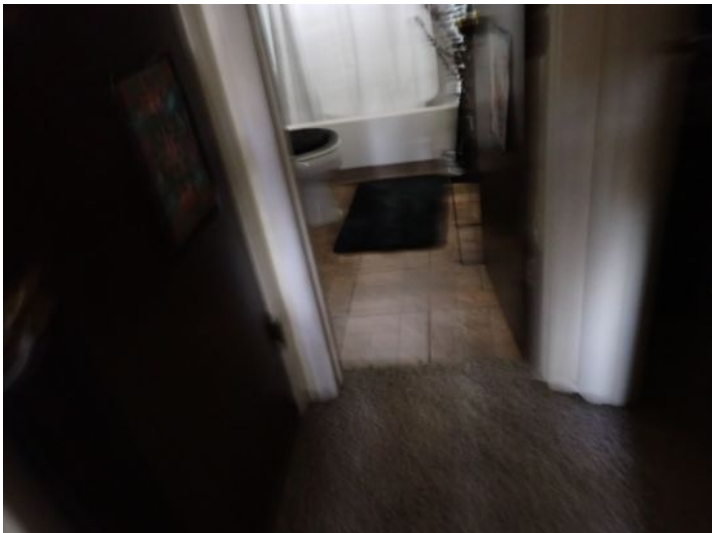
Unit 24: Carpet in poor condition. Ceiling/wall junction cracking. Vinyl floor damage. Wall damage noted below kitchen sink. Recommend repairs.

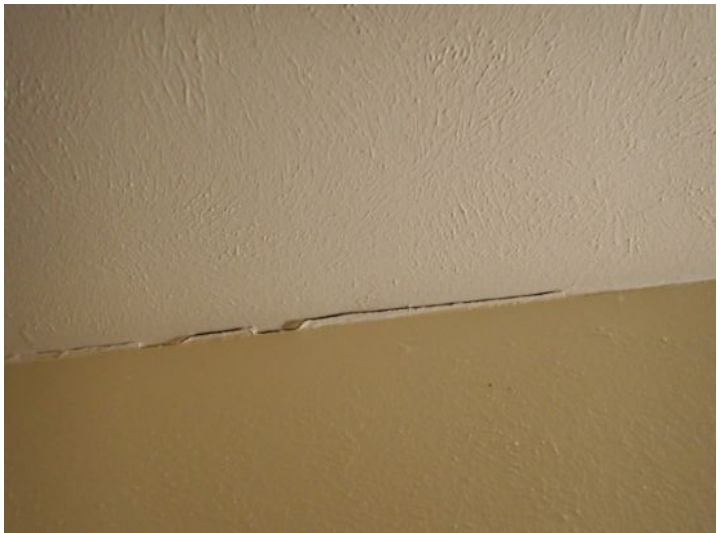
Unit 24: Carpet in poor condition. Ceiling/wall junction cracking. Vinyl floor damage. Wall damage noted below kitchen sink. Recommend repairs.

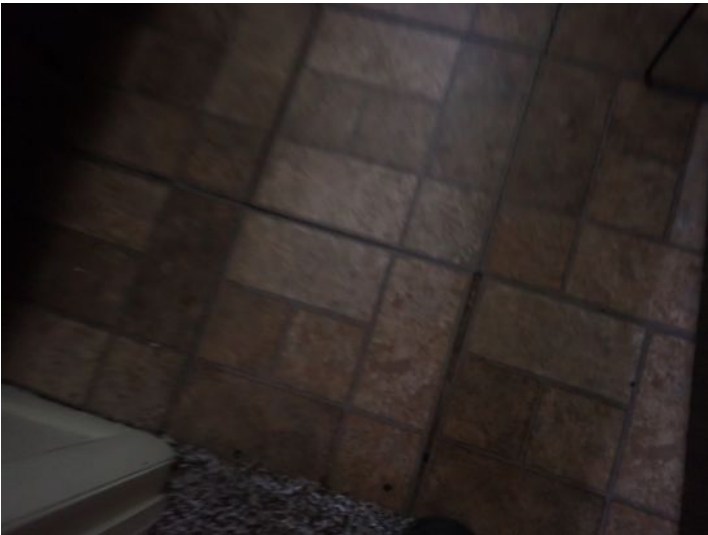
Unit 24: Carpet in poor condition. Ceiling/wall junction cracking. Vinyl floor damage. Wall damage noted below kitchen sink. Recommend repairs.

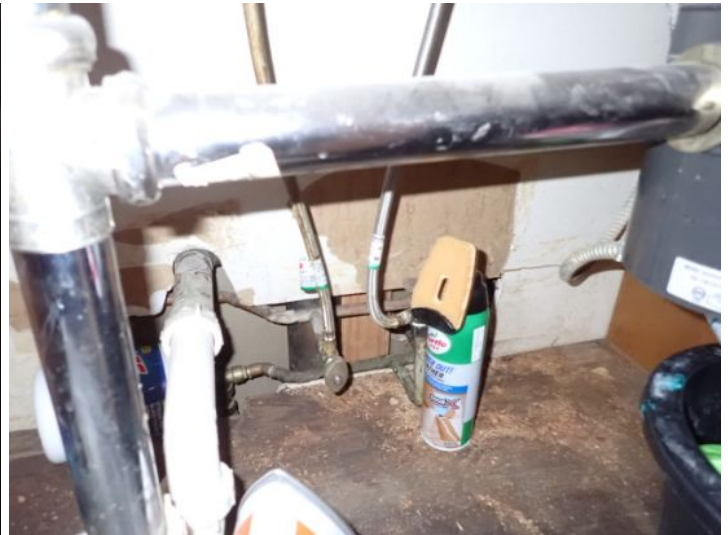
Unit 24: Carpet in poor condition. Ceiling/wall junction cracking. Vinyl floor damage. Wall damage noted below kitchen sink. Recommend repairs.

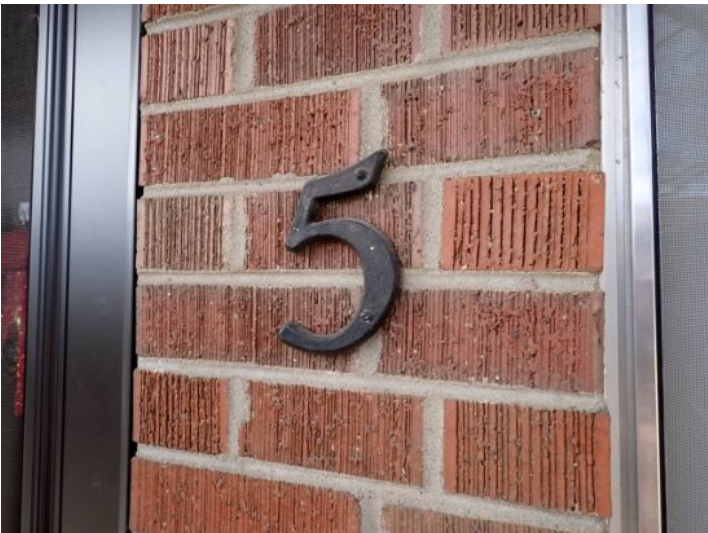
Unit 5: Tub finish in poor condition. Recommend repairs.

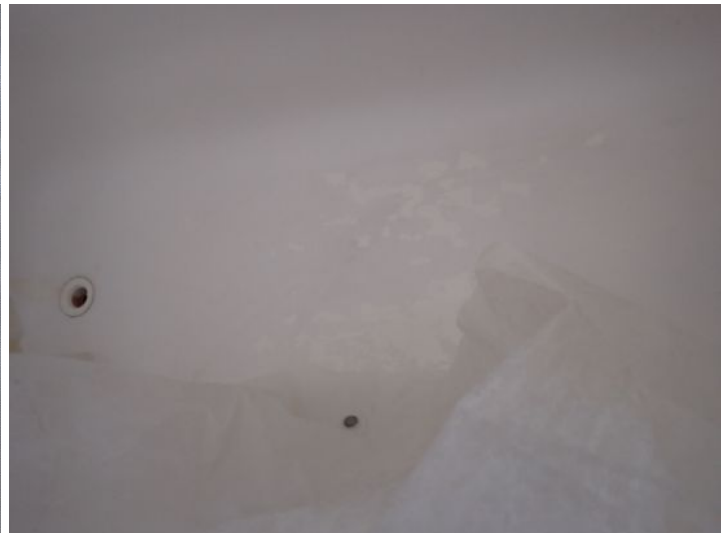
Unit 5: Tub finish in poor condition. Recommend repairs.
