Forman Inspection Services, LLC

Property Inspection Report

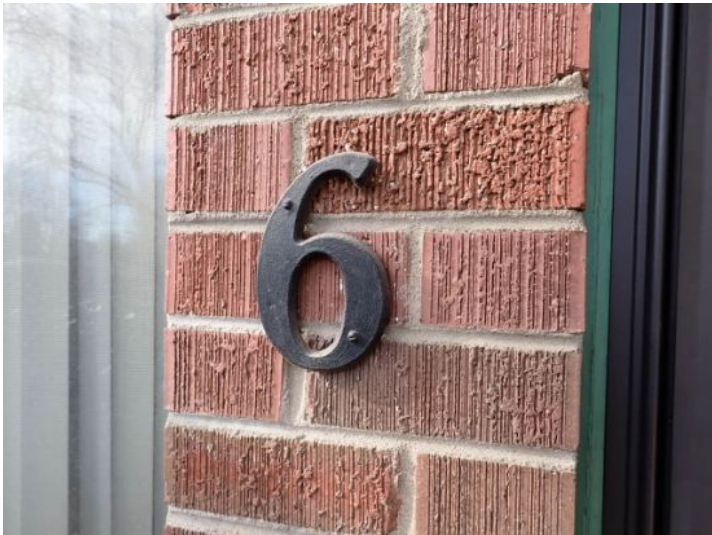
Unit 6: Kitchen sink faucet leaking at valve handle. Recommend repairs.

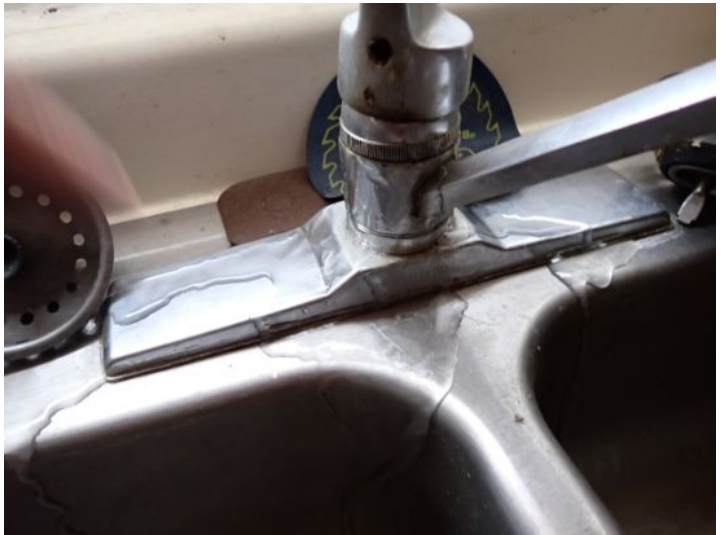
Unit 6: Kitchen sink faucet leaking at valve handle. Recommend repairs.

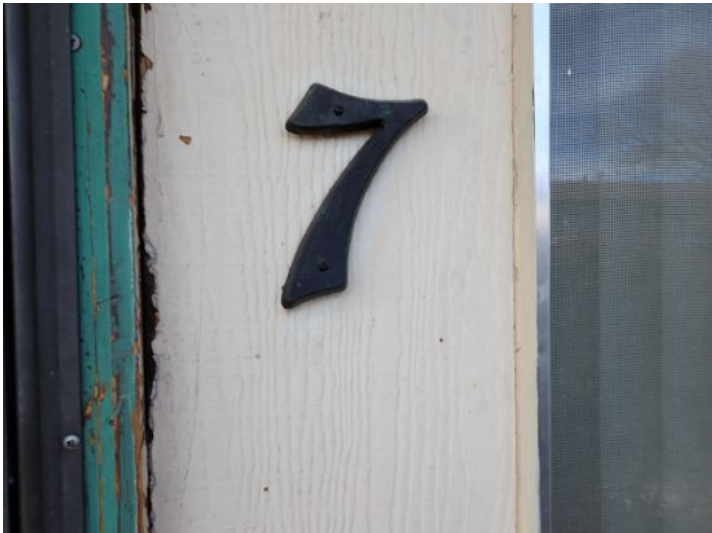
Unit 7: No significant findings noted at the time of the inspection.

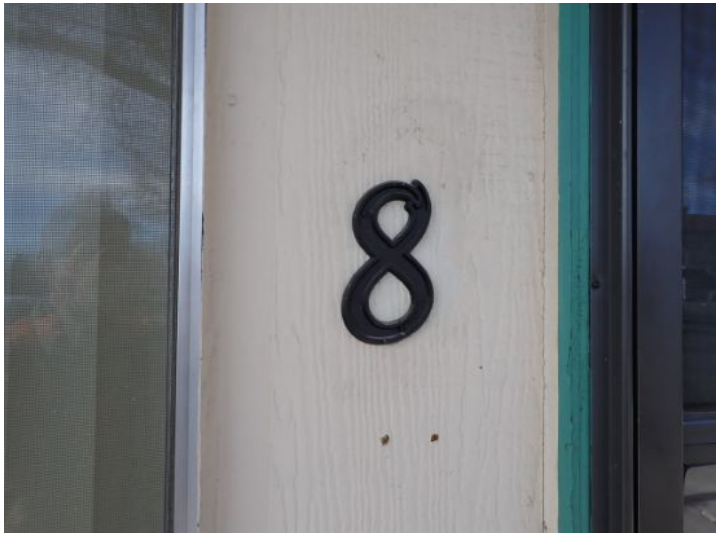
Unit 8: Carpet in poor condition. Recommend repairs.

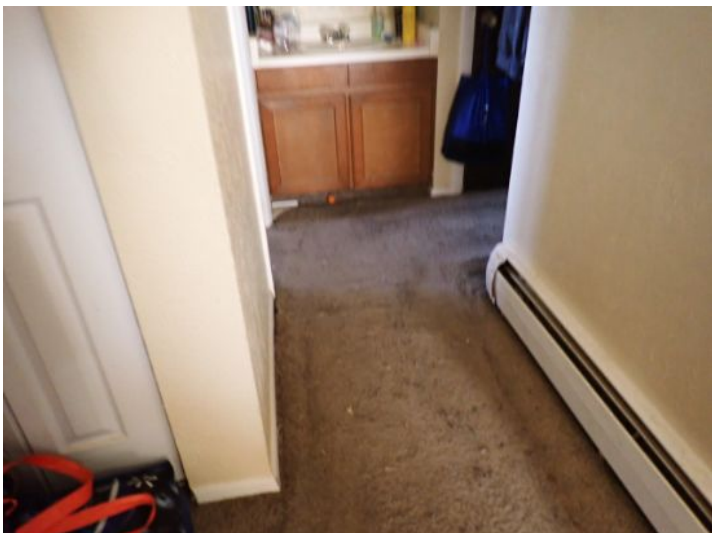
Unit 8: Carpet in poor condition. Recommend repairs.

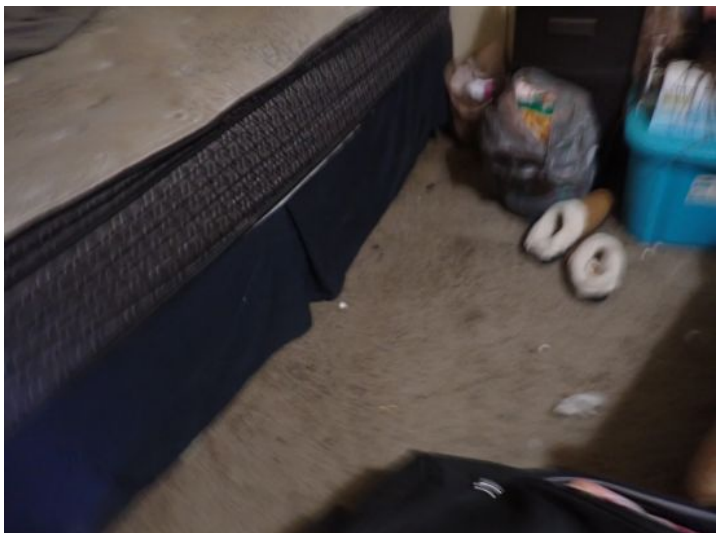
Unit 8: Carpet in poor condition. Recommend repairs.

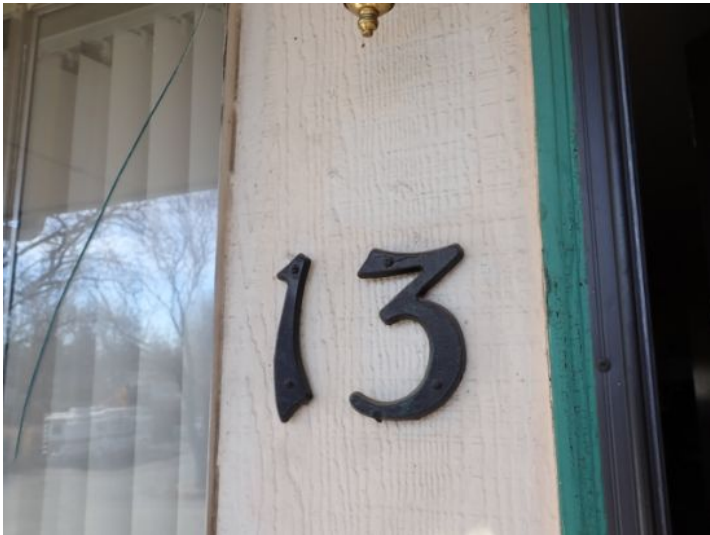
Unit 13: Cracked window glass. Broken window glass in rear of unit. Tub/shower surround requires caulk/grout repairs. Tub finish in poor condition. Closet door damage noted. Vinyl flooring damage noted. Recommend repairs.

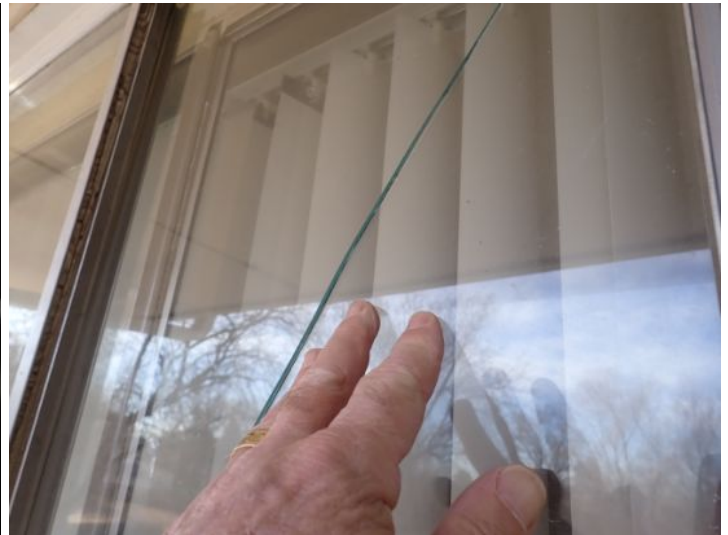
Unit 13: Cracked window glass. Broken window glass in rear of unit. Tub/shower surround requires caulk/grout repairs. Tub finish in poor condition. Closet door damage noted. Vinyl flooring damage noted. Recommend repairs.

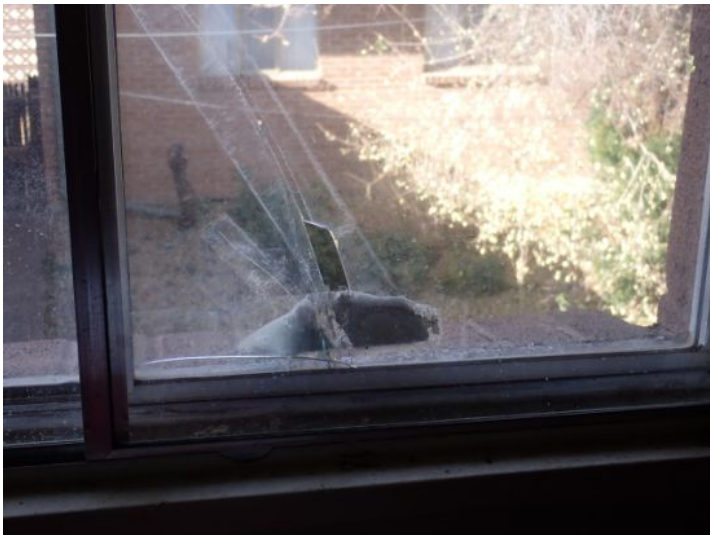
Unit 13: Cracked window glass. Broken window glass in rear of unit. Tub/shower surround requires caulk/grout repairs. Tub finish in poor condition. Closet door damage noted. Vinyl flooring damage noted. Recommend repairs.

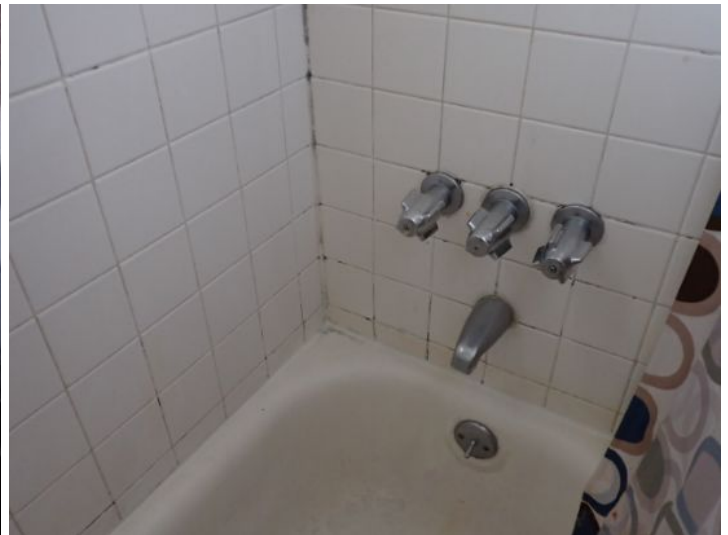
Unit 13: Cracked window glass. Broken window glass in rear of unit. Tub/shower surround requires caulk/grout repairs. Tub finish in poor condition. Closet door damage noted. Vinyl flooring damage noted. Recommend repairs.

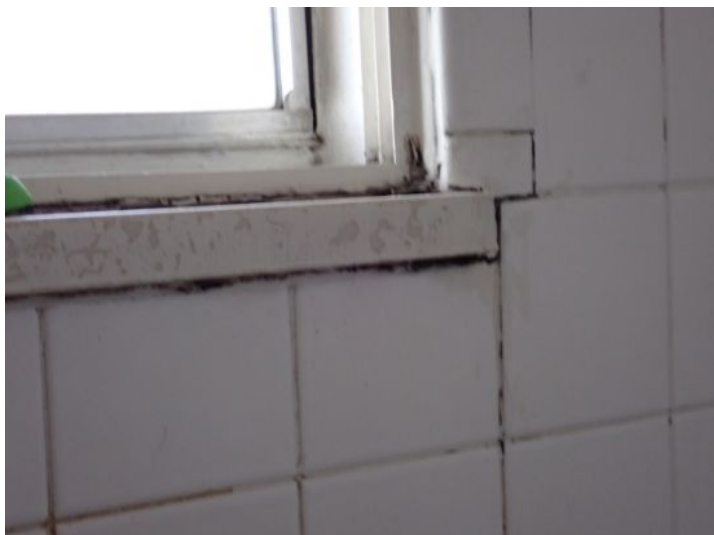
Unit 13: Cracked window glass. Broken window glass in rear of unit. Tub/shower surround requires caulk/grout repairs. Tub finish in poor condition. Closet door damage noted. Vinyl flooring damage noted. Recommend repairs.

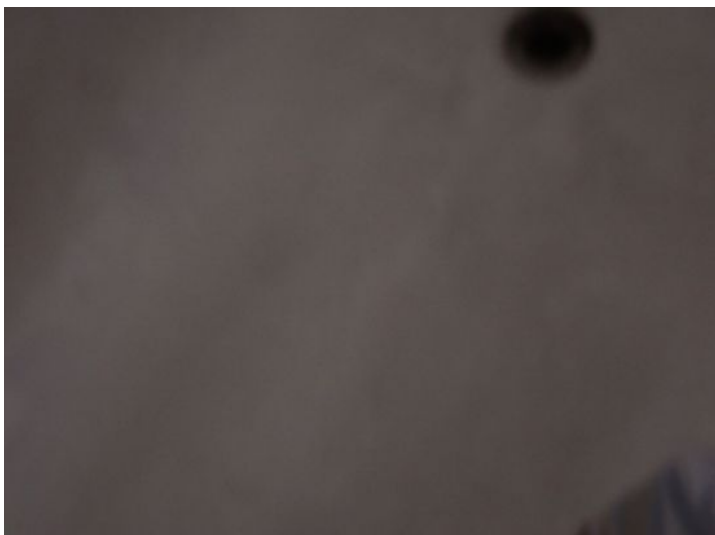
Unit 13: Cracked window glass. Broken window glass in rear of unit. Tub/shower surround requires caulk/grout repairs. Tub finish in poor condition. Closet door damage noted. Vinyl flooring damage noted. Recommend repairs.

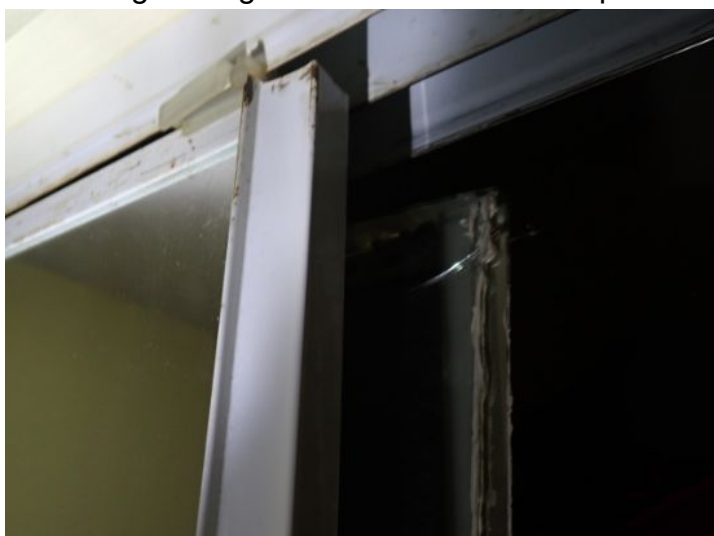
Unit 13: Cracked window glass. Broken window glass in rear of unit. Tub/shower surround requires caulk/grout repairs. Tub finish in poor condition. Closet door damage noted. Vinyl flooring damage noted. Recommend repairs.

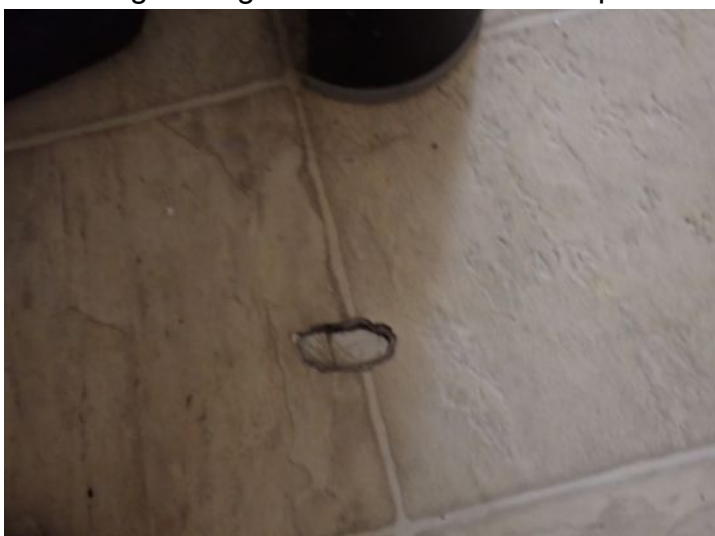
Unit 13: Cracked window glass. Broken window glass in rear of unit. Tub/shower surround requires caulk/grout repairs. Tub finish in poor condition. Closet door damage noted. Vinyl flooring damage noted. Recommend repairs.

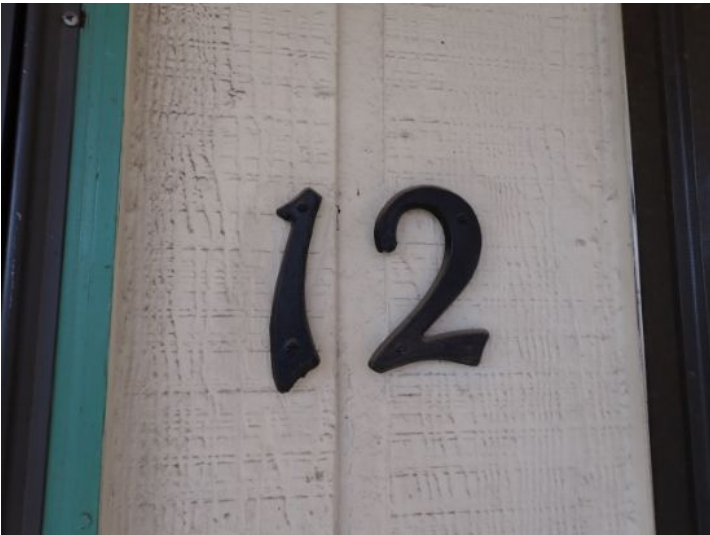
Unit 12: Carpet in poor condition. Vinyl flooring damage. Moisture damage noted below bedroom window. Recommend repairs.

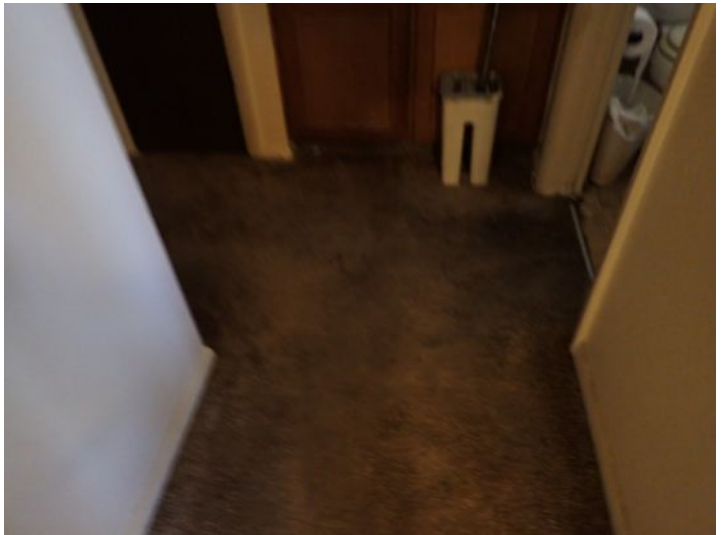
Unit 12: Carpet in poor condition. Vinyl flooring damage. Moisture damage noted below bedroom window. Recommend repairs.

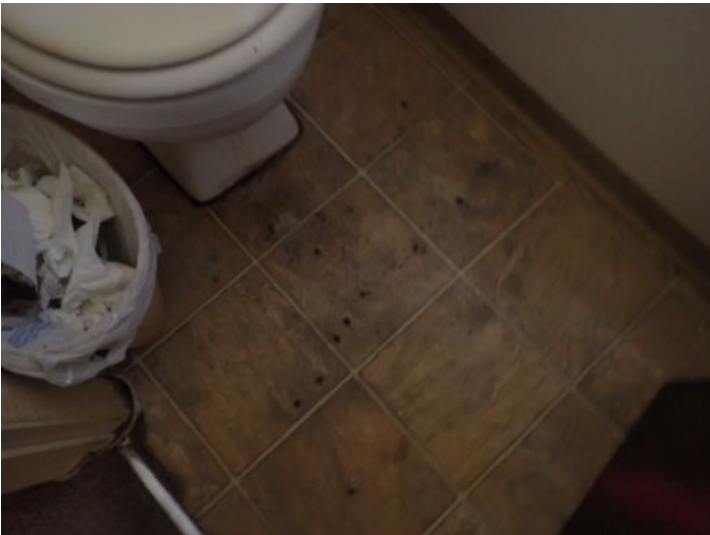
Unit 12: Carpet in poor condition. Vinyl flooring damage. Moisture damage noted below bedroom window. Recommend repairs.

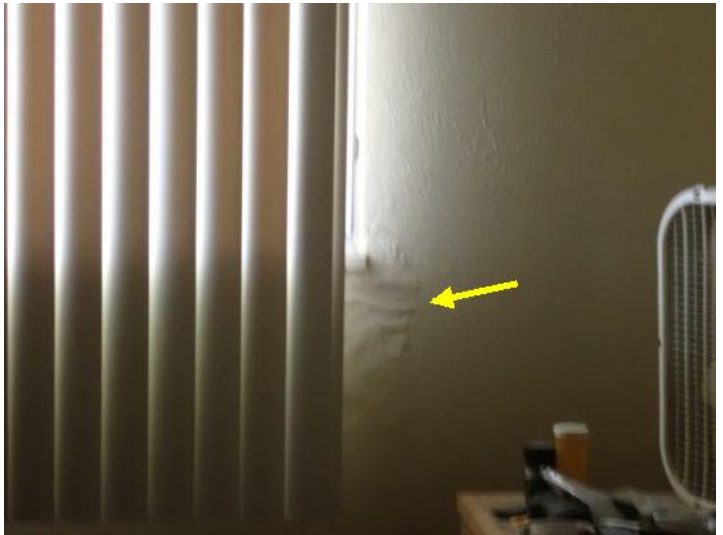
Unit 12: Carpet in poor condition. Vinyl flooring damage. Moisture damage noted below bedroom window. Recommend repairs.

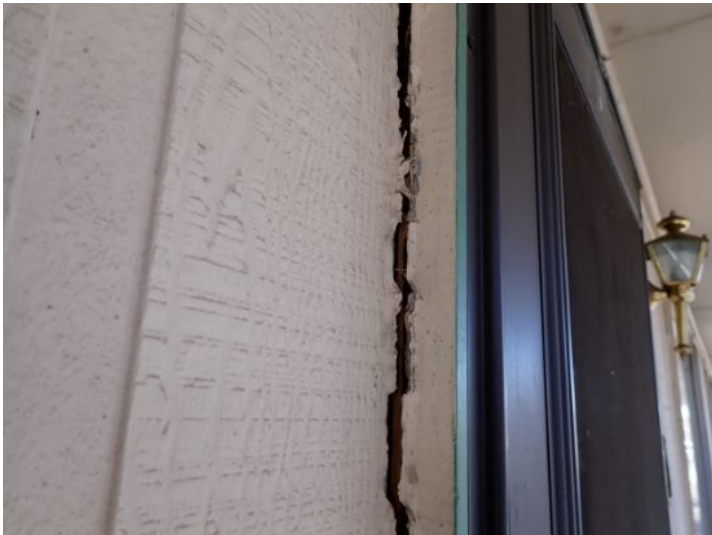
Unit 11: Front door trim damaged. Significant flooring deflection. Flooring damage noted. Recommend repairs.

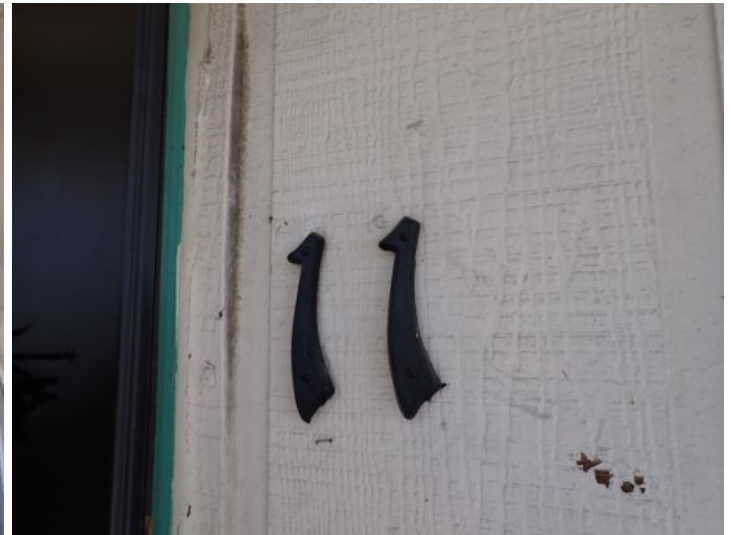
Unit 11: Front door trim damaged. Significant flooring deflection. Flooring damage noted. Recommend repairs.

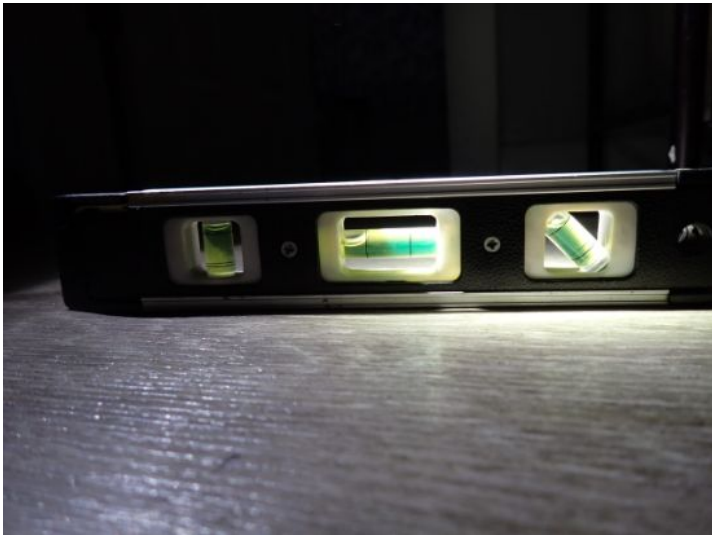
Unit 11: Front door trim damaged. Significant flooring deflection. Flooring damage noted. Recommend repairs.

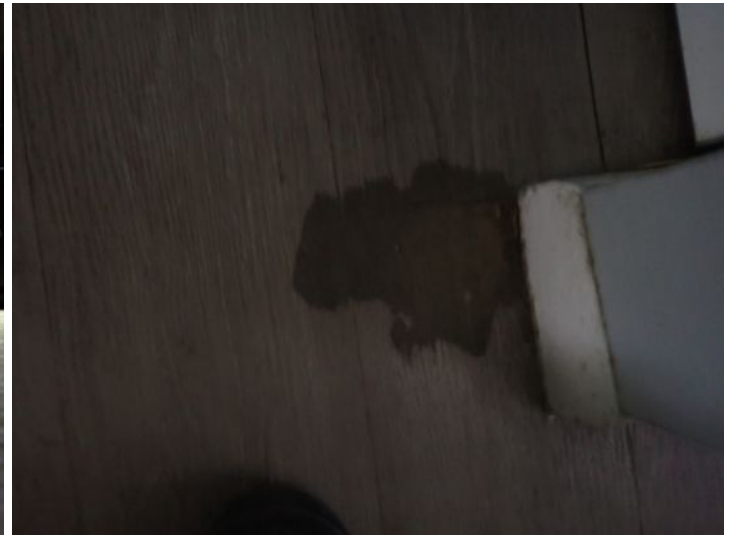
Unit 11: Front door trim damaged. Significant flooring deflection. Flooring damage noted. Recommend repairs.

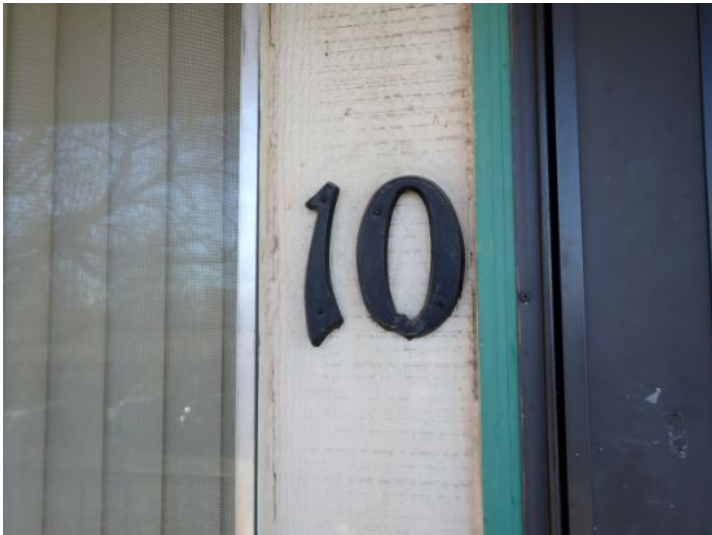
Unit 10: Flooring damage. Tub/shower surround requires caulk/grout repairs. Tub finish in poor condition. Broken bathroom window glass. Recommend repairs.

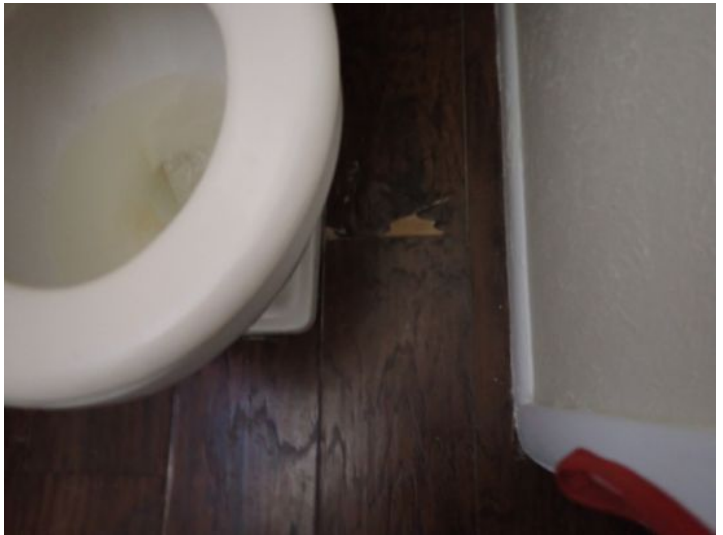
Unit 10: Flooring damage. Tub/shower surround requires caulk/grout repairs. Tub finish in poor condition. Broken bathroom window glass. Recommend repairs.

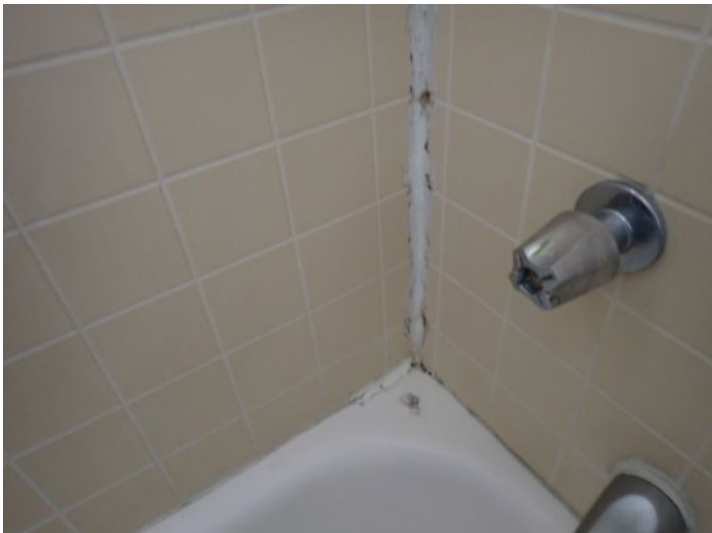
Unit 10: Flooring damage. Tub/shower surround requires caulk/grout repairs. Tub finish in poor condition. Broken bathroom window glass. Recommend repairs.

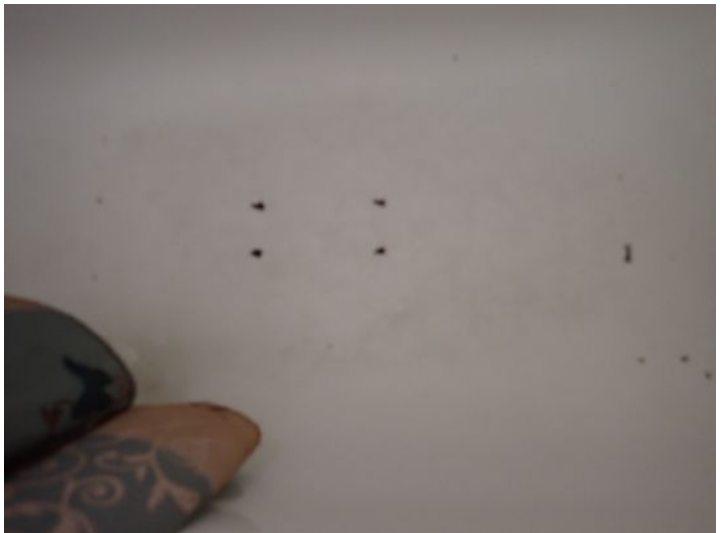
Unit 10: Flooring damage. Tub/shower surround requires caulk/grout repairs. Tub finish in poor condition. Broken bathroom window glass. Recommend repairs.

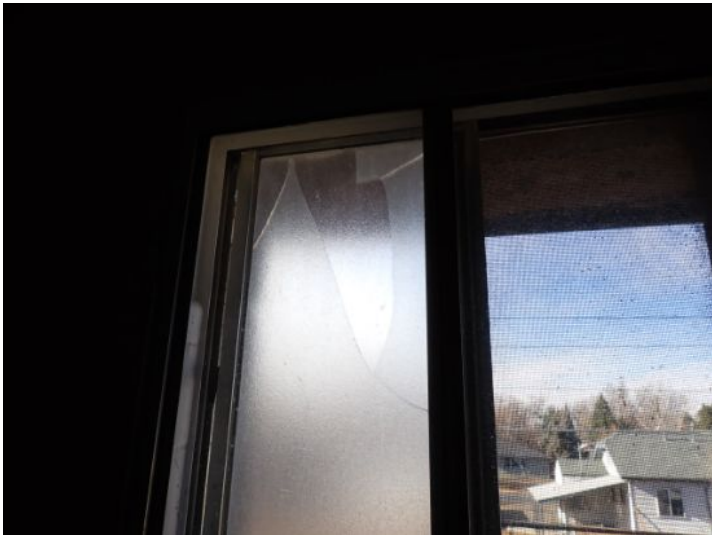
Unit 10: Flooring damage. Tub/shower surround requires caulk/grout repairs. Tub finish in poor condition. Broken bathroom window glass. Recommend repairs.

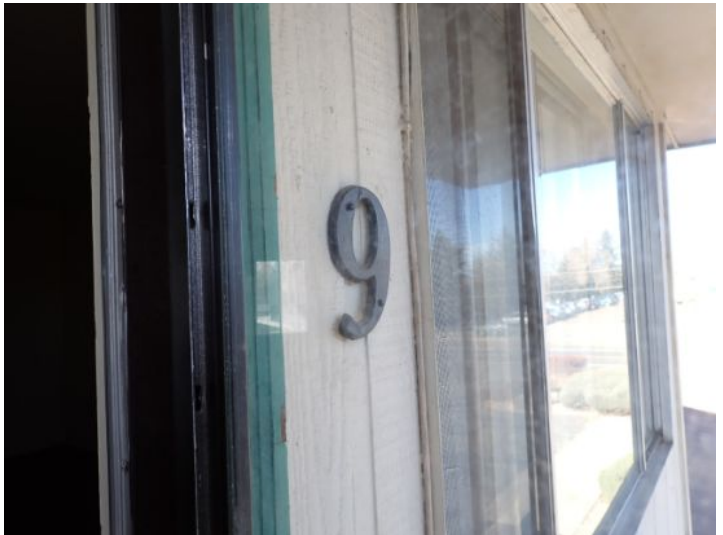
Unit 9: Ceiling cracking. Sub standard plumbing noted below kitchen sink. Carpet in poor condition. Tub finish in poor condition. Recommend repairs.

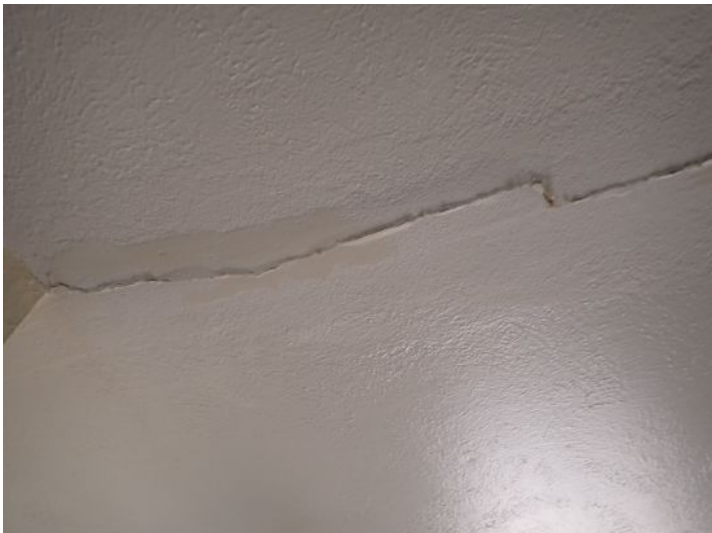
Unit 9: Ceiling cracking. Sub standard plumbing noted below kitchen sink. Carpet in poor condition. Tub finish in poor condition. Recommend repairs.

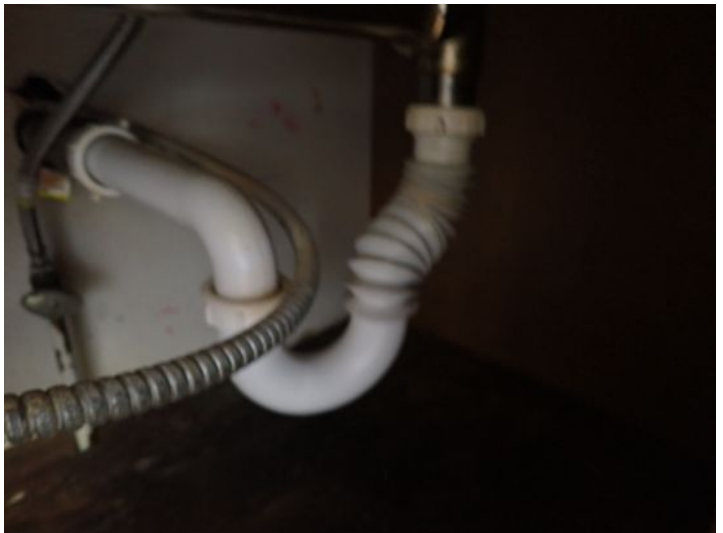
Unit 9: Ceiling cracking. Sub standard plumbing noted below kitchen sink. Carpet in poor condition. Tub finish in poor condition. Recommend repairs.

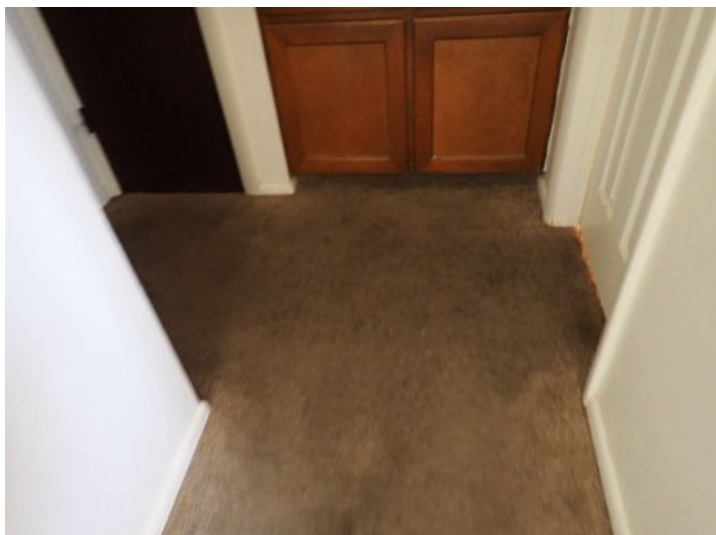
Unit 9: Ceiling cracking. Sub standard plumbing noted below kitchen sink. Carpet in poor condition. Tub finish in poor condition. Recommend repairs.

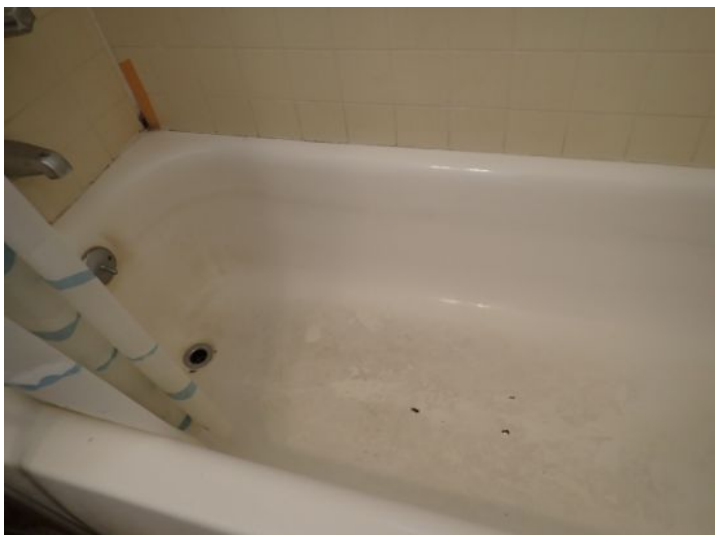
Unit 9: Ceiling cracking. Sub standard plumbing noted below kitchen sink. Carpet in poor condition. Tub finish in poor condition. Recommend repairs.

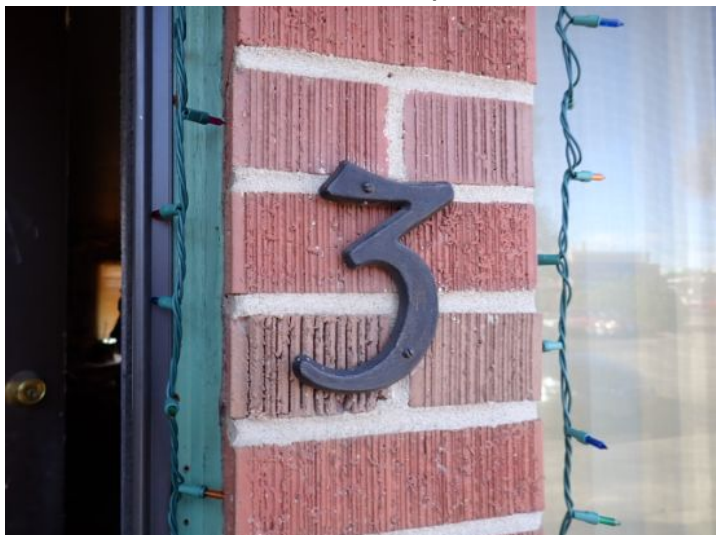
Unit 3: Carpet damage. Separation noted between kitchen counter and wall. Kitchen cabinet failure noted. Vinyl flooring damage. Tub/shower surround requires caulk/grout repairs. Bedroom closet door damage noted. Recommend repairs.

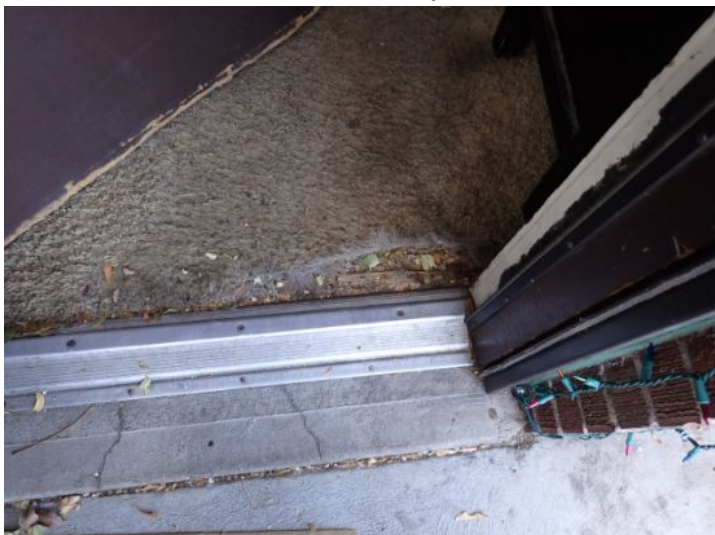
Unit 3: Carpet damage. Separation noted between kitchen counter and wall. Kitchen cabinet failure noted. Vinyl flooring damage. Tub/shower surround requires caulk/grout repairs. Bedroom closet door damage noted. Recommend repairs.

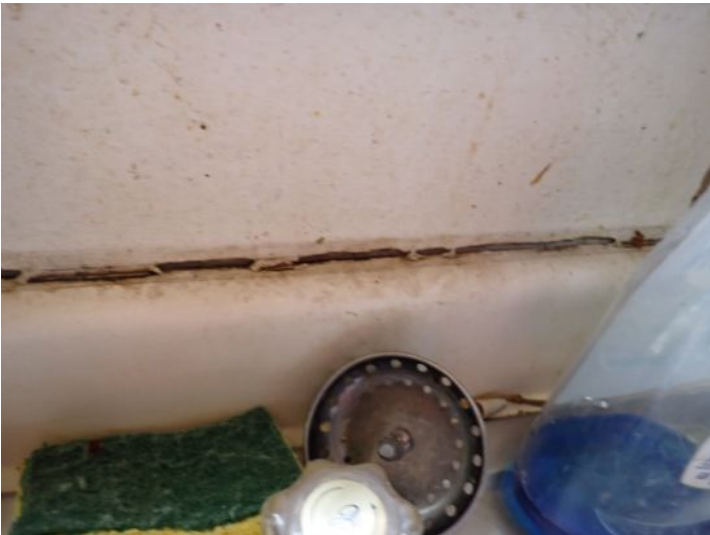
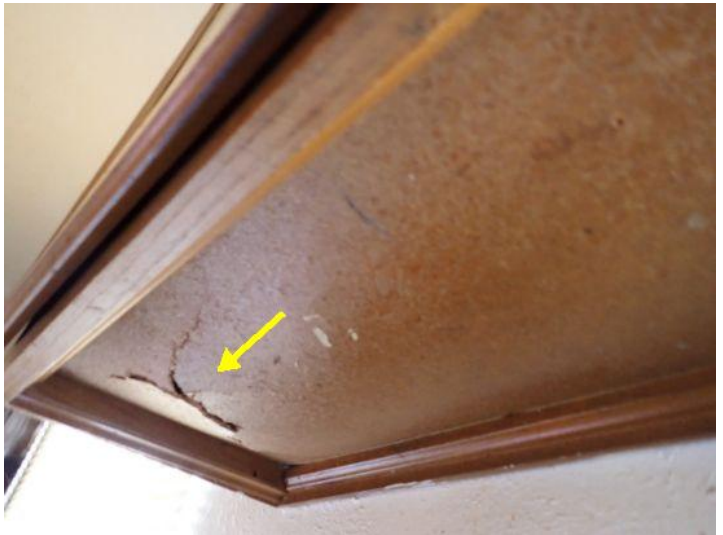
Unit 3: Carpet damage. Separation noted between kitchen counter and wall. Kitchen cabinet failure noted. Vinyl flooring damage. Tub/shower surround requires caulk/grout repairs. Bedroom closet door damage noted. Recommend repairs.

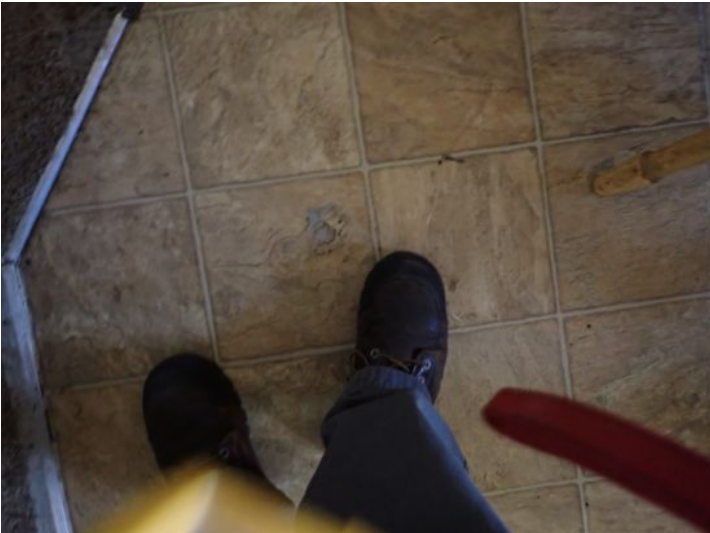
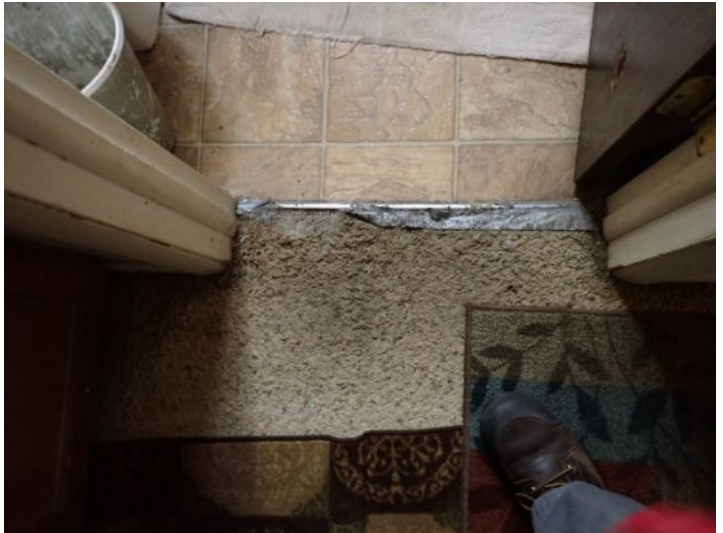
Unit 3: Carpet damage. Separation noted between kitchen counter and wall. Kitchen cabinet failure noted. Vinyl flooring damage. Tub/shower surround requires caulk/grout repairs. Bedroom closet door damage noted. Recommend repairs.

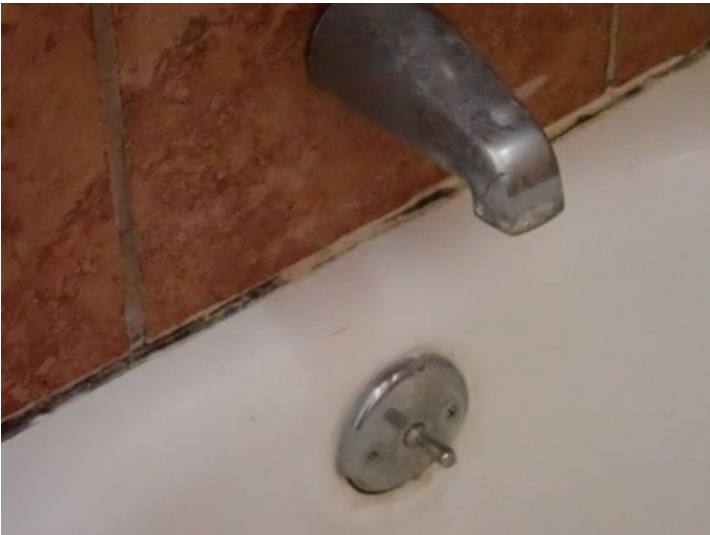
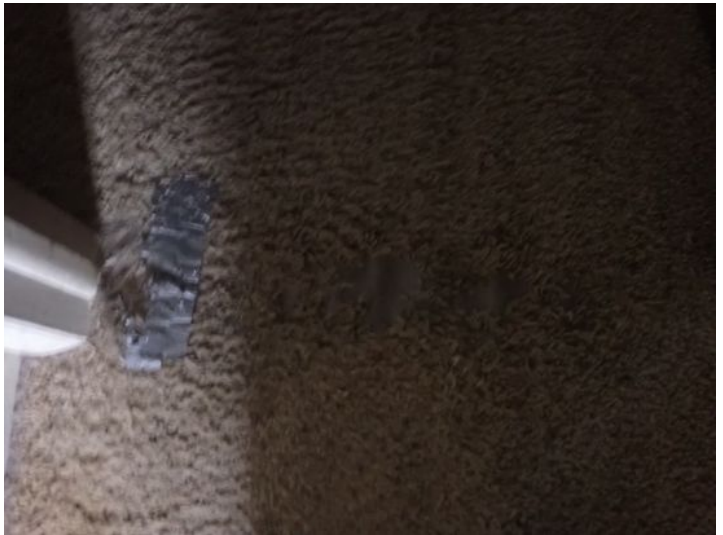
Unit 3: Carpet damage. Separation noted between kitchen counter and wall. Kitchen cabinet failure noted. Vinyl flooring damage. Tub/shower surround requires caulk/grout repairs. Bedroom closet door damage noted. Recommend repairs.

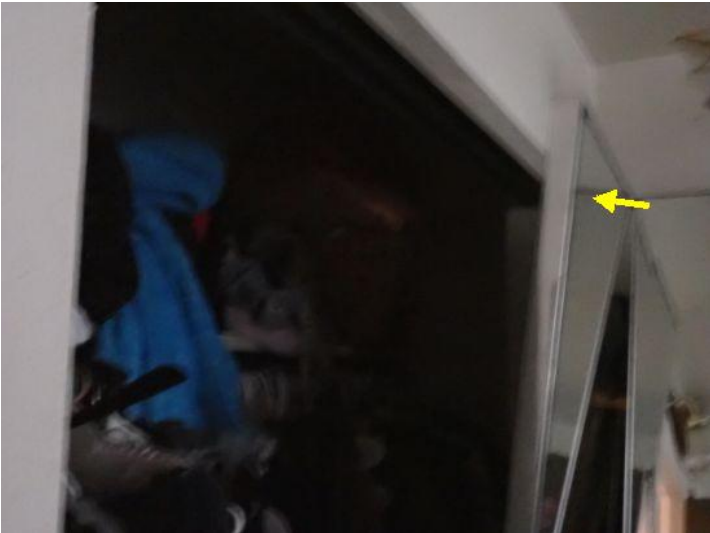
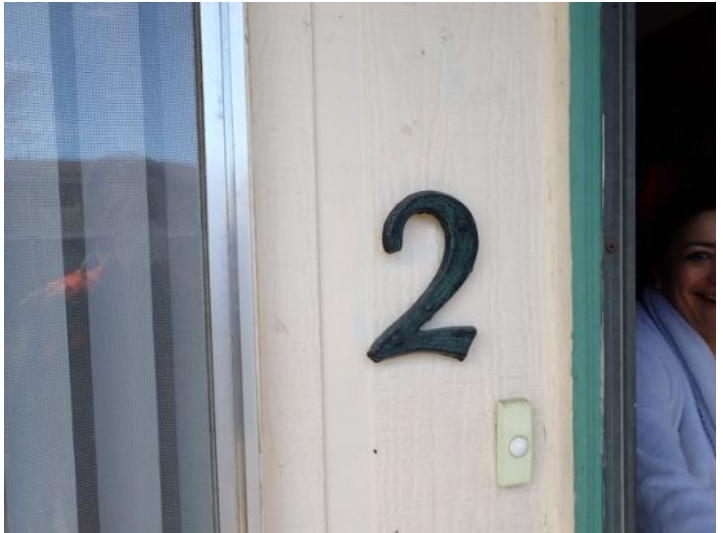
Unit 3: Carpet damage. Separation noted between kitchen counter and wall. Kitchen cabinet failure noted. Vinyl flooring damage. Tub/shower surround requires caulk/grout repairs. Bedroom closet door damage noted. Recommend repairs.

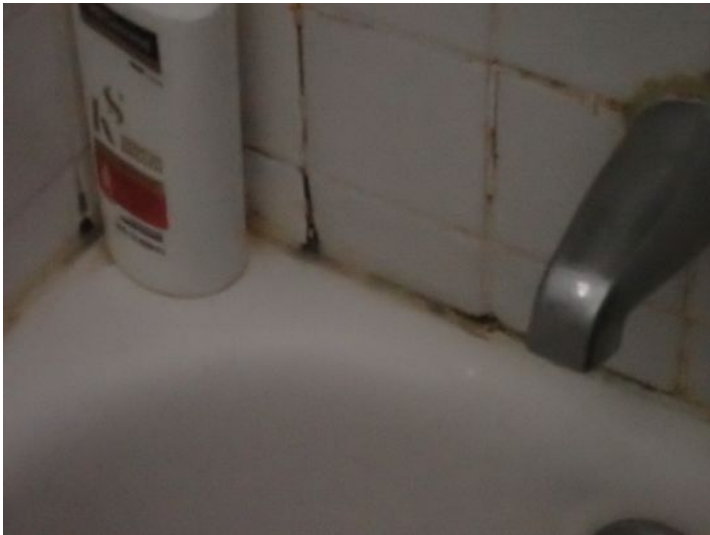
Unit 2: Tub/shower surround requires caulk/grout repairs. Significant ceiling cracking noted. Significant wall movement noted. Recommend repairs.

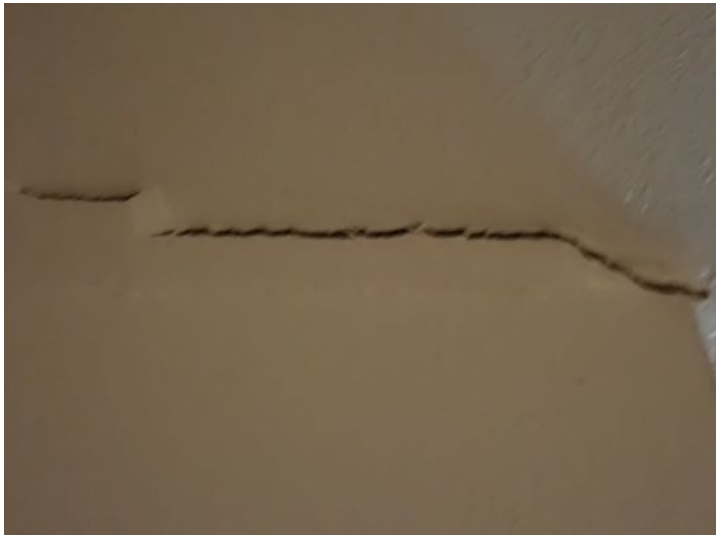
Unit 2: Tub/shower surround requires caulk/grout repairs. Significant ceiling cracking noted. Significant wall movement noted. Recommend repairs.

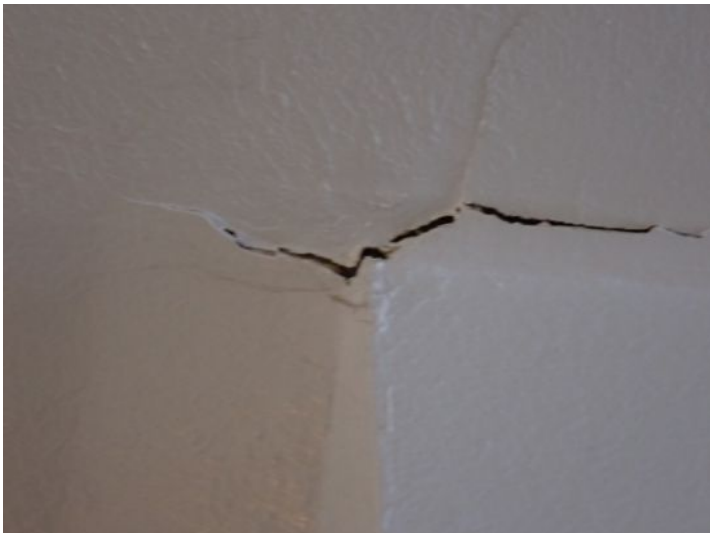
Unit 2: Tub/shower surround requires caulk/grout repairs. Significant ceiling cracking noted. Significant wall movement noted. Recommend repairs.

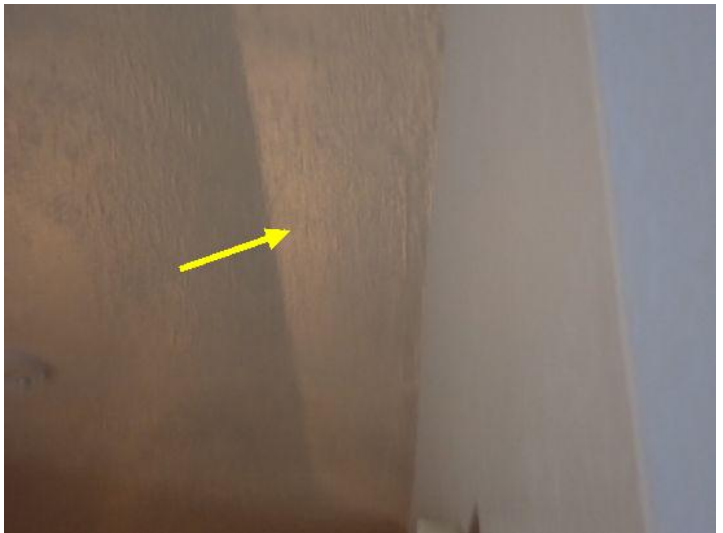
Unit 2: Tub/shower surround requires caulk/grout repairs. Significant ceiling cracking noted. Significant wall movement noted. Recommend repairs.

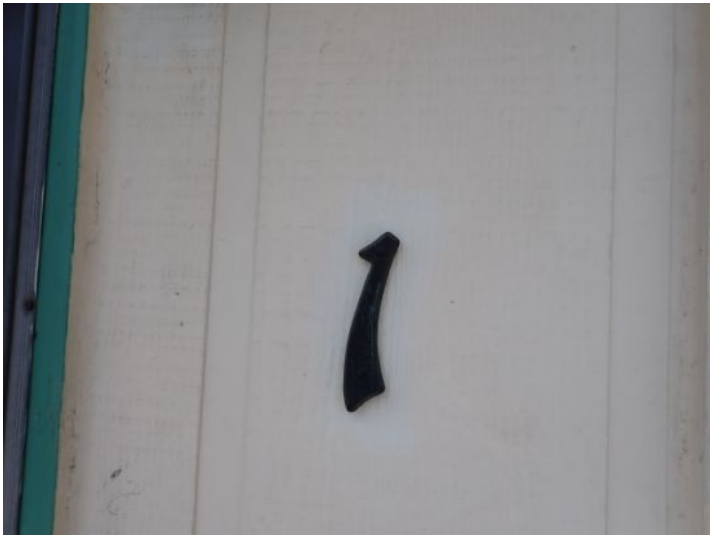
Unit 1: Significant floor deflection noted. Missing bedroom door. Significant wall/ceiling junction cracking noted. Carpet damage. Significant floor settling noted. Recommend repairs.

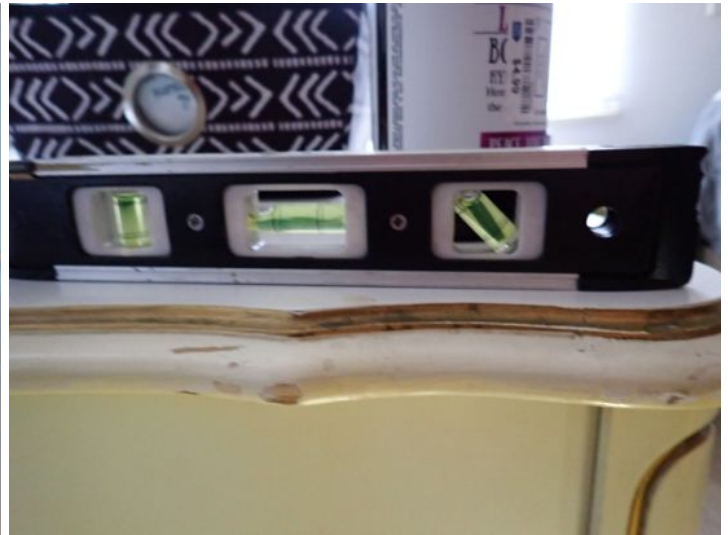
Unit 1: Significant floor deflection noted. Missing bedroom door. Significant wall/ceiling junction cracking noted. Carpet damage. Significant floor settling noted. Recommend repairs.

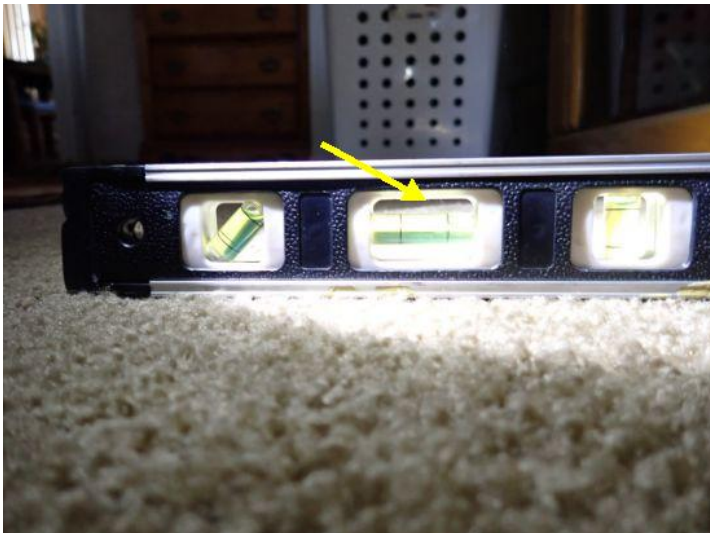
Unit 1: Significant floor deflection noted. Missing bedroom door. Significant wall/ceiling junction cracking noted. Carpet damage. Significant floor settling noted. Recommend repairs.

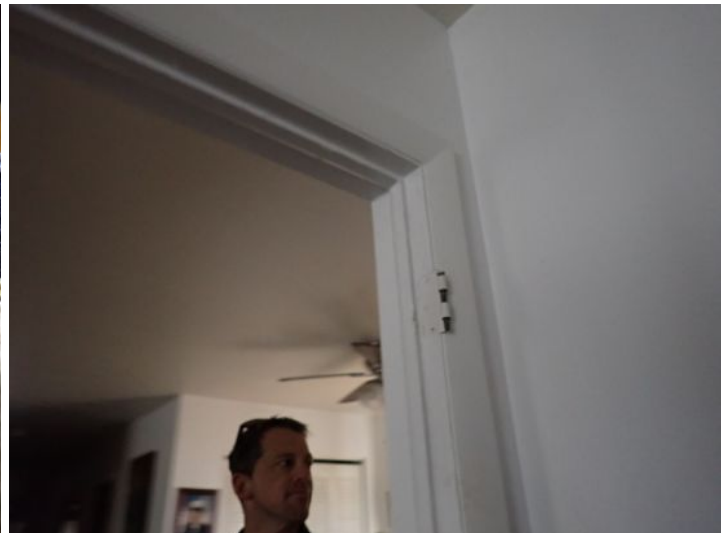
Unit 1: Significant floor deflection noted. Missing bedroom door. Significant wall/ceiling junction cracking noted. Carpet damage. Significant floor settling noted. Recommend repairs.

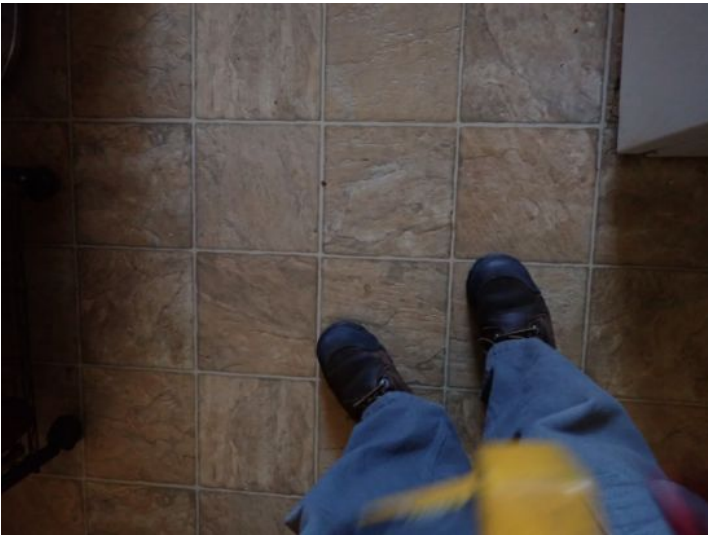
Unit 1: Significant floor deflection noted. Missing bedroom door. Significant wall/ceiling junction cracking noted. Carpet damage. Significant floor settling noted. Recommend repairs.

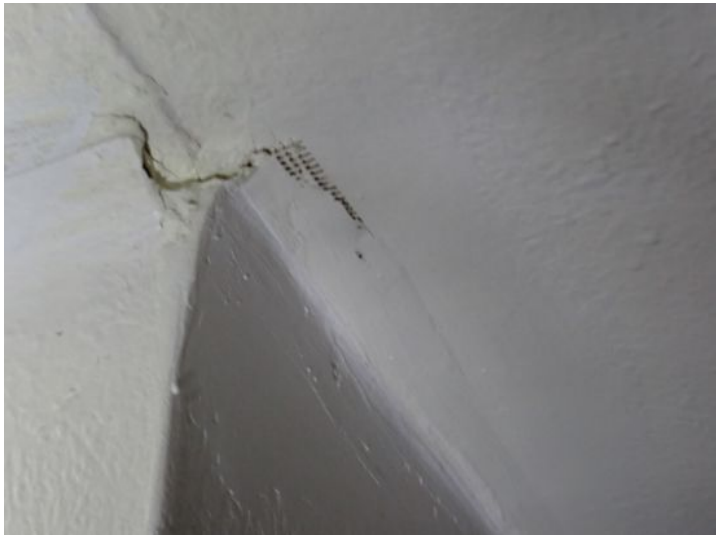
Unit 1: Significant floor deflection noted. Missing bedroom door. Significant wall/ceiling junction cracking noted. Carpet damage. Significant floor settling noted. Recommend repairs.

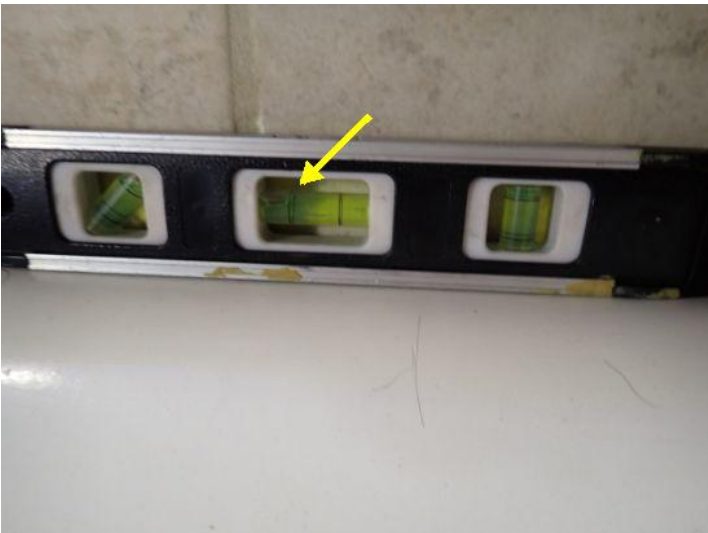
Unit 1: Significant floor deflection noted. Missing bedroom door. Significant wall/ceiling junction cracking noted. Carpet damage. Significant floor settling noted. Recommend repairs.

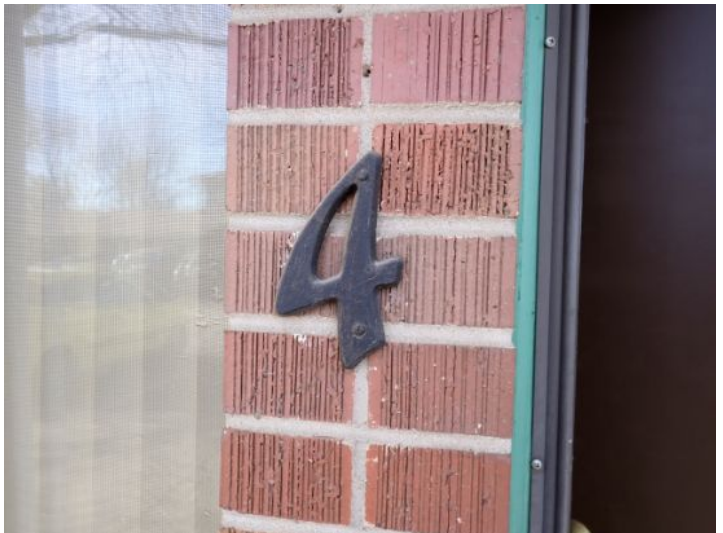
Unit 4: Kitchen counter and wall separation noted. Vanity sink rusting. Past moisture damage noted in bathroom wall but no moisture present at the time of the inspection. Recommend repairs.
