Forman Inspection Services, LLC

Property Inspection Report

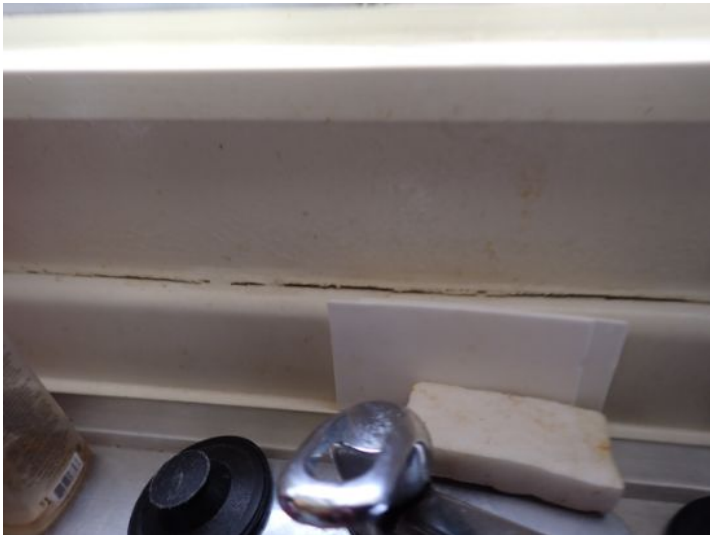
Unit 4: Kitchen counter and wall separation noted. Vanity sink rusting. Past moisture damage noted in bathroom wall but no moisture present at the time of the inspection. Recommend repairs.

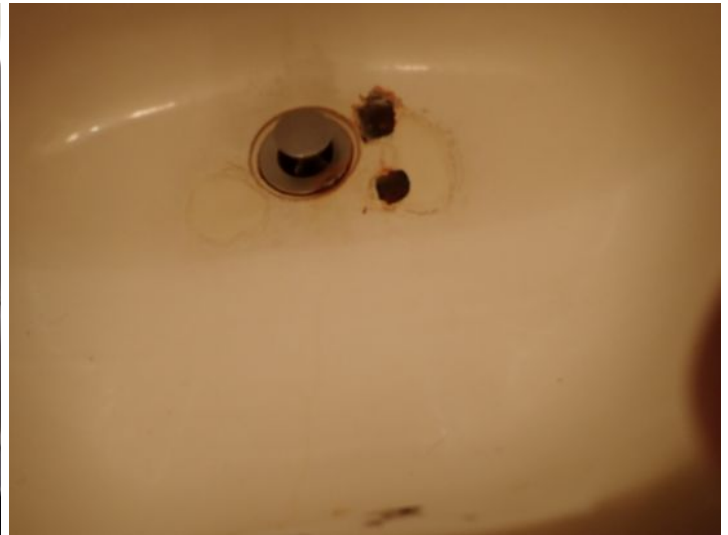
Unit 4: Kitchen counter and wall separation noted. Vanity sink rusting. Past moisture damage noted in bathroom wall but no moisture present at the time of the inspection. Recommend repairs.

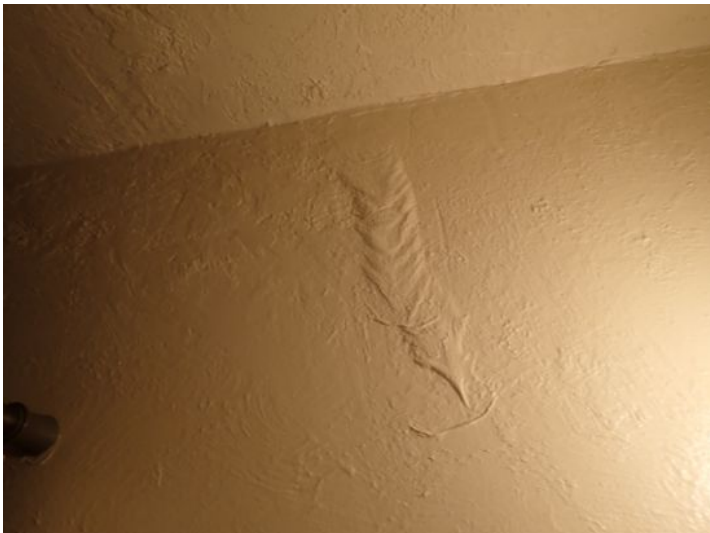
Unit 4: Kitchen counter and wall separation noted. Vanity sink rusting. Past moisture damage noted in bathroom wall but no moisture present at the time of the inspection. Recommend repairs.

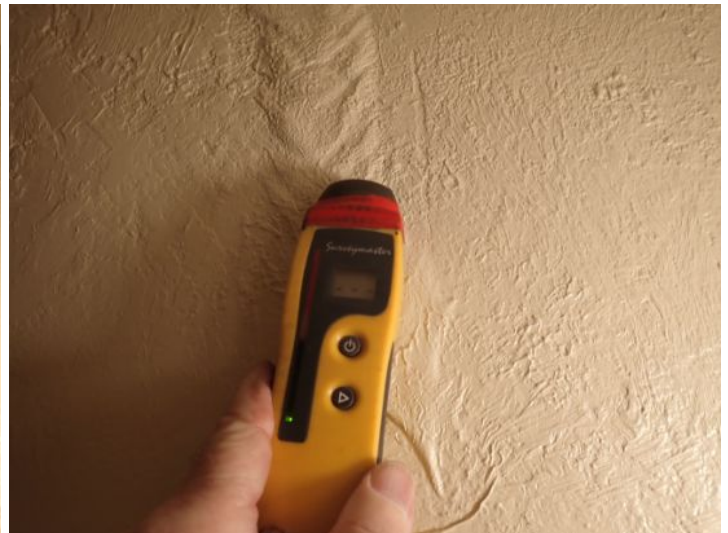
Unit 4: Kitchen counter and wall separation noted. Vanity sink rusting. Past moisture damage noted in bathroom wall but no moisture present at the time of the inspection. Recommend repairs.

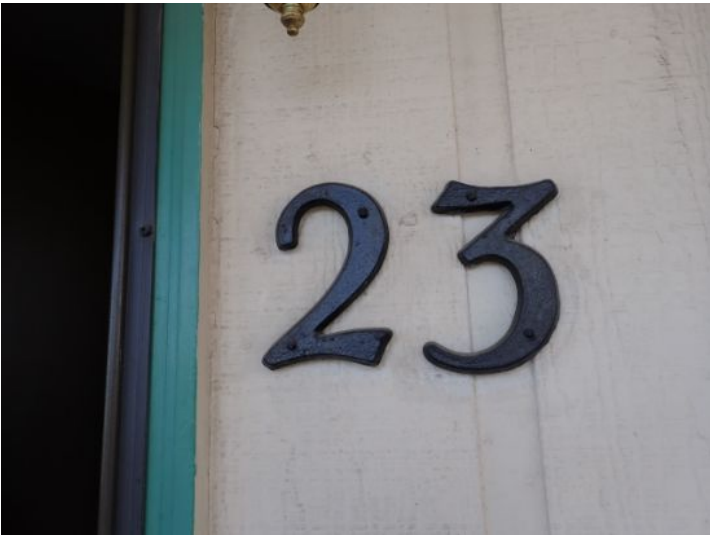
Unit 23: Carpet damage noted. Tub in poor condition. Recommend repairs.

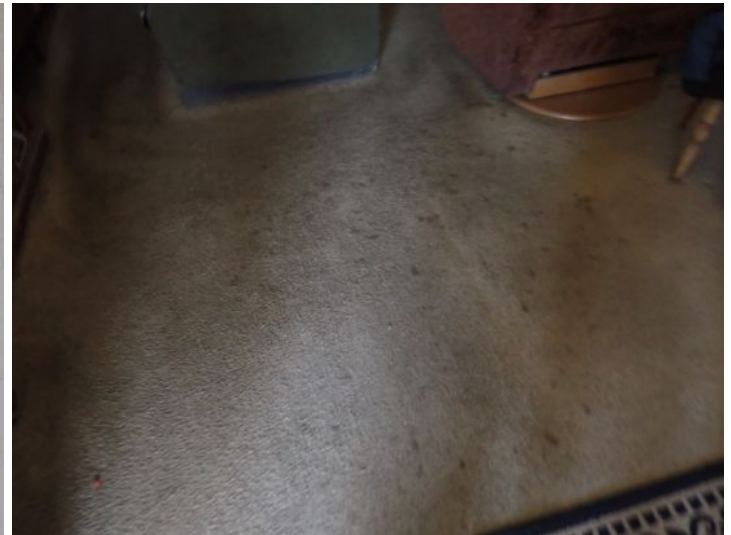
Unit 23: Carpet damage noted. Tub in poor condition. Recommend repairs.

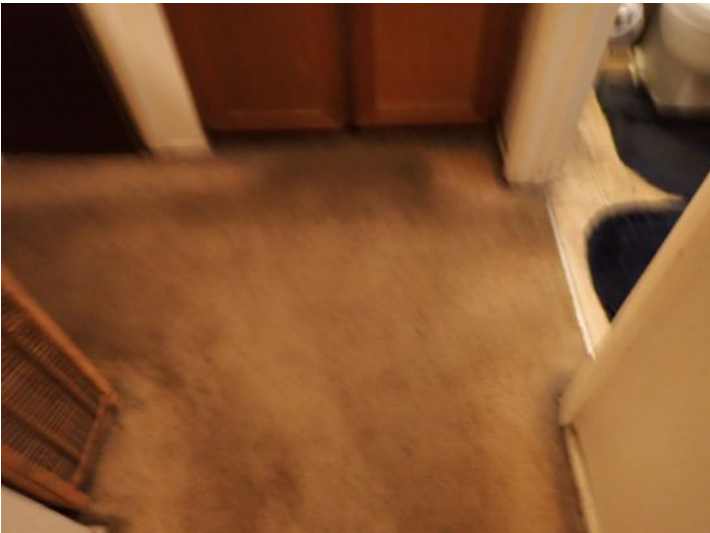
Unit 23: Carpet damage noted. Tub in poor condition. Recommend repairs.

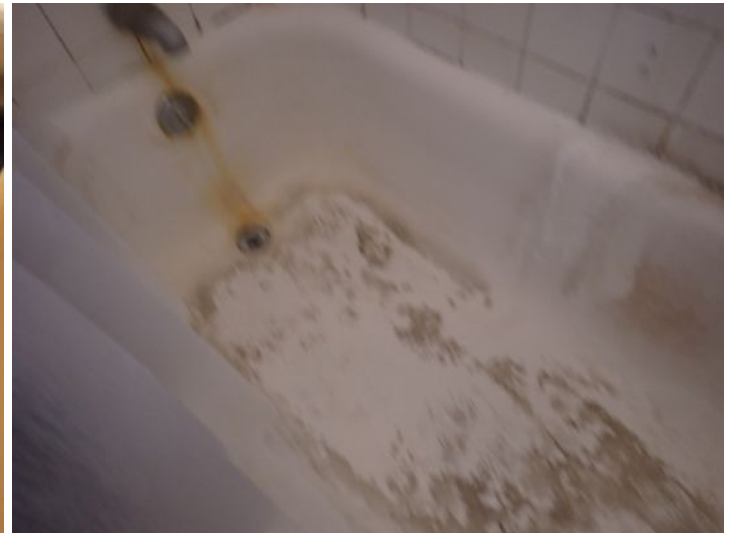
Unit 23: Carpet damage noted. Tub in poor condition. Recommend repairs.

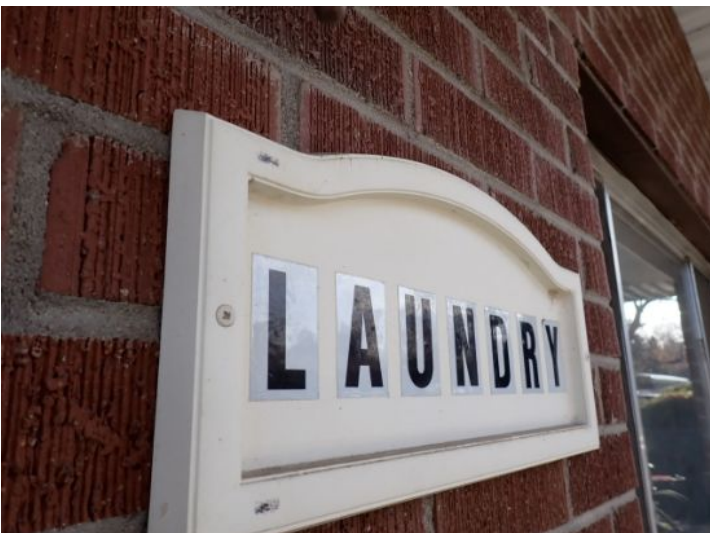
Laundry Room: Flooring damage noted. Recommend repairs.

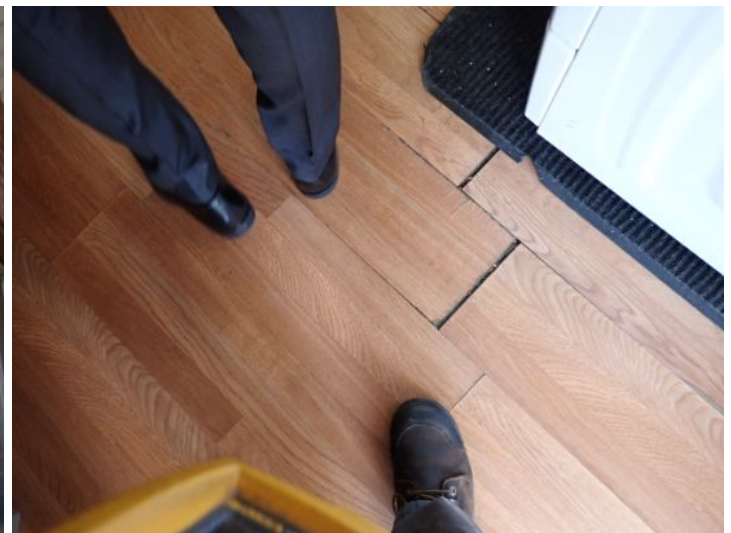
Laundry Room: Flooring damage noted. Recommend repairs.
