# *Forman Inspection Services, LLC*

## Property Inspection Report

1234 Retail St., Somewhere, CO 12345

Date of Inspection: 9/16/2022 Time: 10:00 Size: 93,886 sq. ft. per listing

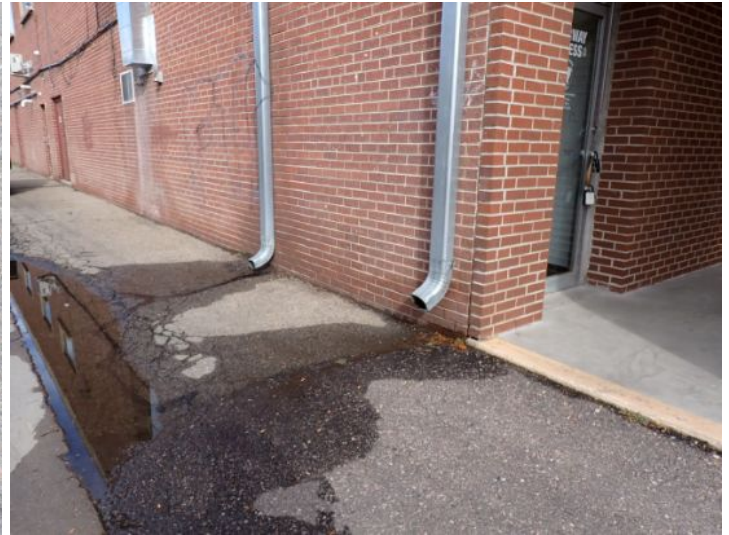
Gutters down spouts missing extensions to direct storm water away from the foundation of the structure. Recommend repairs.

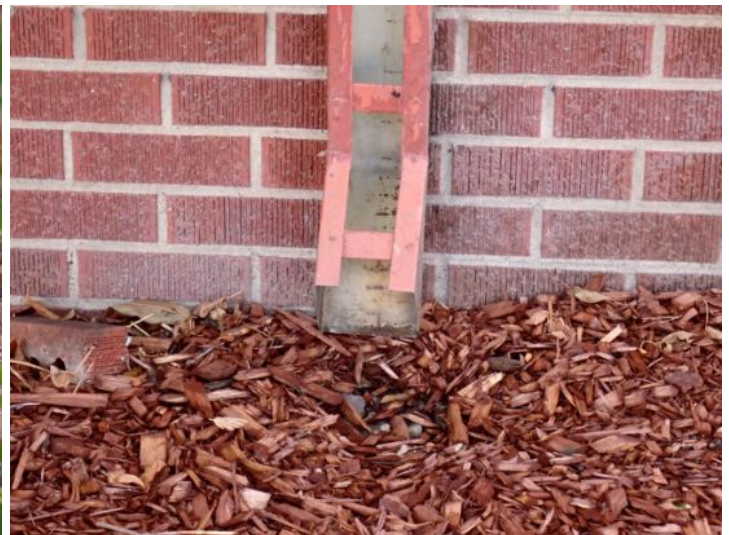
Gutters down spouts missing extensions to direct storm water away from the foundation of the structure. Recommend repairs.

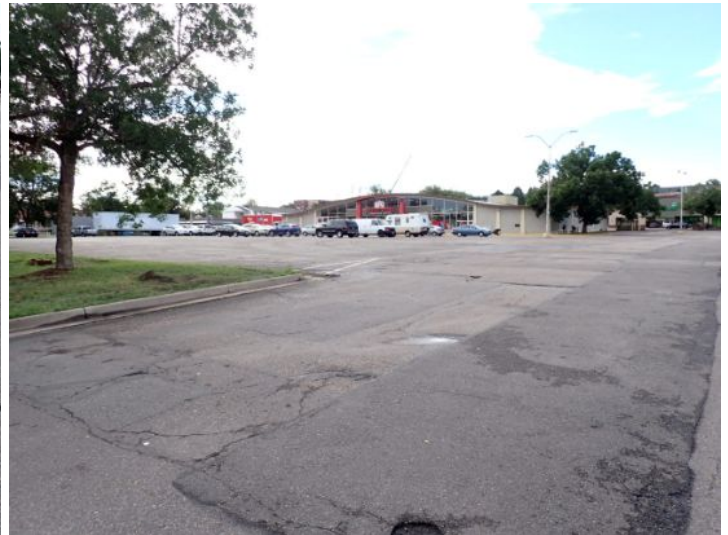
Deteriorated paving material noted in areas. Recommend repairs by a licensed contractor.

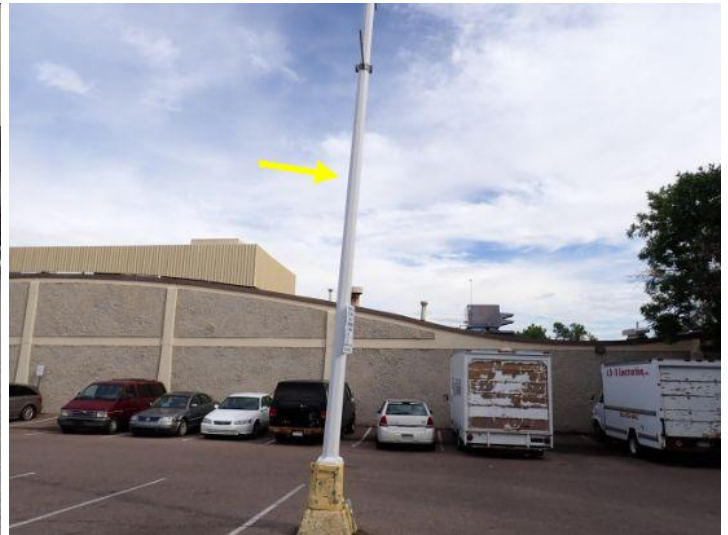
Leaning light post noted on the east side of the parking lot at the time of the inspection. Recommend repairs by a licensed contractor.

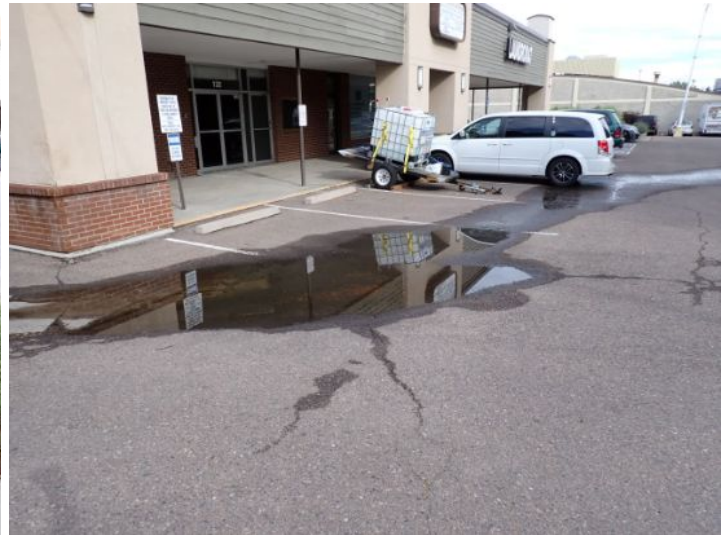
Poor drainage noted in areas. Recommend repairs by a licensed contractor.

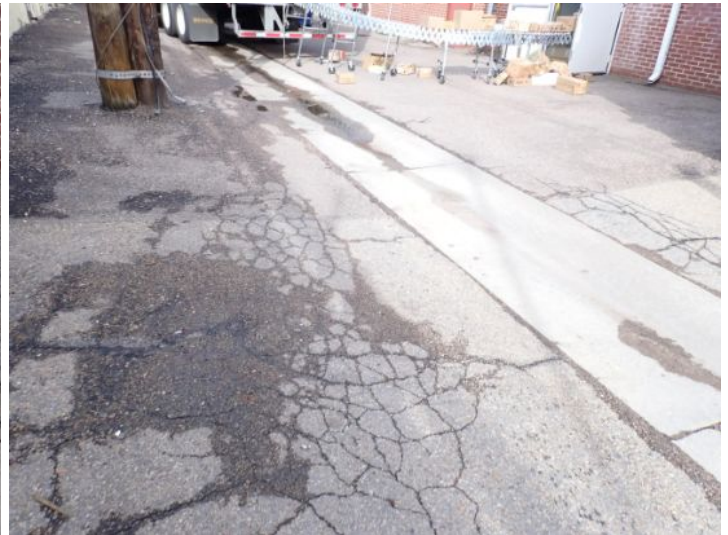
The asphalt running along the rear south side of the structure was in poor condition at the time of the inspection. Recommend resurfacing by a licensed contractor.

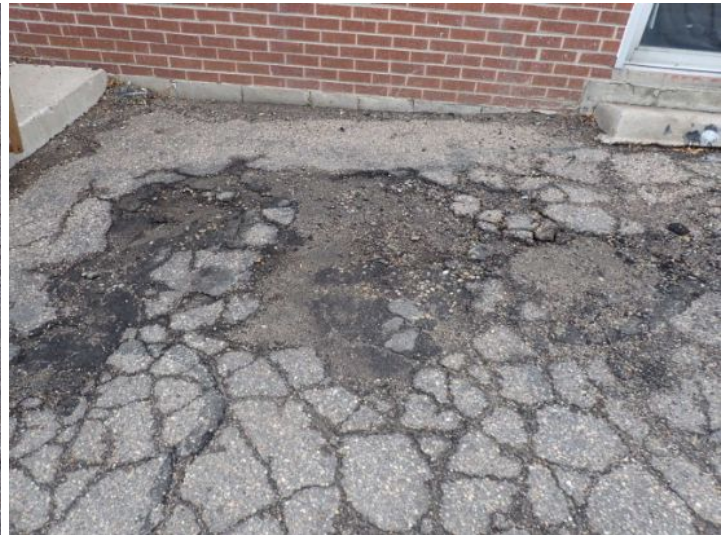
The asphalt running along the rear west side of the structure was in poor condition at the time of the inspection. Recommend resurfacing by a licensed contractor.

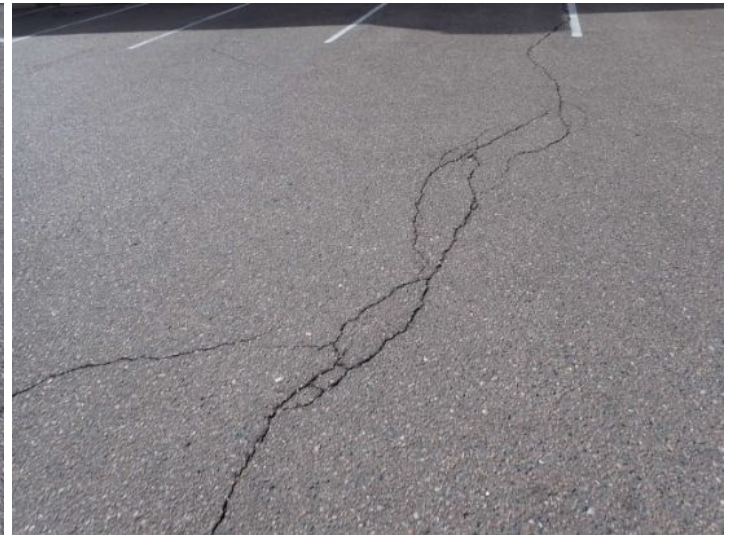
Recommend crack filling to aid in extending the life of the existing asphalt surface. Recommend repairs by a licensed contractor.

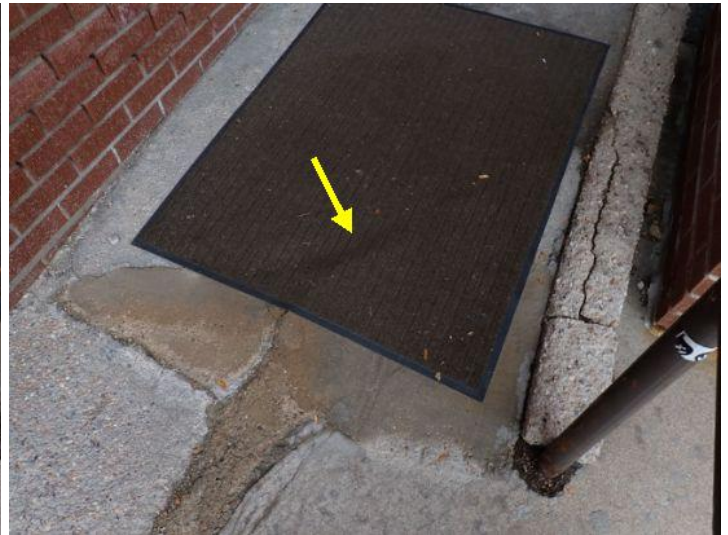
Damage/heaving noted on the flatwork at the ADA ramp for unit 100 (restaurant) at the time of the inspection. Recommend repairs by a licensed contractor.

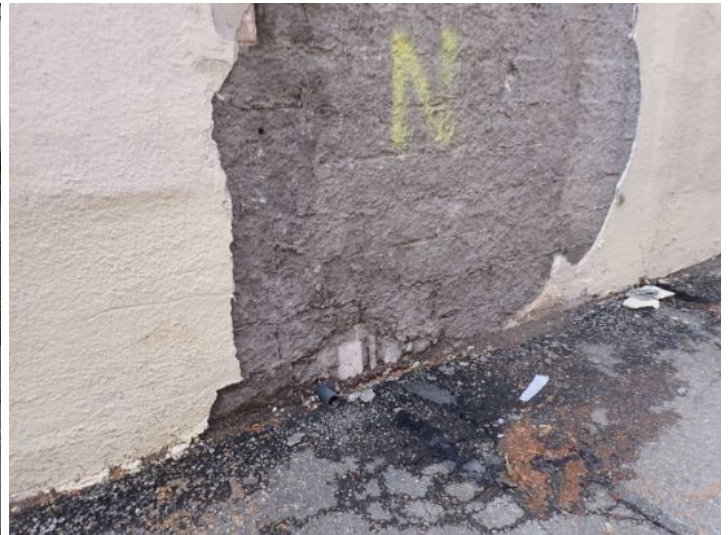
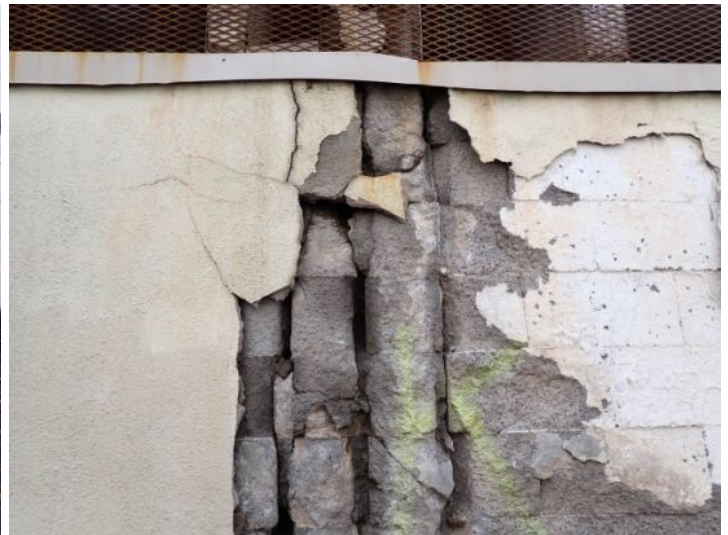
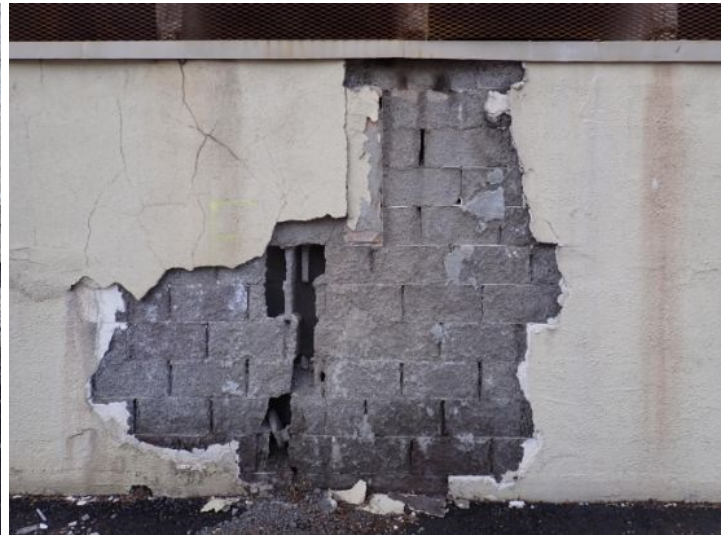
The block retaining wall for the neighboring parking garage was showing signs of significant moisture damage and deterioration in areas. Recommend monitoring to aid in possibly preventing wall failure onto your property.

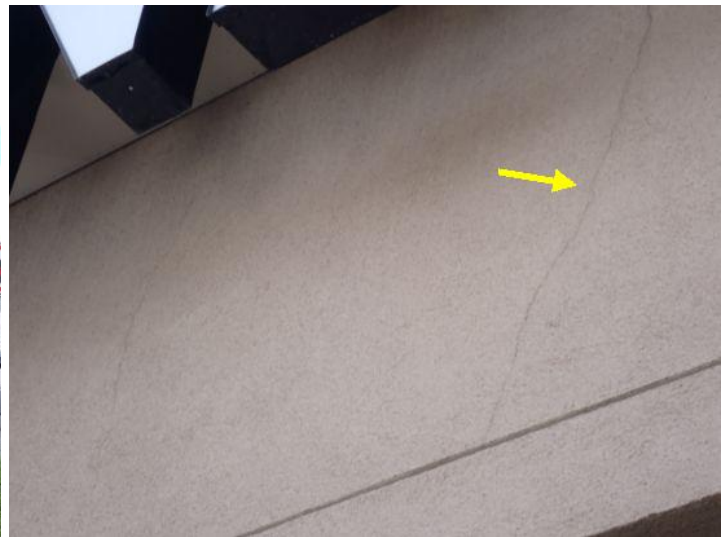
Stucco cracking noted in areas around the structure at the time of the inspection. Recommend repairs by a licensed contractor.

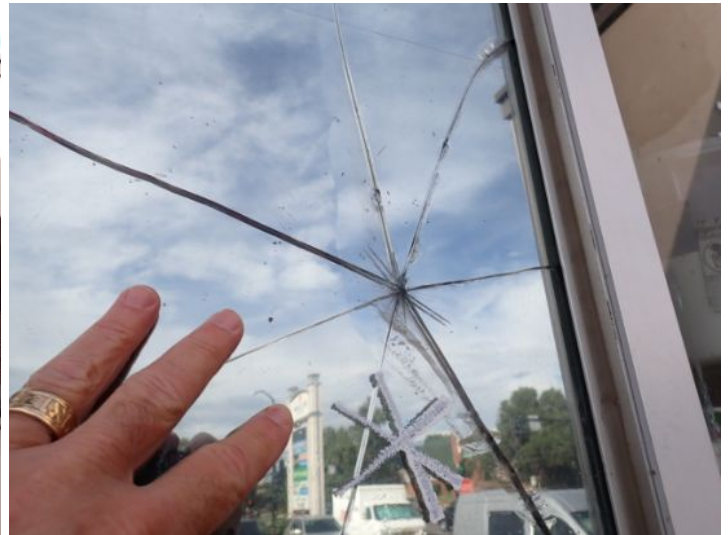
Cracked/broken window glass noted on the front of unit 100 (restaurant) at the time of the inspection. Recommend repairs by a licensed contractor.

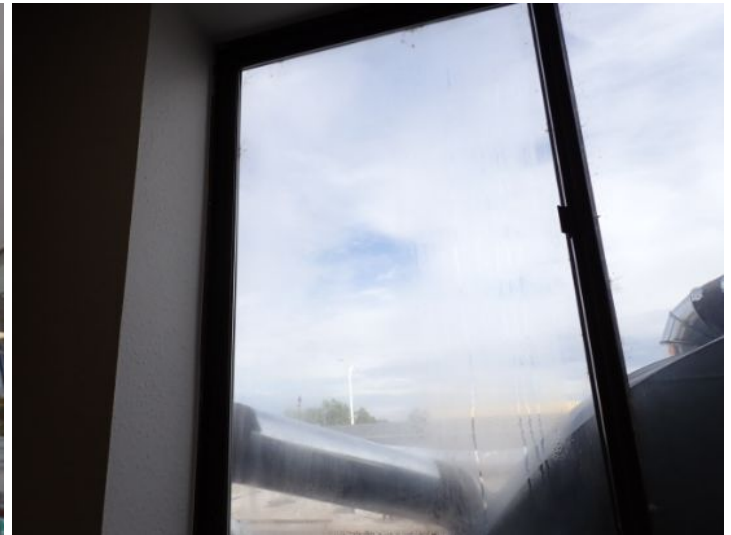
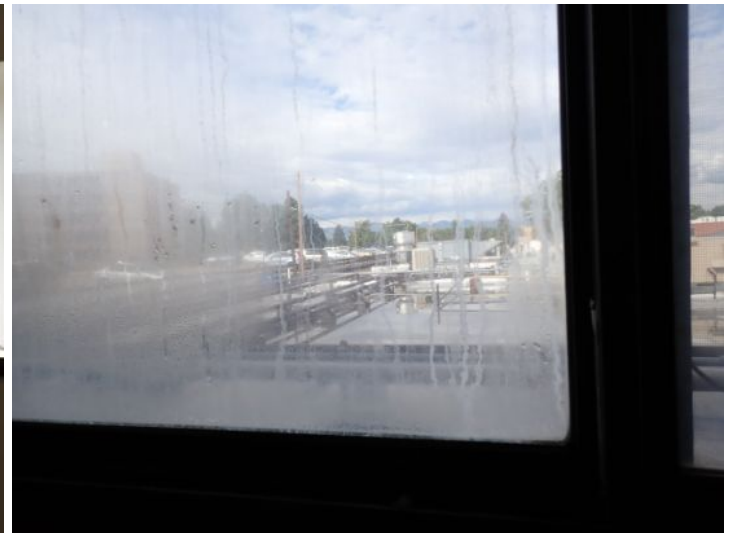
Failed seals noted in multiple insulated window units at the time of the inspection. Recommend repairs by a licensed contractor.

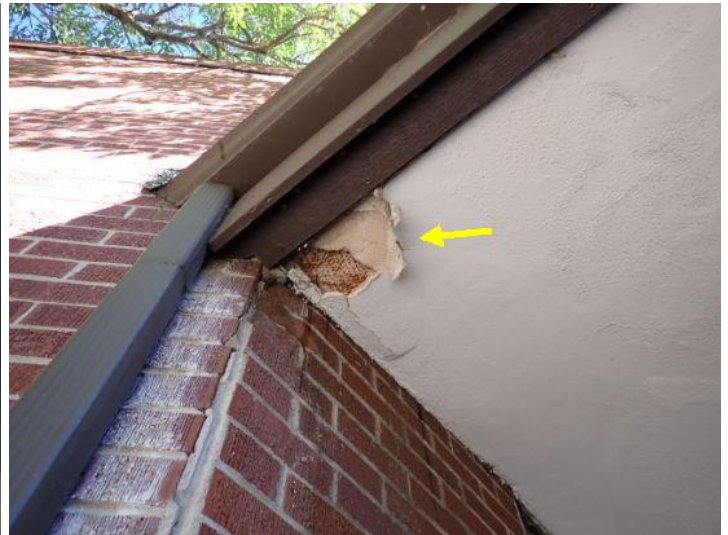
Moisture damage noted in awning ceiling. Recommend repairs by a licensed contractor.

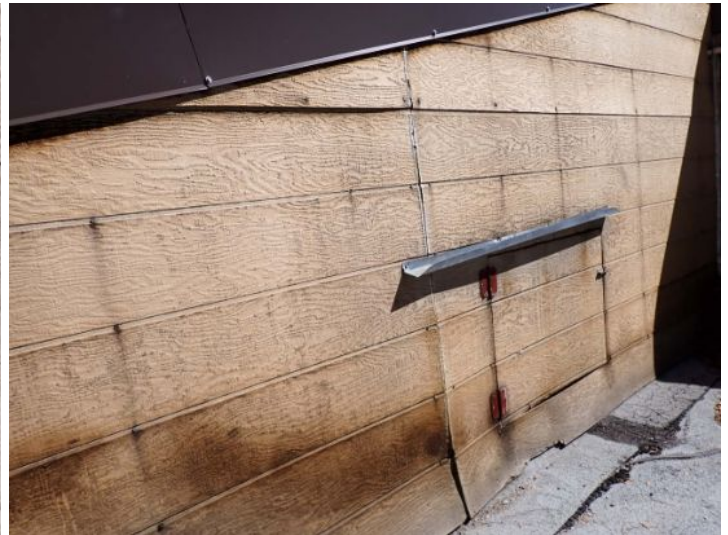
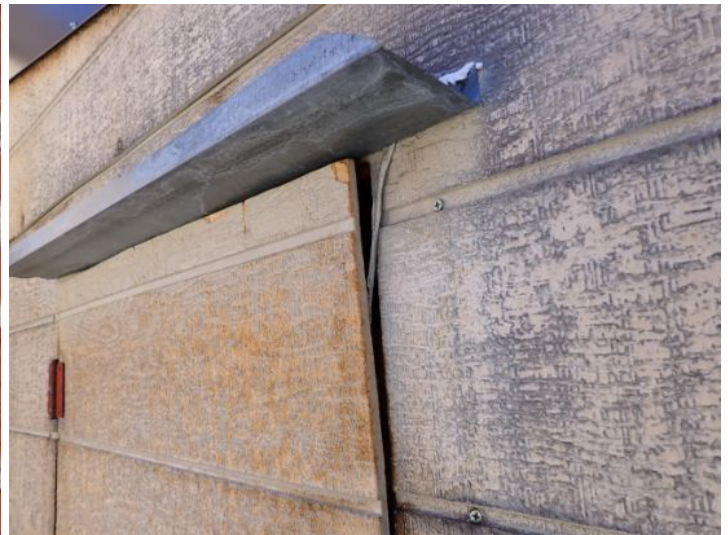
The wood siding material located above the corner awning roof on the ends of the pitched roof sections were in poor condition at the time of the inspection. Recommend repairs by a licensed contractor.

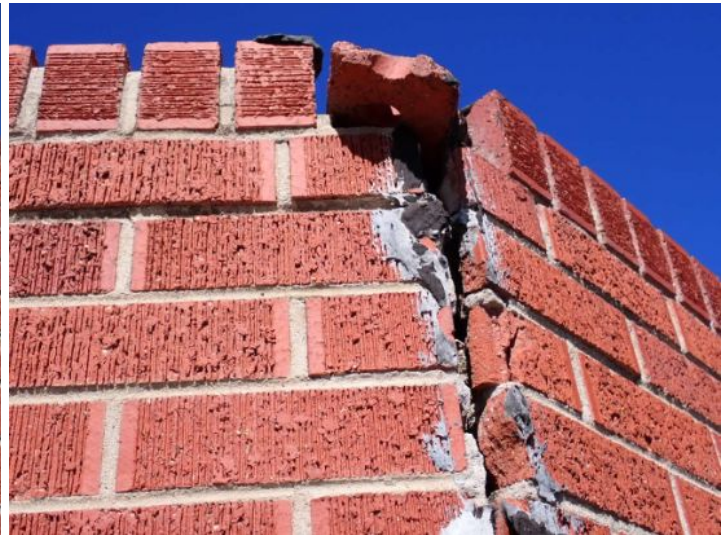
Minor brick damaged and movement noted in the brick siding material at the awning area between the structures. Recommend repairs by a licensed contractor.

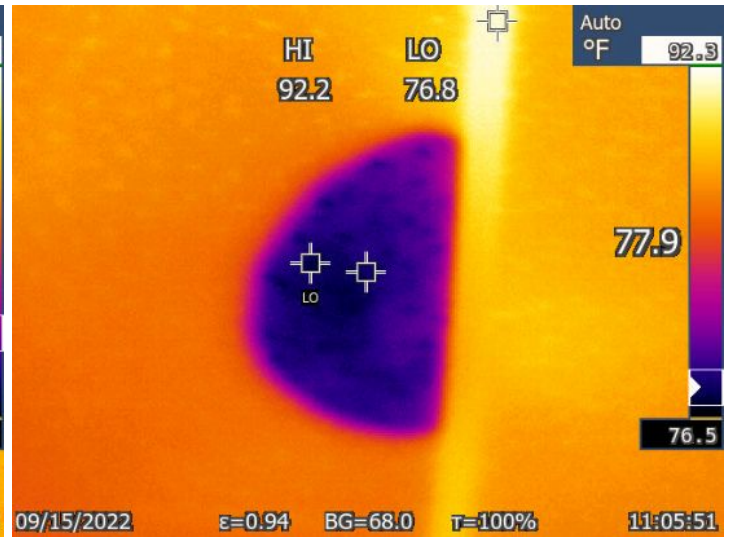
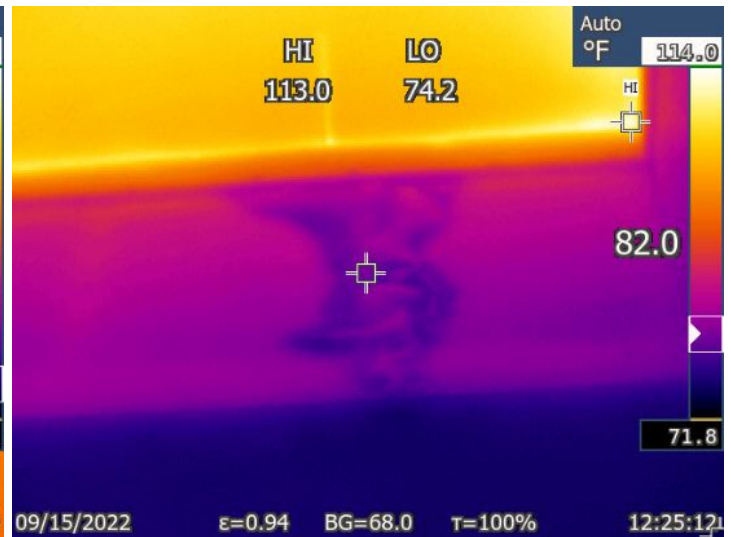
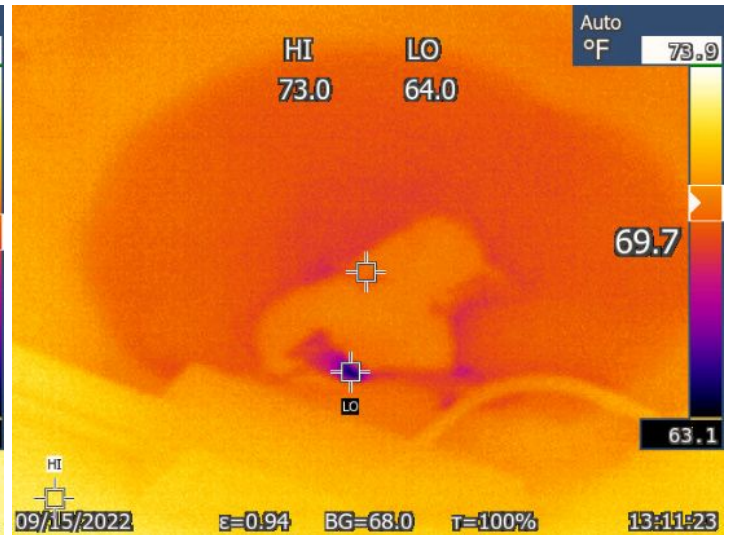
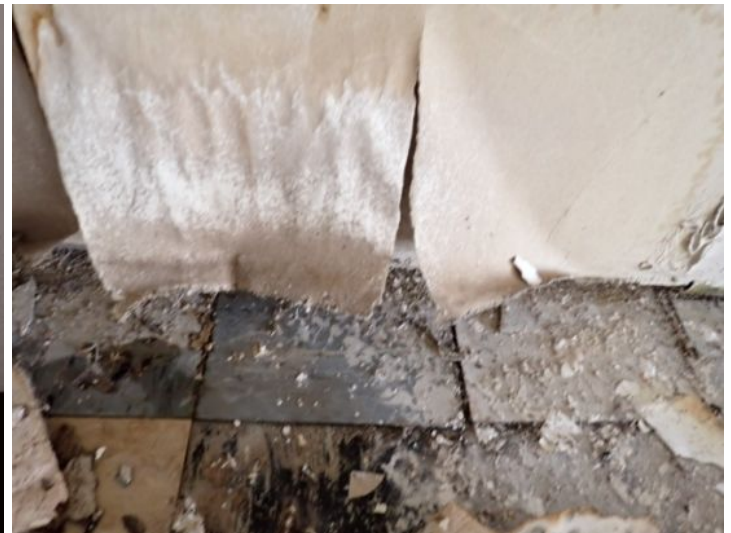
Active roof leaks noted in multiple units at the time of the inspection. Recommend repair/replacement as needed by a licensed contractor.

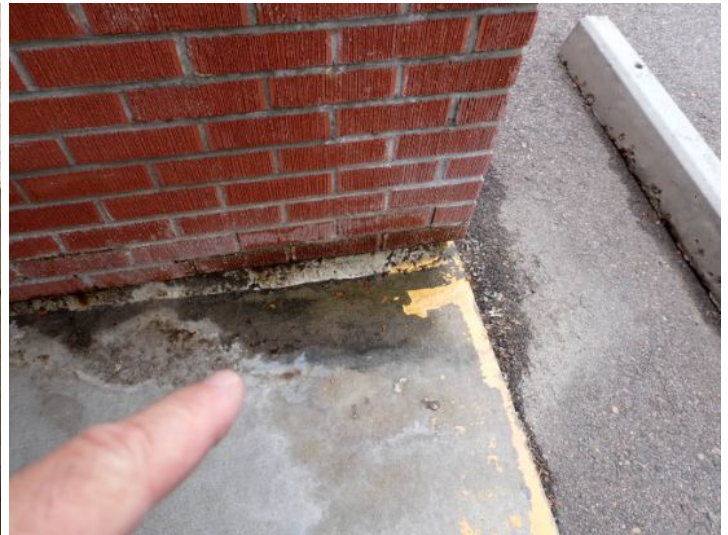
Due to flashing issues storm water was getting into one of the stucco awning support pillars and running down the inside of the system. Recommend repairs as needed by a licensed contractor.

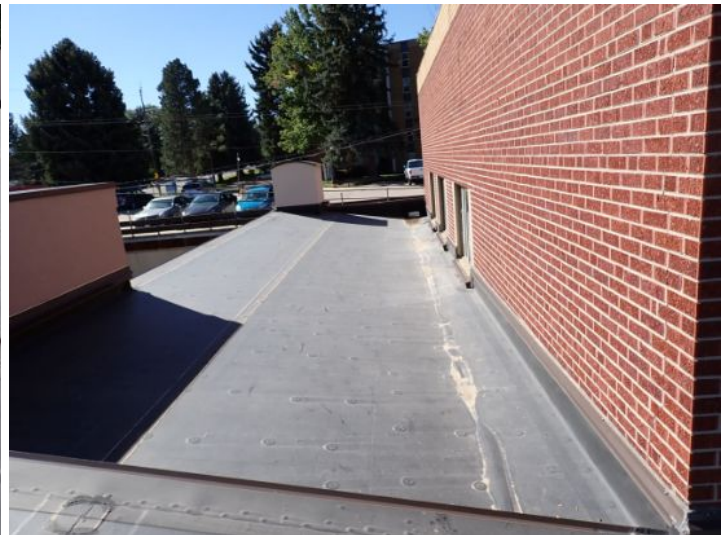
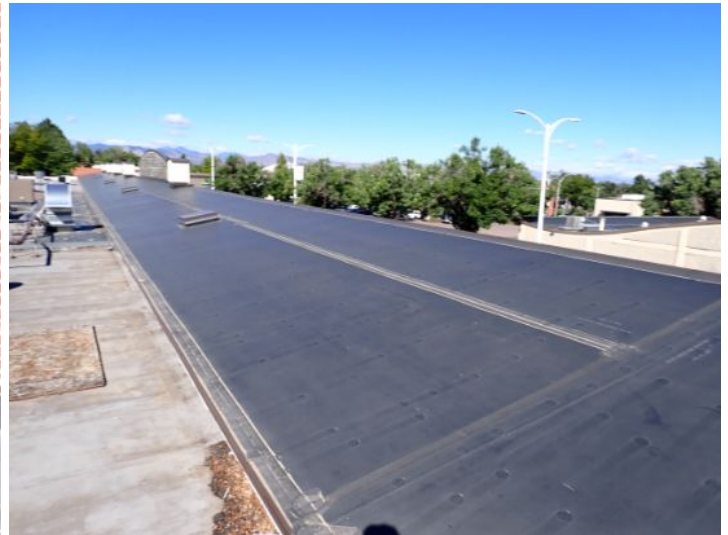
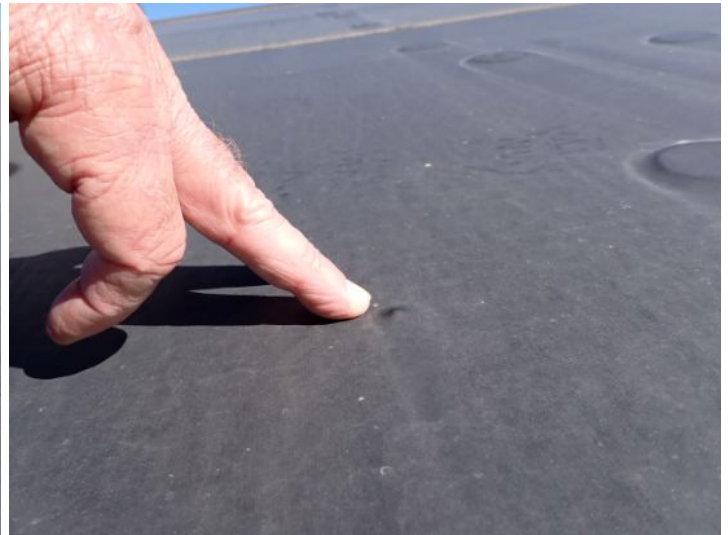
The EPDM membrane on the low slope front sections of each wing appeared be in fair condition at time of inspection. There were areas where it appeared that debris below the membrane was attempting to push through the membrane but had not penetrated at the time of the inspection. Recommend monitoring for future repairs.

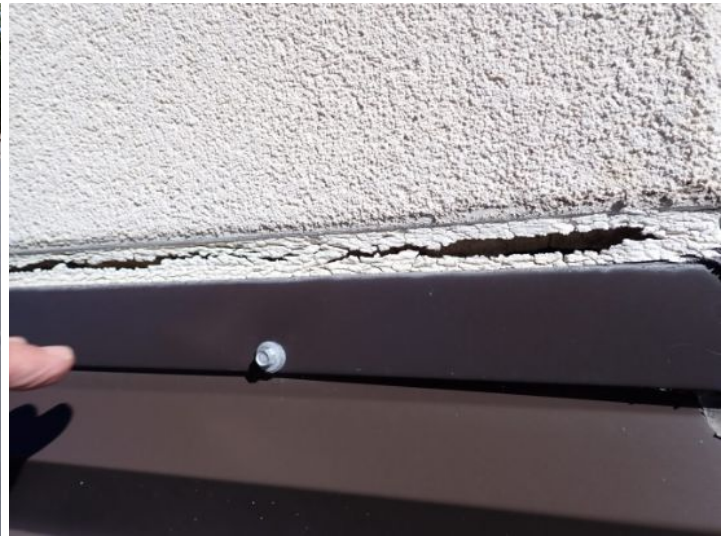
Caulking of the flashing in areas of the EPDM membrane is required in areas. Recommend repairs by licensed contractor.

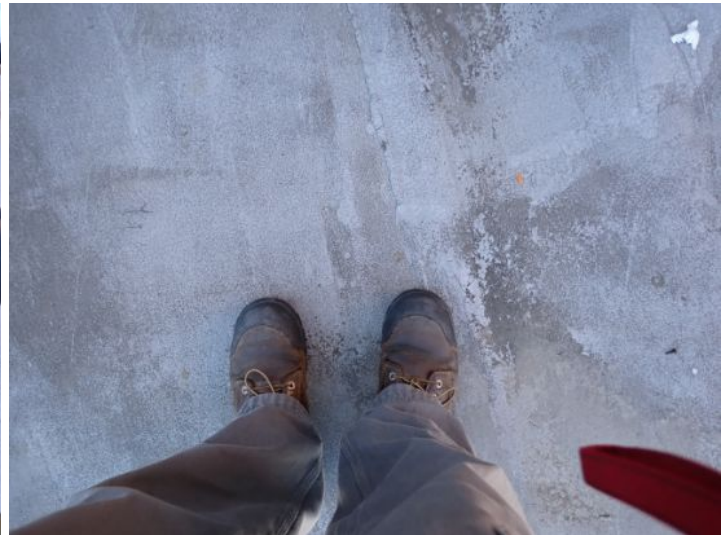
The rolled torch down roofing system located above the east end of the south wing appeared to have reached the end of its serviceable life expectancy with areas of significant ponding and cracking noted. Recommend repairs/replacement by licensed contractor.

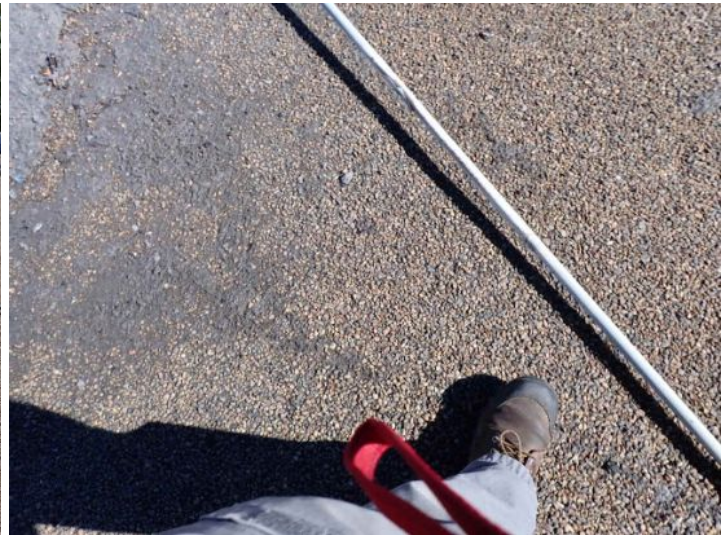
The BUR roofing system located on the east end of the south wing of the building is showing signs of excessive wear excessive ponding it was an extremely poor condition at the time of the inspection. Recommend replacement by a licensed contractor.

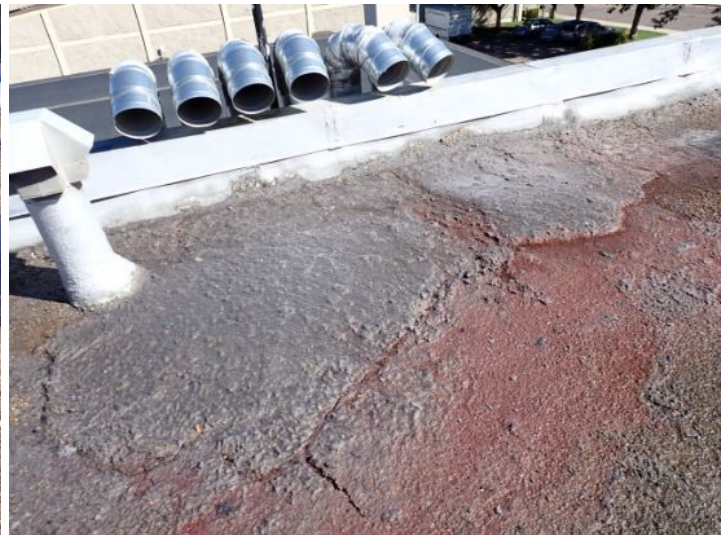
Excessive lint buildup noted on the roof tops above the laundry at the time of the inspection. This could be considered a fire hazard. Recommend cleaning by licensed contractor.

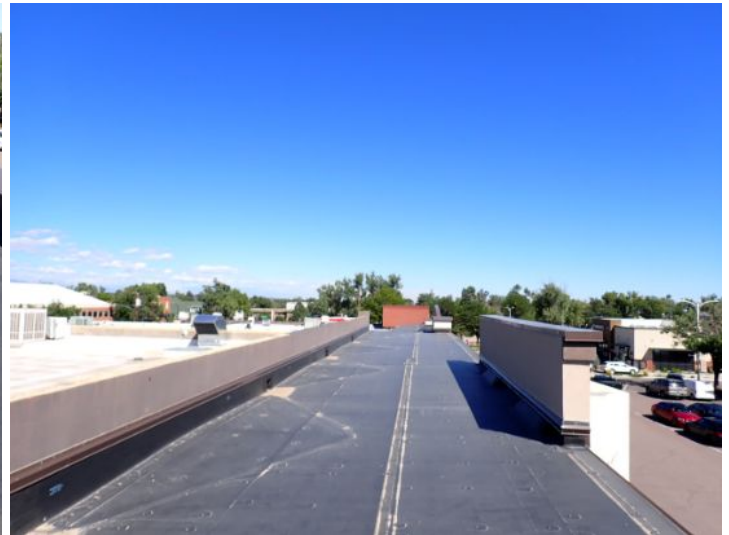
The EPDM membrane on the low slope front sections of each wing appeared to be in fair condition at time of inspection. There were areas where it appeared that debris below the membrane was attempting to push through the membrane but had not penetrated at the time of the inspection. Recommend monitoring for future repairs.

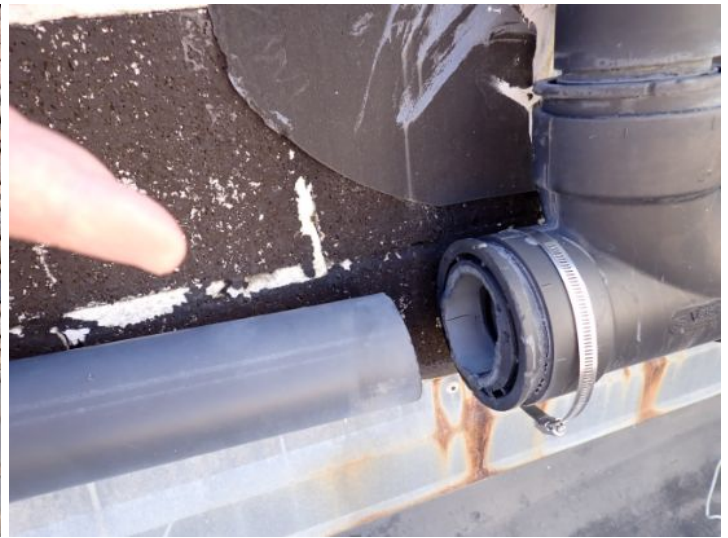
There was what appeared to be a 4 inch wet Vent piping located on the narrow roof above the center of the west wing that was not strapped properly and it becomes separated overtime. This could cause odor issues inside the building. Recommend repairs by licensed contractor.

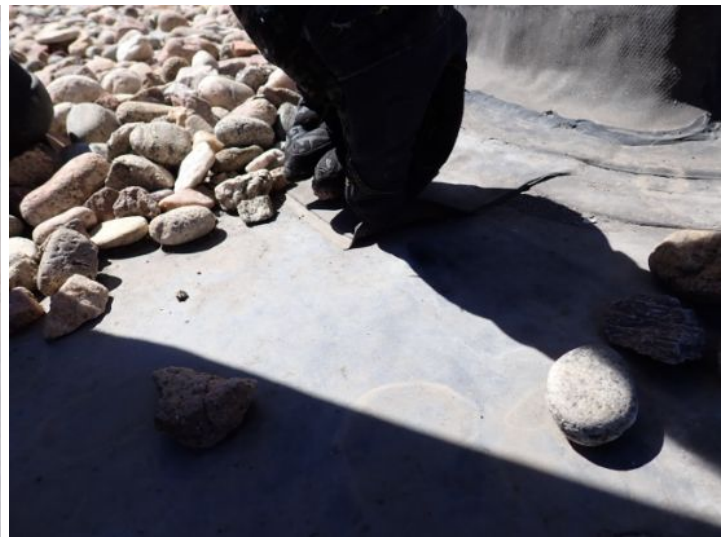
The gravel coated EPDM roofing membrane located near the north end of the west direction is showing signs of poor drainage and seem issues at the time of the inspection and appeared to have reached the end of its serviceable life expectancy. Recommend replacement by licensed roofing contractor.

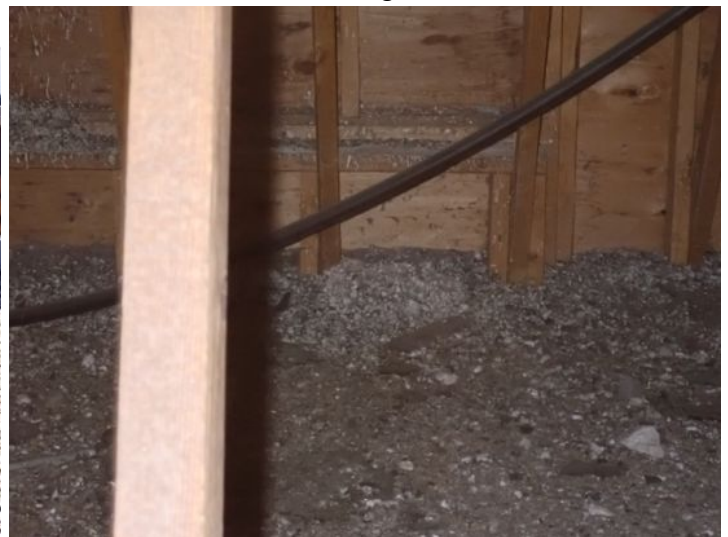
Bird and possible rodent nesting noted in the low slope front area above the unit next to the lifetime fitness center at time of inspection. Loose access panel noted at that time. Recommend bird and rodent removal cleaning of the interior of the area and repairs to the access panel by licensed contractor.

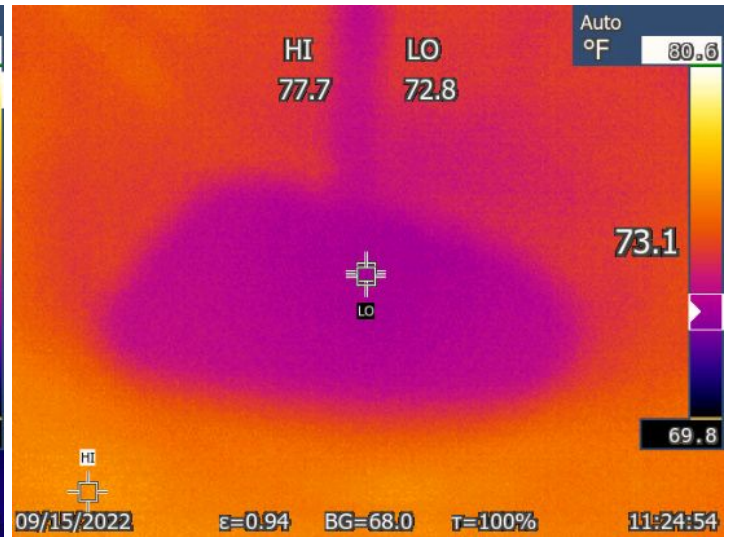
Unit 118: Water heater did not appear functional at the time of the inspection. Recommend repairs by a licensed contractor.

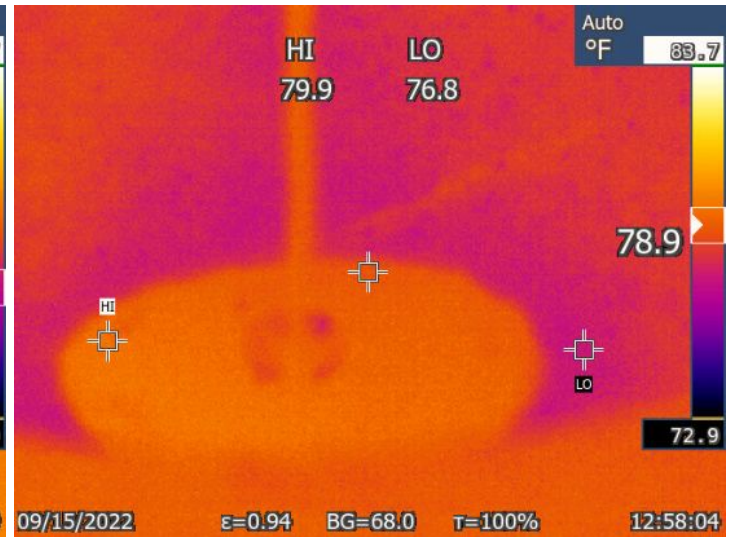
Unit 105: Water heater did not appear functional at the time of the inspection. Recommend repairs by a licensed contractor.

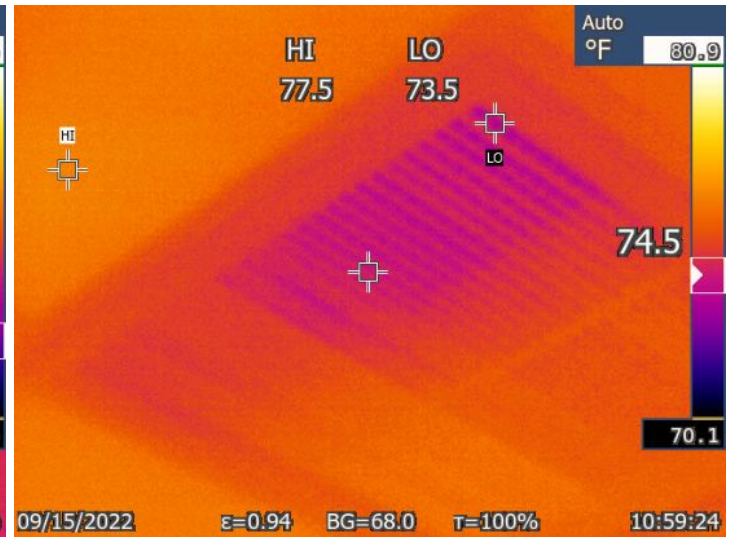
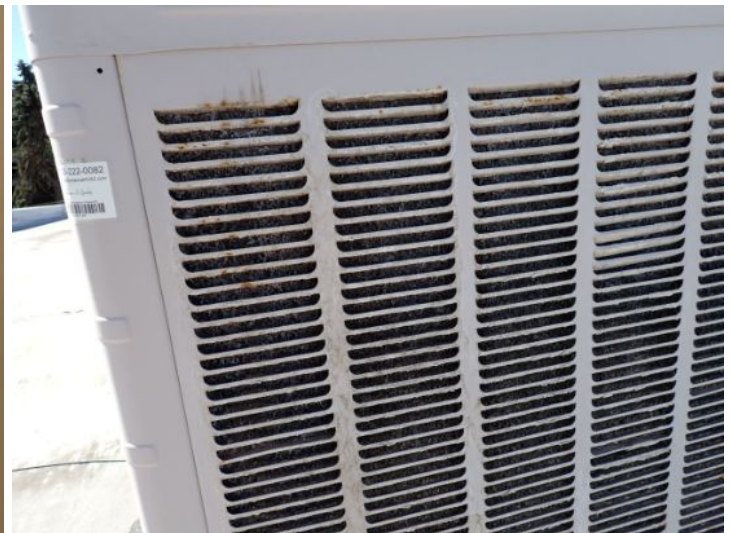
The swamp coolers located above the old theater area that is now being used as office or in fair to poor condition and require servicing and filter repairs by a licensed contractor. Recommend repairs prior to taking possession of the property.

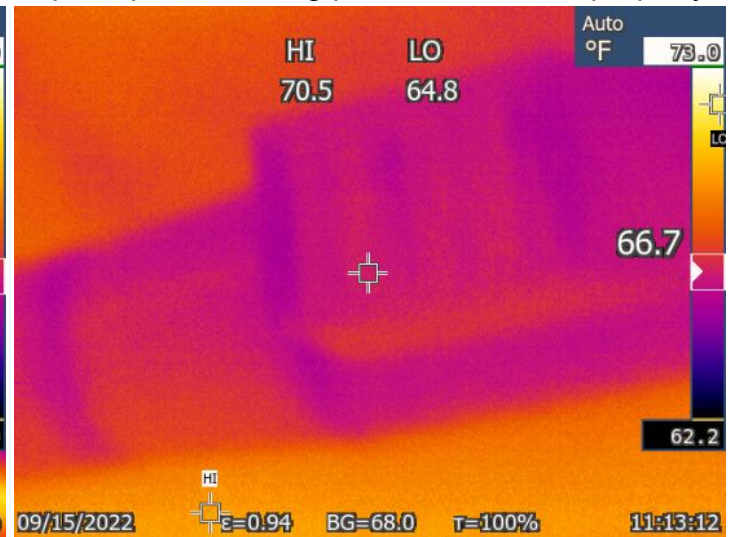
Unit 118: Cooling system did not appear to be functioning properly. Recommend repairs by a licensed contractor

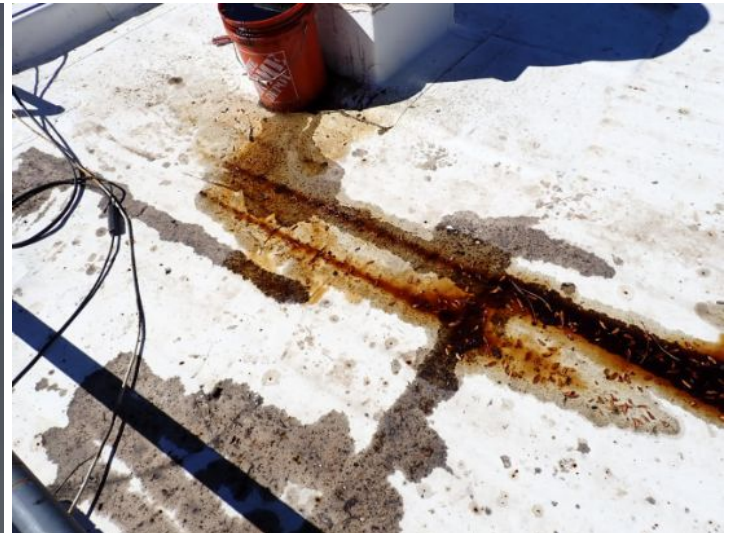
One or more kitchen roof top vent systems were showing signs of significant deferred maintenance. Recommend repairs by a licensed contractor.

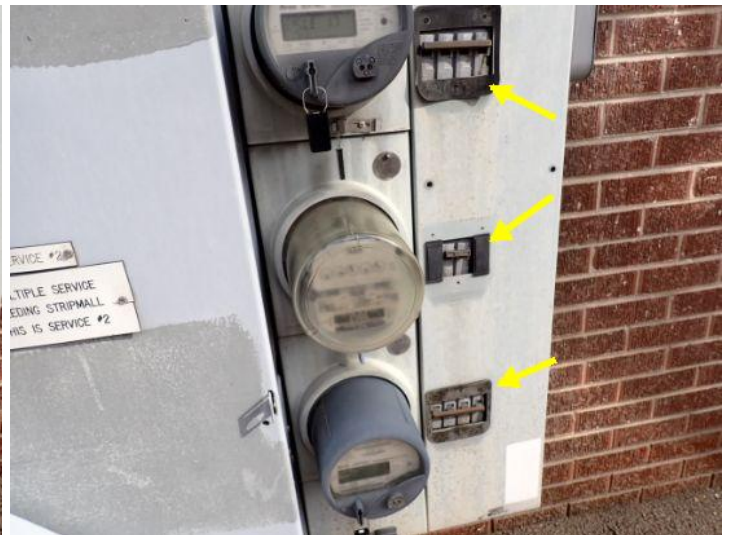
Missing weather covers noted on multiple exterior main breaker systems. Recommend repairs by a licensed contractor.

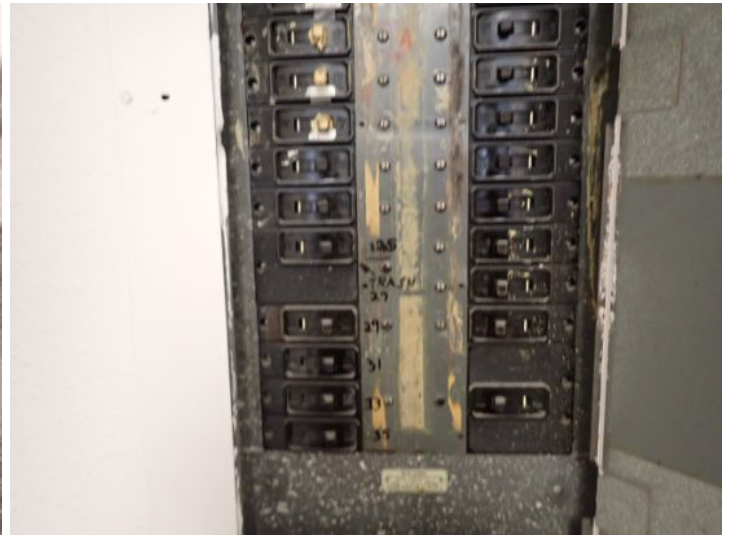
The nominal serviceable life expectancy of an electrical breaker system is 30 years. Based on the inspectors findings at the time of the inspection there were multiple panels and breaker systems that appeared to have surpassed their serviceable life expectancy. Recommend repair/replacement of these systems by a licensed electrician prior to taking possession of the property.

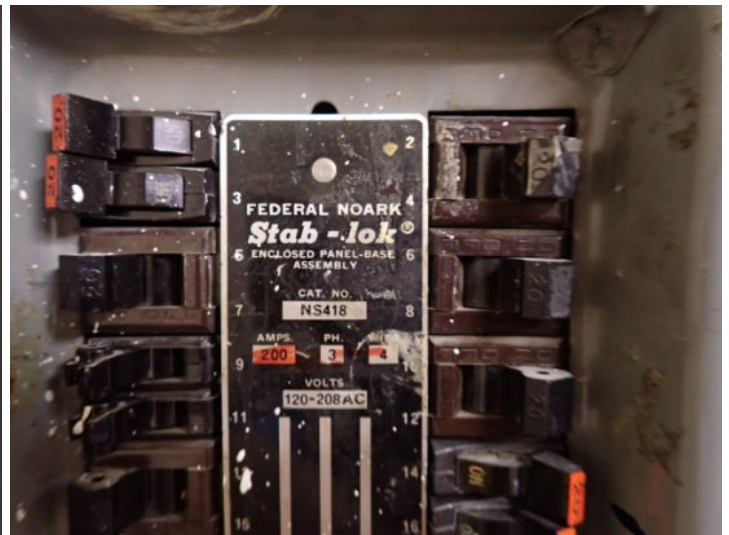
Old Federal Pacific Stab Lock breaker systems noted in some of the units at the time of the inspection. These systems have been proven to be safety/fire issues. Recommend replacement of all FPE panels and stab lock breaker systems by a licensed contractor prior to taking possession of the property.

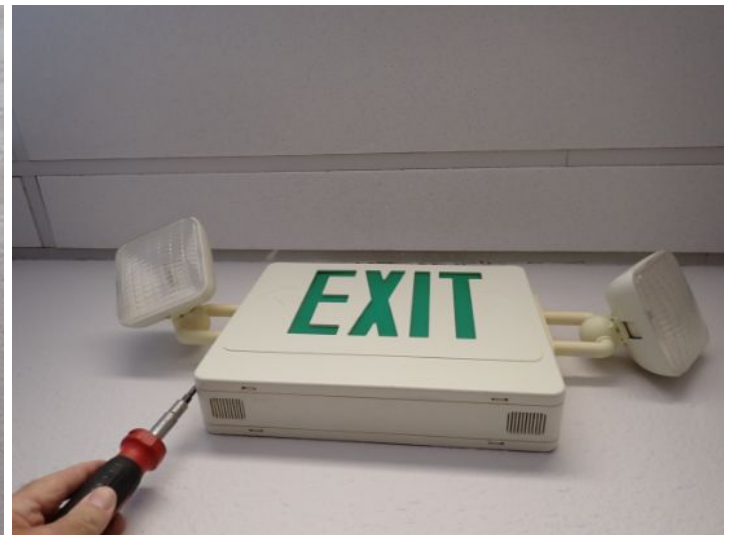
Multiple emergency lighting systems failed when tested at the time of the inspection. Recommend repairs as needed by a licensed contractor.

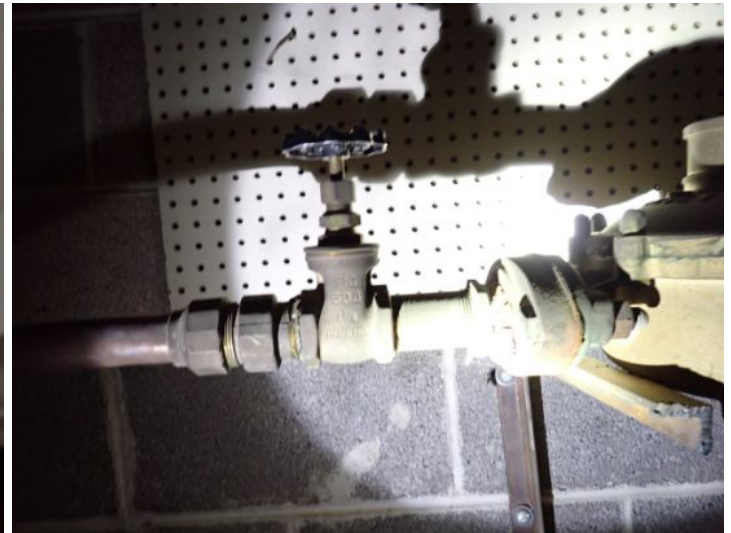
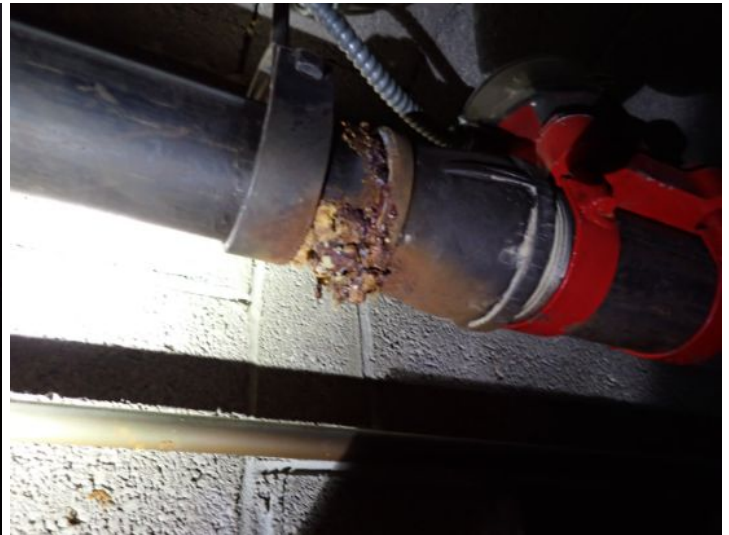
The old fire suppression system located in the basement below the large vacant unit will most likely require updating prior to placing a tenant in the unit. Recommend consulting with the current management company and local fire marshal concerning this matter as updating of fire suppression and alarm systems could be considered a significant capital investment.

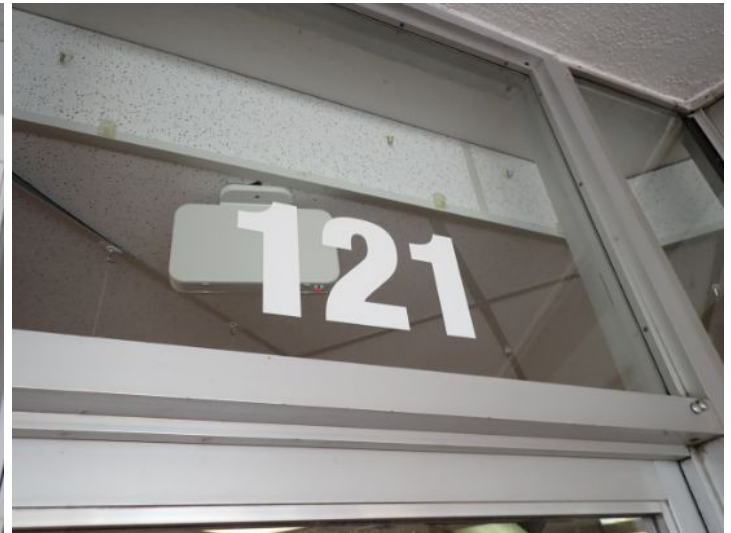
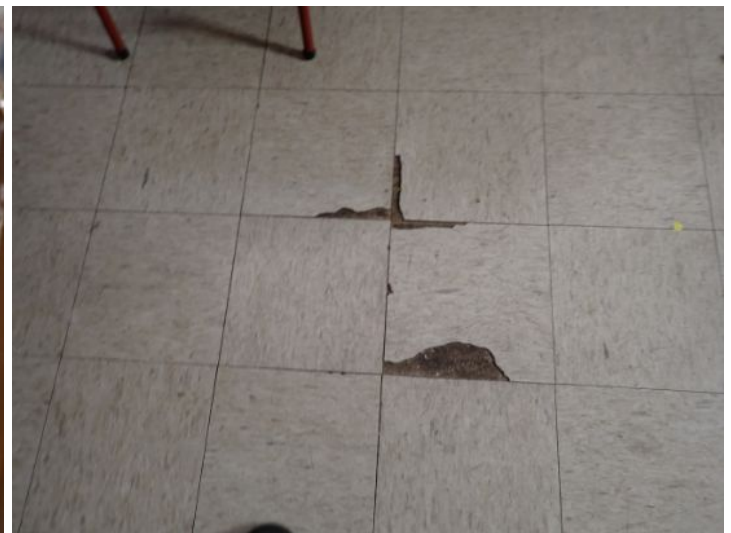
Unit 121: VCT flooring damage noted. Recommend repairs.

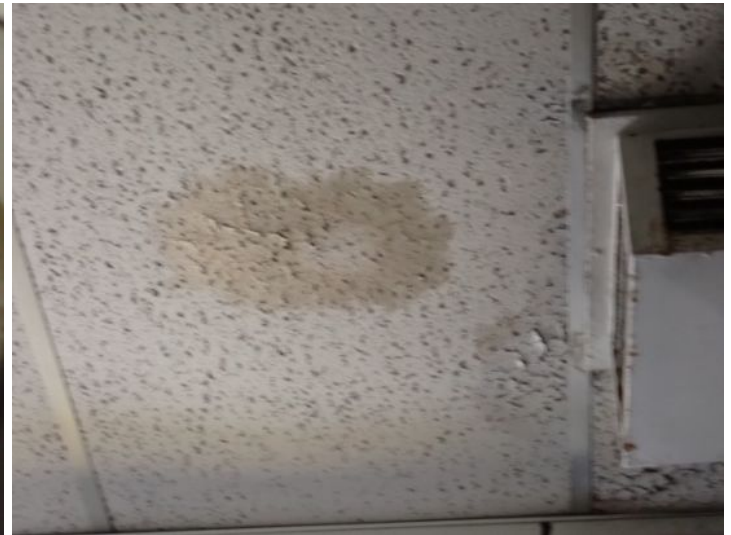
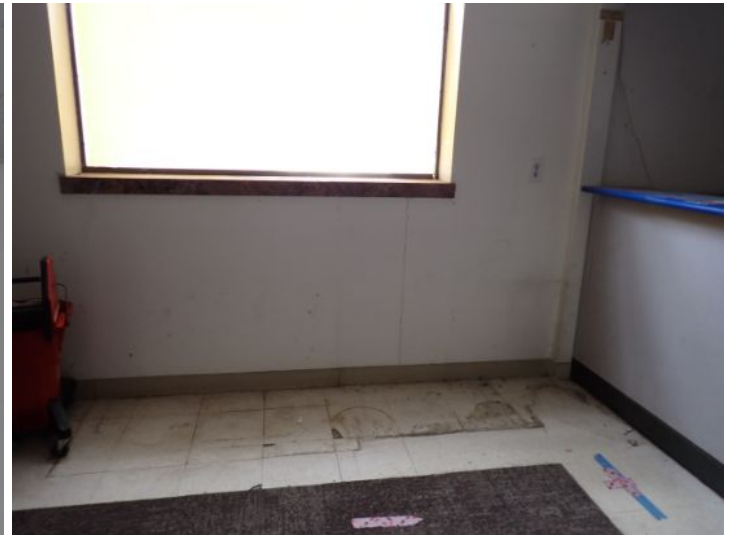
Unit 110E: Unit was vacant and will require renovations prior to placing a tenant. Recommend repairs by a licensed contractor.

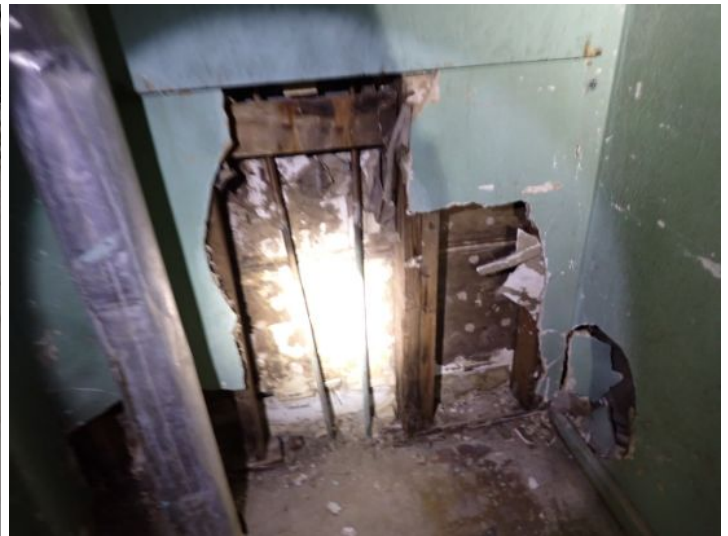
Unit 108-107: Vacant: Unit will require significant renovations prior to installing tenant. Active moisture noted in interior wall with possible microbial growth. Significant drywall damage noted in ceiling in loading dock area. Basement area in poor condition. Basement bathrooms in poor condition. Electrical not working at the time of the inspection. Moisture intrusion/damage noted in basement walls. Recommend repairs as needed by a licensed contractor.
