Forman Inspection Services, LLC

Property Inspection Report

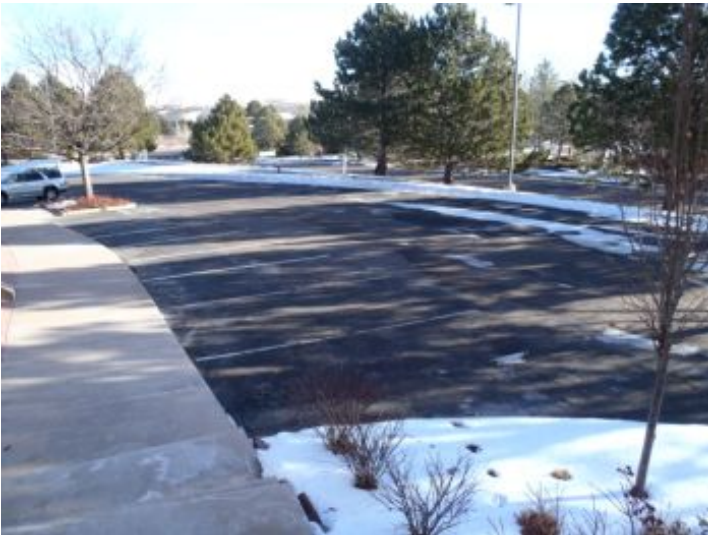
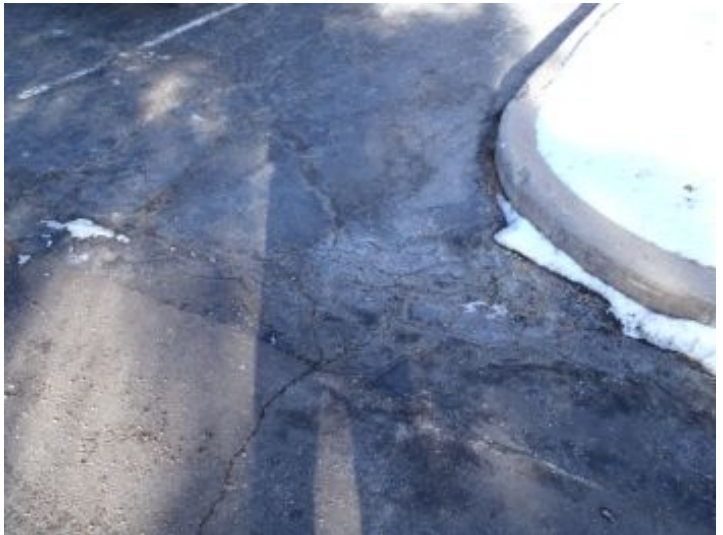
Parking consists of an asphalt paved parking lot that is in fair condition. The parking lot is being resurfaced in stages which is being paid for out of the tenants association dues. The lot consists of approximately 4 spaces per 1000 sq. ft. of space. The lot has concrete curbs which appeared to be in good condition at the time of inspection.

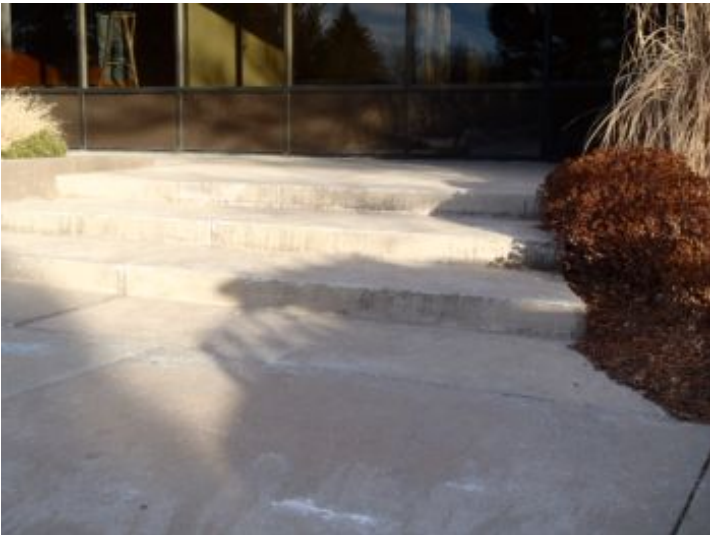
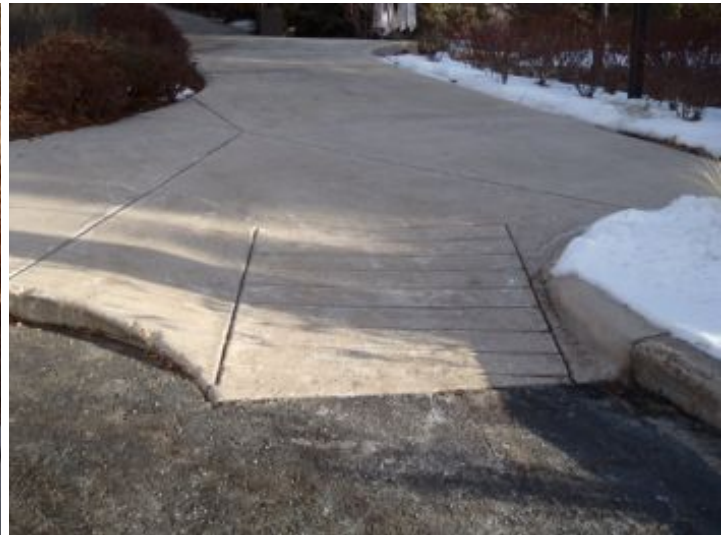
There is a concrete sidewalk leading to the condo. The sidewalk incorporates an ADA compliant ramp leading up from the upper level of the parking lot. The rise of the ramp complies with ADA regulations. There are steps leading up from the lower level of the parking lot to the sidewalk. The sidewalk appeared to be in good condition with only some minor cracking which did not appear to be an issue.

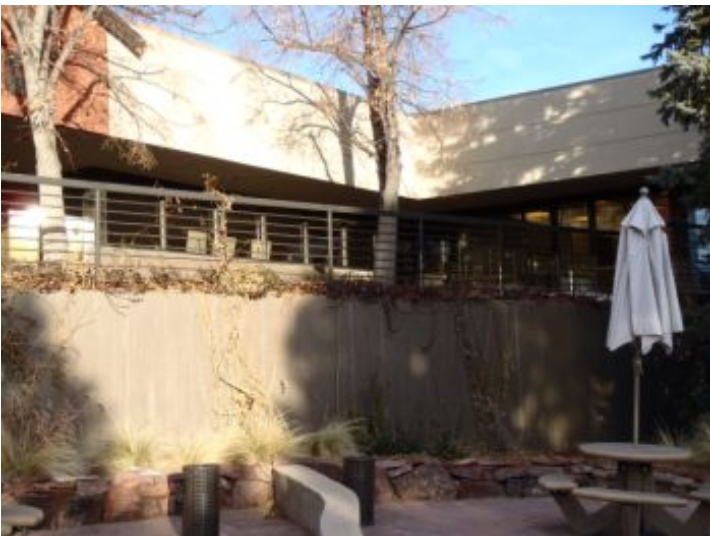
At the bottom of the steps, on the lower parking level, there is a patio area. On the upper level near the structure are planned flower beds with several trees.

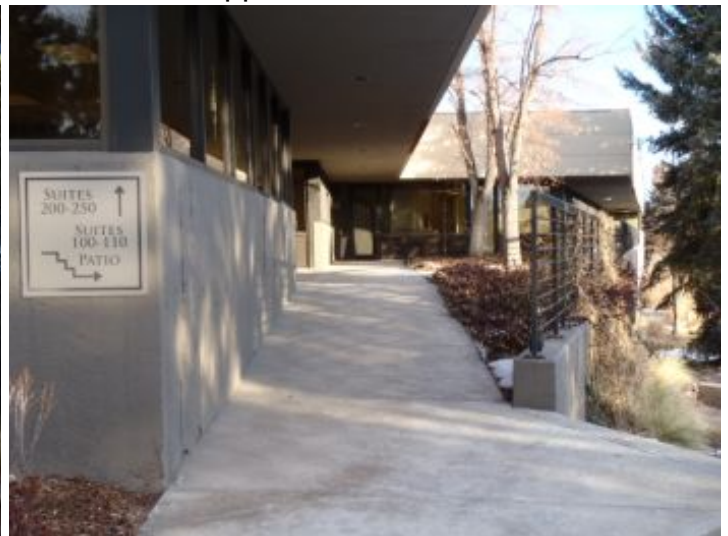
There is a concrete sidewalk leading to the condo. The sidewalk incorporates an ADA compliant ramp leading up from the upper level of the parking lot. The rise of the ramp complies with ADA regulations. There are steps leading up from the lower level of the parking lot to the sidewalk. The sidewalk appeared to be in good condition with only some minor cracking which did not appear to be an issue.

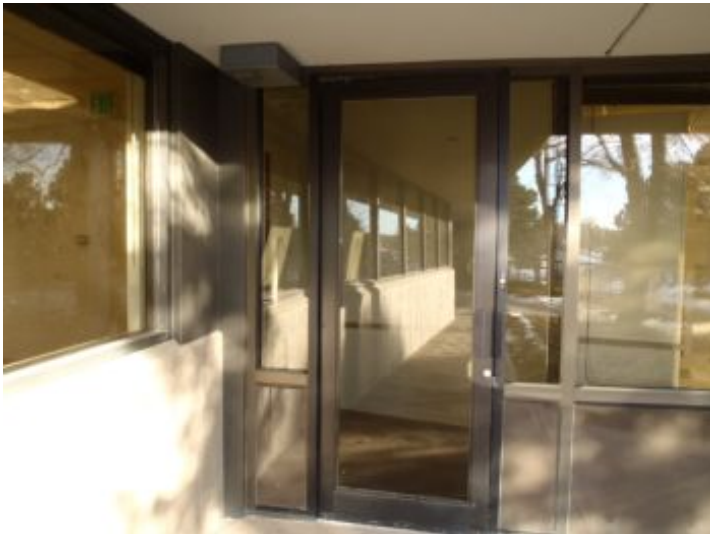
The current entrance door to the unit would not be considered ADA compliant as it requires too much force to open and closes too quickly. Upon interviewing Bill Woodward concerning the remodel that is taking place in the unit inspector was informed that the new entrance door will be ADA compliant.

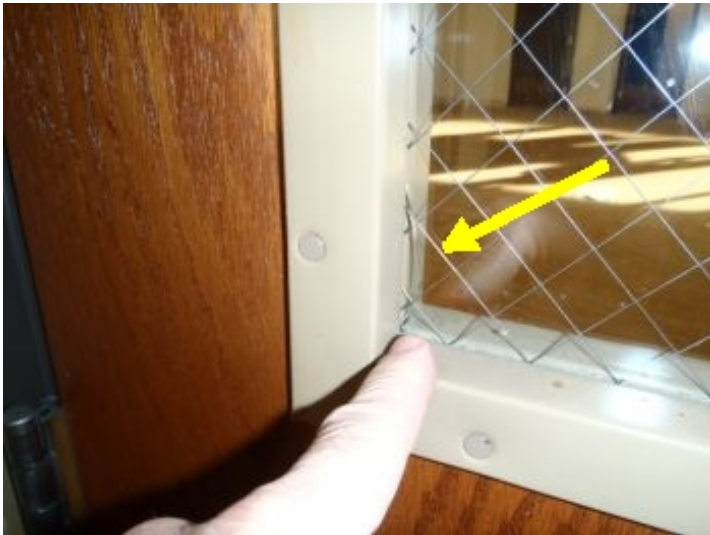
The secondary entrance door, that is equipped with the wire safety glass, has a crack in the glass. Recommend repair/replacement.

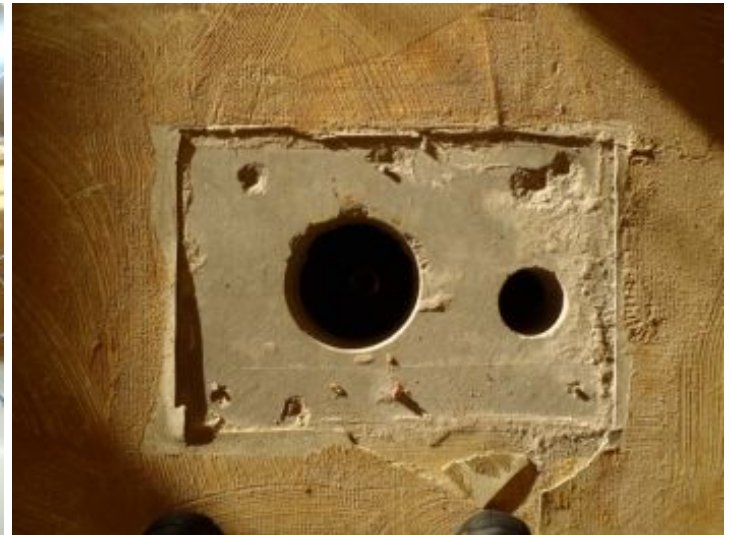
There is evidence of previous movement of the buildings slab. The slab was mud jacked to repair it. At the time of the inspection the slab appeared to be in good condition, and was relatively level throughout. There is a noticeable crack near the wall to the next to the condo south with a slight rise in the floor. When interviewing Bill Woodward he informed inspector that the association is responsible for the buildings slab. There is a whole in the slab from an old water line. The line has been decommissioned and the holes will be filled.

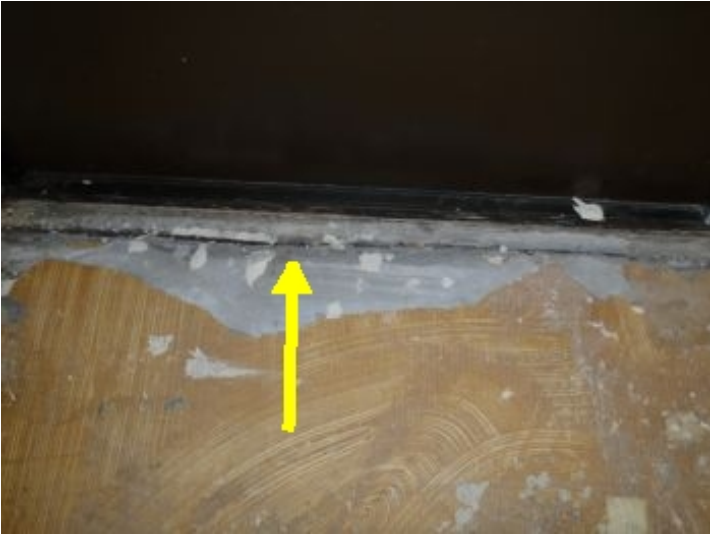
There is evidence of previous movement of the buildings slab. The slab was mud jacked to repair it. At the time of the inspection the slab appeared to be in good condition, and was relatively level throughout. There is a noticable crack near the wall to the next to the condo south with a slight rise in the floor. When interviewing Bill Woodward he informed inspector that the association is responsible for the buildings slab. There is a whole in the slab from an old water line. The line has been decommissioned and the holes will be filled.

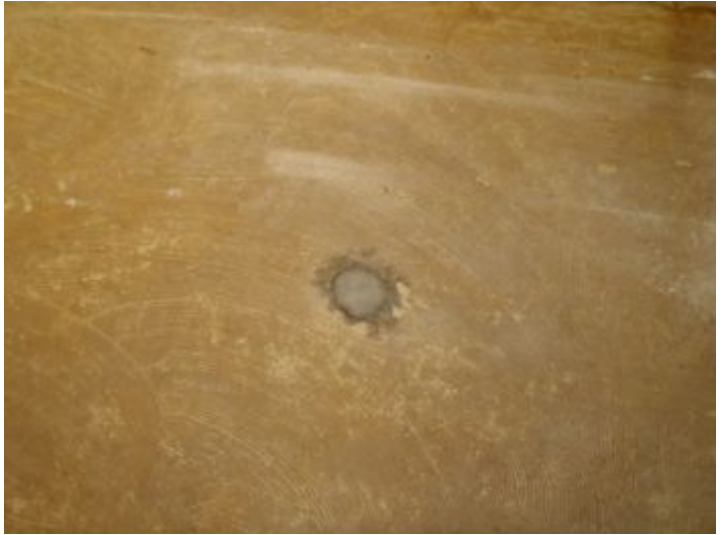
There is evidence of previous movement of the buildings slab. The slab was mud jacked to repair it. At the time of the inspection the slab appeared to be in good condition, and was relatively level throughout. There is a noticable crack near the wall to the next to the condo south with a slight rise in the floor. When interviewing Bill Woodward he informed inspector that the association is responsible for the buildings slab. There is a whole in the slab from an old water line. The line has been decommissioned and the holes will be filled.

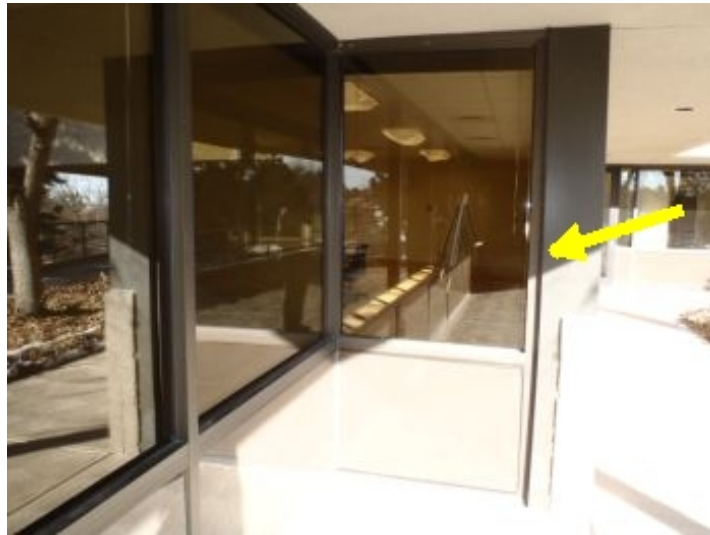
Location of new ADA compliant entrance door.

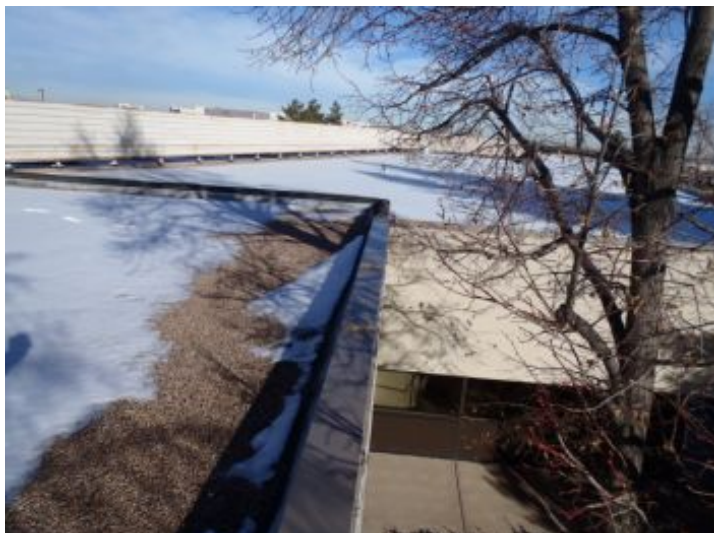
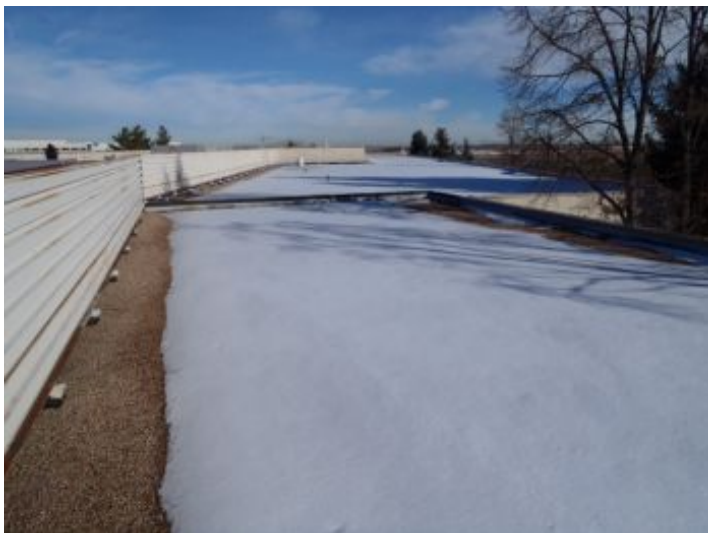
Type of membrane: The roof consist of a 1 1/2" deep steel roof deck supported on bar joists spaced 6' on center. The joists are supported on steel wide flange girders which are in turn supported on steel tube or wide flange columns. The roof decking is covered with a membrane that is protected by tar and gravel. Inspection of the roof showed no deterioration. The roof was cleaned and refurbished in 2000.

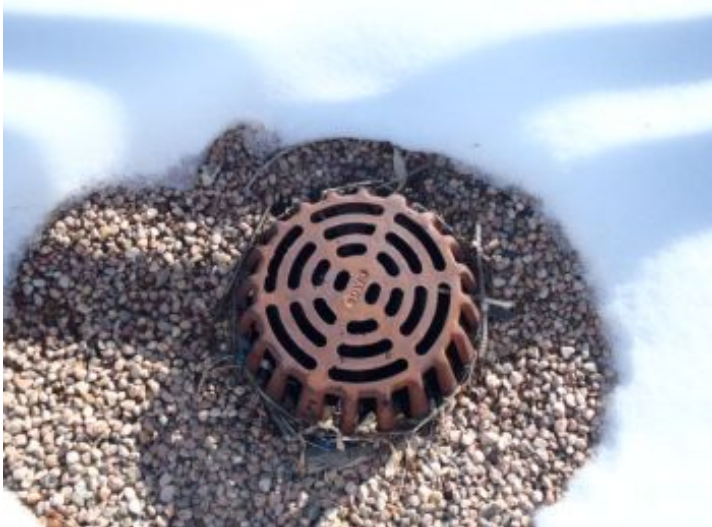
Drainage: The roof is sloped to the back of the building to aid in drainage. The gutter drainage appeared clear. There were additional roof drains located strategically throughout the roofs surface.

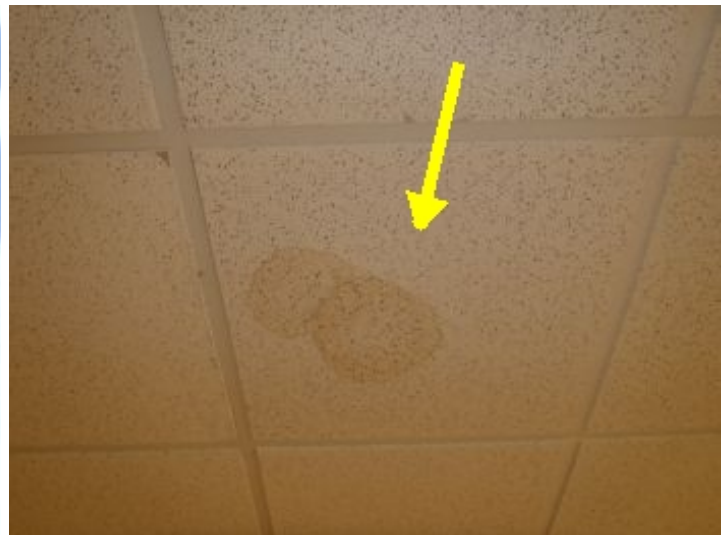
Observed leakage: When viewing the roof from the underside, by lifting interior suspended roof tiles, there were no leaks observed at the time of the inspection. There is a moisture stain in one of the ceiling tiles, but there was not moisture present at the time of the inspection.

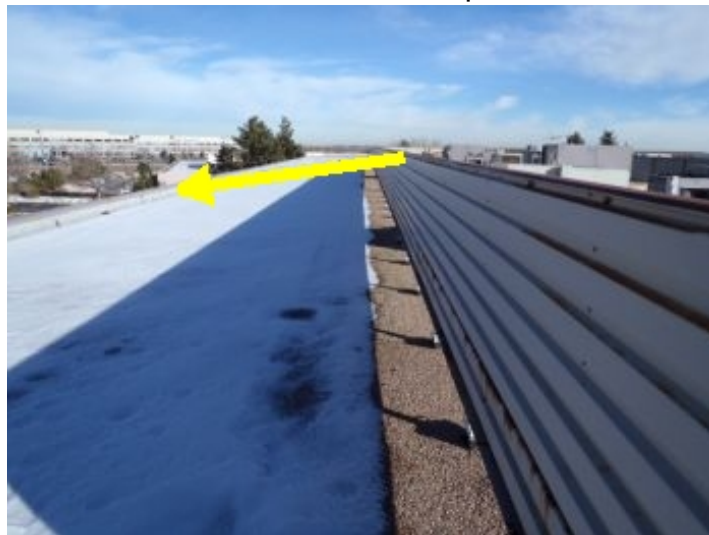
Drainage: The roof is sloped to the back of the building to aid in drainage. The gutter drainage appeared clear. There were additional roof drains located strategically throughout the roofs surface.

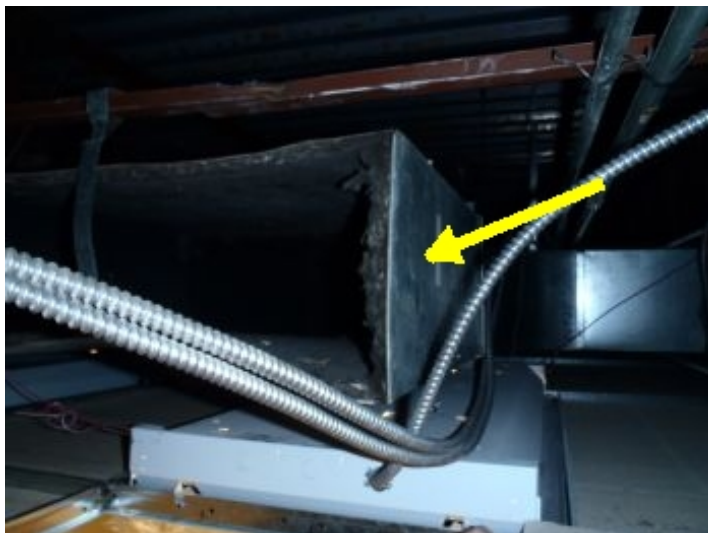
There appears to be some abandoned duct work in the ceiling of the condo. Recommend having an HVAC contractor to evaluate when they come in to run duct work and balance the units after the build out/remodel.

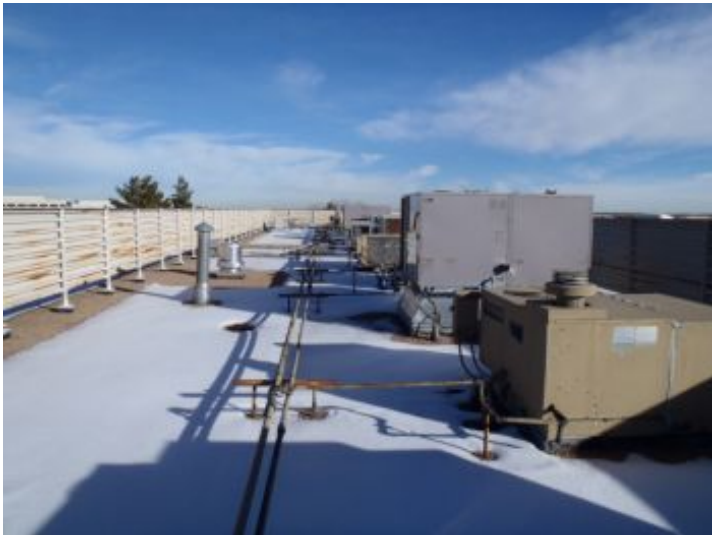
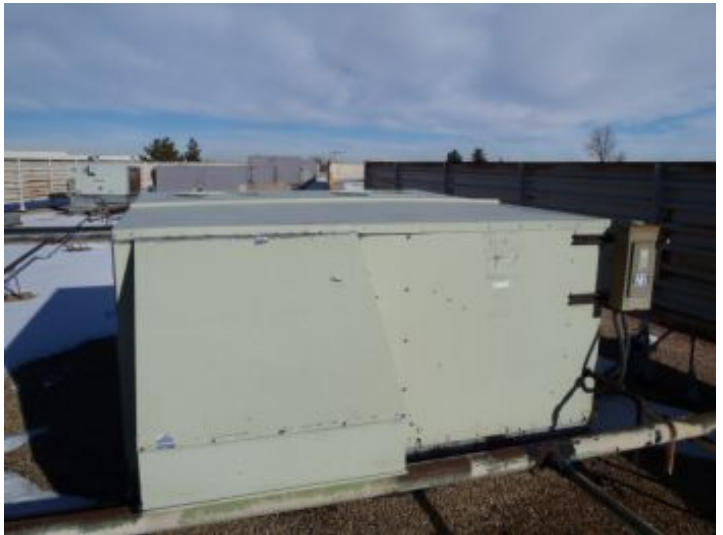
There are currently two units supplying conditioned air to the condo. These are the same units that provide heat to the condo. Currently the two units provide 12.5 tons of cooling. One unit is a 7.5 ton unit and one is a 5 ton unit. Both units have recently been evaluated by an HVAC contractor. The 5 ton unit has been determined to be good however the 7.5 ton unit is in need of repair. According to Bill Woodward the 7.5 ton unit is not worth repairing and is being replaced with a new 5 ton unit. When the new unit is installed, and after the remodel/build out, the tenant will be responsible for hiring an HVAC contractor to run needed duct work and balance the units accordingly.

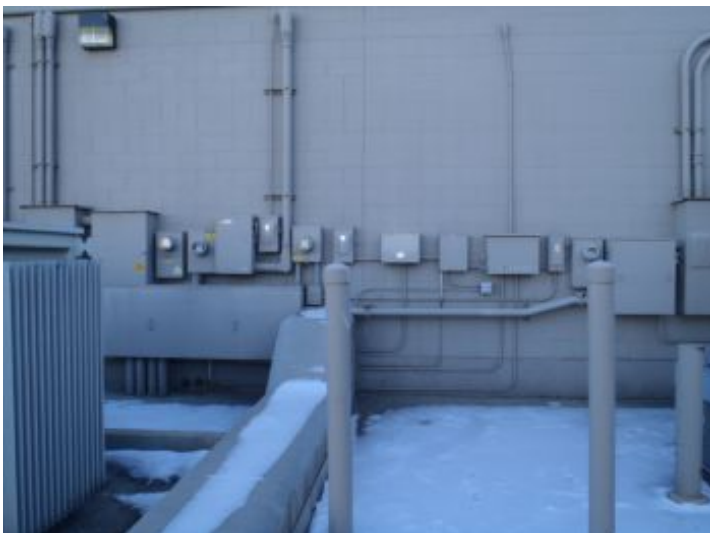
Current Electrical is located on the outside of the building. New electrical will be placed in an electrical room.

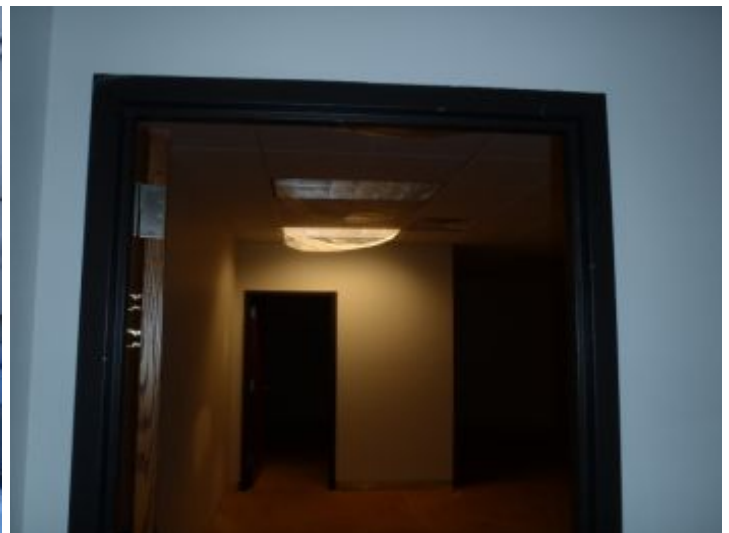
At the time of the inspection there was one overhead light that remained on in each office after all switches were turned off. Recommend evaluation by a licensed electrical contractor when they come in to run the new electrical.

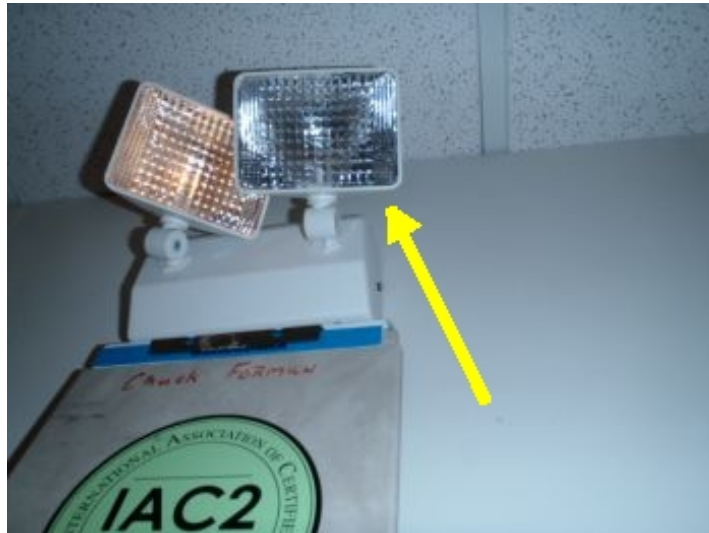
At the time of the inspection there were no fire extinguishers on the property. Inspector did not see any sprinkler system or smoke evacuation systems. Recommend buyer contact sellers and inquire about any proposed fire safety items. There were two emergency lighting units present. When tested one of the units did not work properly. Recommend repair or replacement.

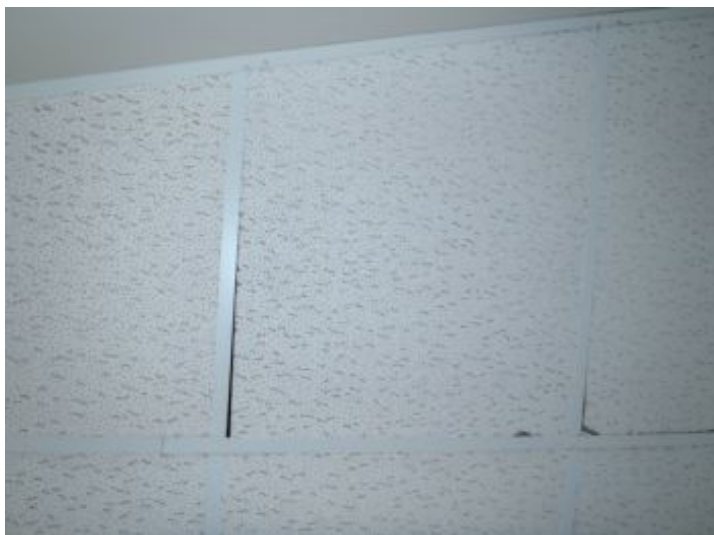
There are several damaged, or dirty, ceiling tiles. Recommend replacement after the remodel/build out.

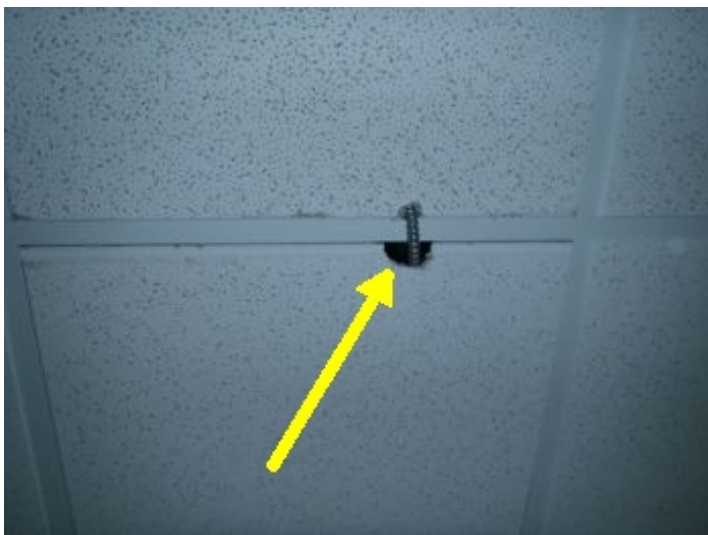
In the back office there is a section of flexible electrical conduit running through two ceiling tiles and around a suspended ceiling support. Recommend repair/replacement when electrical contractor is running new electrical in the building.

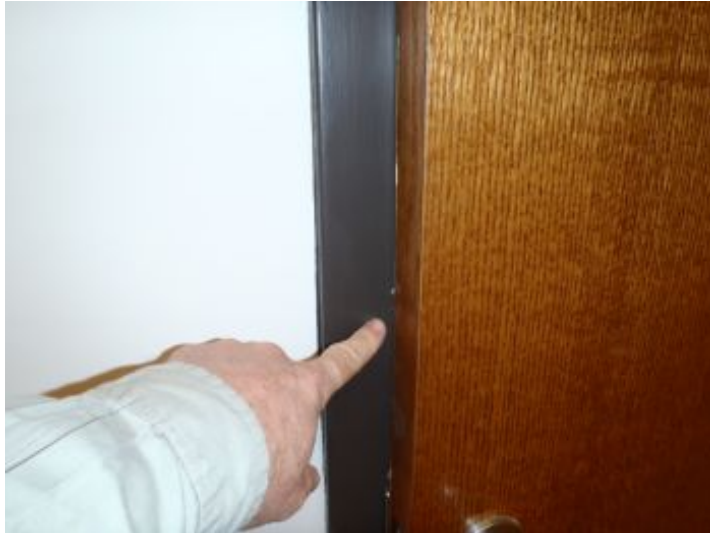
At the time of the inspection one of the office doors is sticking and requires adjustment.
