# *Forman Inspection Services, LLC*

## Property Inspection Report

12345 Industrial Rd., Somewhere, CO 12345  
Inspection prepared for: John Smith  
Real Estate Agent: John Smith - Commercial Real Estate Company

Date of Inspection: 11/28/2022 Time: 10:00 Size: 10,400 sq. ft.  
Weather: Cloudy/Cool

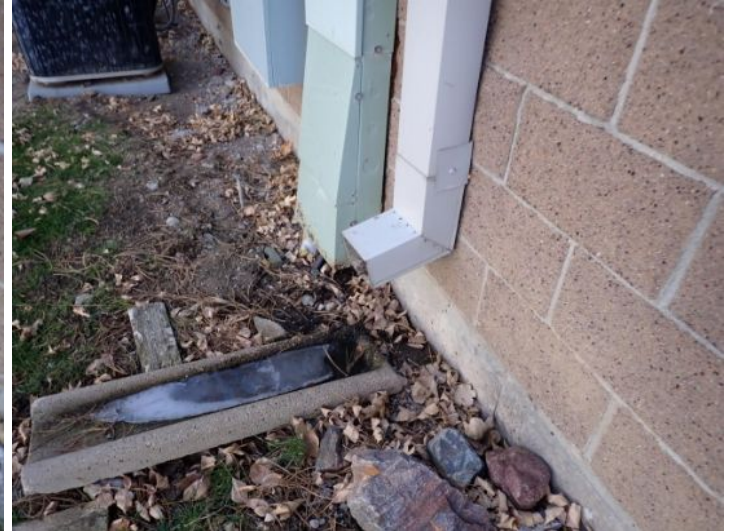
Signs of poor drainage noted along the rear of the structure at the time of the inspection. Recommend repairs by a licensed contractor.

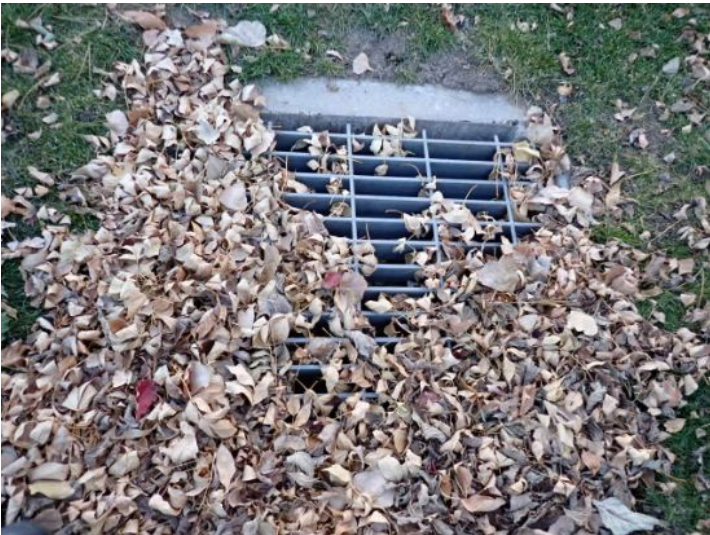
There were storm water catch basins located on the property at the time of the inspection.

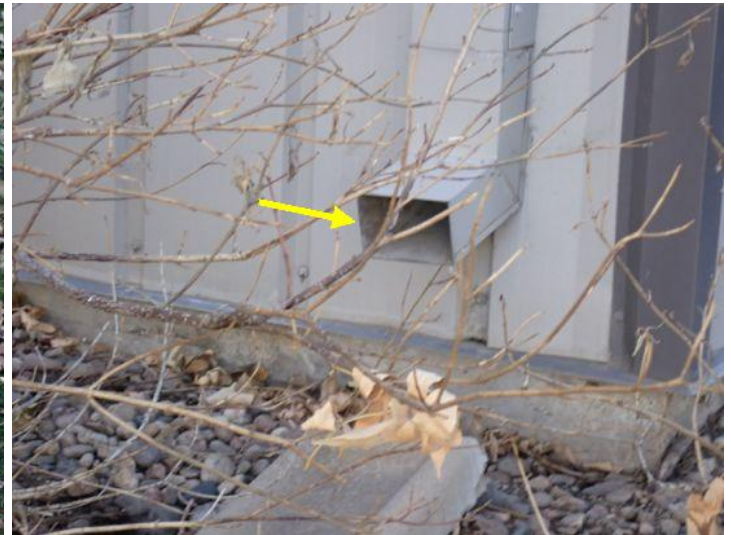
Gutters down spouts missing extensions to direct storm water away from the foundation of the structure. Recommend repairs.

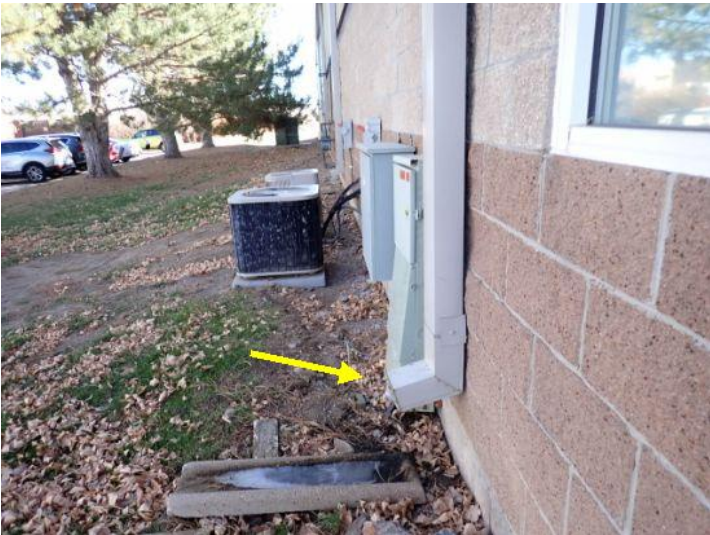
Gutters down spouts missing extensions to direct storm water away from the foundation of the structure. Recommend repairs.

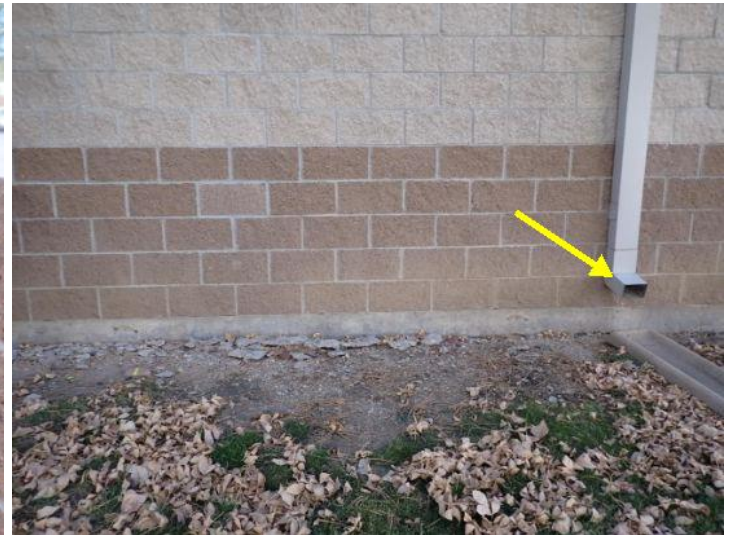
Gutters down spouts missing extensions to direct storm water away from the foundation of the structure. Recommend repairs.

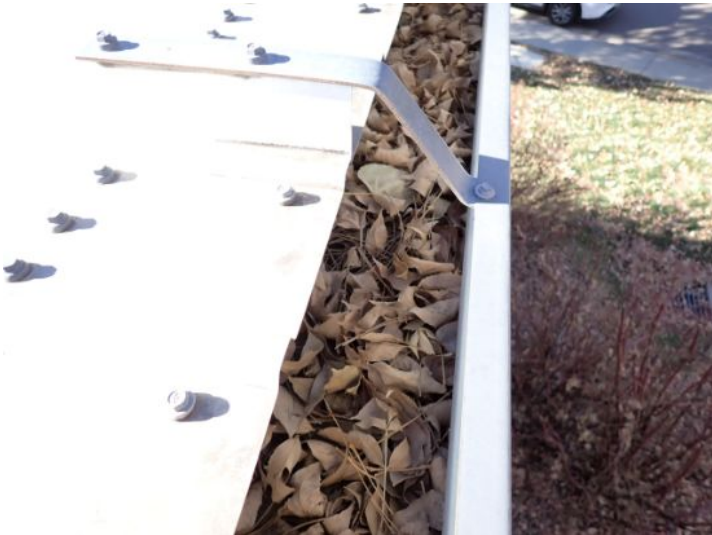
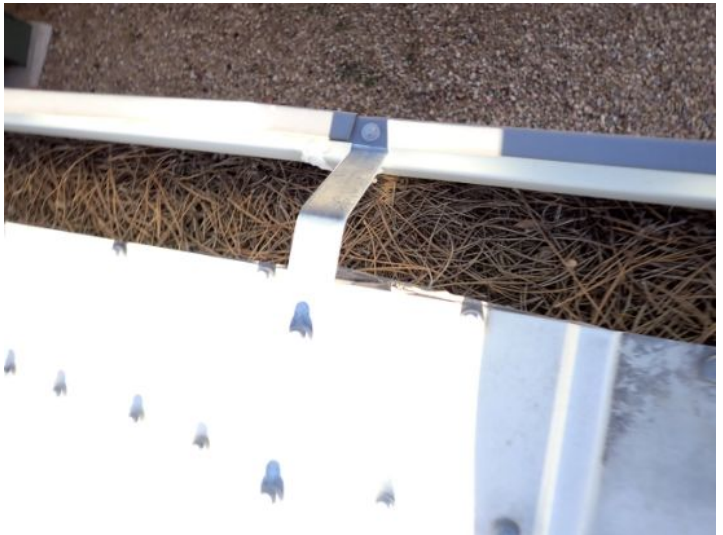
Roof gutter systems were clogged with debris at the time of the inspection. Recommend repairs by a licensed contractor.

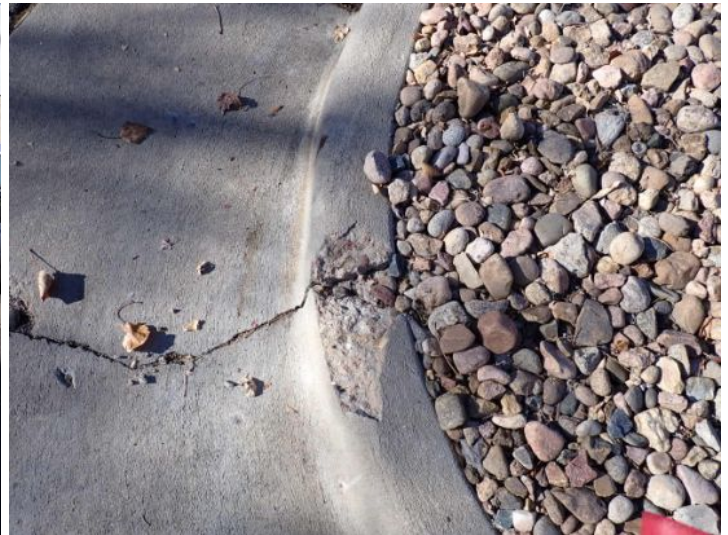
Minor curbing damage noted in areas. Recommend repairs.

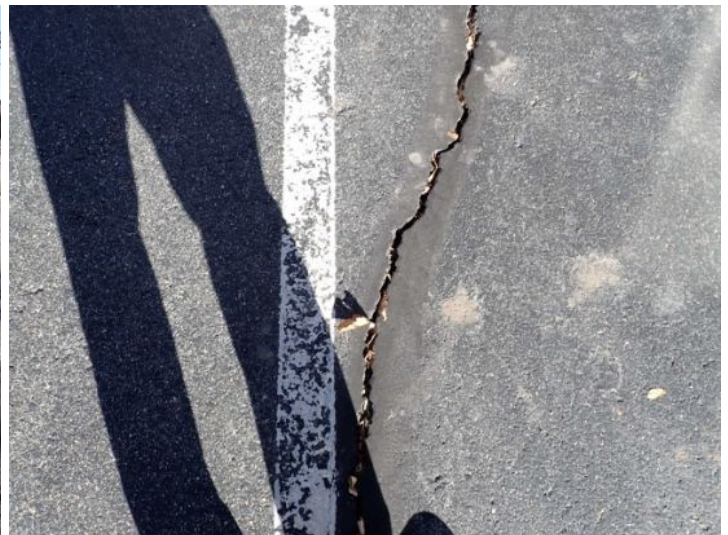
Recommend crack filling to aid in extending the life of the existing asphalt. Recommend repairs by a licensed contractor.

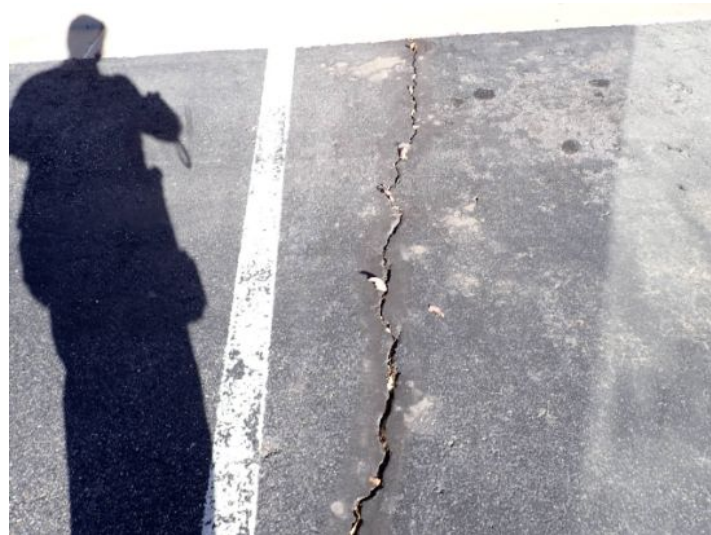
Recommend crack filling to aid in extending the life of the existing asphalt. Recommend repairs by a licensed contractor.

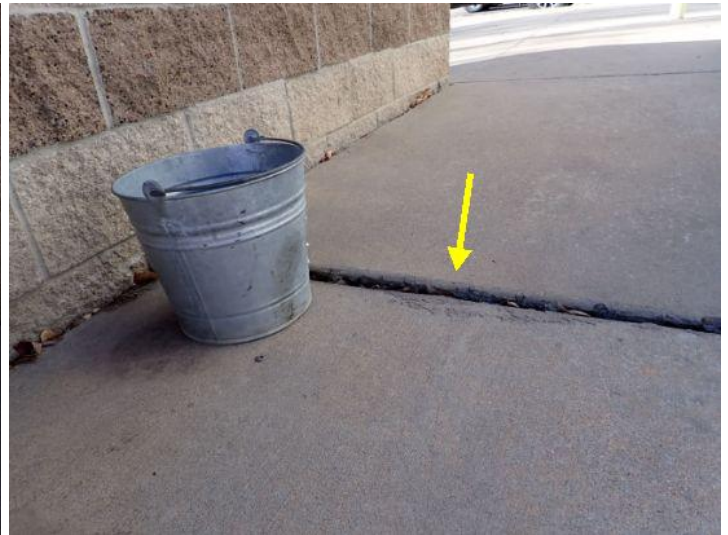
Trip hazards noted. Recommend repairs.

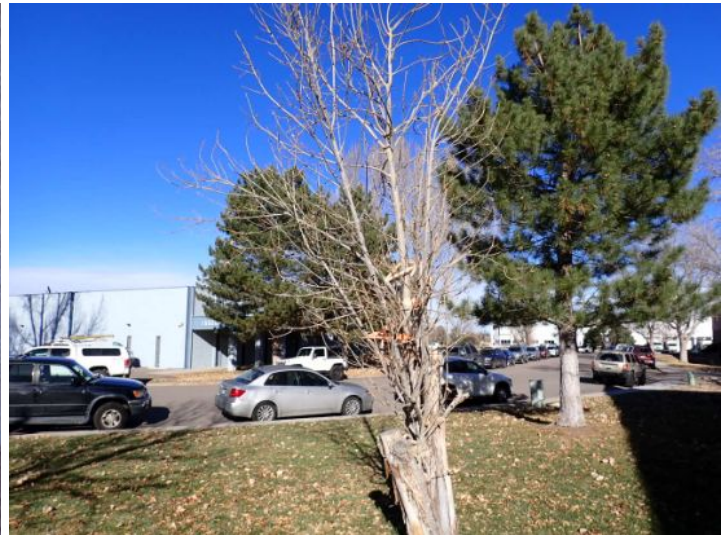
Dead tree noted. Recommend replacement.

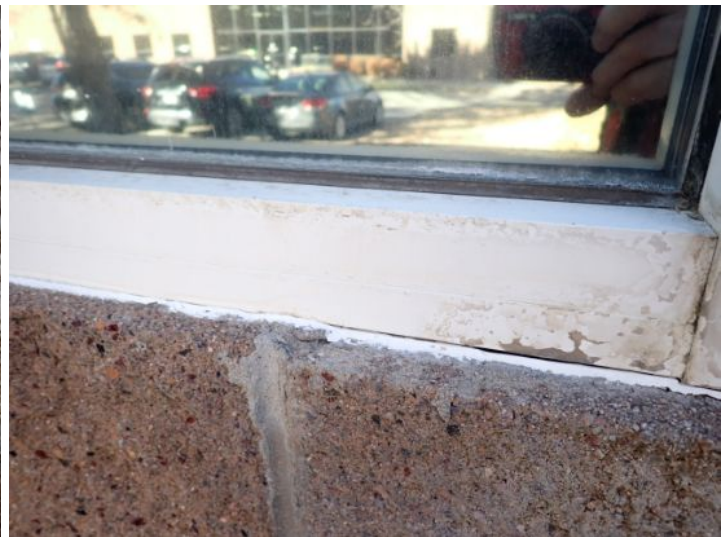
Recommend assuring that any area where two separate substrates meet be properly caulked/sealed. Recommend repairs by a licensed contractor.

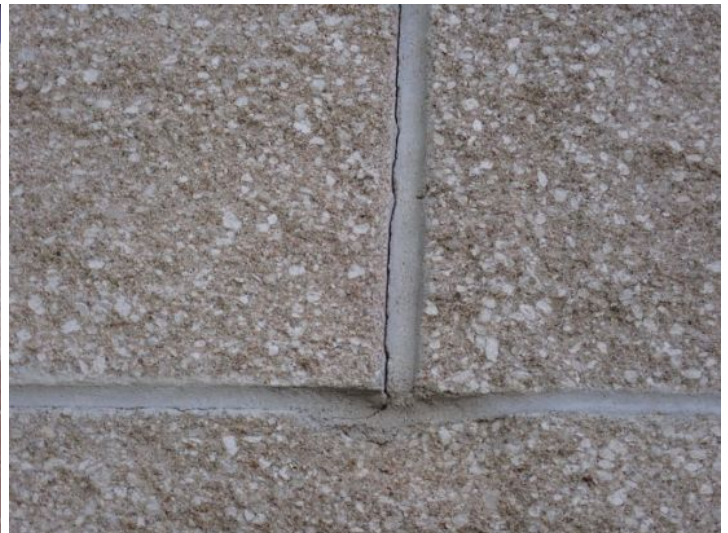
Minor stair stepping noted in the mortar on the rear of the structure at the time of the inspection. Recommend monitoring for future repairs.

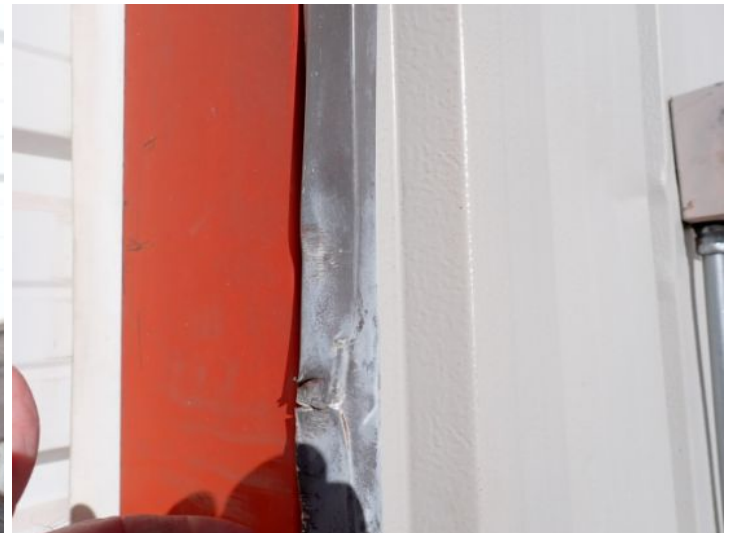
Minor steel trim damage noted around one or more of the overhead doors at the time of the inspection. Recommend repairs by a licensed contractor.

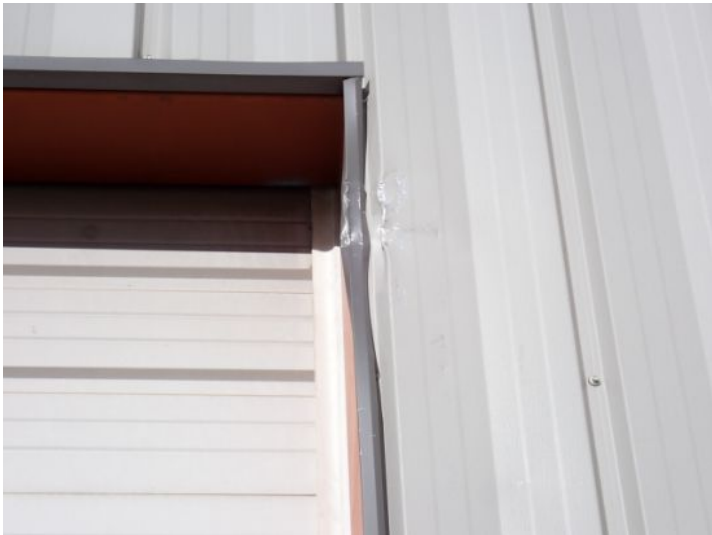
Minor steel trim damage noted around one or more of the overhead doors at the time of the inspection. Recommend repairs by a licensed contractor.

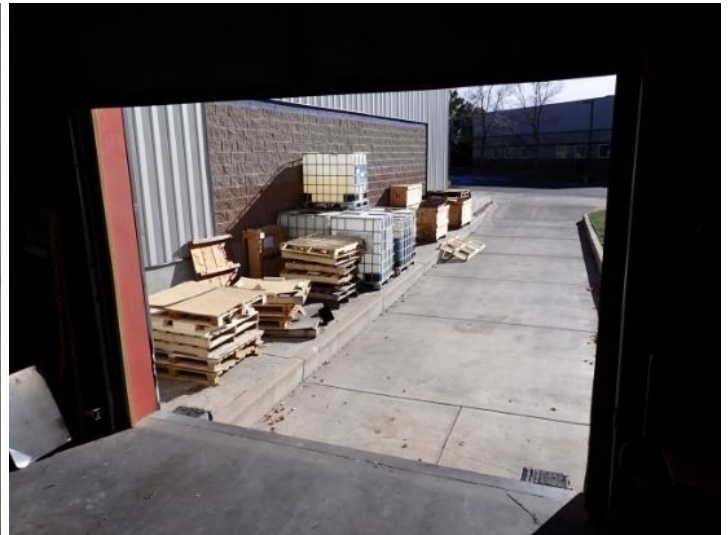
Minor slab cracking noted within the structure at the time of the inspection. Recommend monitoring for future movement/repairs.

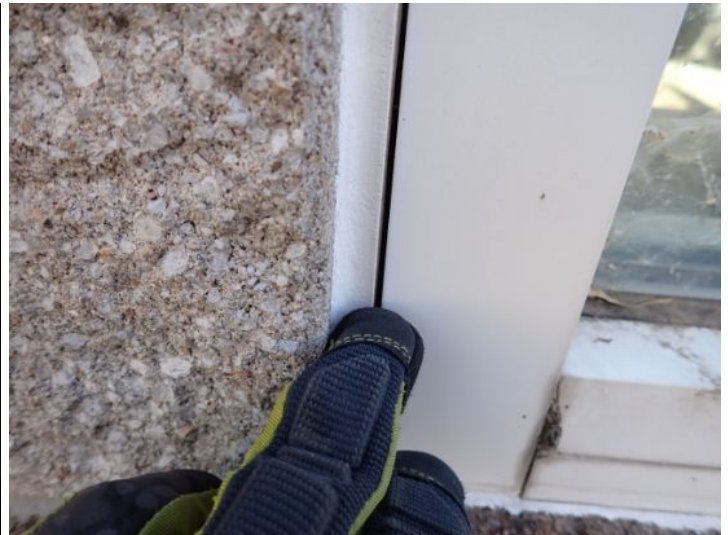
Recommend assuring that any area where two separate substrates meet be properly caulked/sealed. Recommend repairs by a licensed contractor.

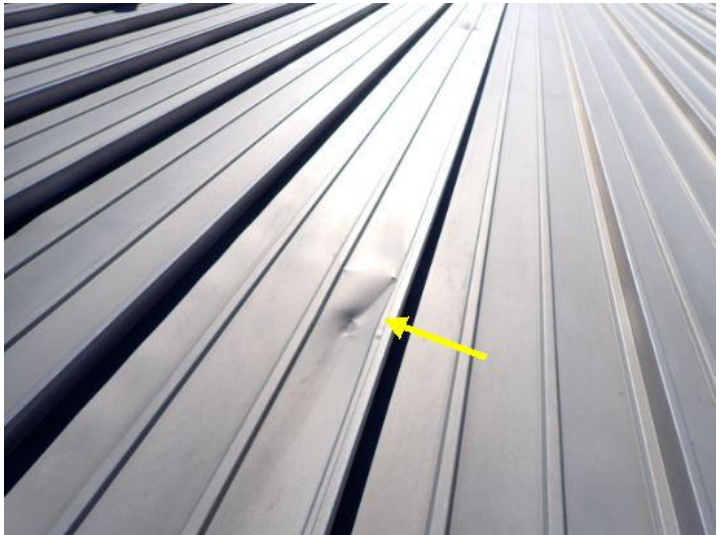
There were a couple of areas noted on the roof top where there were fairly large indentation's noted in the steel roofing system causing ponding. Recommend repairs by a licensed contractor.

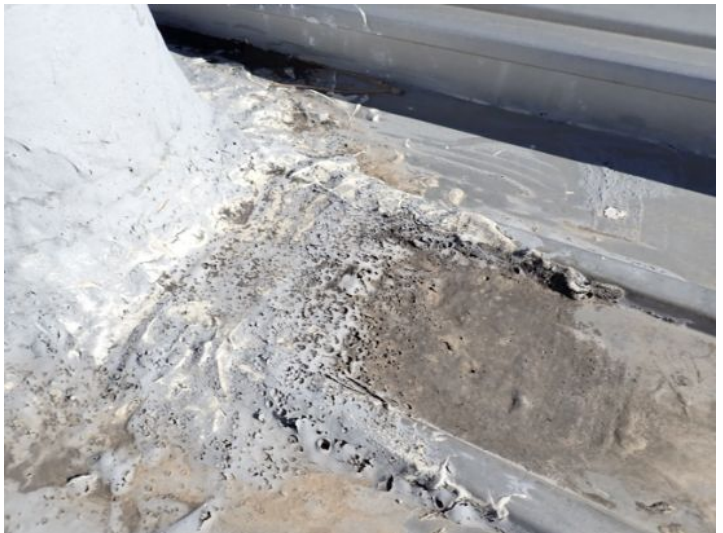
The sealant around the roof penetrations appeared to have reached its serviceable life expectancy and may begin leaking soon. Recommend repairs as needed by a licensed contractor.

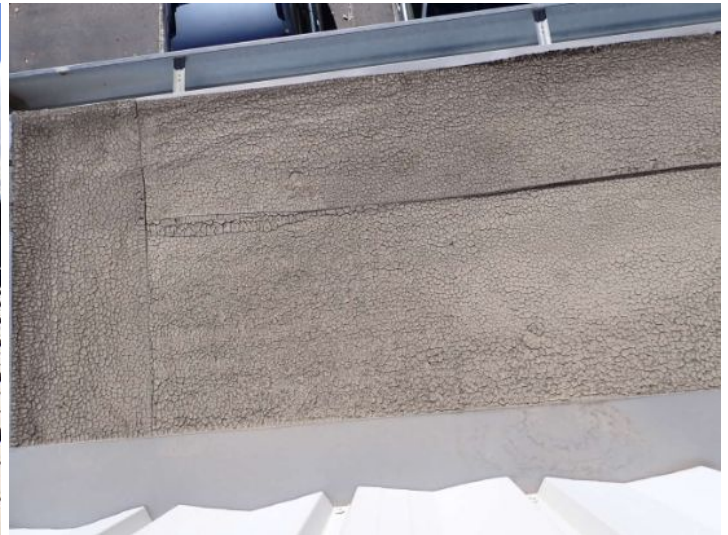
The roofing system located above the front entry was in poor condition and requires complete replacement. Recommend replacement by a licensed contractor.

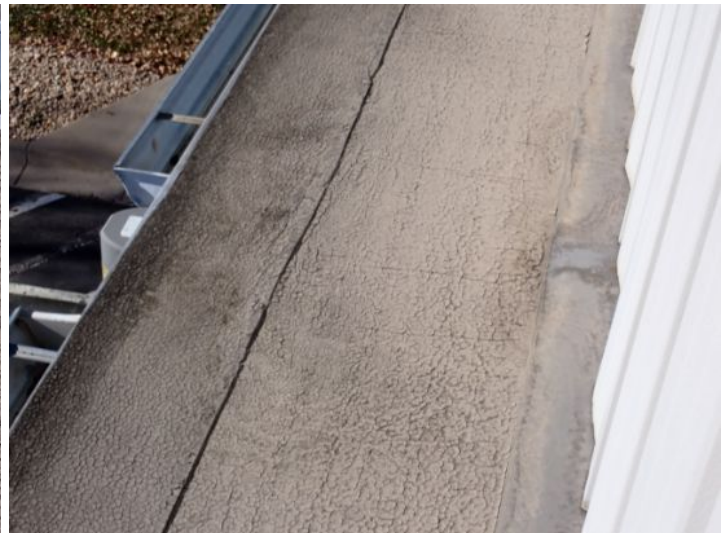
The roofing system located above the front entry was in poor condition and requires complete replacement. Recommend replacement by a licensed contractor.

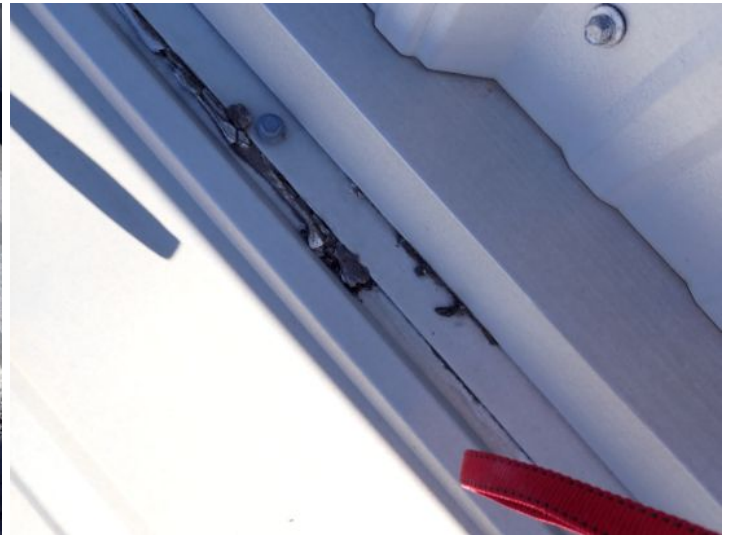
Sealant/repairs noted in areas along the parapet walls of the roofing system. At the time of the inspection the sealant appeared to have reached or be nearing its serviceable life expectancy. Recommend repairs as needed by a licensed contractor.

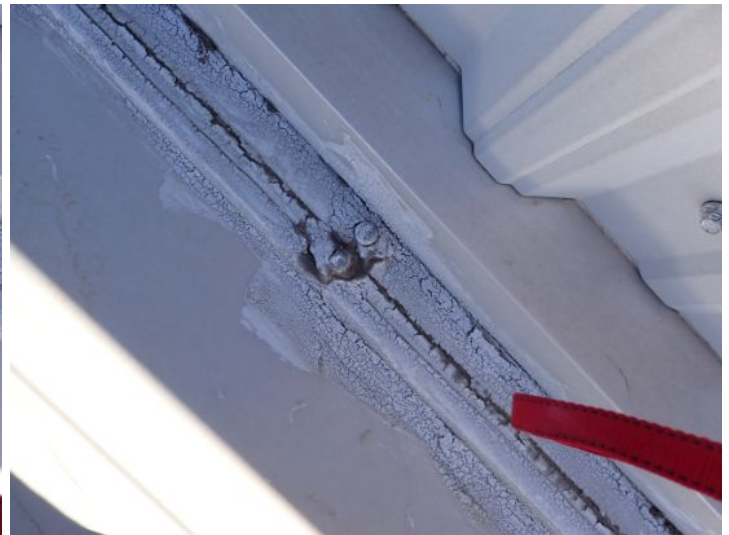
Sealant/repairs noted in areas along the parapet walls of the roofing system. At the time of the inspection the sealant appeared to have reached or be nearing its serviceable life expectancy. Recommend repairs as needed by a licensed contractor.

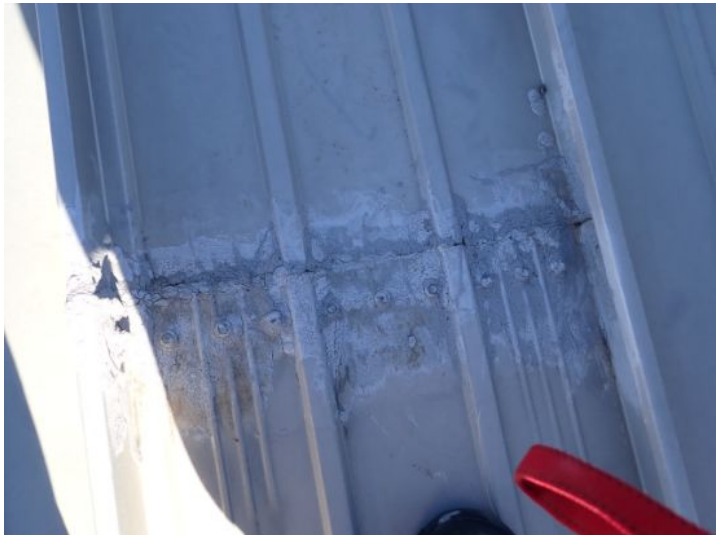
Past repairs/sealant noted in areas of the roofing system. At the time of the inspection the sealant appeared to be nearing failure. Recommend repairs as needed by a licensed contractor.

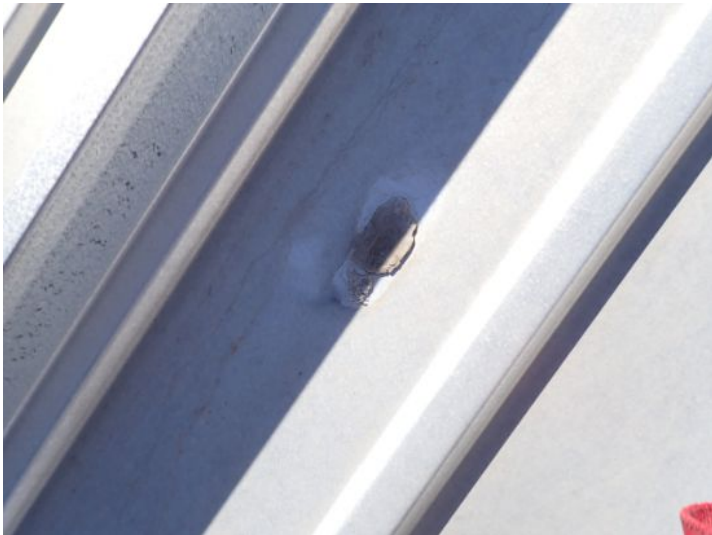
Past repairs/sealant noted in areas of the roofing system. At the time of the inspection the sealant appeared to be nearing failure. Recommend repairs as needed by a licensed contractor.

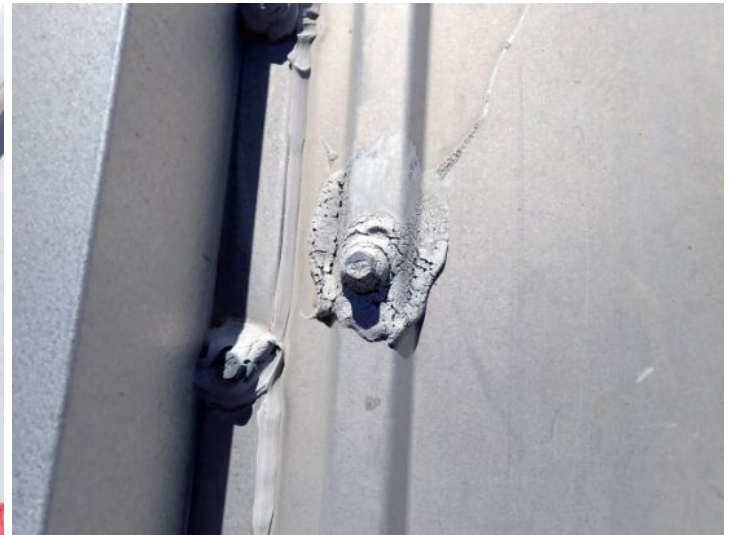
Past repairs/sealant noted in areas of the roofing system. At the time of the inspection the sealant appeared to be nearing failure. Recommend repairs as needed by a licensed contractor.

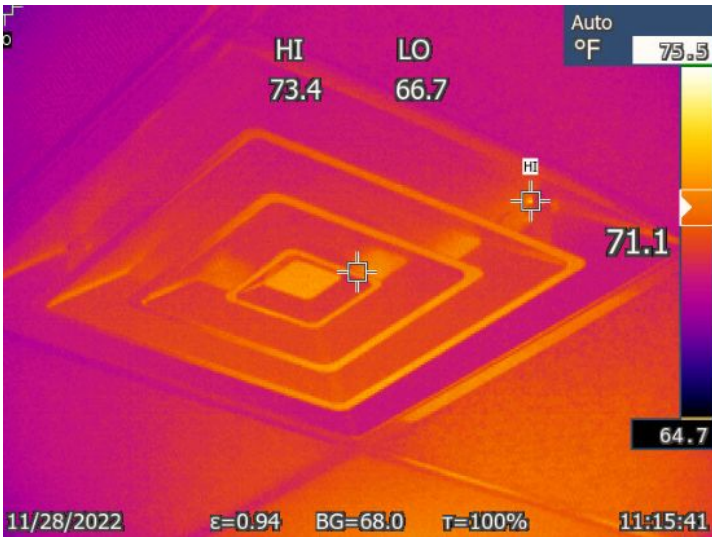
The furnace for the west side of the office was not functioning properly at the time of the inspection. Recommend repairs by a licensed contractor.

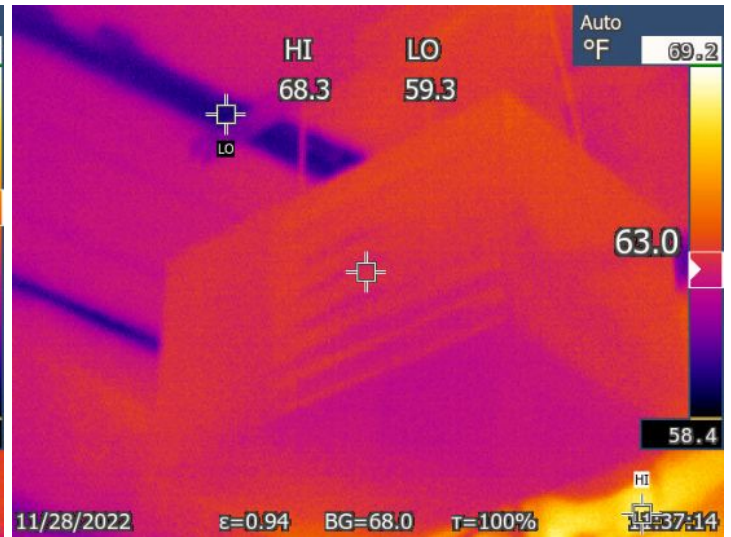
The shop heaters located in the east side of the warehouse were not functional at the time of the inspection. Recommend repairs as needed by a licensed contractor.

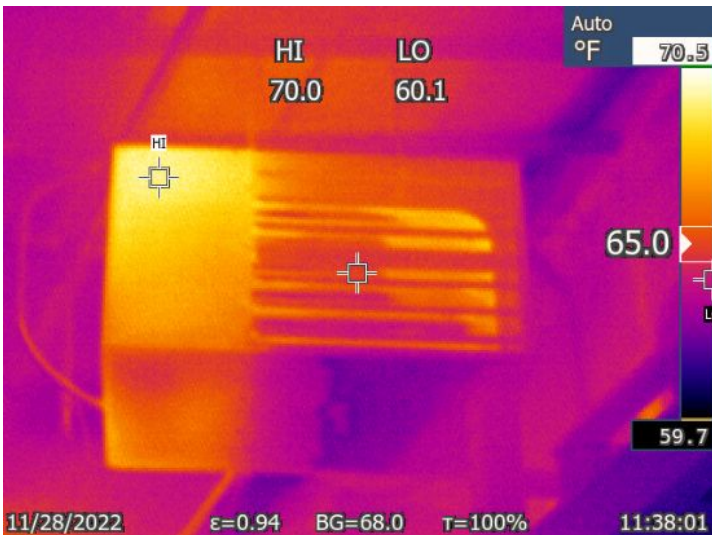
The shop heaters located in the east side of the warehouse were not functional at the time of the inspection. Recommend repairs as needed by a licensed contractor.

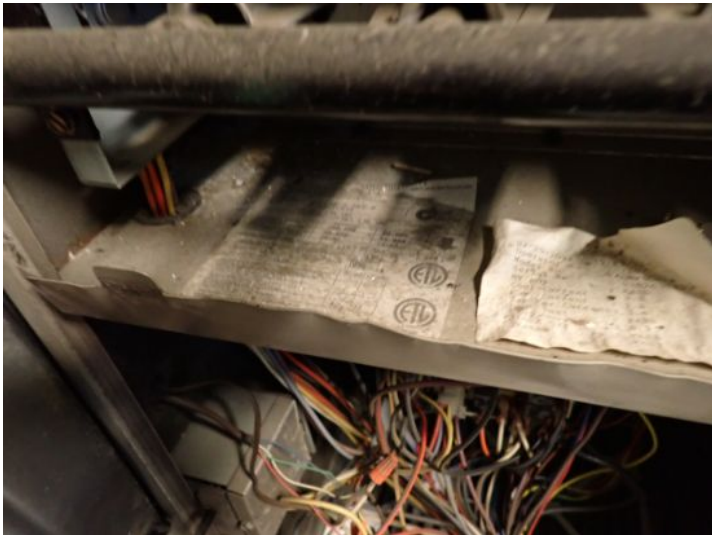
Deferred maintenance noted on the furnaces at the time of the inspection. Recommend servicing by a licensed contractor.

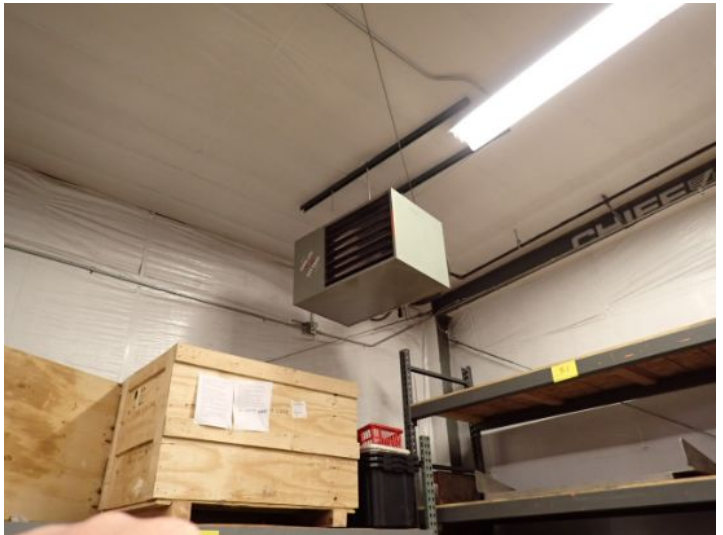
The shop heaters located in the east side of the warehouse were not functional at the time of the inspection. Recommend repairs as needed by a licensed contractor.

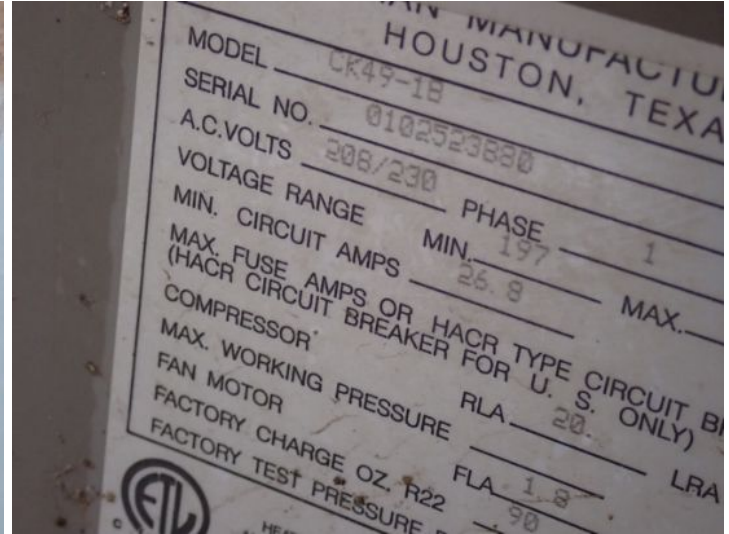
Hail damage noted on the external cooling fins of CU 1 at the time of the inspection. CU 1: Goodman: M/N CK49-18 S/N 0102523880. Manufacture year 2001.

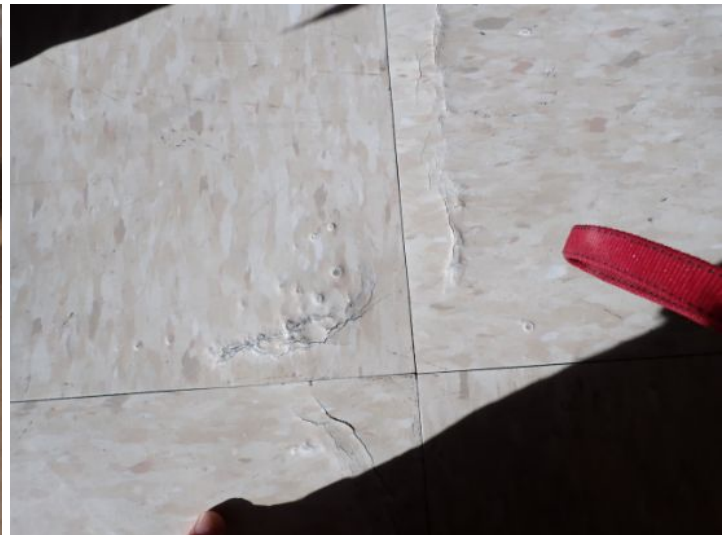
VCT flooring damage noted in the main entry area. Recommend repairs as needed by a licensed contractor.
