# *Forman Inspection Services, LLC*

## Property Inspection Report

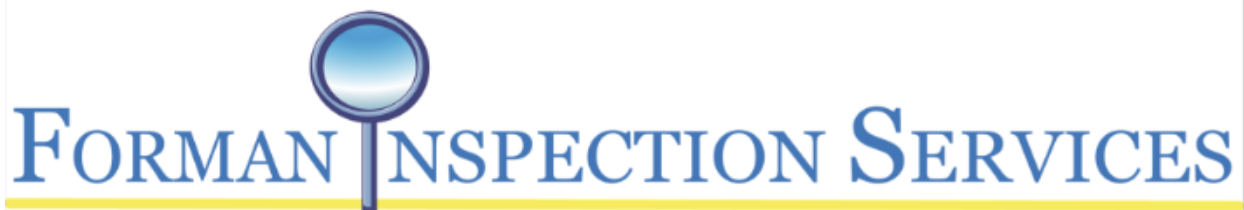
Email: [cforman61@gmail.com](mailto:cforman61@gmail.com)

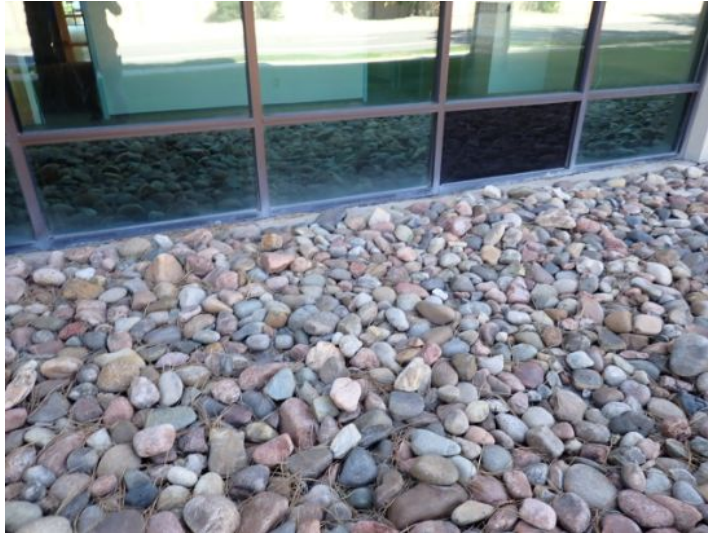
The topography of the property requires attention, particularly on the west side, to assure that the grade directs ground/storm water away from the foundation of the structure.

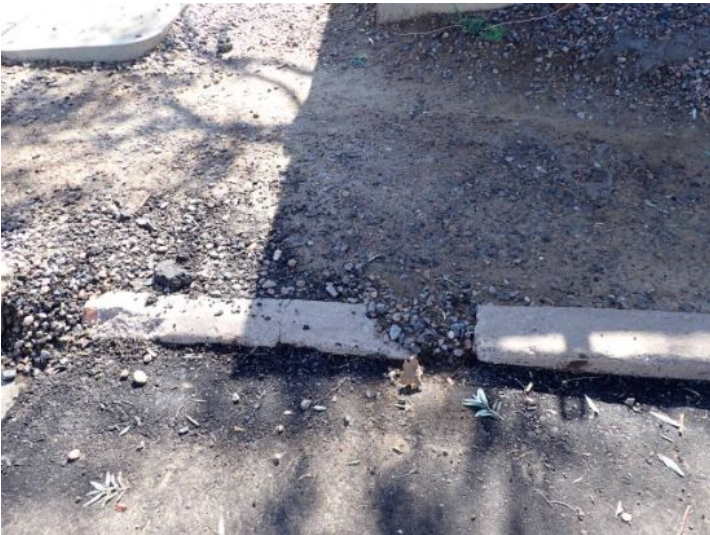
Curbing damage noted in areas. Recommend repairs.

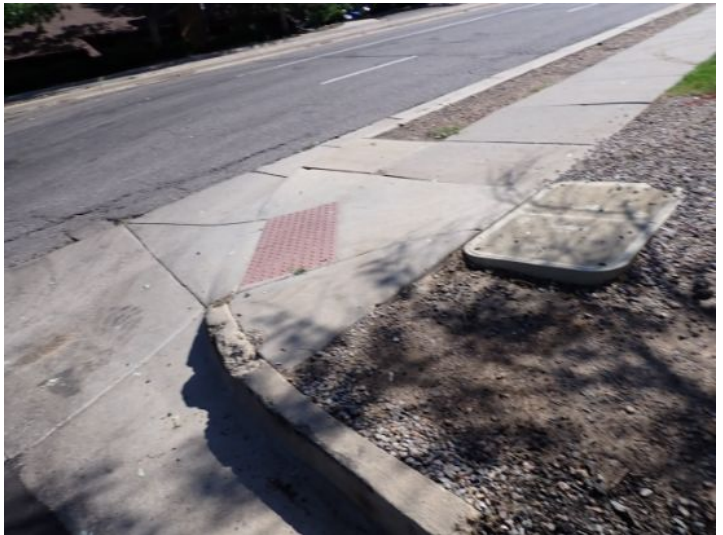
Curbing damage noted in areas. Recommend repairs.

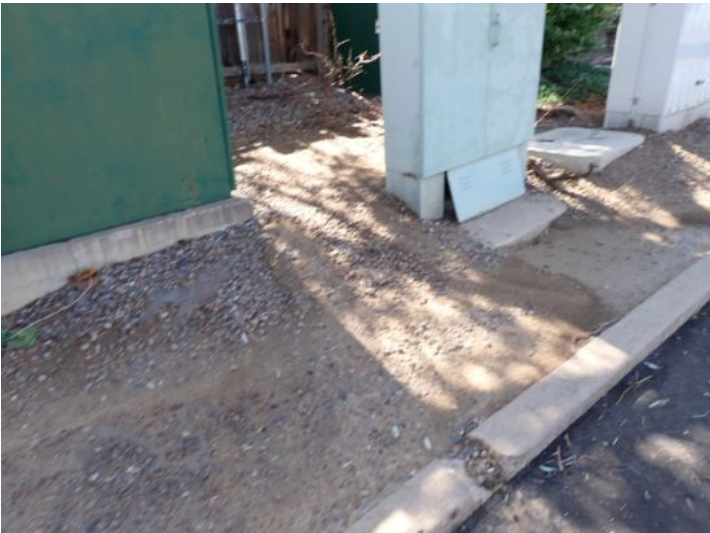
Curbing damage noted in areas. Recommend repairs.

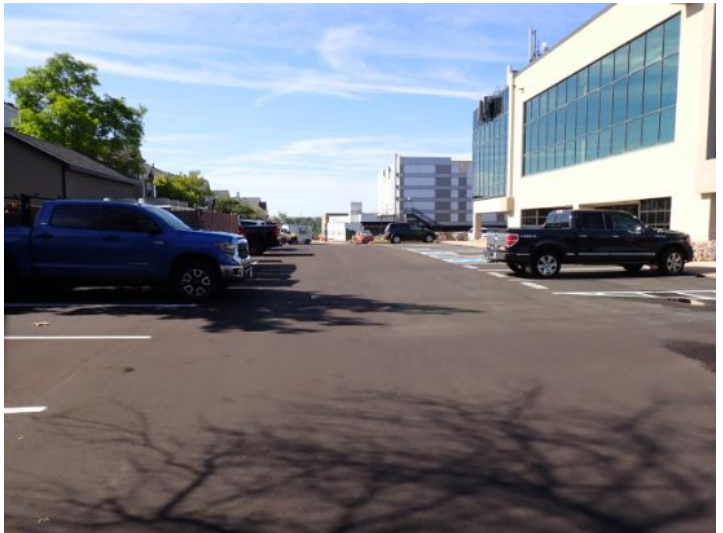
The parking lot surface was in fair condition at the time of the inspection.

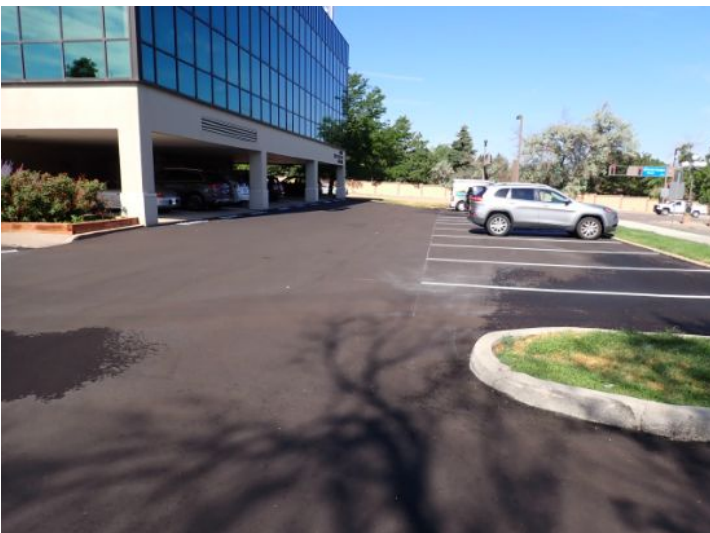
The parking lot surface was in fair condition at the time of the inspection.

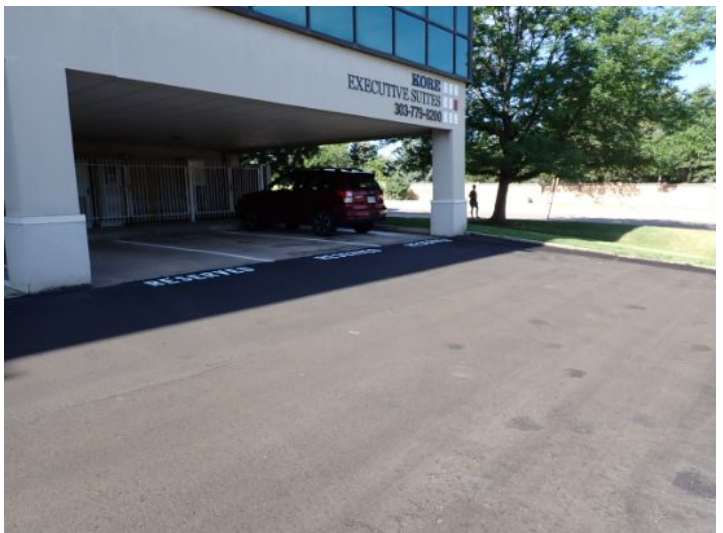
The parking lot surface was in fair condition at the time of the inspection.

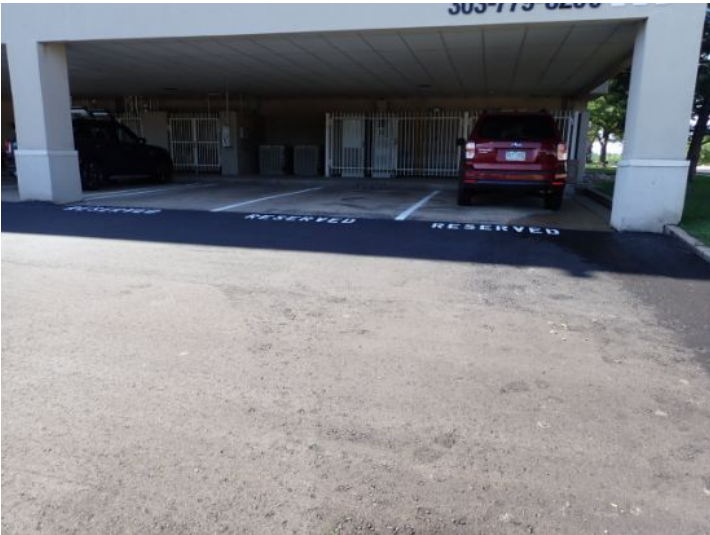
The parking lot surface was in fair condition at the time of the inspection.

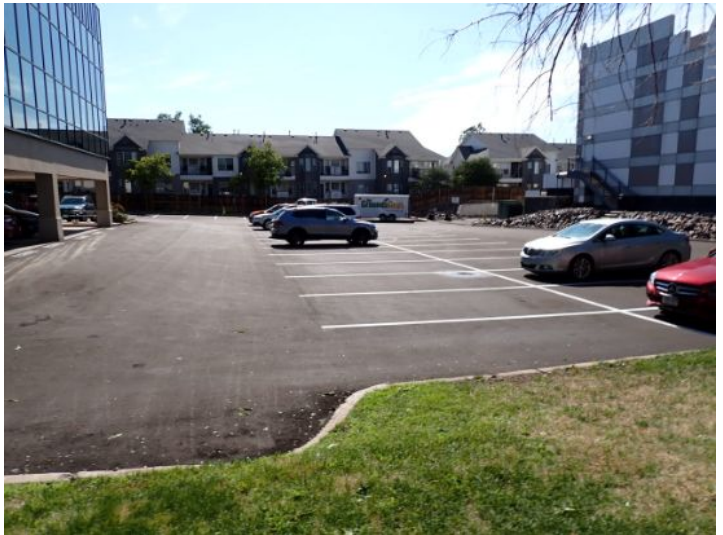
The parking lot surface was in fair condition at the time of the inspection.

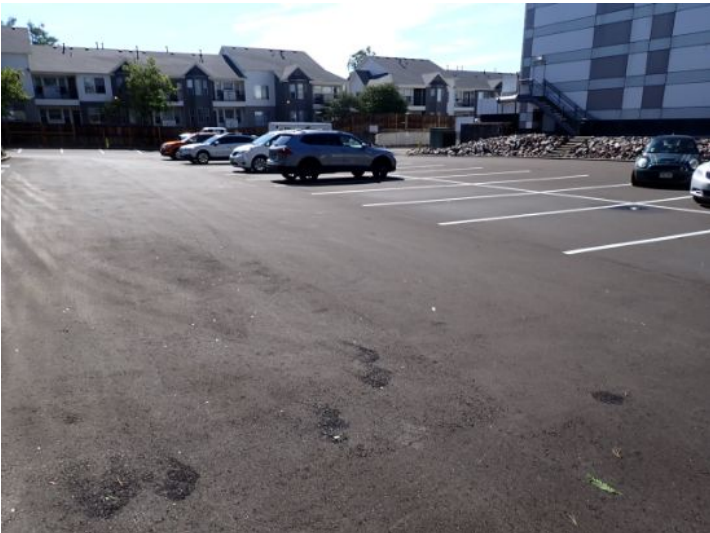
The parking lot surface was in fair condition at the time of the inspection.

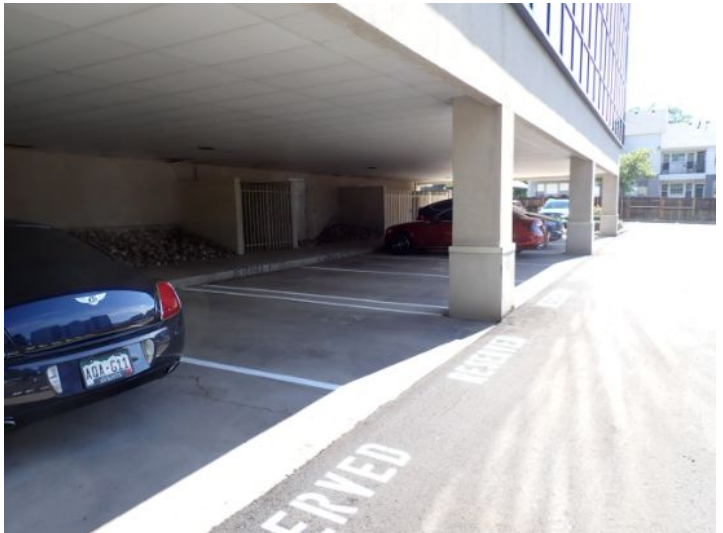
The parking lot surface was in fair condition at the time of the inspection.

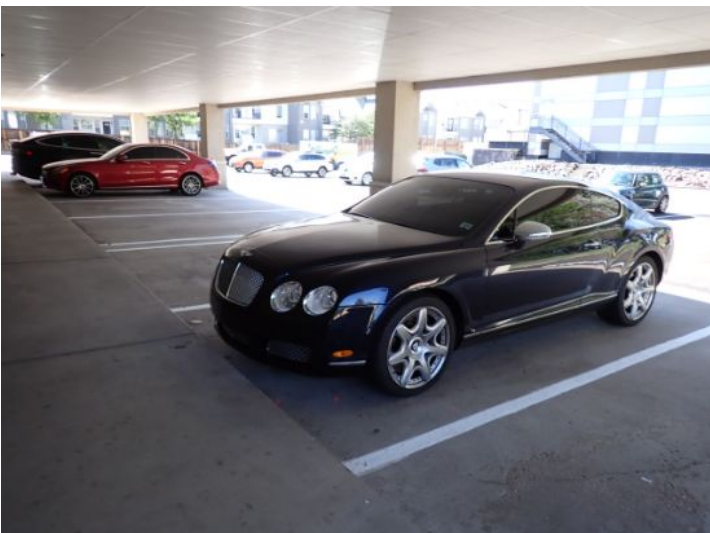
The parking lot surface was in fair condition at the time of the inspection.

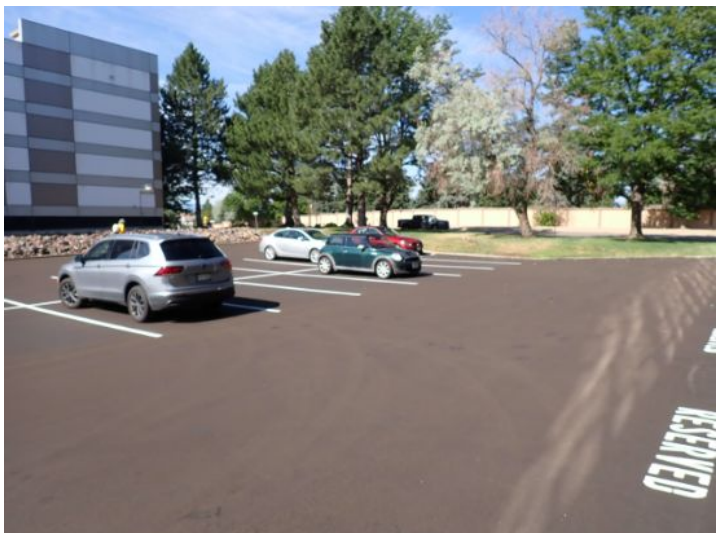
The parking lot surface was in fair condition at the time of the inspection.

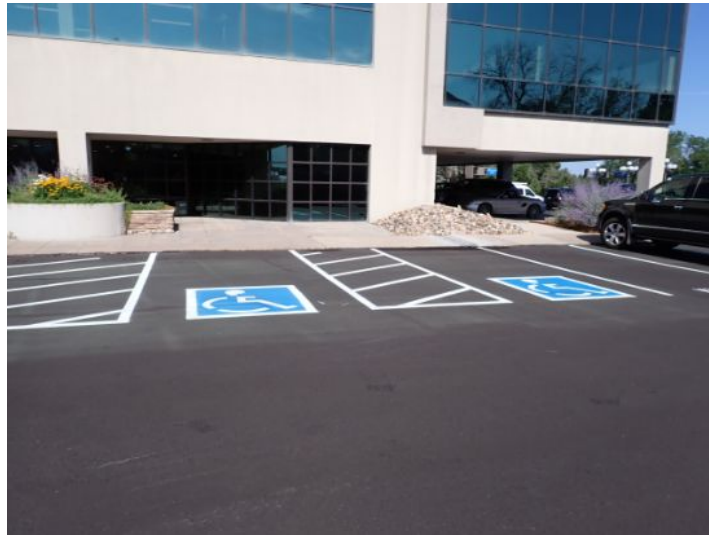
ADA parking was clearly marked at the time of the inspection.

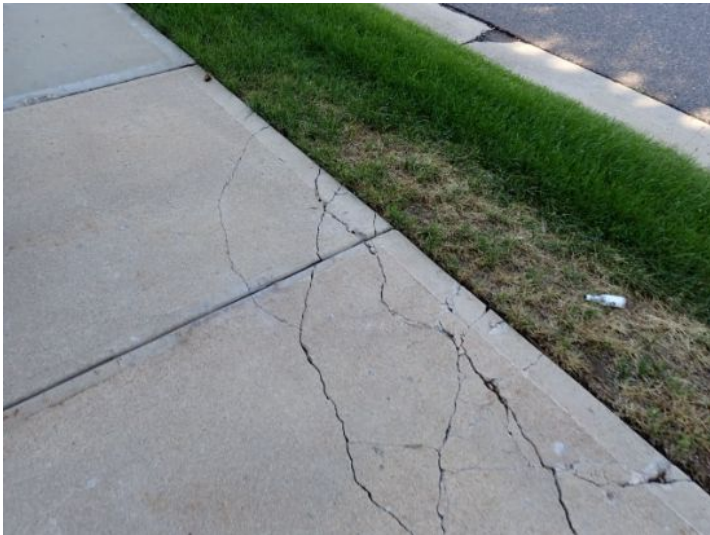
Significant cracking and deterioration noted in areas of the public/city sidewalk system at the time of the inspection. Many municipalities are requiring property owners to maintain the city sidewalks around their property. Recommend repairs as needed by a licensed contractor.

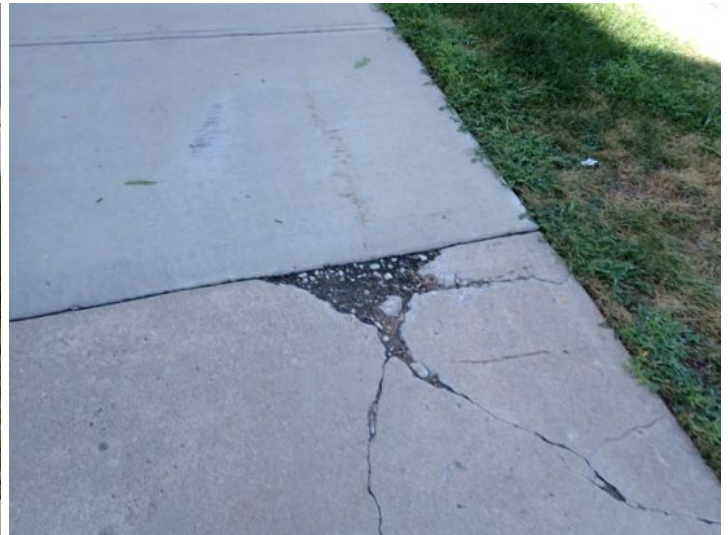
Significant cracking and deterioration noted in areas of the public/city sidewalk system at the time of the inspection. Many municipalities are requiring property owners to maintain the city sidewalks around their property. Recommend repairs as needed by a licensed contractor.

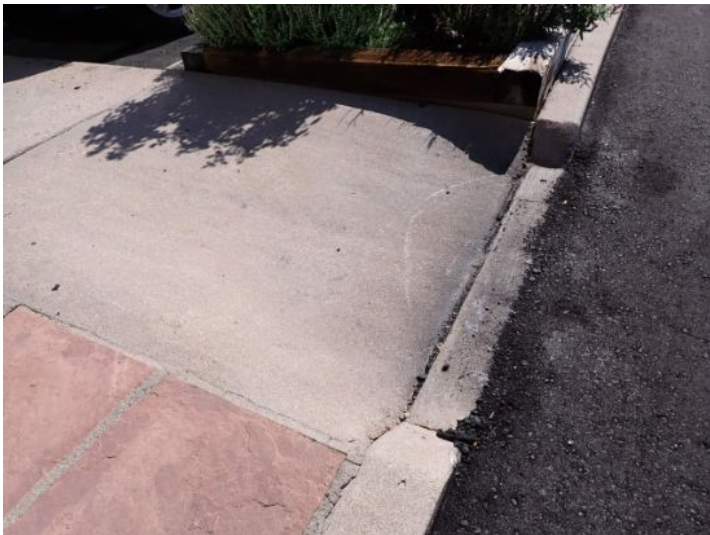
The ADA ramps were checked for proper grade and no significant issues were noted at the time of the inspection.

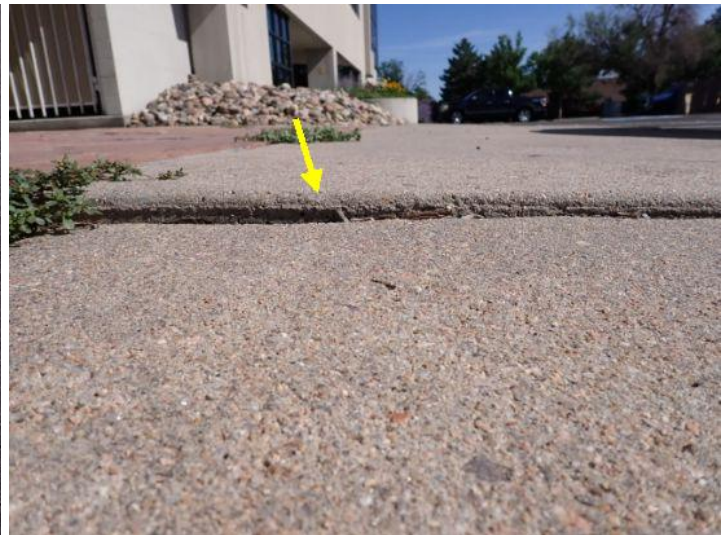
Trip hazards noted. Recommend repairs.

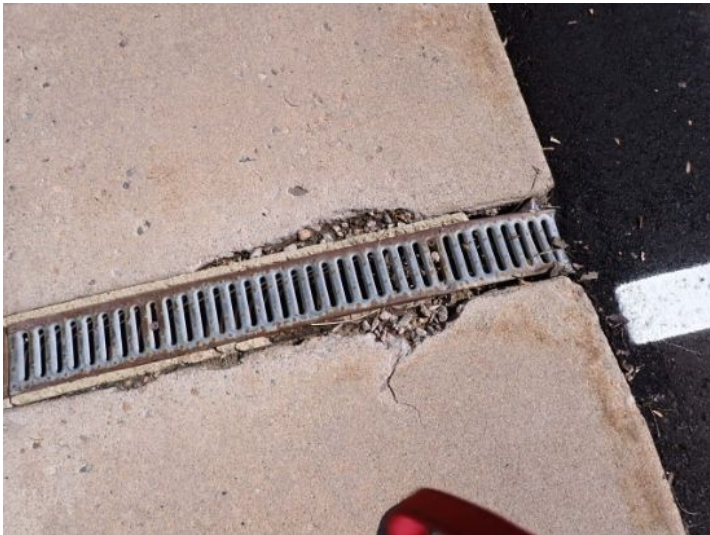
Significant cracking and deterioration noted in areas of the public/city sidewalk system at the time of the inspection. Many municipalities are requiring property owners to maintain the city sidewalks around their property. Recommend repairs as needed by a licensed contractor.

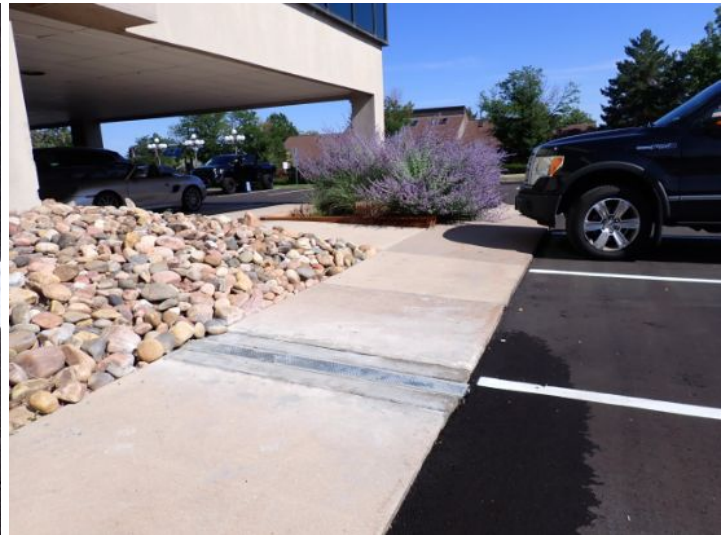
Missing ADA ramps noted where the ADA parking was designated and the main entrance to the building was located. Recommend repairs by a licensed contractor.

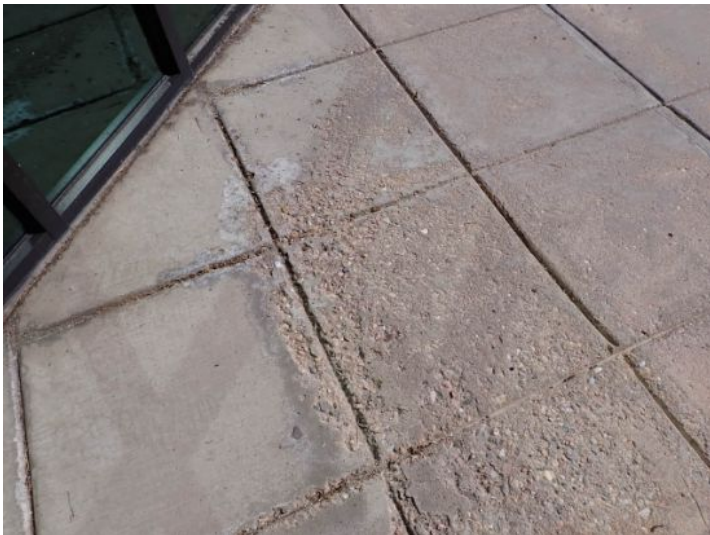
Significant spalling noted on the flatwork on the east side of the structure at the time of the inspection. Recommend repairs by a licensed contractor.

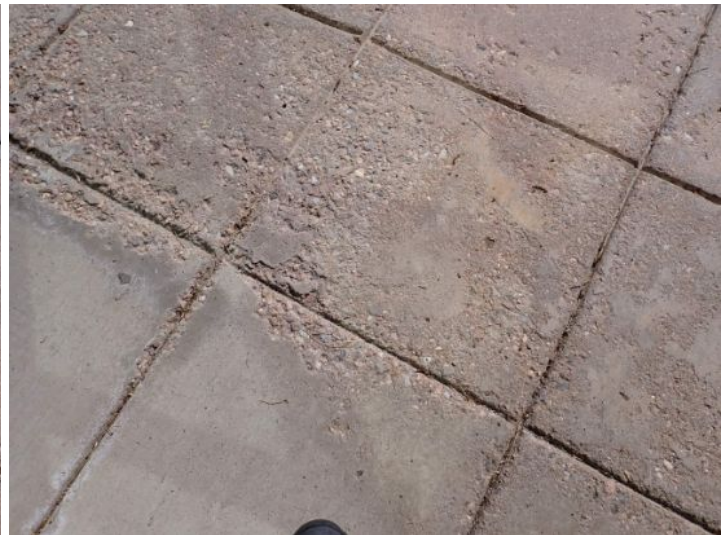
Significant spalling noted on the flatwork on the east side of the structure at the time of the inspection. Recommend repairs by a licensed contractor.

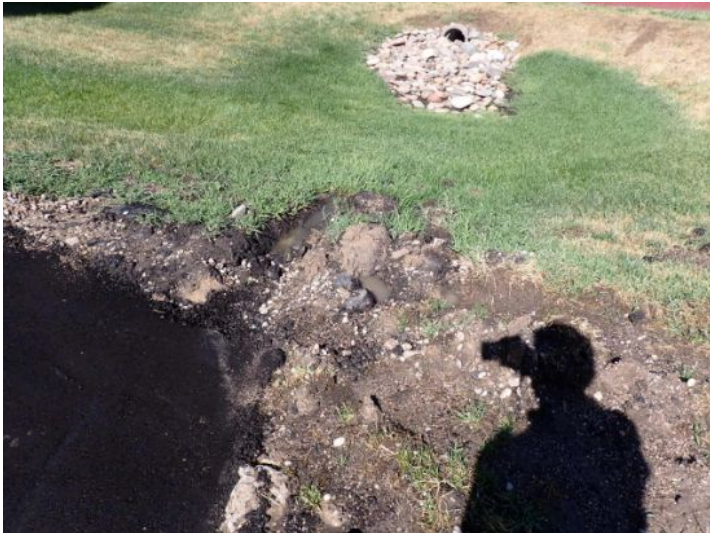
The landscaping requires attention in areas.

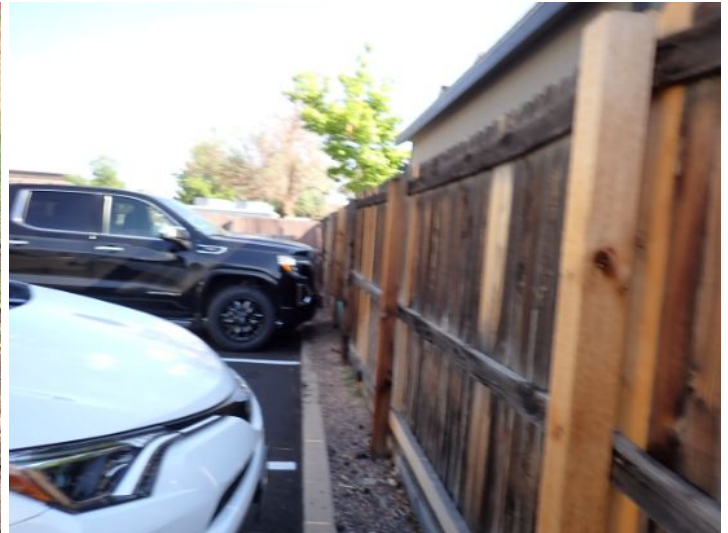
Fencing damage noted on the side of the property at the time of the inspection. Recommend repairs.

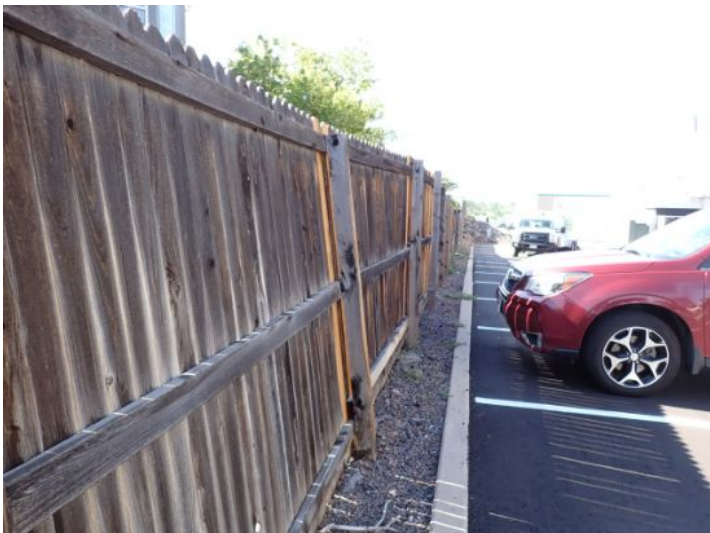
Fencing damage noted on the side of the property at the time of the inspection. Recommend repairs.

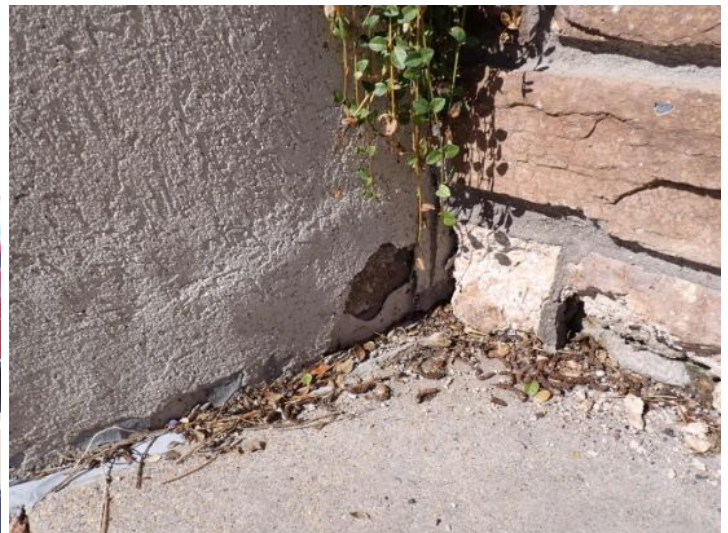
Damaged stucco coating noted on planting beds. Recommend repairs by a licensed contractor.

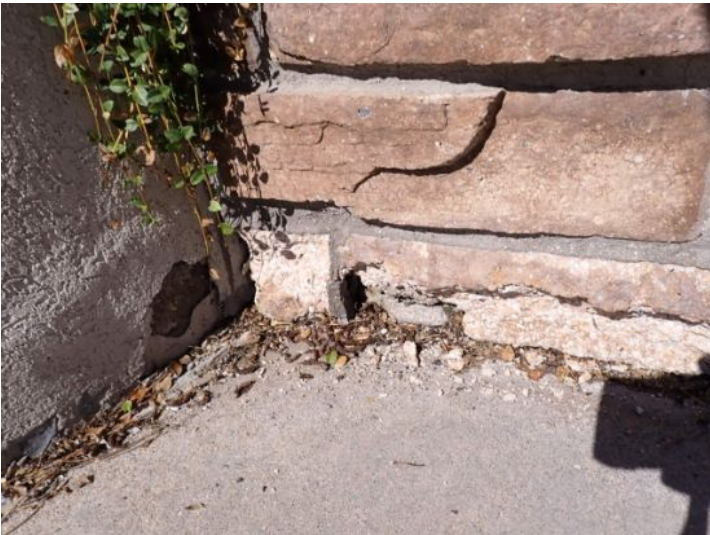
Damaged/deteriorated stone noted around the planting beds at the time of the inspection. Recommend repairs by a licensed contractor.

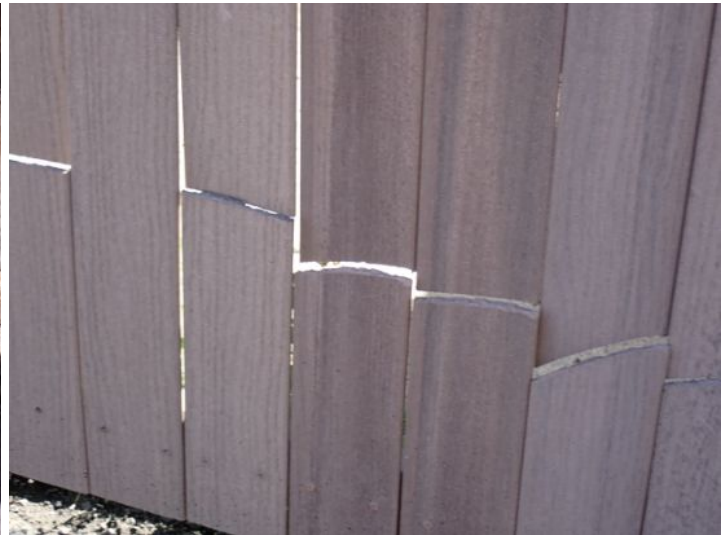
The fencing enclosure for the chiller system was in poor condition at the time of the inspection. Recommend repairs

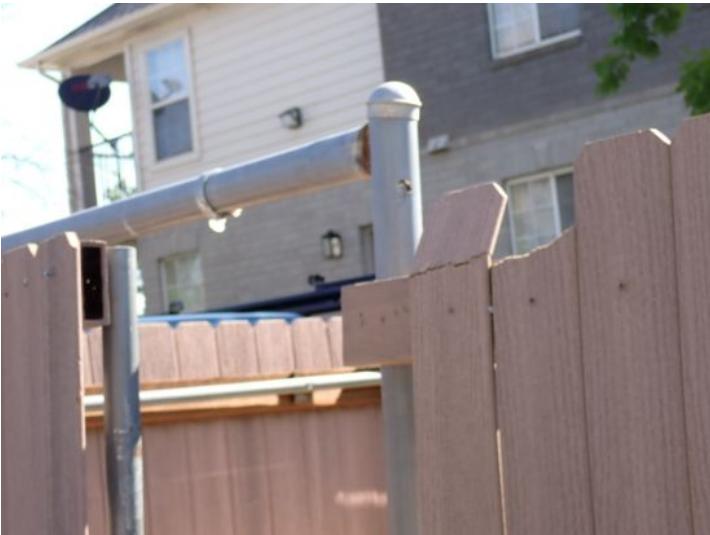
The fencing enclosure for the chiller system was in poor condition at the time of the inspection. Recommend repairs

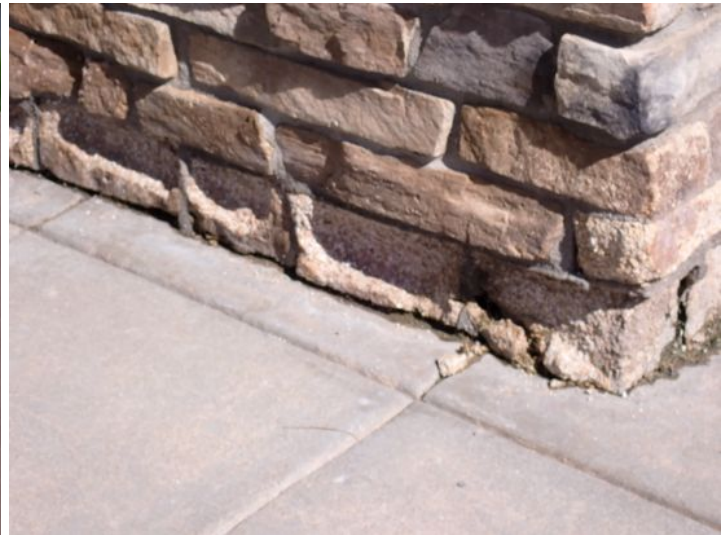
Damaged/deteriorated stone noted around the planting beds at the time of the inspection. Recommend repairs by a licensed contractor.

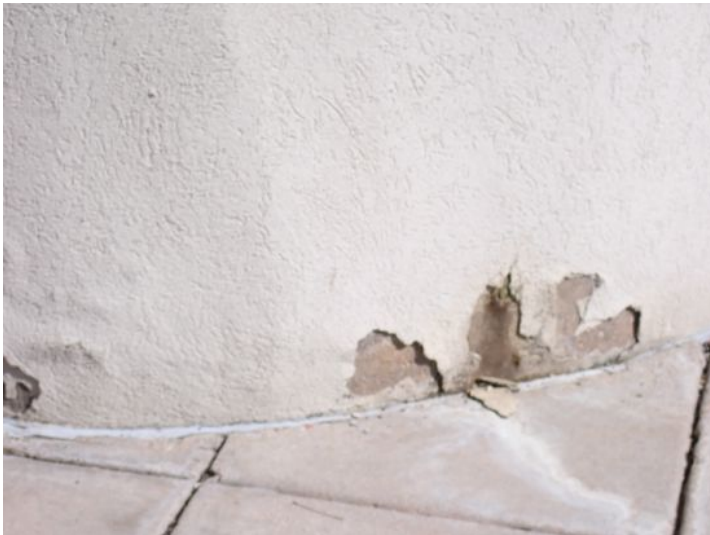
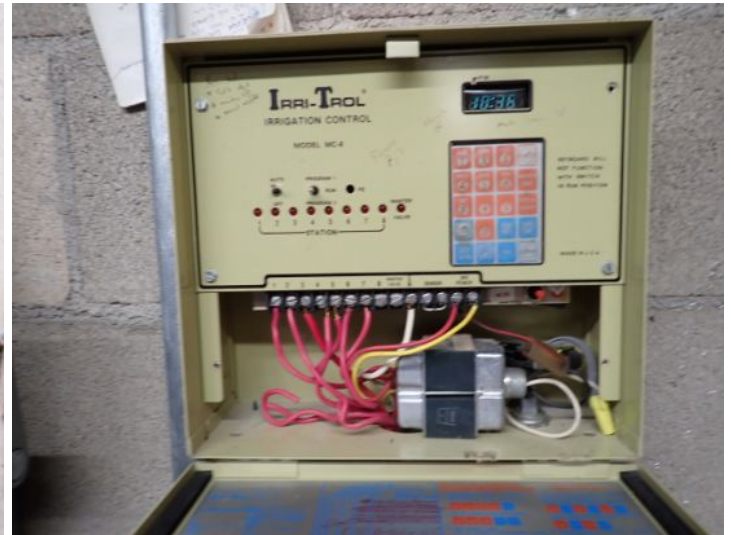
Damaged stucco coating noted on planting beds. The property had an irrigation system at the time of the inspection.  
Recommend repairs by a licensed contractor.

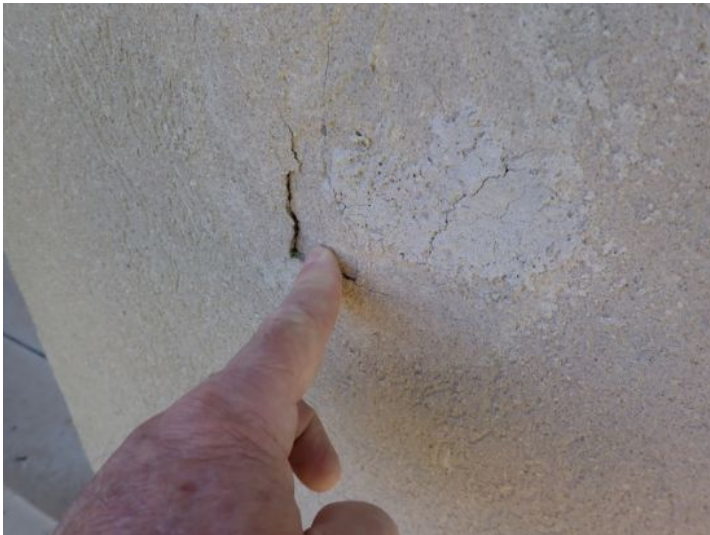
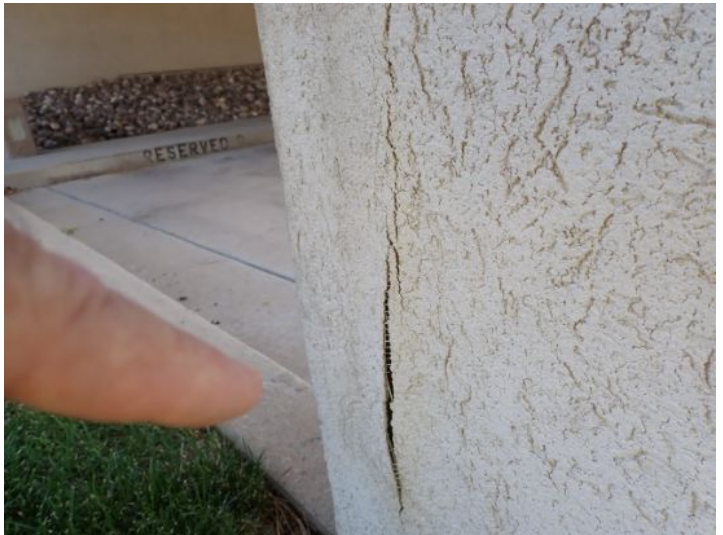
EIFS damage/cracking and past patching noted in areas around the structure. Recommend repairs as needed by a licensed contractor.

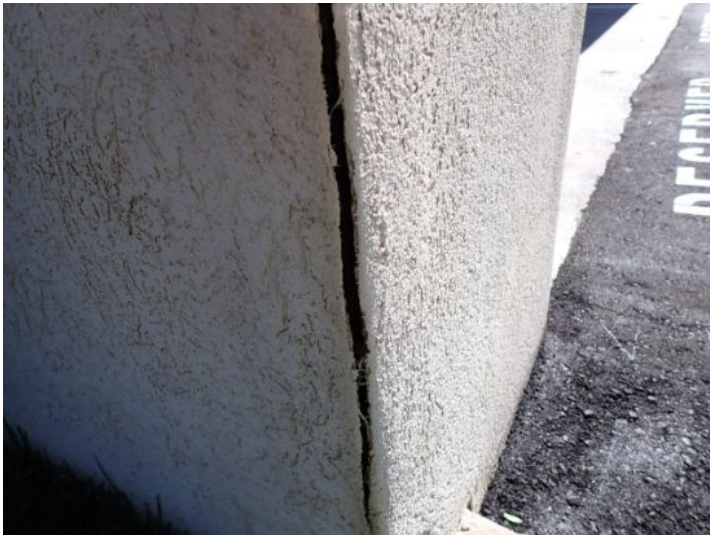
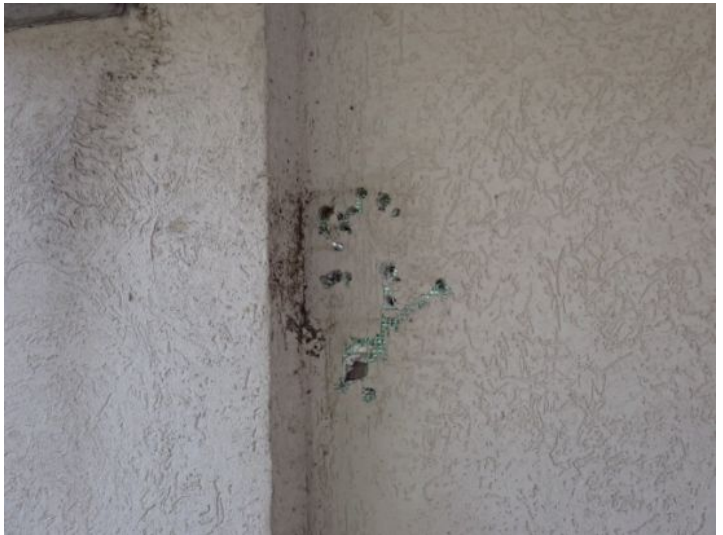
EIFS damage/cracking and past patching noted in areas around the structure. Recommend repairs as needed by a licensed contractor.

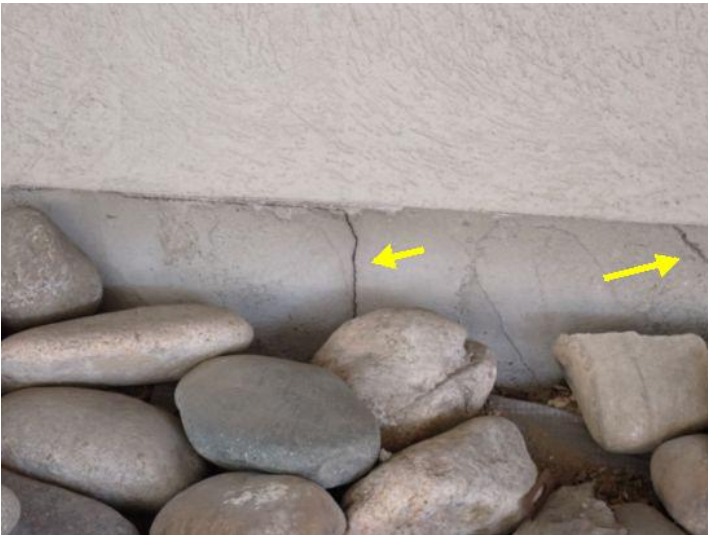
Minor cracking noted in the slab perimeter on the south side of the structure at the time of the inspection. Recommend monitoring for future repairs.

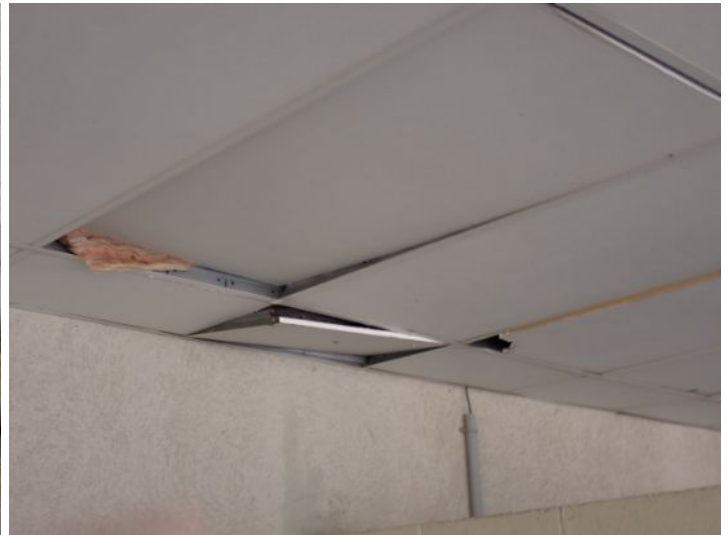
Loose/damaged/missing suspended ceiling tiles noted in areas of the covered parking at the time of the inspection. Recommend repairs.

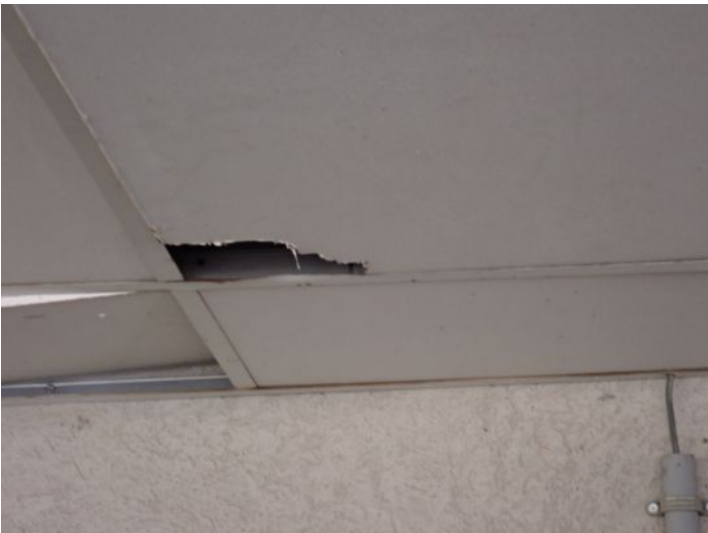
Loose/damaged/missing suspended ceiling tiles noted in areas of the covered parking at the time of the inspection. Recommend repairs.

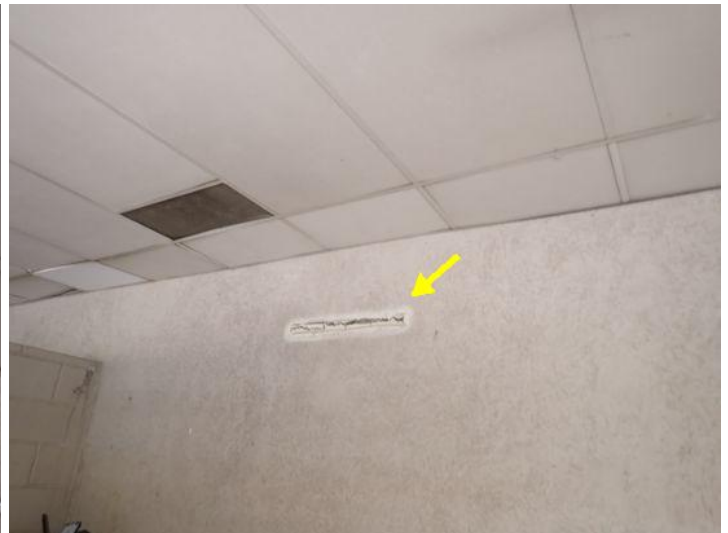
EIFS damage/cracking and past patching noted in areas around the structure. Recommend repairs as needed by a licensed contractor.

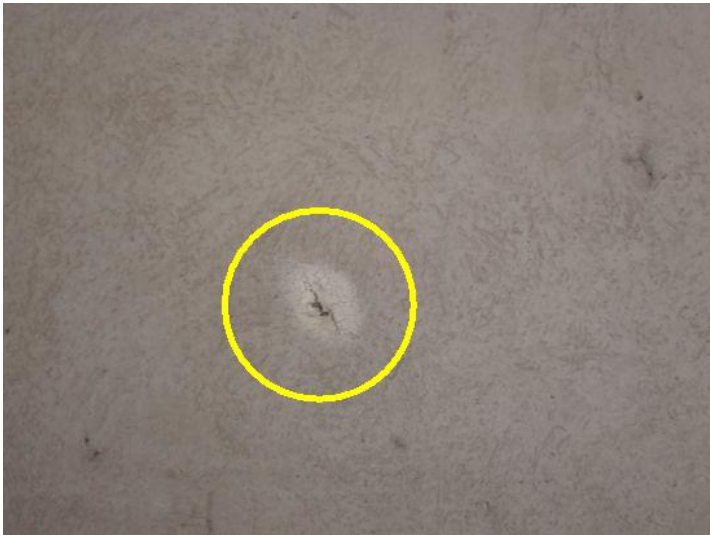
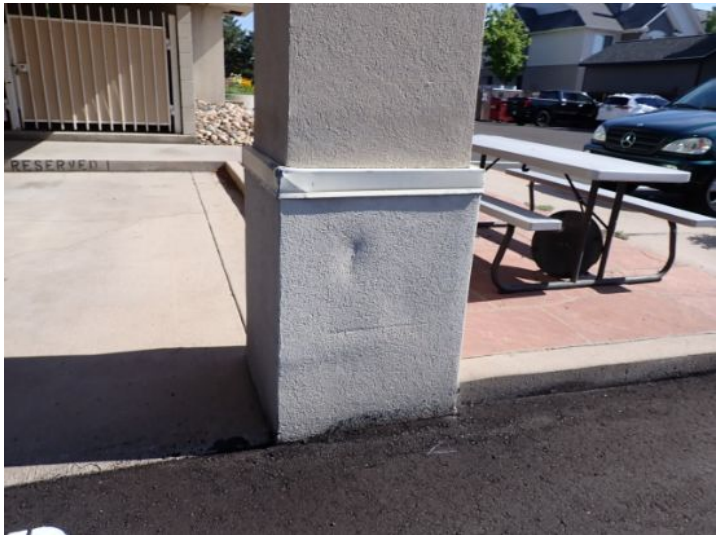
EIFS damage/cracking and past patching noted in areas around the structure. Recommend repairs as needed by a licensed contractor.

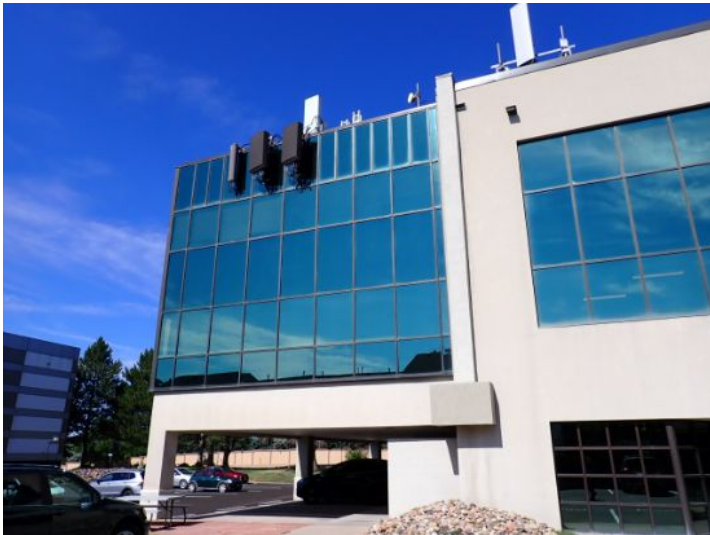
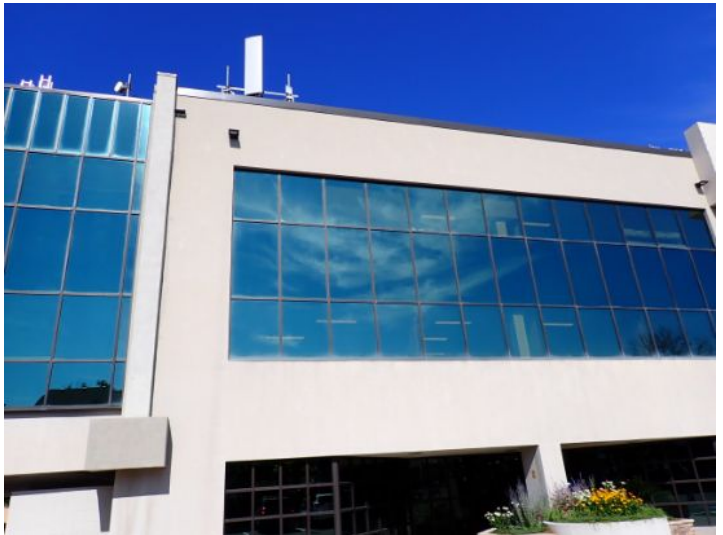
The majority of the exterior envelope of the structure appeared to be in fair condition at the time of the inspection.

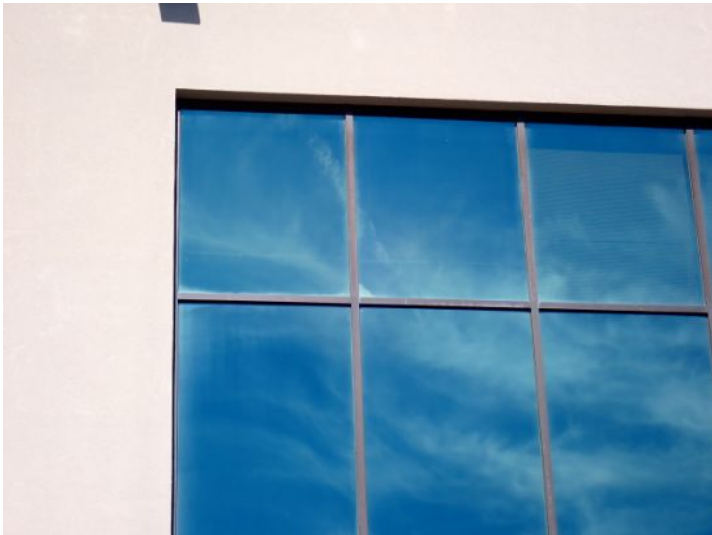
Failed seals noted in one or more insulated window panels at the time of the inspection. Recommend repairs by a licensed contractor.

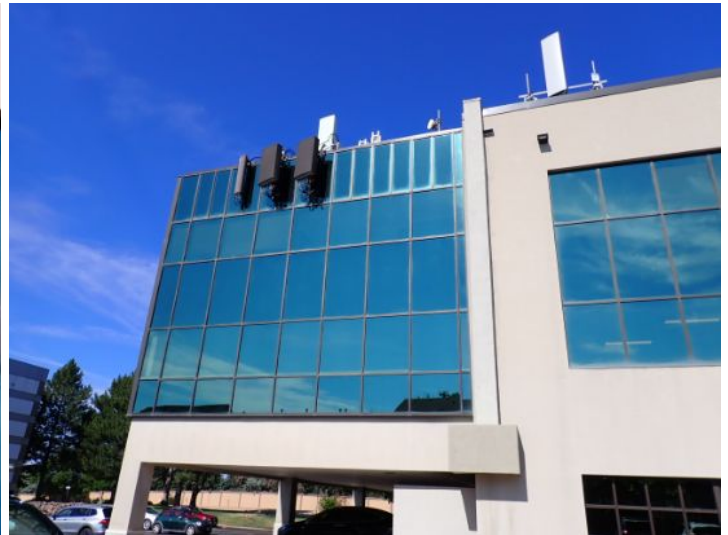
The majority of the exterior envelope of the structure appeared to be in fair condition at the time of the inspection.

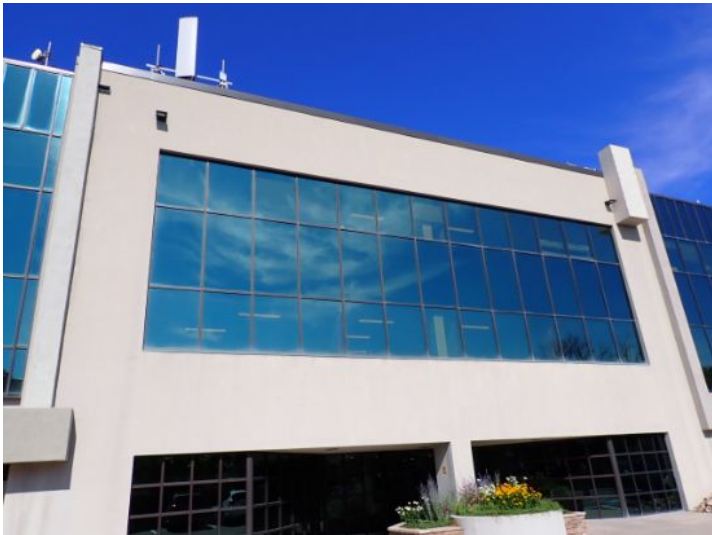
The majority of the exterior envelope of the structure appeared to be in fair condition at the time of the inspection.

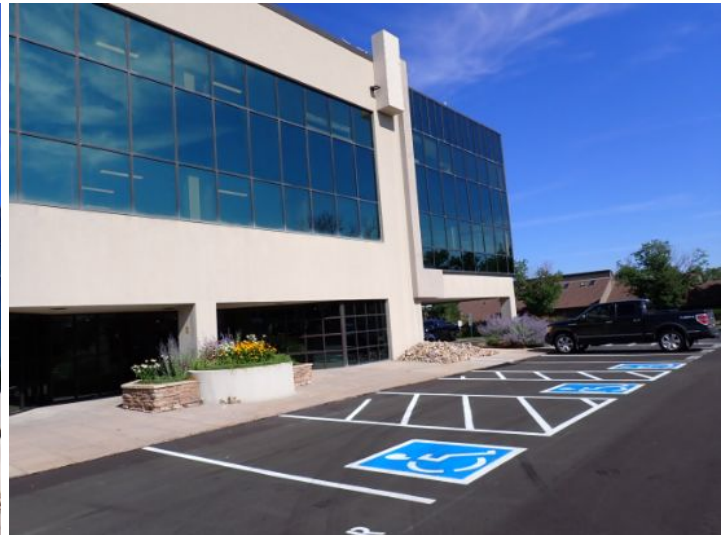
The majority of the exterior envelope of the structure appeared to be in fair condition at the time of the inspection.

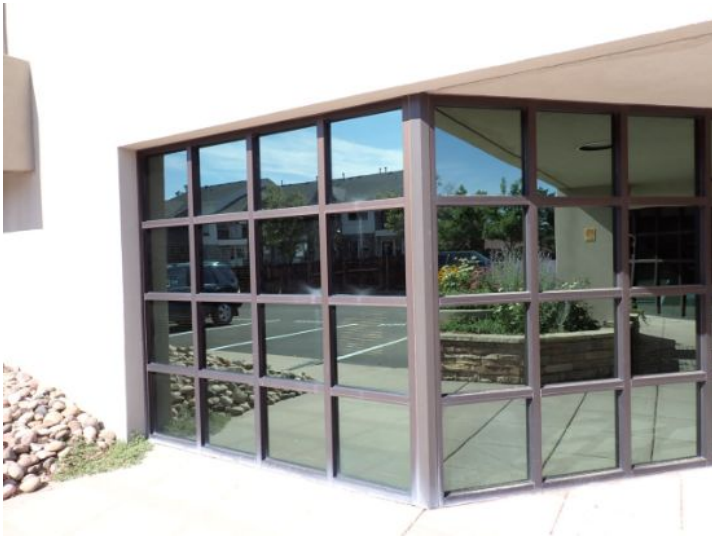
The majority of the exterior envelope of the structure appeared to be in fair condition at the time of the inspection.

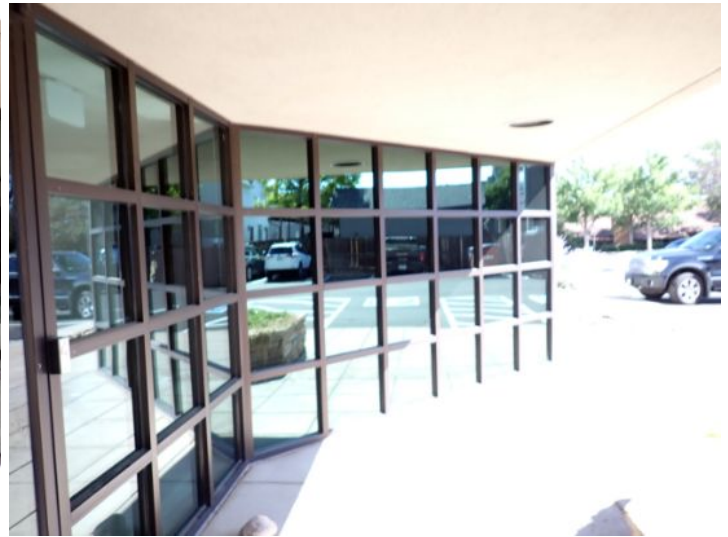
The majority of the exterior envelope of the structure appeared to be in fair condition at the time of the inspection.

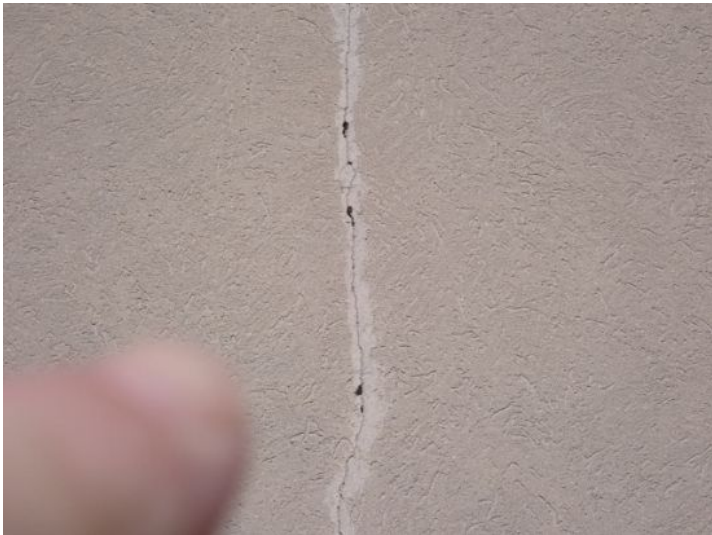
EIFS damage/cracking and past patching noted in areas around the structure. Recommend repairs as needed by a licensed contractor.

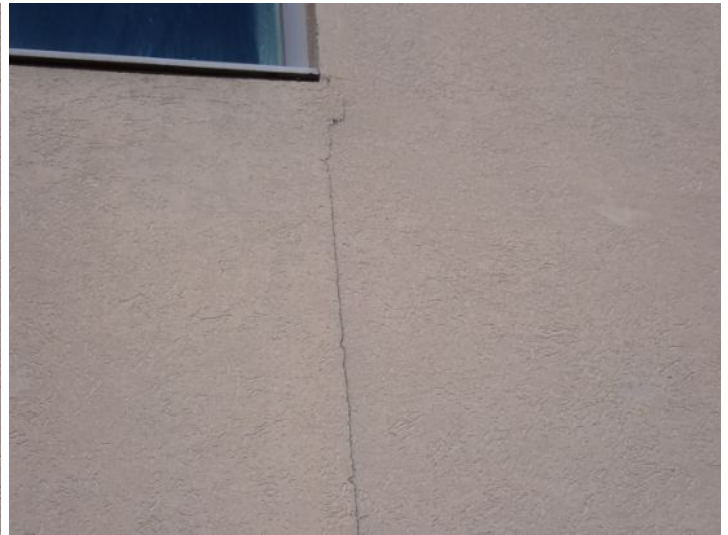
EIFS damage/cracking and past patching noted in areas around the structure. Recommend repairs as needed by a licensed contractor.

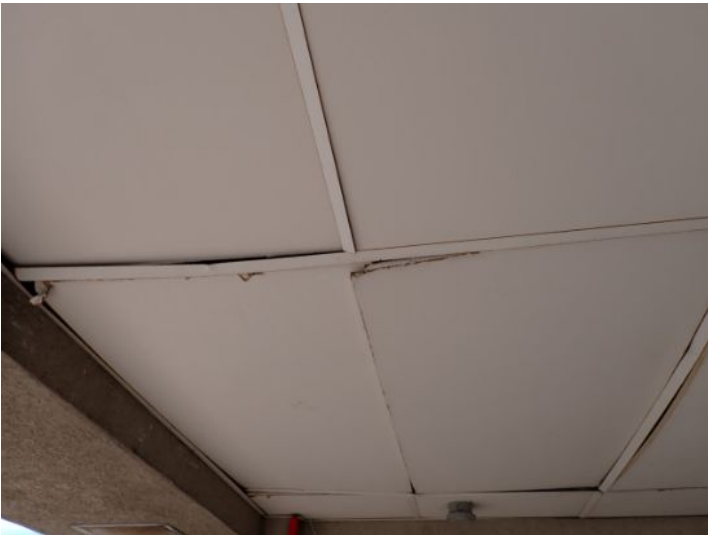
Loose/damaged/missing suspended ceiling tiles noted in areas of the covered parking at the time of the inspection. Recommend repairs.

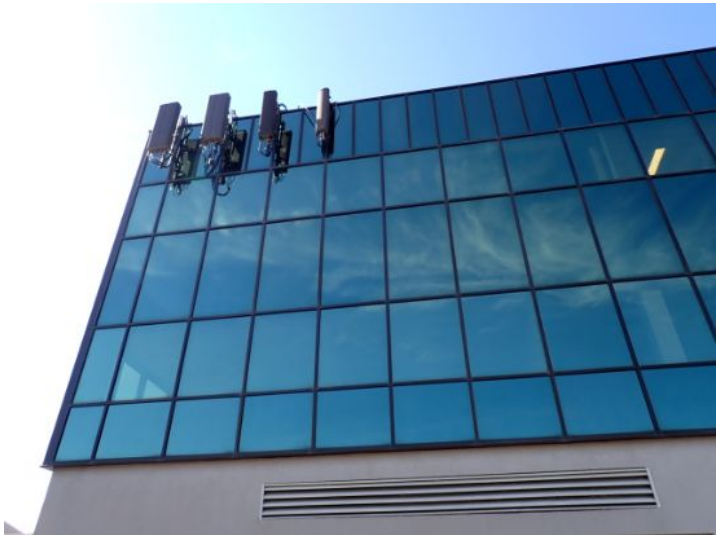
The majority of the exterior envelope of the structure appeared to be in fair condition at the time of the inspection.

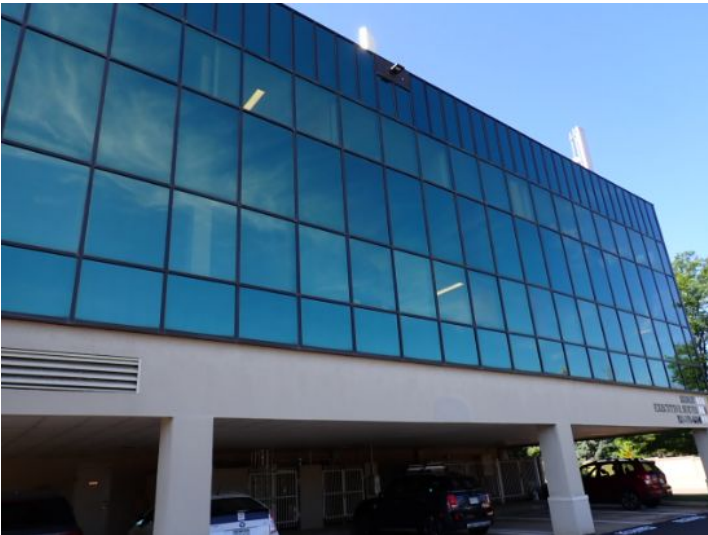
The majority of the exterior envelope of the structure appeared to be in fair condition at the time of the inspection.
