# *Forman Inspection Services, LLC*

## Property Inspection Report

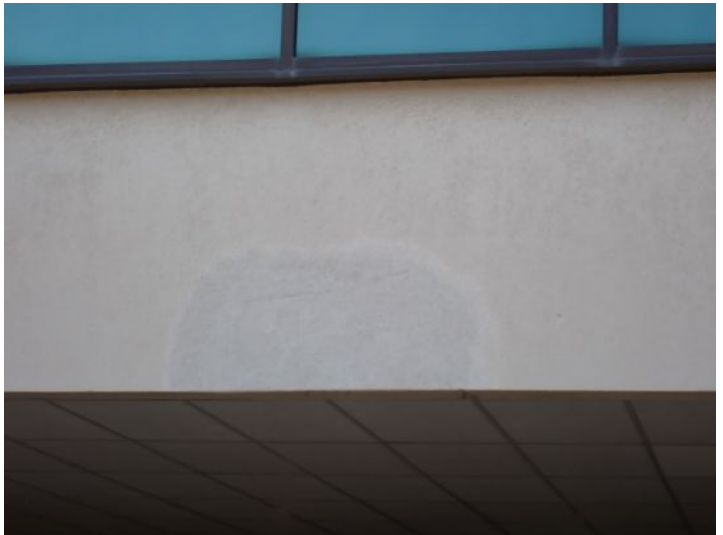
EIFS damage/cracking and past patching noted in areas around the structure. Recommend repairs as needed by a licensed contractor.

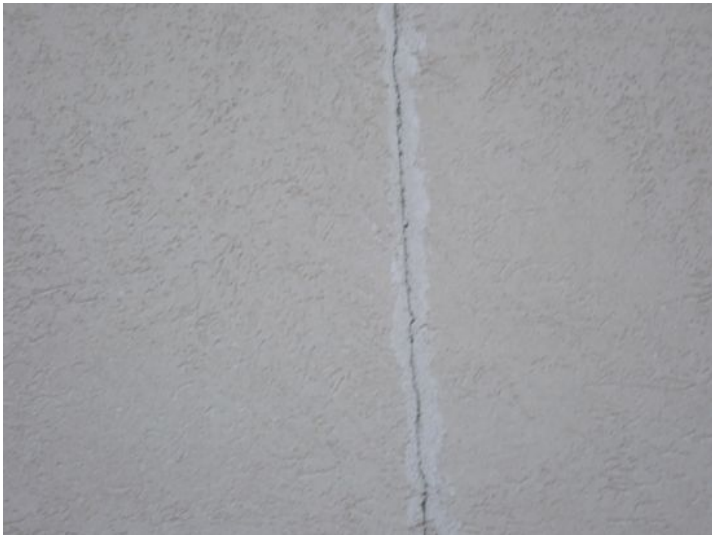
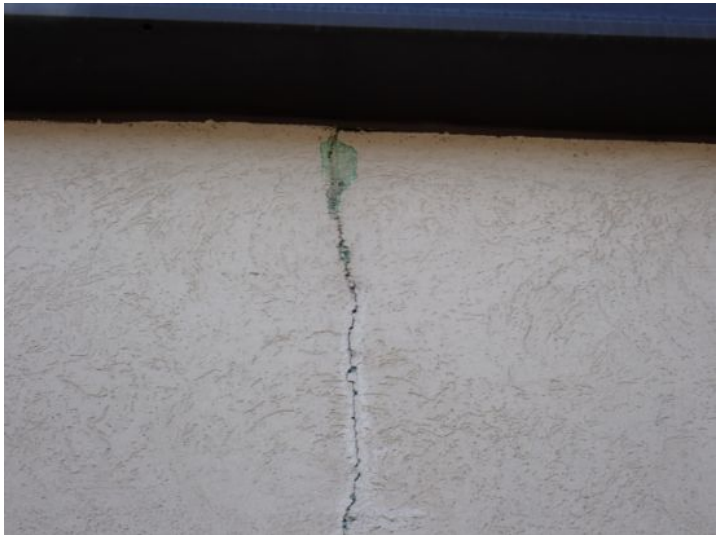
EIFS damage/cracking and past patching noted in areas around the structure. Recommend repairs as needed by a licensed contractor.

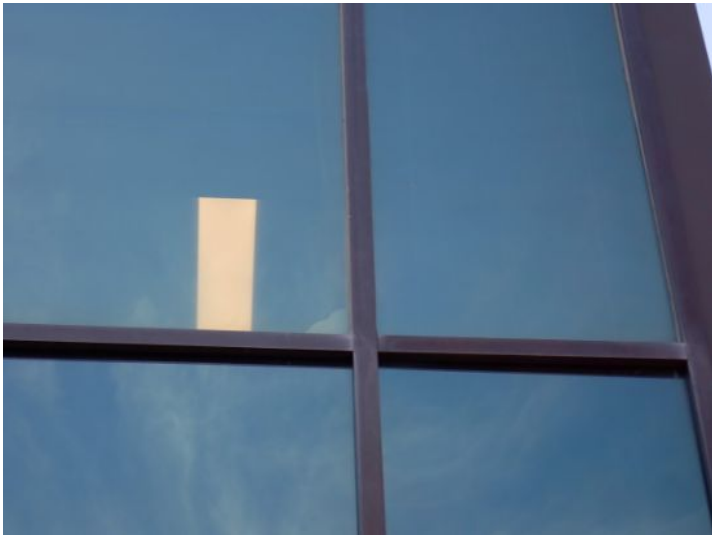
Failed seals noted in one or more insulated window panels at the time of the inspection. Recommend repairs by a licensed contractor.

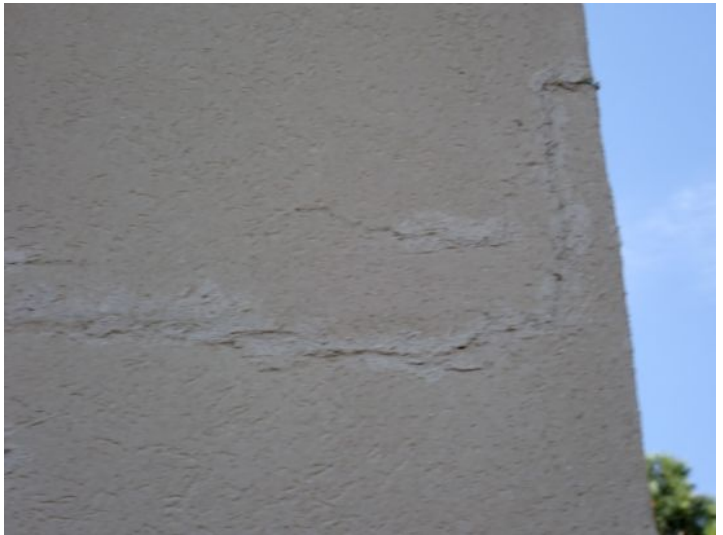
EIFS damage/cracking and past patching noted in areas around the structure. Recommend repairs as needed by a licensed contractor.

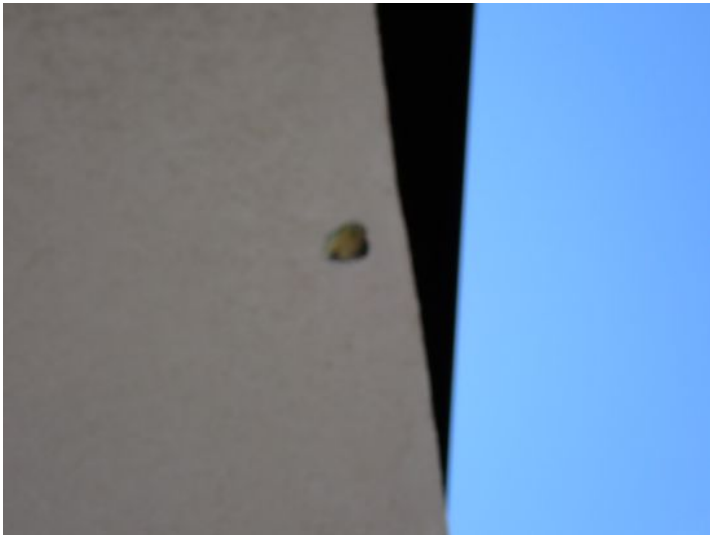
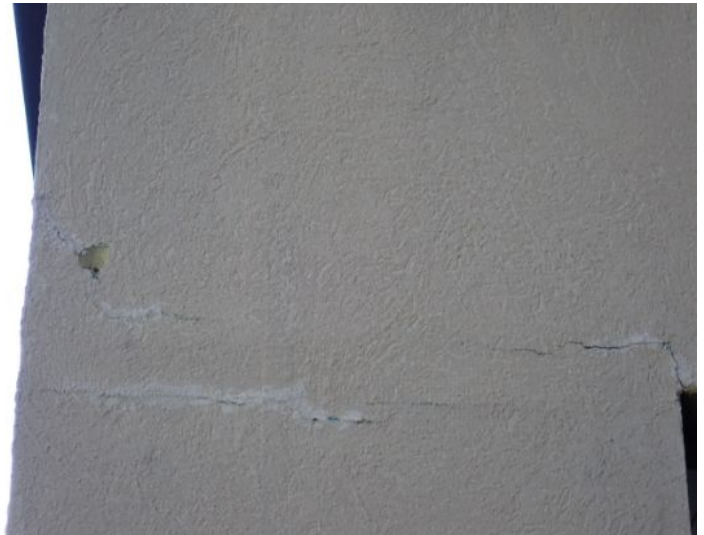
EIFS damage/cracking and past patching noted in areas around the structure. Recommend repairs as needed by a licensed contractor.

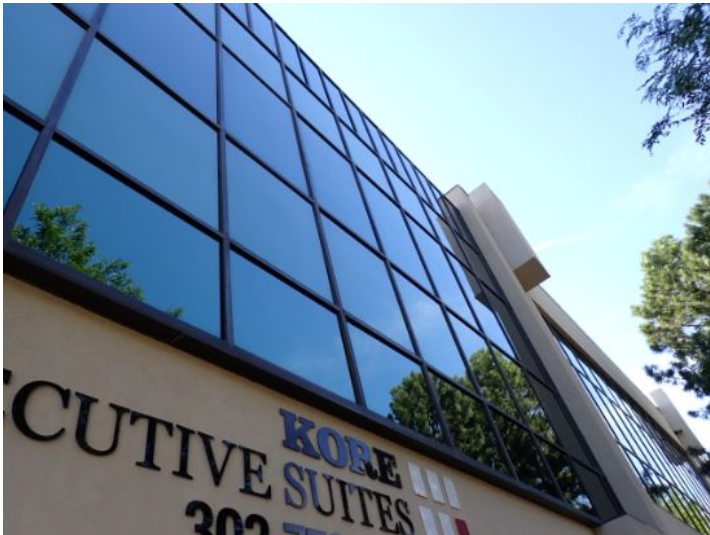
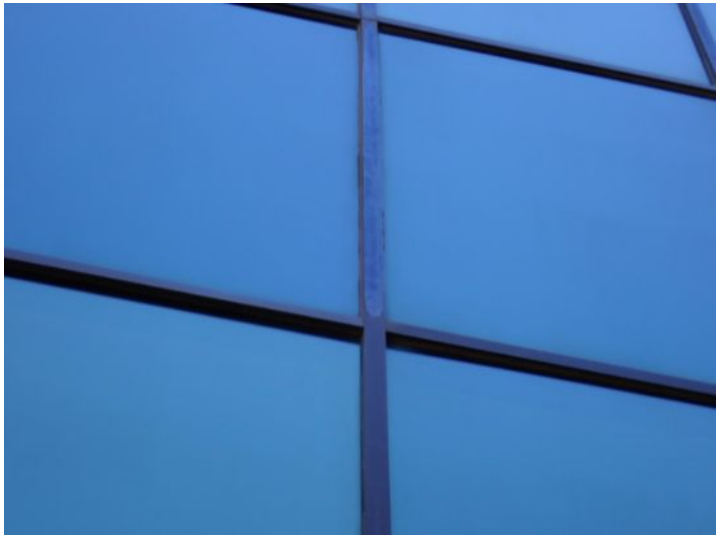
The majority of the exterior envelope of the structure appeared to be in fair condition at the time of the inspection.

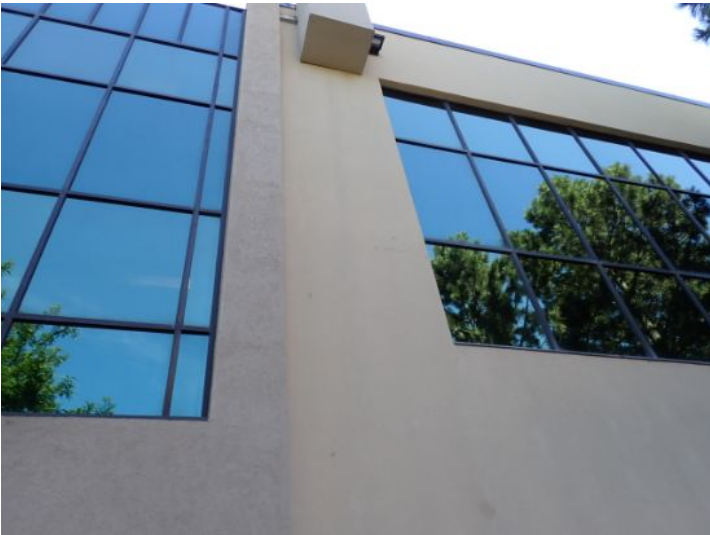
The majority of the exterior envelope of the structure appeared to be in fair condition at the time of the inspection.

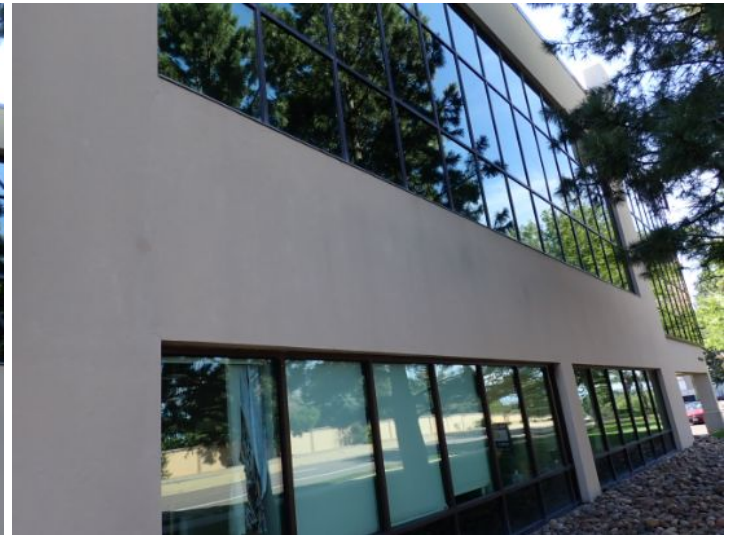
The majority of the exterior envelope of the structure appeared to be in fair condition at the time of the inspection.

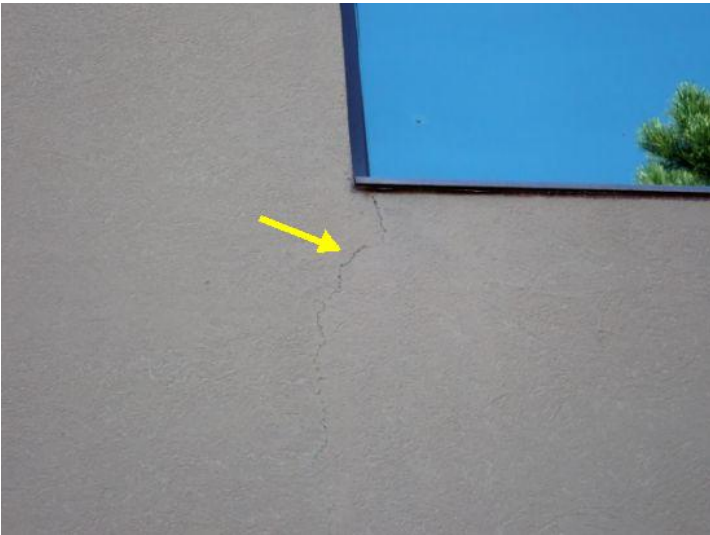
EIFS damage/cracking and past patching noted in areas around the structure. Recommend repairs as needed by a licensed contractor.

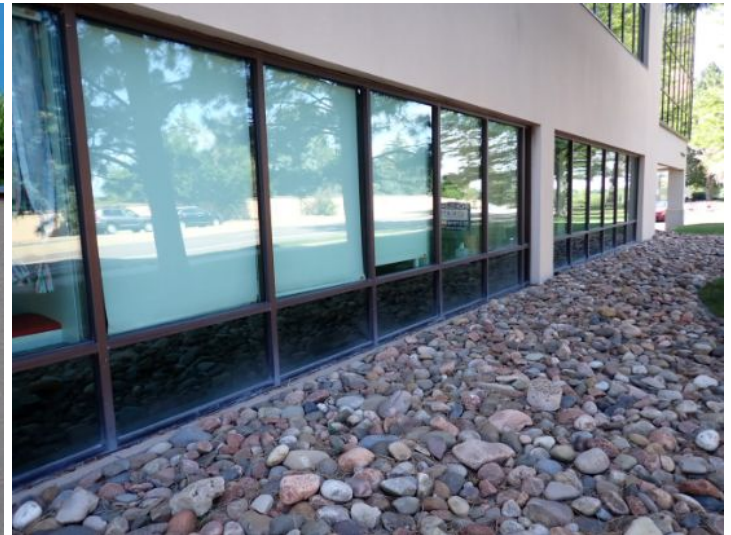
The majority of the exterior envelope of the structure appeared to be in fair condition at the time of the inspection.

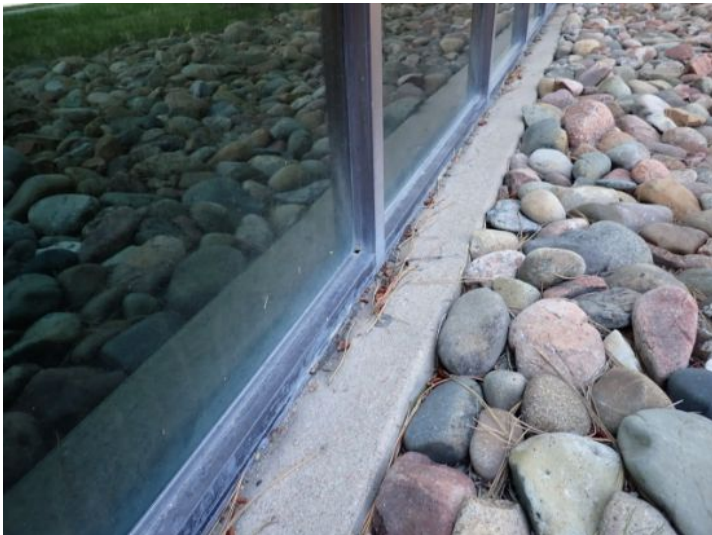
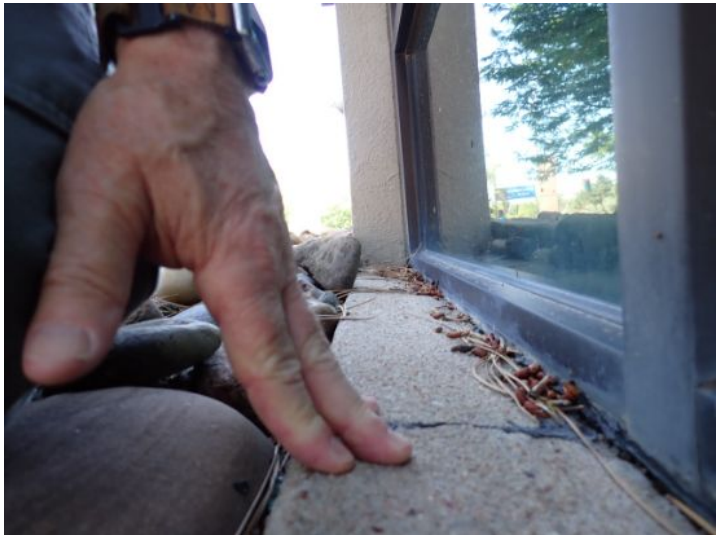
The concrete perimeter beam located on the lower west side of the structure had failed and was settling toward the structure at the time of the inspection. Recommend repairs by a licensed contractor.

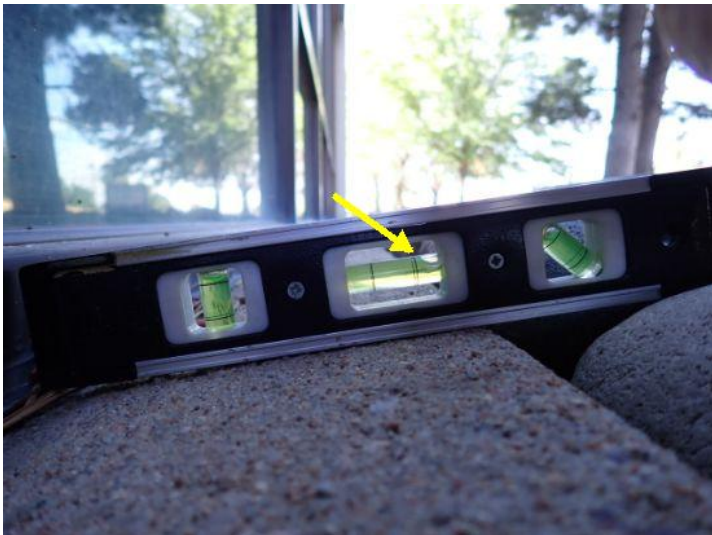
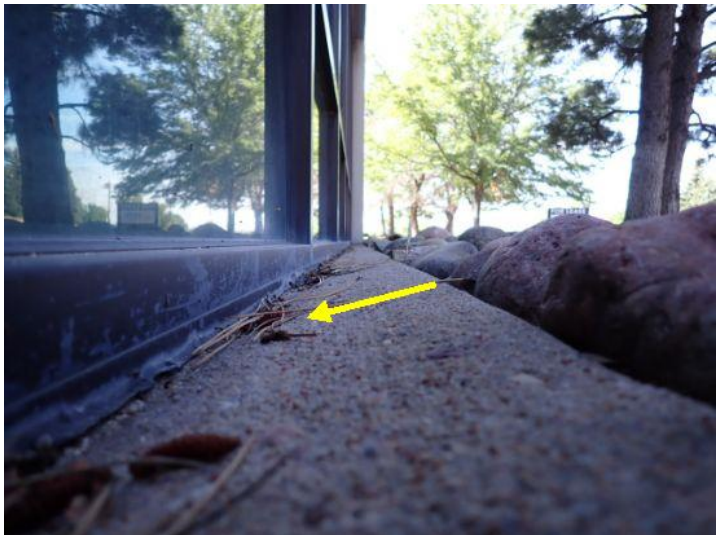
The concrete perimeter beam located on the lower west side of the structure had failed and was settling toward the structure at the time of the inspection. Recommend repairs by a licensed contractor.

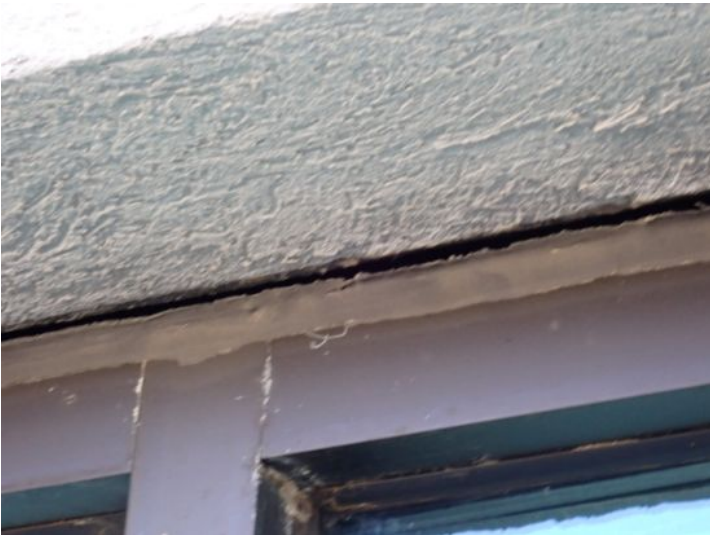
Due to failure of the concrete beam on the west side of the structure the storefront material is settling and pulling away from the structure at the top. Recommend repairs as needed by a licensed contractor.

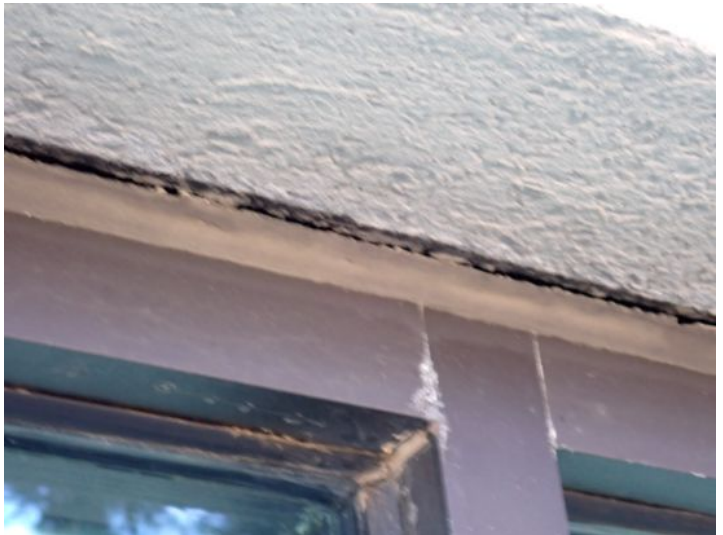
Due to failure of the concrete beam on the west side of the structure the storefront material is settling and pulling away from the structure at the top. Recommend repairs as needed by a licensed contractor.

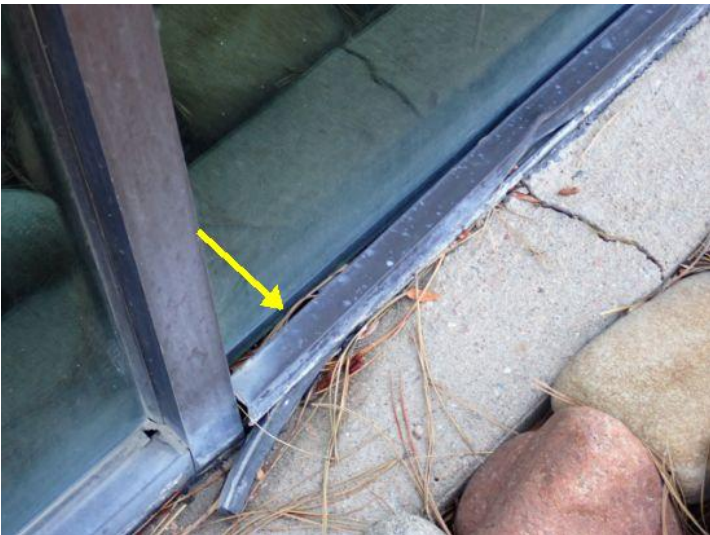
Damaged glass stop noted on the west side bottom of the storefront system at the time of the inspection. Recommend repairs by a licensed contractor.

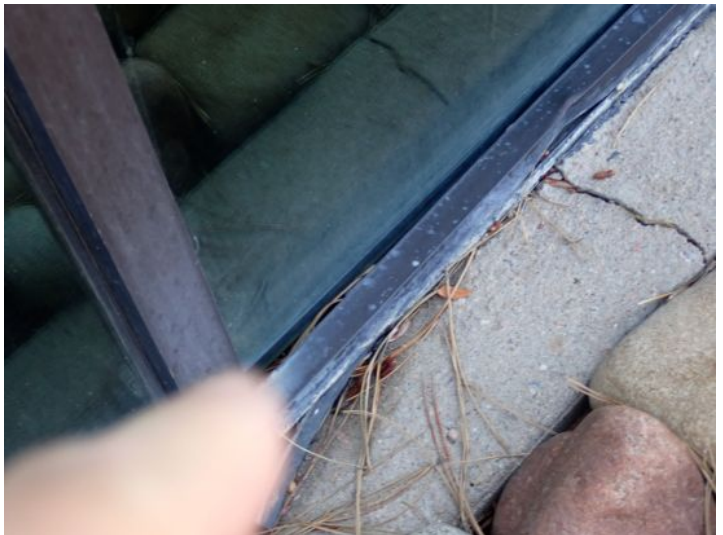
The concrete perimeter beam located on the lower west side of the structure had failed and was settling toward the structure at the time of the inspection. Recommend repairs by a licensed contractor.

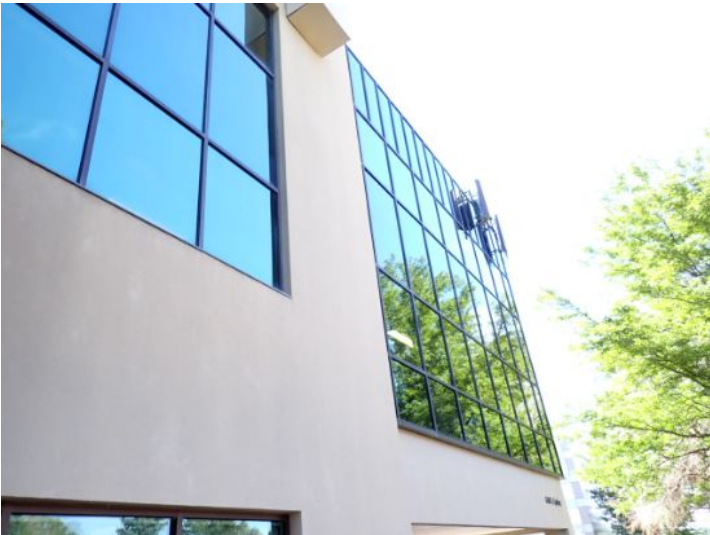
The majority of the exterior envelope of the structure appeared to be in fair condition at the time of the inspection.

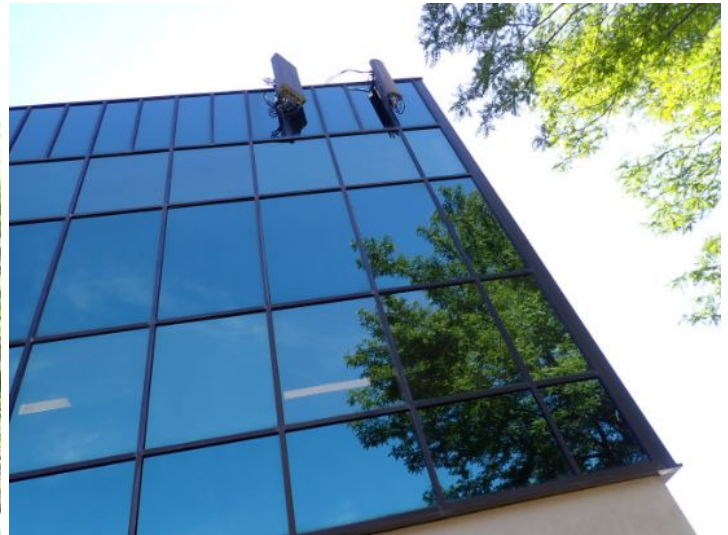
The majority of the exterior envelope of the structure appeared to be in fair condition at the time of the inspection.

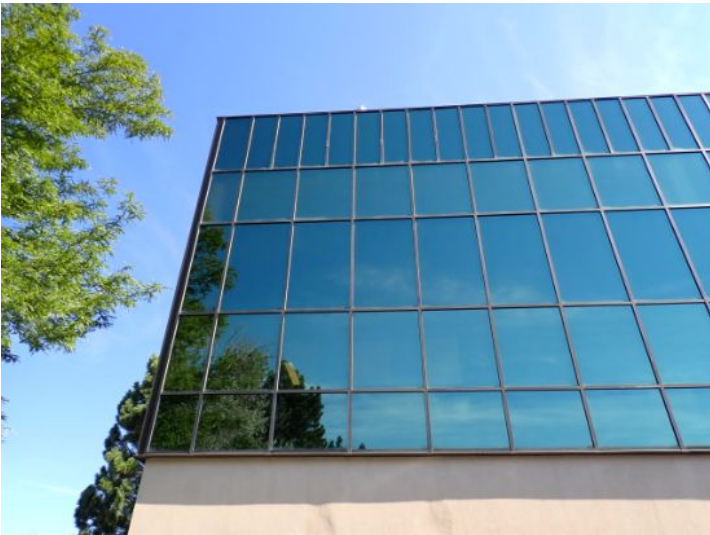
The majority of the exterior envelope of the structure appeared to be in fair condition at the time of the inspection.

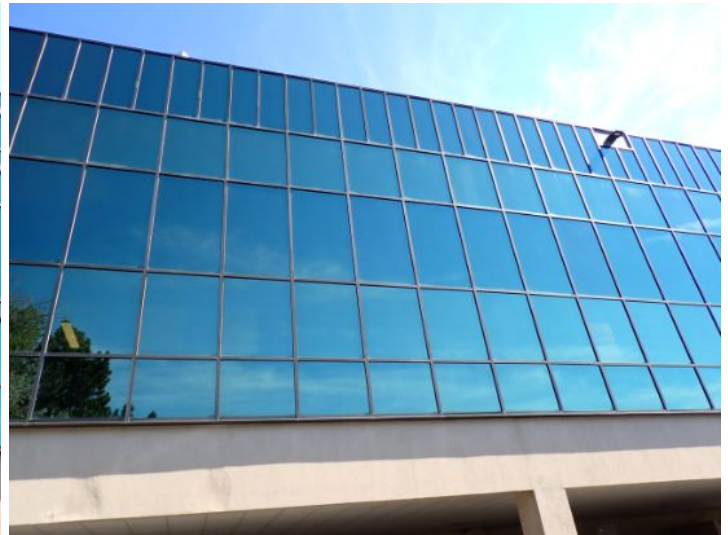
The majority of the exterior envelope of the structure appeared to be in fair condition at the time of the inspection.

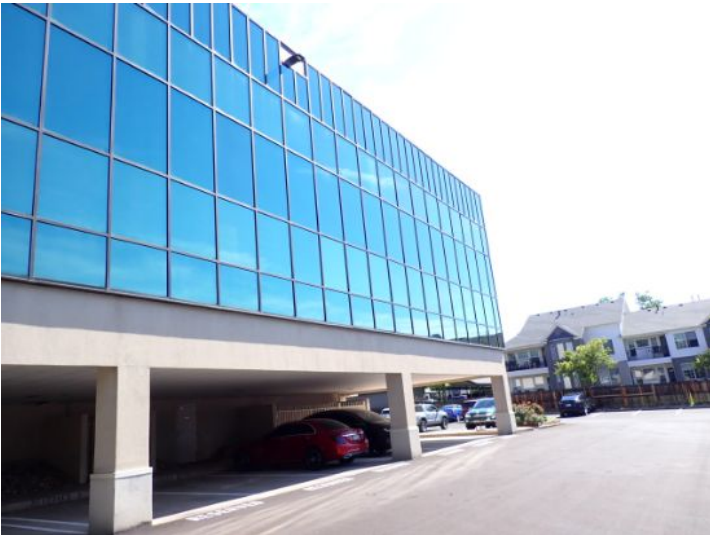
The majority of the exterior envelope of the structure appeared to be in fair condition at the time of the inspection.

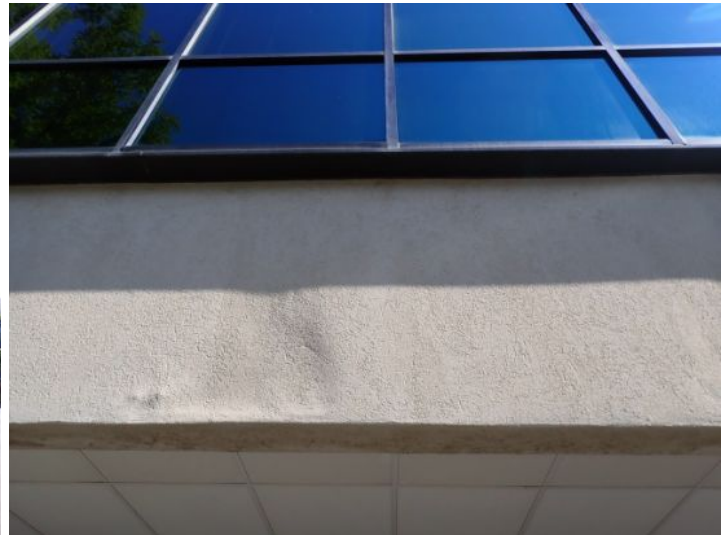
EIFS damage/cracking and past patching noted in areas around the structure. Recommend repairs as needed by a licensed contractor.

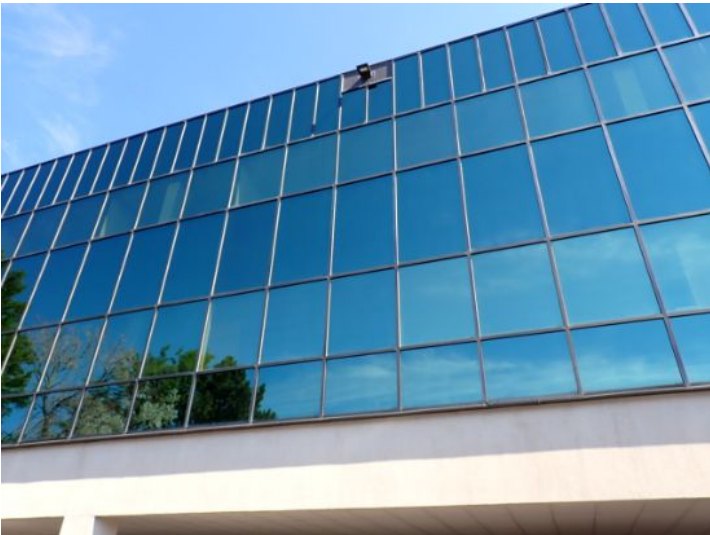
The majority of the exterior envelope of the structure appeared to be in fair condition at the time of the inspection.

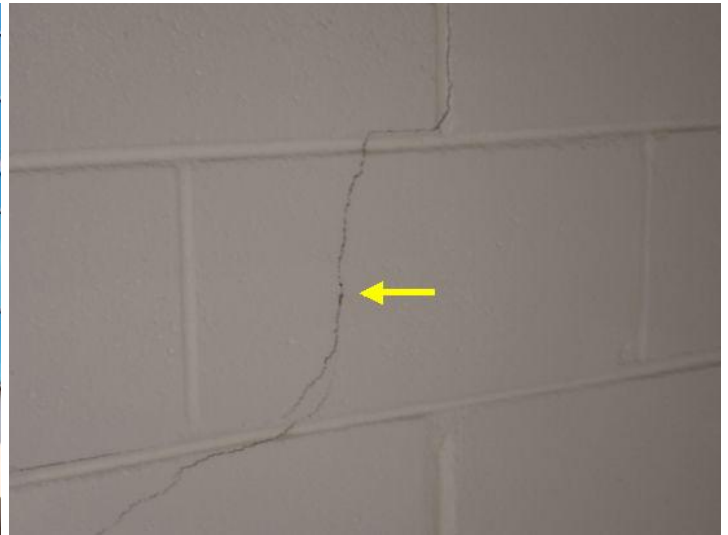
Minor mortar and block cracking noted in the stairwell area at the time of the inspection. Recommend repairs by a licensed contractor.

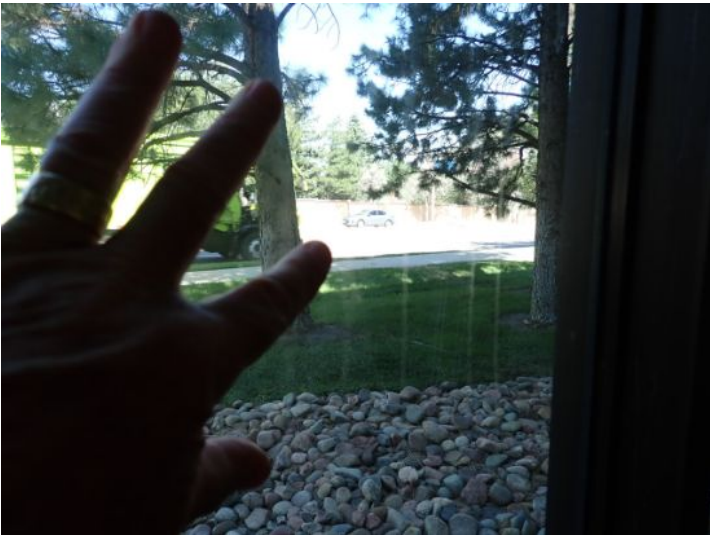
Failed seals noted in one or more insulated window panels at the time of the inspection. Recommend repairs by a licensed contractor.

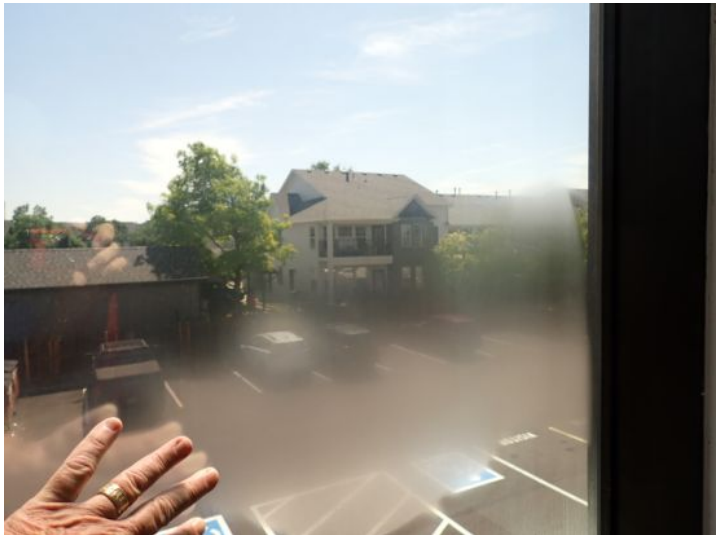
Failed seals noted in one or more insulated window panels at the time of the inspection. Recommend repairs by a licensed contractor.

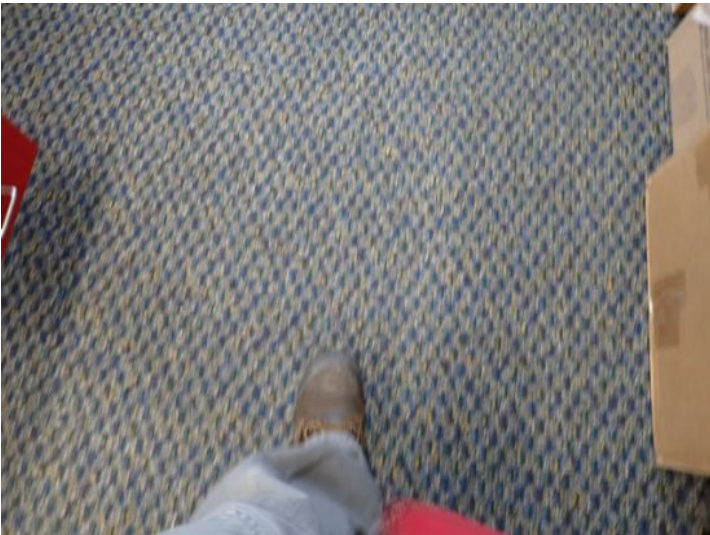
Flooring deflection noted under foot in areas. Recommend monitoring for future repairs.

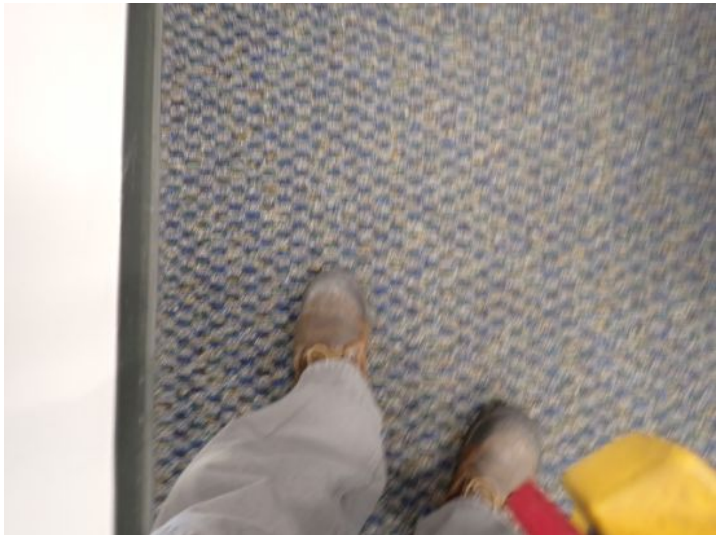
Flooring deflection noted under foot in areas. Recommend monitoring for future repairs.

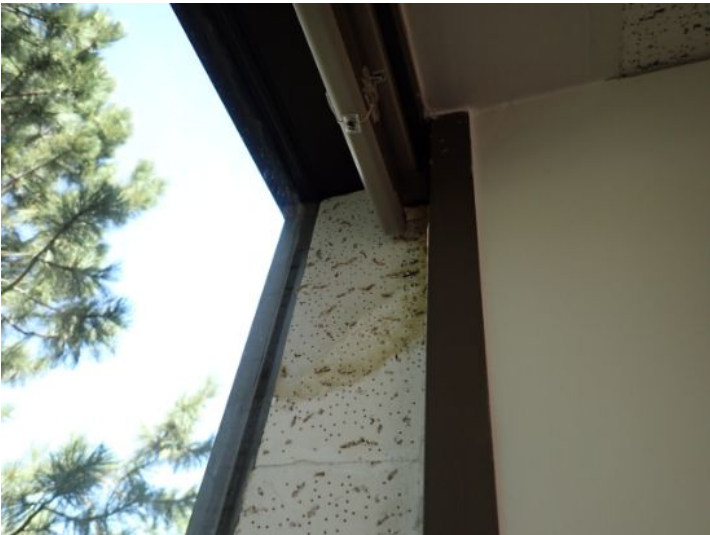
Active moisture intrusion noted in areas of the structure on the outside walls. Recommend having a licensed contractor properly weather proof all of the window systems prior to taking possession of the property.

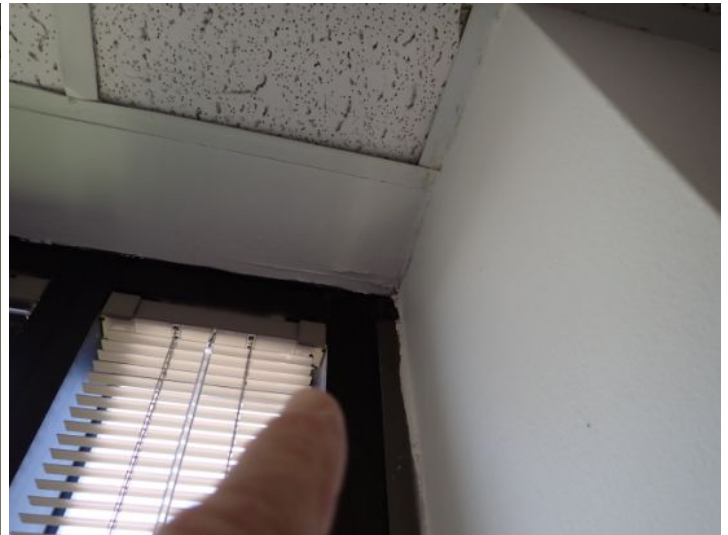
Active moisture intrusion noted in areas of the structure on the outside walls. Recommend having a licensed contractor properly weather proof all of the window systems prior to taking possession of the property.

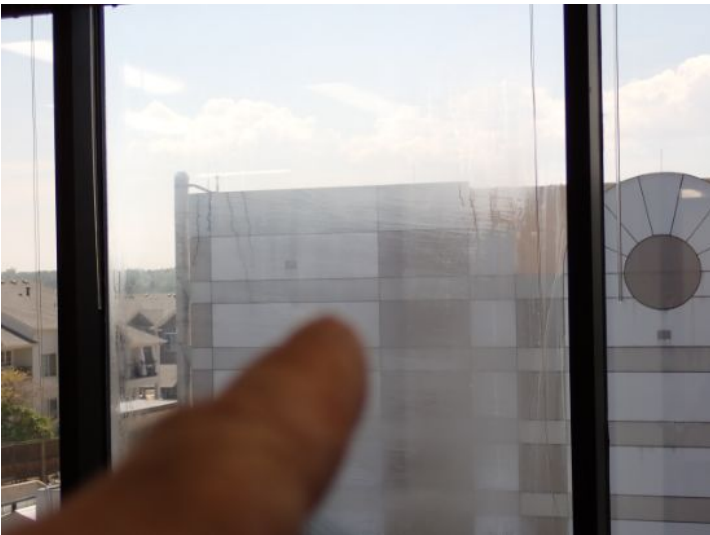
Failed seals noted in one or more insulated window panels at the time of the inspection. Recommend repairs by a licensed contractor.

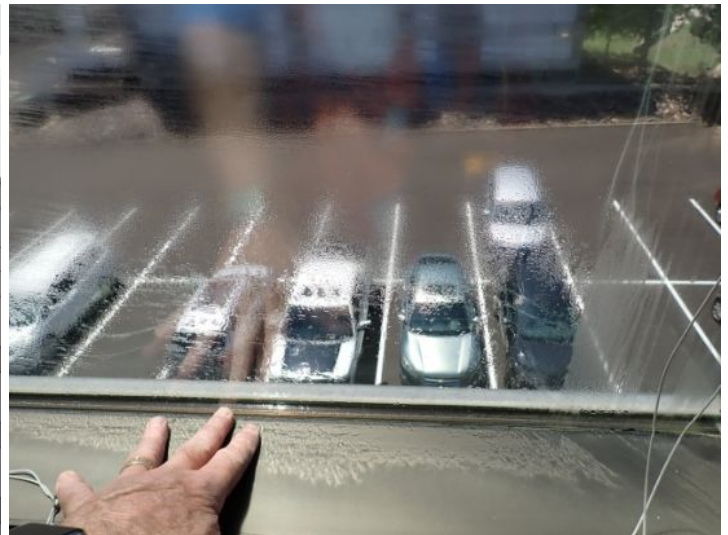
Failed seals noted in one or more insulated window panels at the time of the inspection. Recommend repairs by a licensed contractor.

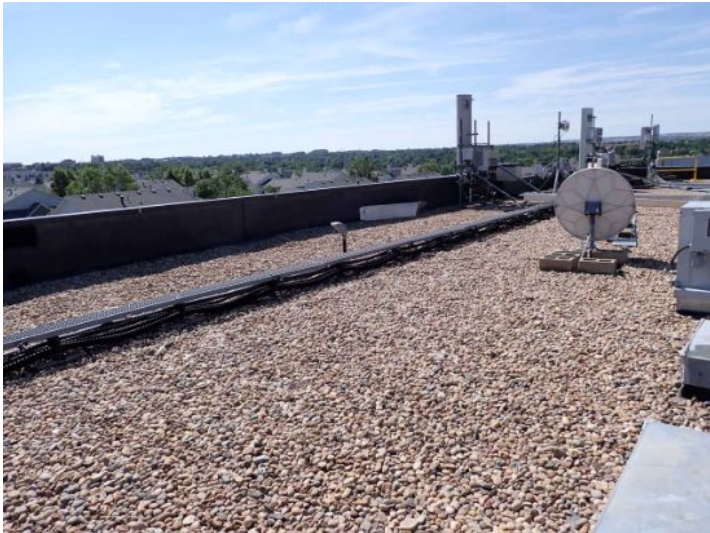
The majority of the roofing system appeared to be in fair condition at the time of the inspection.

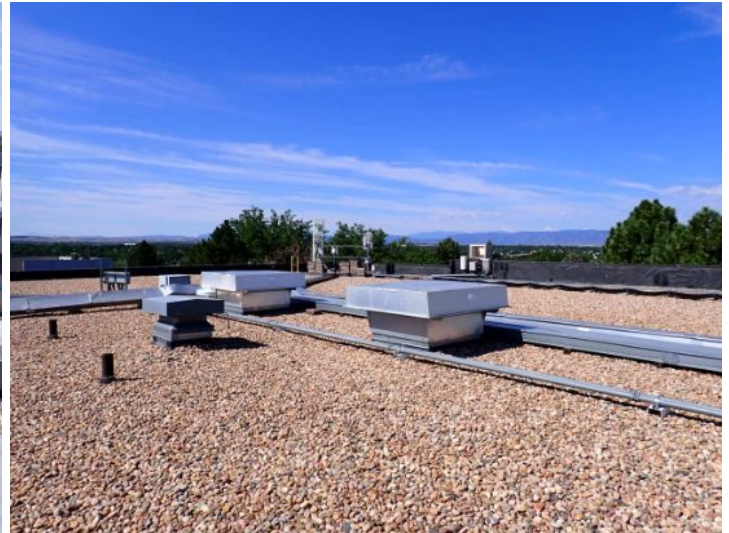
The roofing membrane was last replaced in 2001. The nominal serviceable life expectancy of an EPDM membrane, with proper slope, is 20 years which would be slightly extended with the use of gravel ballast.

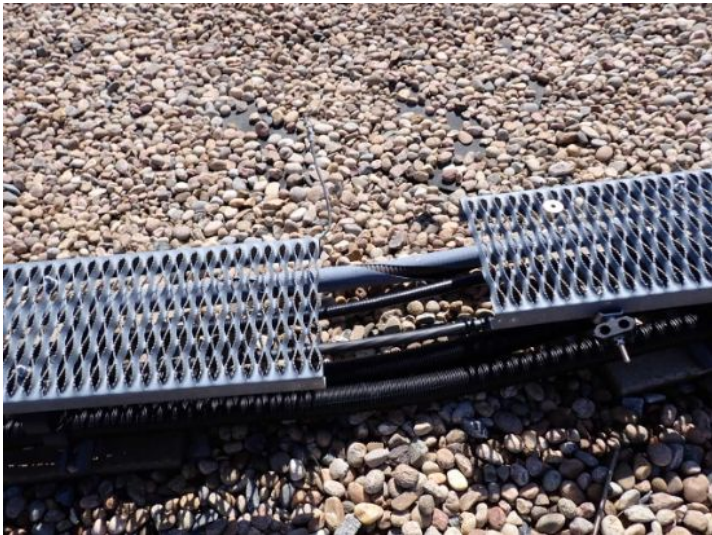
Multiple damaged cable tray systems noted on the roof top at the time of the inspection. Recommend repairs by the cellular contractors to aid in preventing possible membrane damage.

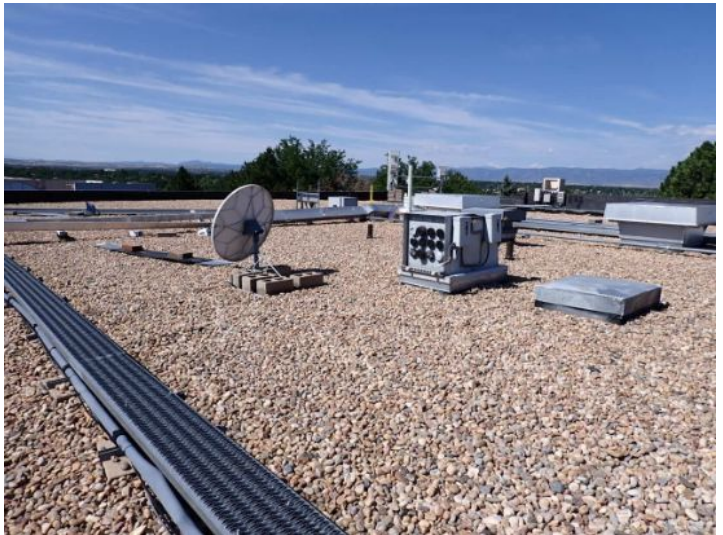
The majority of the roofing system appeared to be in fair condition at the time of the inspection.

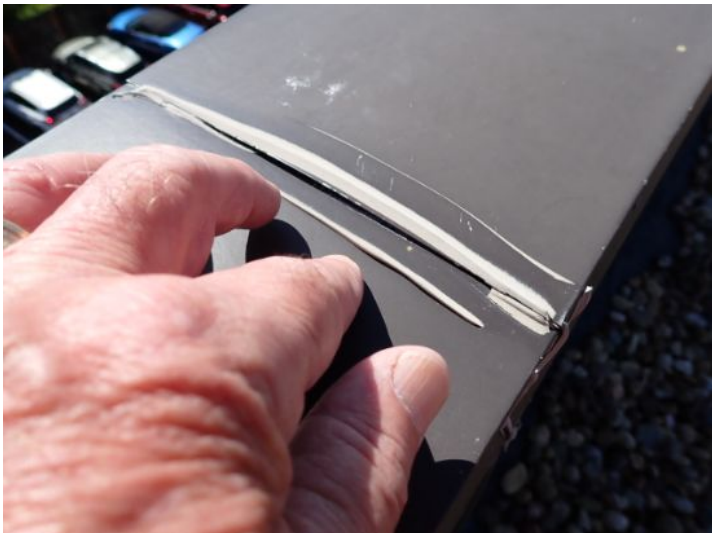
Recommend sealant repairs on parapet wall cap seams. Recommend repairs by a licensed contractor.

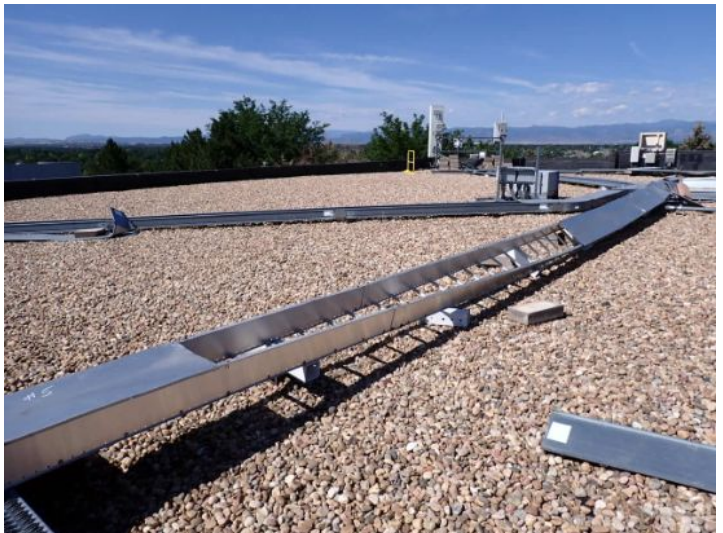
Multiple damaged cable tray systems noted on the roof top at the time of the inspection. Recommend repairs by the cellular contractors to aid in preventing possible membrane damage.

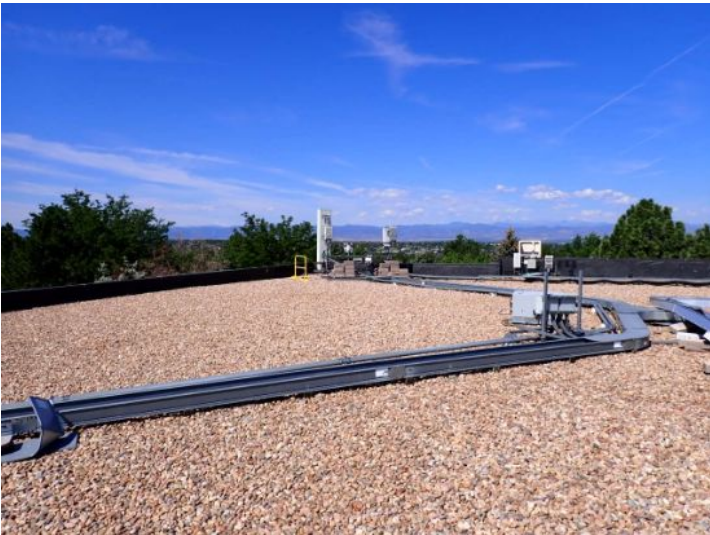
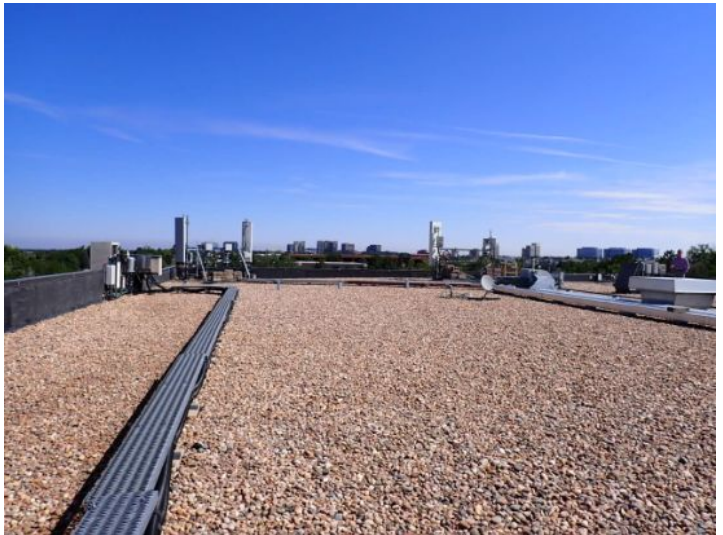
The majority of the roofing system appeared to be in fair condition at the time of the inspection.

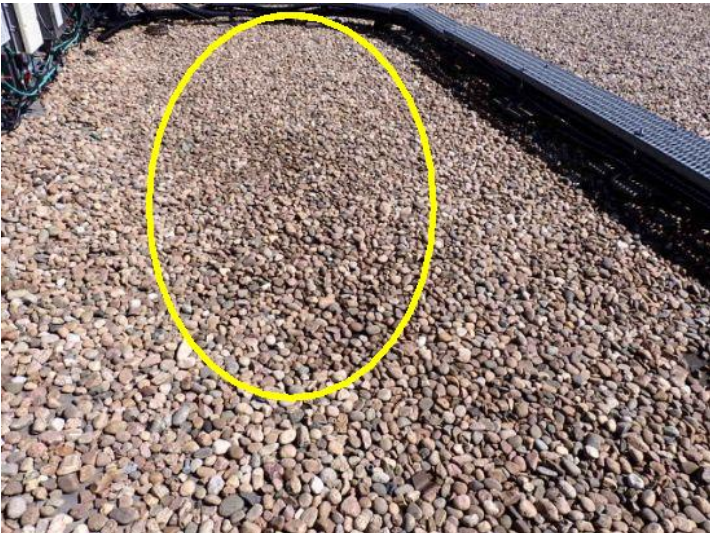
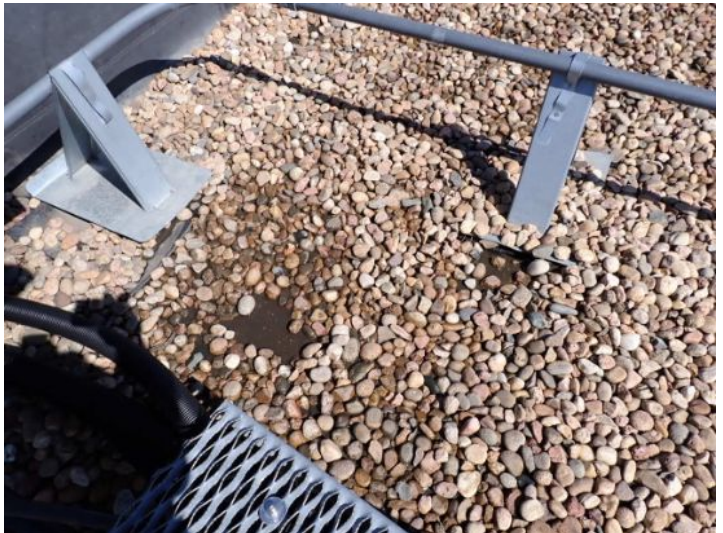
Minor ponding noted in areas. Recommend monitoring for future repairs.

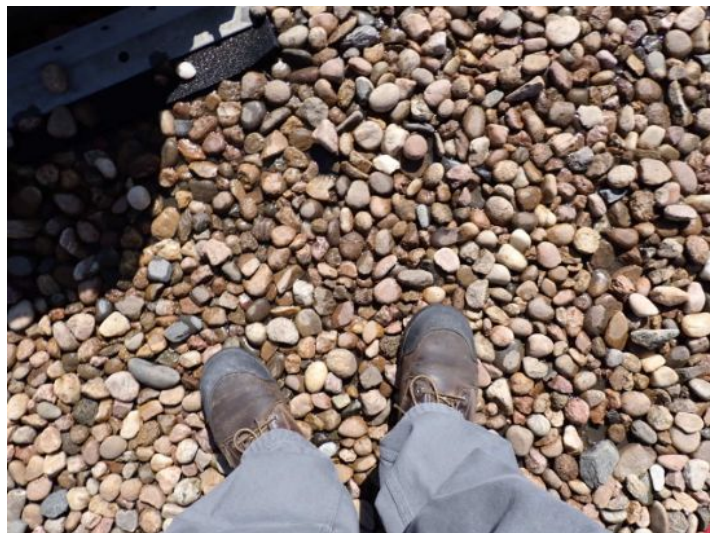
Minor ponding noted in areas. Recommend monitoring for future repairs.

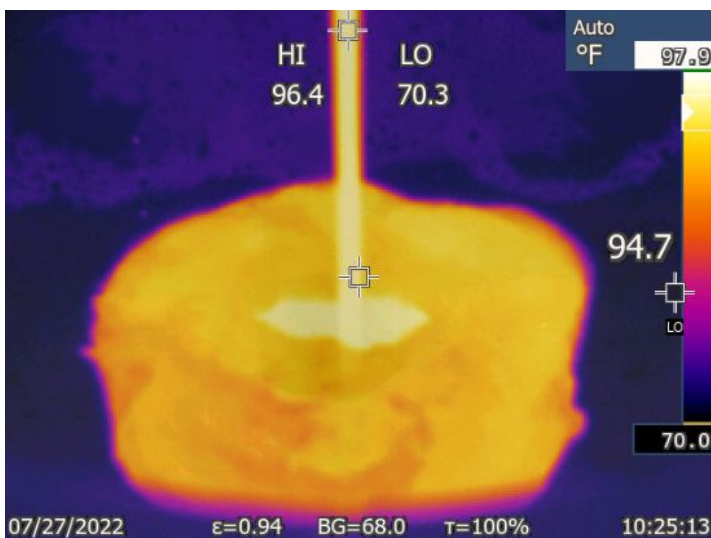
The water heater was tested and functional at the time of the inspection.

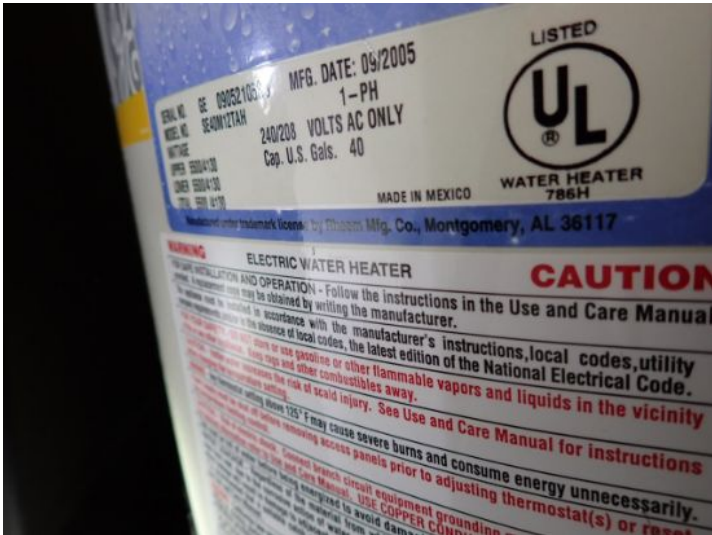
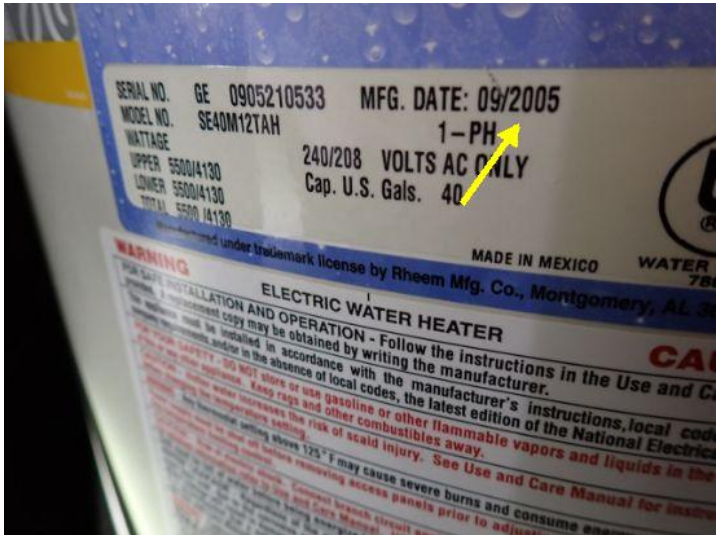
Water Heater: GE: M/N SE40M12TAH S/N GE 0905210533. Manufacture year 2005.

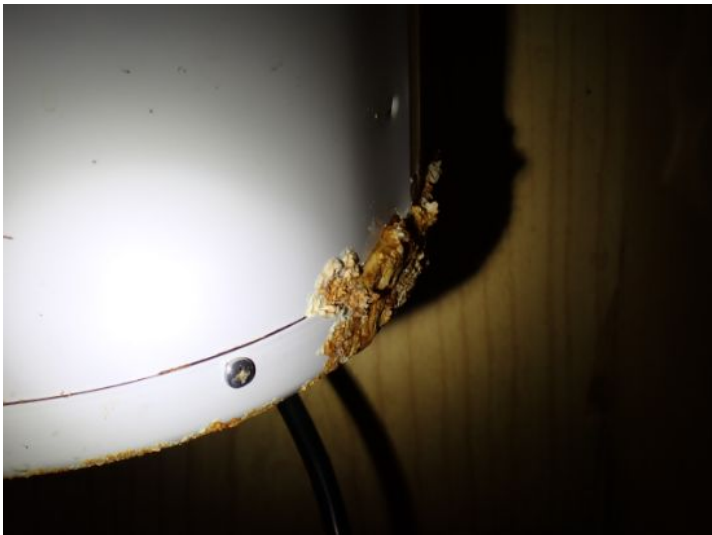
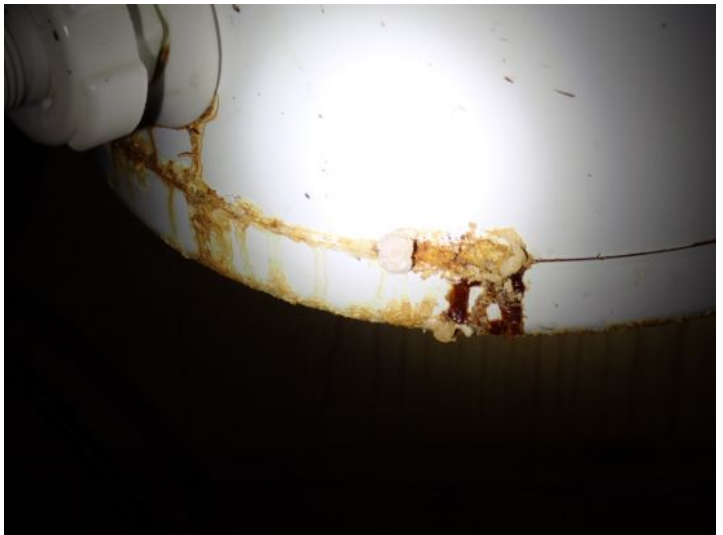
One of the small electric water heaters located in one of the second level suites was in poor condition at the time of the inspection. Although functional at the time of the inspection we recommend replacing the unit prior to failure and leaking into the structure. Recommend repairs by a licensed contractor.

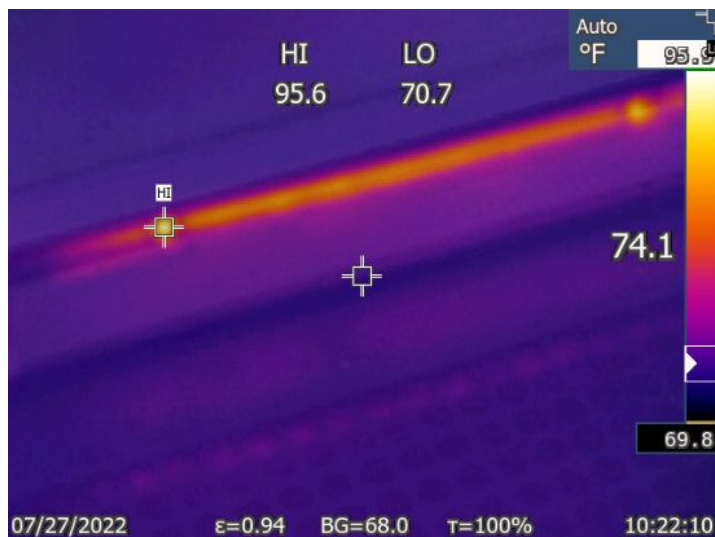
The heating systems appeared functional at the time of the inspection.

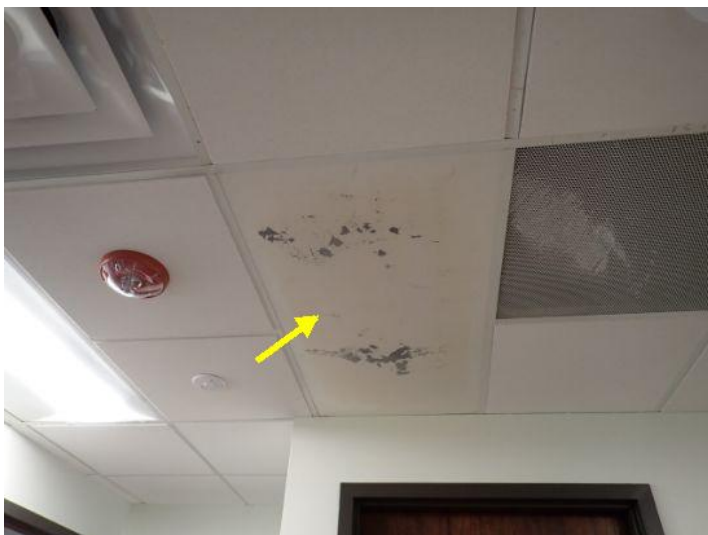
Several of the ceiling mounted radiant heating panels were showing signs of age/wear at the time of the inspection. Recommend repair/replacement as needed by a licensed contractor.
