# *Forman Inspection Services, LLC*

## Property Inspection Report

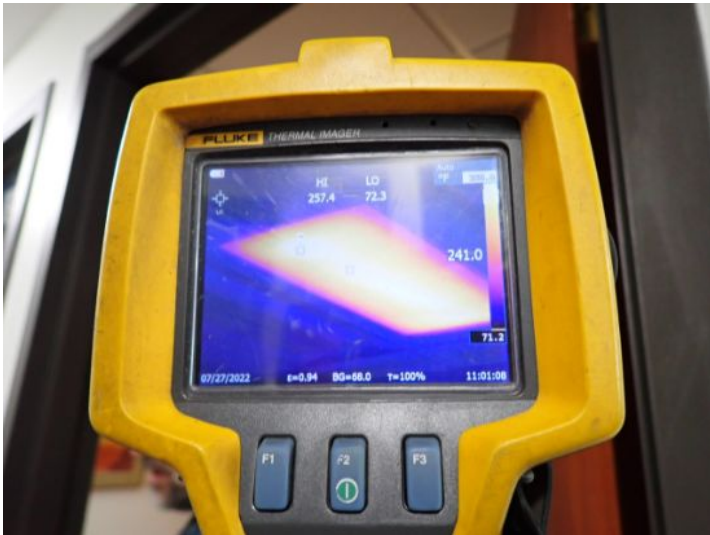
The heating systems appeared functional at the time of the inspection.

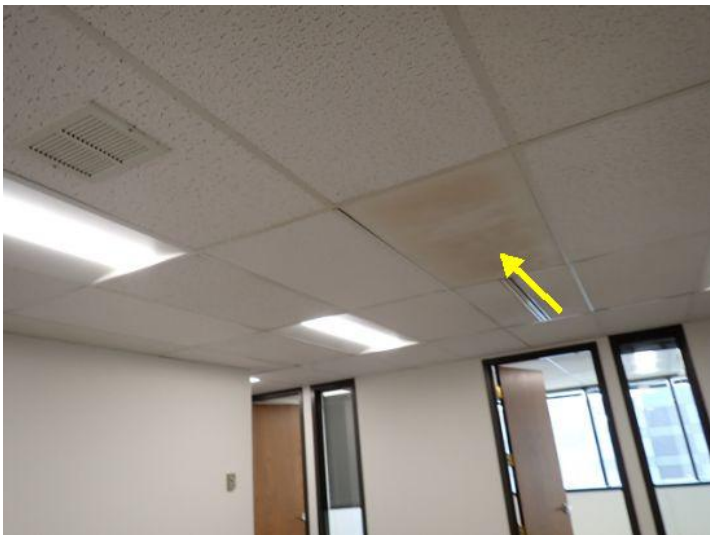
Several of the ceiling mounted radiant heating panels were showing signs of age/wear at the time of the inspection. Recommend repair/replacement as needed by a licensed contractor.

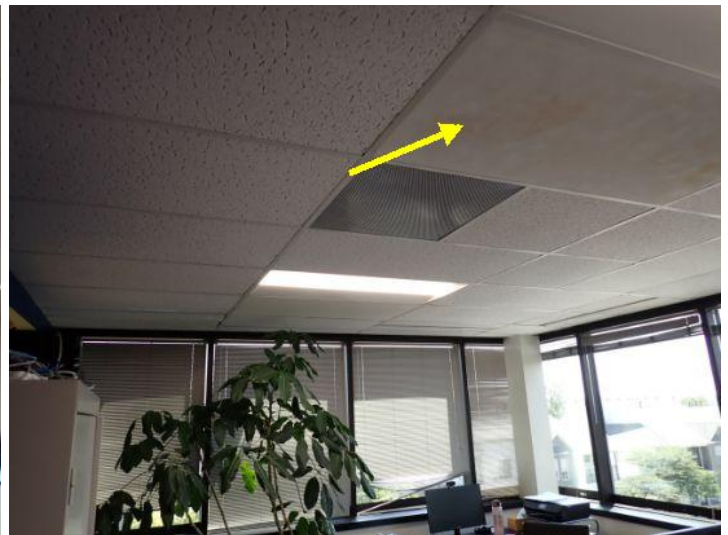
Several of the ceiling mounted radiant heating panels were showing signs of age/wear at the time of the inspection. Recommend repair/replacement as needed by a licensed contractor.

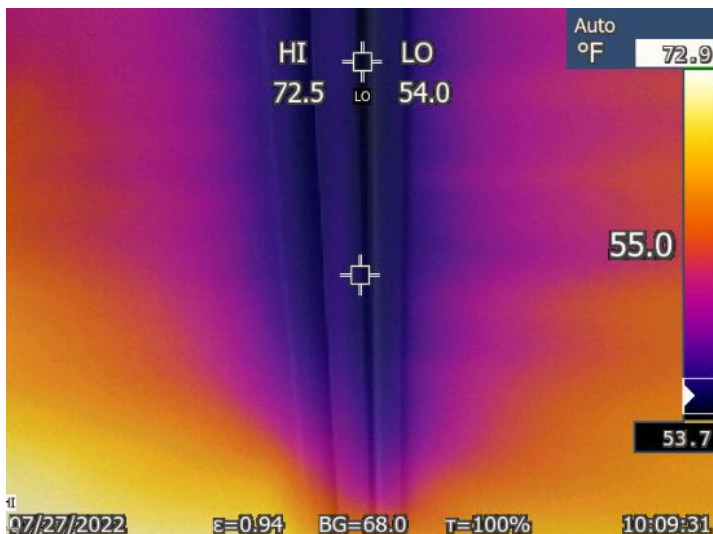
The a/c system was functional at the time of the inspection.

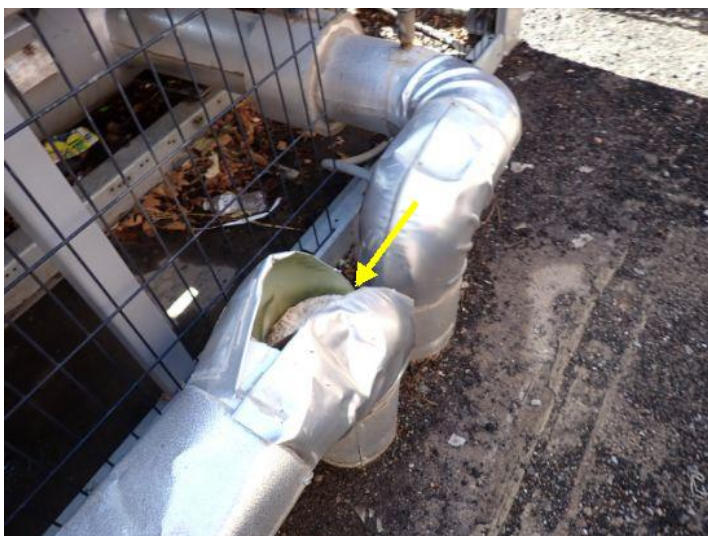
Damaged insulation noted on the cooling lines at the chiller system. Recommend repairs by a licensed contractor.

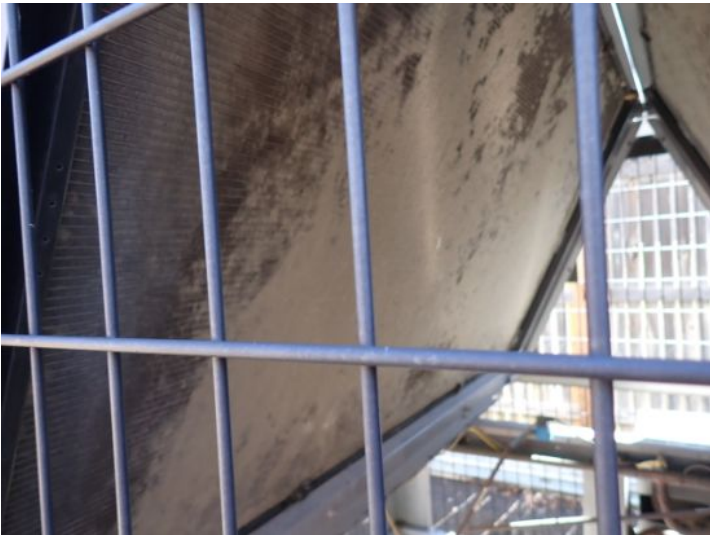
Recommend cleaning/servicing of the a/c chiller system.

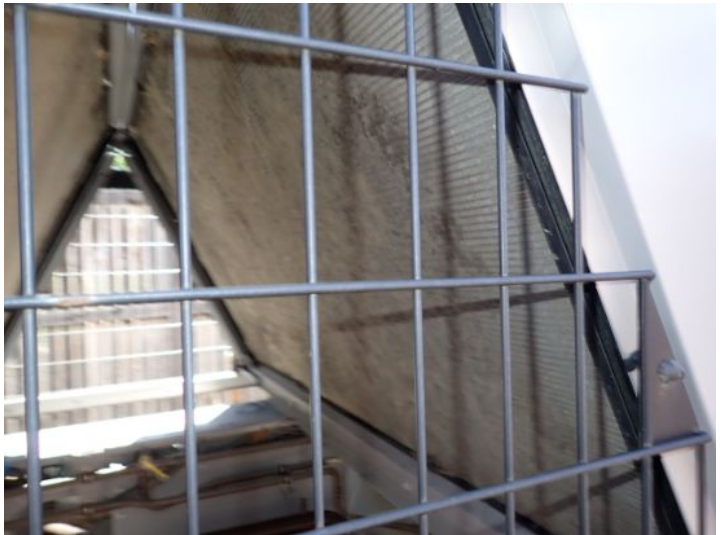
Recommend cleaning/servicing of the a/c chiller system.

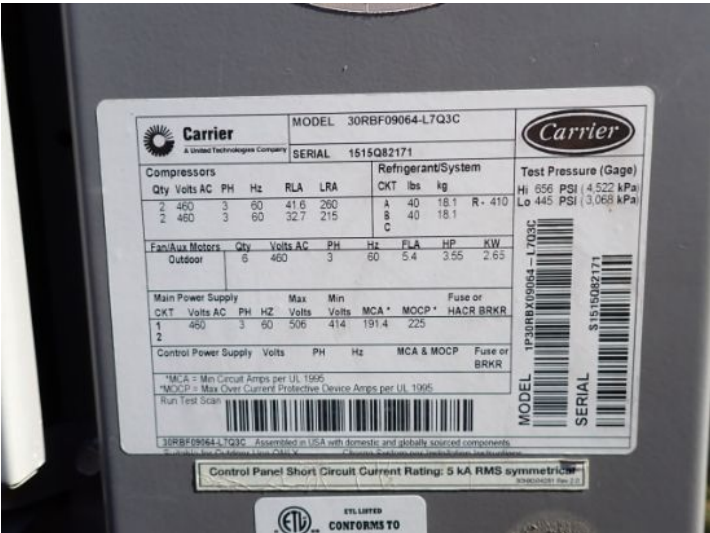
Chiller: Carrier: M/N 30RBF09064-L7Q3C S/N 1515Q82171. Manufacture year 2015.

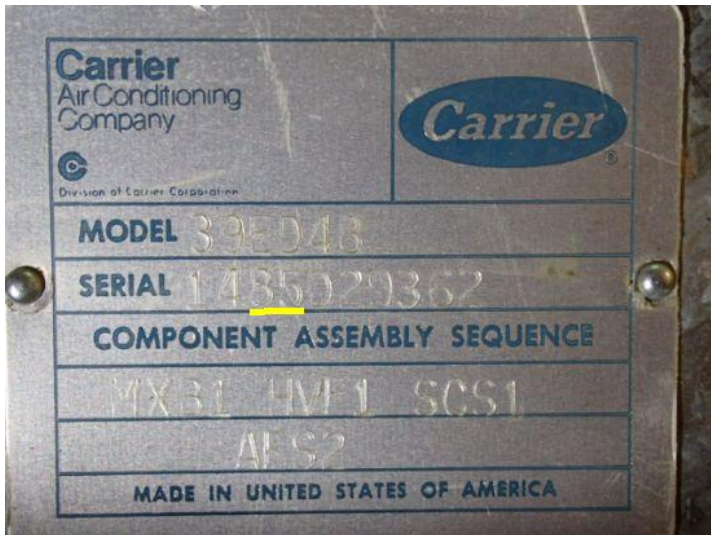
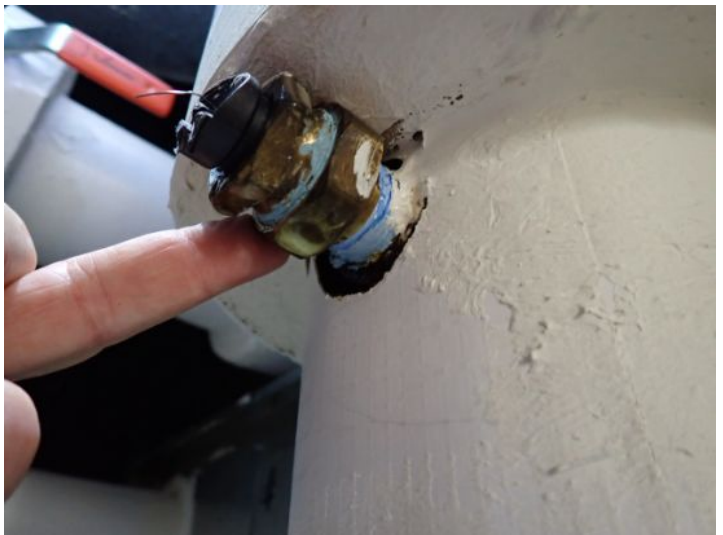
The air handler system was original to the structure. The nominal serviceable life expectancy of an air handler 25-30 years. Based on the age and condition of the unit we recommend budgeting to replace the unit in the next several years.

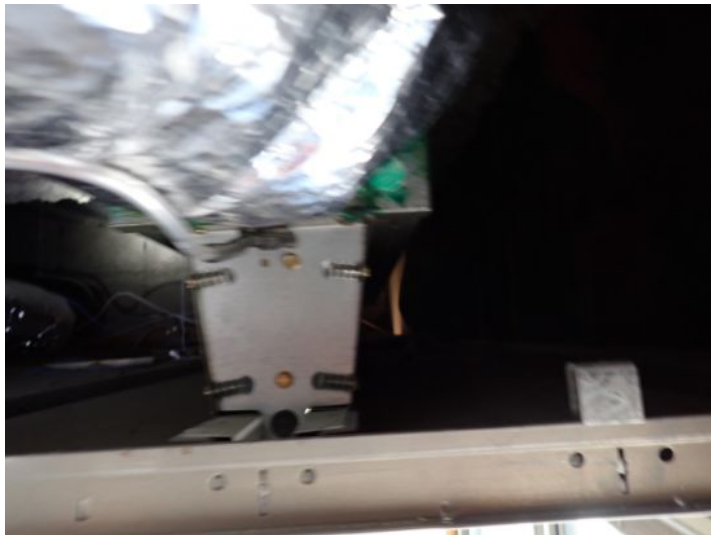
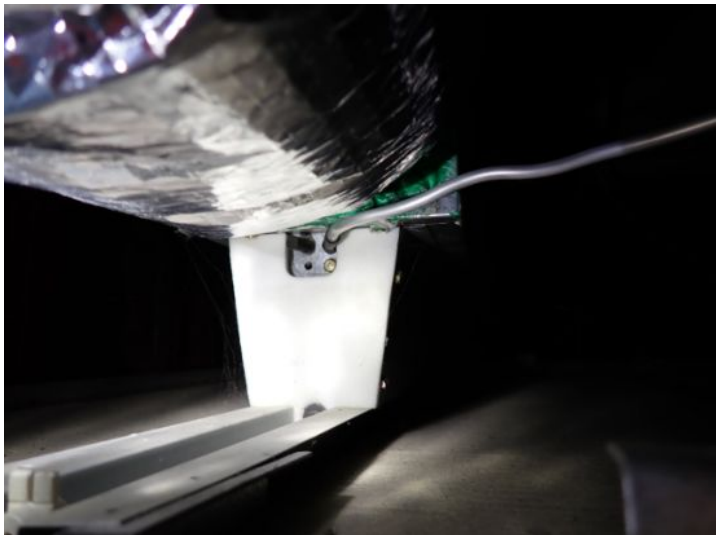
The VAV systems appeared to be original to the structure. The nominal serviceable life expectancy of a VAV system (Cooling Only) is 25 years. Based on the age of the units viewed they appear to have surpassed their serviceable life expectancy. Recommend budgeting to begin replacing the units over the next several years. We recommend consulting with the current property managers to determine if any of the VAV's have been changed out and how many are original to the structure.

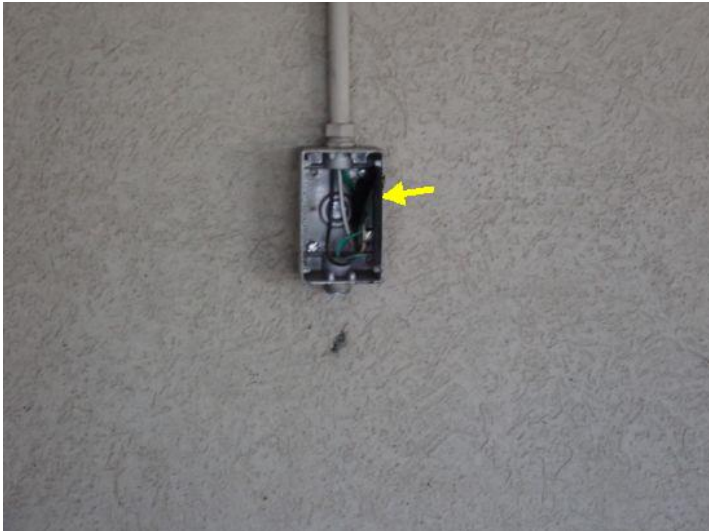
Missing cover and exposed wiring noted on the exterior north side of the structure at the time of the inspection. Recommend repairs.

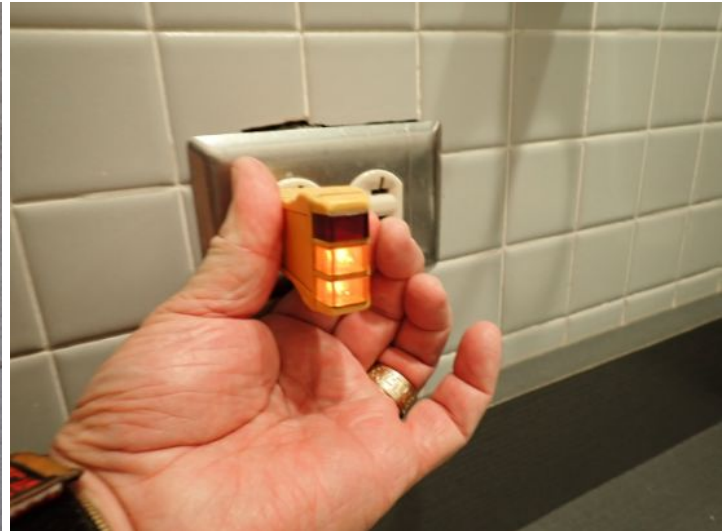
No GFCI protection for the restroom(s) at the time of the inspection. Recommend repairs by a licensed electrician.

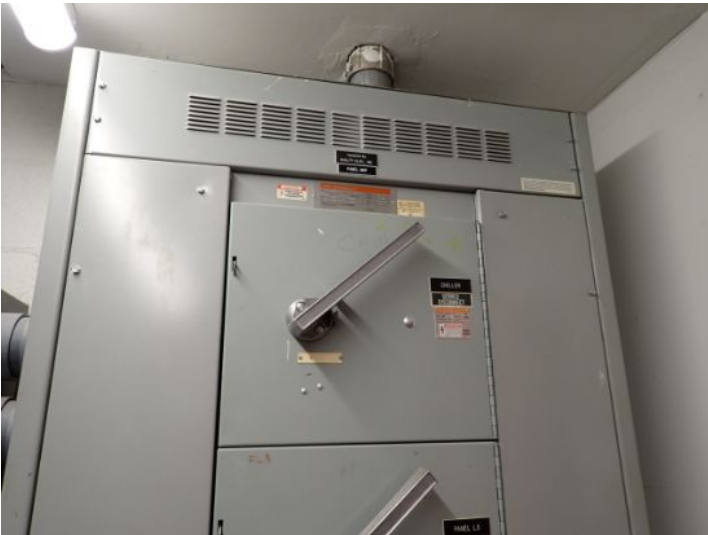
The main electrical disconnects appeared functional at the time of the inspection.

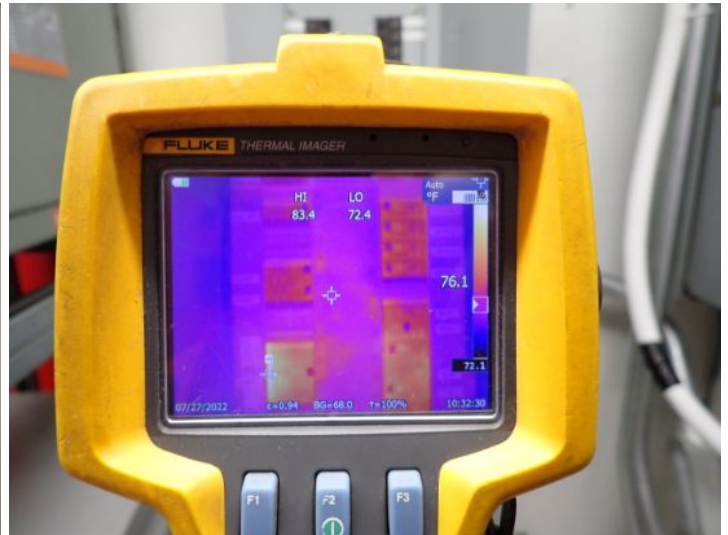
The main electrical panels were scanned with a thermal camera and no abnormalities were noted at the time of the inspection.

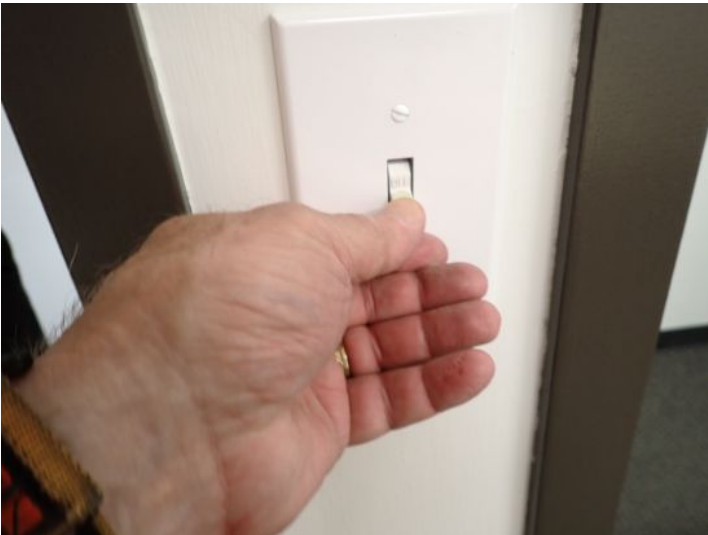
One or more light switches did not appear to operate anything at the time of the inspection. Recommend repairs as needed by a licensed contractor.

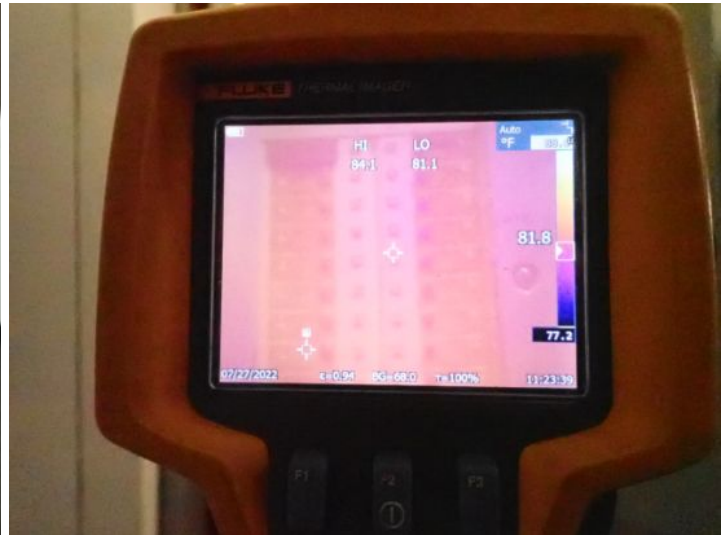
The main electrical panels were scanned with a thermal camera and no abnormalities were noted at the time of the inspection.

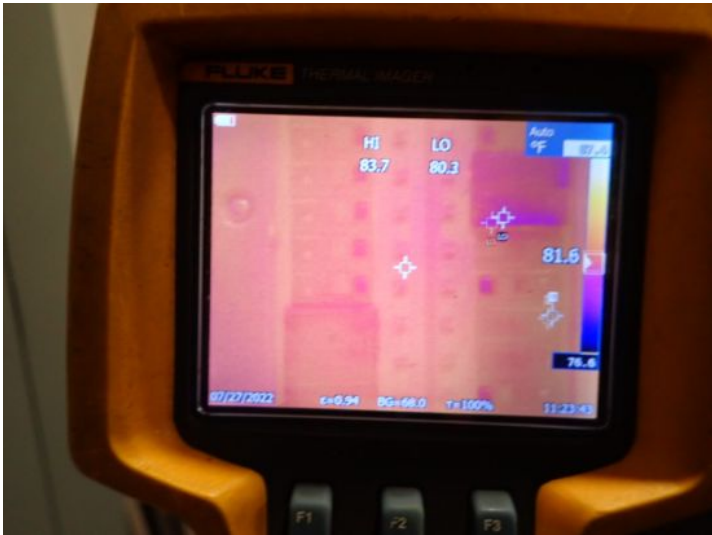
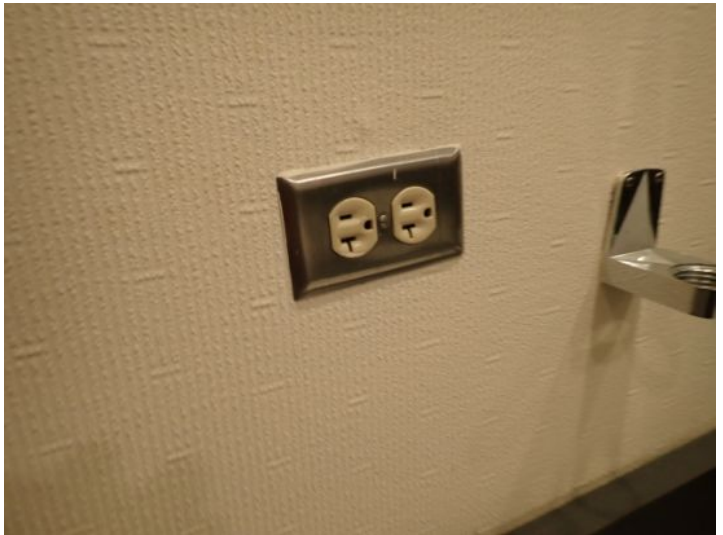
The main electrical panels were scanned with a thermal camera and no abnormalities were noted at the time of the inspection.

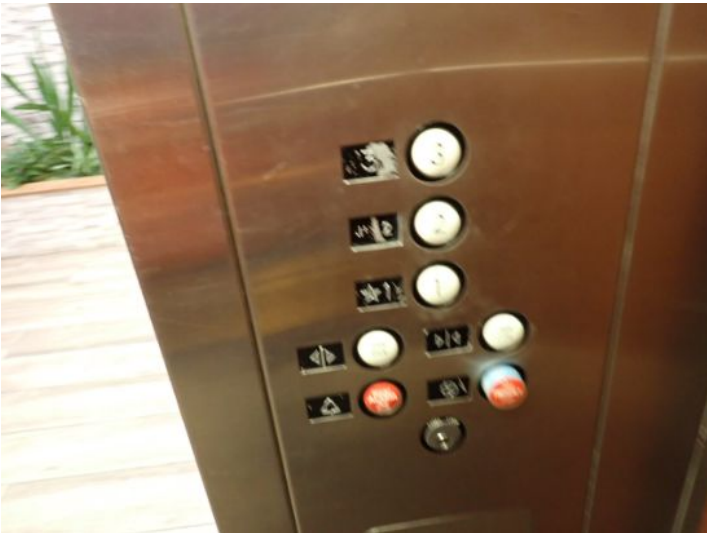
The elevator system was tested and appeared to function properly at the time of the inspection.

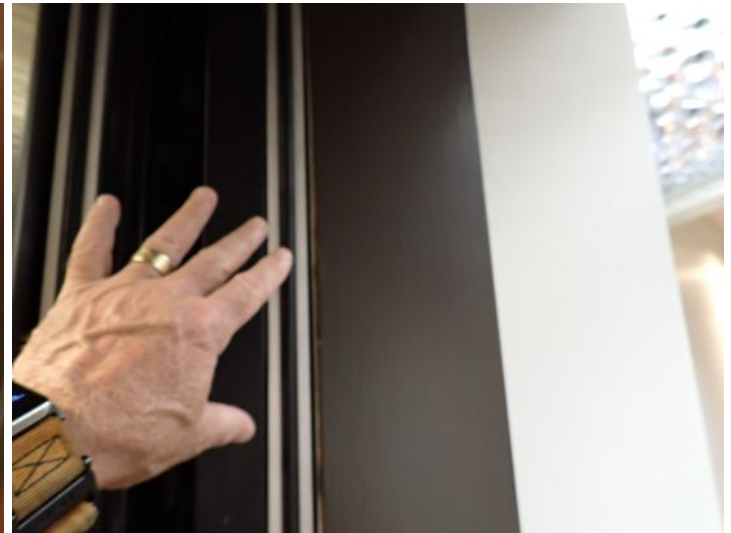
No floor markings noted on the individual floors at the elevator exit. Recommend repairs by a licensed contractor.

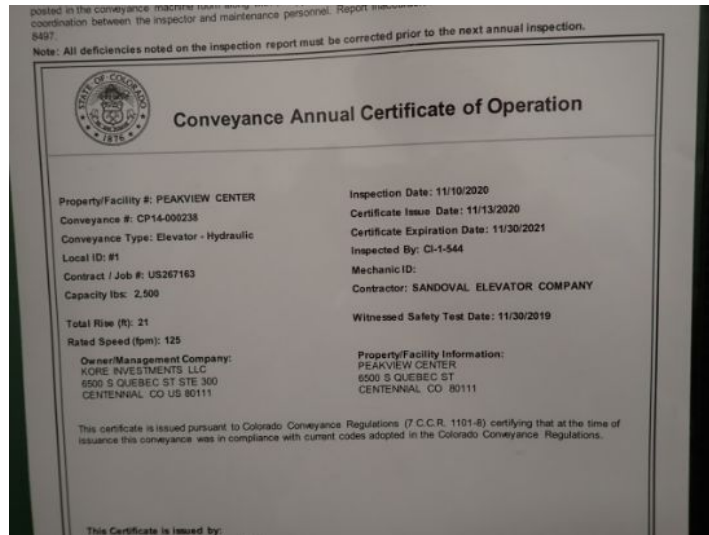
The elevator systems on site certificate shows the last date of inspection/certification was 11/20. Recommend assuring the system is current on all testing and certifications prior to taking possession of the property.

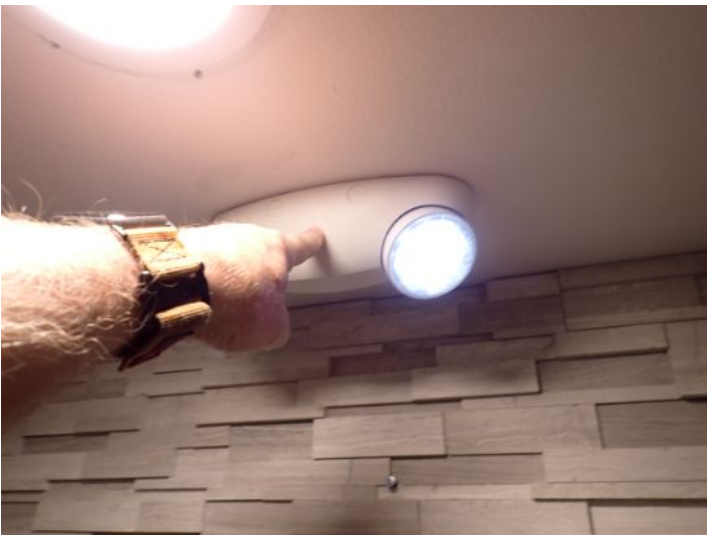
The emergency lighting was tested and functional at the time of the inspection.

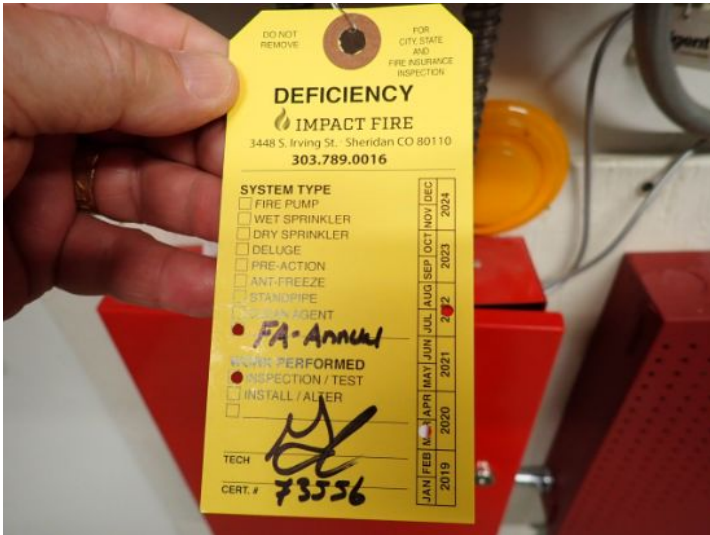
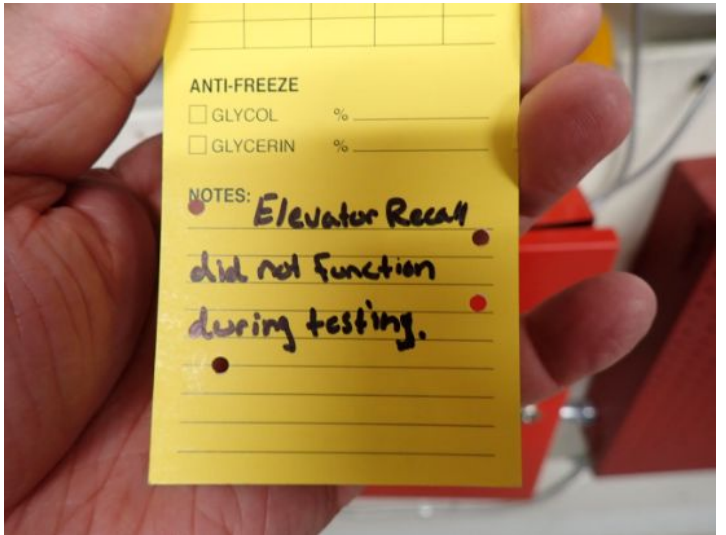
At the time of the inspection there was a Deficiency tag noted on the fire alarm panel. The deficiency appeared to be that the elevator recall function was not operating properly. Recommend assuring that the deficiency is repaired and the alarm systems testing has passed certification prior to taking possession of the property.

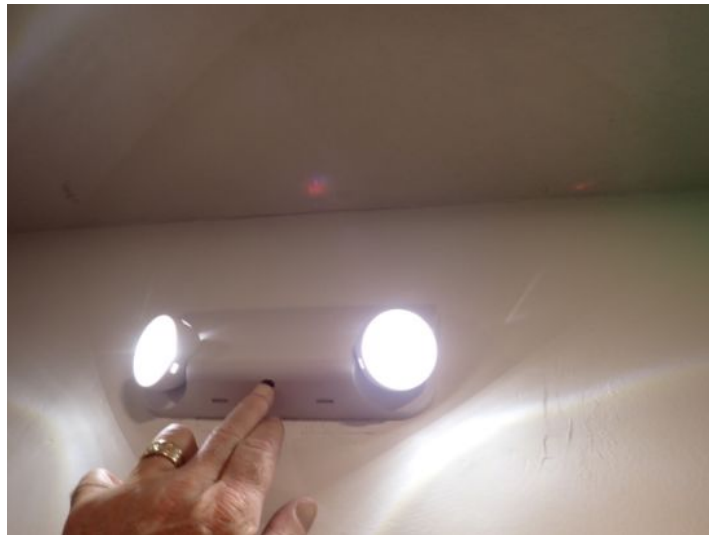
The emergency lighting was tested and functional at the time of the inspection.

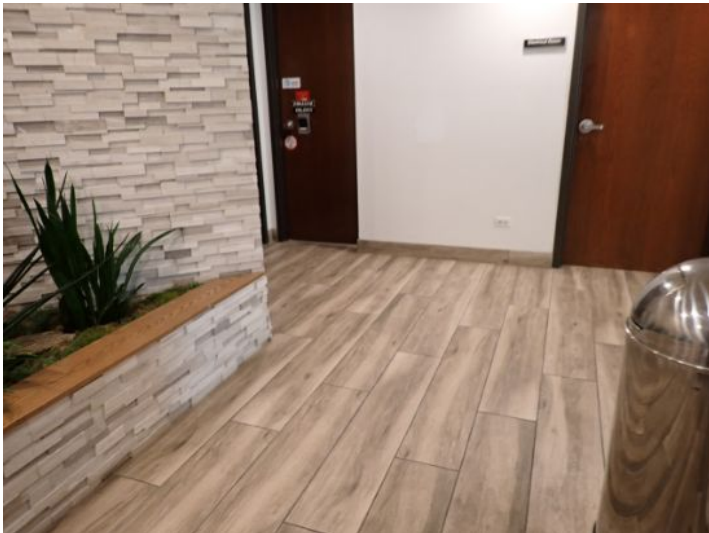
The majority of the common areas appeared to be in fair condition at the time of the inspection.

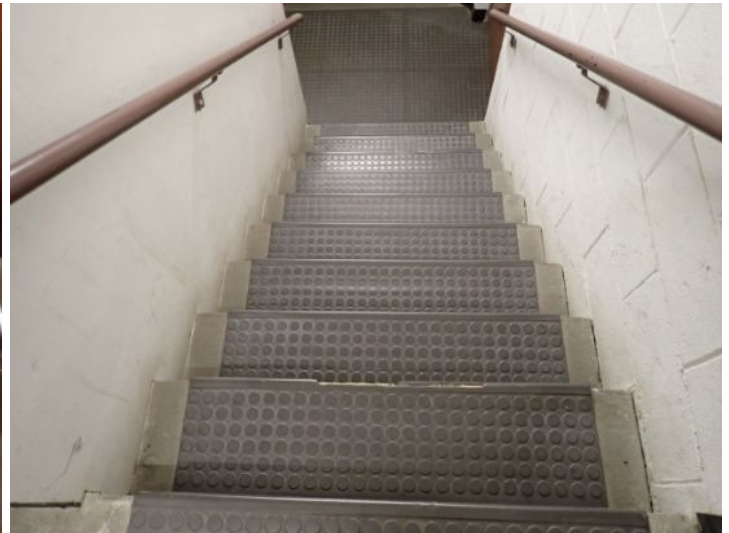
The majority of the common areas appeared to be in fair condition at the time of the inspection.

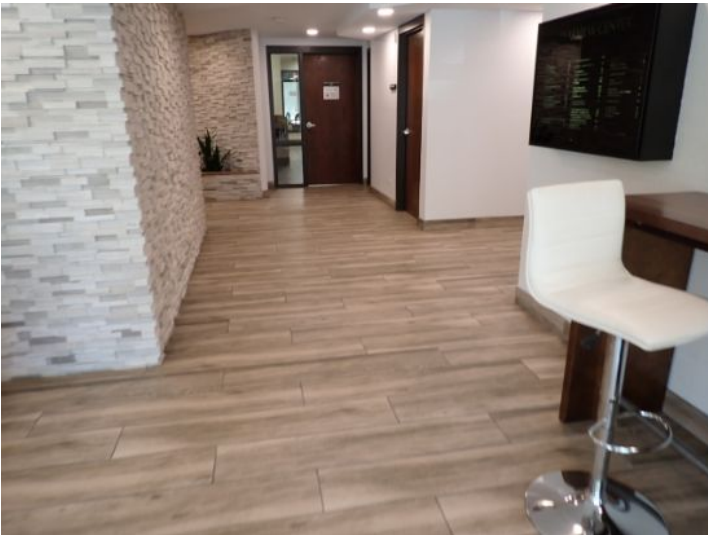
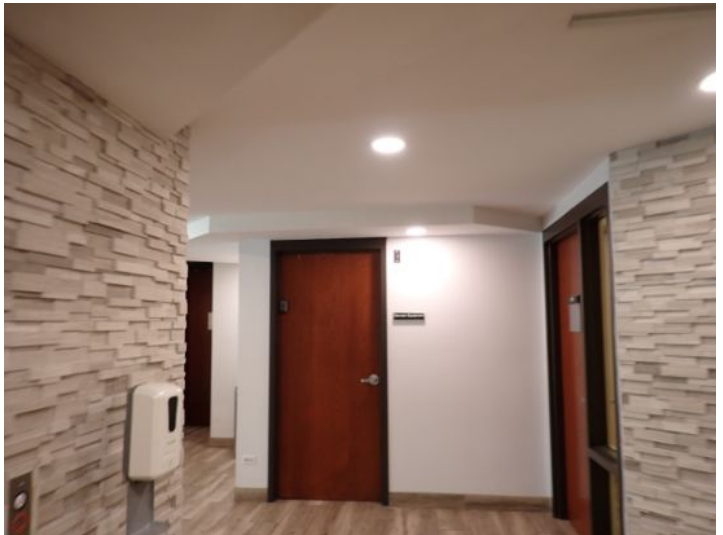
The majority of the common areas appeared to be in fair condition at the time of the inspection.

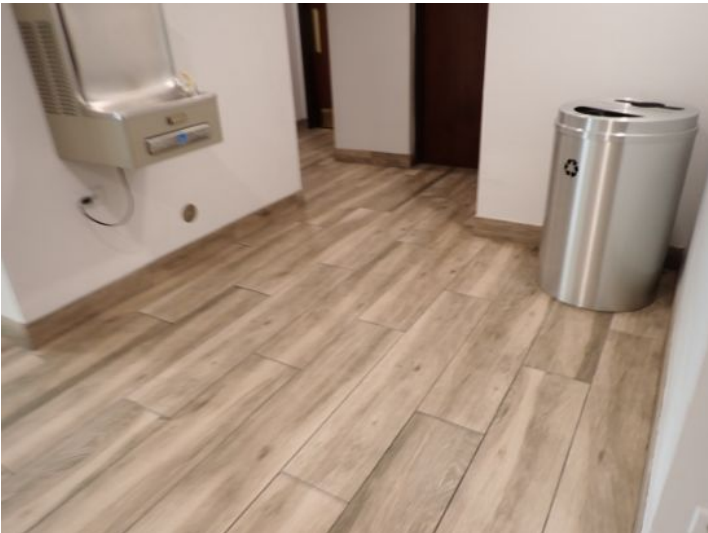
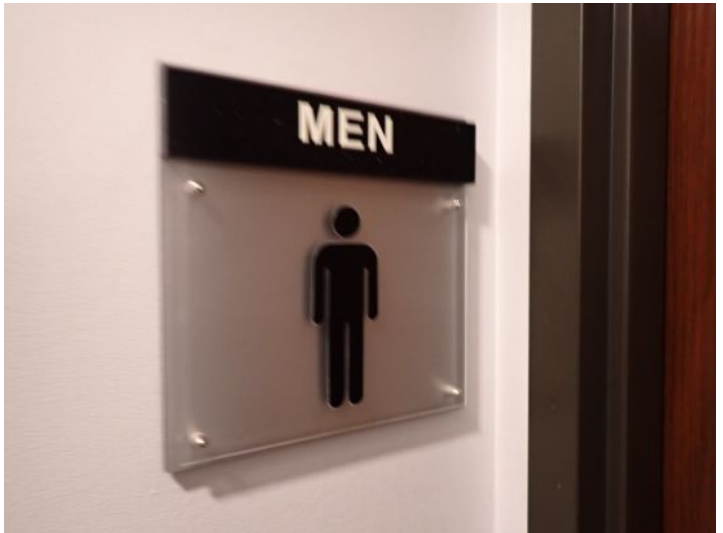
The majority of the common areas appeared to be in fair condition at the time of the inspection.

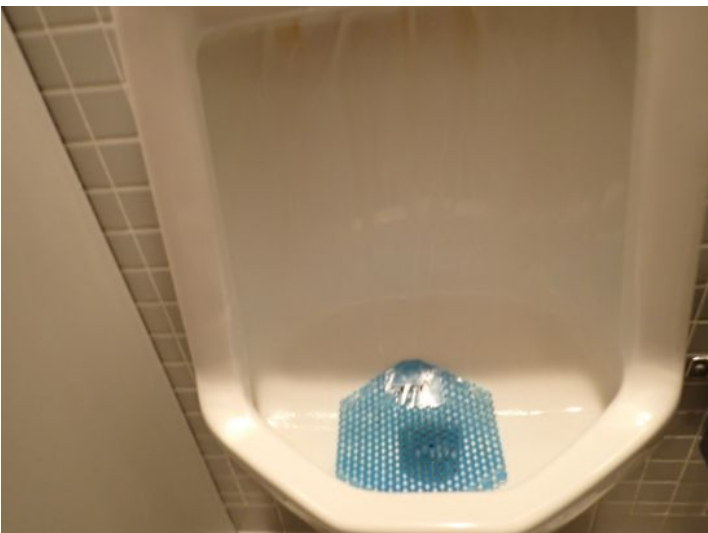
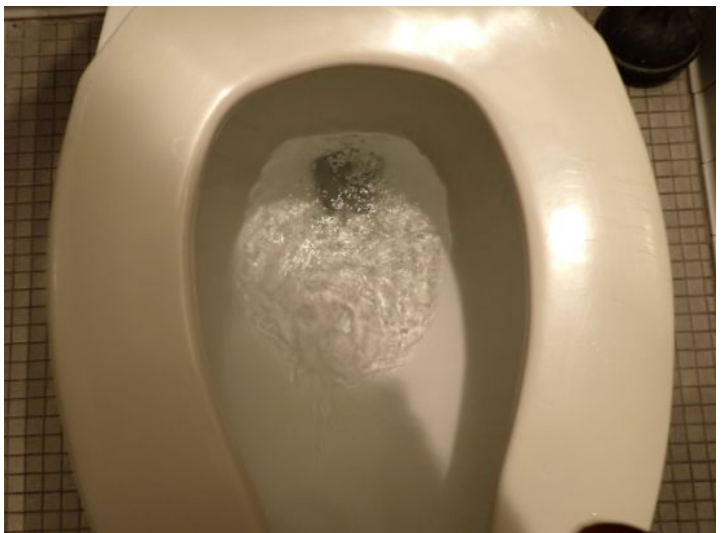
The common restrooms were tested and functional at the time of the inspection.

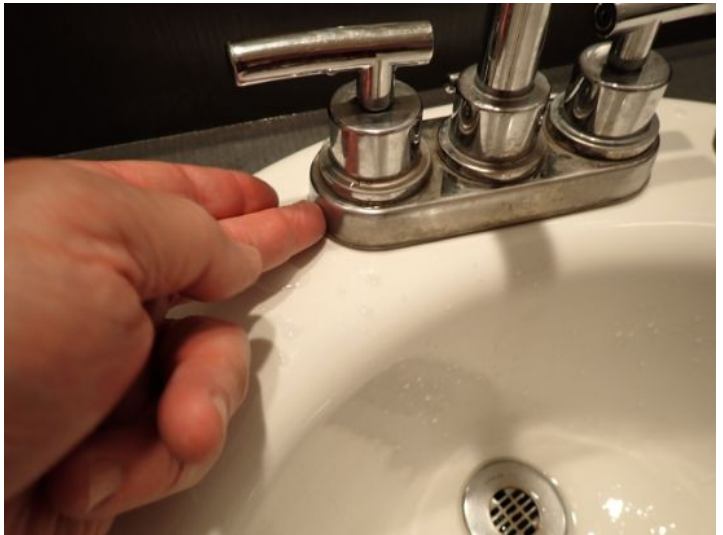
Loose sink faucet noted in the first floors lady's restroom. Recommend repairs.

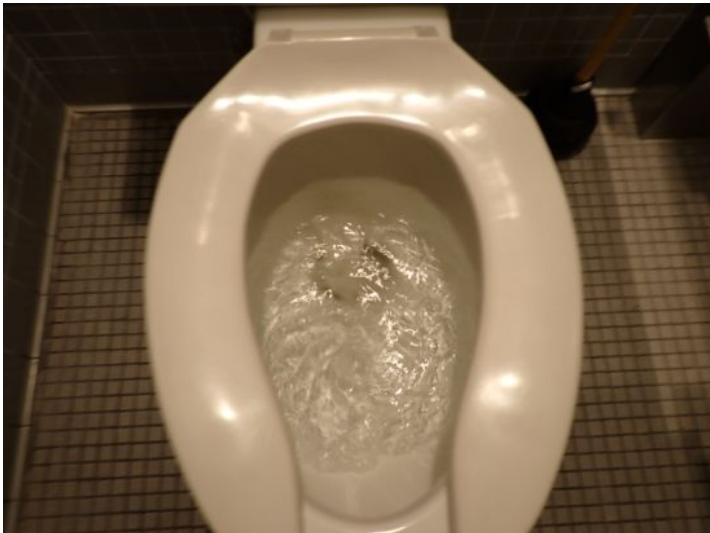
The common restrooms were tested and functional at the time of the inspection.

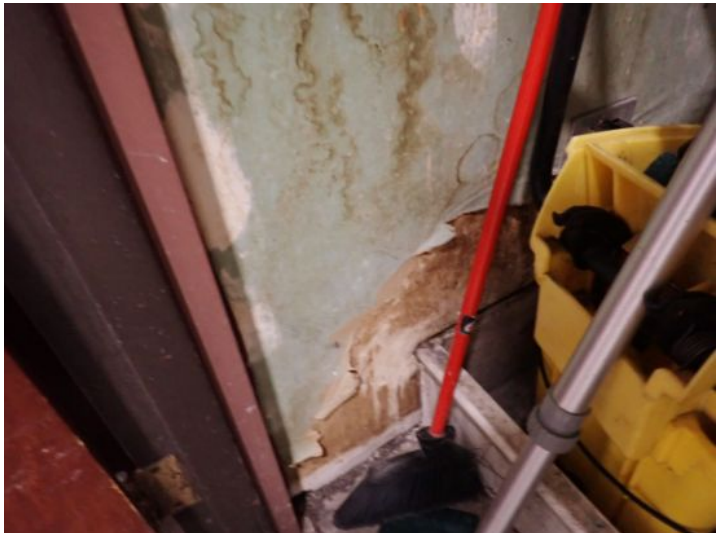
Drywall moisture damage noted in the mop closet on the main level. Recommend repairs by a licensed contractor.

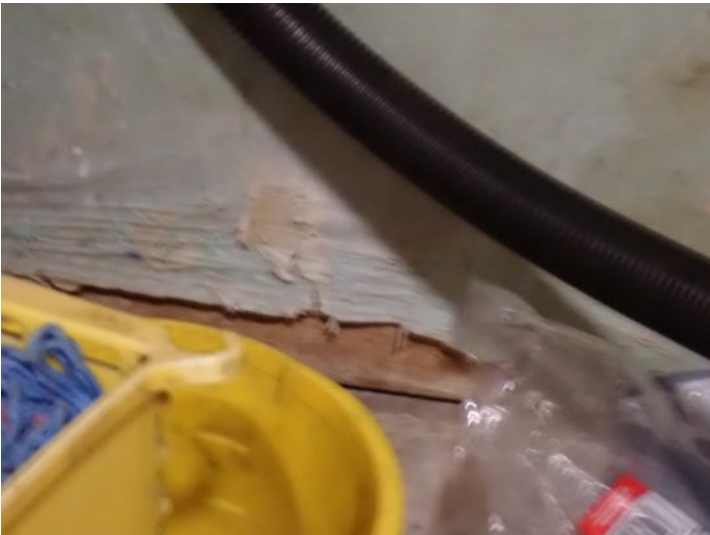
Drywall moisture damage noted in the mop closet on the main level. Recommend repairs by a licensed contractor.

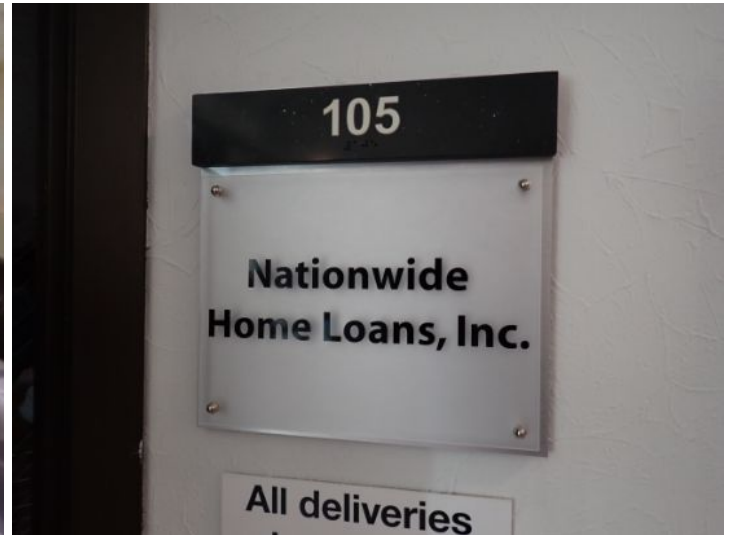
The majority of the interiors of the office suites appeared to be in fair condition at the time of the inspection.

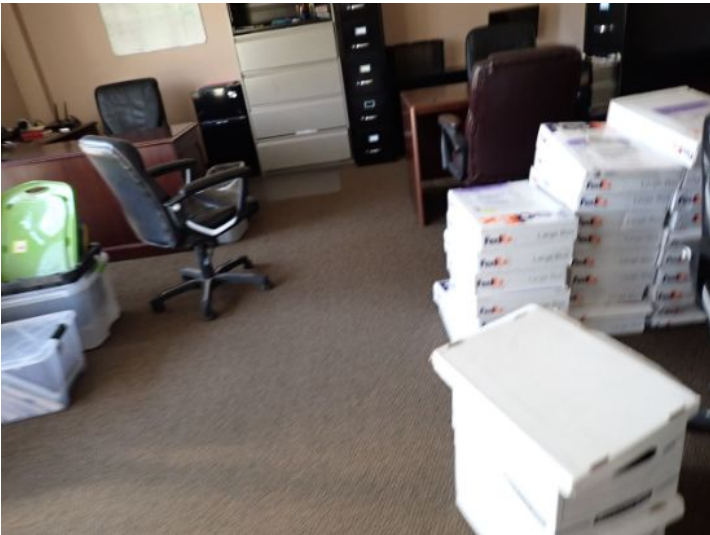
The majority of the interiors of the office suites appeared to be in fair condition at the time of the inspection.

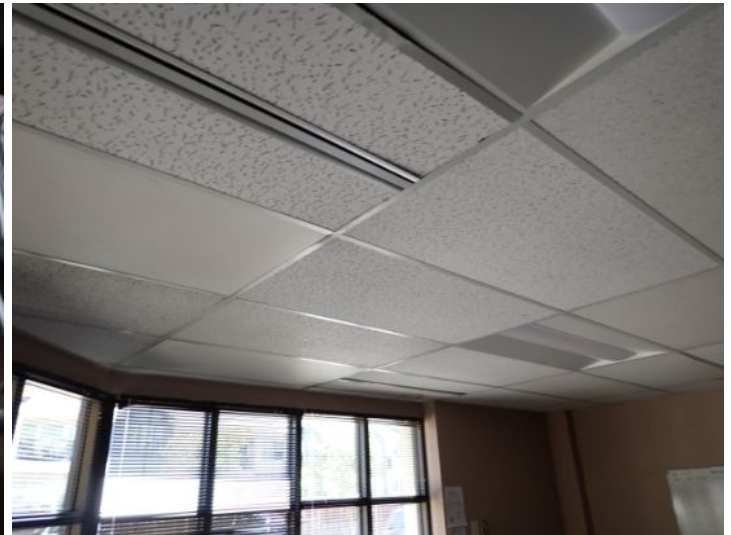
The majority of the interiors of the office suites appeared to be in fair condition at the time of the inspection.

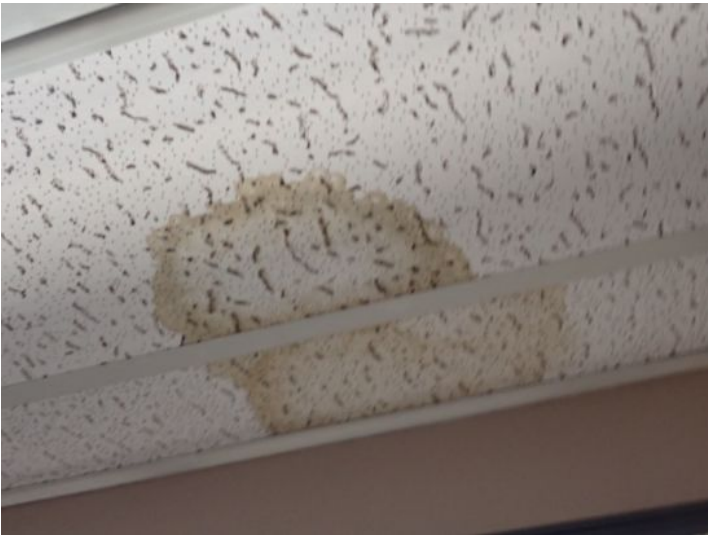
Active moisture intrusion noted in areas of one or more of the suites along the outside walls. Recommend having a licensed contractor properly weather proof all of the window systems prior to taking possession of the property.

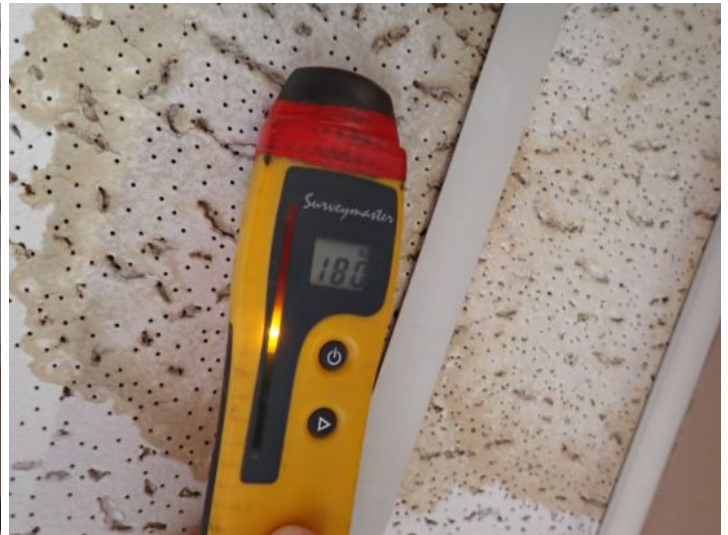
Active moisture intrusion noted in areas of one or more of the suites along the outside walls. Recommend having a licensed contractor properly weather proof all of the window systems prior to taking possession of the property.

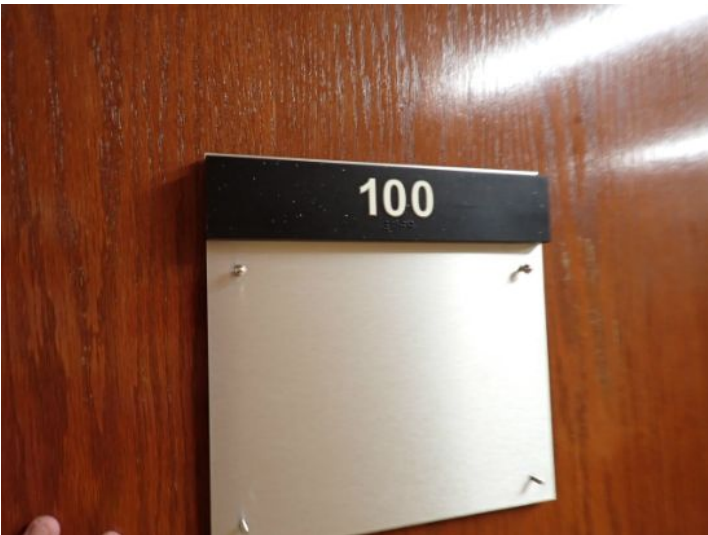
The majority of the interiors of the office suites appeared to be in fair condition at the time of the inspection.

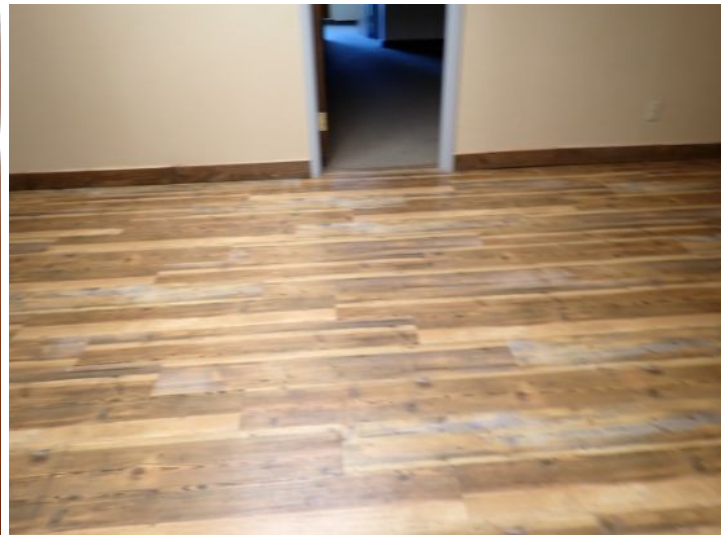
The majority of the interiors of the office suites appeared to be in fair condition at the time of the inspection.

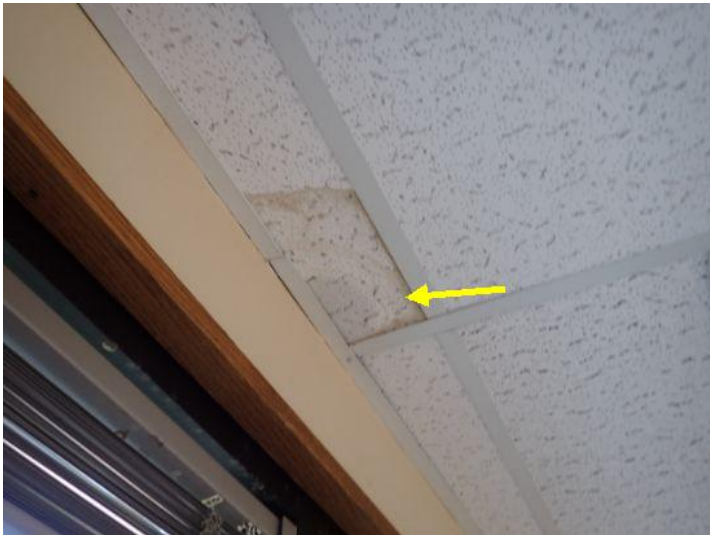
Active moisture intrusion noted in areas of one or more of the suites along the outside walls. Recommend having a licensed contractor properly weather proof all of the window systems prior to taking possession of the property.

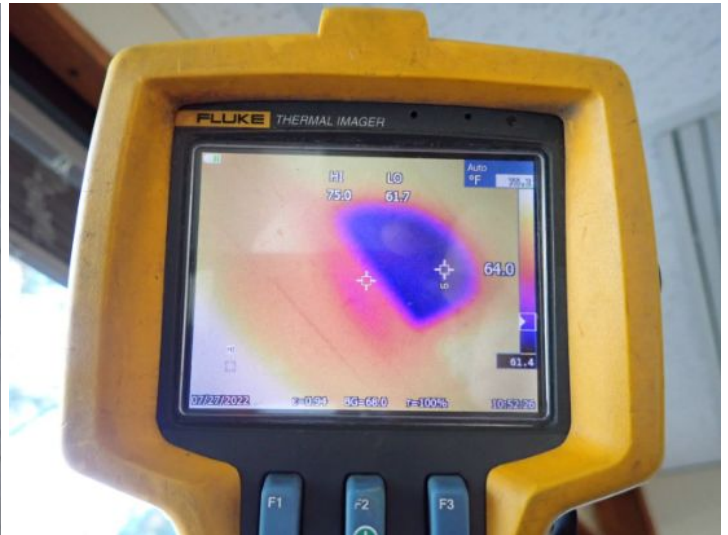
Active moisture intrusion noted in areas of one or more of the suites along the outside walls. Recommend having a licensed contractor properly weather proof all of the window systems prior to taking possession of the property.

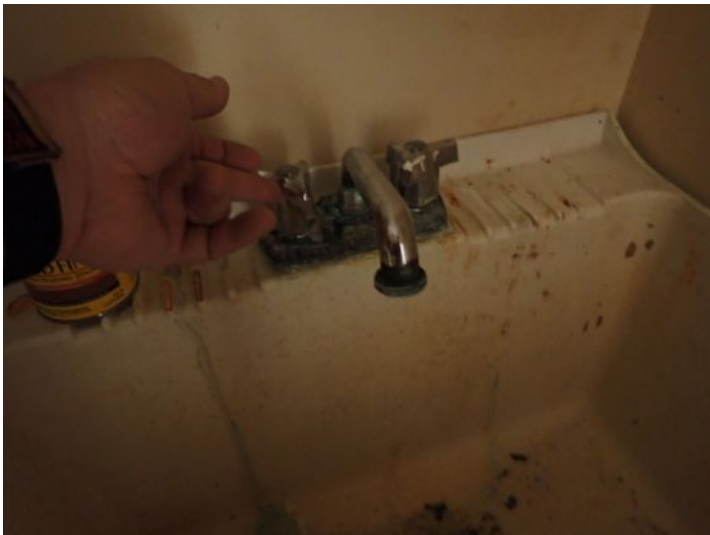
Suite 100: Drywall cracking noted in areas. Sink did not have hot water at the time of the inspection. Recommend repairs.

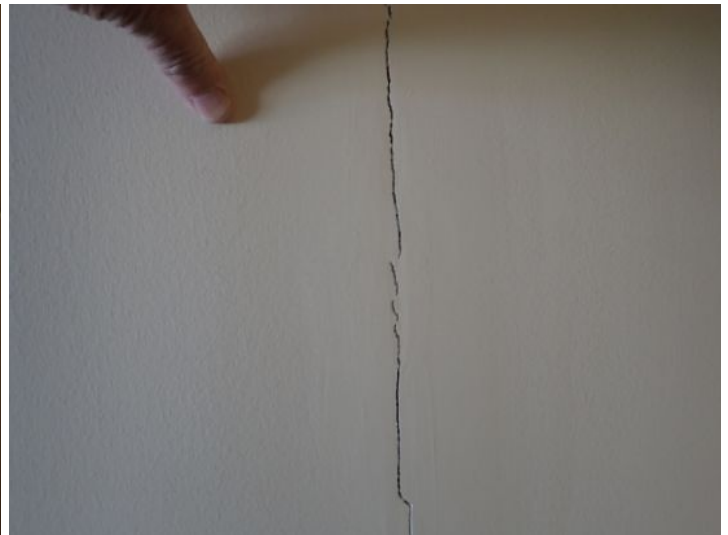
Suite 100: Drywall cracking noted in areas. Sink did not have hot water at the time of the inspection. Recommend repairs.

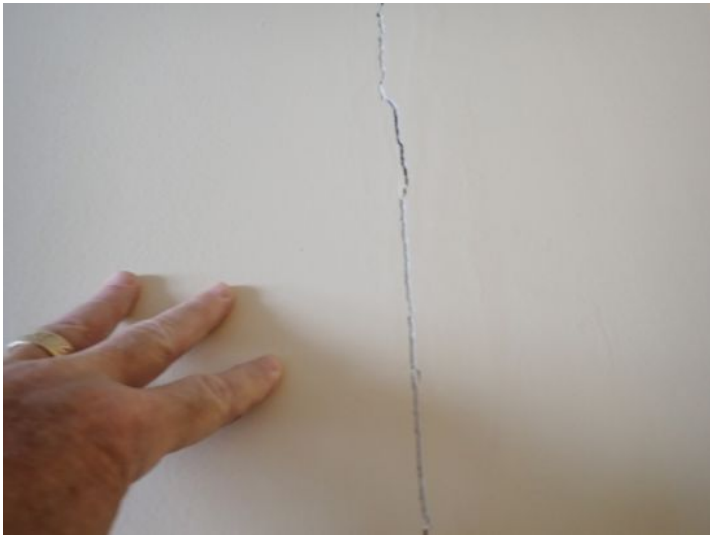
Suite 100: Drywall cracking noted in areas. Sink did not have hot water at the time of the inspection. Recommend repairs.

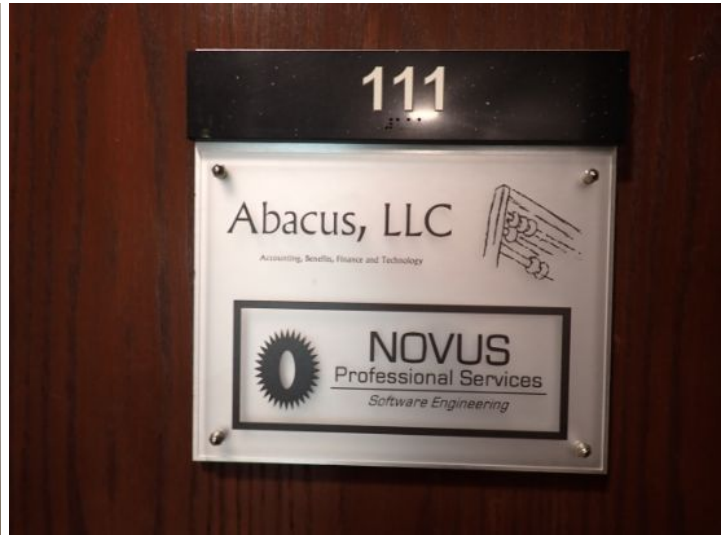
The majority of the interiors of the office suites appeared to be in fair condition at the time of the inspection.

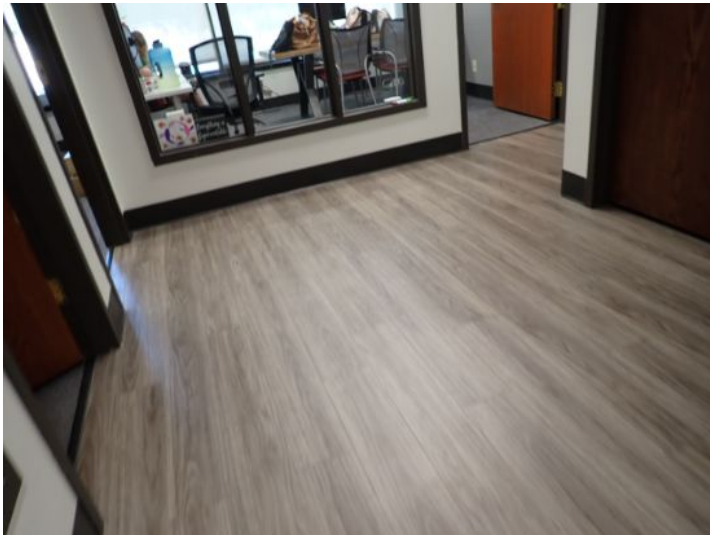
The majority of the interiors of the office suites appeared to be in fair condition at the time of the inspection.

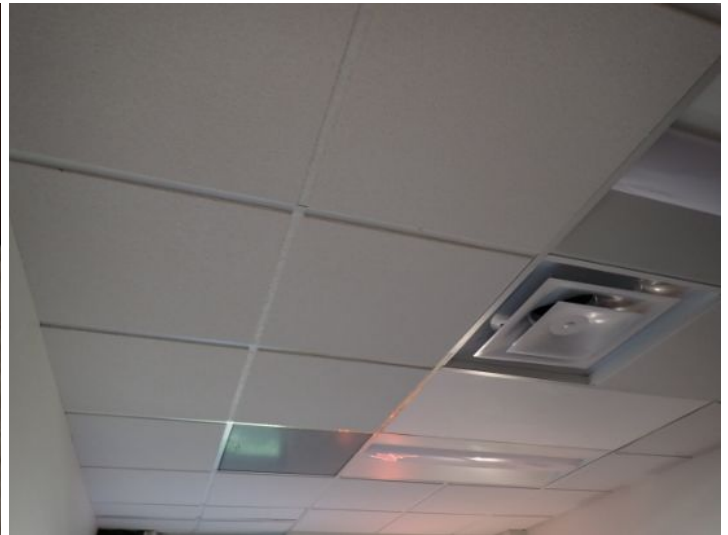
The majority of the interiors of the office suites appeared to be in fair condition at the time of the inspection.

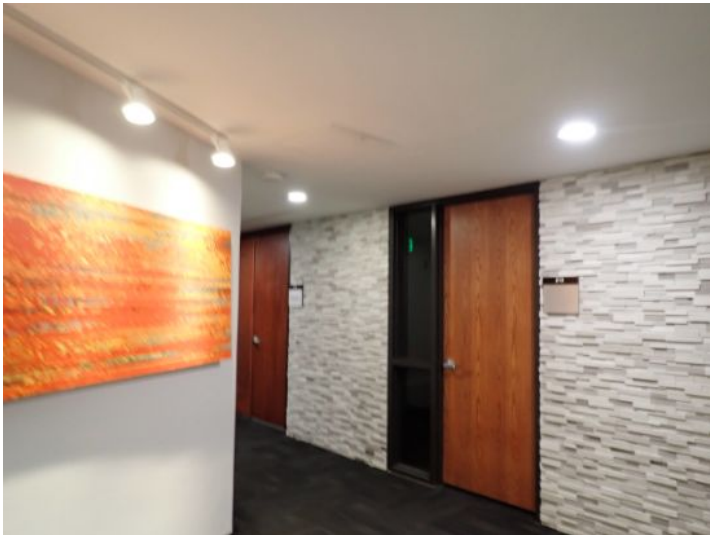
The majority of the common areas appeared to be in fair condition at the time of the inspection.
