# *Forman Inspection Services, LLC*

## Property Inspection Report

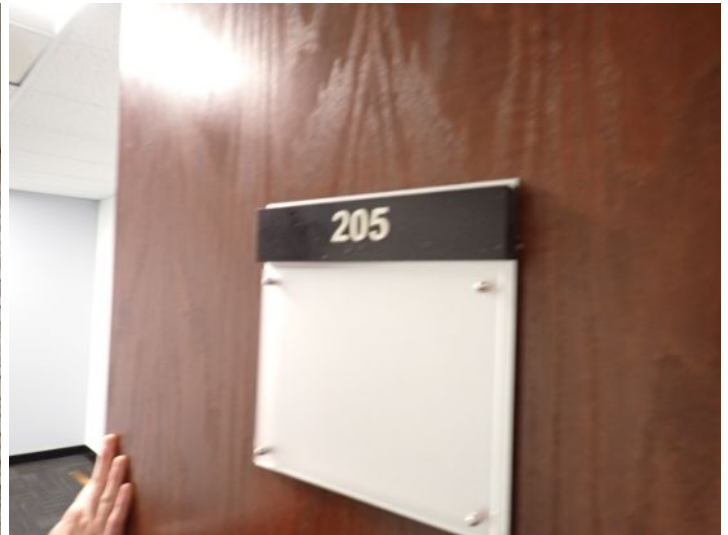
The majority of the interiors of the office suites appeared to be in fair condition at the time of the inspection.

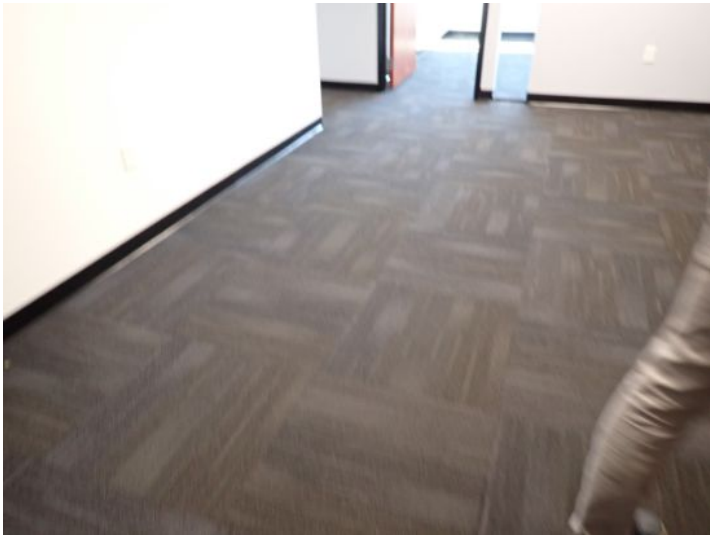
The majority of the interiors of the office suites appeared to be in fair condition at the time of the inspection.

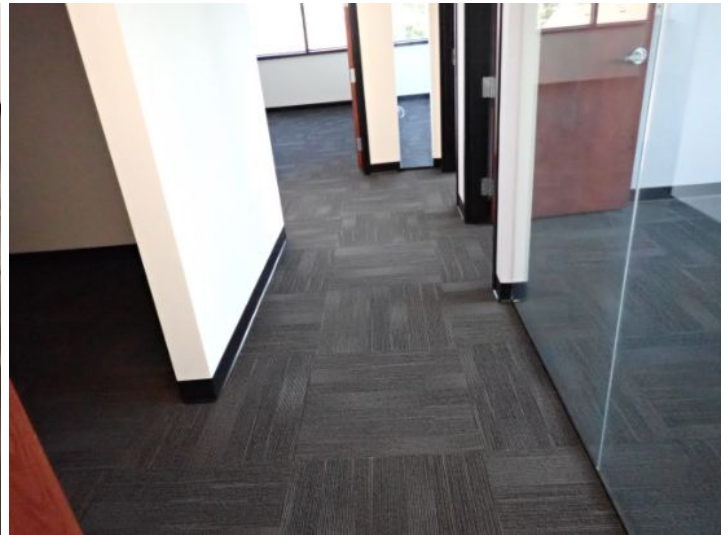
The majority of the interiors of the office suites appeared to be in fair condition at the time of the inspection.

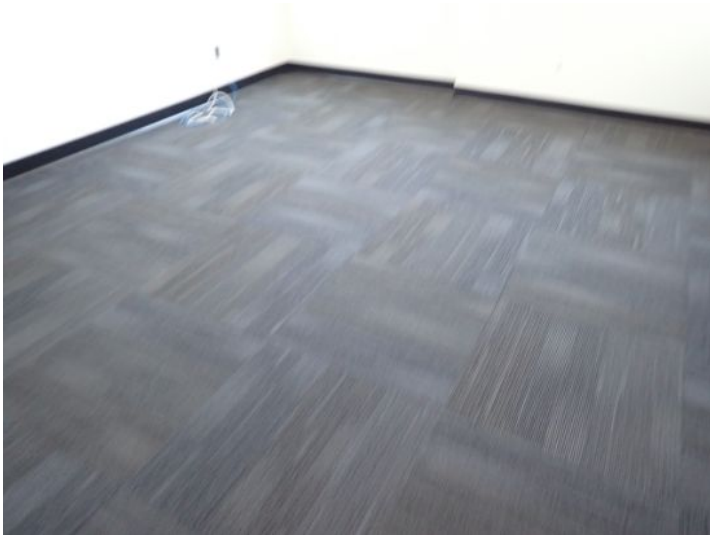
The majority of the interiors of the office suites appeared to be in fair condition at the time of the inspection.

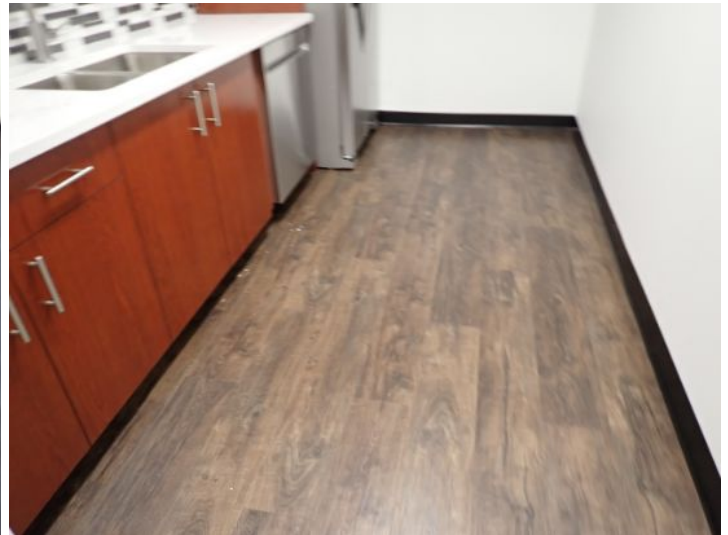
The majority of the interiors of the office suites appeared to be in fair condition at the time of the inspection.

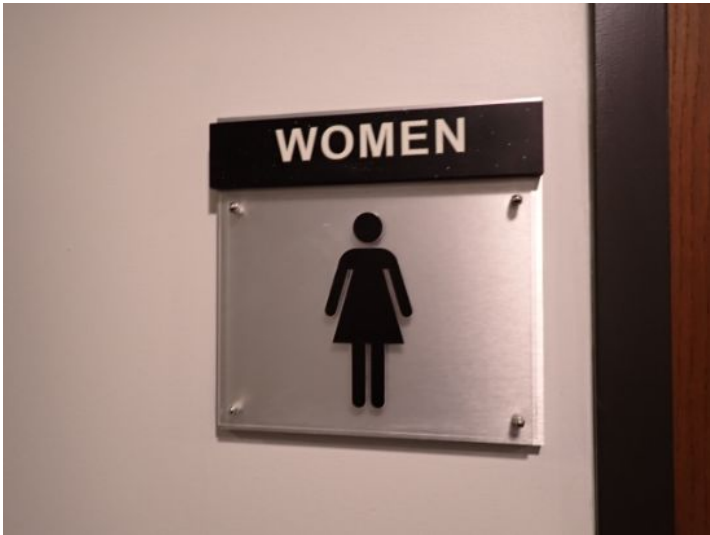
The common restrooms were tested and functional at the time of the inspection.

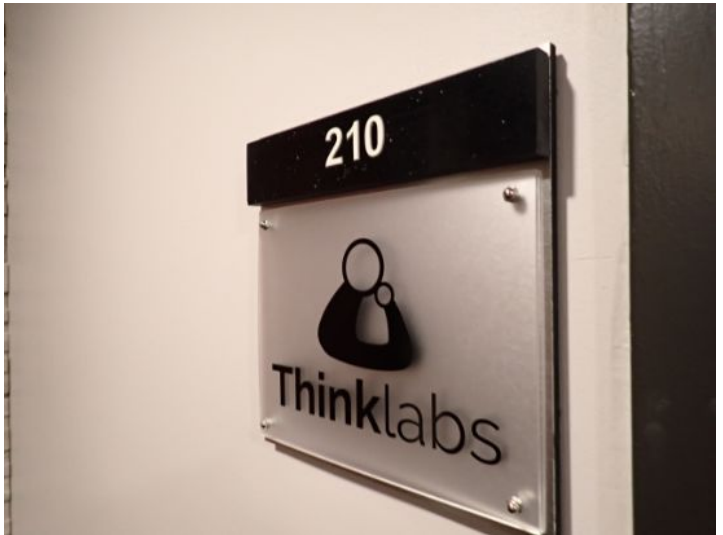
The majority of the interiors of the office suites appeared to be in fair condition at the time of the inspection.

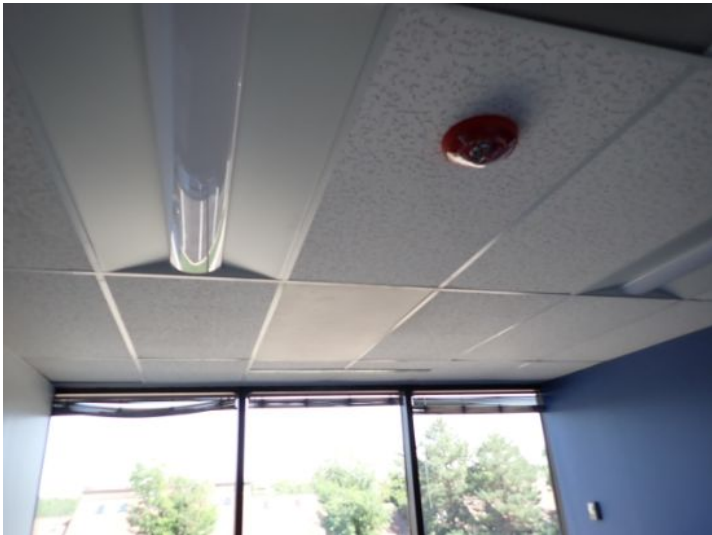
The majority of the interiors of the office suites appeared to be in fair condition at the time of the inspection.

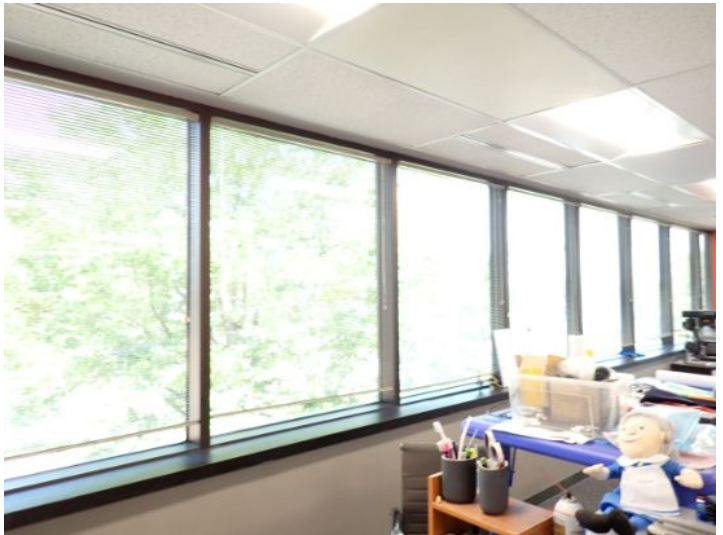
The majority of the interiors of the office suites appeared to be in fair condition at the time of the inspection.

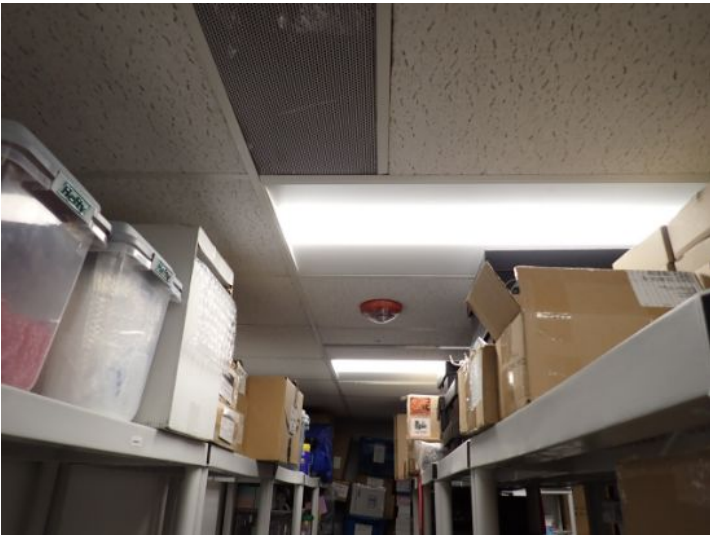
The majority of the interiors of the office suites appeared to be in fair condition at the time of the inspection.

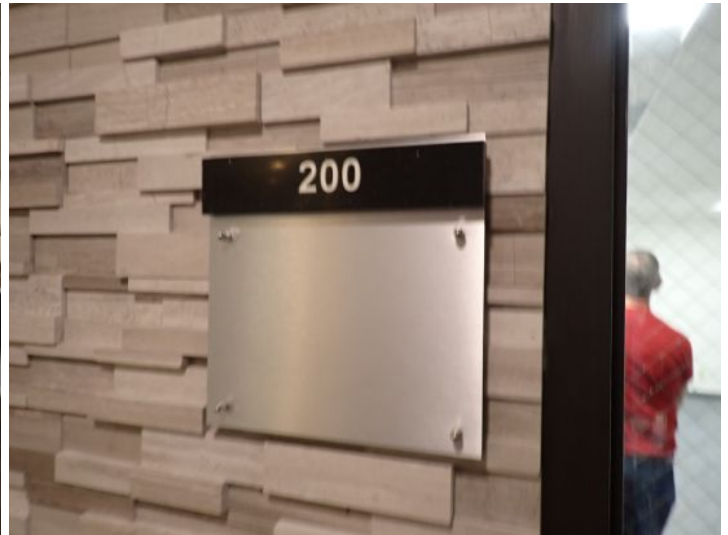
The majority of the interiors of the office suites appeared to be in fair condition at the time of the inspection.

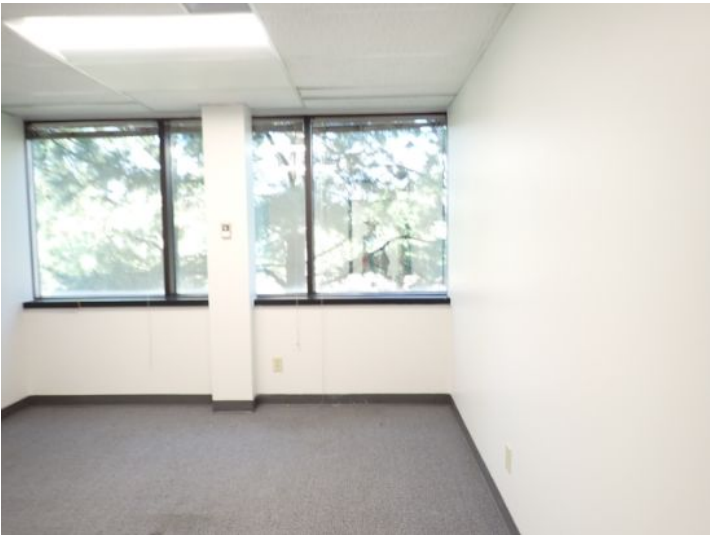
The majority of the interiors of the office suites appeared to be in fair condition at the time of the inspection.

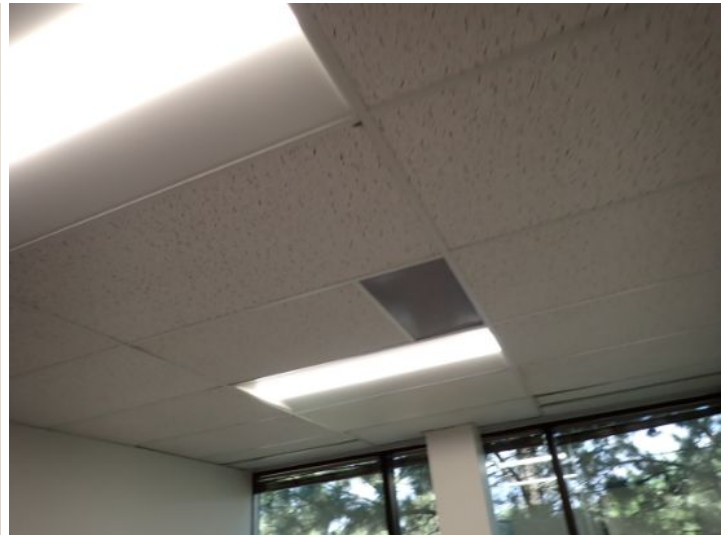
The majority of the interiors of the office suites appeared to be in fair condition at the time of the inspection.

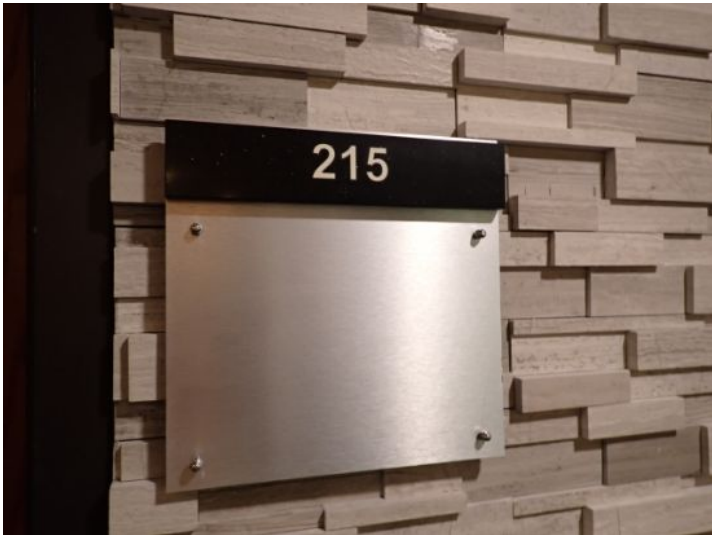
The majority of the interiors of the office suites appeared to be in fair condition at the time of the inspection.

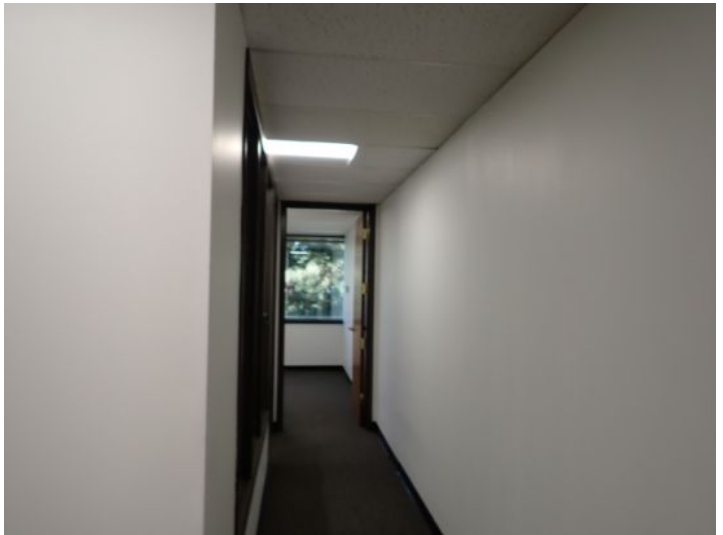
The majority of the interiors of the office suites appeared to be in fair condition at the time of the inspection.

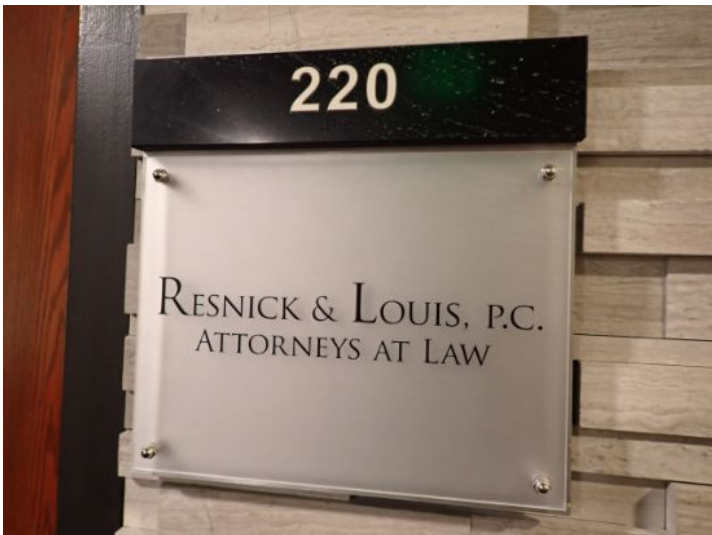
The majority of the interiors of the office suites appeared to be in fair condition at the time of the inspection.

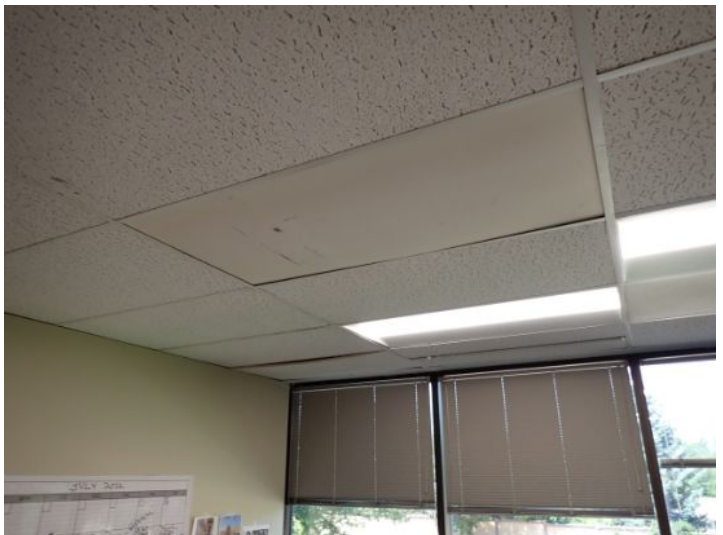
The majority of the interiors of the office suites appeared to be in fair condition at the time of the inspection.

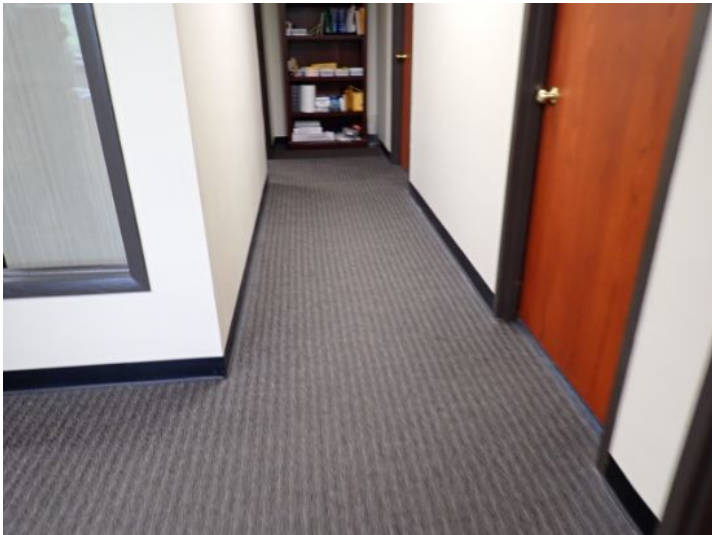
The majority of the interiors of the office suites appeared to be in fair condition at the time of the inspection.

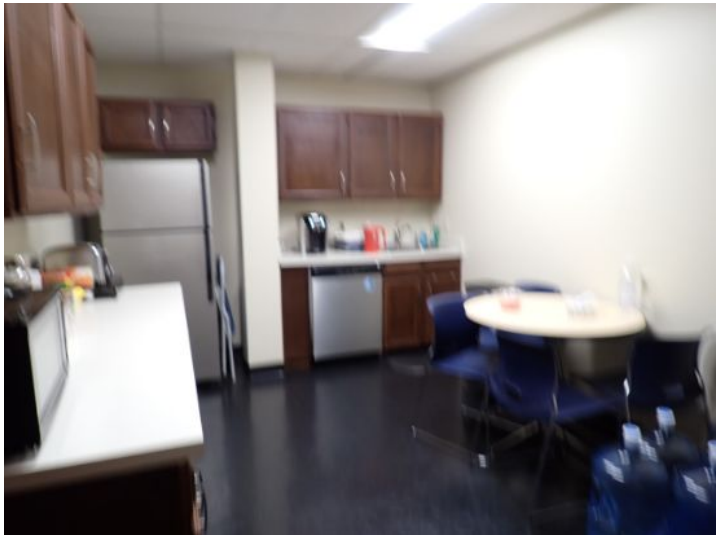
The majority of the interiors of the office suites appeared to be in fair condition at the time of the inspection.

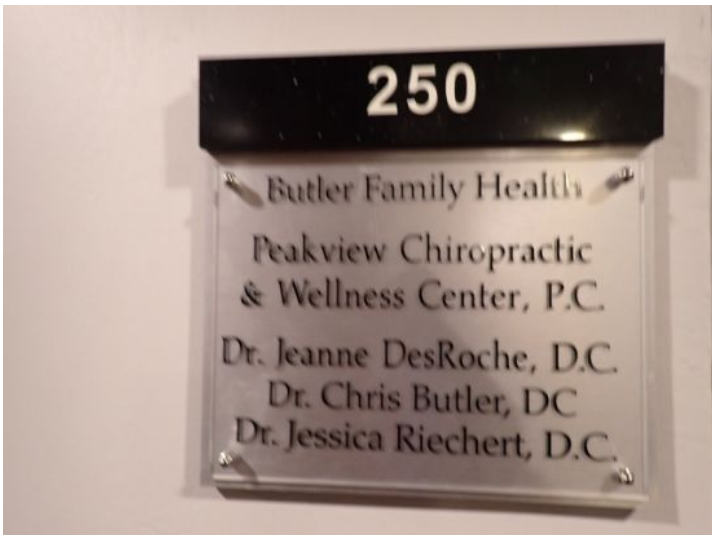
The majority of the interiors of the office suites appeared to be in fair condition at the time of the inspection.

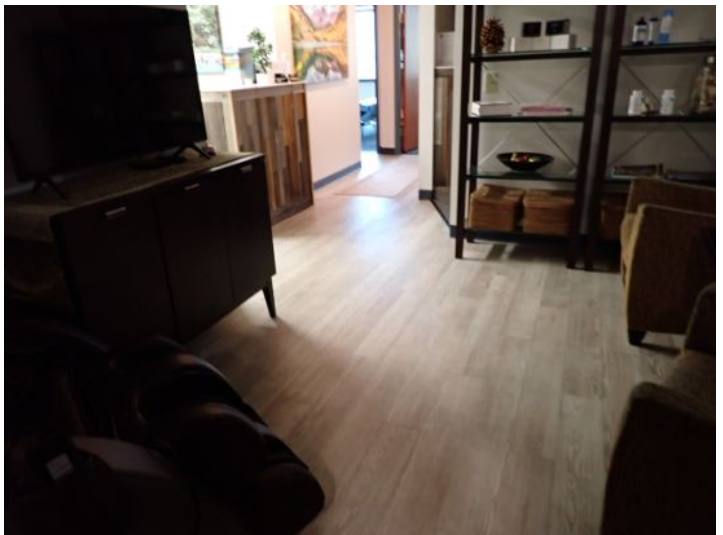
The majority of the interiors of the office suites appeared to be in fair condition at the time of the inspection.

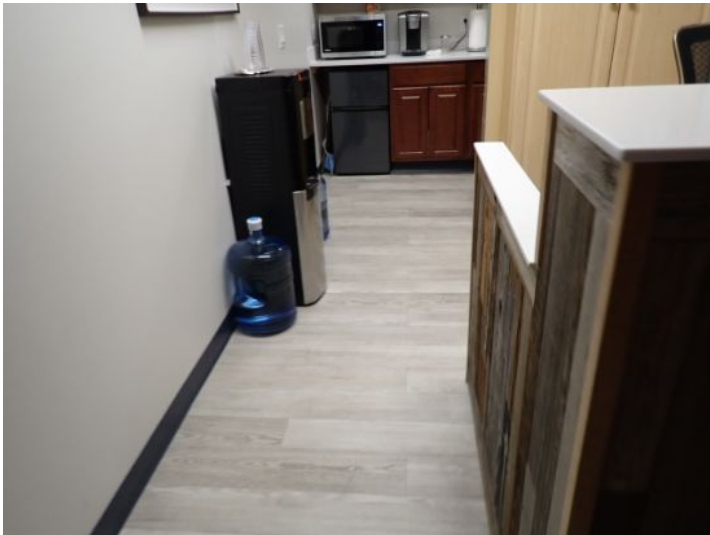
The majority of the interiors of the office suites appeared to be in fair condition at the time of the inspection.

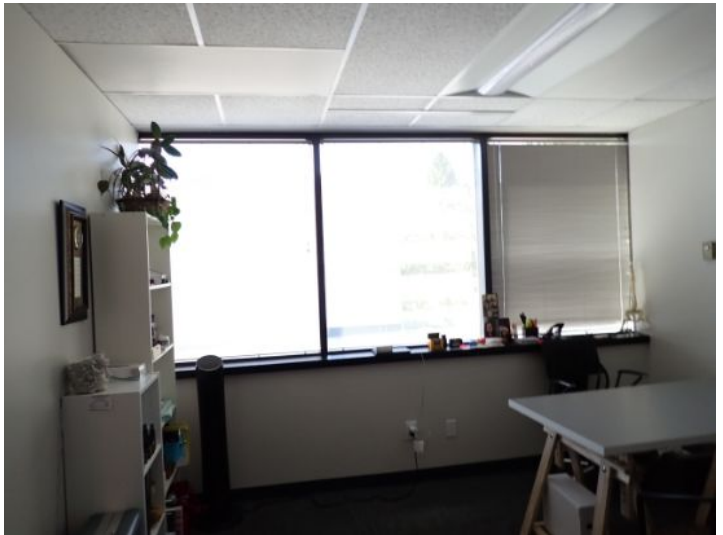
The majority of the interiors of the office suites appeared to be in fair condition at the time of the inspection.

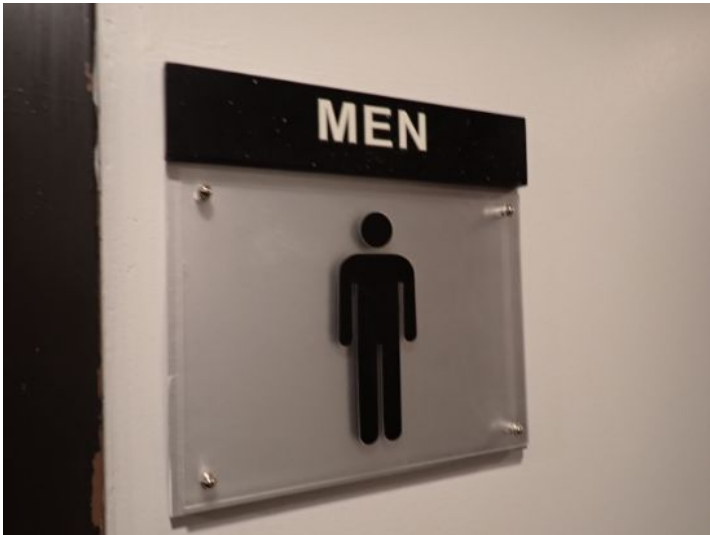
The common restrooms were tested and functional at the time of the inspection.

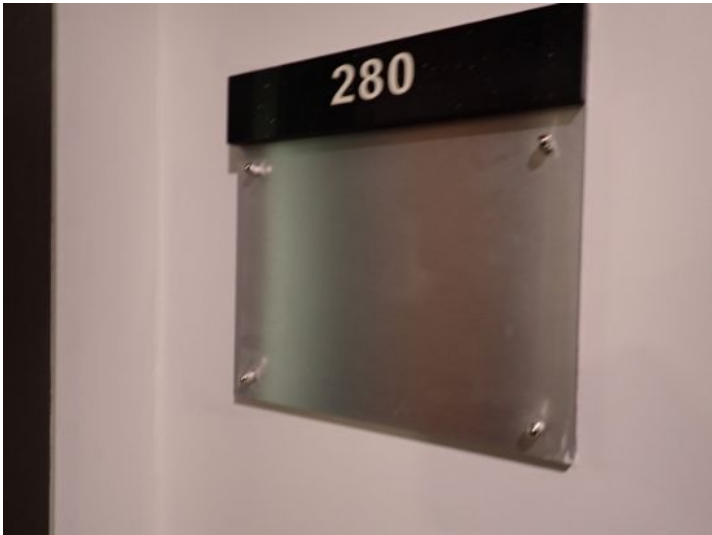
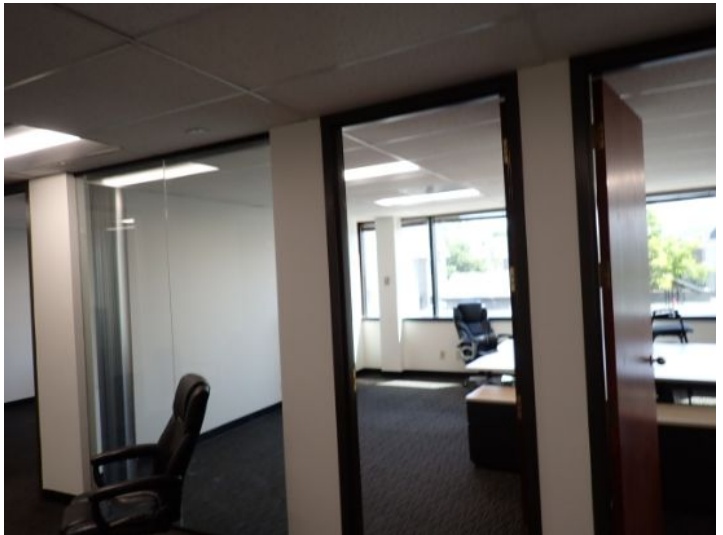
Suite 280: Moisture damage noted below break area sink. Sub standard plumbing noted below break area sink. No GFCI protection at break area sink. Recommend repairs.

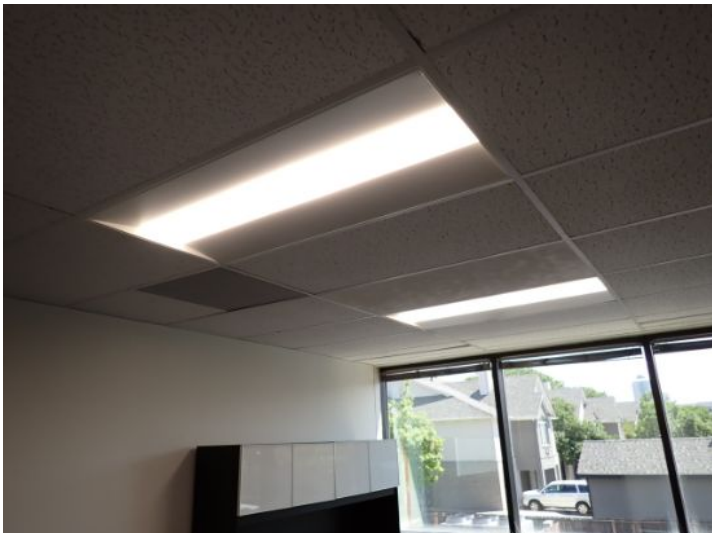
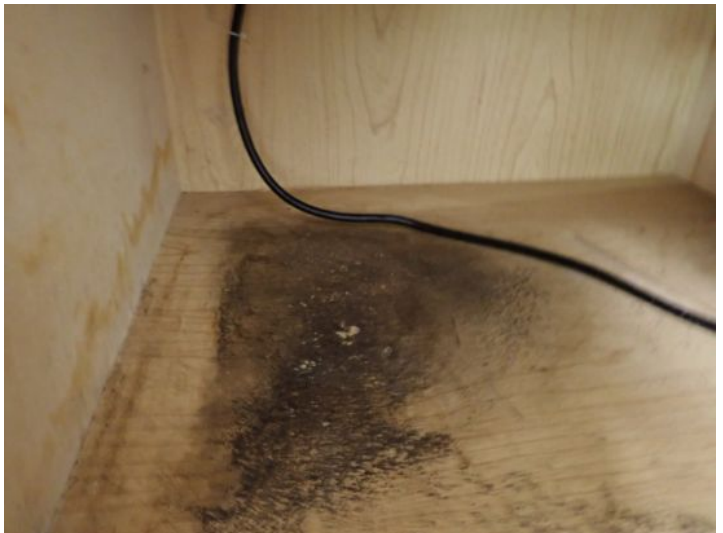
The majority of the interiors of the office suites appeared to be in fair condition at the time of the inspection.

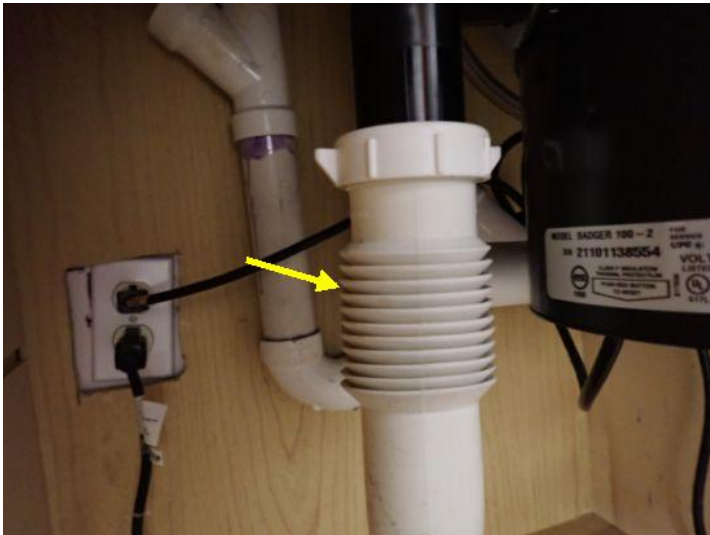
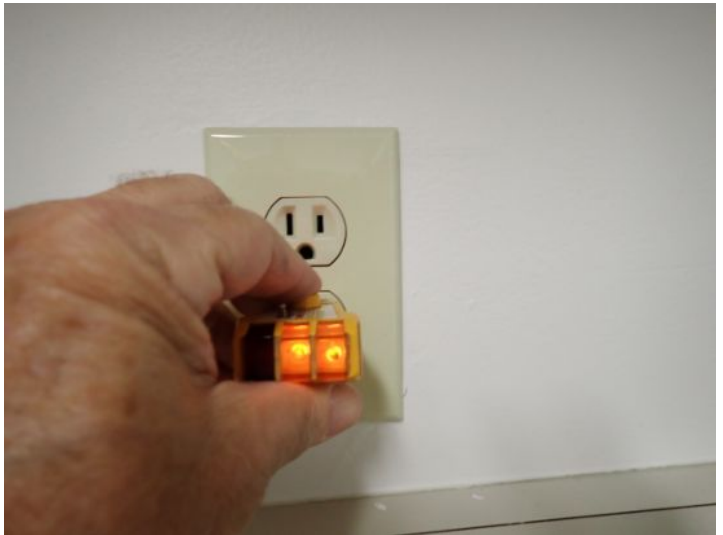
Suite 280: Moisture damage noted below break area sink. Sub standard plumbing noted below break area sink. No GFCI protection at break area sink. Recommend repairs.

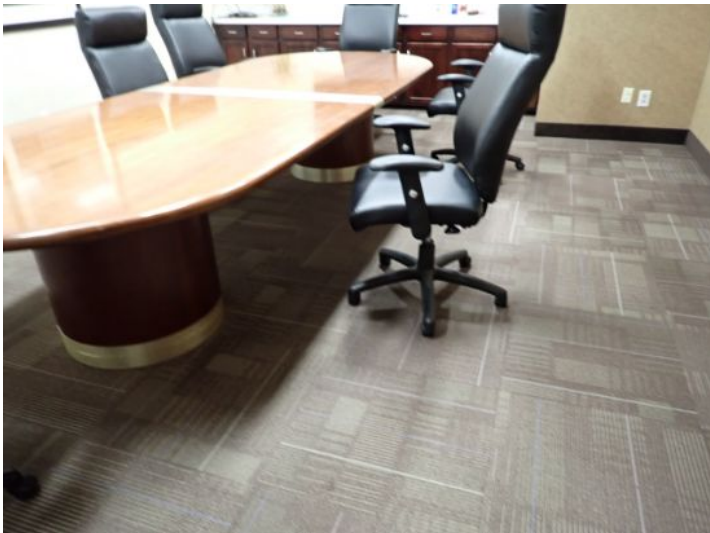
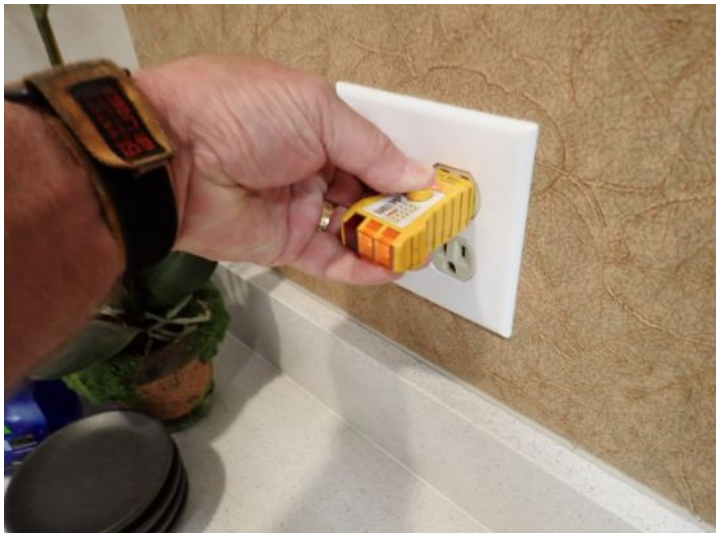
Conference Room (3rd Floor): No GFCI protection noted next to sink. Sub standard plumbing noted below sink. Recommend repairs.

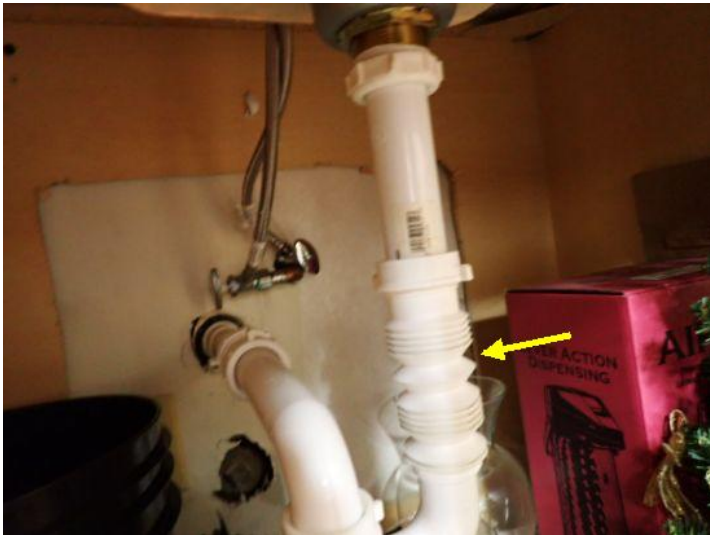
Conference Room (3rd Floor): No GFCI protection noted next to sink. Sub standard plumbing noted below sink. Recommend repairs.

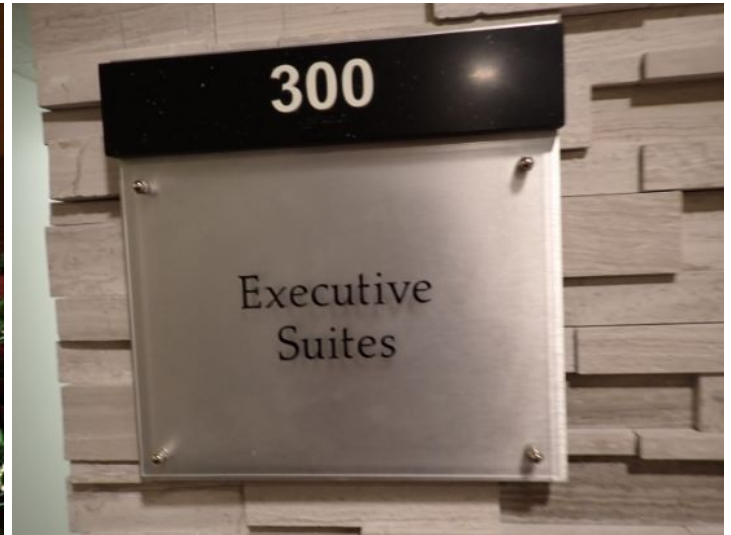
The majority of the interiors of the office suites appeared to be in fair condition at the time of the inspection.

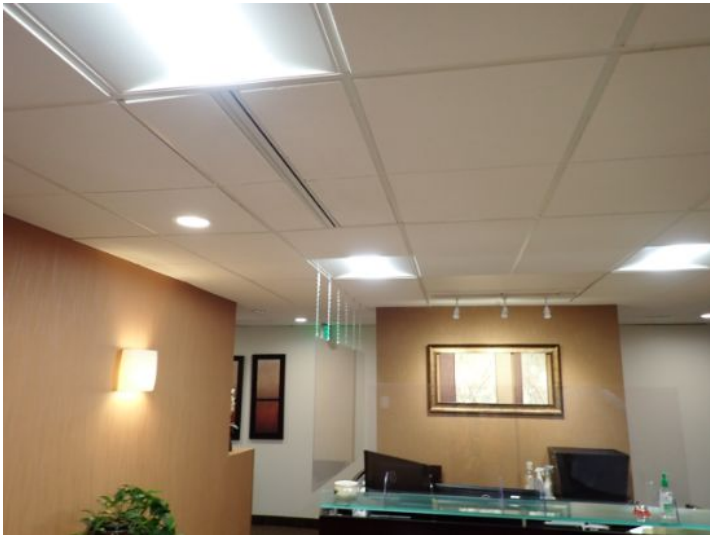
The majority of the interiors of the office suites appeared to be in fair condition at the time of the inspection.

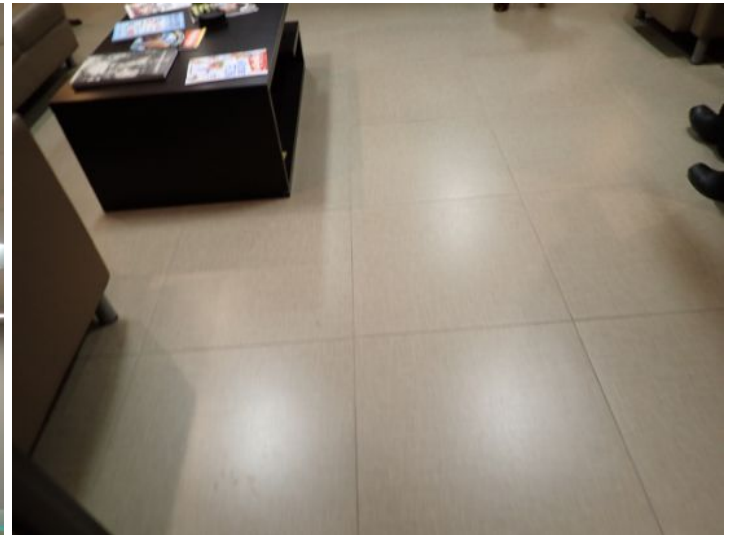
The majority of the interiors of the office suites appeared to be in fair condition at the time of the inspection.

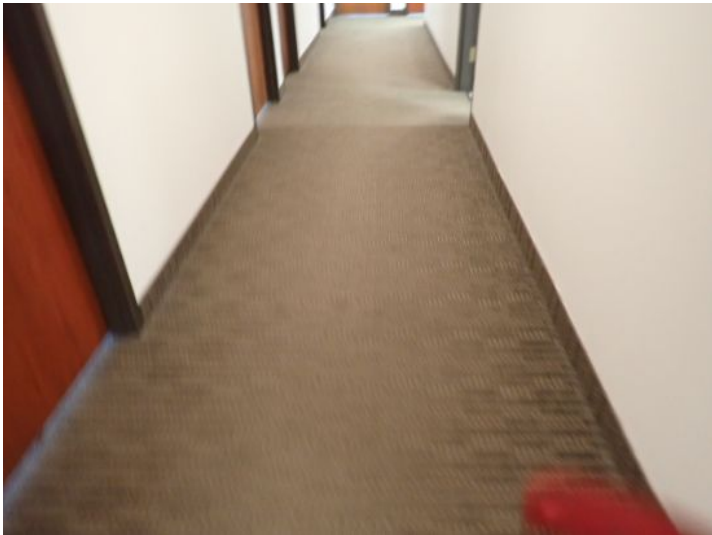
The majority of the interiors of the office suites appeared to be in fair condition at the time of the inspection.

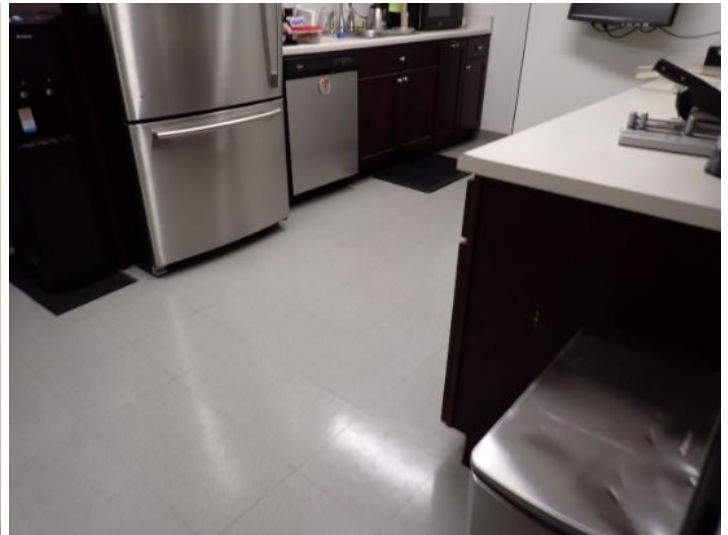
The majority of the interiors of the office suites appeared to be in fair condition at the time of the inspection.

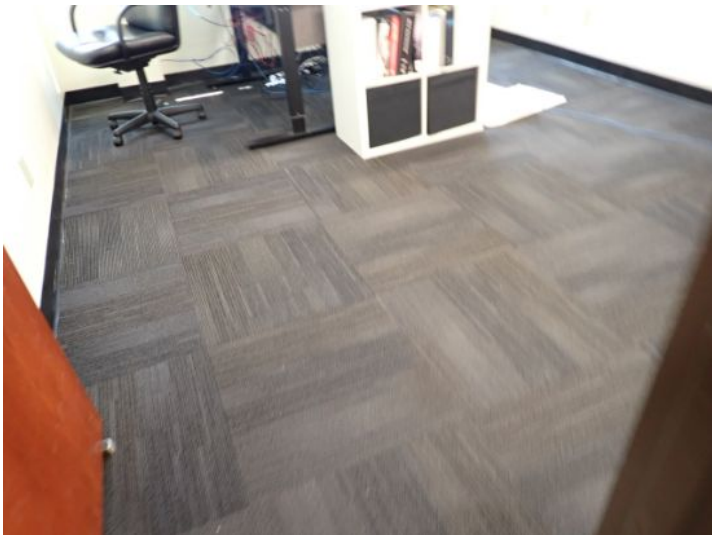
The majority of the interiors of the office suites appeared to be in fair condition at the time of the inspection.

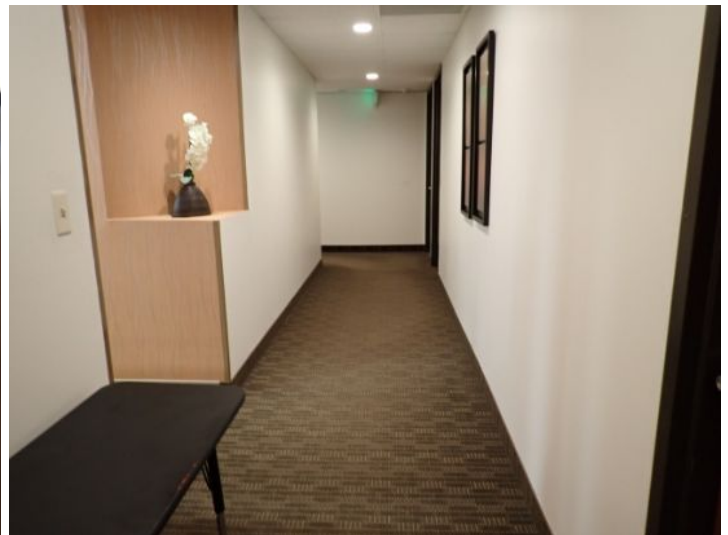
The majority of the interiors of the office suites appeared to be in fair condition at the time of the inspection.

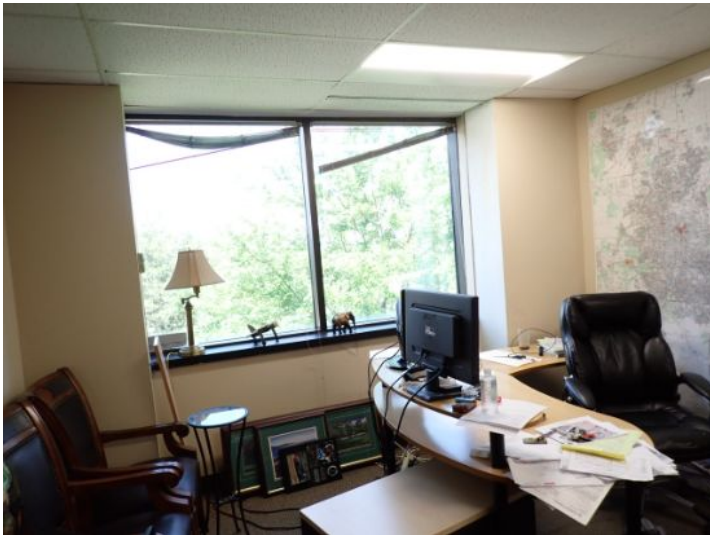
The majority of the interiors of the office suites appeared to be in fair condition at the time of the inspection.

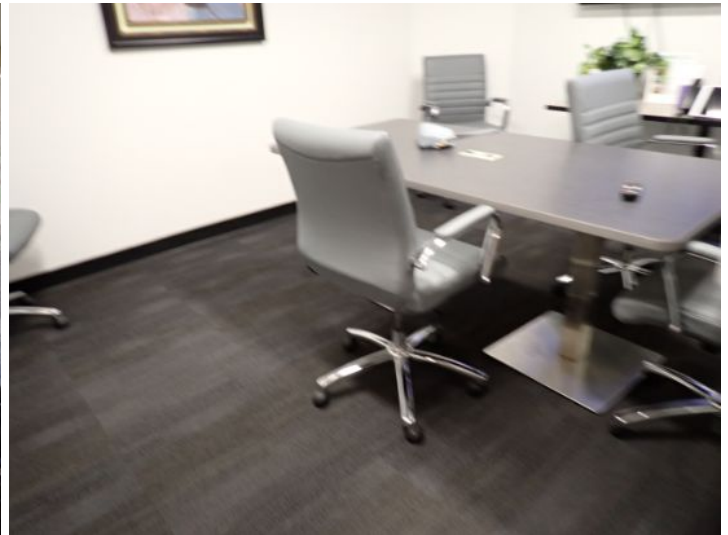
The majority of the interiors of the office suites appeared to be in fair condition at the time of the inspection.

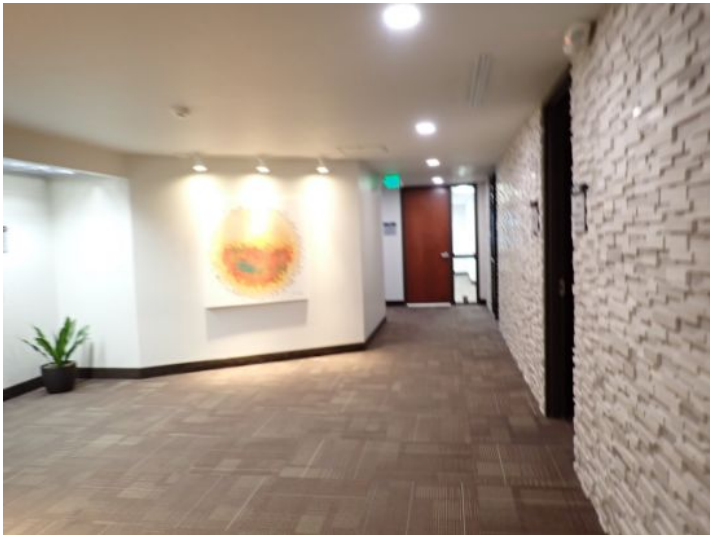
The majority of the common areas appeared to be in fair condition at the time of the inspection.

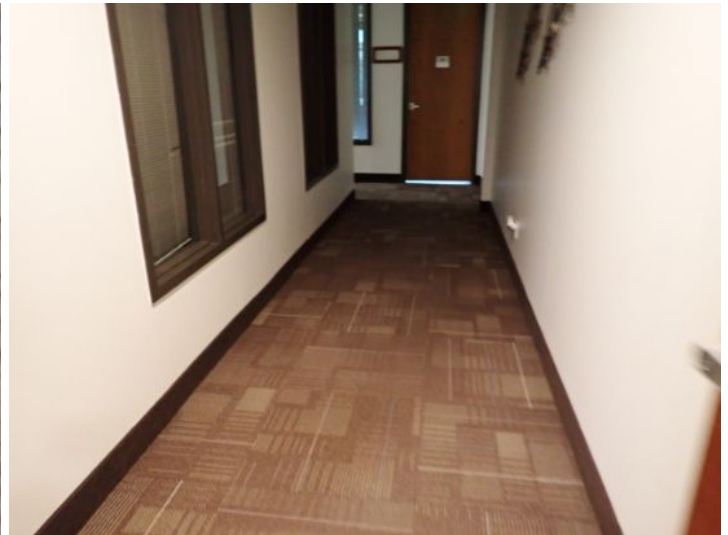
The majority of the interiors of the office suites appeared to be in fair condition at the time of the inspection.

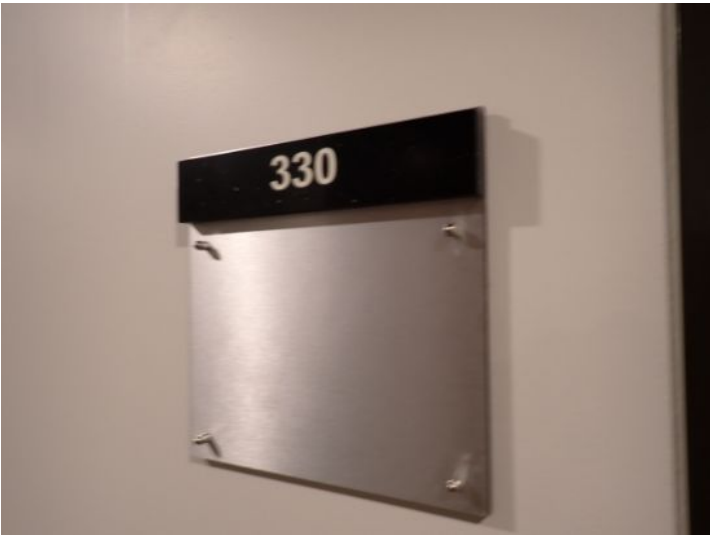
Suite 330: Significant moisture damage noted in the cabinet floor below break area sink. No GFCI protection noted near sink. VCT flooring damage noted. Recommend repairs.

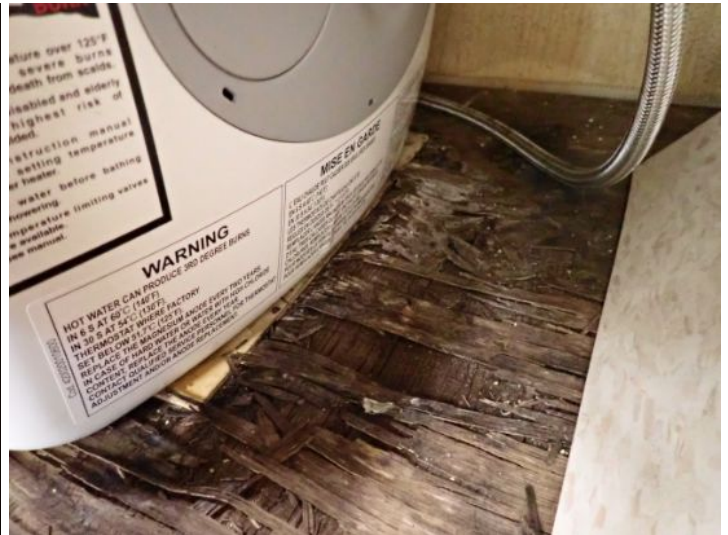
Suite 330: Significant moisture damage noted in the cabinet floor below break area sink. No GFCI protection noted near sink. VCT flooring damage noted. Recommend repairs.

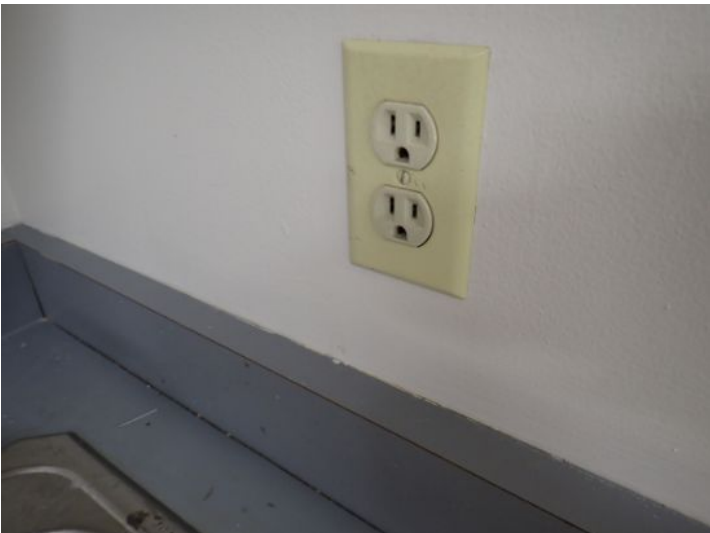
Suite 330: Significant moisture damage noted in the cabinet floor below break area sink. No GFCI protection noted near sink. VCT flooring damage noted. Recommend repairs.

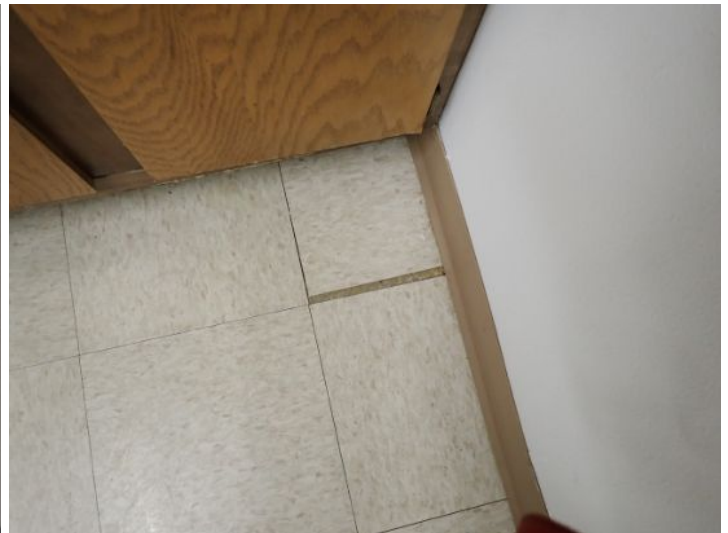
Suite 330: Significant moisture damage noted in the cabinet floor below break area sink. No GFCI protection noted near sink. VCT flooring damage noted. Recommend repairs.

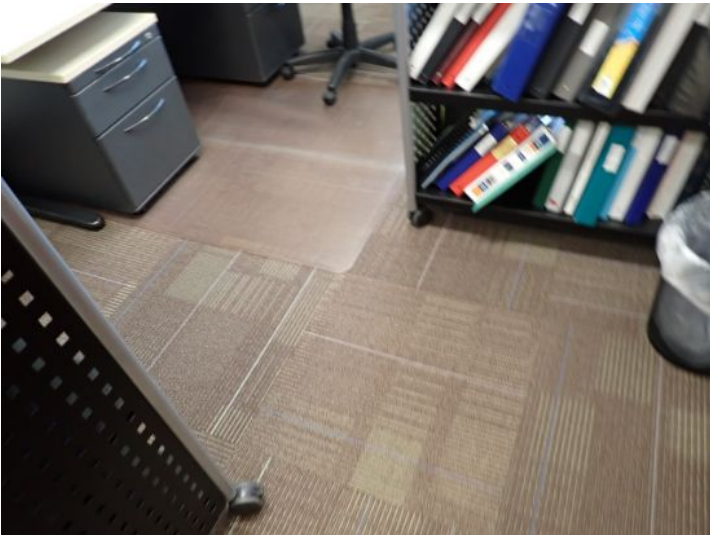
The majority of the interiors of the office suites appeared to be in fair condition at the time of the inspection.

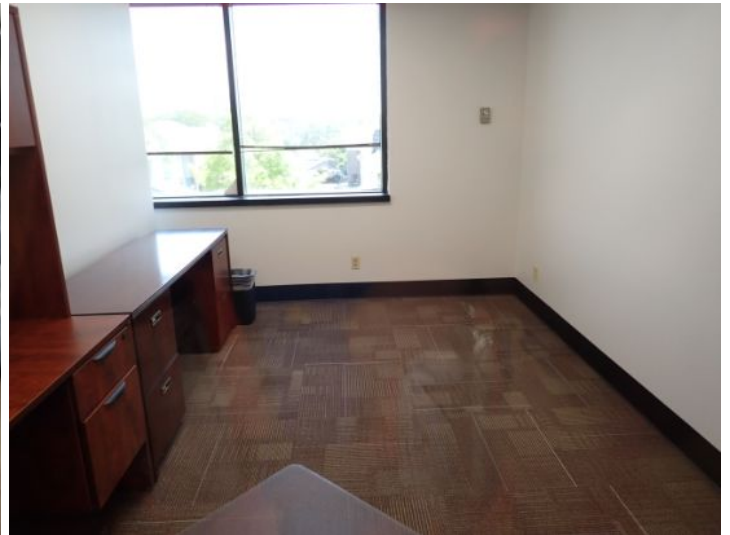
The majority of the interiors of the office suites appeared to be in fair condition at the time of the inspection.

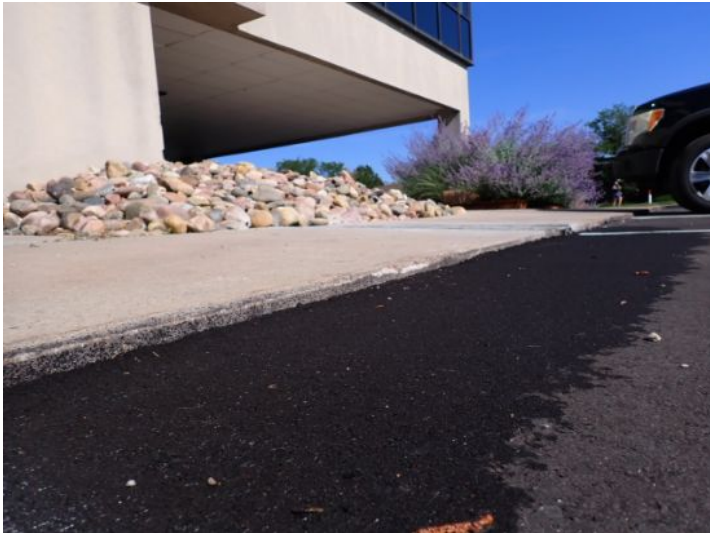
Although we do not perform ADA compliance inspections we do attempt to inform our clients of items that we notice while onsite that may be an issue. At the time of the inspection we noticed several items that could possibly become an ADA compliance issue. Recommend assuring that all possible ADA issues are resolved prior to taking possession of the property.

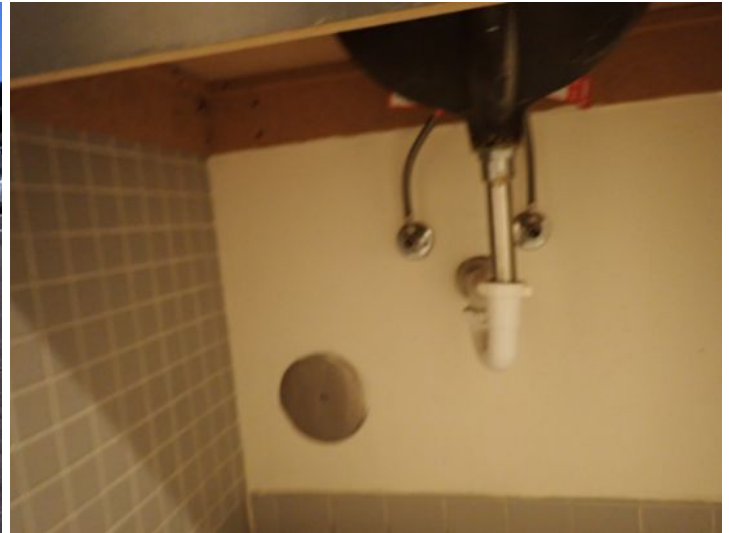
Although we do not perform ADA compliance inspections we do attempt to inform our clients of items that we notice while onsite that may be an issue. At the time of the inspection we noticed several items that could possibly become an ADA compliance issue. Recommend assuring that all possible ADA issues are resolved prior to taking possession of the property.
