# *Forman Inspection Services, LLC*

## Property Inspection Report

1234 Retail St., Somewhere, CO 12345

Date of Inspection: 9/16/2022 Time: 10:00 Size: 93,886 sq. ft. per listing

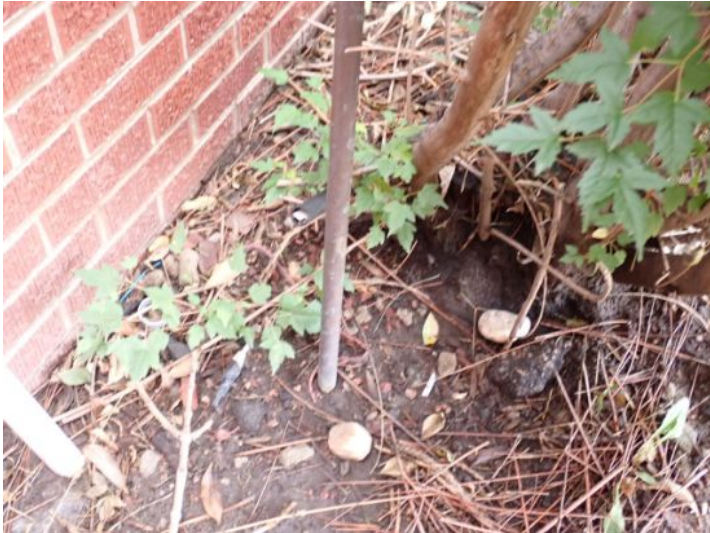
The topography of the property requires attention to assure that the grade directs ground/storm water away from the foundation of the structure.

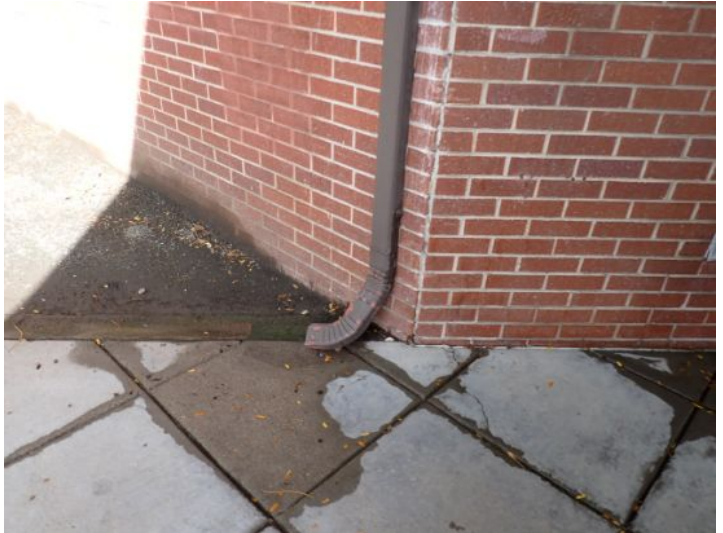
The topography of the property requires attention to assure that the grade directs ground/storm water away from the foundation of the structure.

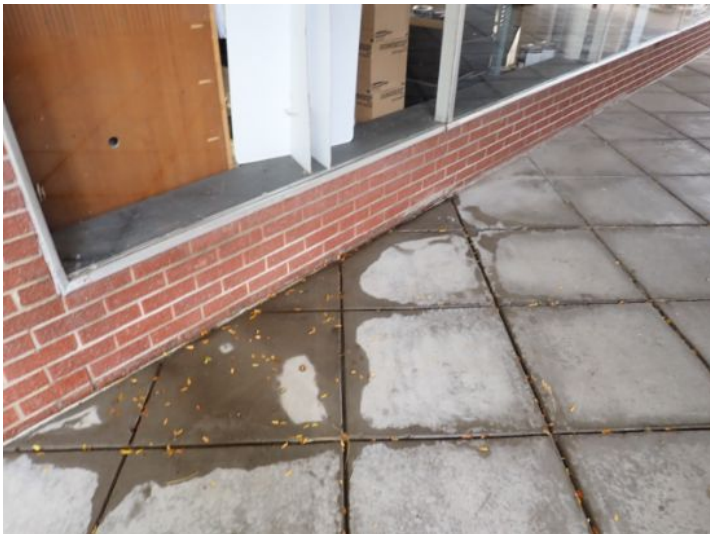
Grade falling toward structure in areas. Recommend repairs by a licensed contractor.

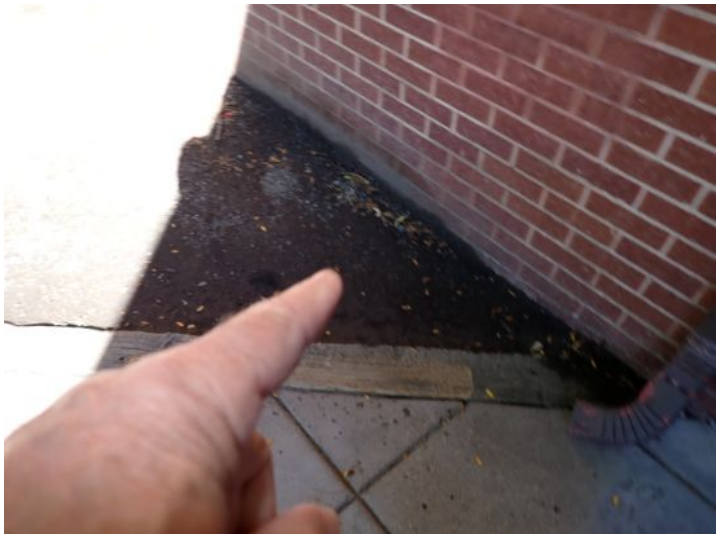
The topography of the property requires attention to assure that the grade directs ground/storm water away from the foundation of the structure.

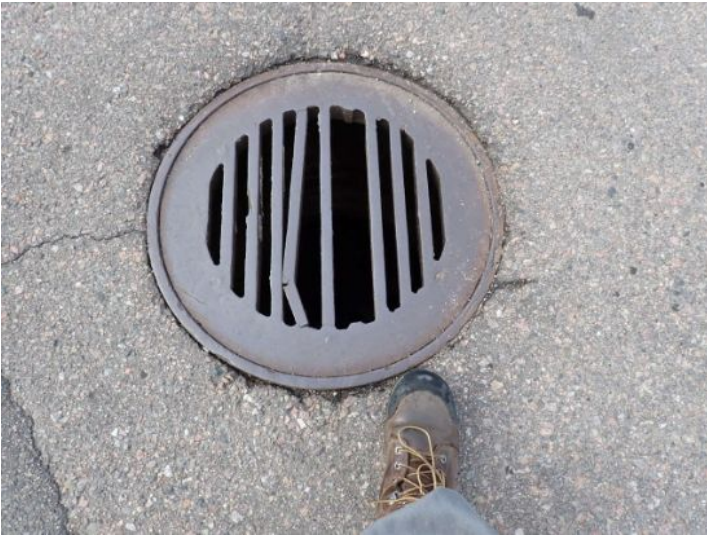
Damaged drainage vent cover noted in the front parking lot area that could be considered a safety hazard. Recommend repairs by a licensed contractor.

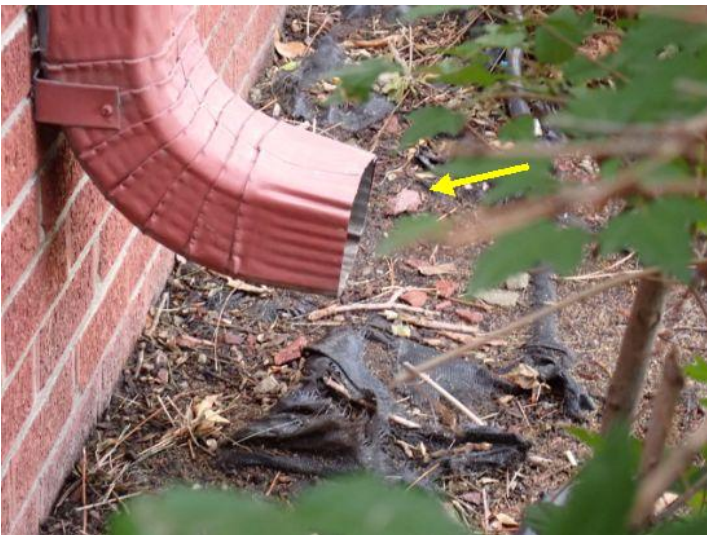
Gutters down spouts missing extensions to direct storm water away from the foundation of the structure. Recommend repairs.

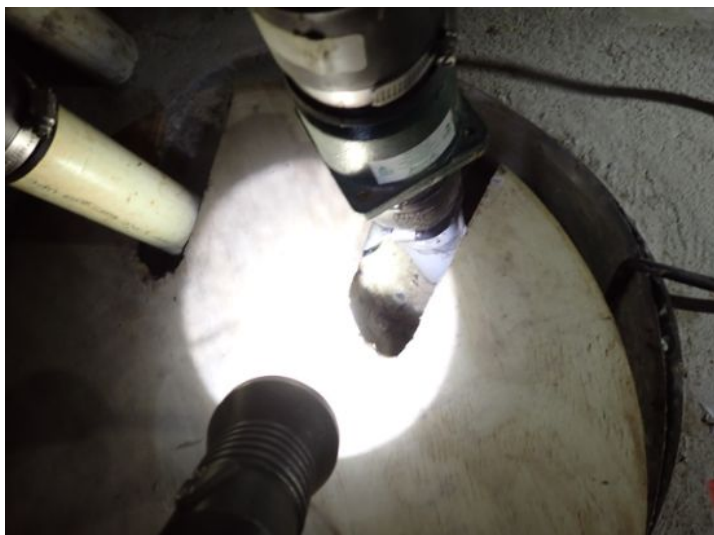
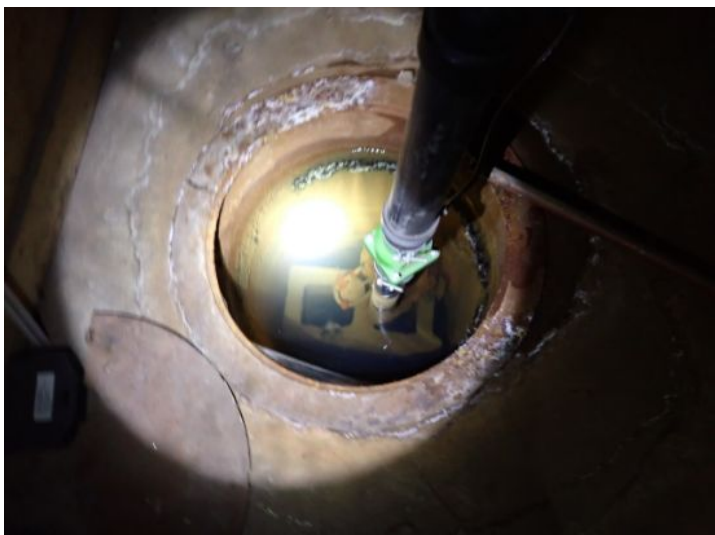
Sump pits and pump systems not functional in the basement below units 108-107 at the time of the inspection. Recommend repairs by a licensed contractor.

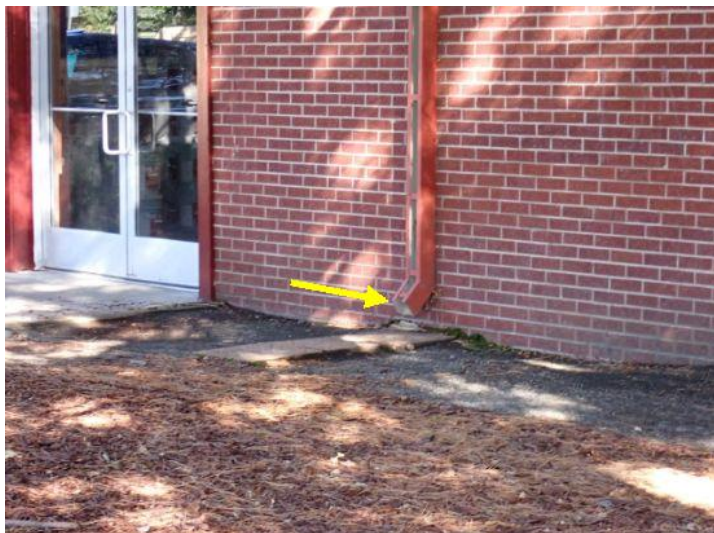
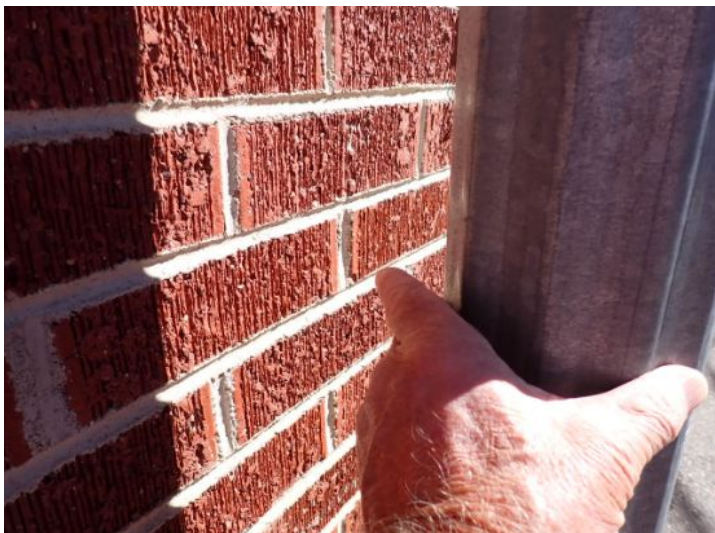
Gutters down spouts missing extensions to direct storm water away from the foundation of the structure. Recommend repairs.

Loose down spouts. Recommend repairs.

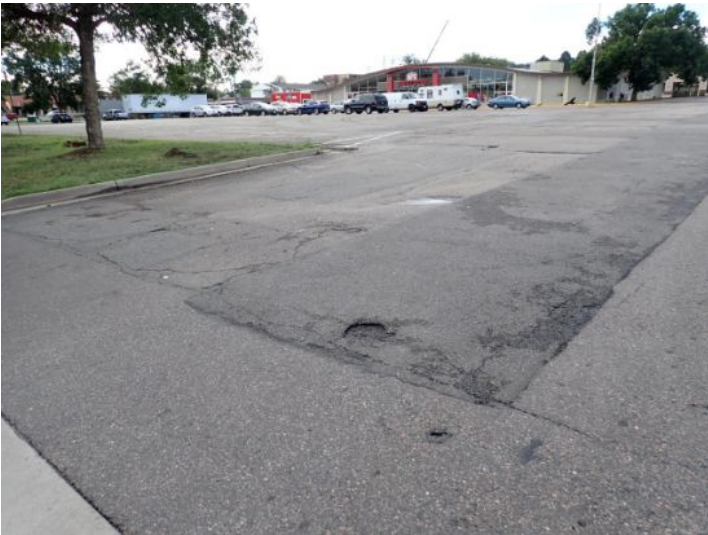
Deteriorated paving material noted in areas. Recommend repairs by a licensed contractor.

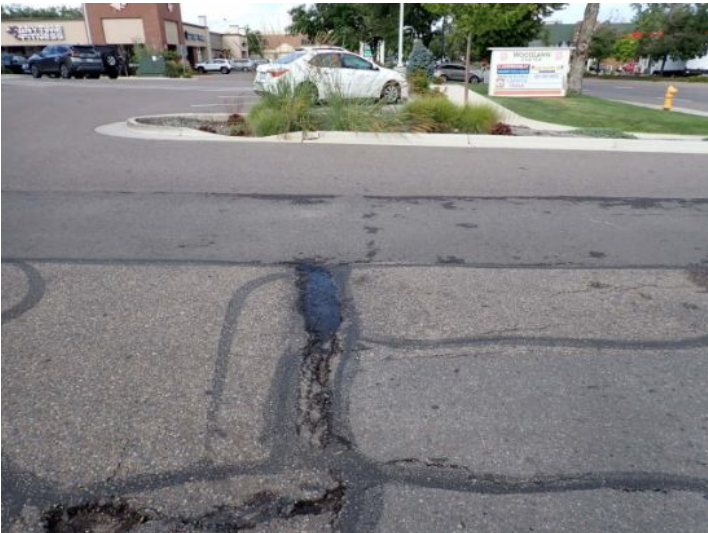
Deteriorated paving material noted in areas. Recommend repairs by a licensed contractor.

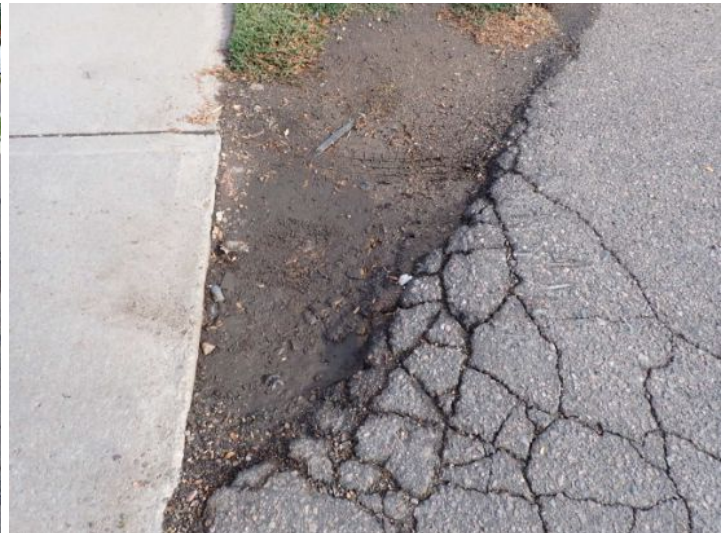
Deteriorated paving material noted in areas. Recommend repairs by a licensed contractor.

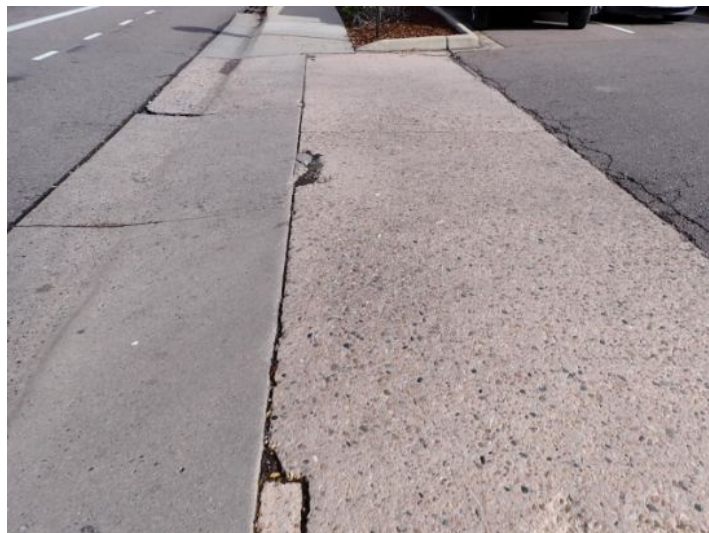
Deteriorated paving material noted in areas. Recommend repairs by a licensed contractor.

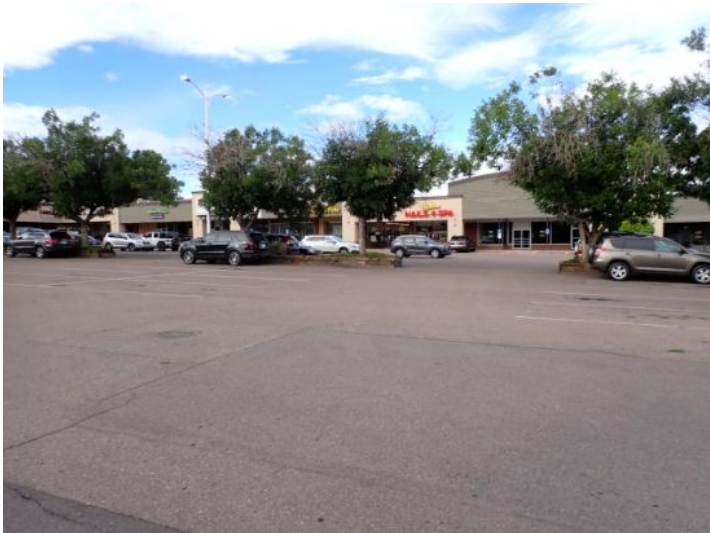
The majority of the parking lot surface was in fair condition at the time of the inspection.

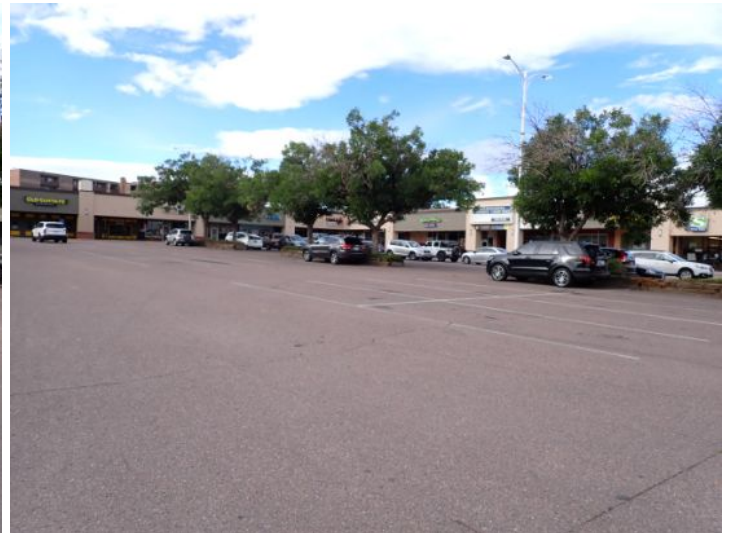
The majority of the parking lot surface was in fair condition at the time of the inspection.

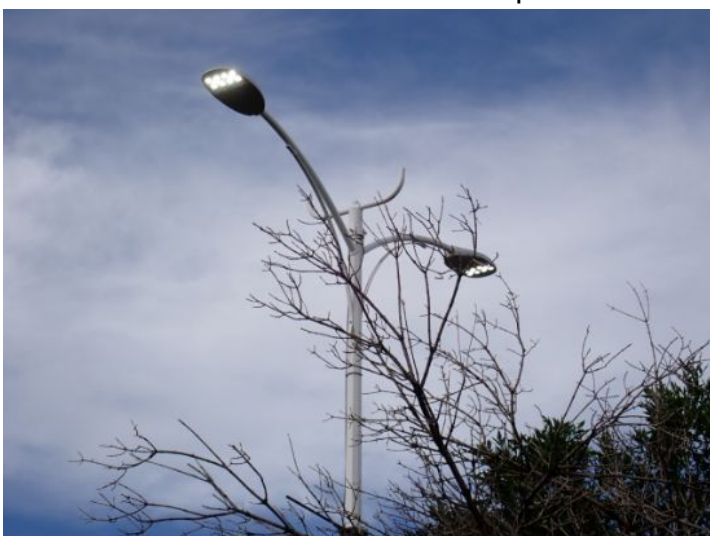
Parking lot lighting system appeared functional at the time of the inspection.

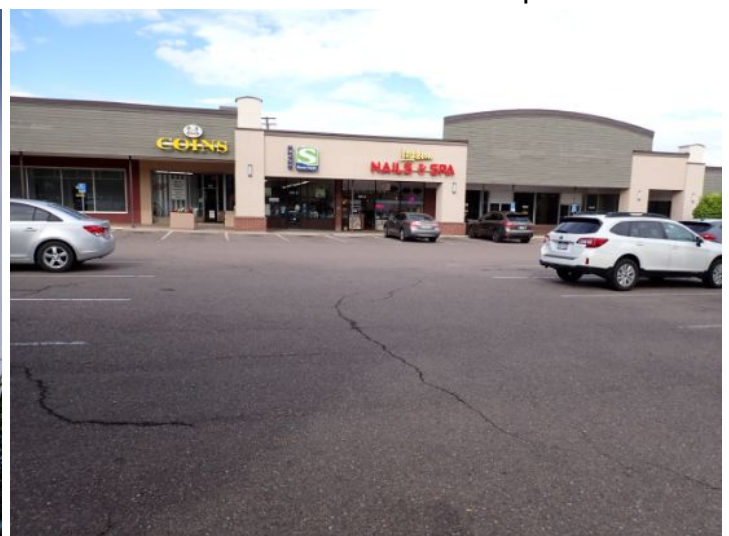
The majority of the parking lot surface was in fair condition at the time of the inspection.

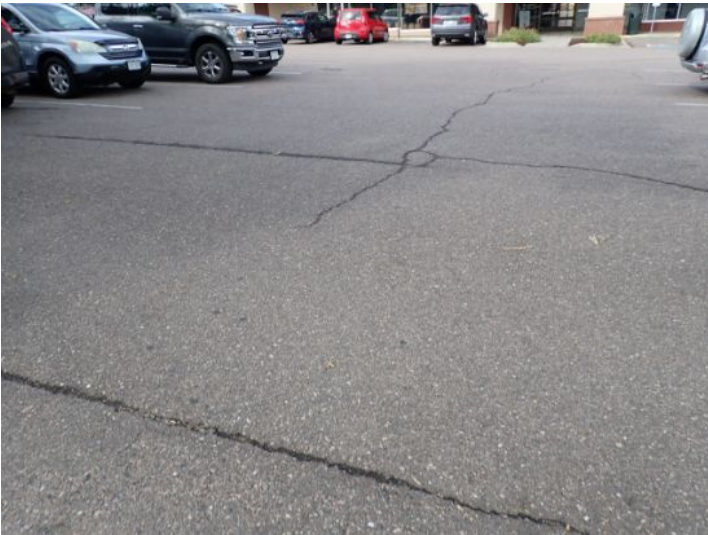
Recommend crack filling to aid in extending the life of the existing asphalt surface. Recommend repairs by a licensed contractor.

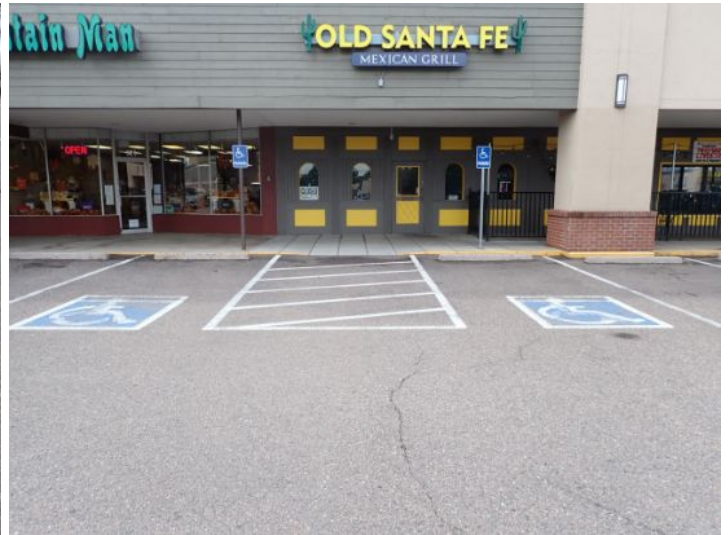
ADA parking was clearly marked at the time of the inspection.

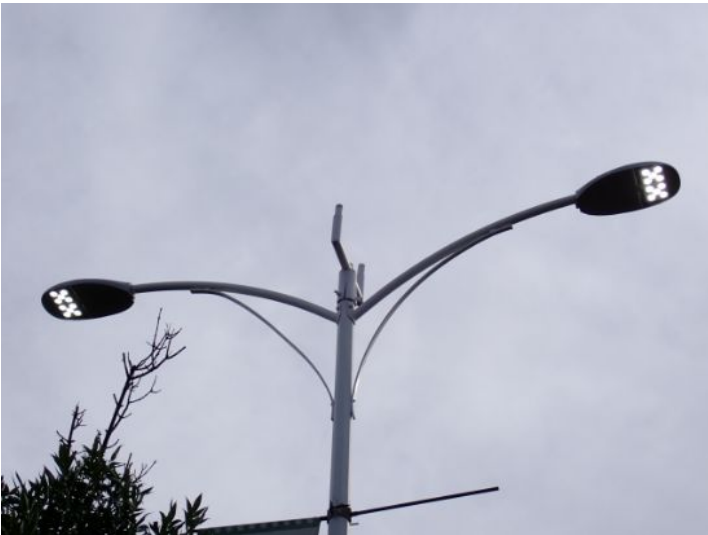
Parking lot lighting system appeared functional at the time of the inspection.

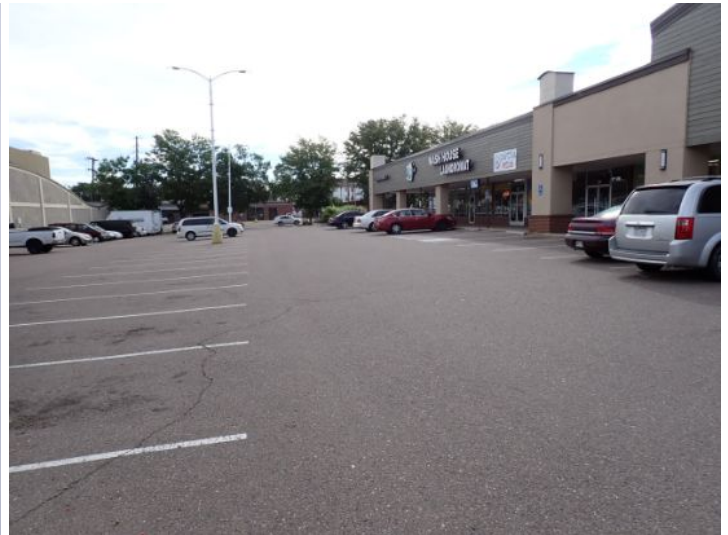
The majority of the parking lot surface was in fair condition at the time of the inspection.

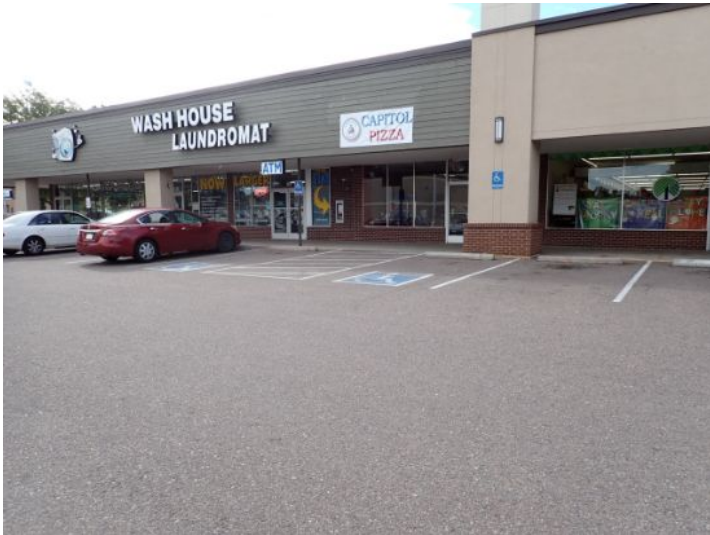
The majority of the parking lot surface was in fair condition at the time of the inspection.

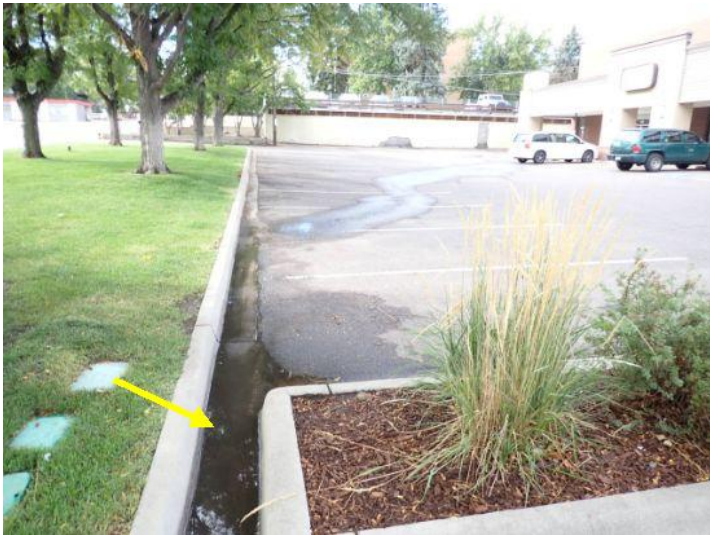
Poor drainage noted in areas. Recommend repairs by a licensed contractor.

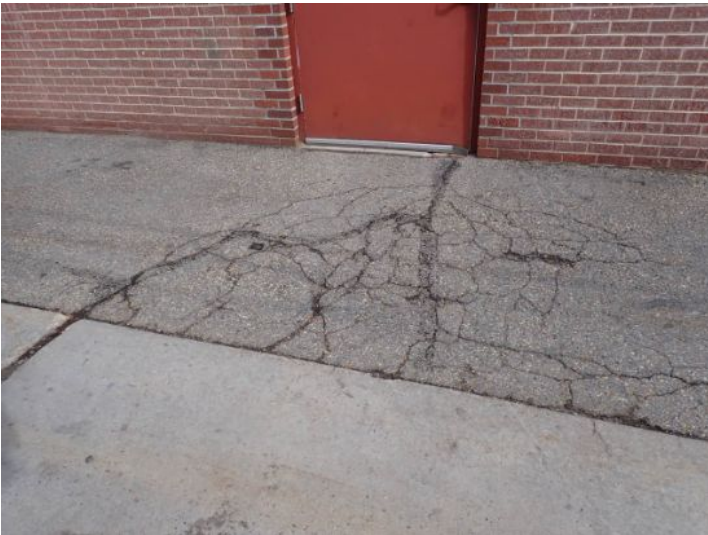
The asphalt running along the rear south side of the structure was in poor condition at the time of the inspection. Recommend resurfacing by a licensed contractor.

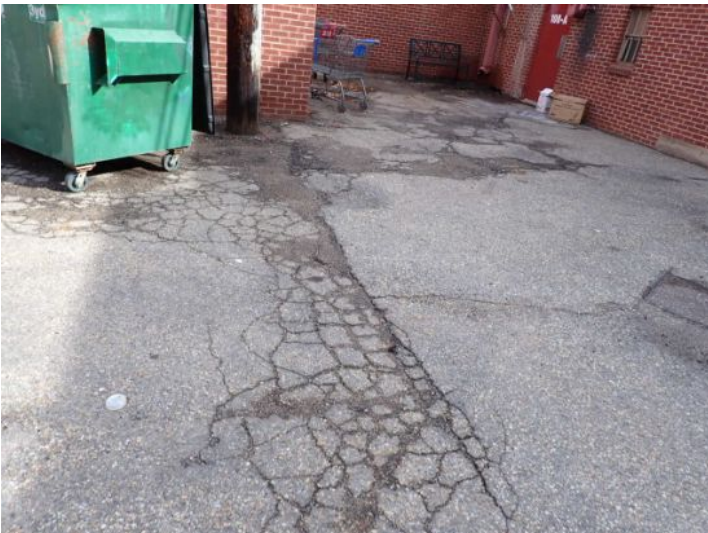
The asphalt running along the rear west side of the structure was in poor condition at the time of the inspection. Recommend resurfacing by a licensed contractor.

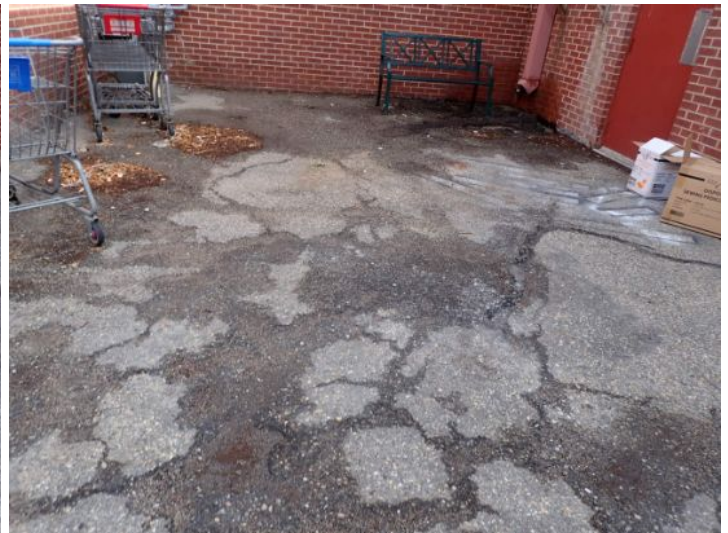
The asphalt running along the rear west side of the structure was in poor condition at the time of the inspection. Recommend resurfacing by a licensed contractor.

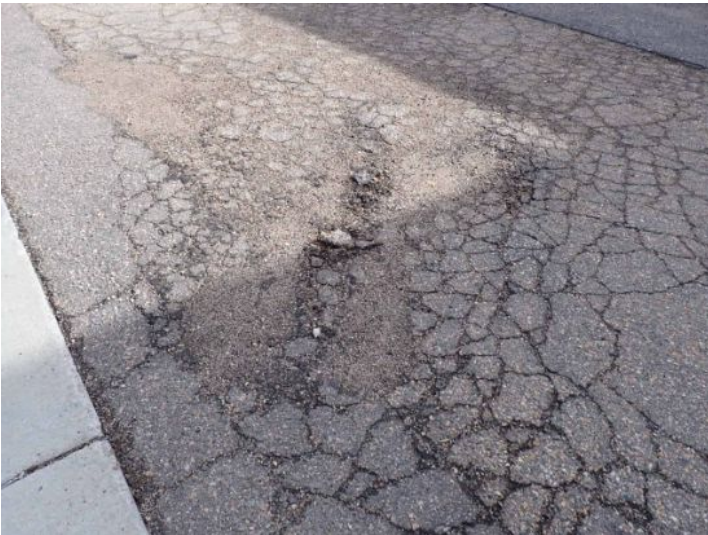
The asphalt running along the rear west side of the structure was in poor condition at the time of the inspection. Recommend resurfacing by a licensed contractor.

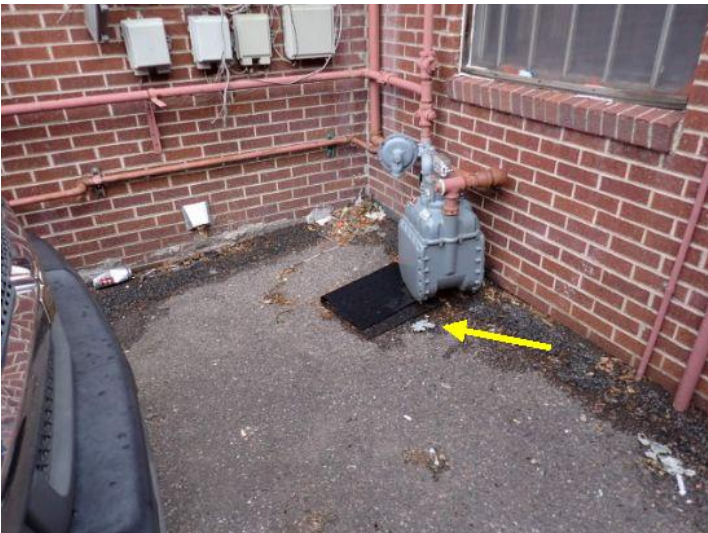
Missing protective bollard noted at one of the gas meters on the west side of the structure at the time of the inspection. Recommend repairs by a licensed contractor.

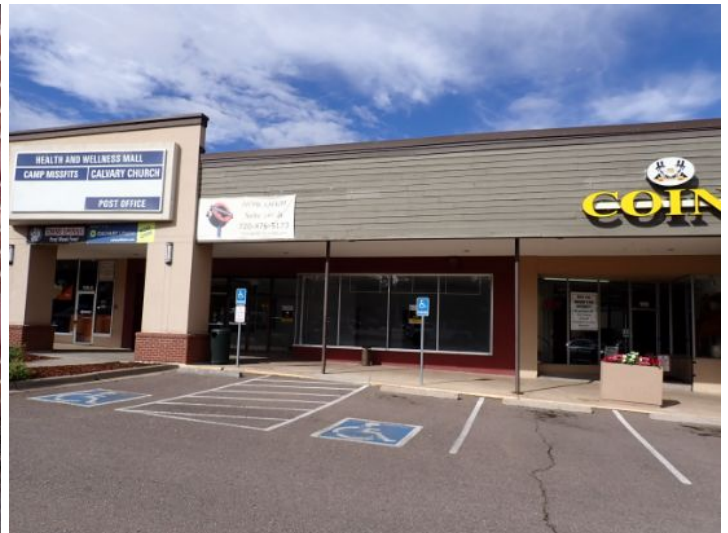
ADA parking was clearly marked at the time of the inspection.

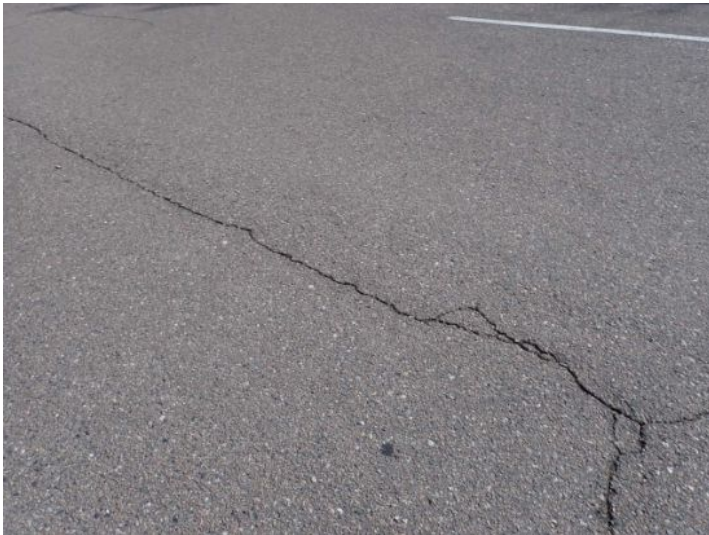
Recommend crack filling to aid in extending the life of the existing asphalt surface. Recommend repairs by a licensed contractor.

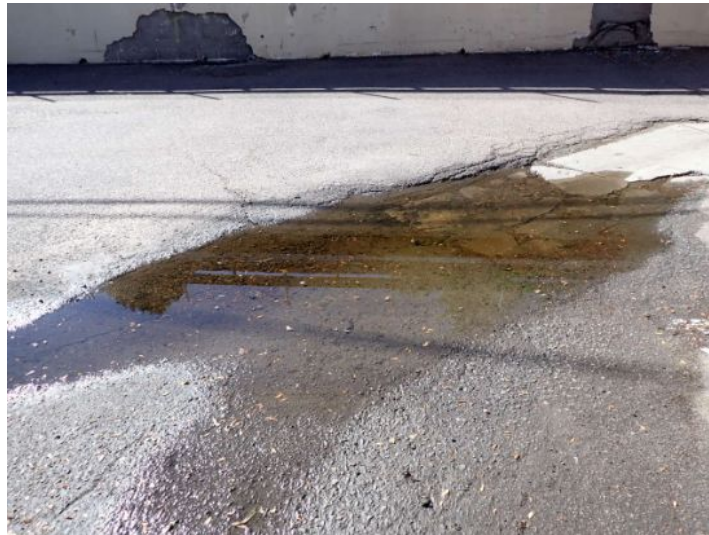
Poor drainage noted in areas. Recommend repairs by a licensed contractor.

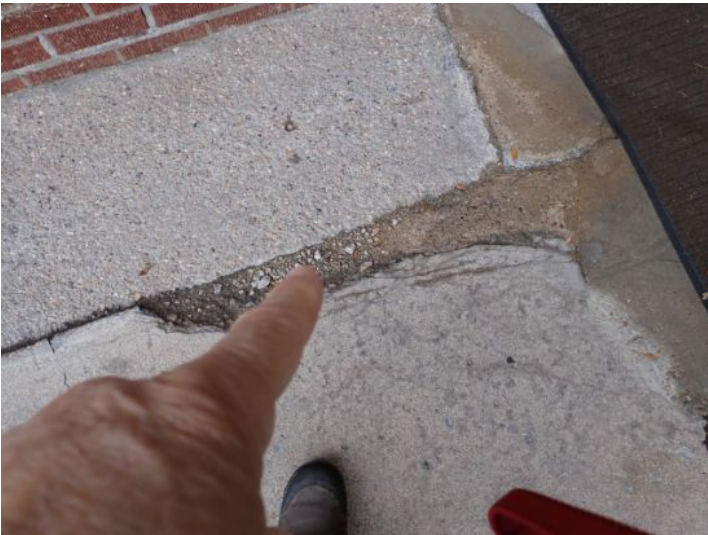
Damage/heaving noted on the flatwork at the ADA ramp for unit 100 (restaurant) at the time of the inspection. Recommend repairs by a licensed contractor.

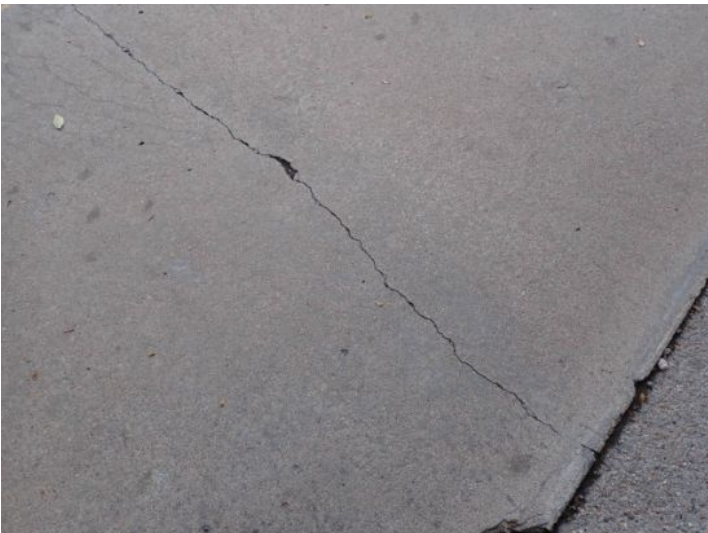
Minor cracking. Recommend monitoring for future repairs.

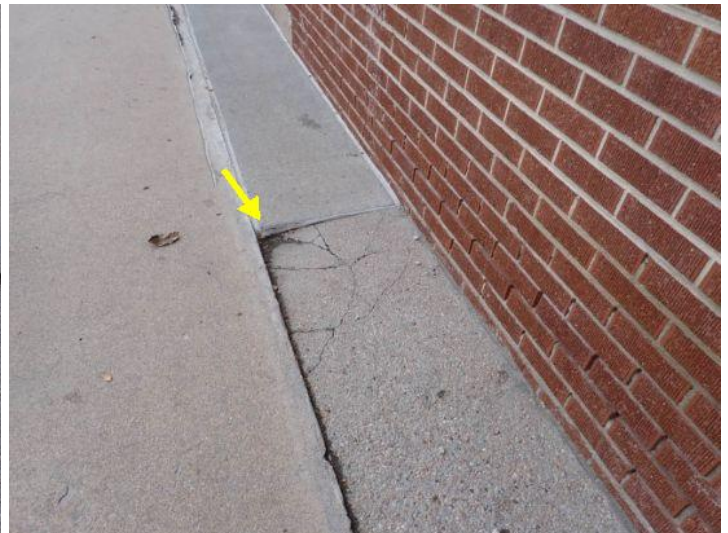
Trip hazards noted. Recommend repairs.

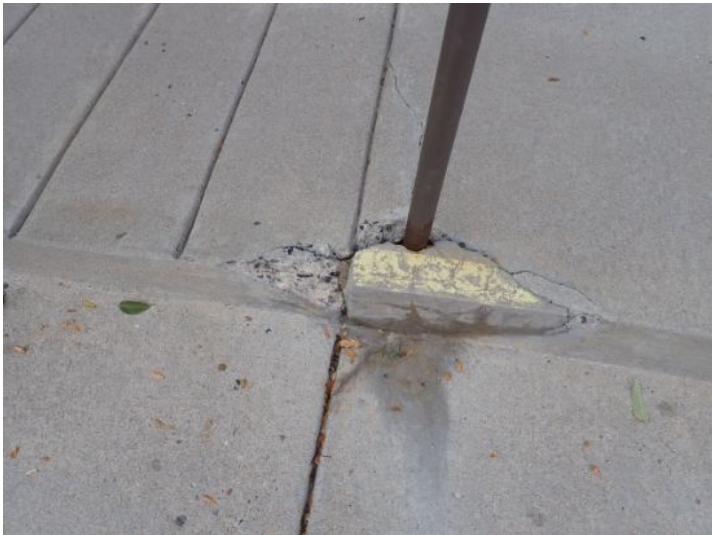
Concrete damage/deterioration noted in areas. Recommend repairs by a licensed contractor.

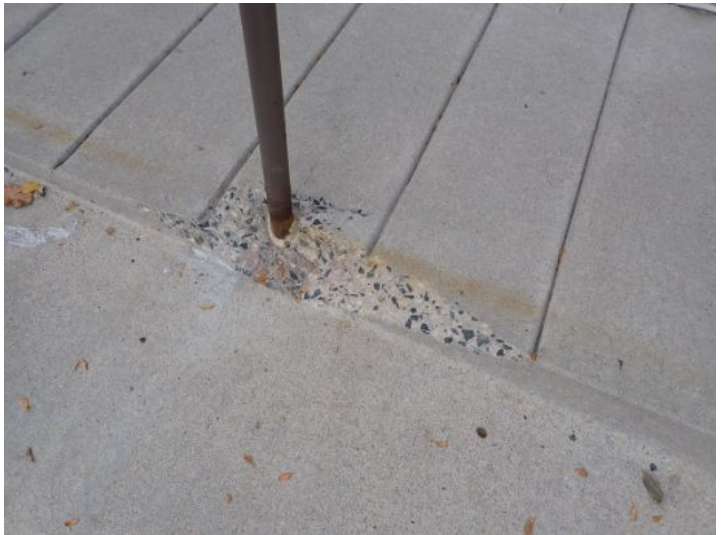
Concrete damage/deterioration noted in areas. Recommend repairs by a licensed contractor.

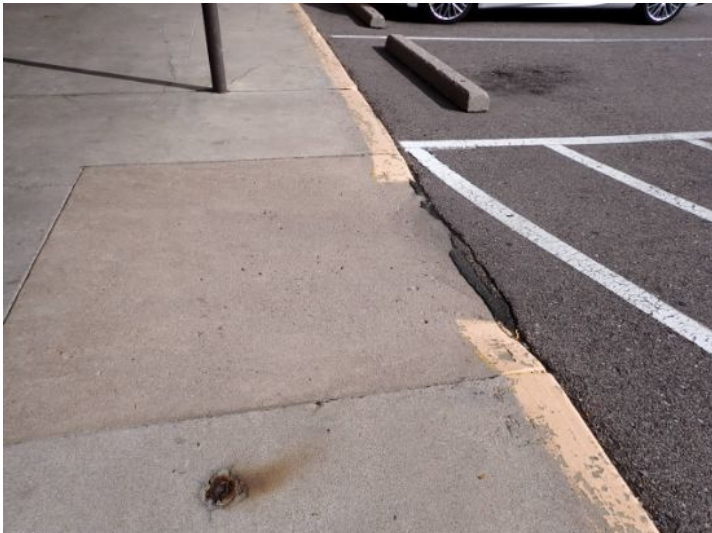
The ADA ramps were checked for proper grade and no significant issues were noted at the time of the inspection.

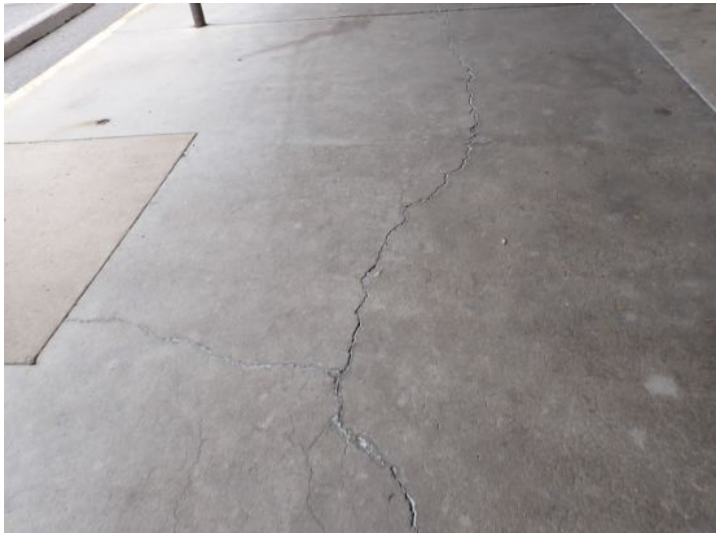
Minor cracking. Recommend monitoring for future repairs.

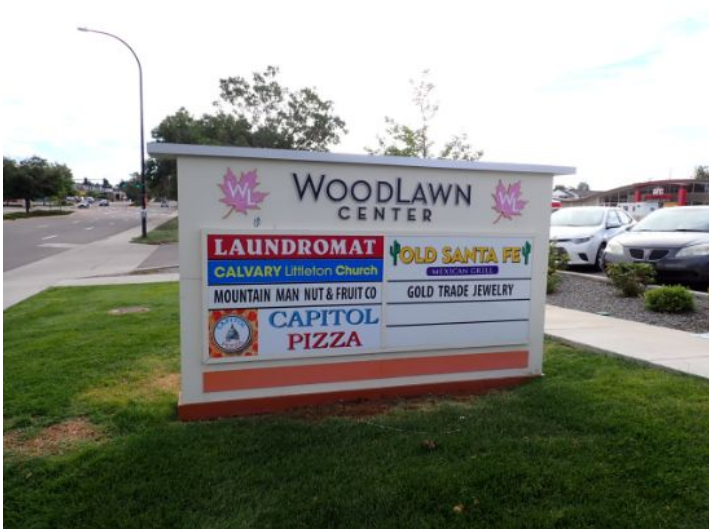
Signage appeared to be in fair condition at the time of the inspection.

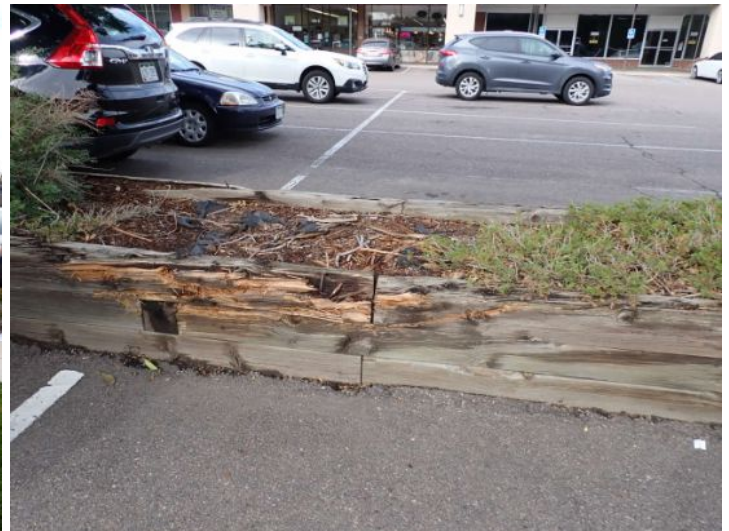
The timber retaining walls located around the planning beds in the parking lot were in poor condition at the time of the inspection. Recommend repairs by a licensed contractor.

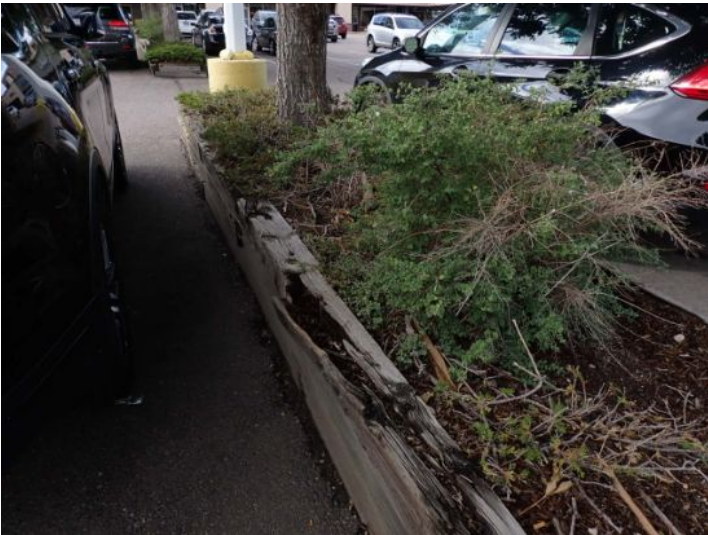
The timber retaining walls located around the planning beds in the parking lot were in poor condition at the time of the inspection. Recommend repairs by a licensed contractor.

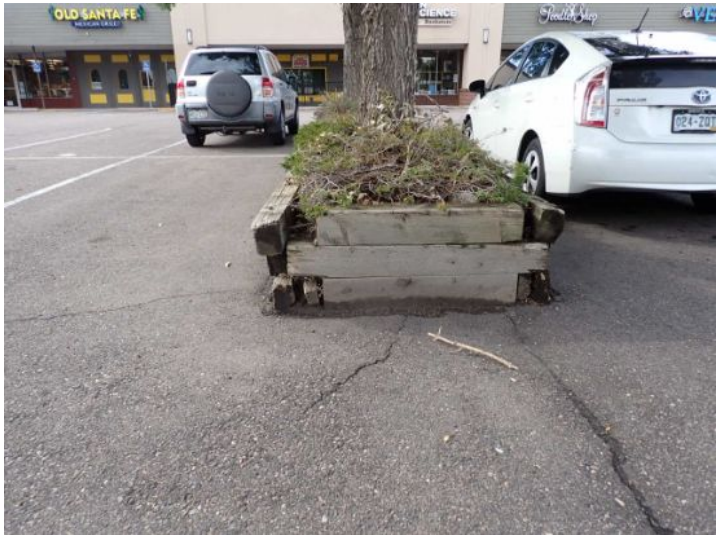
The timber retaining walls located around the planning beds in the parking lot were in poor condition at the time of the inspection. Recommend repairs by a licensed contractor.

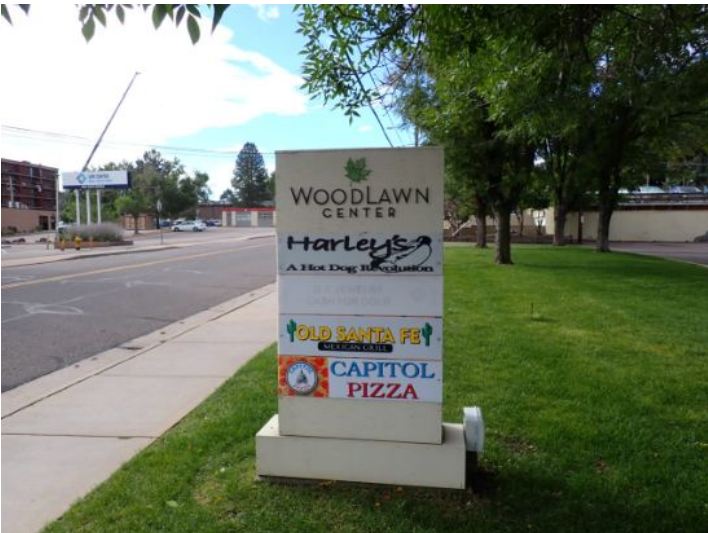
Signage appeared to be in fair condition at the time of the inspection.

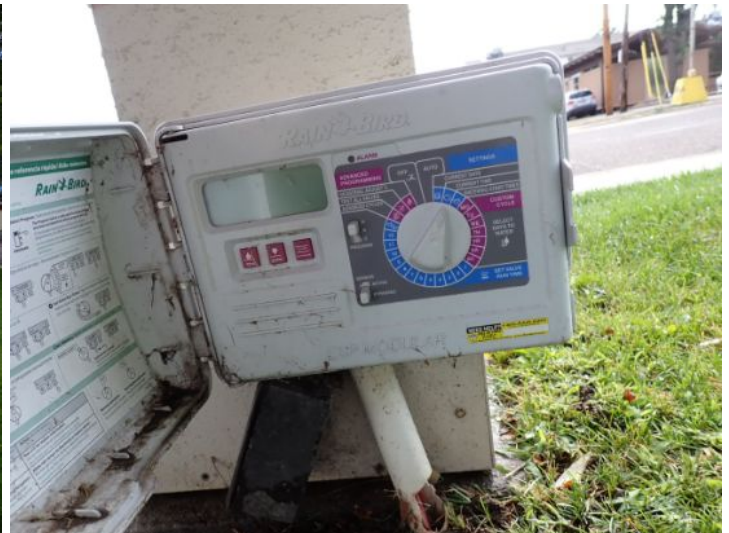
The property had an irrigation system at the time of the inspection.

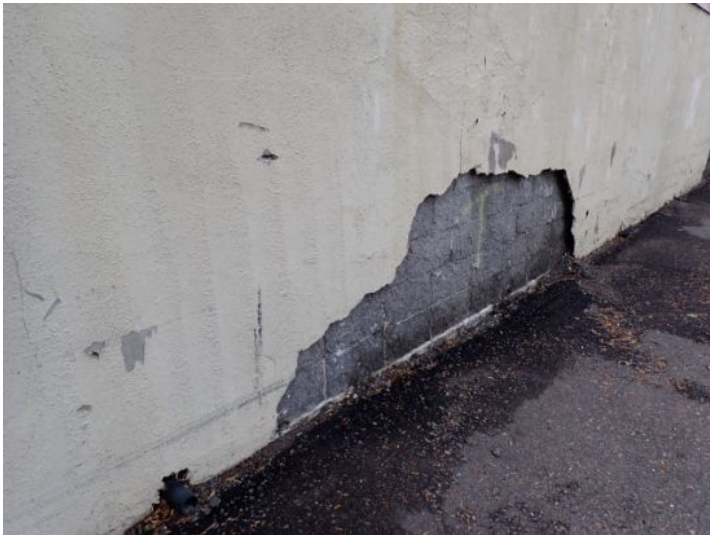
The block retaining wall for the neighboring parking garage was showing signs of significant moisture damage and deterioration in areas. Recommend monitoring to aid in possibly preventing wall failure onto your property.

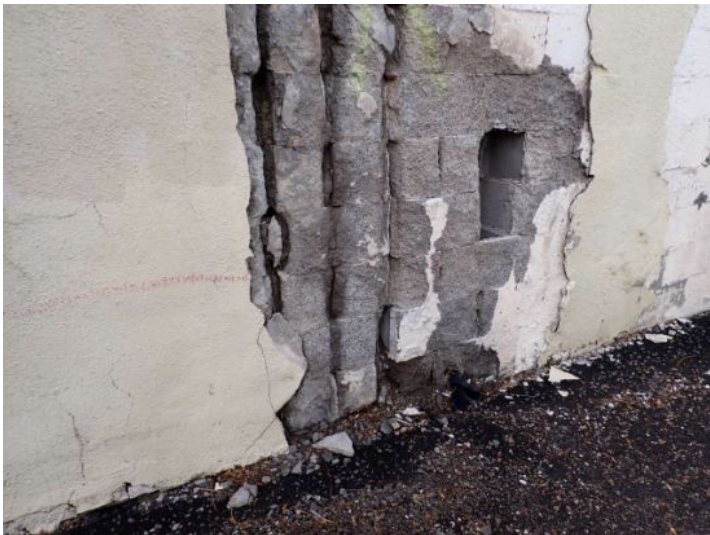
The block retaining wall for the neighboring parking garage was showing signs of significant moisture damage and deterioration in areas. Recommend monitoring to aid in possibly preventing wall failure onto your property.

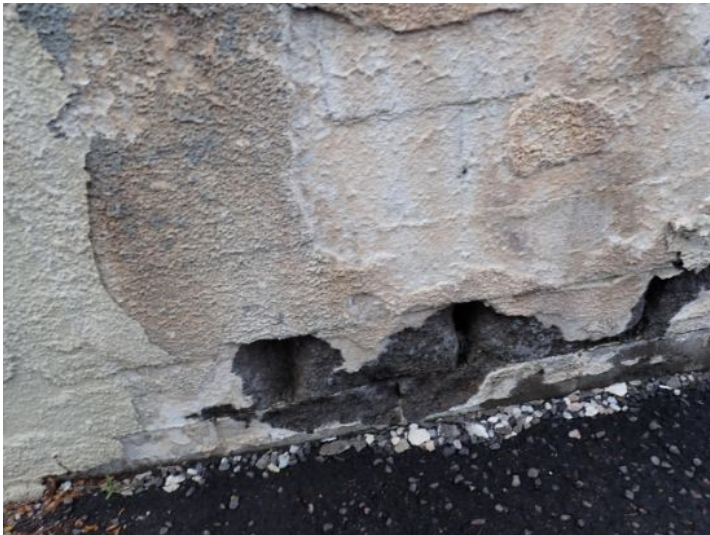
The block retaining wall for the neighboring parking garage was showing signs of significant moisture damage and deterioration in areas. Recommend monitoring to aid in possibly preventing wall failure onto your property.

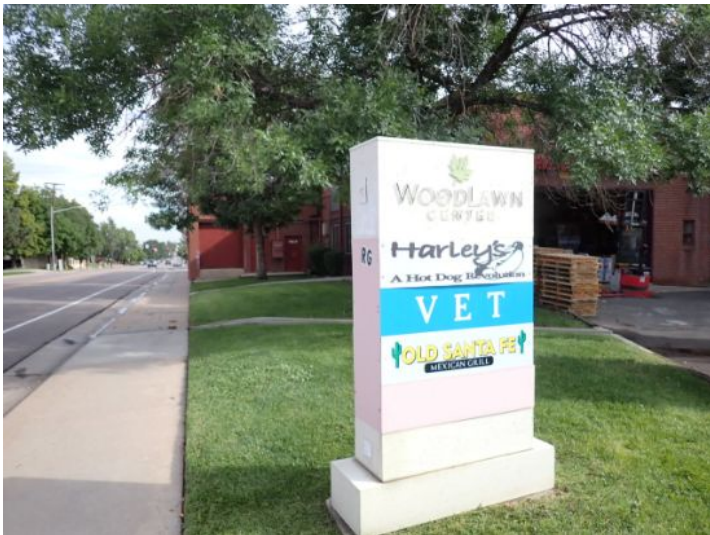
Signage appeared to be in fair condition at the time of the inspection.

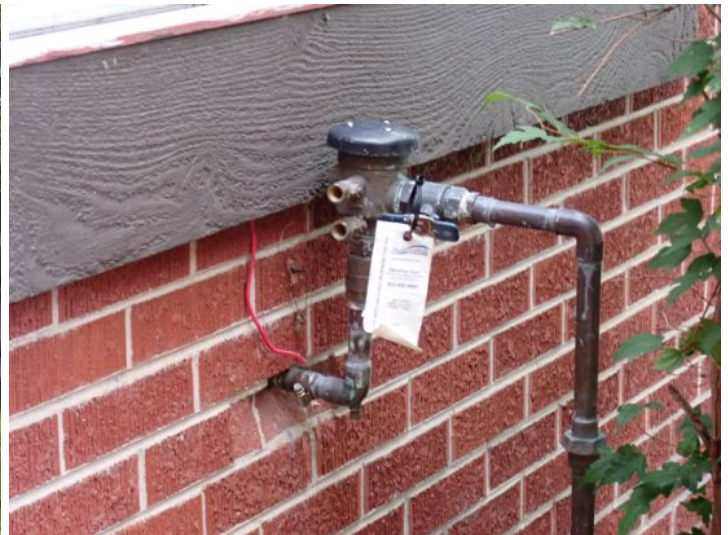
The backflow preventer for the irrigation system appeared to be installed on the roof top above the laundry mat for the east end and in the planting bed behind the paint store for the west end. The backflow preventers appeared functional at the time of the inspection.

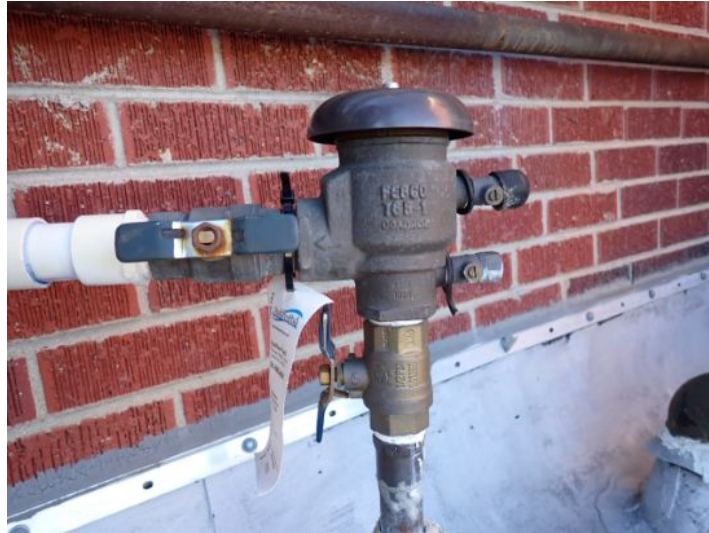
The backflow preventer for the irrigation system appeared to be installed on the roof top above the laundry mat for the east end and in the planting bed behind the paint store for the west end. The backflow preventers appeared functional at the time of the inspection.

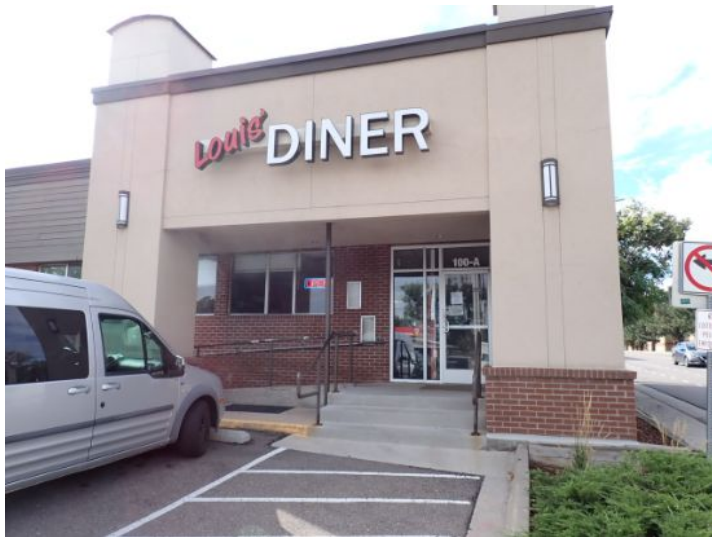
The majority of the exterior envelope of the structure appeared to be in fair condition with no significant structural movement noted at the time of the inspection.

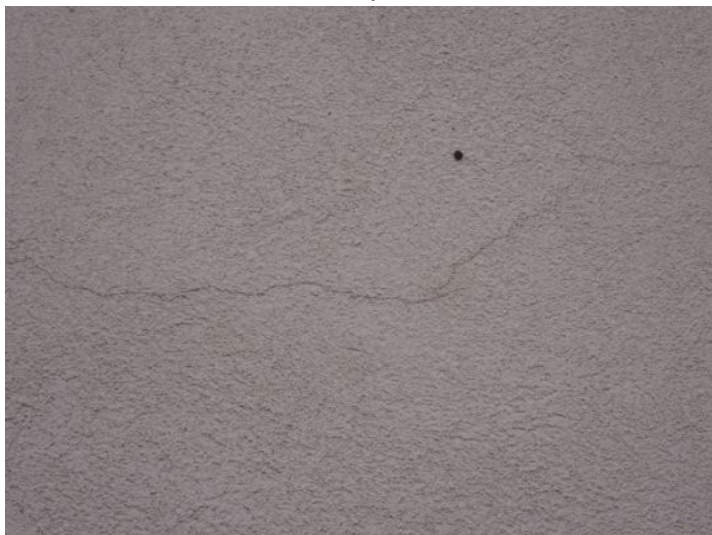
Stucco cracking noted in areas around the structure at the time of the inspection. Recommend repairs by a licensed contractor.

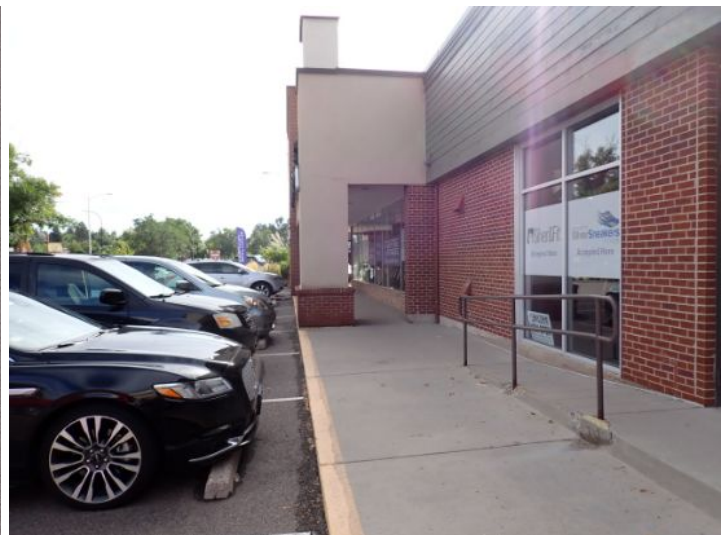
The majority of the exterior envelope of the structure appeared to be in fair condition with no significant structural movement noted at the time of the inspection.

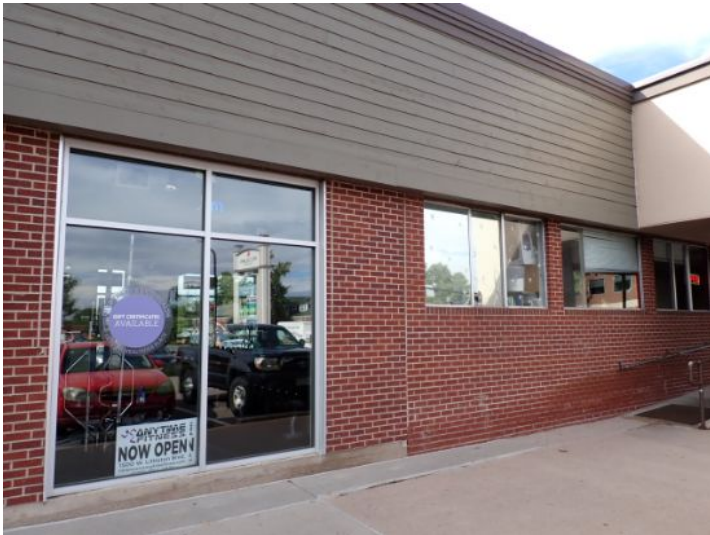
The majority of the exterior envelope of the structure appeared to be in fair condition with no significant structural movement noted at the time of the inspection.
