# *Forman Inspection Services, LLC*

## Property Inspection Report

1234 Retail St., Somewhere, CO 12345

Date of Inspection: 9/16/2022 Time: 10:00 Size: 93,886 sq. ft. per listing

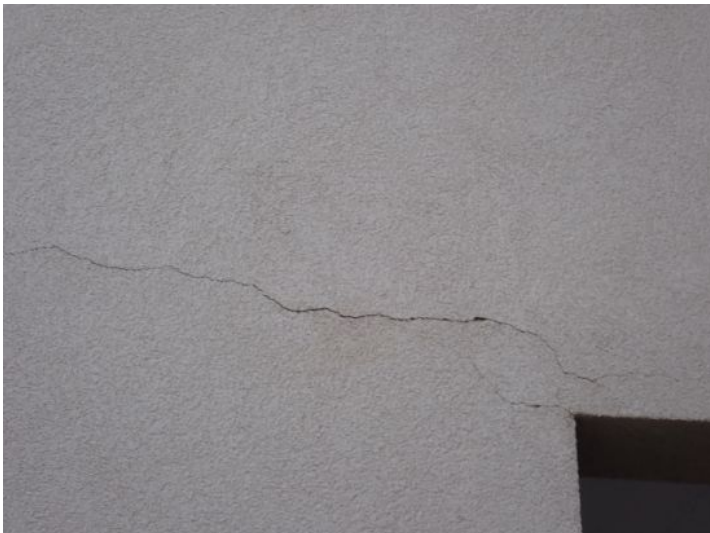
Stucco cracking noted in areas around the structure at the time of the inspection. Recommend repairs by a licensed contractor.

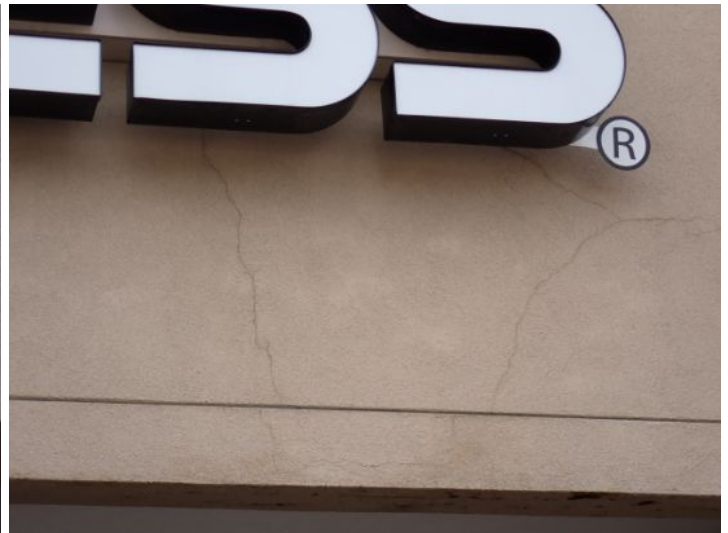
Stucco cracking noted in areas around the structure at the time of the inspection. Recommend repairs by a licensed contractor.

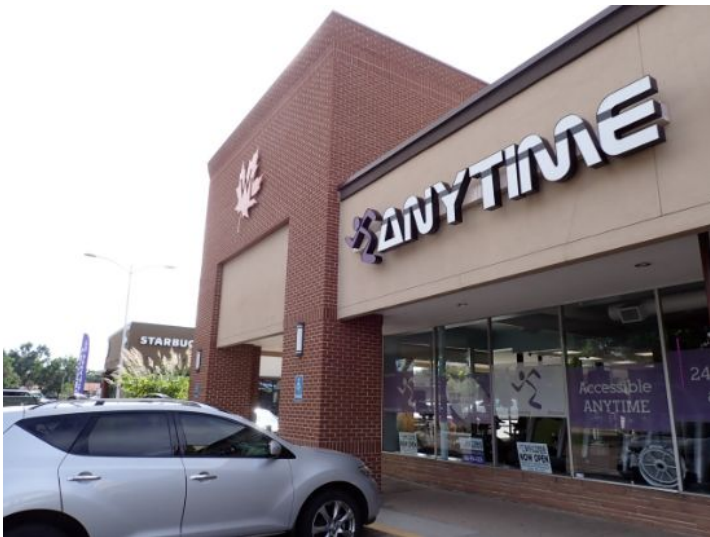
The majority of the exterior envelope of the structure appeared to be in fair condition with no significant structural movement noted at the time of the inspection.

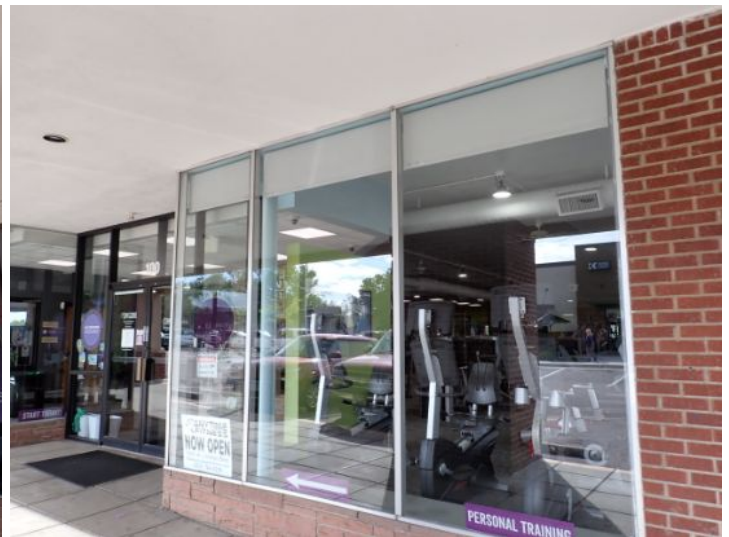
The majority of the exterior envelope of the structure appeared to be in fair condition with no significant structural movement noted at the time of the inspection.

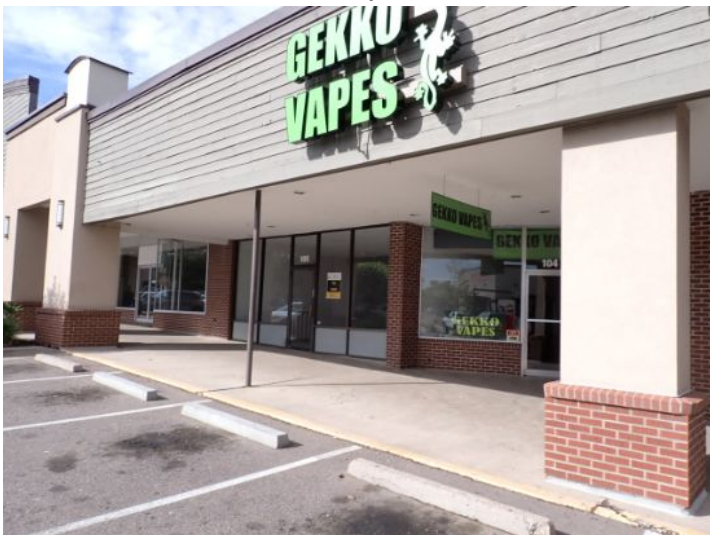
The majority of the exterior envelope of the structure appeared to be in fair condition with no significant structural movement noted at the time of the inspection.

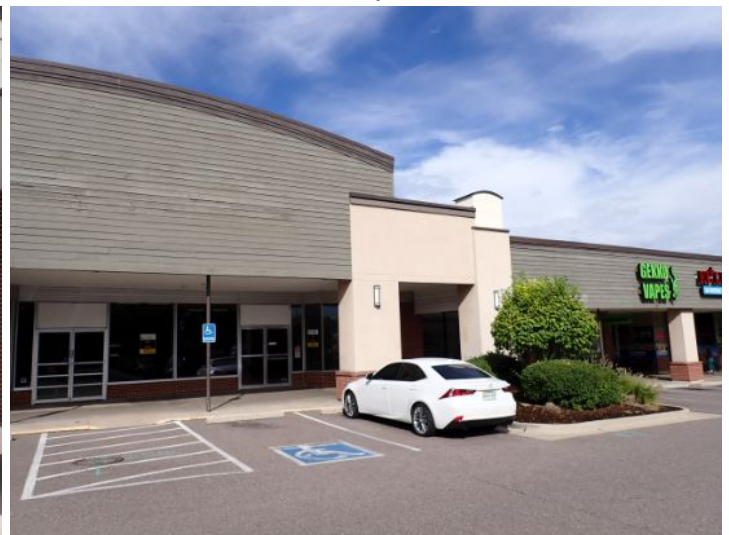
The majority of the exterior envelope of the structure appeared to be in fair condition with no significant structural movement noted at the time of the inspection.

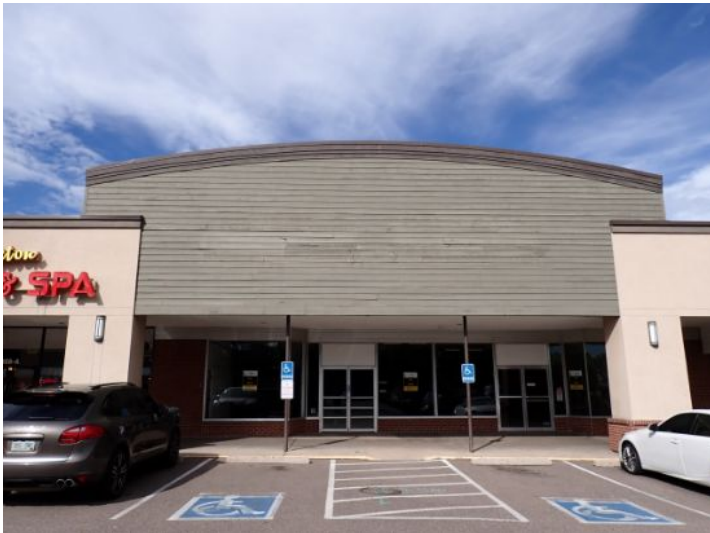
The majority of the exterior envelope of the structure appeared to be in fair condition with no significant structural movement noted at the time of the inspection.

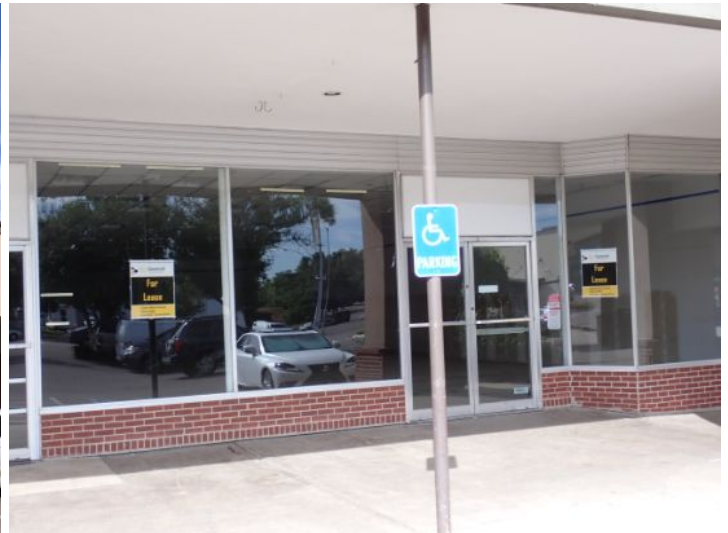
Missing safety stamps noted on some of the required safety glass panels. This is typical of structures of this age. Today's standards require that any glass located within 18" of grade level next to a walkway, in an operable door, with a leaking edge within 24" of an operable door or with a total of 9 sq. ft. or larger be glazed with safety glass and be labeled as such. Recommend repairs as needed by a certified glazing contractor.

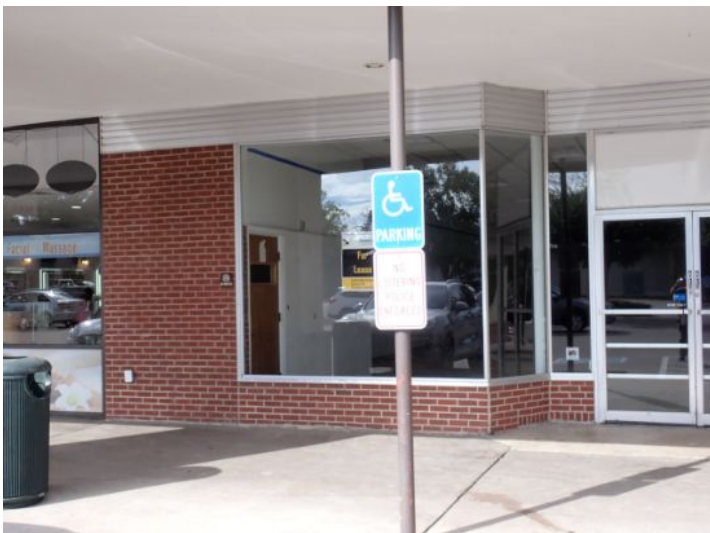
Missing safety stamps noted on some of the required safety glass panels. This is typical of structures of this age. Today's standards require that any glass located within 18" of grade level next to a walkway, in an operable door, with a leaking edge within 24" of an operable door or with a total of 9 sq. ft. or larger be glazed with safety glass and be labeled as such. Recommend repairs as needed by a certified glazing contractor.

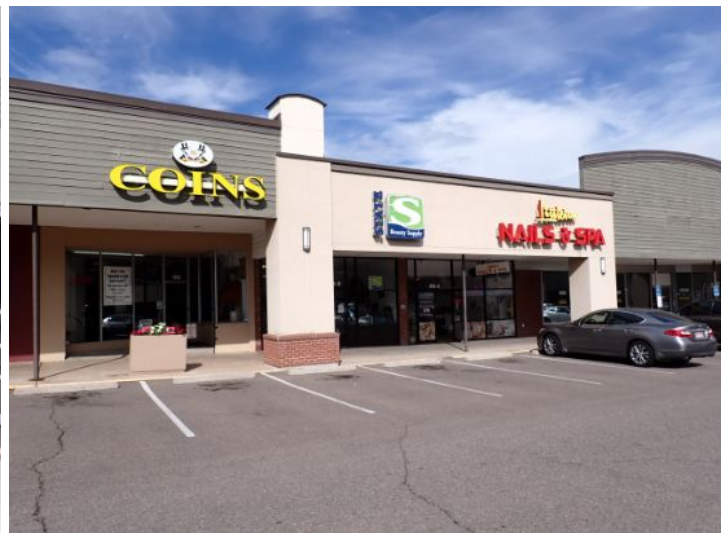
The majority of the exterior envelope of the structure appeared to be in fair condition with no significant structural movement noted at the time of the inspection.

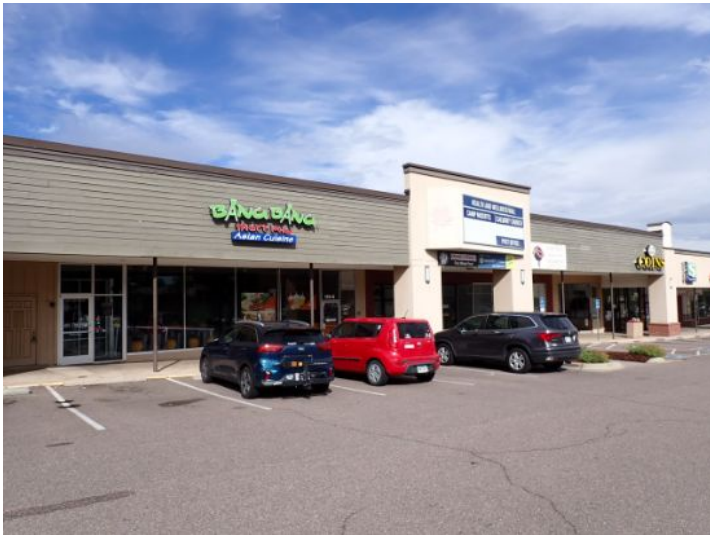
The majority of the exterior envelope of the structure appeared to be in fair condition with no significant structural movement noted at the time of the inspection.

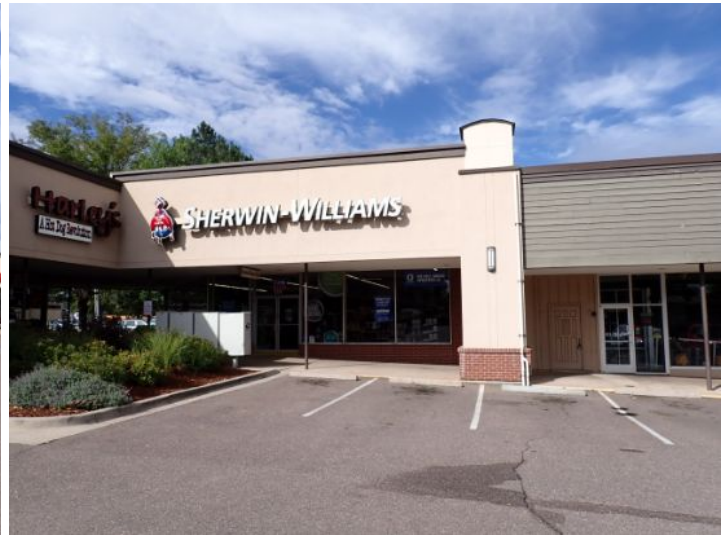
The majority of the exterior envelope of the structure appeared to be in fair condition with no significant structural movement noted at the time of the inspection.

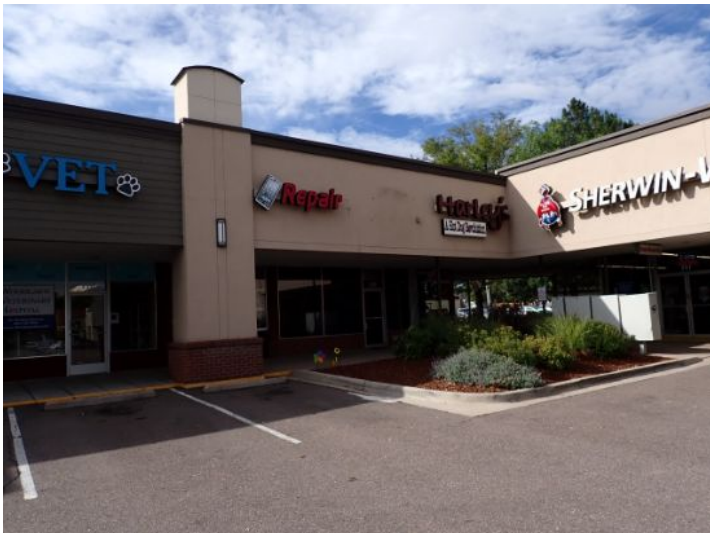
The majority of the exterior envelope of the structure appeared to be in fair condition with no significant structural movement noted at the time of the inspection.

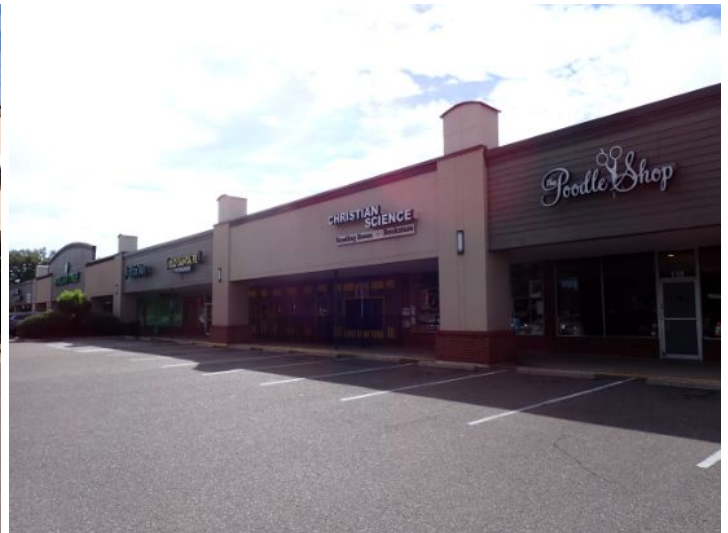
The majority of the exterior envelope of the structure appeared to be in fair condition with no significant structural movement noted at the time of the inspection.

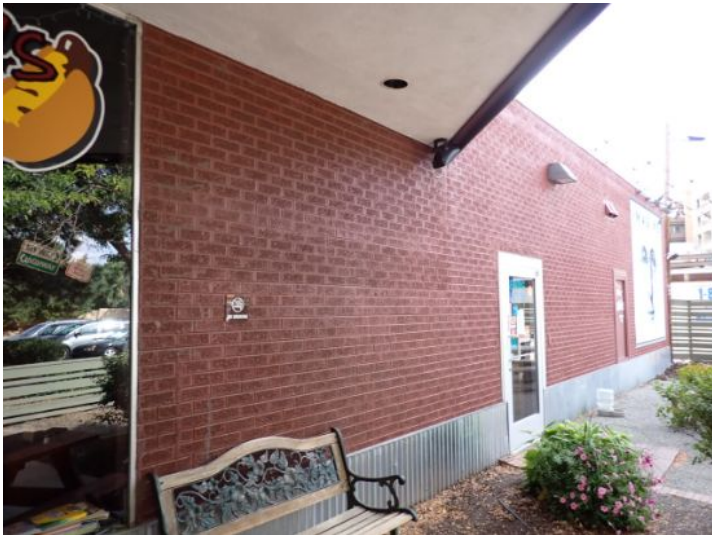
The majority of the exterior envelope of the structure appeared to be in fair condition with no significant structural movement noted at the time of the inspection.

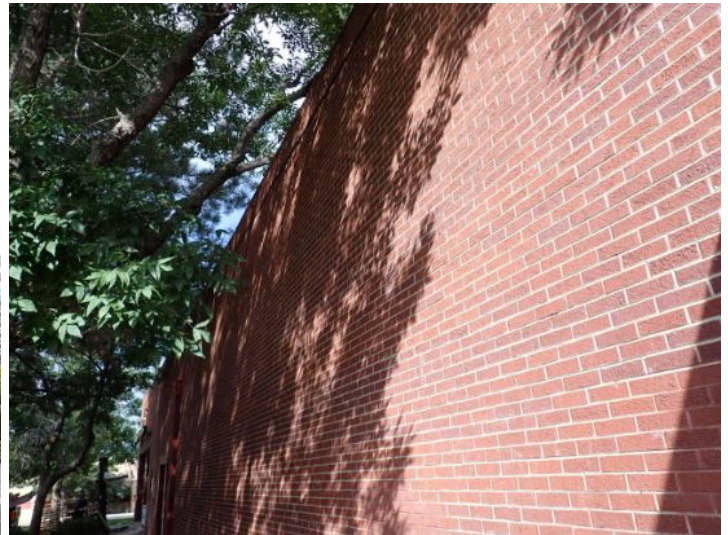
The majority of the exterior envelope of the structure appeared to be in fair condition with no significant structural movement noted at the time of the inspection.

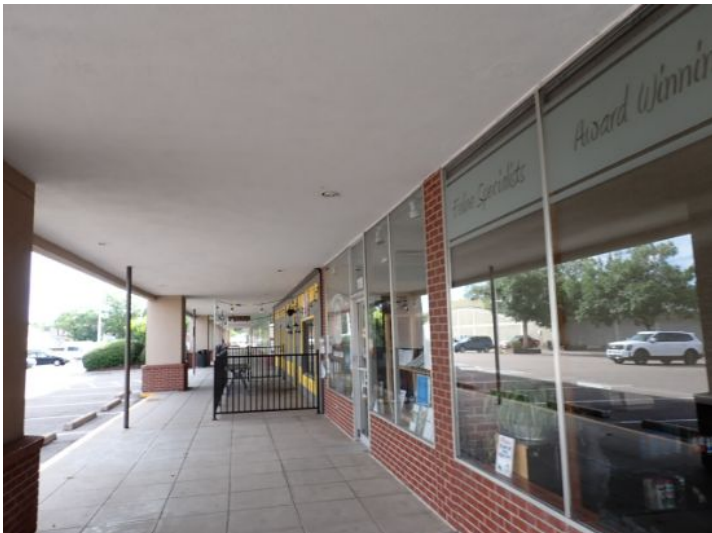
The majority of the exterior envelope of the structure appeared to be in fair condition with no significant structural movement noted at the time of the inspection.

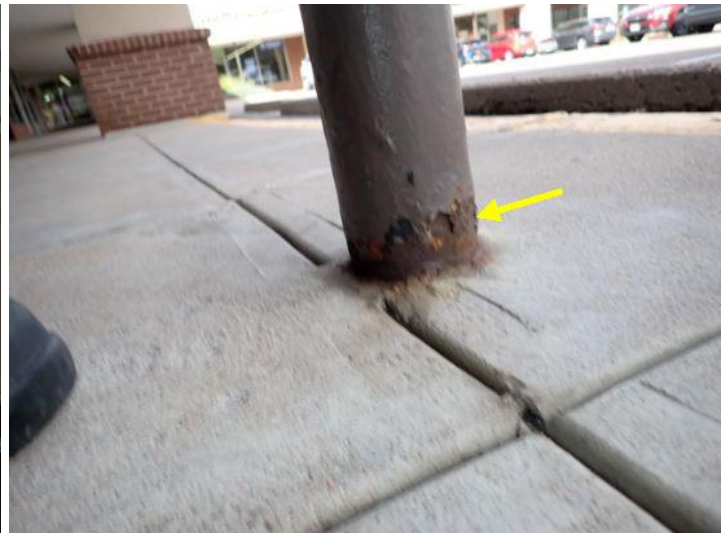
Minor rusting noted on some of the steel support posts for the front overhangs. Recommend repairs by a licensed contractor.

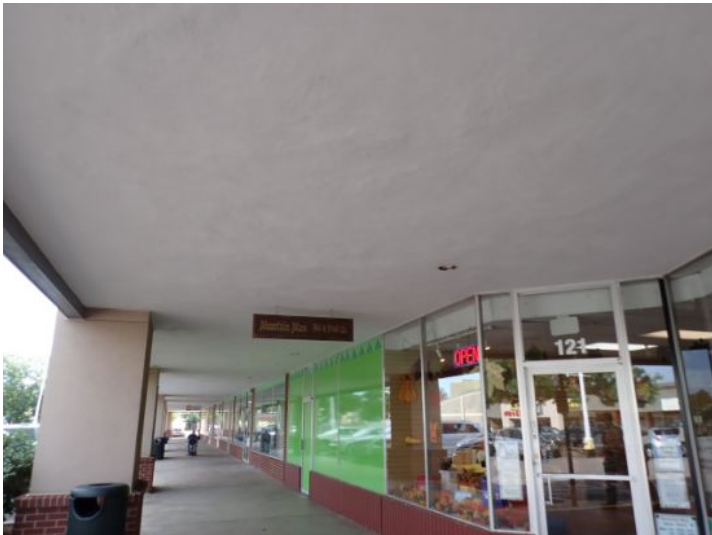
The majority of the exterior envelope of the structure appeared to be in fair condition with no significant structural movement noted at the time of the inspection.

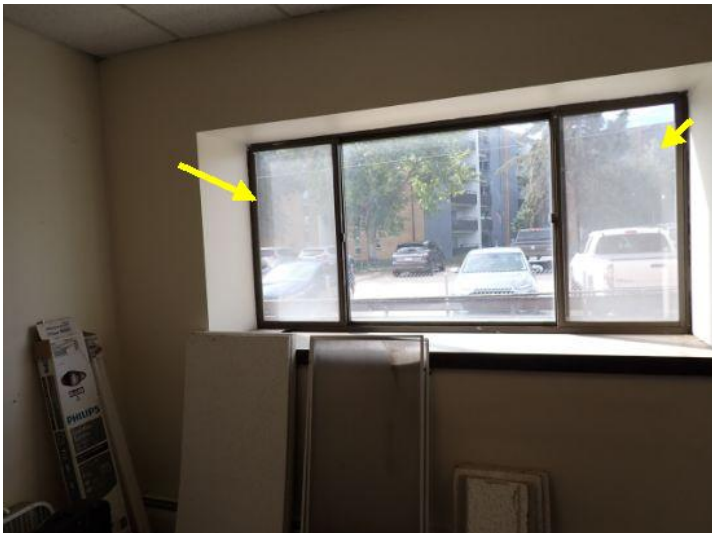
Failed seals noted in multiple insulated window units at the time of the inspection. Recommend repairs by a licensed contractor.

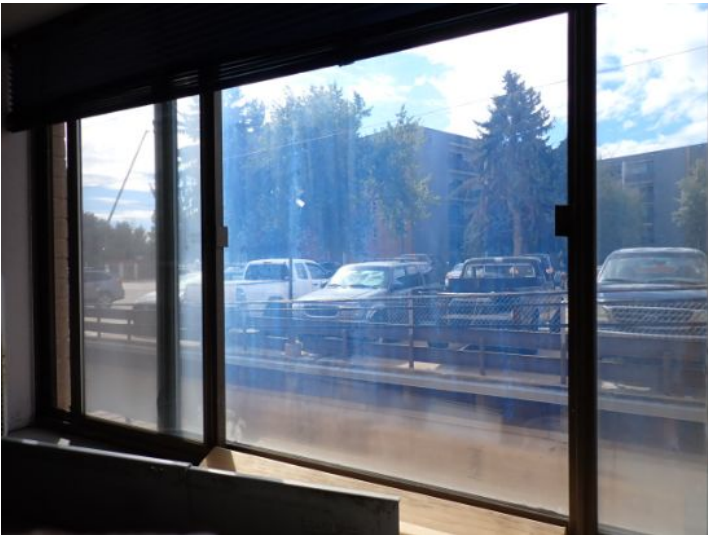
Failed seals noted in multiple insulated window units at the time of the inspection. Recommend repairs by a licensed contractor.

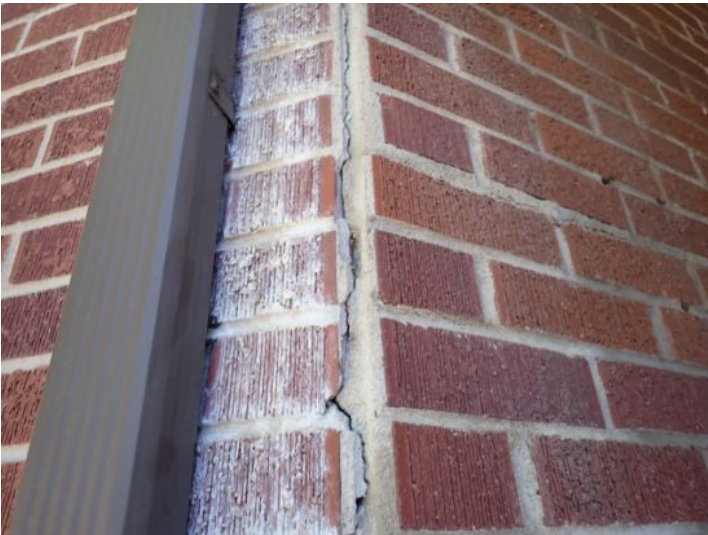
Minor brick damaged and movement noted in the brick siding material at the awning area between the structures. Recommend repairs by a licensed contractor.

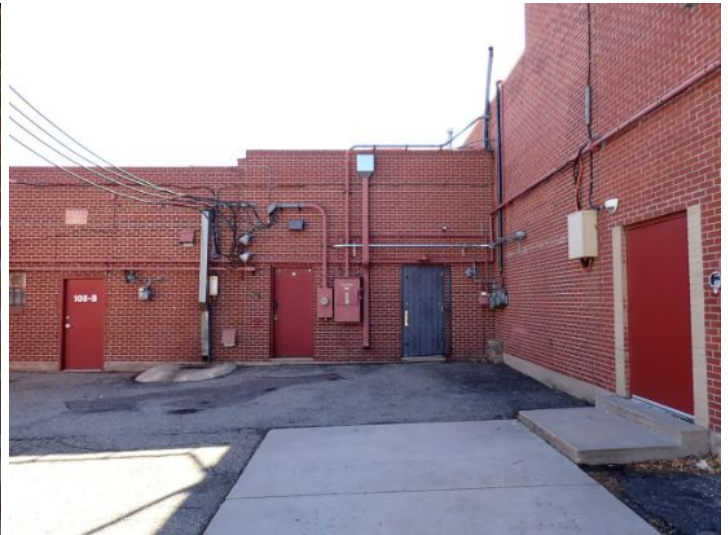
The majority of the exterior envelope of the structure appeared to be in fair condition with no significant structural movement noted at the time of the inspection.

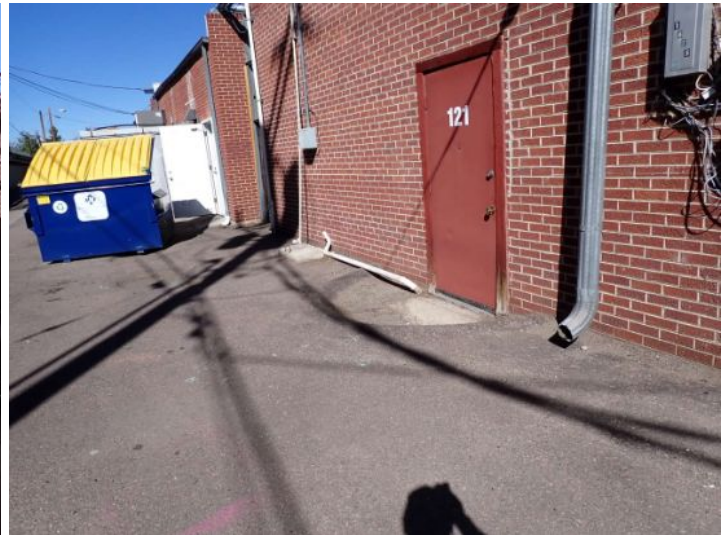
The majority of the exterior envelope of the structure appeared to be in fair condition with no significant structural movement noted at the time of the inspection.

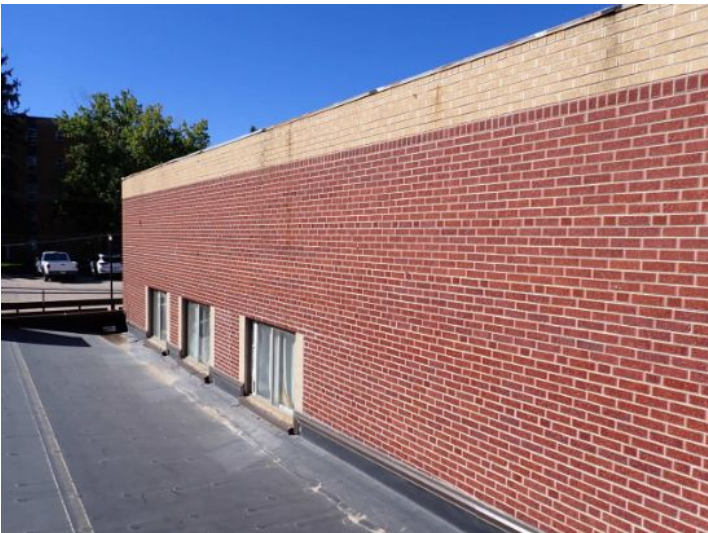
The majority of the exterior envelope of the structure appeared to be in fair condition with no significant structural movement noted at the time of the inspection.

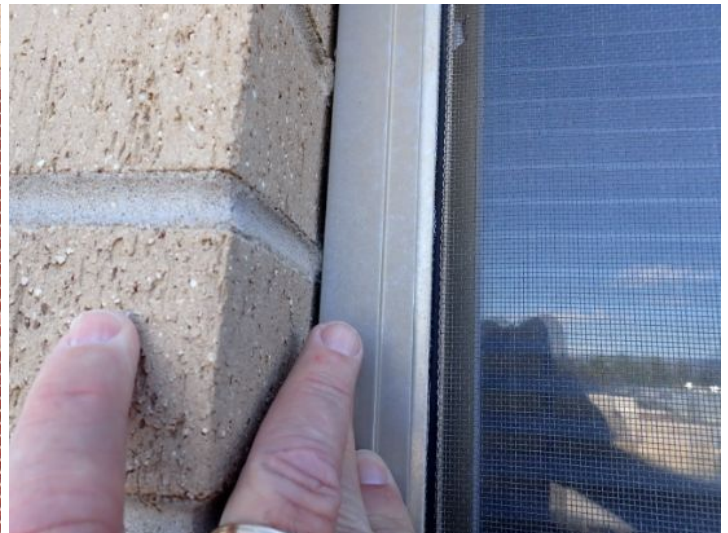
The majority of the exterior envelope of the structure appeared to be in fair condition with no significant structural movement noted at the time of the inspection.

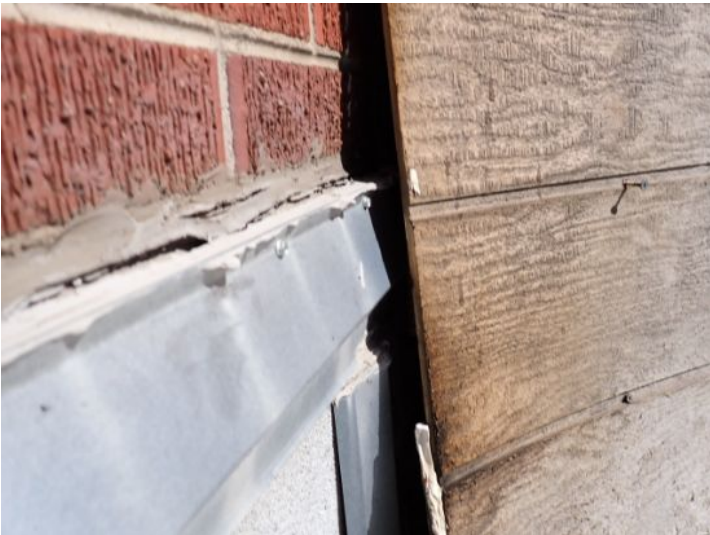
Any area where two separate substrates meet should be properly caulked and sealed. Recommend repairs as needed by a licensed contractor.

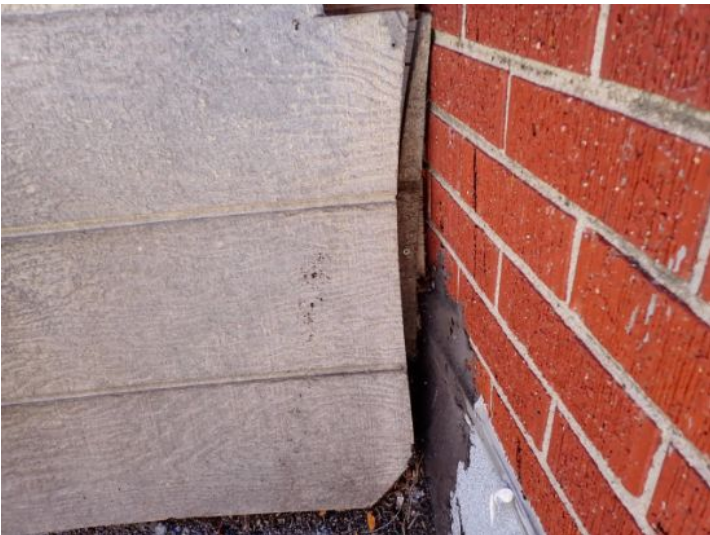
The wood siding material located above the corner awning roof on the ends of the pitched roof sections were in poor condition at the time of the inspection. Recommend repairs by a licensed contractor.

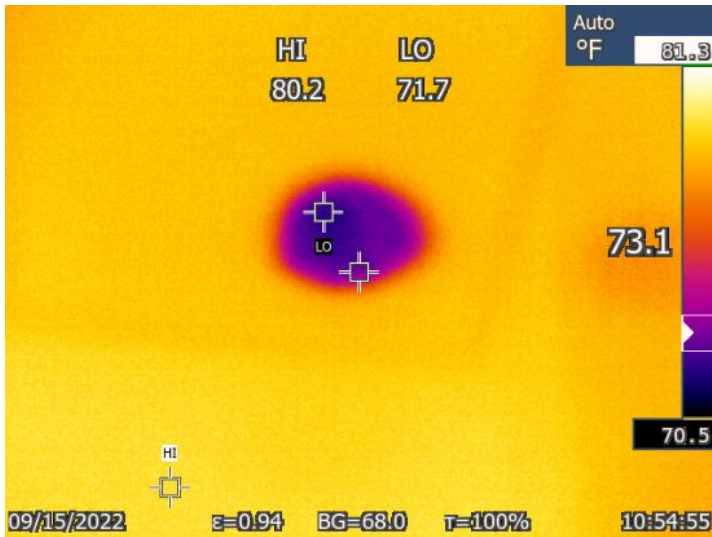
- Active roof leaks noted in multiple units at the time of the inspection. Recommend repair/replacement as needed by a licensed contractor.
- The BUR roofing system located on the east end of the south wing of the building is showing signs of excessive wear excessive ponding it was an extremely poor condition at the time of the inspection. Recommend replacement by a licensed contractor.

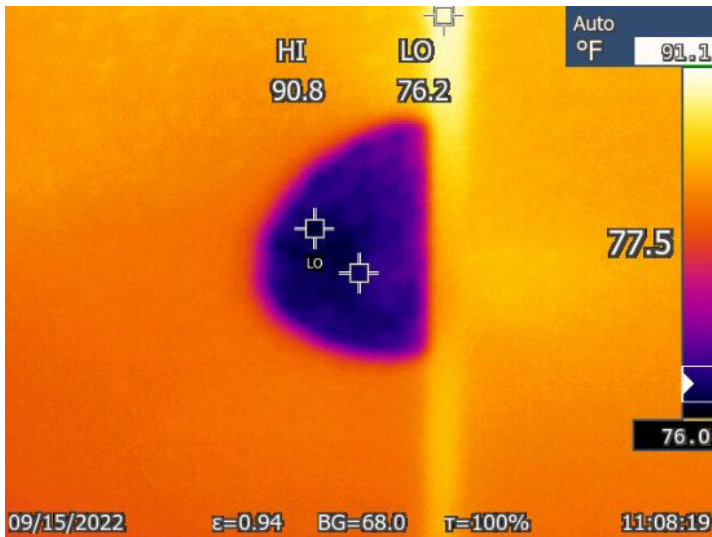
Active roof leaks noted in multiple units at the time of the inspection. Recommend repair/replacement as needed by a licensed contractor.

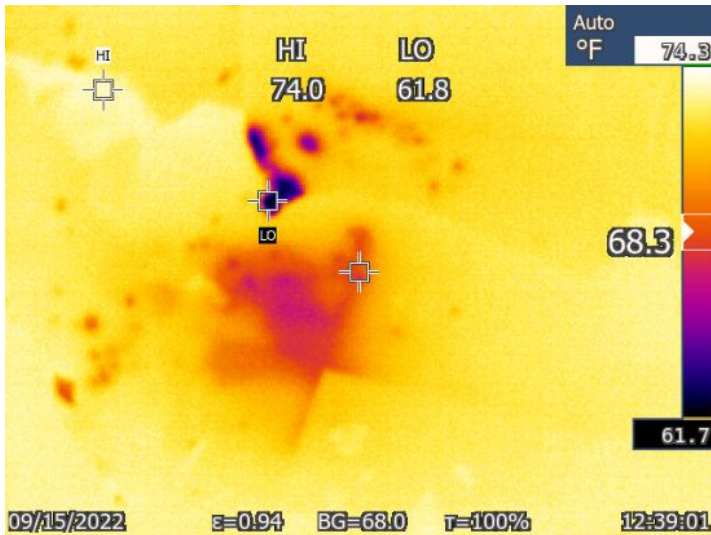
Active roof leaks noted in multiple units at the time of the inspection. Recommend repair/replacement as needed by a licensed contractor.

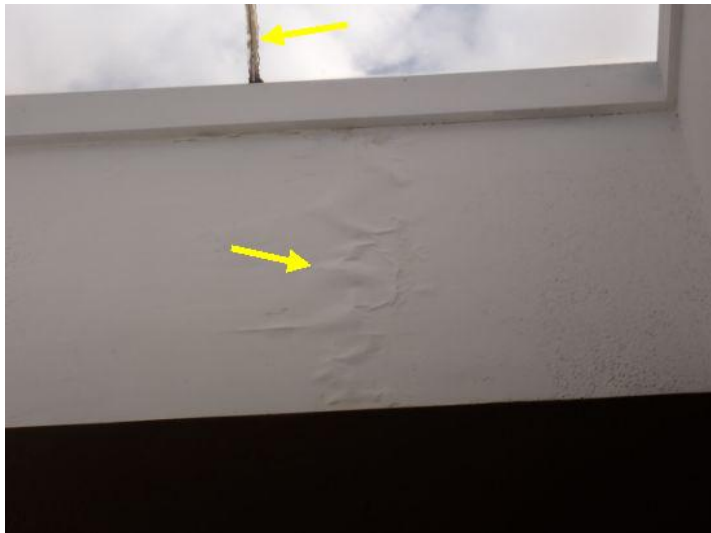
Active roof leaks noted in multiple units at the time of the inspection. Recommend repair/replacement as needed by a licensed contractor.

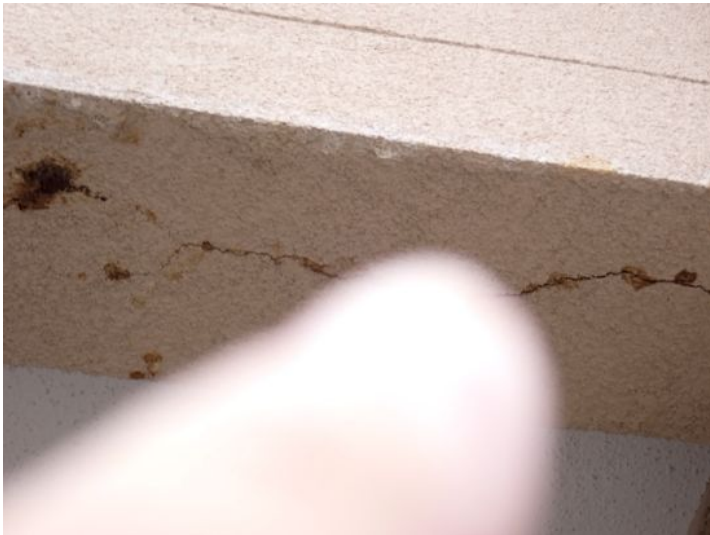
Active roof leaks noted in multiple units at the time of the inspection. Recommend repair/replacement as needed by a licensed contractor.

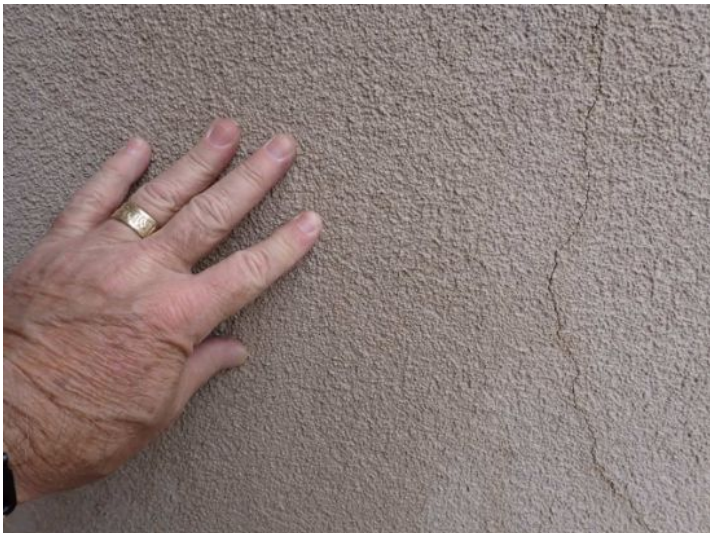
Due to flashing issues storm water was getting into one of the stucco awning support pillars and running down the inside of the system. Recommend repairs as needed by a licensed contractor.

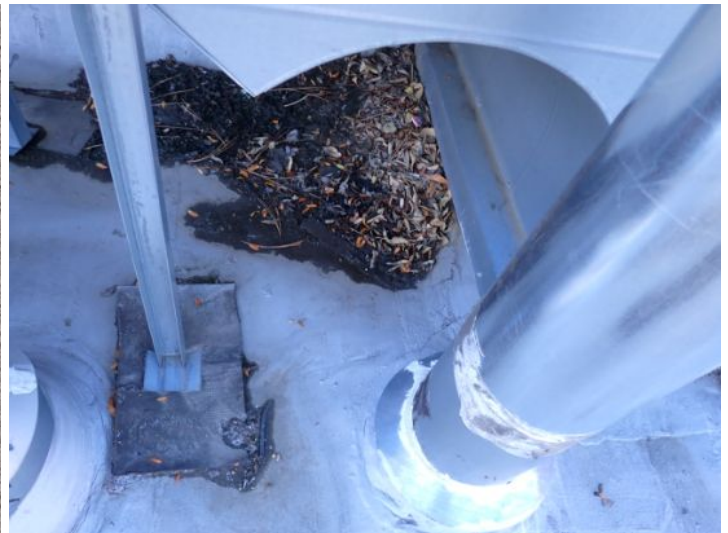
Due to flashing issues storm water was getting into one of the stucco awning support pillars and running down the inside of the system. Recommend repairs as needed by a licensed contractor.

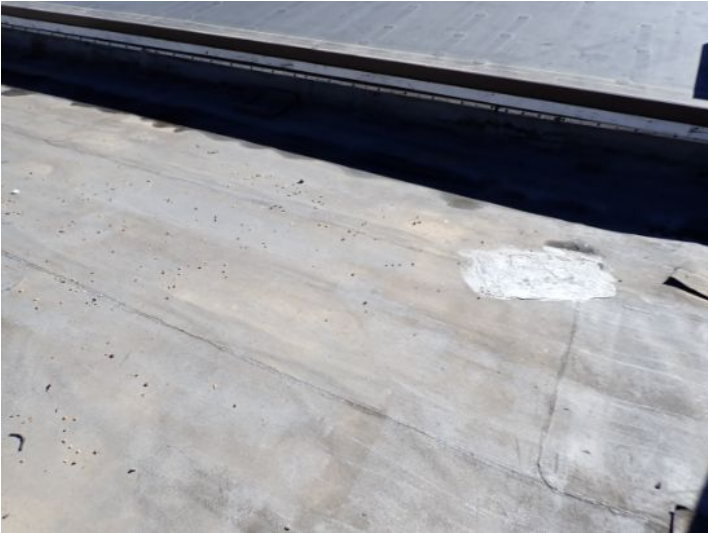
The rolled torch down roofing system located above the east end of the south wing appear did reach the end of its serviceable life expectancy with areas of significant ponding and cracking noted. Recommend repairs/replacement by licensed contractor.

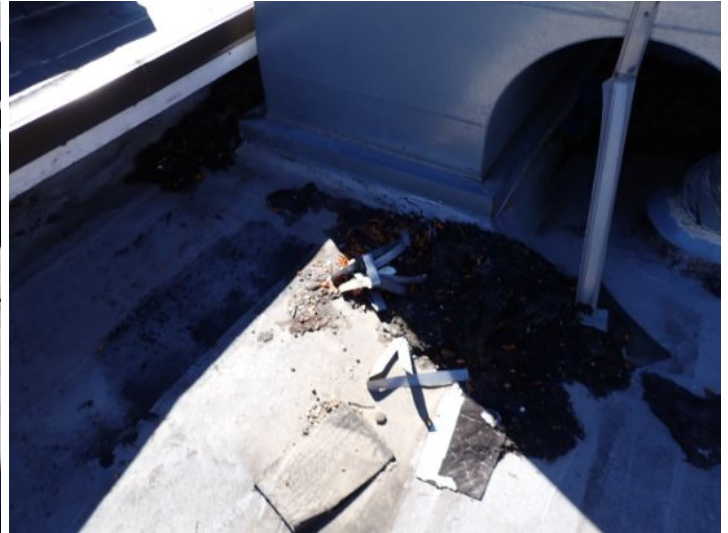
The rolled torch down roofing system located above the east end of the south wing appear did reach the end of its serviceable life expectancy with areas of significant ponding and cracking noted. Recommend repairs/replacement by licensed contractor.

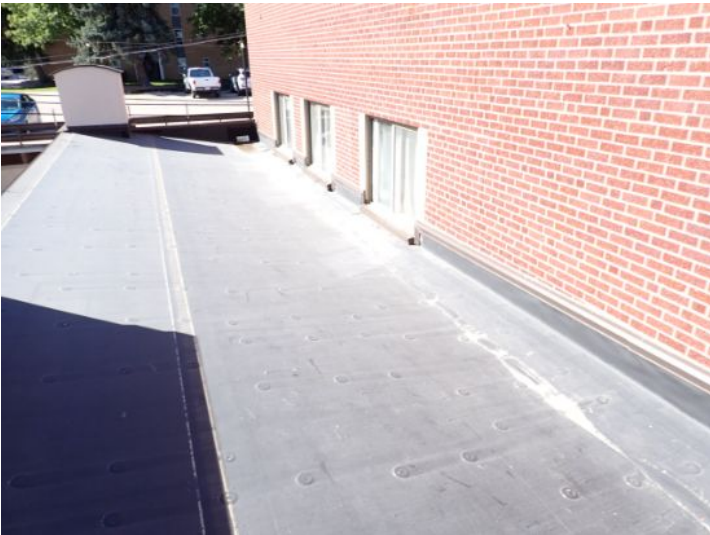
The EPDM membrane on the low slope front sections of each wing appeared be in fair condition at time of inspection. There were areas where it appeared that debris below the membrane was attempting to push through the membrane but had not penetrated at the time of the inspection. Recommend monitoring for future repairs.

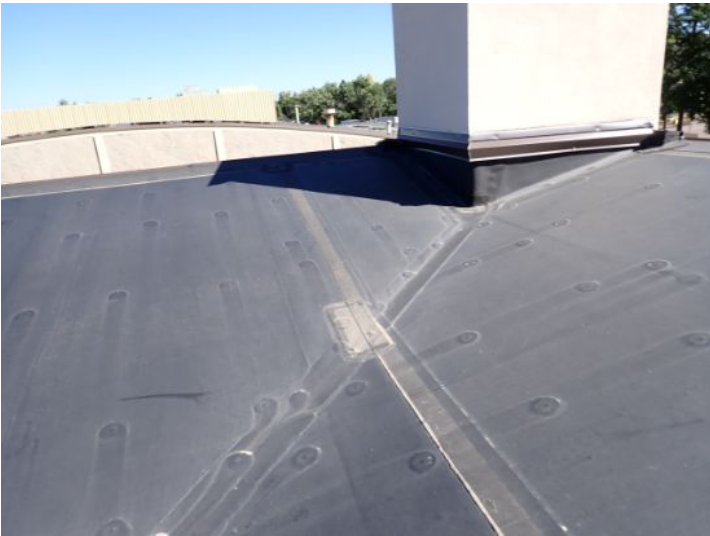
The EPDM membrane on the low slope front sections of each wing appeared be in fair condition at time of inspection. There were areas where it appeared that debris below the membrane was attempting to push through the membrane but had not penetrated at the time of the inspection. Recommend monitoring for future repairs.

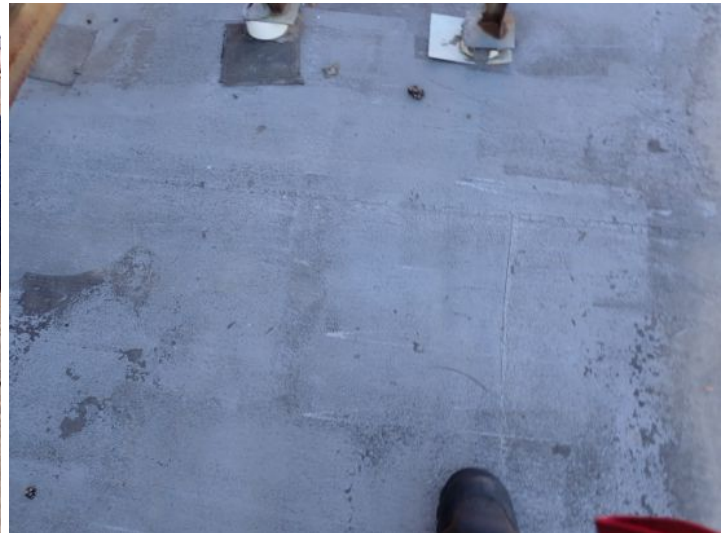
The rolled torch down roofing system located above the east end of the south wing appeared to have reached the end of its serviceable life expectancy with areas of significant ponding and cracking noted. Recommend repairs/replacement by licensed contractor.

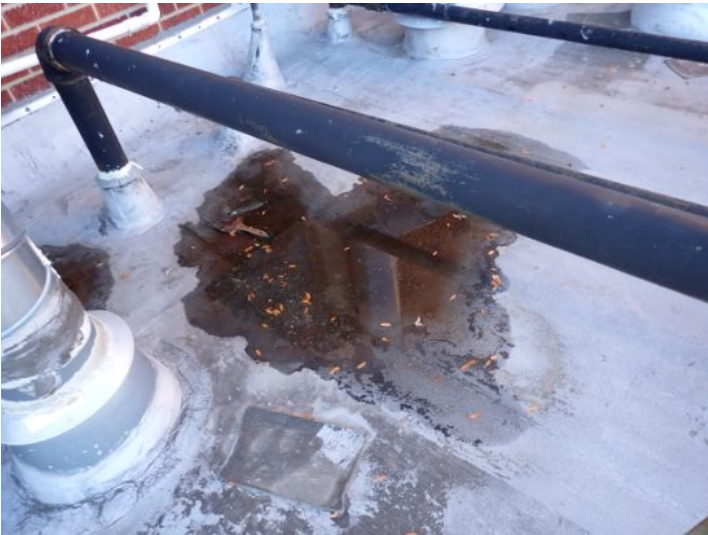
The rolled torch down roofing system located above the east end of the south wing appeared to have reached the end of its serviceable life expectancy with areas of significant ponding and cracking noted. Recommend repairs/replacement by licensed contractor.

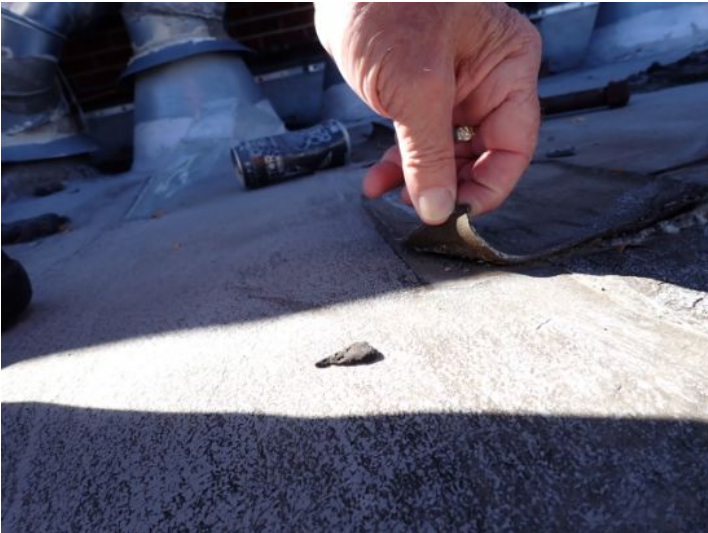
The rolled torch down roofing system located above the east end of the south wing appeared to have reached the end of its serviceable life expectancy with areas of significant ponding and cracking noted. Recommend repairs/replacement by licensed contractor.

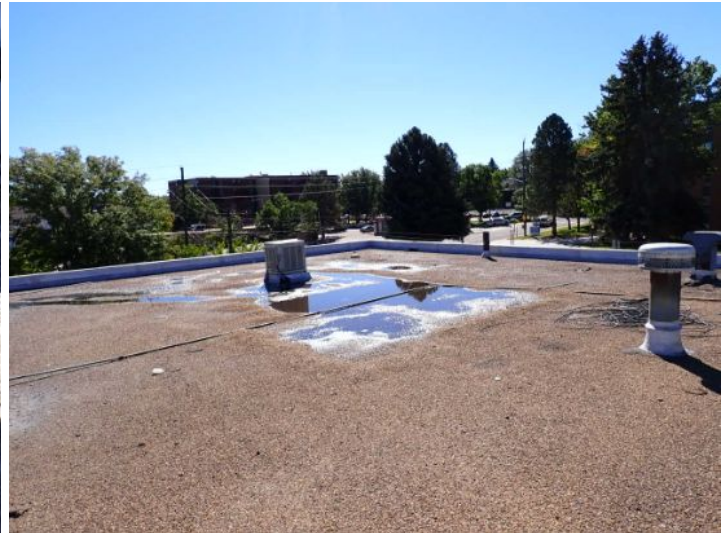
The rolled torch down roofing system located above the east end of the south wing appeared to have reached the end of its serviceable life expectancy with areas of significant ponding and cracking noted. Recommend repairs/replacement by licensed contractor.

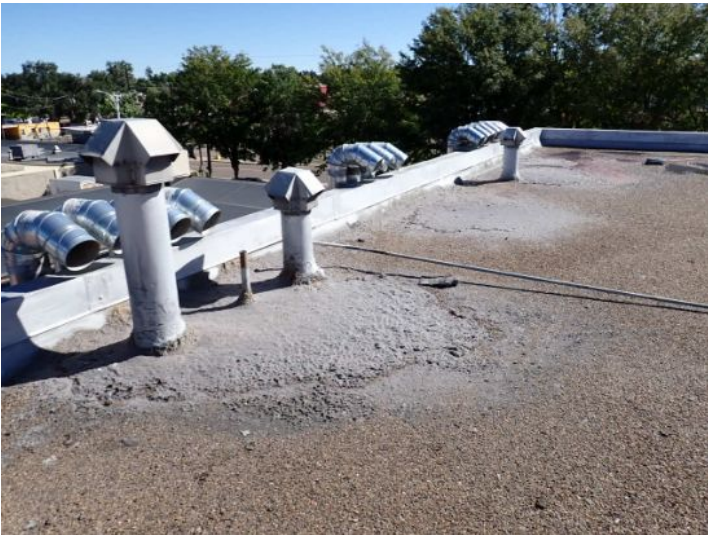
The BUR roofing system located on the east end of the south wing of the building is showing signs of excessive wear excessive ponding it was an extremely poor condition at the time of the inspection. Recommend replacement by a licensed contractor.

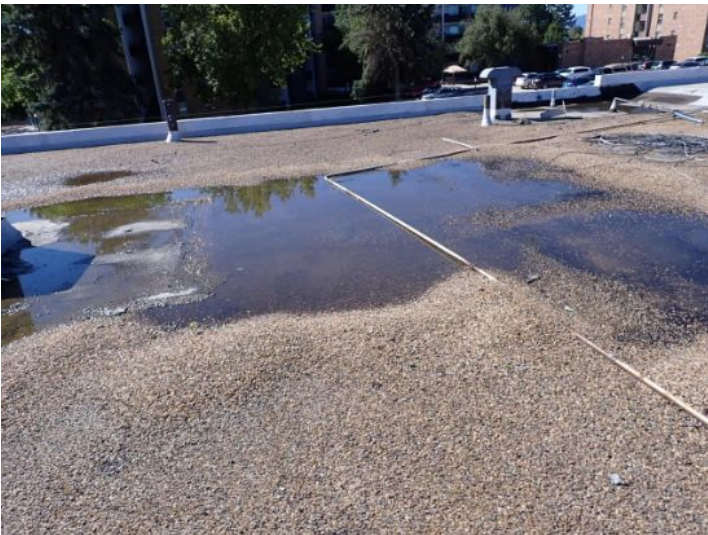
The BUR roofing system located on the east end of the south wing of the building is showing signs of excessive wear excessive ponding it was an extremely poor condition at the time of the inspection. Recommend replacement by a licensed contractor.

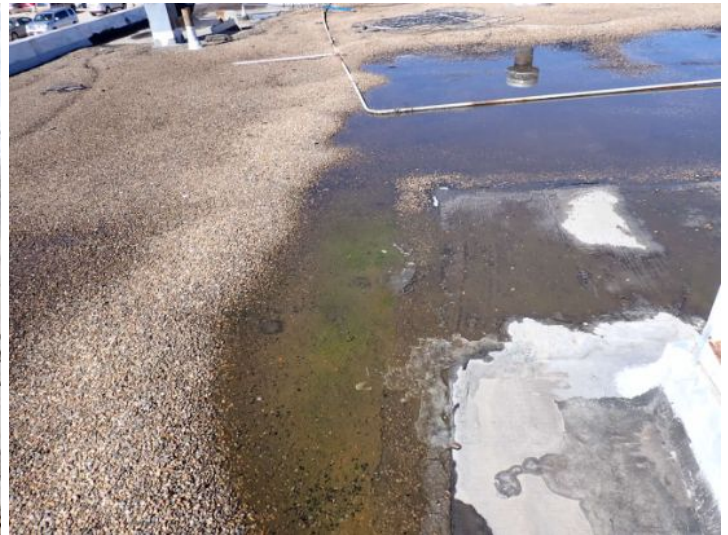
The rolled torch down roofing system above what used to be the old theater it is now currently being used as the office area appeared to be original to the structure and was showing signs of hail damage excessive ponding where and patching. Recommend replacement by licensed contractor.

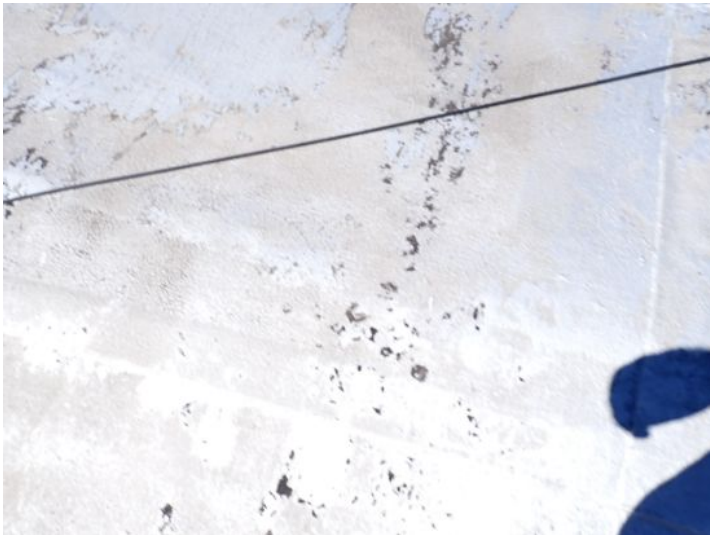
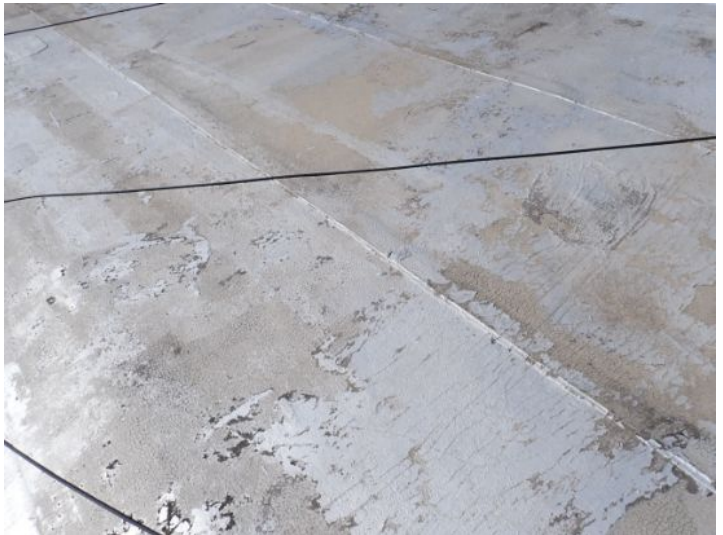
The rolled torch down roofing system above what used to be the old theater it is now currently being used as the office area appeared to be original to the structure and was showing signs of hail damage excessive ponding where and patching. Recommend replacement by licensed contractor.

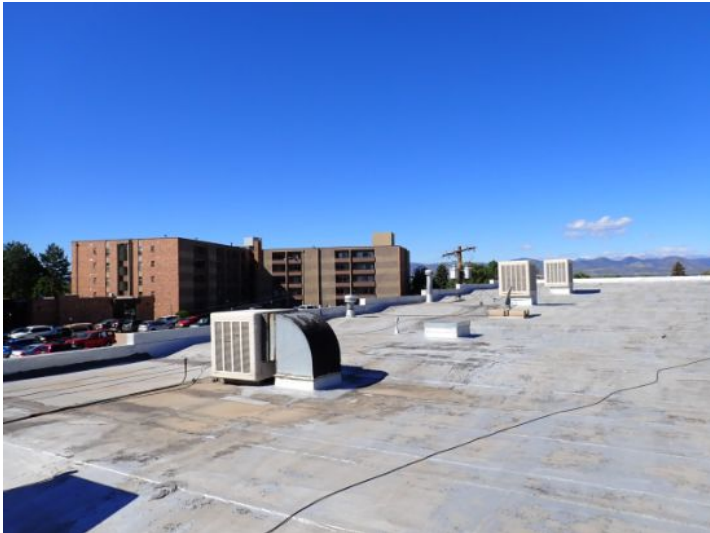
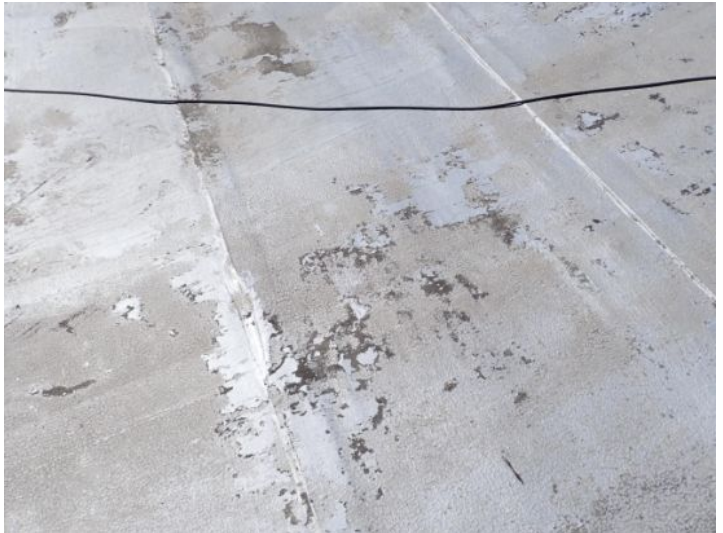
The rolled torch down roofing system above what used to be the old theater it is now currently being used as the office area appeared to be original to the structure and was showing signs of hail damage excessive ponding where and patching. Recommend replacement by licensed contractor.

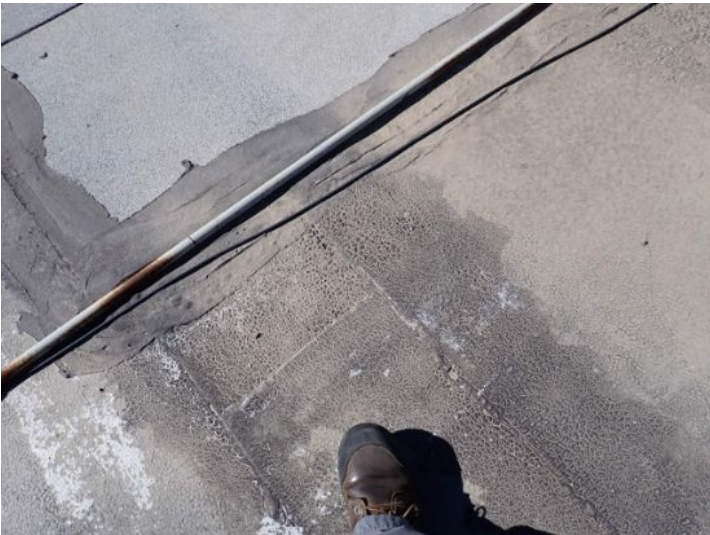
The rolled torch down roofing system above what used to be the old theater it is now currently being used as the office area appeared to be original to the structure and was showing signs of hail damage excessive ponding where and patching. Recommend replacement by licensed contractor.

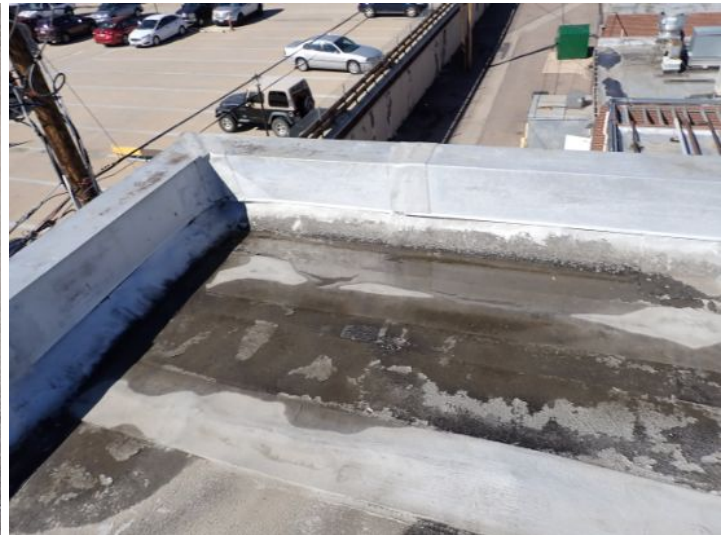
The rolled torch down roofing system above what used to be the old theater it is now currently being used as the office area appeared to be original to the structure and was showing signs of hail damage excessive ponding where and patching. Recommend replacement by licensed contractor.
