# *Forman Inspection Services, LLC*

## Property Inspection Report

1234 Retail St., Somewhere, CO 12345

Date of Inspection: 9/16/2022 Time: 10:00 Size: 93,886 sq. ft. per listing

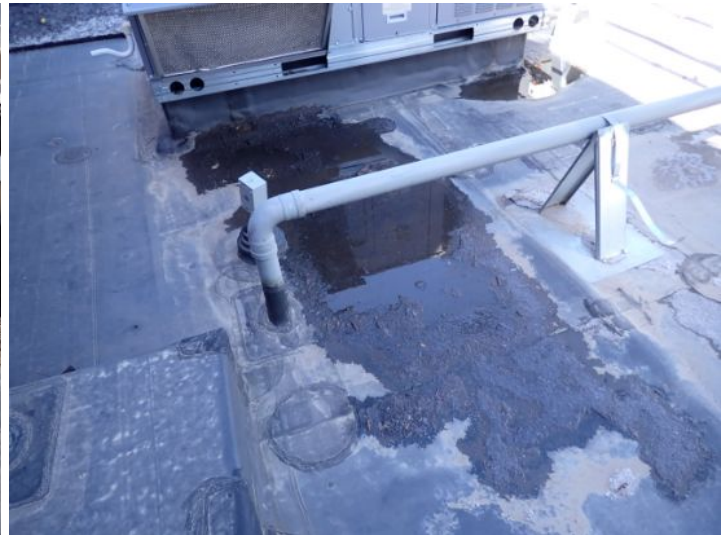
The EPDM roofing membrane located on the lower level of the south wing appeared to be in fair condition at the time of the inspection but was showing signs of excessive ponding and minor seam issues in areas. Recommend repairs as required by a licensed contractor.

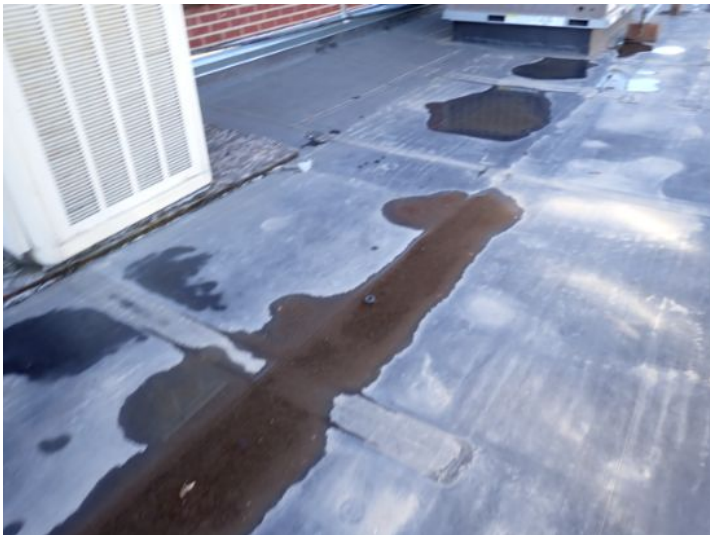
The EPDM roofing membrane located on the lower level of the south wing appeared to be in fair condition at the time of the inspection but was showing signs of excessive ponding and minor seam issues in areas. Recommend repairs as required by a licensed contractor.

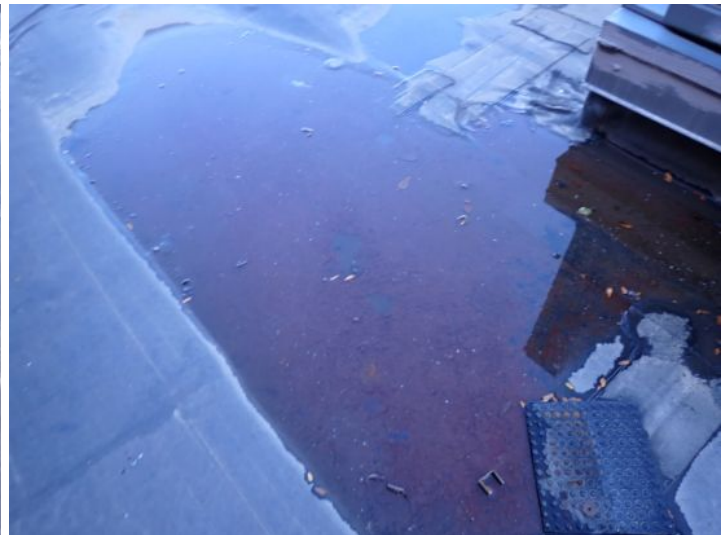
The EPDM roofing membrane located on the lower level of the south wing appeared to be in fair condition at the time of the inspection but was showing signs of excessive ponding and minor seam issues in areas. Recommend repairs as required by a licensed contractor.

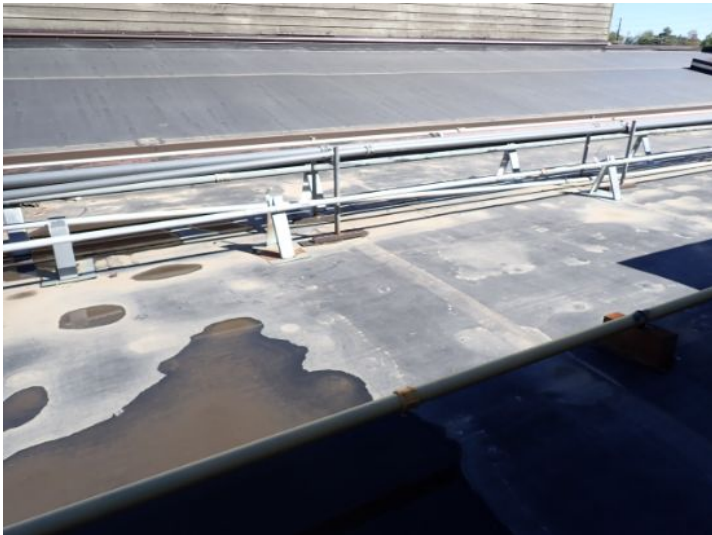
The EPDM roofing membrane located on the lower level of the south wing appeared to be in fair condition at the time of the inspection but was showing signs of excessive ponding and minor seam issues in areas. Recommend repairs as required by a licensed contractor.

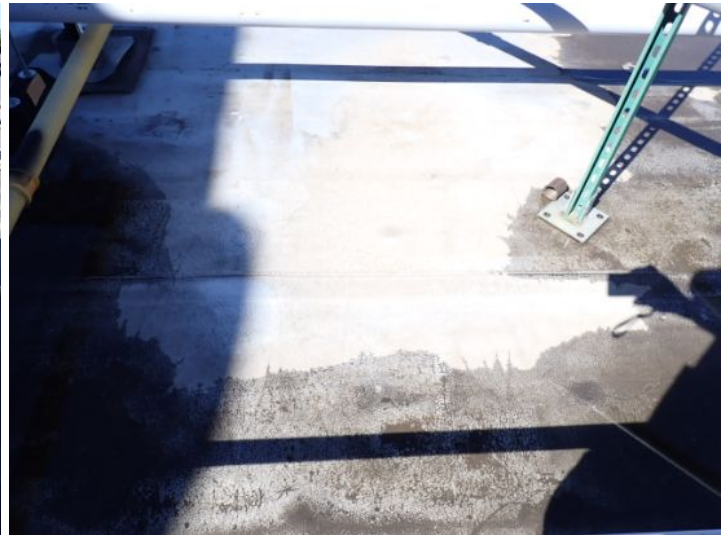
The EPDM roofing membrane located on the lower level of the south wing appeared to be in fair condition at the time of the inspection but was showing signs of excessive ponding and minor seam issues in areas. Recommend repairs as required by a licensed contractor.

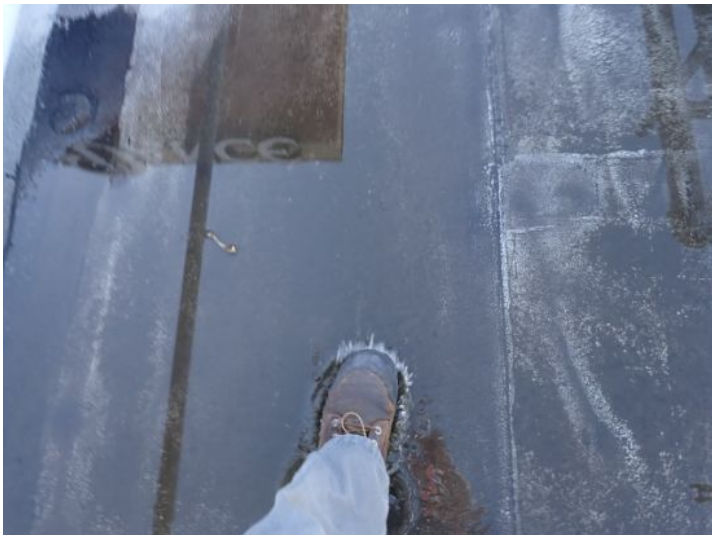
The rolled torch down roofing system located on the lower level south wing of the structure showing signs of excessive deferred maintenance, excessive ponding, possible hail damage and age. Recommend complete replacement by licensed contractor.

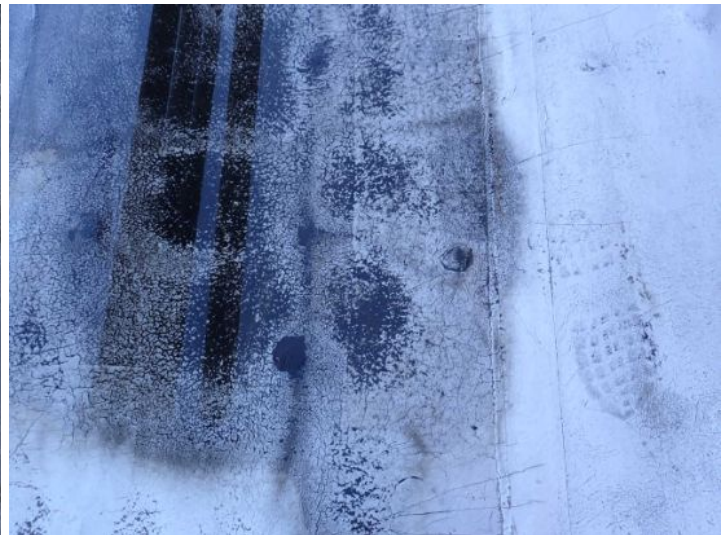
The rolled torch down roofing system located on the lower level south wing of the structure showing signs of excessive deferred maintenance, excessive ponding, possible hail damage and age. Recommend complete replacement by licensed contractor.

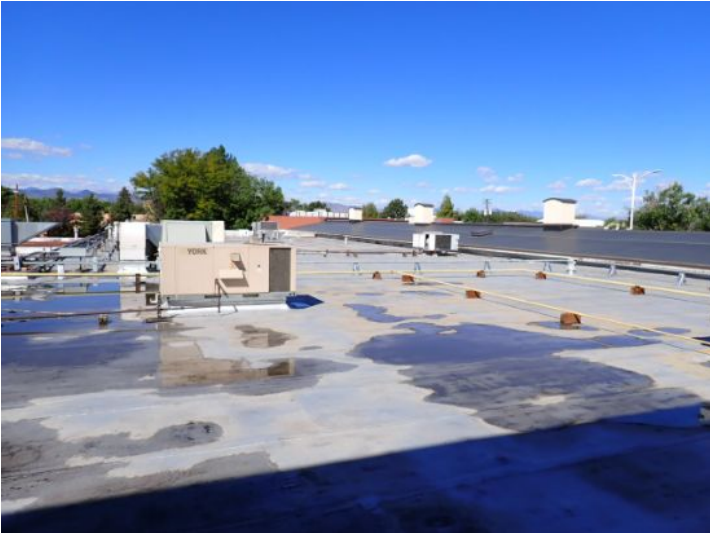
The rolled torch down roofing system located above the east end of the south wing appeared to have reached the end of its serviceable life expectancy with areas of significant ponding and cracking noted. Recommend repairs/replacement by licensed contractor.

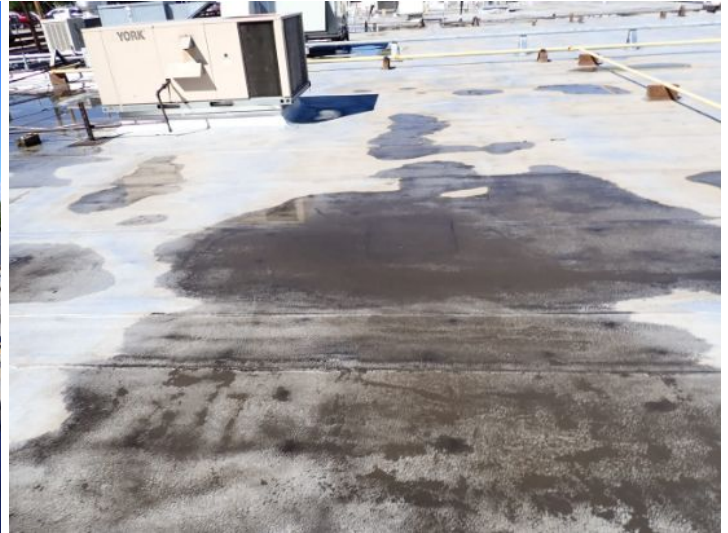
The rolled torch down roofing system located on the lower level south wing of the structure showing signs of excessive deferred maintenance, excessive ponding, possible hail damage and age. Recommend complete replacement by licensed contractor.

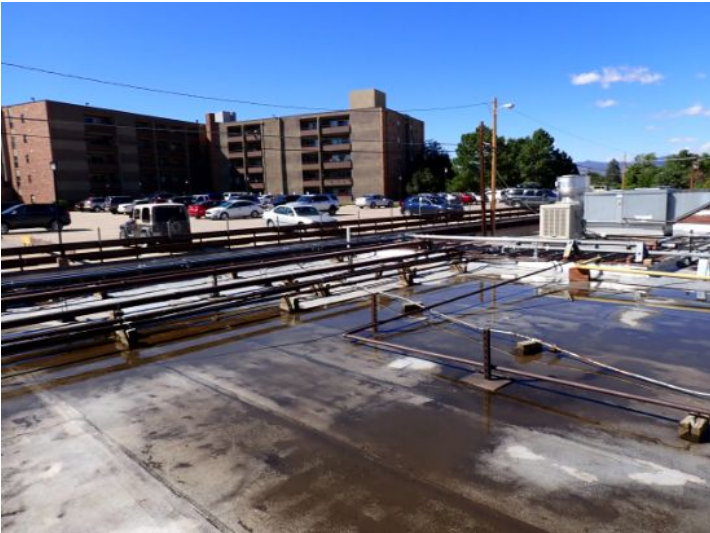
The rolled torch down roofing system located on the lower level south wing of the structure showing signs of excessive deferred maintenance, excessive ponding, possible hail damage and age. Recommend complete replacement by licensed contractor.

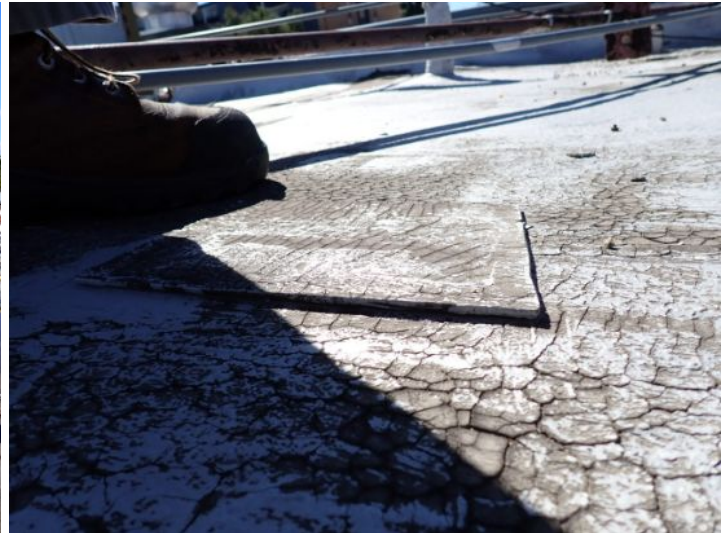
The rolled torch down roofing system located on the lower level south wing of the structure showing signs of excessive deferred maintenance, excessive ponding, possible hail damage and age. Recommend complete replacement by licensed contractor.

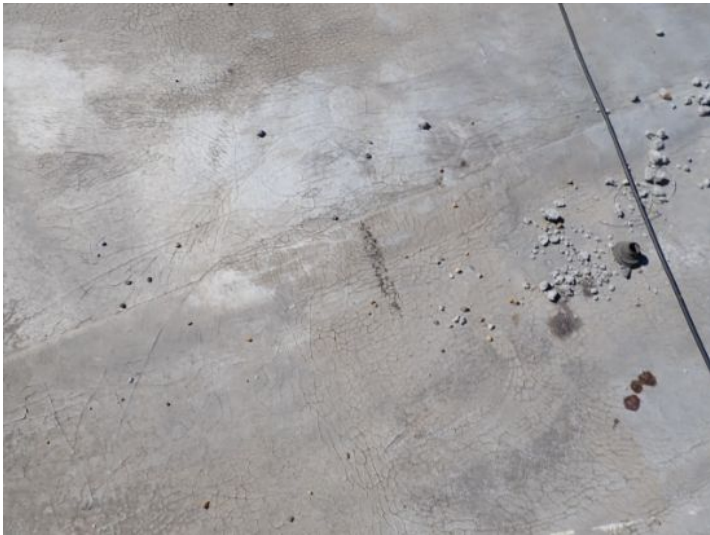
The rolled torch down roofing system located on the lower level south wing of the structure showing signs of excessive deferred maintenance, excessive ponding, possible hail damage and age. Recommend complete replacement by licensed contractor.

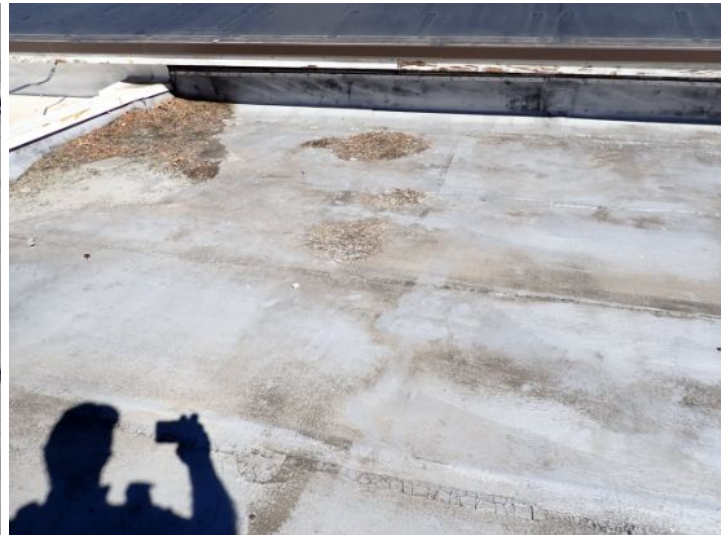
The rolled torch down roofing system located on the lower level south wing of the structure showing signs of excessive deferred maintenance, excessive ponding, possible hail damage and age. Recommend complete replacement by licensed contractor.

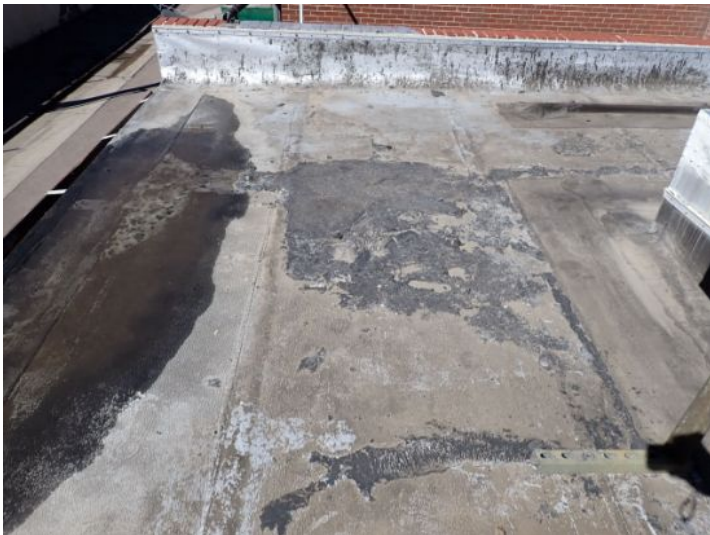
The rolled torch down roofing system located on the lower level south wing of the structure showing signs of excessive deferred maintenance, excessive ponding, possible hail damage and age. Recommend complete replacement by licensed contractor.

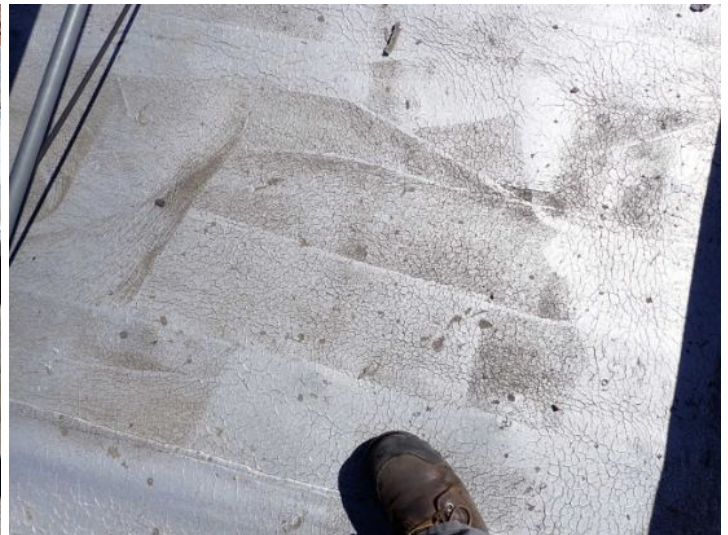
The rolled torch down roofing system located on the lower level south wing of the structure showing signs of excessive deferred maintenance, excessive ponding, possible hail damage and age. Recommend complete replacement by licensed contractor.

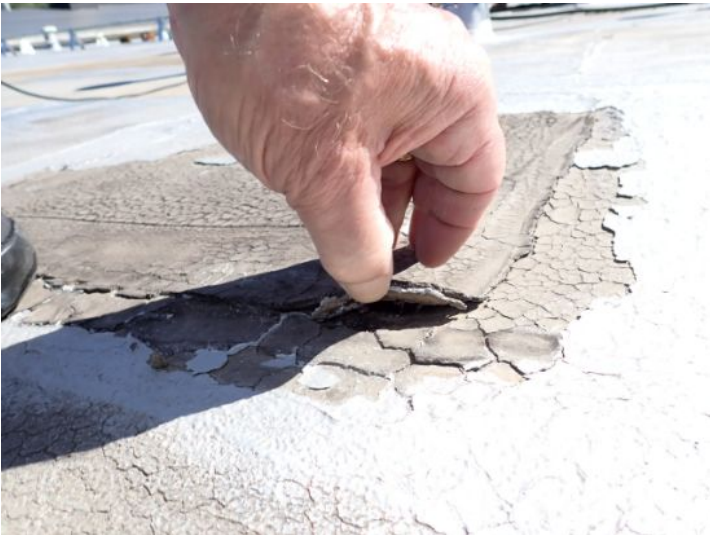
The rolled torch down roofing system located on the lower level south wing of the structure showing signs of excessive deferred maintenance, excessive ponding, possible hail damage and age. Recommend complete replacement by licensed contractor.

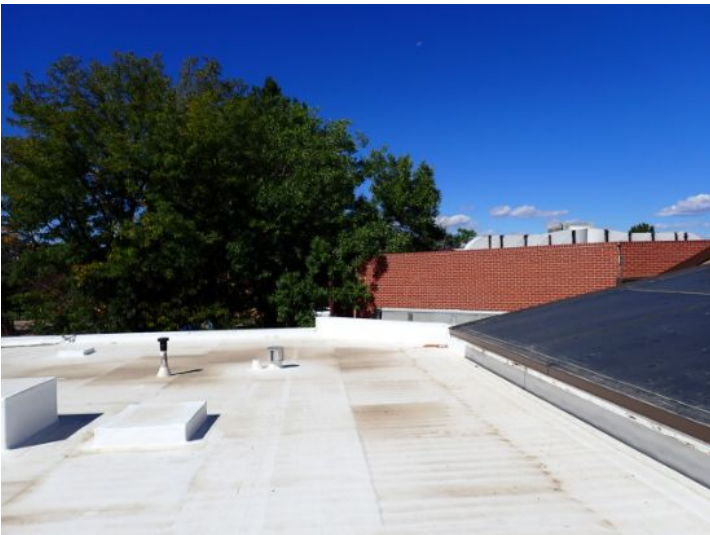
The TPO membrane located above the lower level west end of the south unit appeared to be in fair condition at time of inspection.

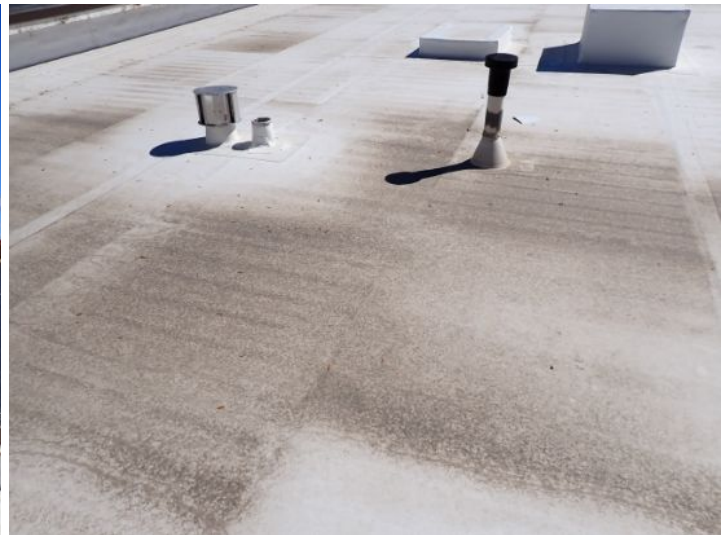
The TPO membrane located above the lower level west end of the south unit appeared to be in fair condition at time of inspection.

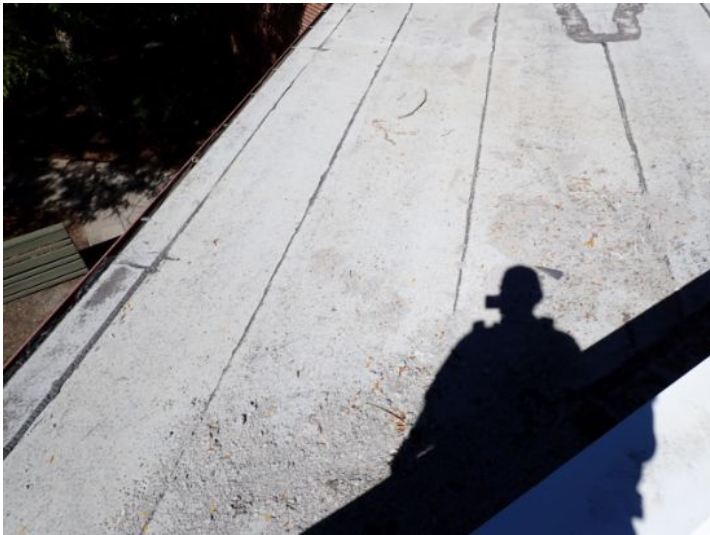
The TPO membrane located above the lower level west end of the south unit appeared to be in fair condition at time of inspection.

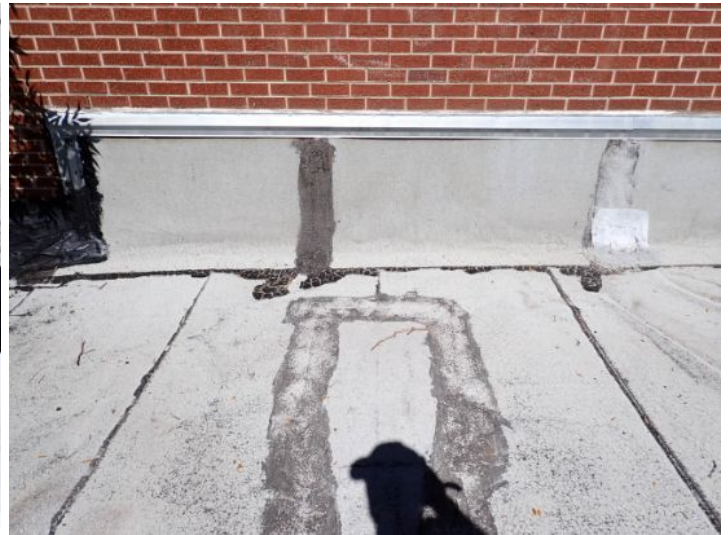
The rolled asphalt composition roof and system located above the awning between the two wings was in extremely poor condition why is it a plate replacement. Recommend repair by a licensed contractor.

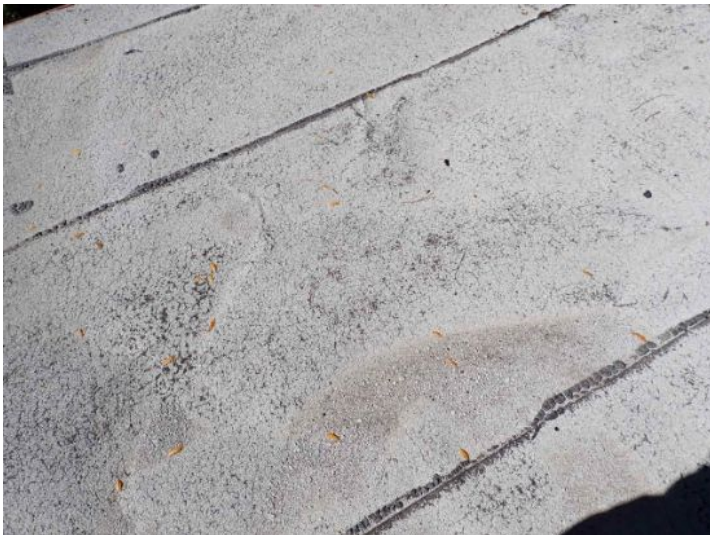
The rolled asphalt composition roof and system located above the awning between the two wings was in extremely poor condition why is it a plate replacement. Recommend repair by a licensed contractor.

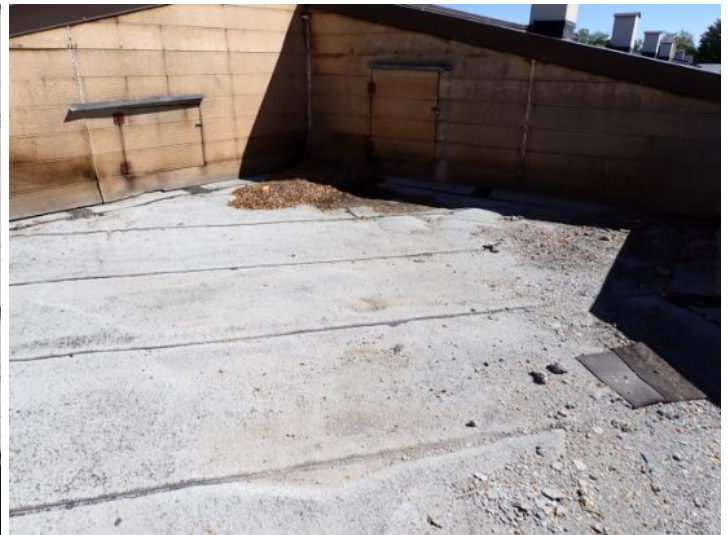
The rolled asphalt composition roof and system located above the awning between the two wings was in extremely poor condition why is it a plate replacement. Recommend repair by a licensed contractor.

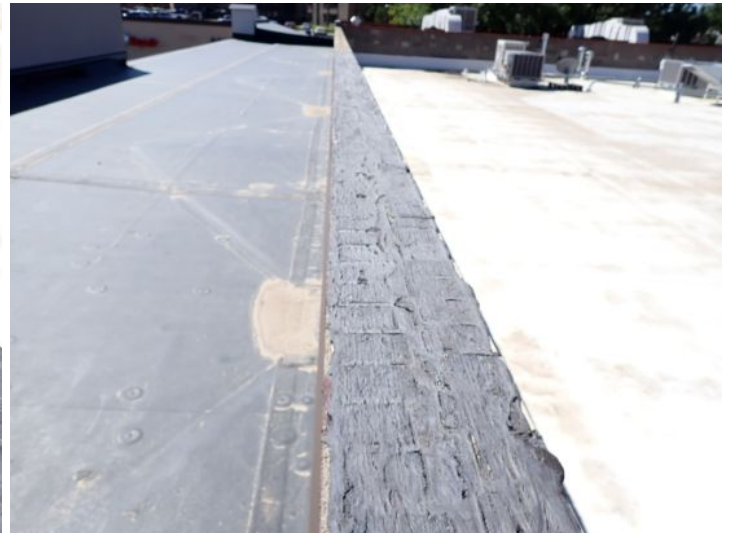
Recommend capping of all brick/block parapet walls with metal capping material. Recommend repairs by a licensed contractor.

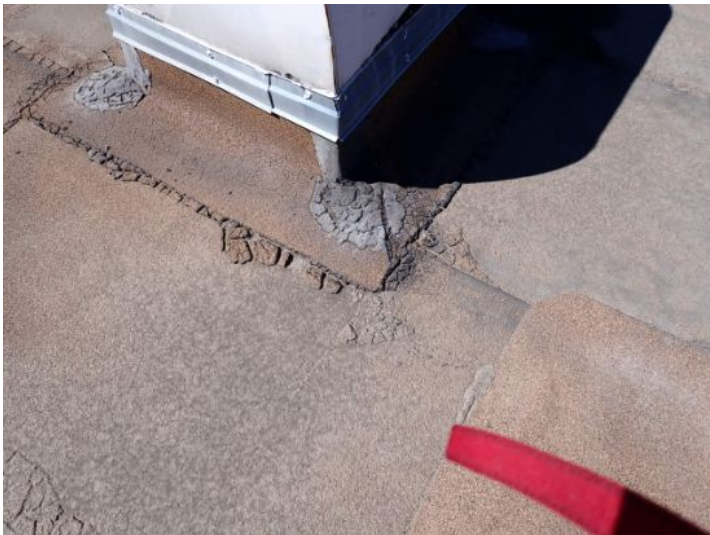
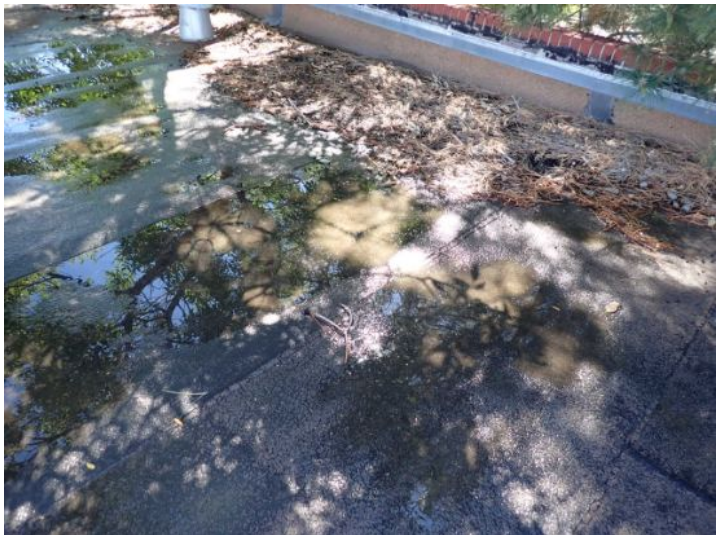
The rolled asphalt composition roofing system located above the south end of the west wing was in poor condition with excessive ponding, deferred maintenance, excessive debris and excessive granular loss at the time of the inspection. Recommend complete replacement by licensed roofing contractor.

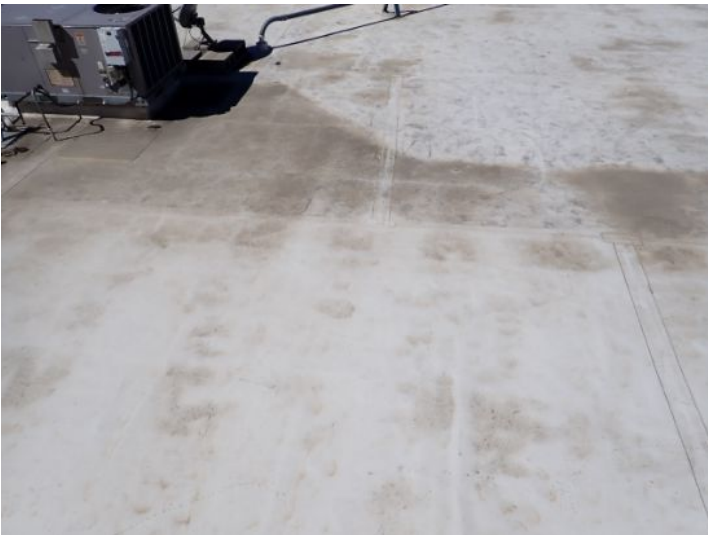
TPO roofing membrane located above the mall area of the property while appearing to be in fair condition was showing signs of excessive deferred maintenance and ponding at the time of the inspection. Recommend repairs by licensed contractor.

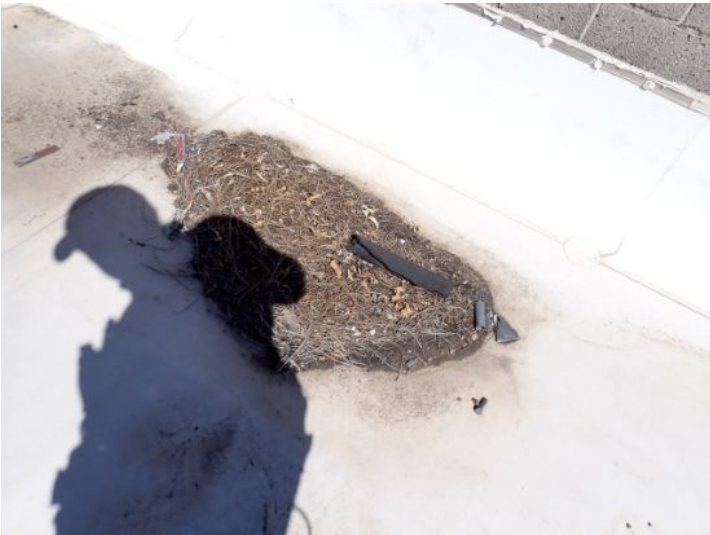
Recommend capping of all brick/block parapet walls with metal capping material. Recommend repairs by a licensed contractor.

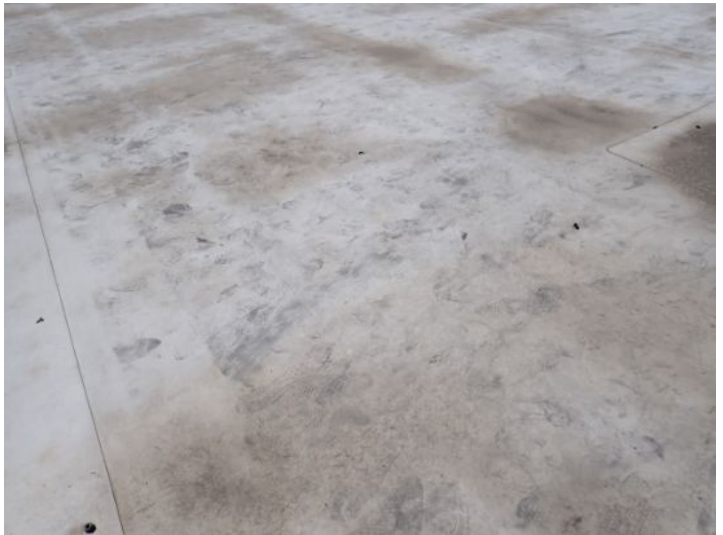
TPO roofing membrane located above the mall area of the property while appearing to be in fair condition was showing signs of excessive deferred maintenance and ponding at the time of the inspection. Recommend repairs by licensed contractor.

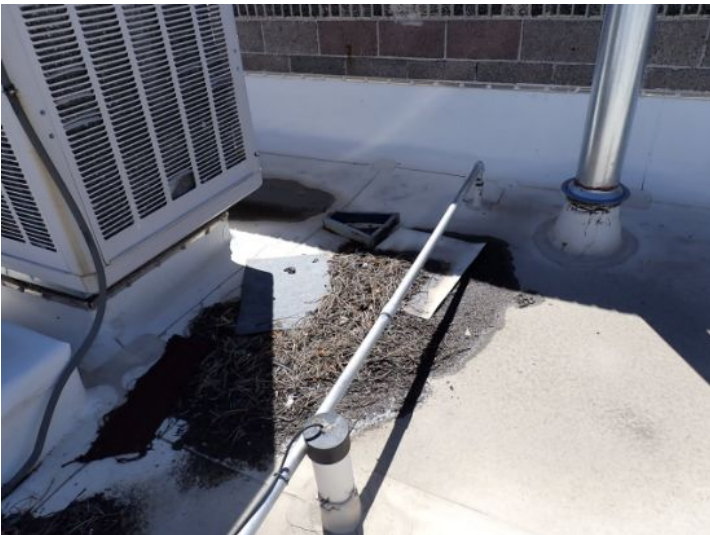
TPO roofing membrane located above the mall area of the property while appearing to be in fair condition was showing signs of excessive deferred maintenance and ponding at the time of the inspection. Recommend repairs by licensed contractor.

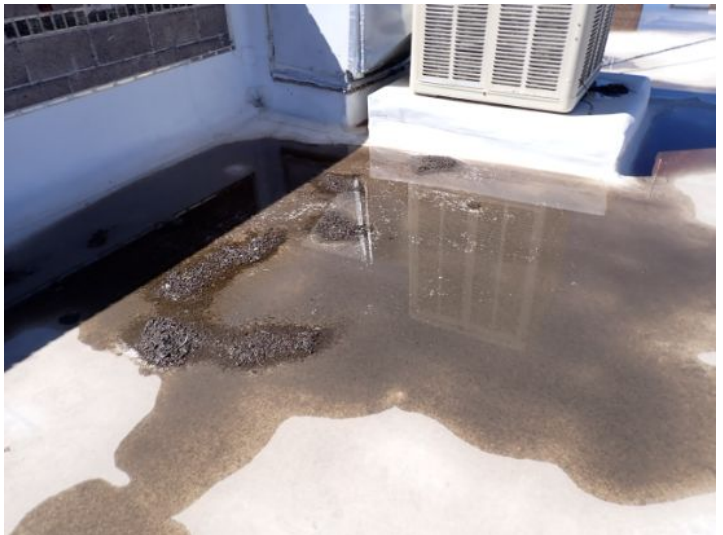
TPO roofing membrane located above the mall area of the property while appearing to be in fair condition was showing signs of excessive deferred maintenance and ponding at the time of the inspection. Recommend repairs by licensed contractor.

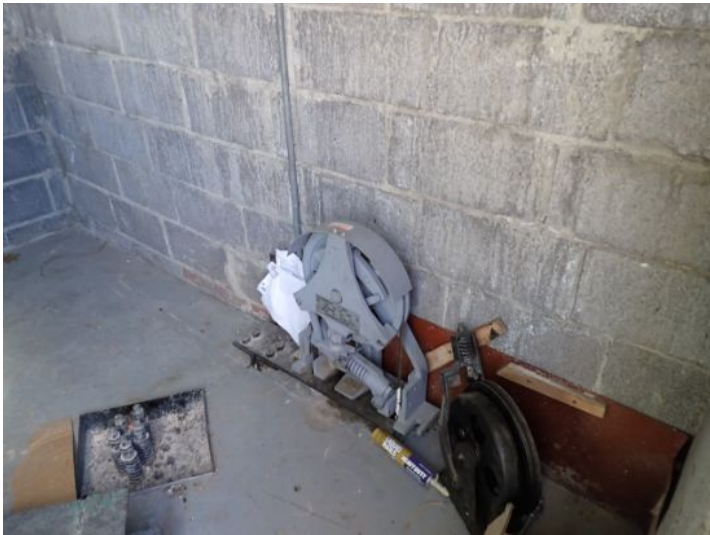
TPO roofing membrane located above the mall area of the property while appearing to be in fair condition was showing signs of excessive deferred maintenance and ponding at the time of the inspection. Recommend repairs by licensed contractor.

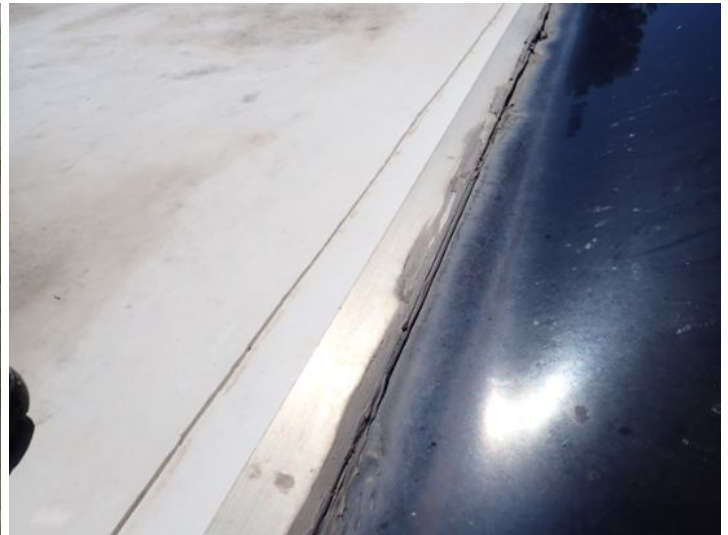
There was an old elevator room located on the roof above the mall area at time the inspection that no longer appear to be in use.

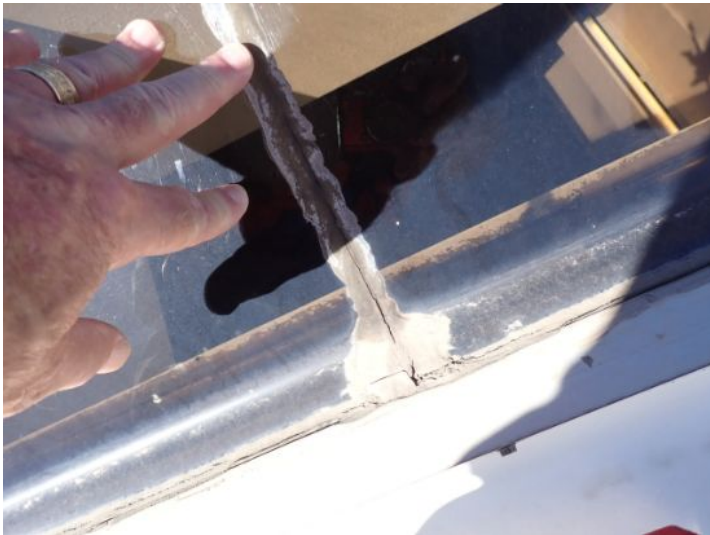
Cracked/leaking skylight system noted above the mall area. Recommend replacement by a licensed contractor.

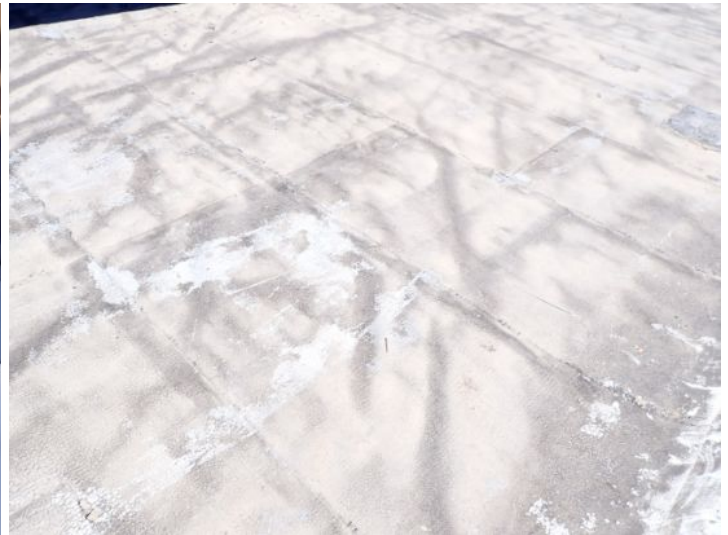
The narrow or small rolled torch down roofing system located approximately the center of the West Wing was an extremely poor condition of time inspection and requires completely recommend a licensed roofing contractor

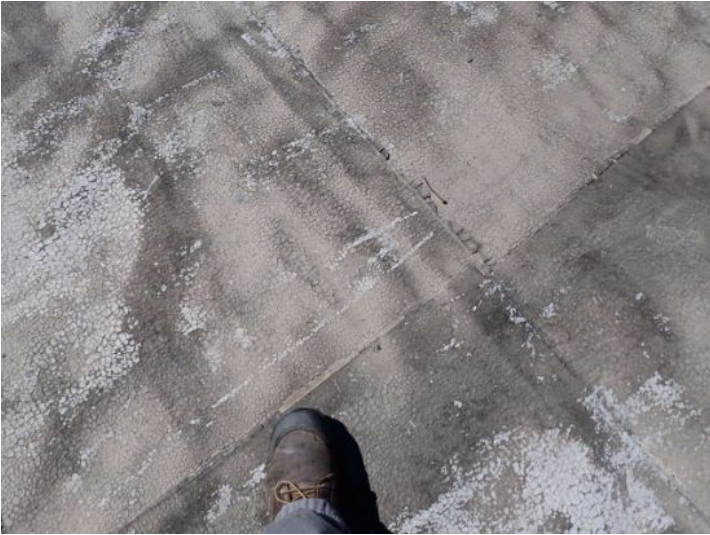
The narrow or small rolled torch down roofing system located approximately the center of the West Wing was an extremely poor condition of time inspection and requires completely recommend a licensed roofing contractor

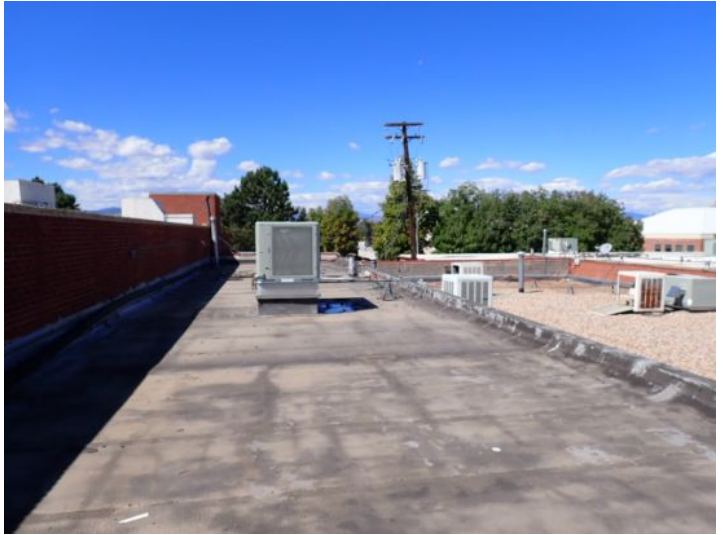
The narrow or small rolled torch down roofing system located approximately the center of the West Wing was an extremely poor condition of time inspection and requires completely recommend a licensed roofing contractor

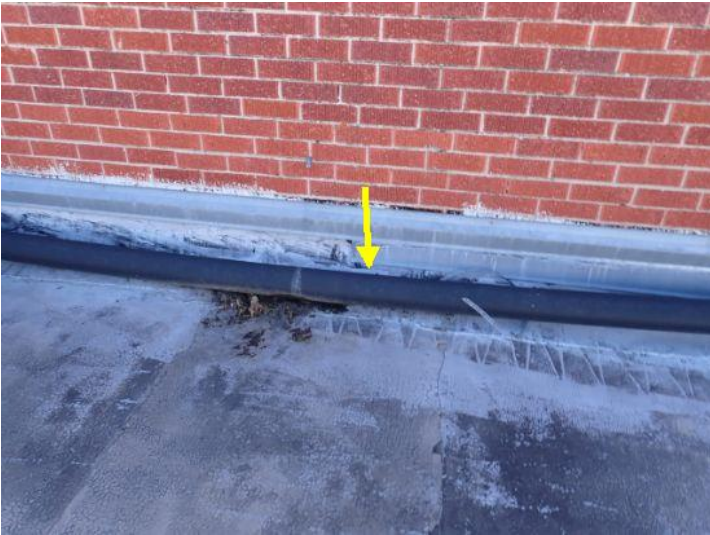
There was what appeared to be a 4 inch wet Vent piping located on the narrow roof above the center of the west wing that was not strapped properly and it becomes separated overtime. This could cause odor issues inside the building. Recommend repairs by licensed contractor.

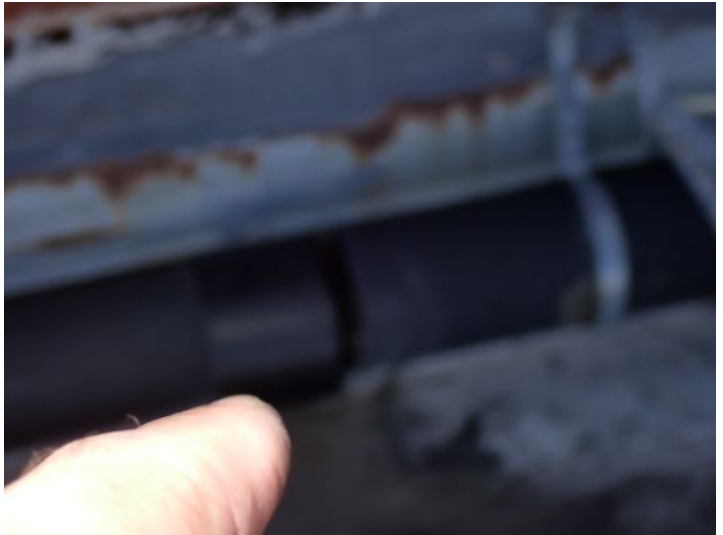
There was what appeared to be a 4 inch wet Vent piping located on the narrow roof above the center of the west wing that was not strapped properly and it becomes separated overtime. This could cause odor issues inside the building. Recommend repairs by licensed contractor.

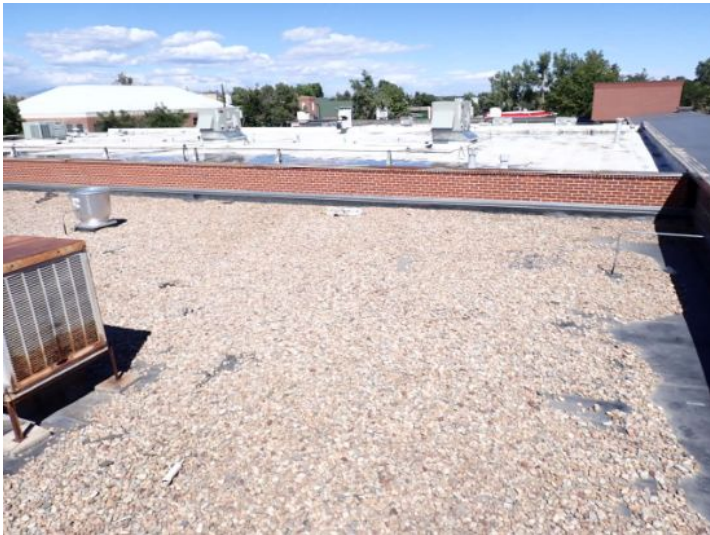
The gravel coated EPDM roofing membrane located towards the north end of the west structure was showing signs of significant ponding and deferred maintenance at the time of the inspection. Recommend repair by licensed contractor.

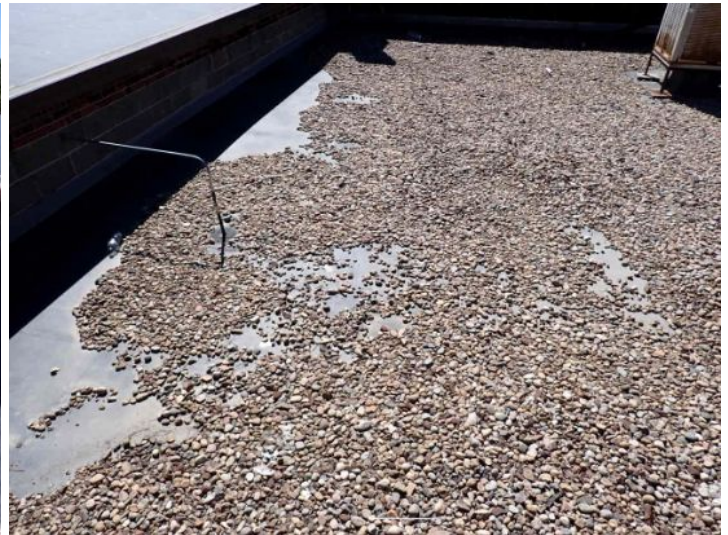
The gravel coated EPDM roofing membrane located towards the north end of the west structure was showing signs of significant ponding and deferred maintenance at the time of the inspection. Recommend repair by licensed contractor.

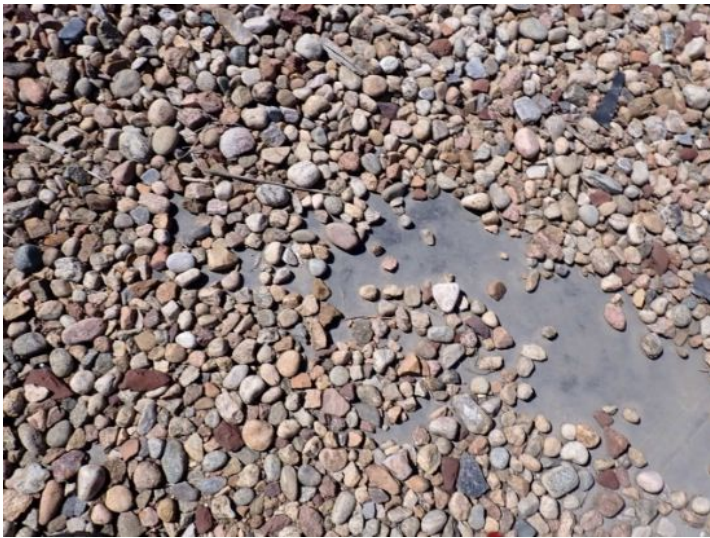
The gravel coated EPDM roofing membrane located towards the north end of the west structure was showing signs of significant ponding and deferred maintenance at the time of the inspection. Recommend repair by licensed contractor.

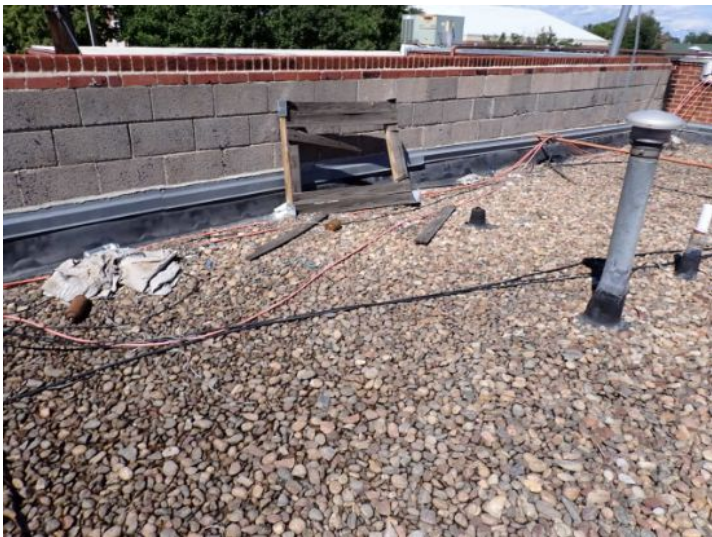
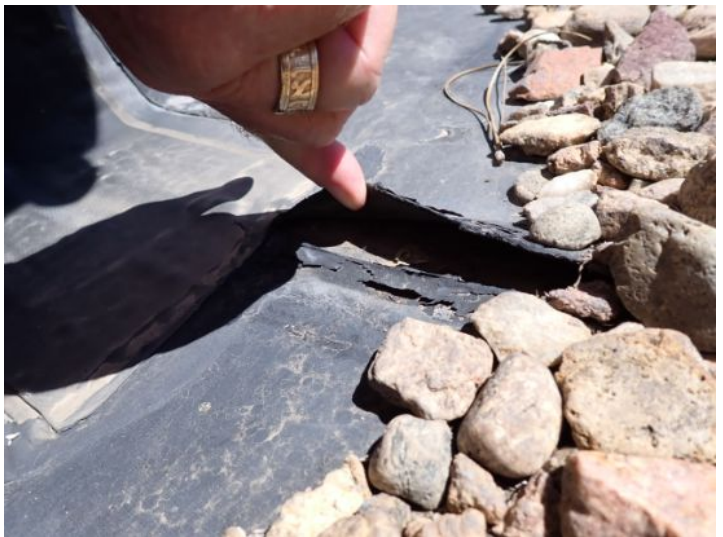
The gravel coated EPDM roofing membrane located towards the north end of the west structure was showing signs of significant ponding and deferred maintenance at the time of the inspection. Recommend repair by licensed contractor.

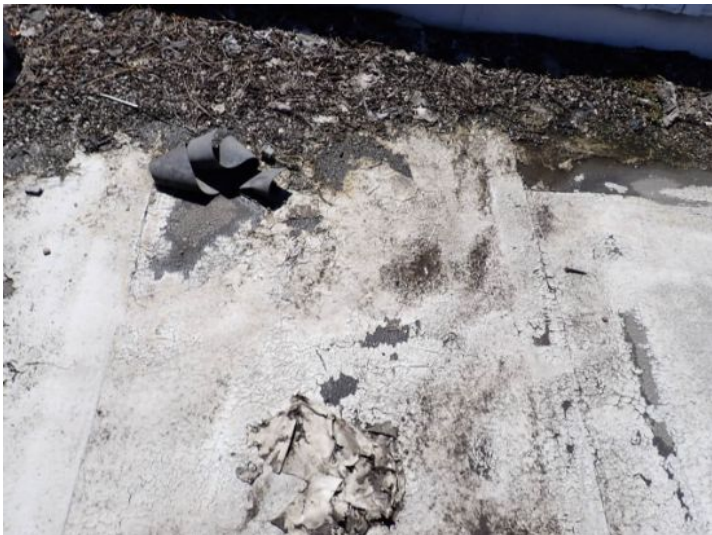
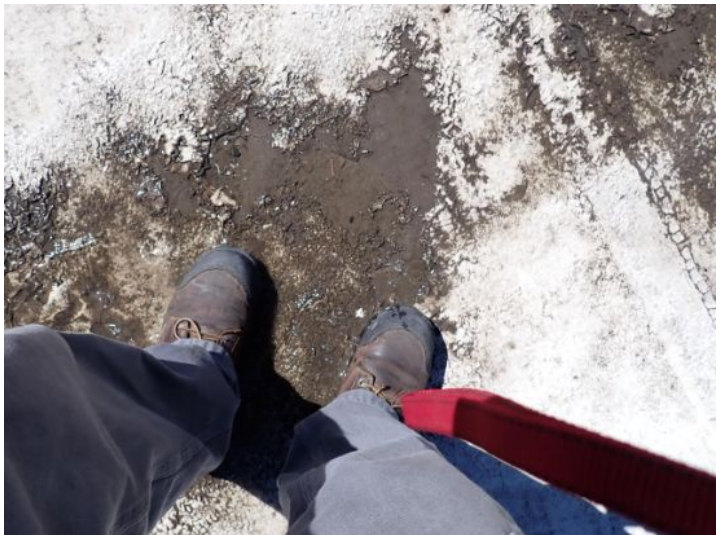
The rolled torch down roofing system above what appeared to be the old family dollar store and the vacant unit was an extremely poor condition excessive ponding feeling coding possible hail damage and excessive wear noted at the time of the inspection. Recommend complete replacement by licensed contractor.

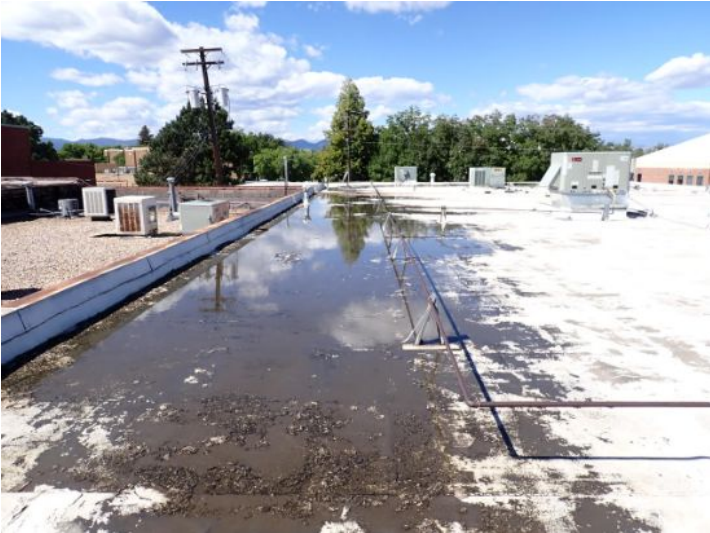
The rolled torch down roofing system above what appeared to be the old family dollar store and the vacant unit was an extremely poor condition excessive ponding feeling coding possible hail damage and excessive wear noted at the time of the inspection. Recommend complete replacement by licensed contractor.

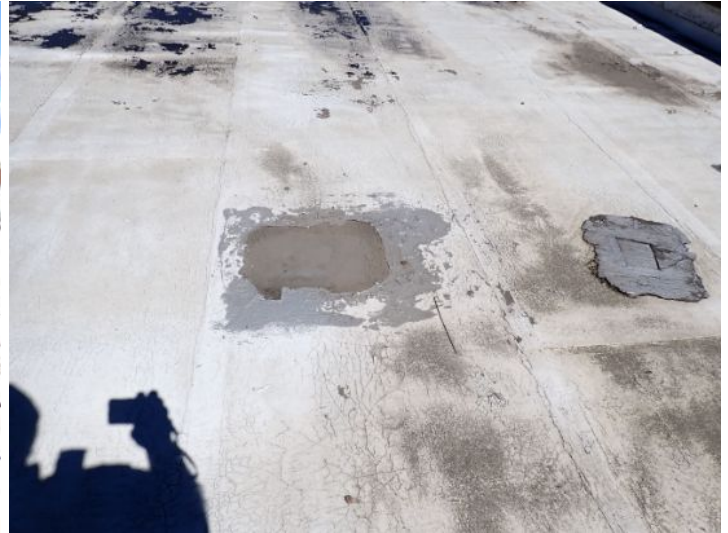
The rolled torch down roofing system above what appeared to be the old family dollar store and the vacant unit was an extremely poor condition excessive ponding feeling coding possible hail damage and excessive wear noted at the time of the inspection. Recommend complete replacement by licensed contractor.

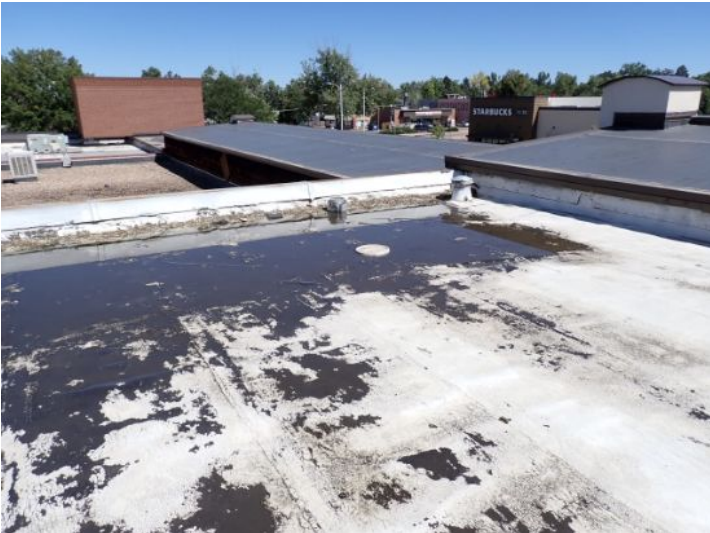
The rolled torch down roofing system above what appeared to be the old family dollar store and the vacant unit was an extremely poor condition excessive ponding feeling coding possible hail damage and excessive wear noted at the time of the inspection. Recommend complete replacement by licensed contractor.

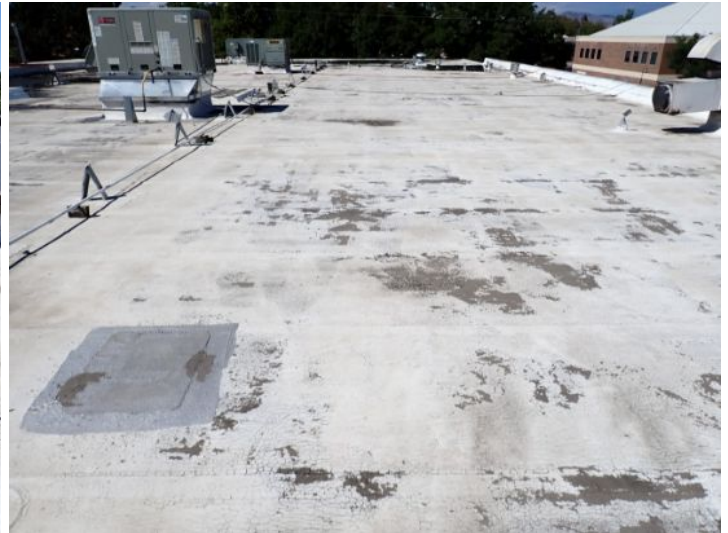
The rolled torch down roofing system above what appeared to be the old family dollar store and the vacant unit was an extremely poor condition excessive ponding feeling coding possible hail damage and excessive wear noted at the time of the inspection. Recommend complete replacement by licensed contractor.

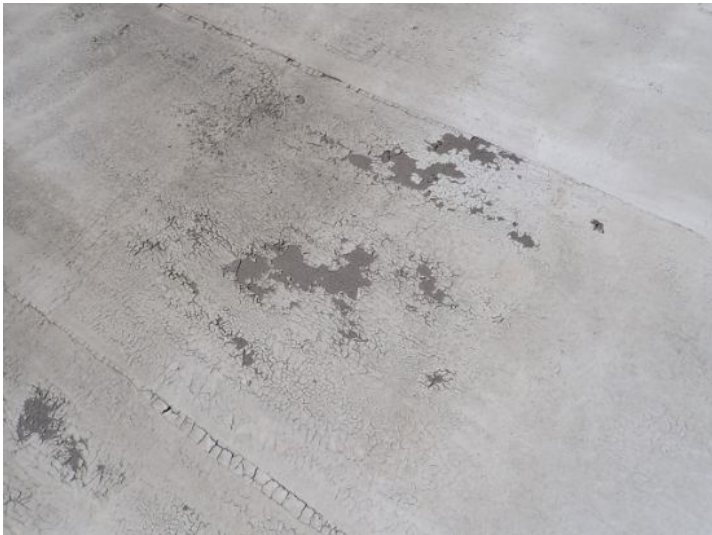
The rolled torch down roofing system above what appeared to be the old family dollar store and the vacant unit was an extremely poor condition excessive ponding feeling coding possible hail damage and excessive wear noted at the time of the inspection. Recommend complete replacement by licensed contractor.

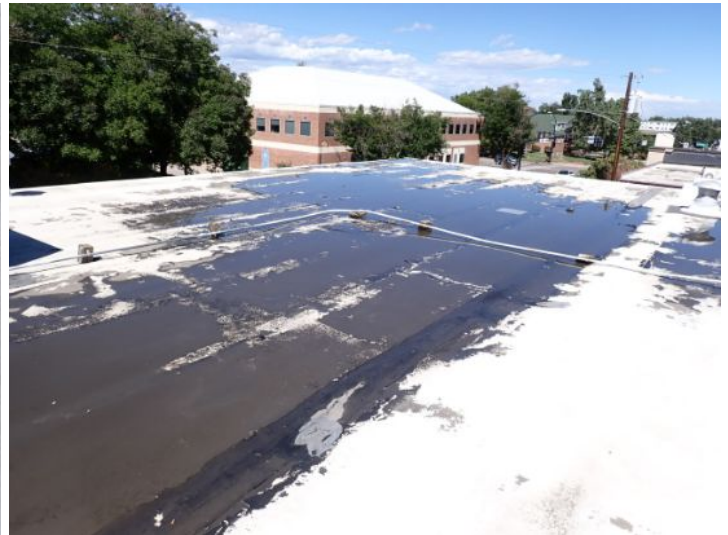
The rolled torch down roofing system above what appeared to be the old family dollar store and the vacant unit was an extremely poor condition excessive ponding feeling coding possible hail damage and excessive wear noted at the time of the inspection. Recommend complete replacement by licensed contractor.
