# *Forman Inspection Services, LLC*

## Property Inspection Report

1234 Retail St., Somewhere, CO 12345

Date of Inspection: 9/16/2022 Time: 10:00 Size: 93,886 sq. ft. per listing

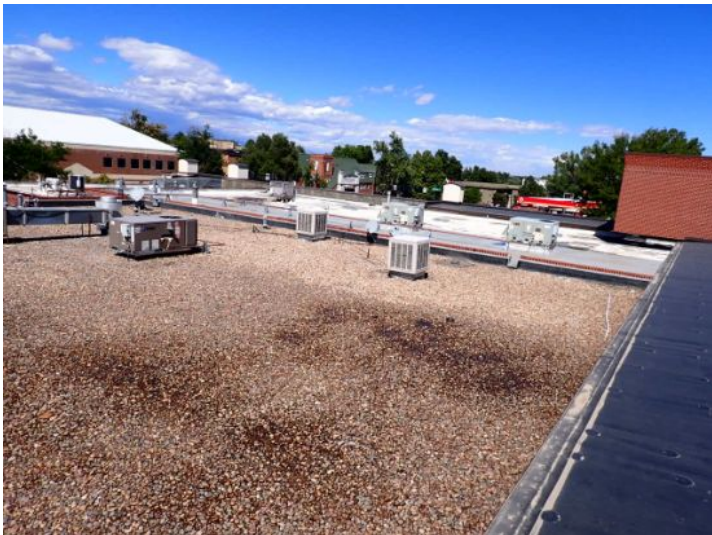
The gravel coated EPDM roofing membrane located towards the north end of the west structure was showing signs of significant ponding and deferred maintenance at the time of the inspection. Recommend repair by licensed contractor.

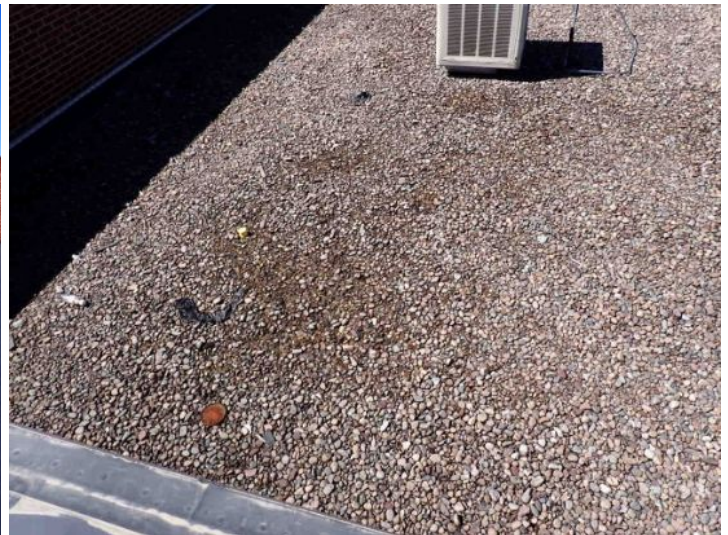
The gravel coated EPDM roofing membrane located towards the north end of the west structure was showing signs of significant ponding and deferred maintenance at the time of the inspection. Recommend repair by licensed contractor.

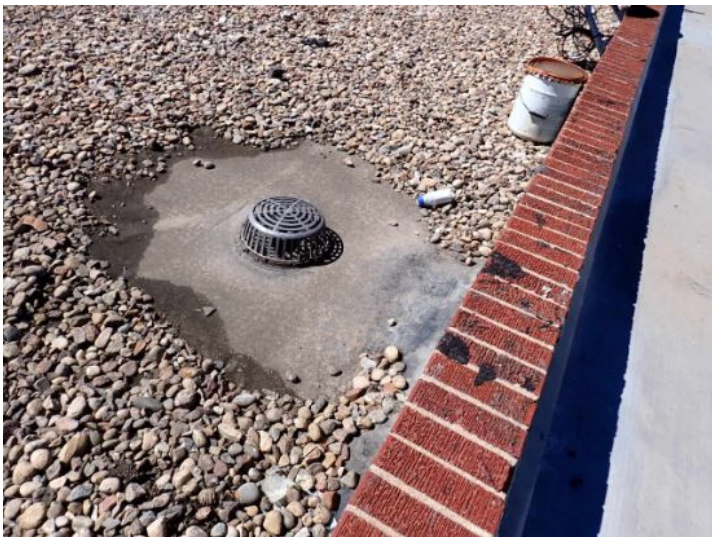
The gravel coated EPDM roofing membrane located towards the north end of the west structure was showing signs of significant ponding and deferred maintenance at the time of the inspection. Recommend repair by licensed contractor.

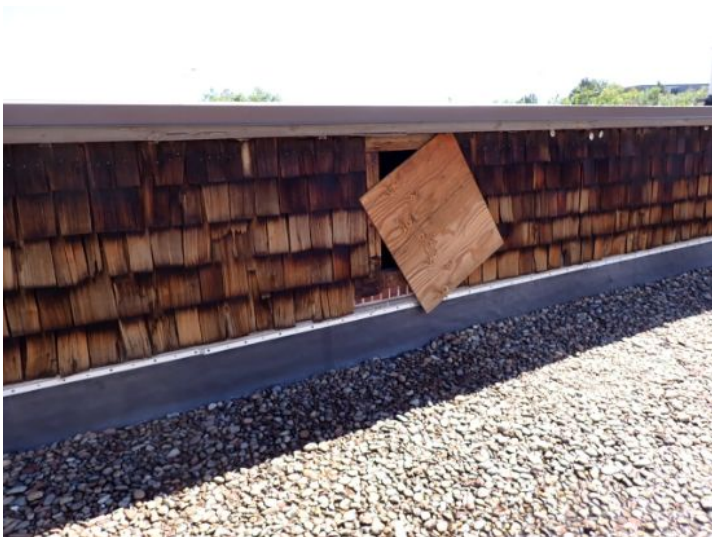
Bird and possible rodent nesting noted in the low slope front area above the unit next to the lifetime fitness center at time of inspection. Loose access panel noted at that time. Recommend bird and rodent removal cleaning of the interior of the area and repairs to the access panel by licensed contractor.

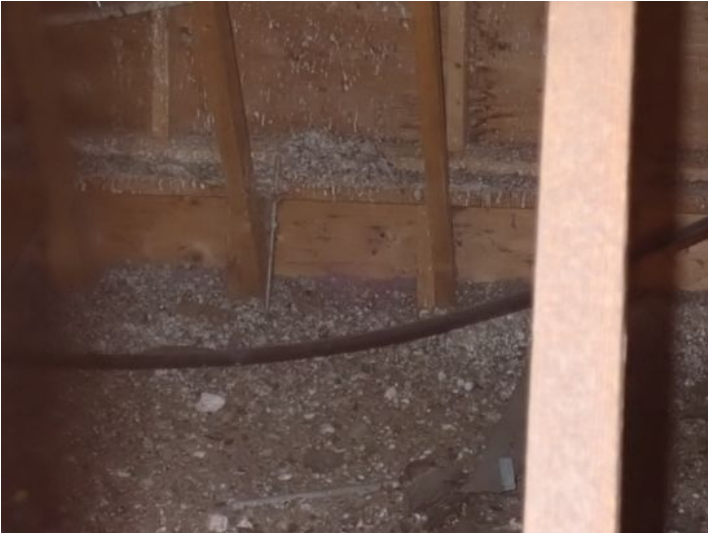
Bird and possible rodent nesting noted in the low slope front area above the unit next to the lifetime fitness center at time of inspection. Loose access panel noted at that time. Recommend bird and rodent removal cleaning of the interior of the area and repairs to the access panel by licensed contractor.

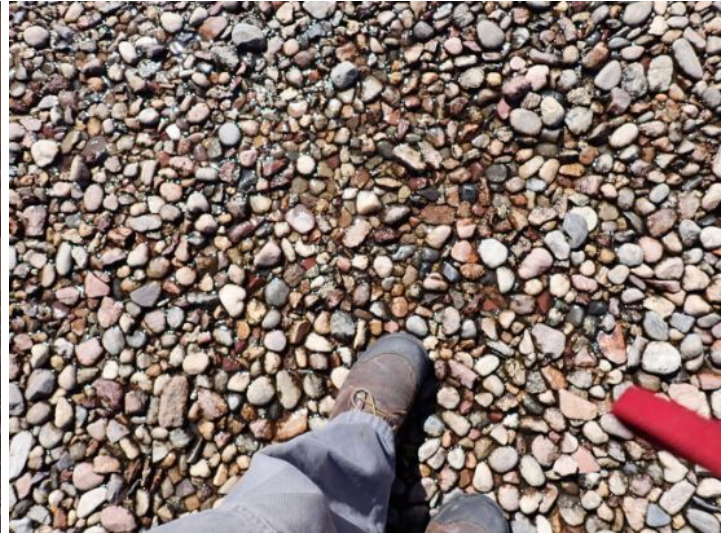
The gravel coated EPDM roofing membrane located near the north end of the west direction is showing signs of poor drainage and seem issues at the time of the inspection and appeared to have reached the end of its serviceable life expectancy. Recommend replacement by licensed roofing contractor.

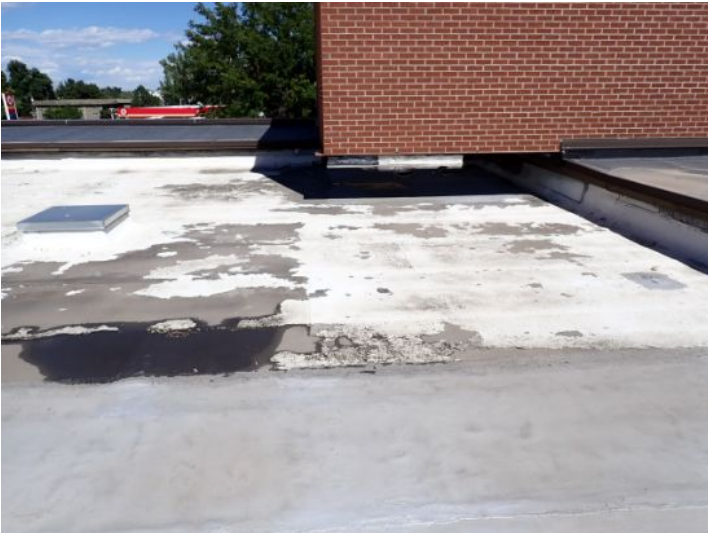
The rolled torch down roofing membrane located above the fitness center on the north end of the west wing was an extremely poor condition and has reached the end of the service for life expectancy. Recommend complete replacement by licensed roofing contractor.

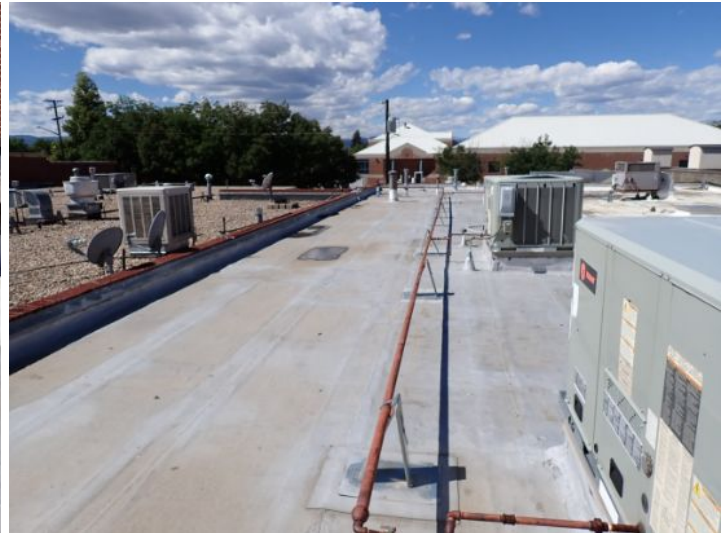
The rolled torch down roofing membrane located above the fitness center on the north end of the west wing was an extremely poor condition and has reached the end of the service for life expectancy. Recommend complete replacement by licensed roofing contractor.

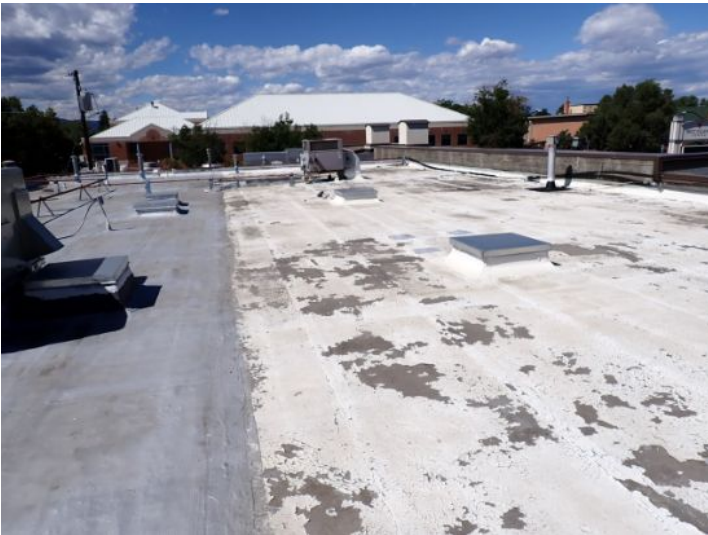
The rolled torch down roofing membrane located above the fitness center on the north end of the west wing was an extremely poor condition and has reached the end of the service for life expectancy. Recommend complete replacement by licensed roofing contractor.

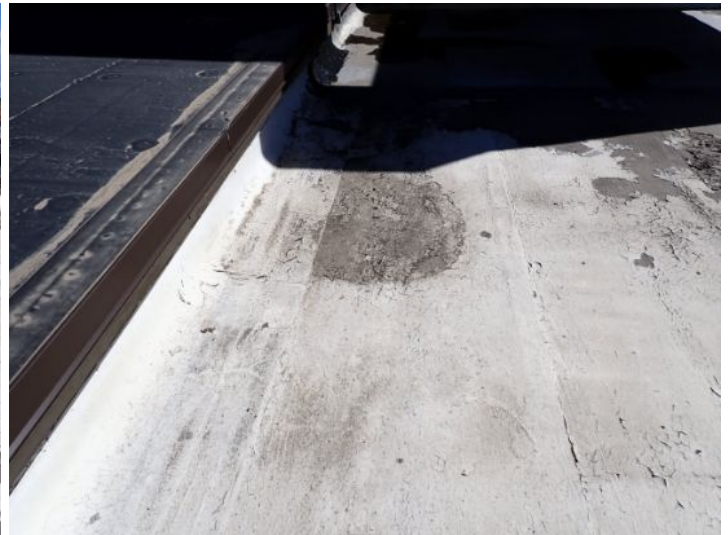
The rolled torch down roofing membrane located above the fitness center on the north end of the west wing was an extremely poor condition and has reached the end of the service for life expectancy. Recommend complete replacement by licensed roofing contractor.

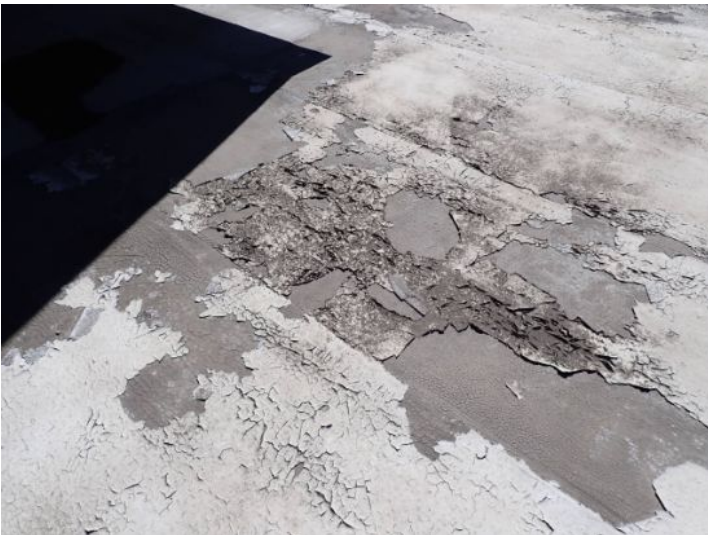
The rolled torch down roofing membrane located above the fitness center on the north end of the west wing was an extremely poor condition and has reached the end of the service for life expectancy. Recommend complete replacement by licensed roofing contractor.

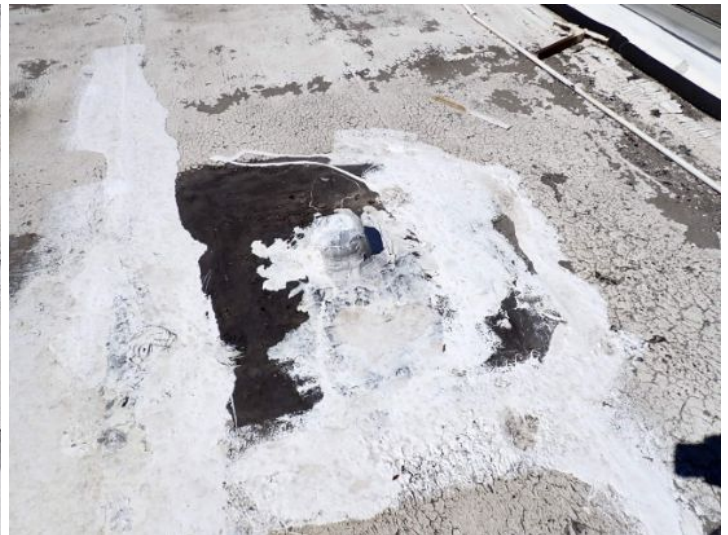
The rolled torch down roofing membrane located above the fitness center on the north end of the west wing was an extremely poor condition and has reached the end of the service for life expectancy. Recommend complete replacement by licensed roofing contractor.

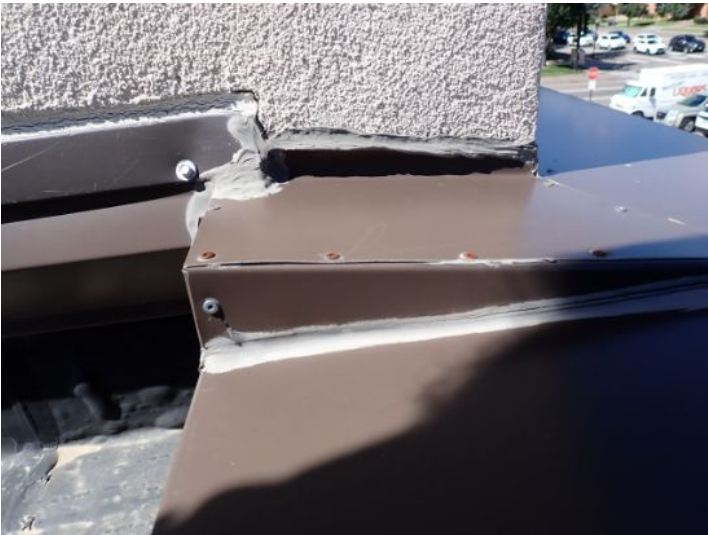
Due to flashing issues storm water was getting into one of the stucco awning support pillars and running down the inside of the system. Recommend repairs as needed by a licensed contractor.

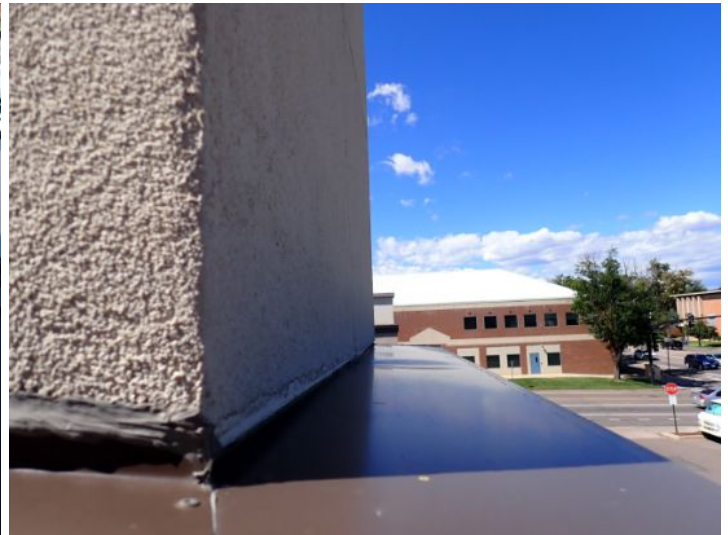
Due to flashing issues storm water was getting into one of the stucco awning support pillars and running down the inside of the system. Recommend repairs as needed by a licensed contractor.

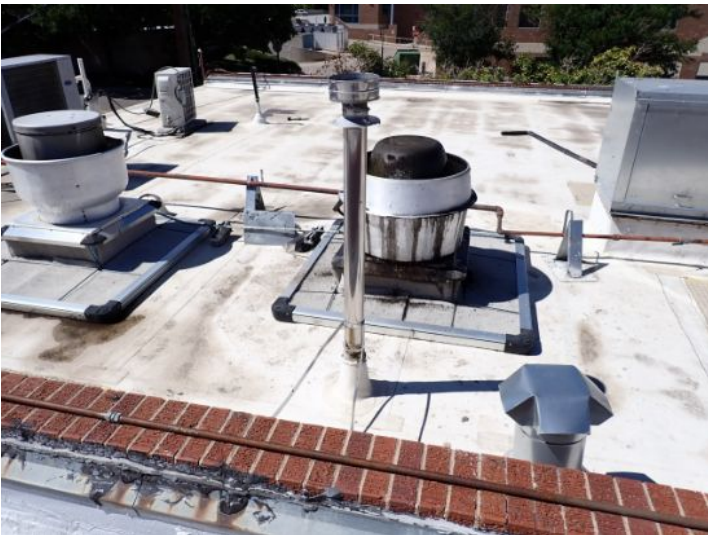
The TPO membrane located above the restaurant on the north end of the West Wing appear to be in fair condition at time of inspection.

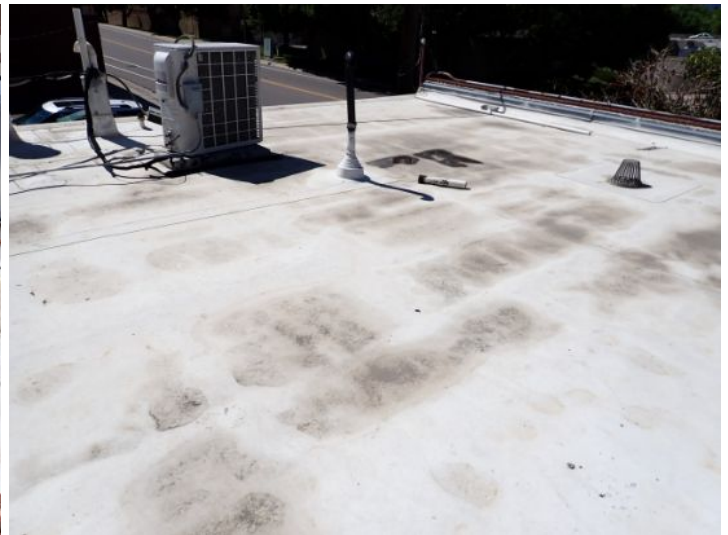
The TPO membrane located above the restaurant on the north end of the West Wing appear to be in fair condition at time of inspection.

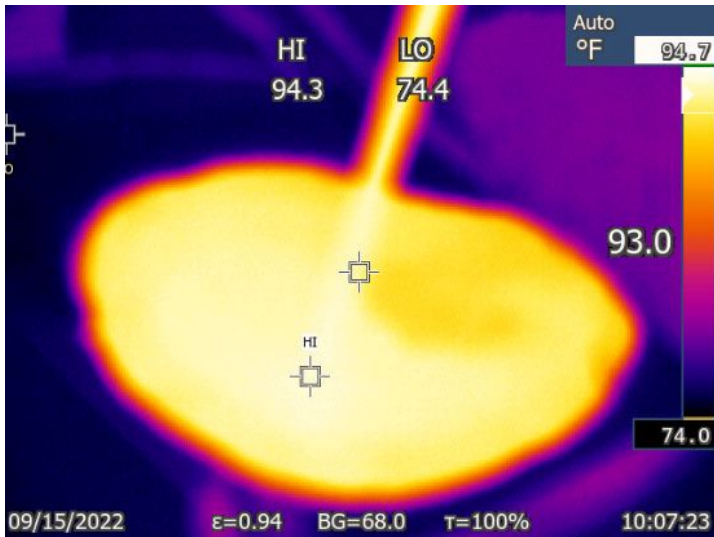
Most of the water heaters were functional at the time of the inspection.

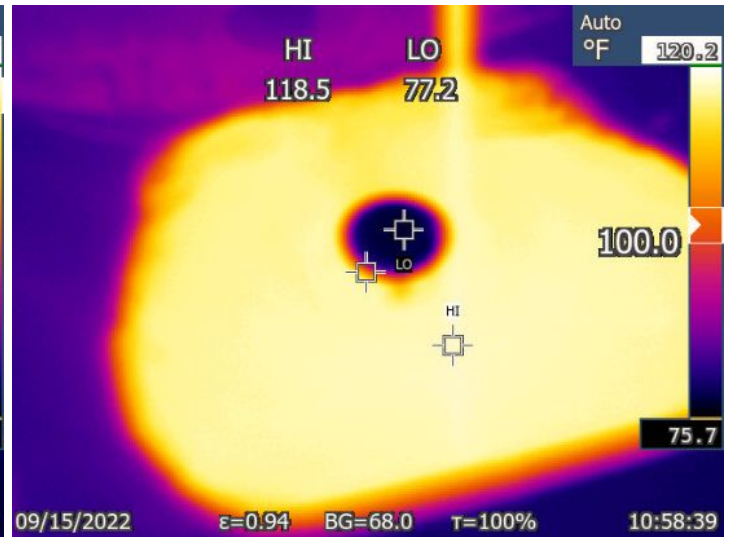
Most of the water heaters were functional at the time of the inspection.

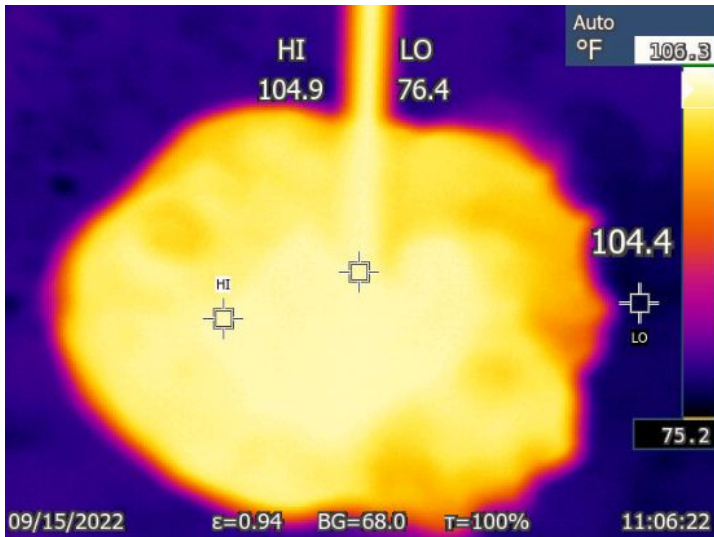
Most of the water heaters were functional at the time of the inspection.

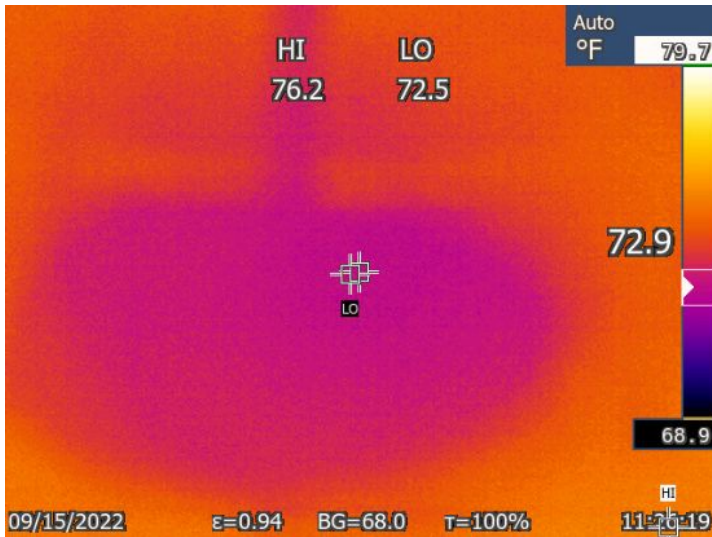
Unit 113: Water heater did not appear functional at the time of the inspection. Recommend repairs by a licensed contractor.

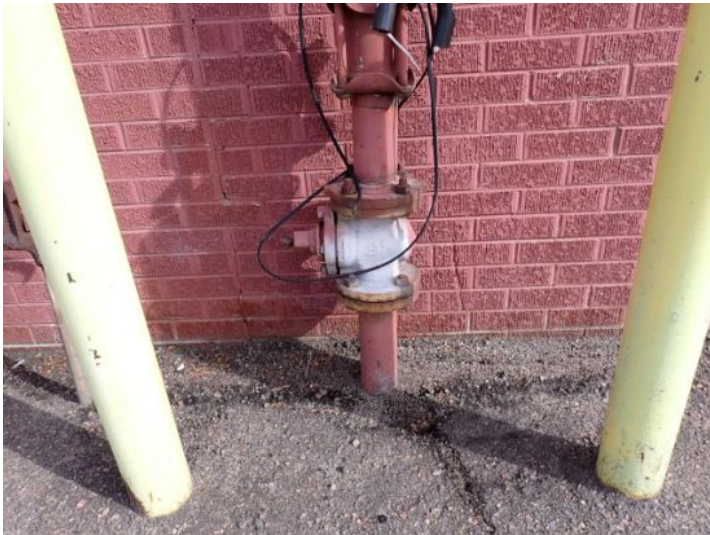
The main gas shutoff valve(s) was/were functional at the time of the inspection

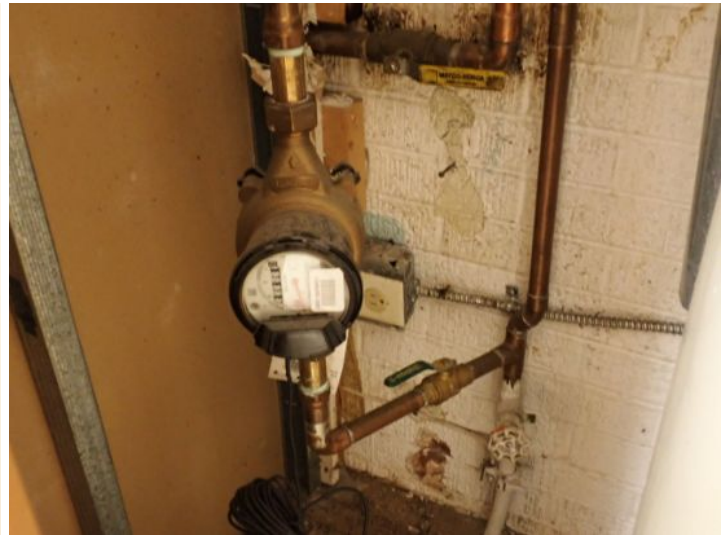
Several shutoff valves were noted in tenant units that did not have backflow preventers installed on them but appeared to be metered. Recommend repairs as needed by a licensed contractor.

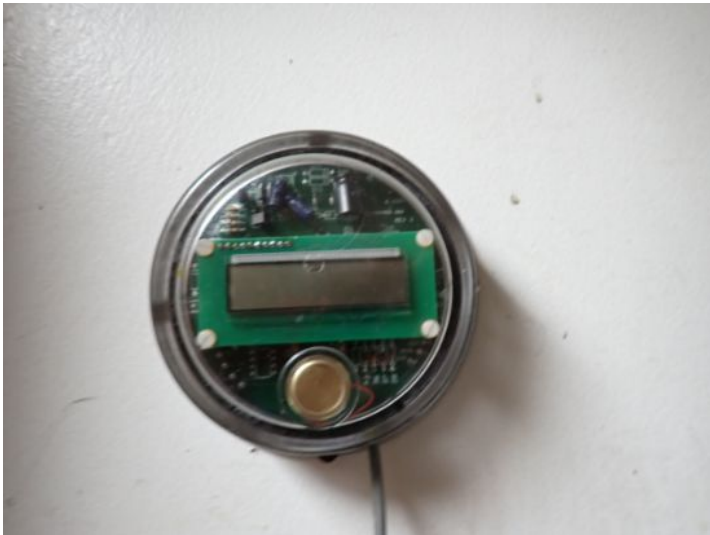
Some of the tenant units appeared to have sub meters located within them but the meters did not appear to be functional at the time of the inspection. Recommend consulting with the current owners/management company to determine what is going on with these systems as well as where the main shutoffs are all located and how water metering is performed.

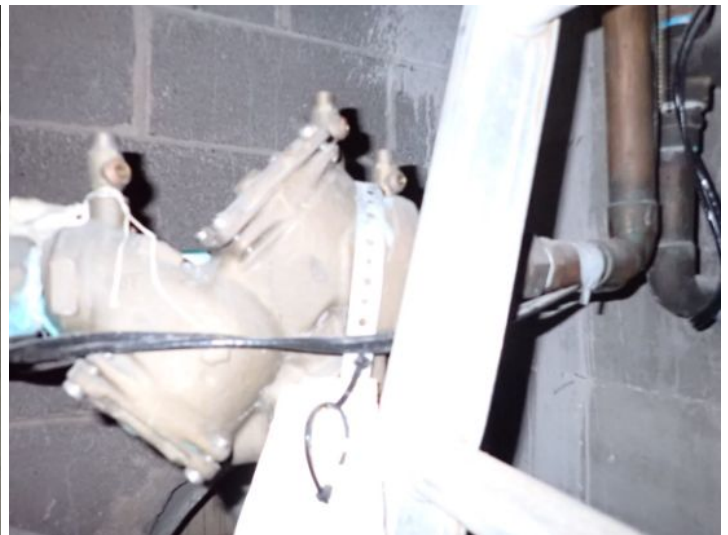
The main water shut off valves appeared functional at the time of the inspection.

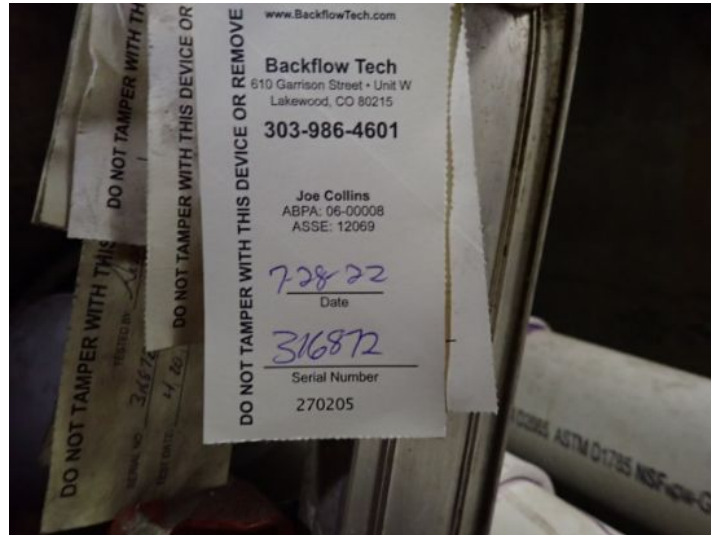
Last date of inspection/certification of the main backflow preventers appeared to be 7/22.

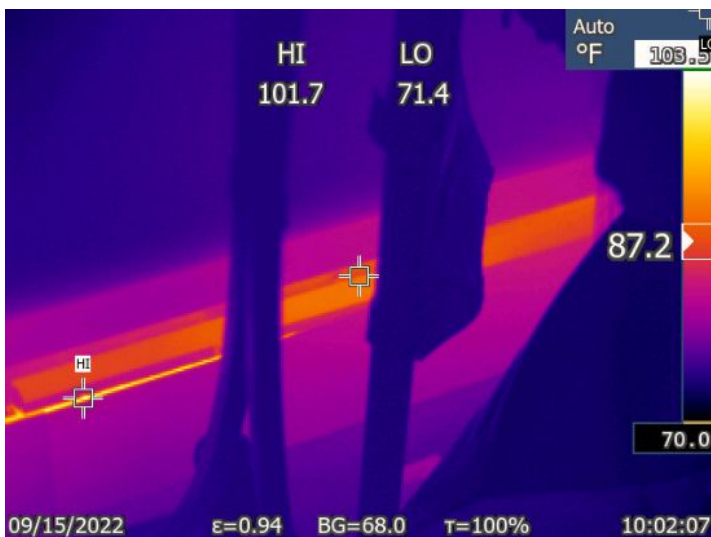
The boiler was functional at the time of the inspection.

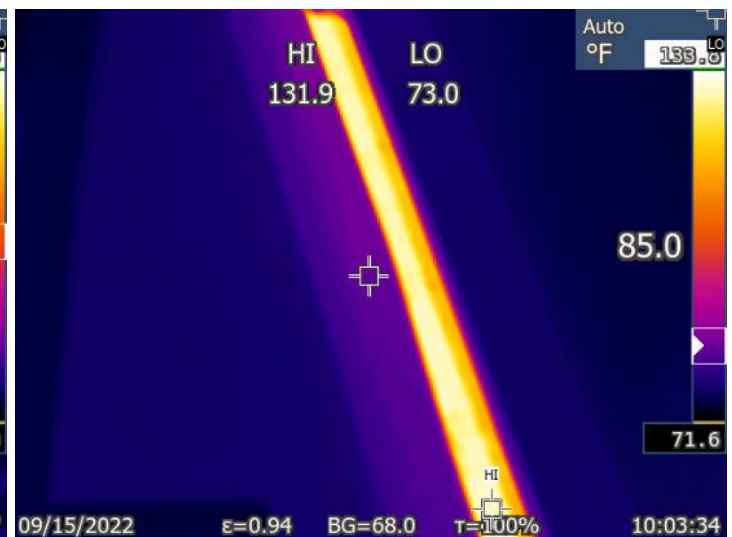
The boiler was functional at the time of the inspection.

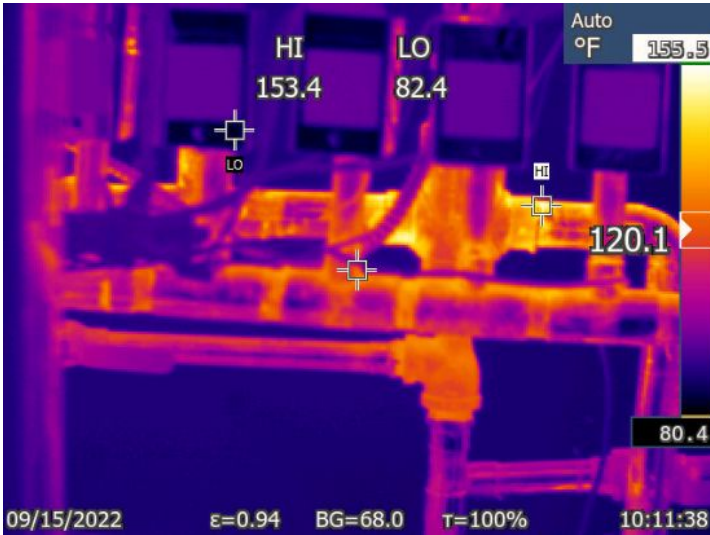
The boiler was functional at the time of the inspection.

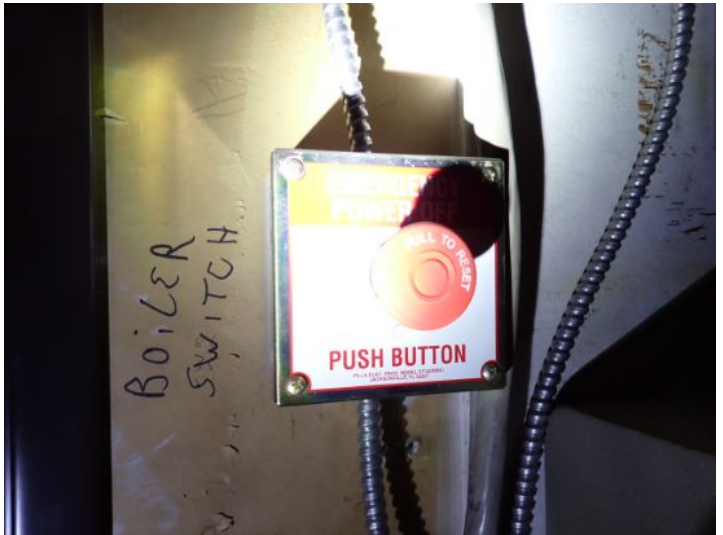
Emergency shutoff switch for the active boiler system was in place and appeared functional at the time of the inspection.

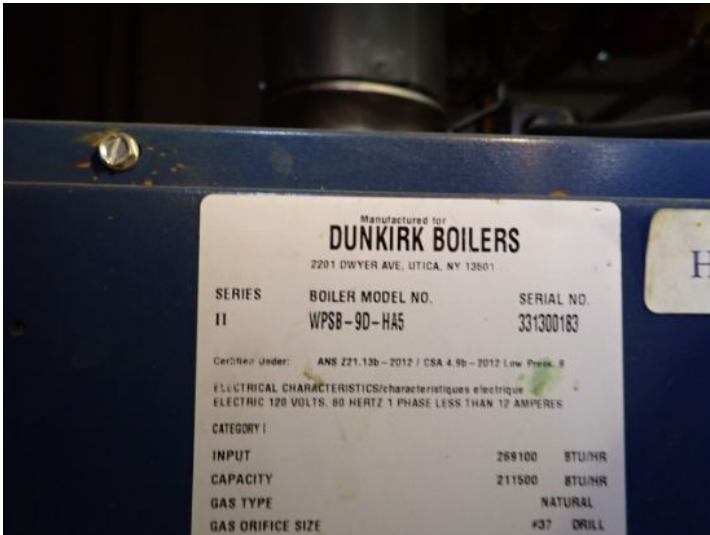
Office Building Boiler: Dunkirk: M/N WPSB-9D-HA5 S/N 331300183. Manufacture year 2013. Colorado Boiler #100396. Last date of state inspection/certification was 5/22.

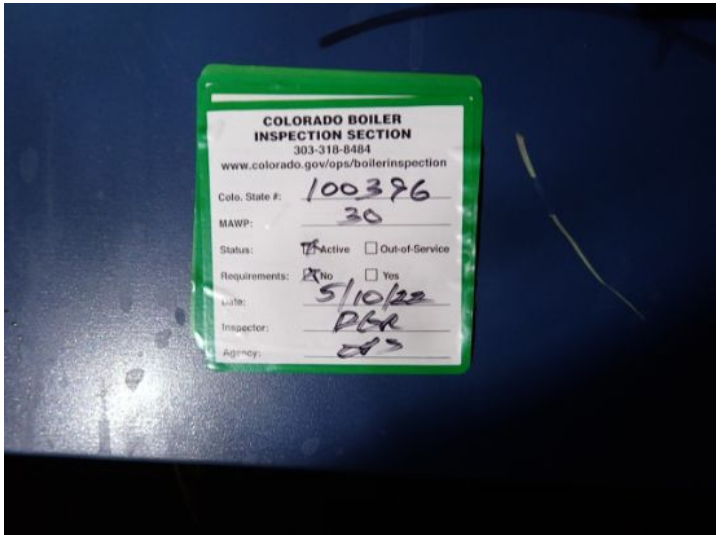
Office Building Boiler: Dunkirk: M/N WPSB-9D-HA5 S/N 331300183. Manufacture year 2013. Colorado Boiler #100396. Last date of state inspection/certification was 5/22.

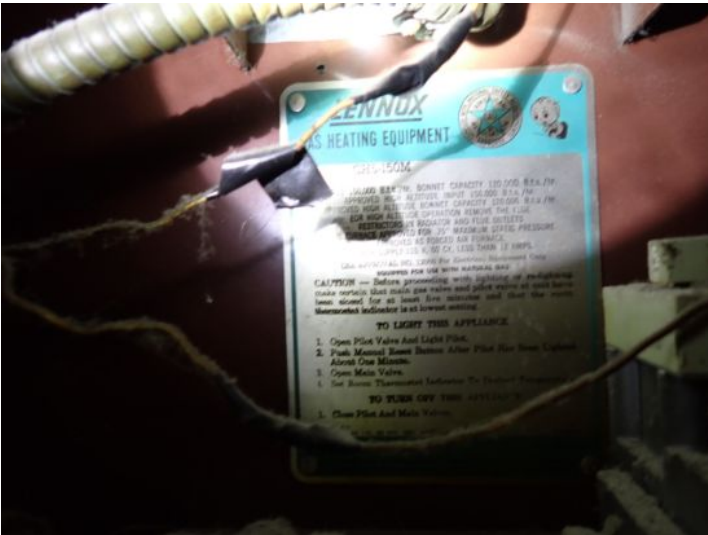
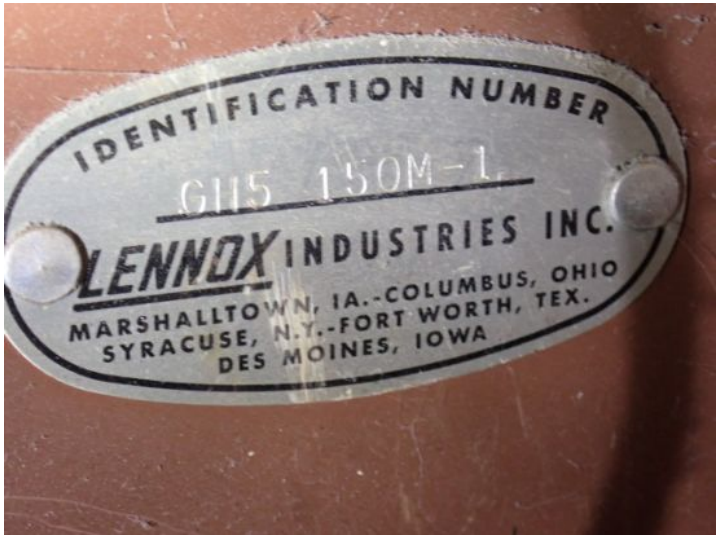
There was an old gas fired forced air furnace located in the main level of the old theater building that although functional had far surpassed its serviceable life expectancy and could be considered a safety/health hazard. Recommend replacement by a licensed contractor.

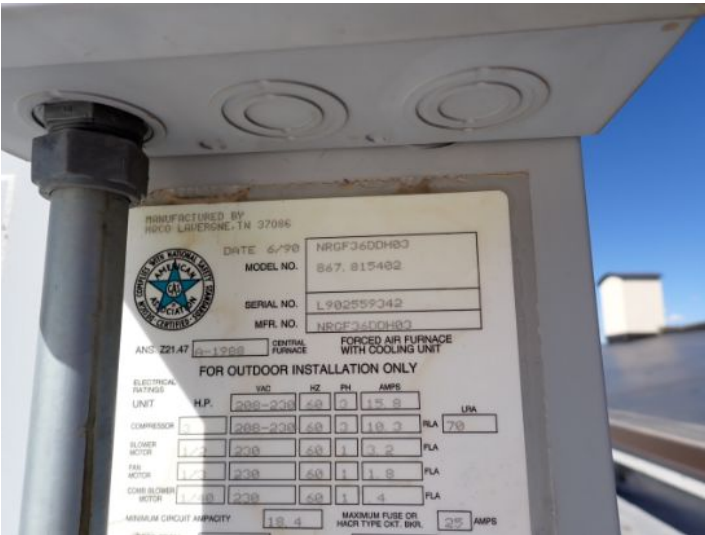
- Old gas fired furnace for the basement area of units 108-107 was in poor condition and requires complete replacement.
- RTU 10 was in extremely poor condition and requires replacement. Recommend replacement by a licensed contractor.

RTU 10: HRCO: M/N NRGF36DDH03 S/N L902559342. Manufacture year 1990.

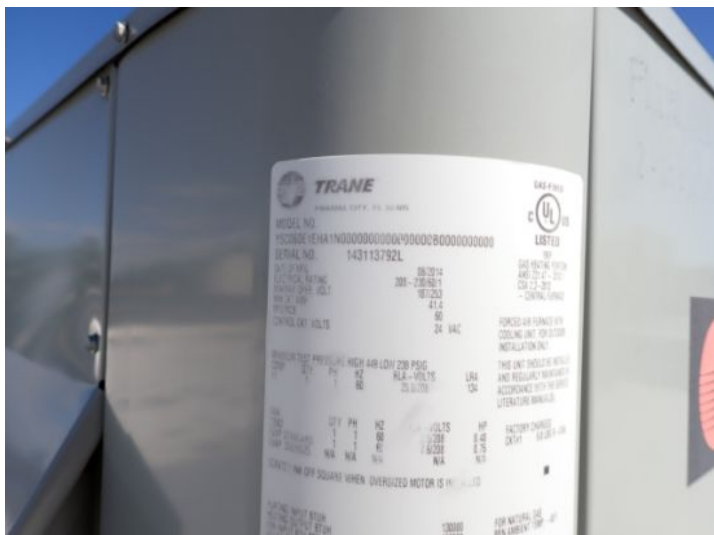
Missing side cover plate noted on RTU 29. Recommend repairs by a licensed contractor.

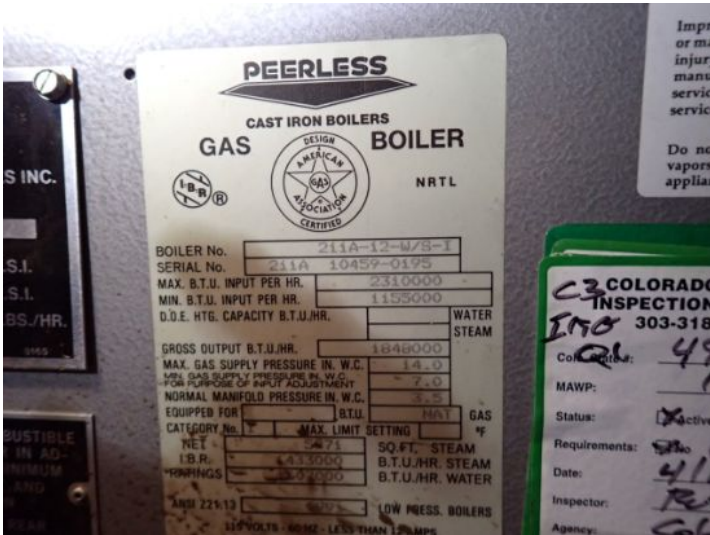
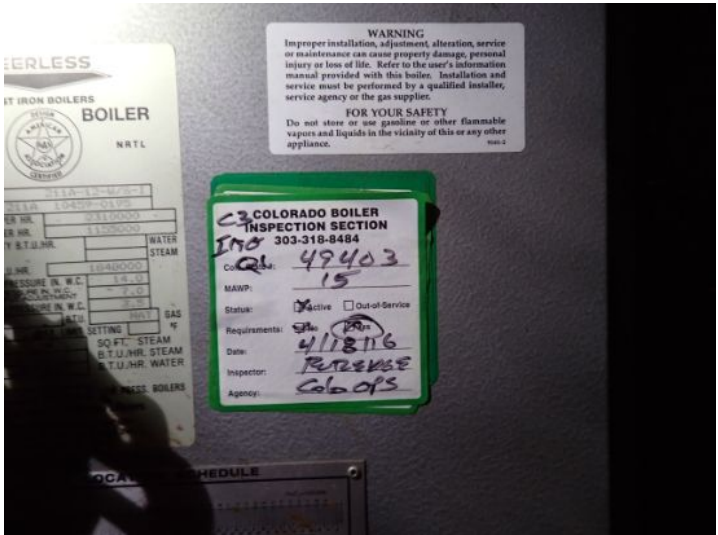
There was an old boiler system located in the rear of unit 140B that appeared to be no longer in service. Recommend removal of the system from the building if no longer in use.

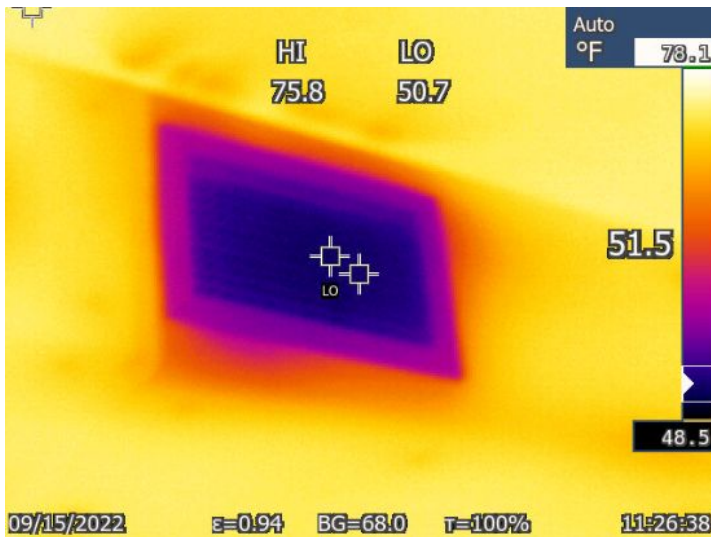
Unit 118: Cooling system did not appear to be functioning properly. Recommend repairs by a licensed contractor

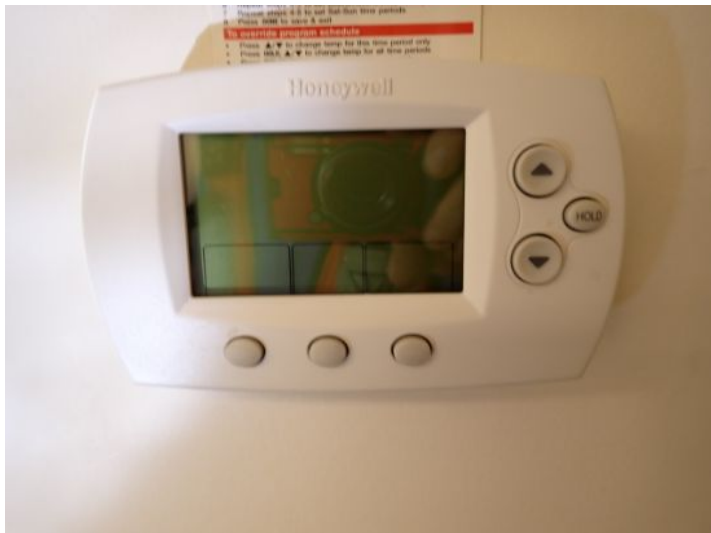
One or more thermostats not responding at the time of the inspection. Recommend repairs by a licensed contractor prior to taking possession of the property.

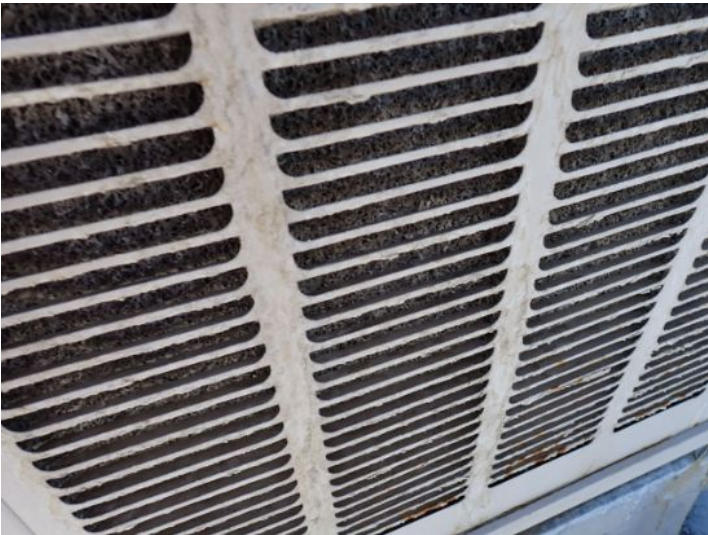
The swamp coolers located above the old theater area that is now being used as office or in fair to poor condition and require servicing and filter repairs by a licensed contractor. Recommend repairs prior to taking possession of the property.

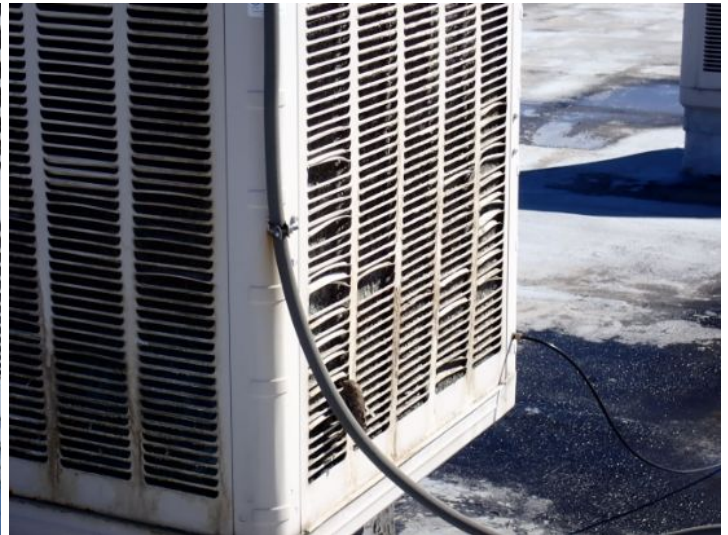
The swamp coolers located above the old theater area that is now being used as office or in fair to poor condition and require servicing and filter repairs by a licensed contractor. Recommend repairs prior to taking possession of the property.

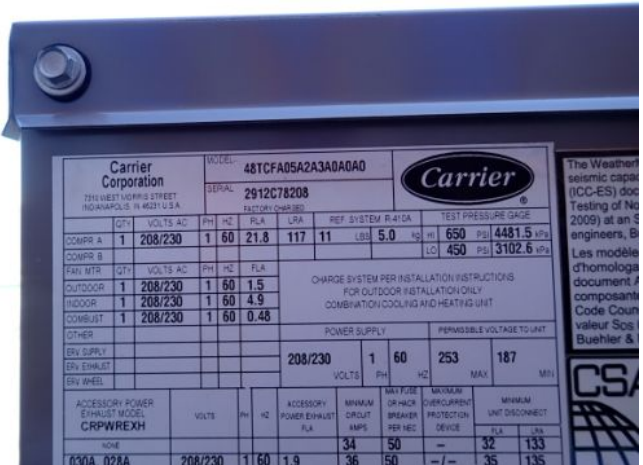
The nominal serviceable life expectancy of an RTU is 15 years. Based on the age of one or more of the RTU's they have neared or surpassed their serviceable life expectancy. Recommend replacement or budgeting for replacement of these units in the near future.

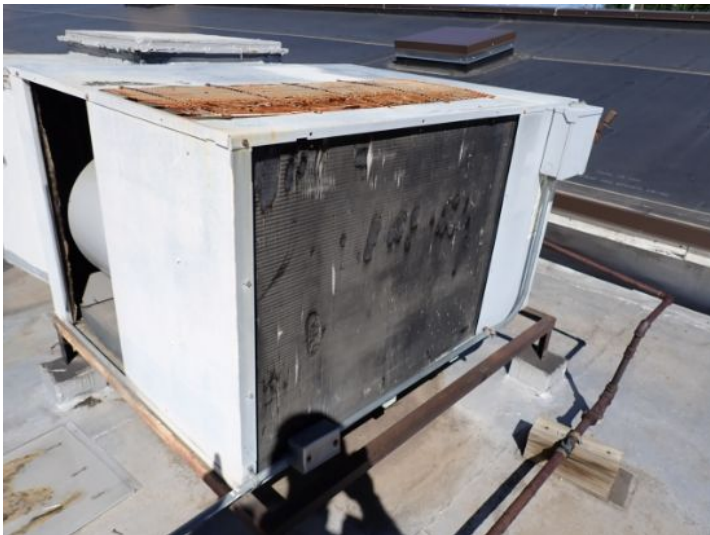
The small swamp cooler located on the upper level roof on the east end of the property was in poor condition at time of the inspection requires complete replacement. Recommend replacement by a licensed contractor.

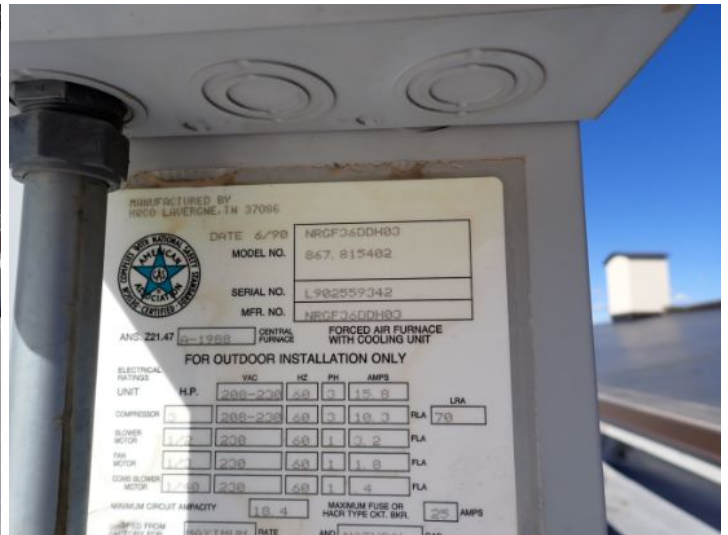
RTU 10: HRCO: M/N NRGF36DDH03 S/N L902559342. Manufacture year 1990.

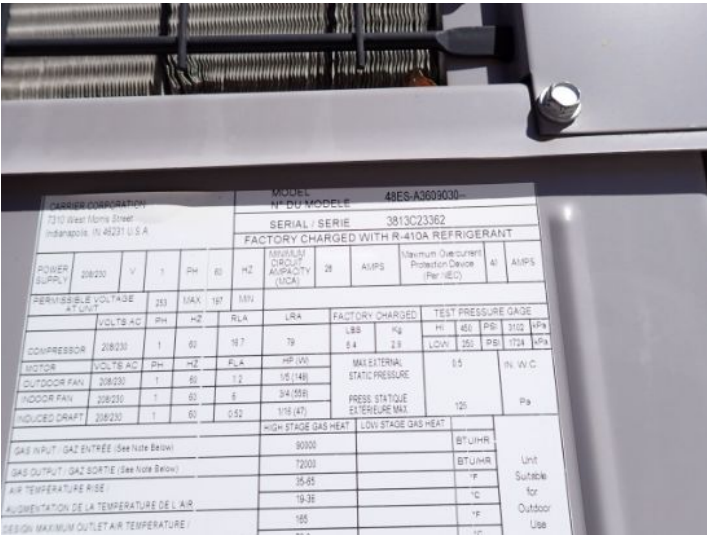
RTU 11: Carrier: M/N 48ES-A3609030 S/N 3813C23362. Manufacture year 2013.

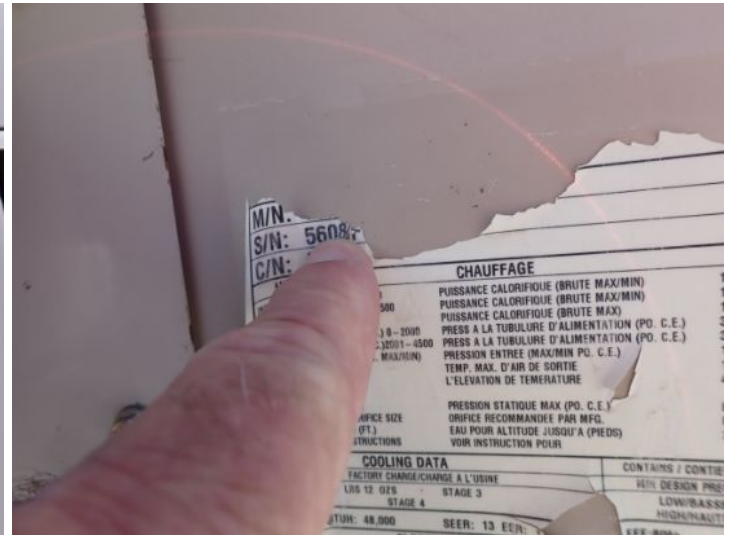
RTU 12: Allied: M/N ? S/N 5608? Manufacture year 2008.

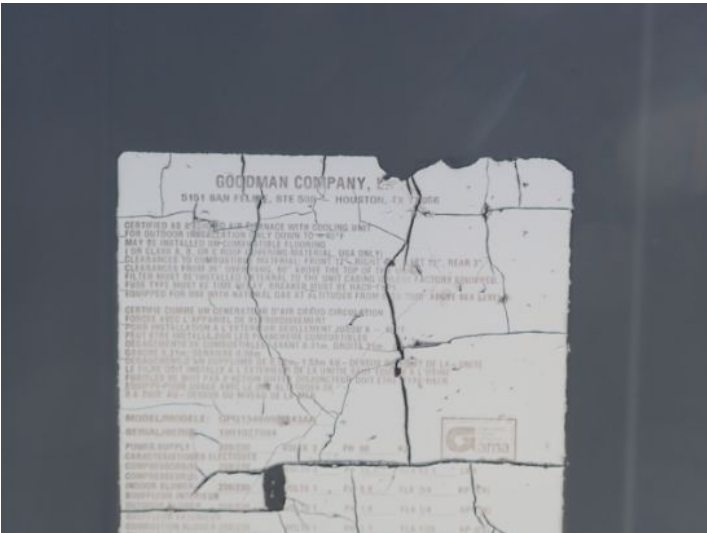
RTU 13: Goodman: M/N GPG134809M43AA S/N 1001027084. Manufacture year 2010.

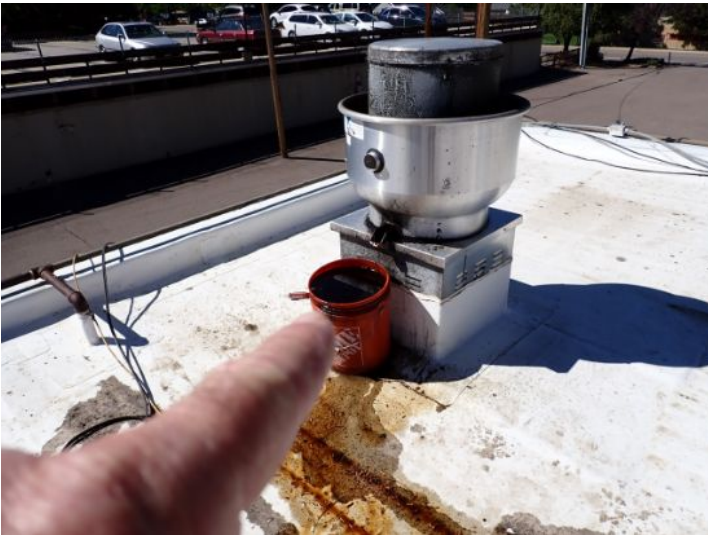
One or more kitchen roof top vent systems were showing signs of significant deferred maintenance. Recommend repairs by a licensed contractor.

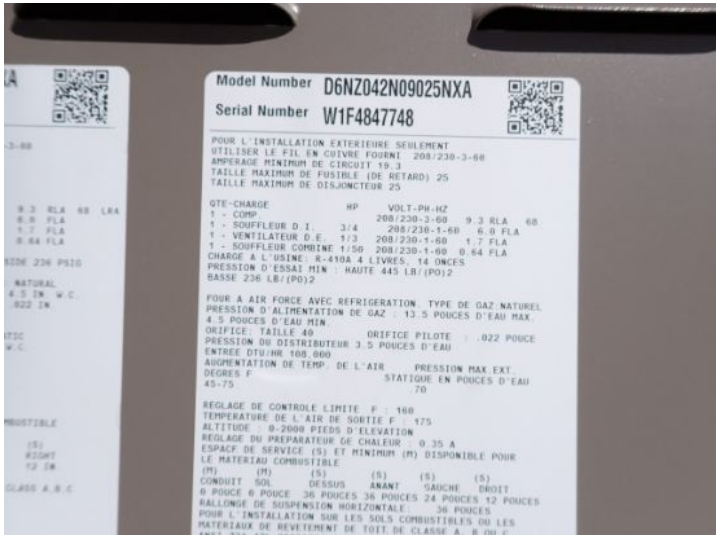
RTU 14: York: M/N D6NZ042N09025NXA S/N W1F4847748. Manufacture year 2014.

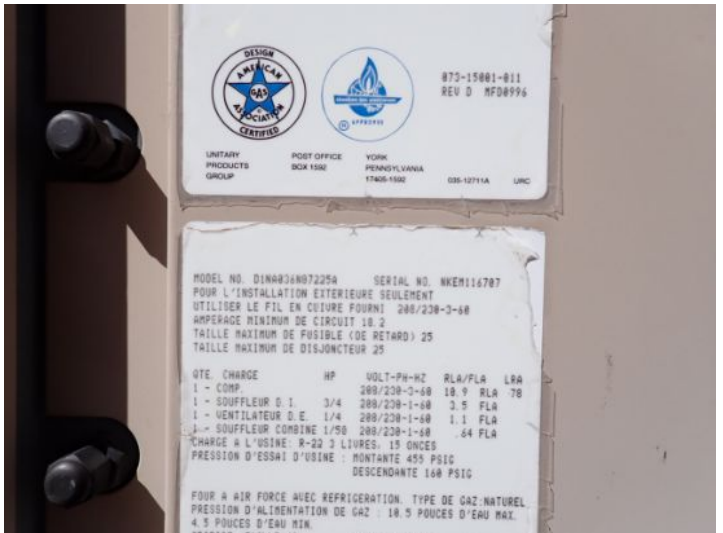
The nominal serviceable life expectancy of an RTU is 15 years. Based on the age of one or more of the RTU's they have neared or surpassed their serviceable life expectancy. Recommend replacement or budgeting for replacement of these units in the near future.

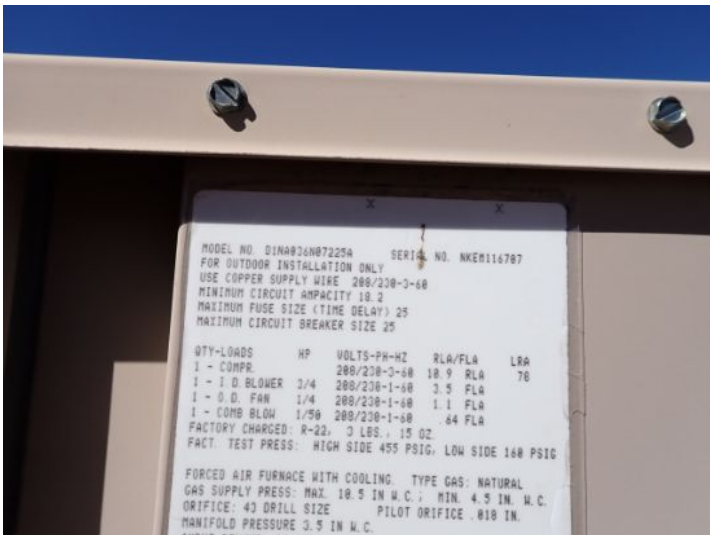
RTU 15: York: M/N D1NA036N07225A S/N NKEM116707. Manufacture year 1996.

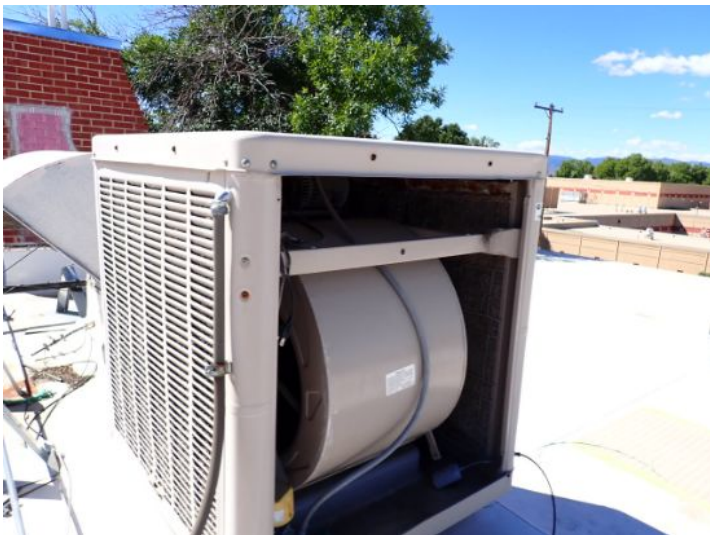
The swamp coolers located on the roofing system above the mall area were in poor condition or not functional at the time of the inspection. If the systems are still in use they require repair or replacement by licensed contractor.

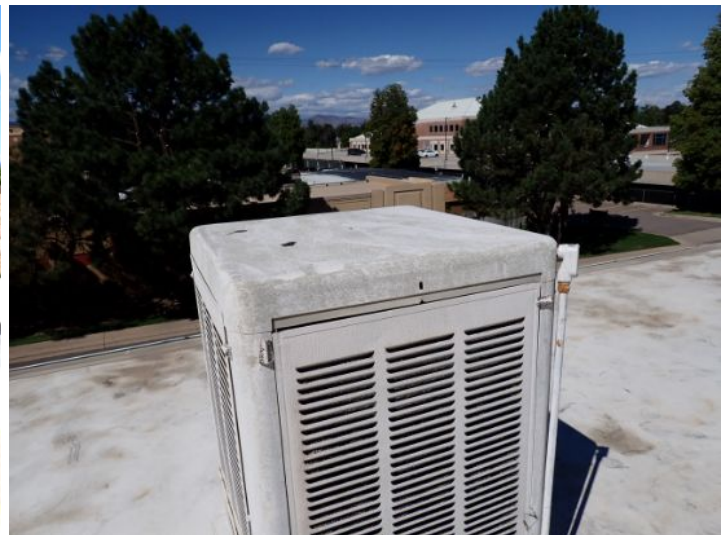
The swamp coolers located on the roofing system above the mall area were in poor condition or not functional at the time of the inspection. If the systems are still in use they require repair or replacement by licensed contractor.
