# *Forman Inspection Services, LLC*

## Property Inspection Report

1234 Retail St., Somewhere, CO 12345

Date of Inspection: 9/16/2022 Time: 10:00 Size: 93,886 sq. ft. per listing

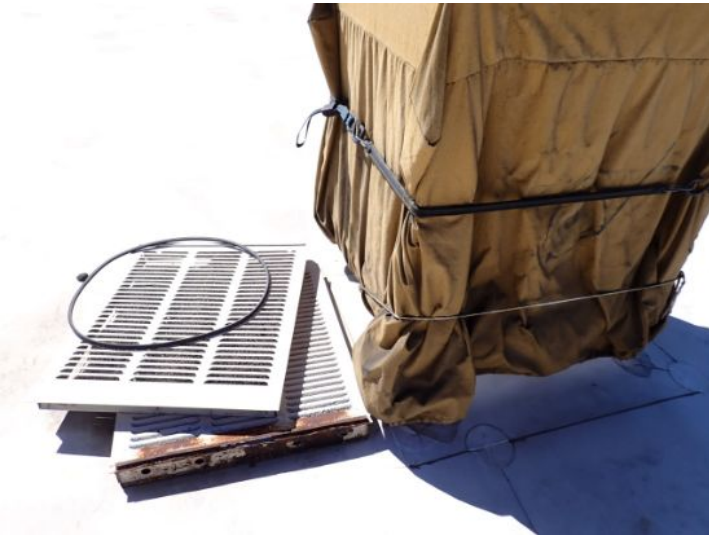
The swamp coolers located on the roofing system above the mall area were in poor condition or not functional at the time of the inspection. If the systems are still in use they require repair or replacement by licensed contractor.

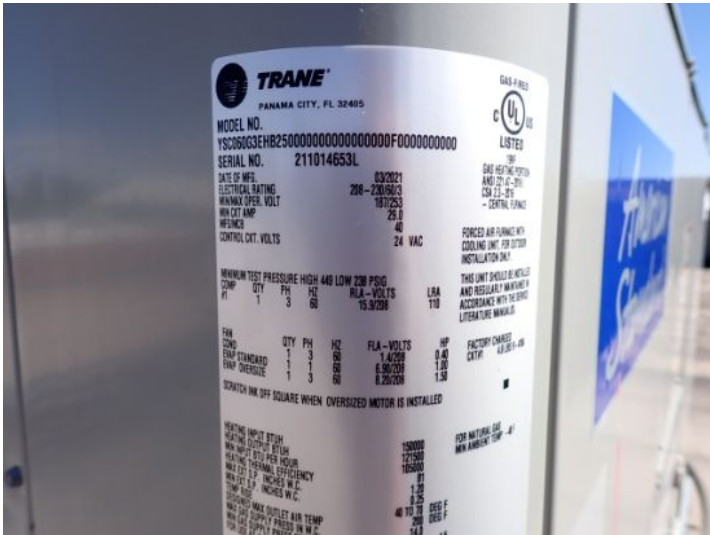
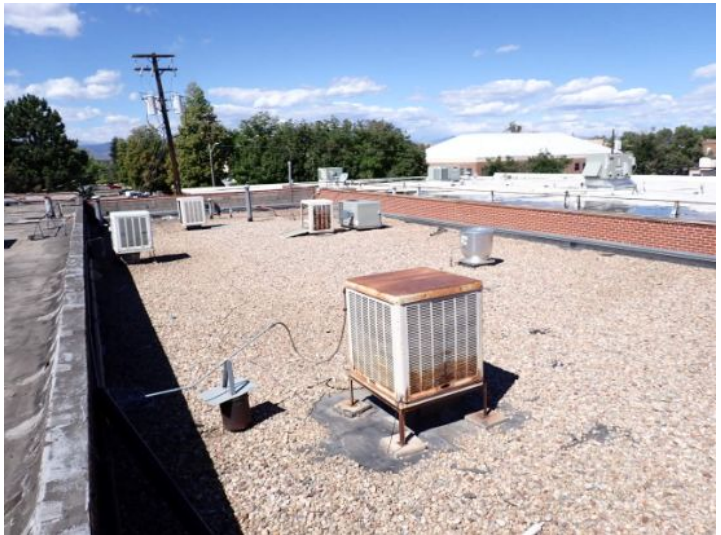
The swamp coolers for units 108-107 were in poor condition at the time of the inspection. Unit will require new heating/cooling systems for new tenant. Recommend repairs by a licensed contractor.

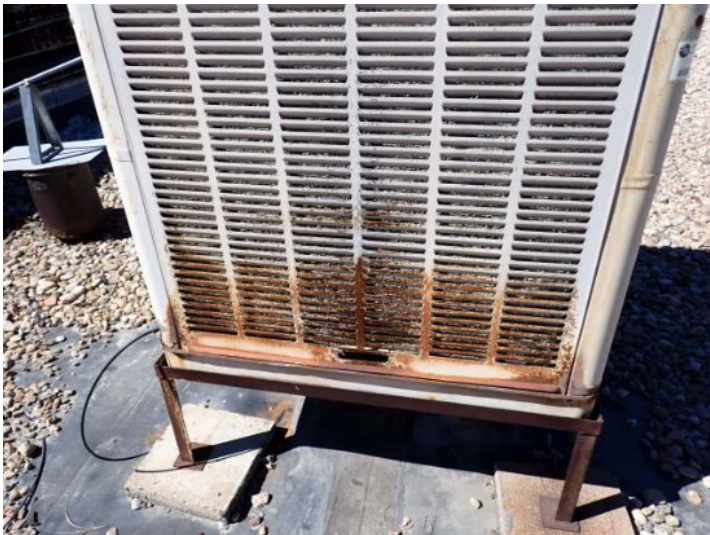
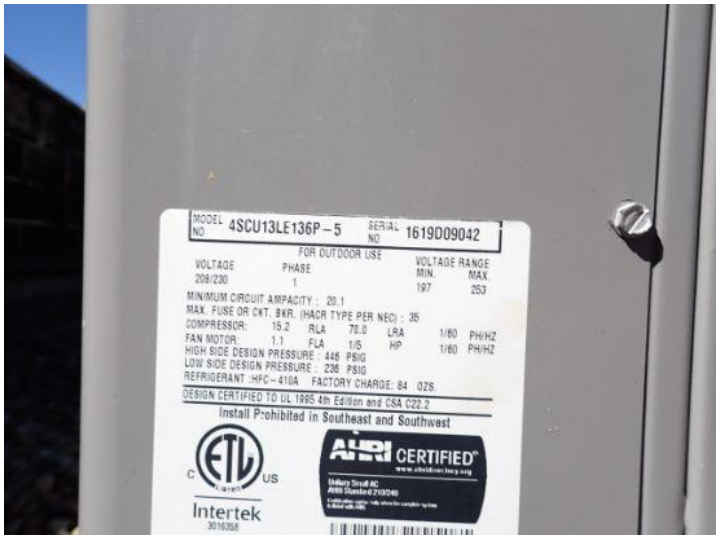
The swamp coolers for units 108-107 were in poor condition at the time of the inspection. Unit will require new heating/cooling systems for new tenant. Recommend repairs by a licensed contractor.

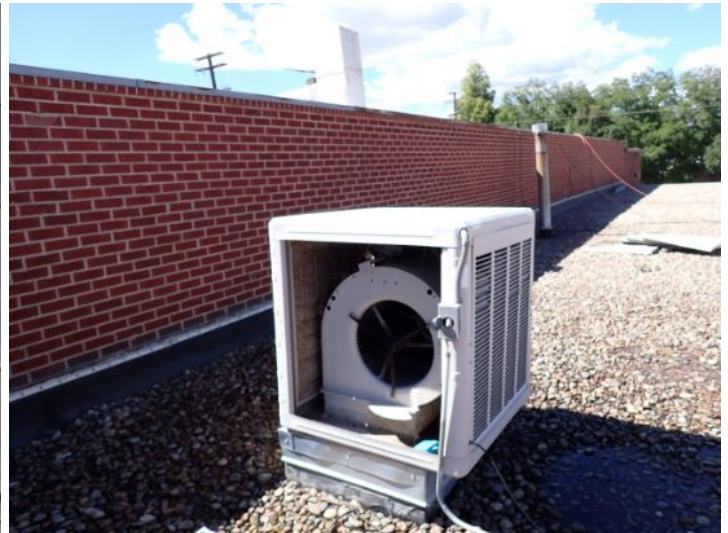
The swamp coolers located on the top of the gravel coated EPDM roofing system located on the north end of the west wing or poor condition in that social time of the inspection. These units are no longer in service we recommend removal.

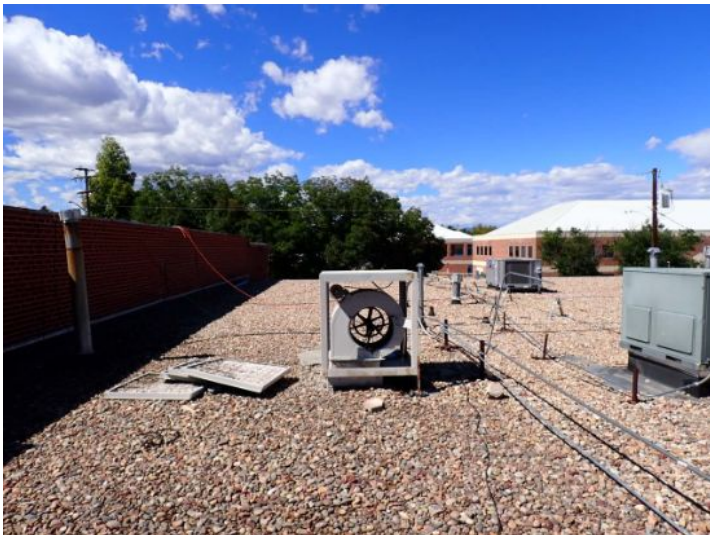
The swamp coolers located on the top of the gravel coated EPDM roofing system located on the north end of the west wing or poor condition in that social time of the inspection. These units are no longer in service we recommend removal.

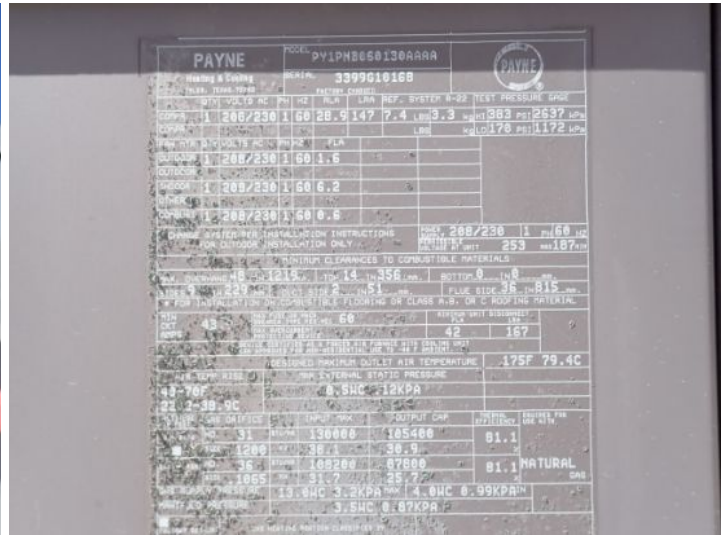
RTU 32: Payne: M/N PY1PNB060130AAAA S/N 3399G10168. Manufacture year 1999.

Significant hail damage noted on RTU 32 at the time of the inspection. Due to the age and condition of the unit we recommend a complete replacement by a licensed hvac contractor.

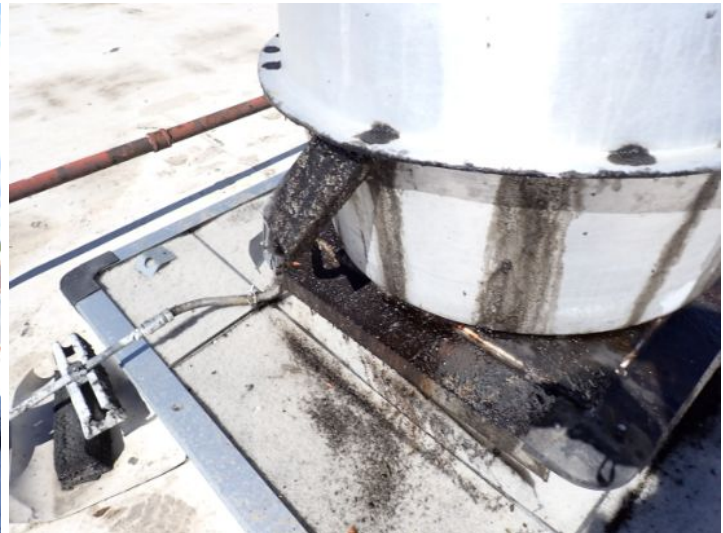
One or more kitchen roof top vent systems were showing signs of significant deferred maintenance. Recommend repairs by a licensed contractor.

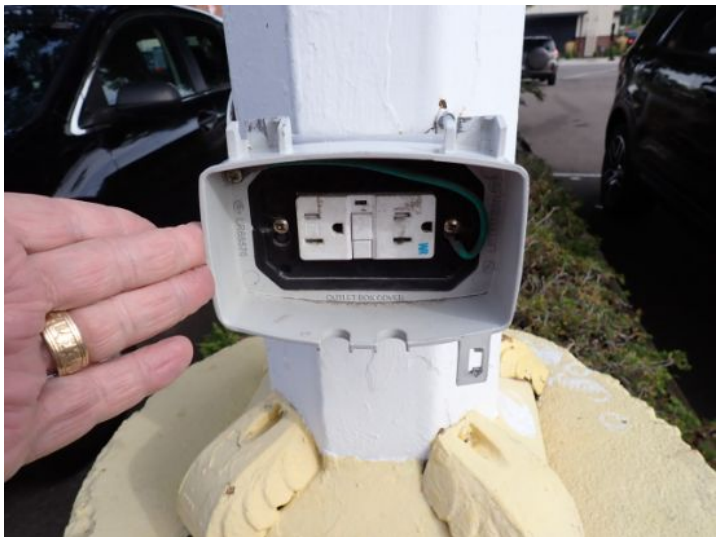
Missing weather cover noted in parking lot area. Recommend repairs by a licensed contractor.

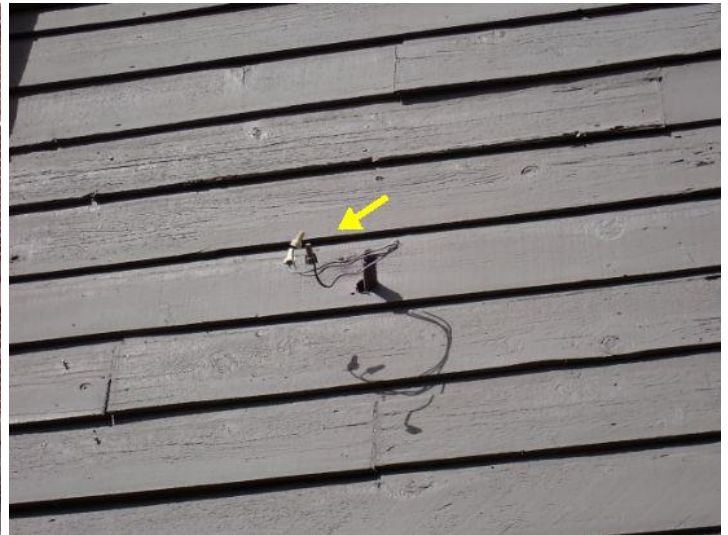
Exposed electrical wiring noted in areas around the exterior and on the roof of the structure at the time of the inspection. Recommend proper repairs by a licensed electrician.

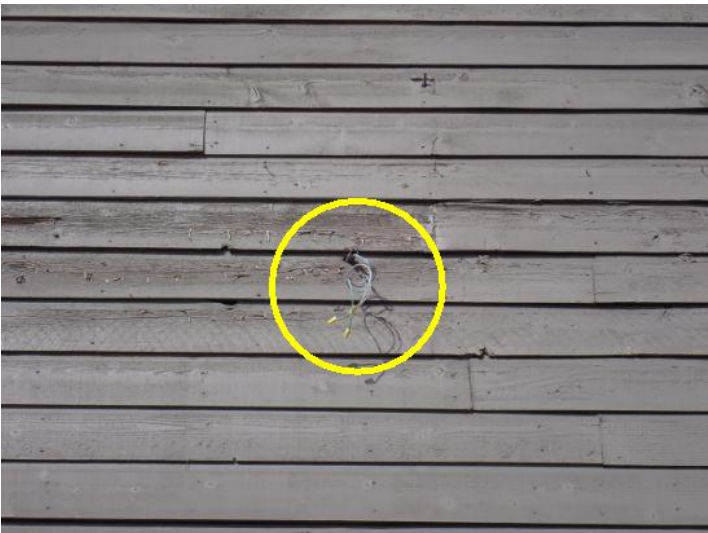
Exposed electrical wiring noted in areas around the exterior and on the roof of the structure at the time of the inspection. Recommend proper repairs by a licensed electrician.

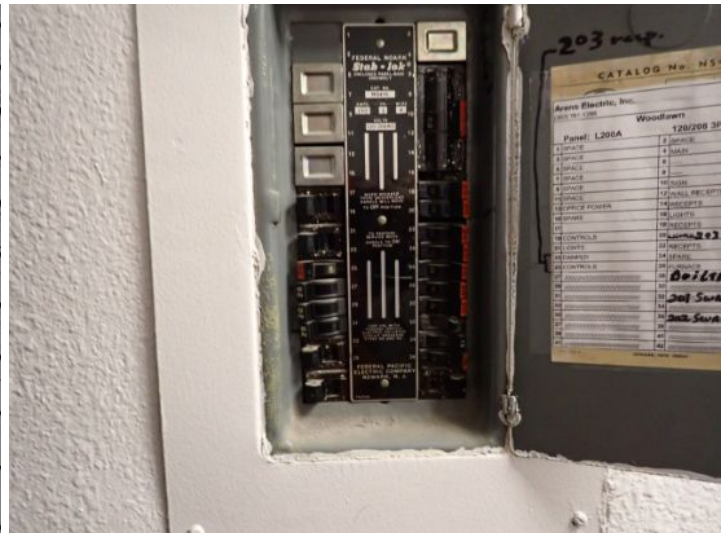
Old Federal Pacific Stab Lock breaker systems noted in some of the units at the time of the inspection. These systems have been proven to be safety/fire issues. Recommend replacement of all FPE panels and stab lock breaker systems by a licensed contractor prior to taking possession of the property.

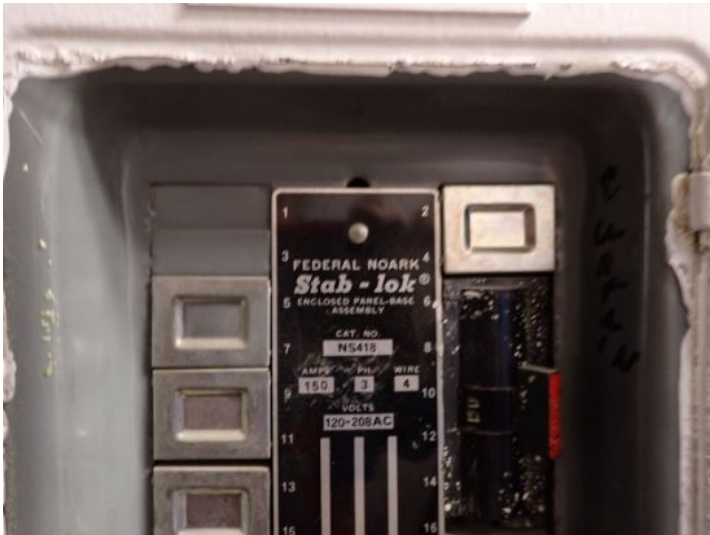
Old Federal Pacific Stab Lock breaker systems noted in some of the units at the time of the inspection. These systems have been proven to be safety/fire issues. Recommend replacement of all FPE panels and stab lock breaker systems by a licensed contractor prior to taking possession of the property.

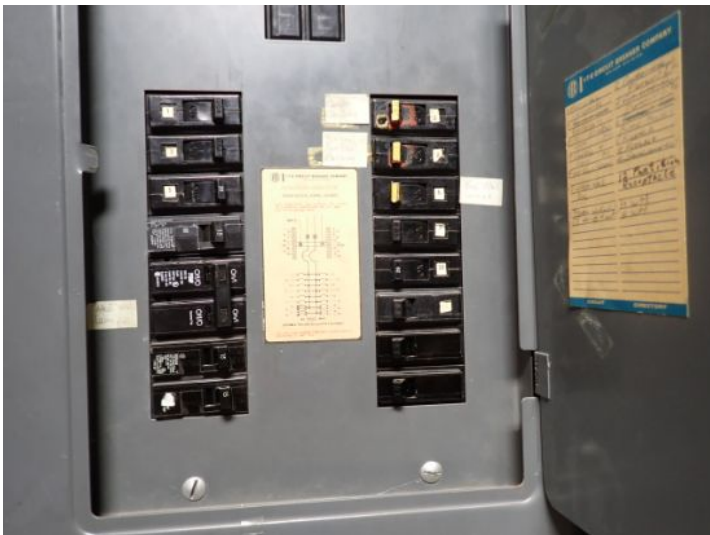
The nominal serviceable life expectancy of an electrical breaker system is 30 years. Based on the inspectors findings at the time of the inspection there were multiple panels and breaker systems that appeared to have surpassed their serviceable life expectancy. Recommend repair/replacement of these systems by a licensed electrician prior to taking possession of the property.

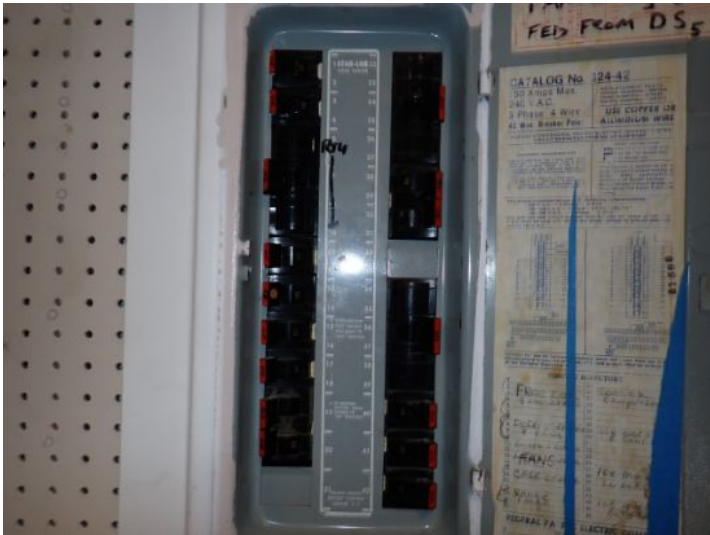
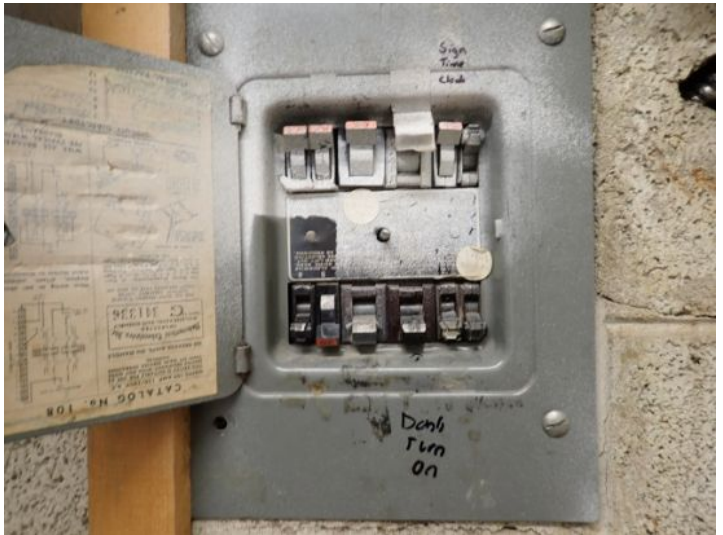
Old Federal Pacific Stab Lock breaker systems noted in some of the units at the time of the inspection. These systems have been proven to be safety/fire issues. Recommend replacement of all FPE panels and stab lock breaker systems by a licensed contractor prior to taking possession of the property.

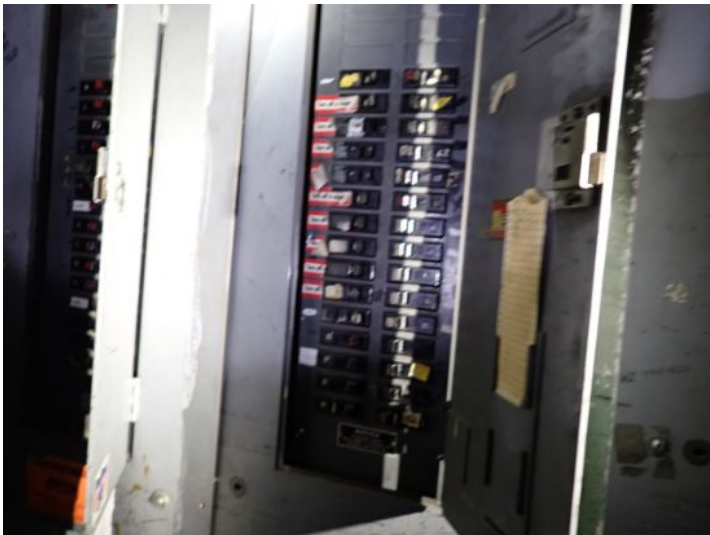
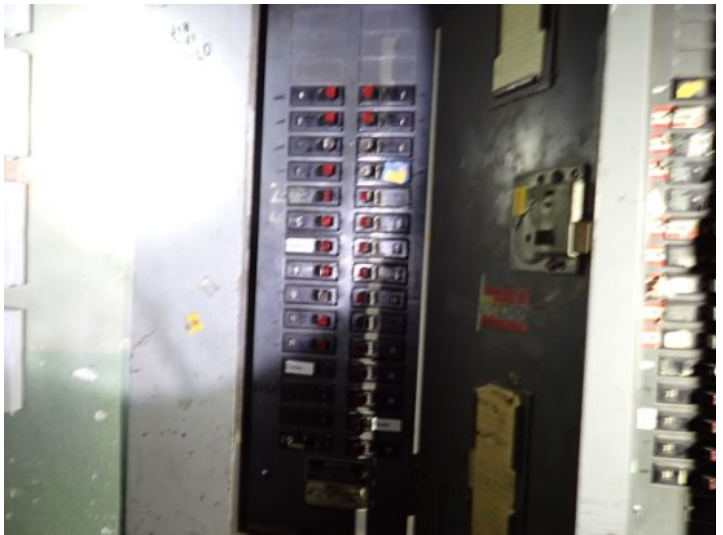
The nominal serviceable life expectancy of an electrical breaker system is 30 years. Based on the inspectors findings at the time of the inspection there were multiple panels and breaker systems that appeared to have surpassed their serviceable life expectancy. Recommend repair/replacement of these systems by a licensed electrician prior to taking possession of the property.

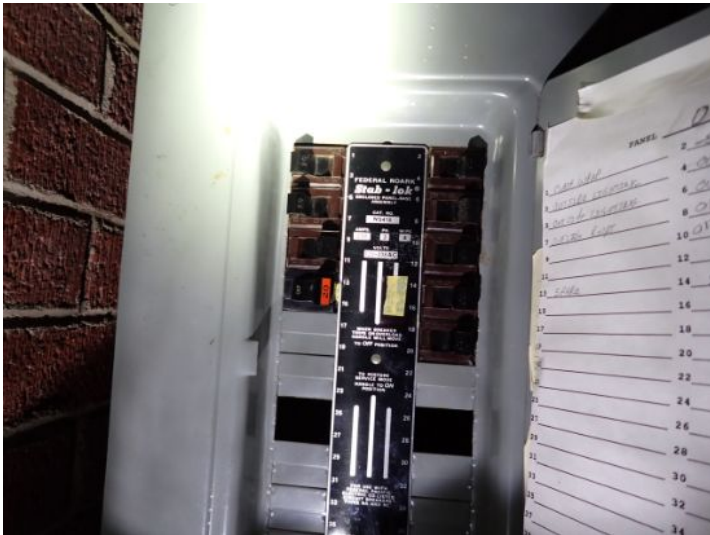
Old Federal Pacific Stab Lock breaker systems noted in some of the units at the time of the inspection. These systems have been proven to be safety/fire issues. Recommend replacement of all FPE panels and stab lock breaker systems by a licensed contractor prior to taking possession of the property.

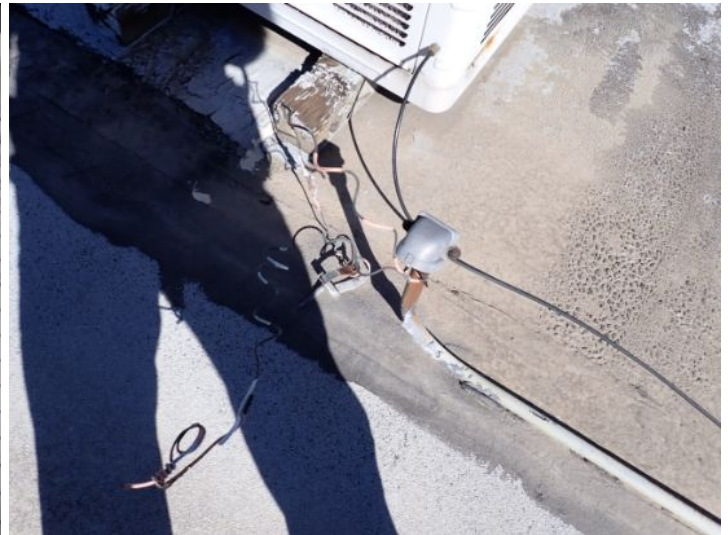
Exposed electrical wiring noted in areas around the exterior and on the roof of the structure at the time of the inspection. Recommend proper repairs by a licensed electrician.

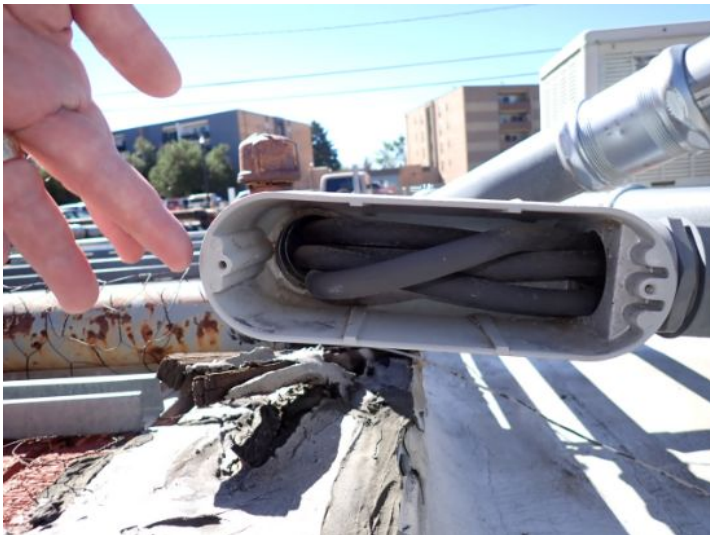
Missing cover plate noted on roof top pull box. Recommend repairs by a licensed contractor.

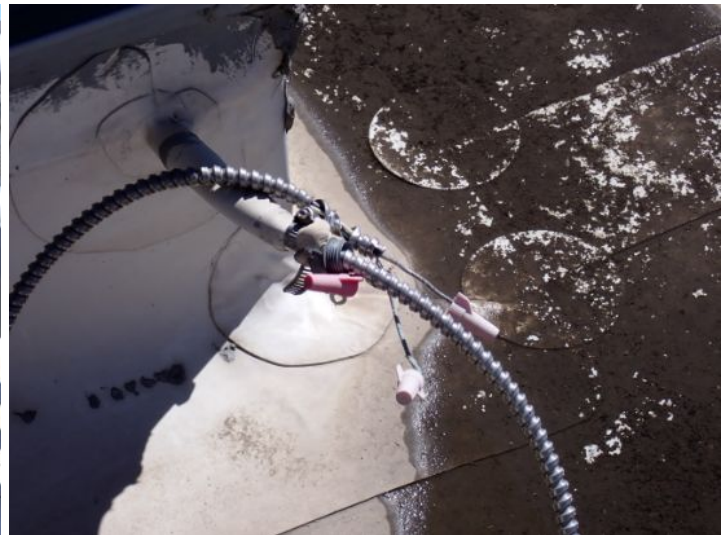
Exposed electrical wiring noted in areas around the exterior and on the roof of the structure at the time of the inspection. Recommend proper repairs by a licensed electrician.

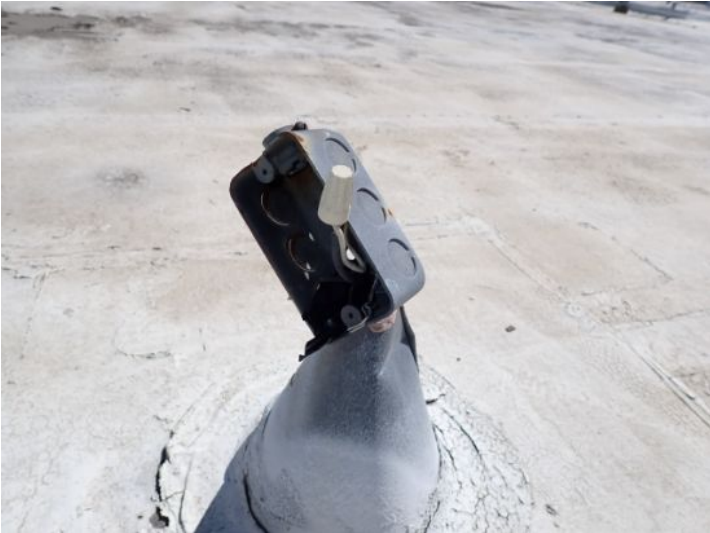
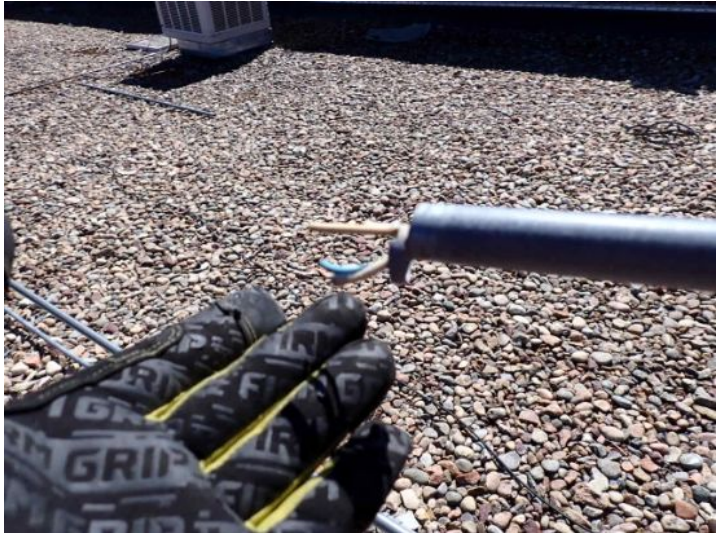
Exposed electrical wiring noted in areas around the exterior and on the roof of the structure at the time of the inspection. Recommend proper repairs by a licensed electrician.

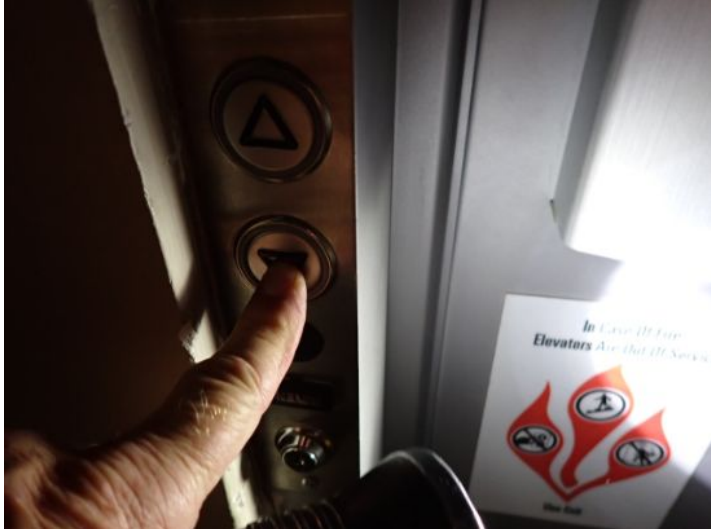
The chair lift system located in the mall area for the church was locked out and could not be tested at the time of the inspection. Based on the inspectors conversation with church personnel the system functions properly.

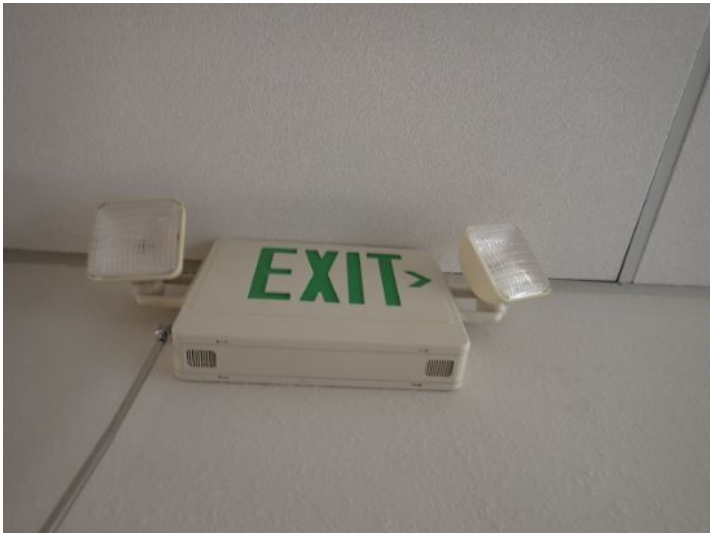
Multiple emergency lighting systems failed when tested at the time of the inspection. Recommend repairs as needed by a licensed contractor.

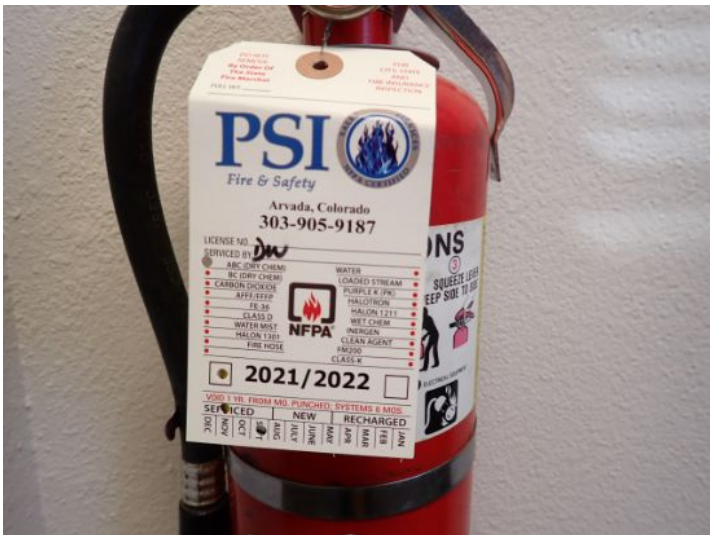
There were fire extinguishers located within the structure

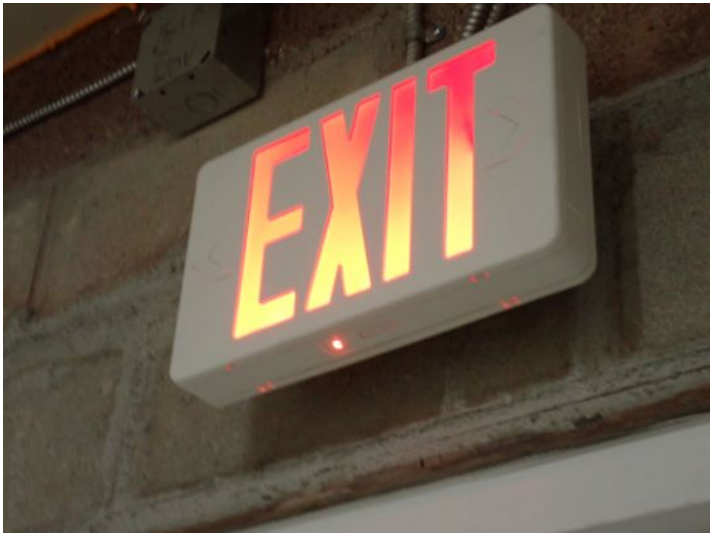
Multiple emergency lighting systems failed when tested at the time of the inspection. Recommend repairs as needed by a licensed contractor.

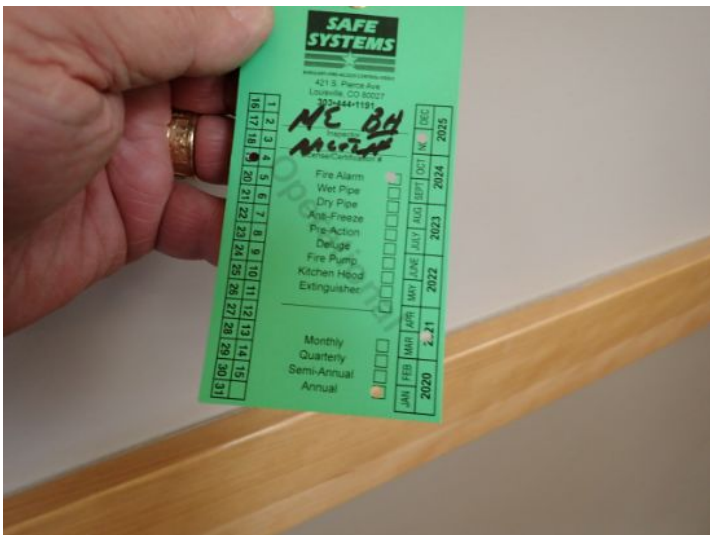
There was a fire alarm and fire suppression system for the basement units located below the mall area. There was also an old fire suppression system located in the basement below the large vacant unit. The remainder of the property did NOT have a fire alarm or fire suppression system located within it at the time of the inspection.

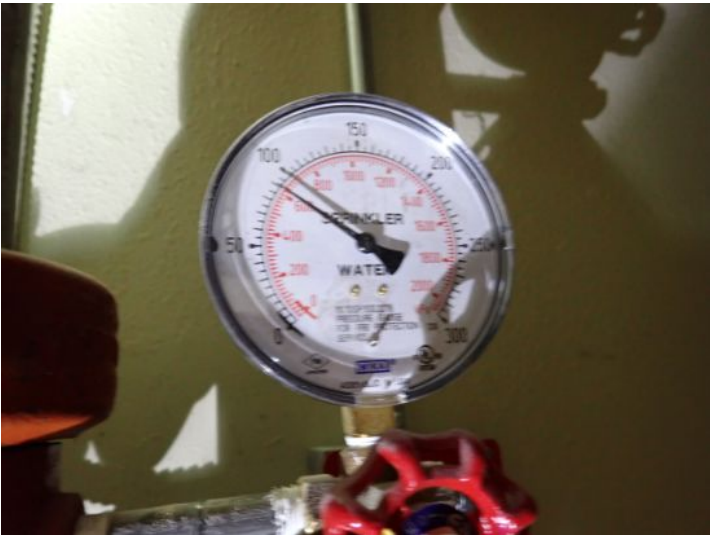
Last date of inspection/certification of the fire suppression systems backflow preventer was 7/22.

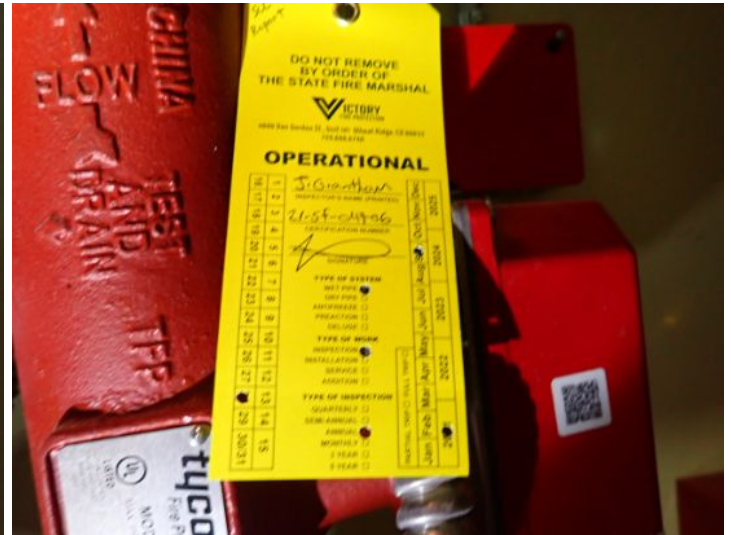
The fire suppression system was holding approximately 90 psi at the time of the inspection.

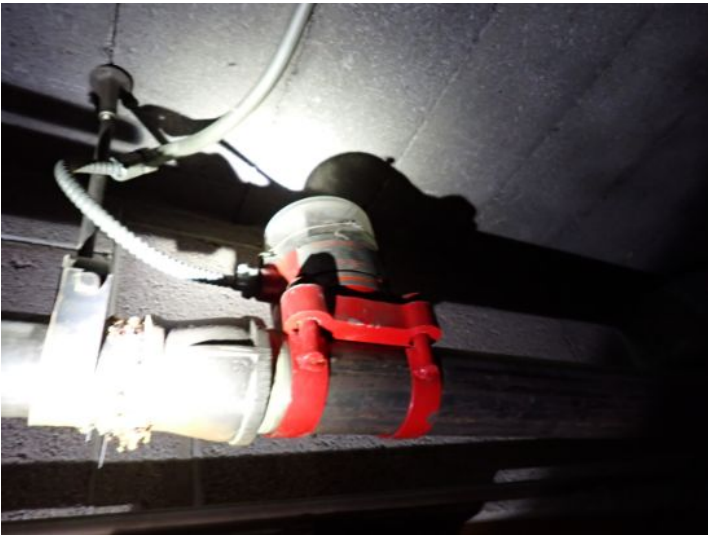
The old fire suppression system located in the basement below the large vacant unit will most likely require updating prior to placing a tenant in the unit. Recommend consulting with the current management company and local fire marshal concerning this matter as updating of fire suppression and alarm systems could be considered a significant capital investment.

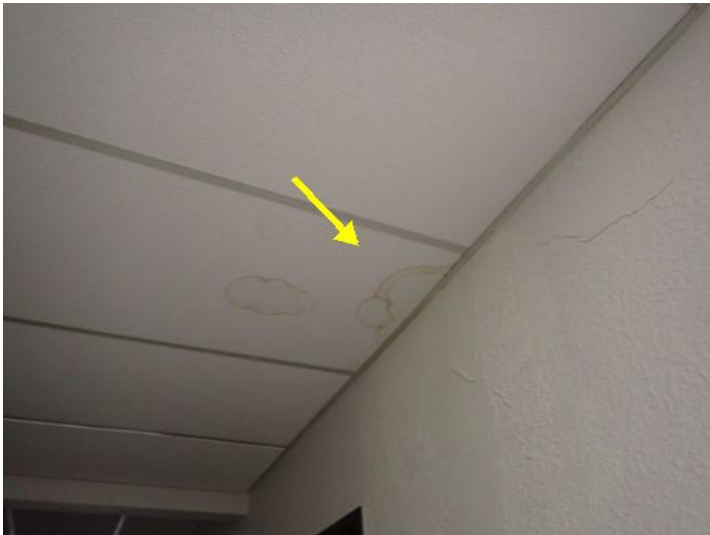
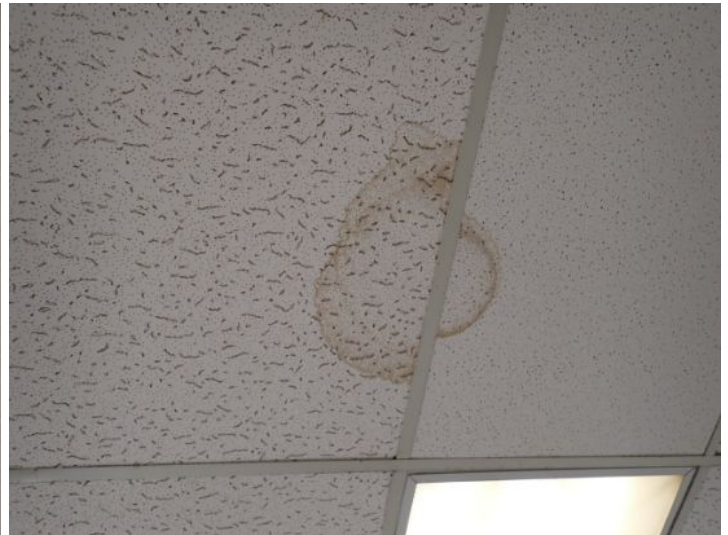
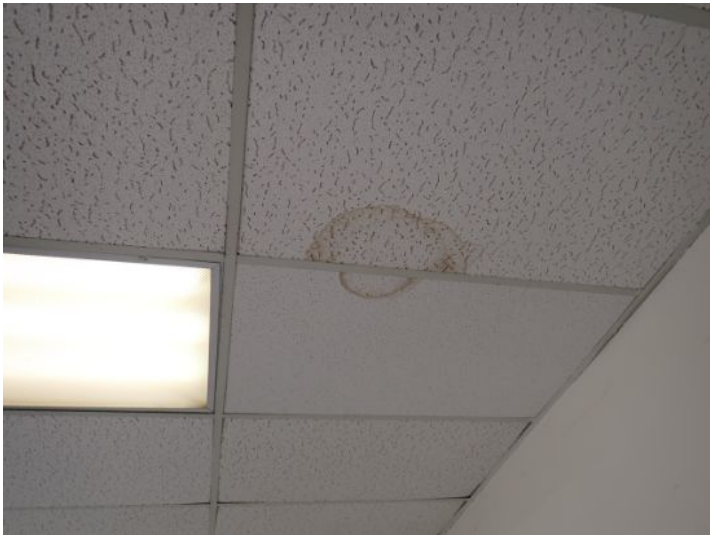
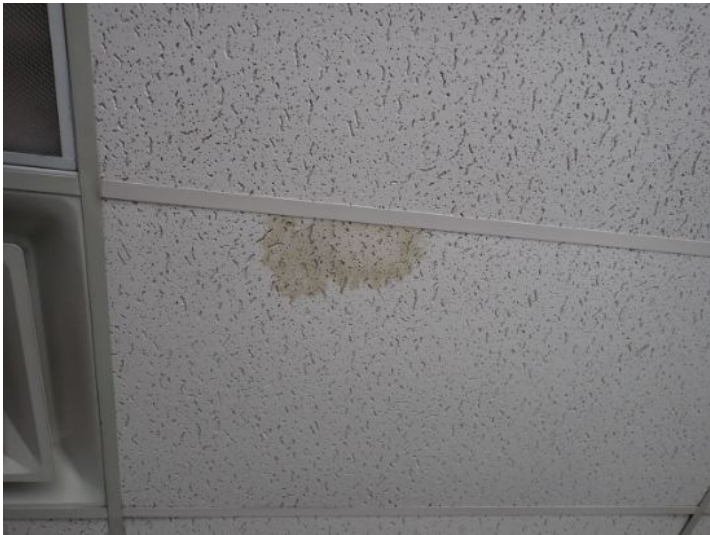
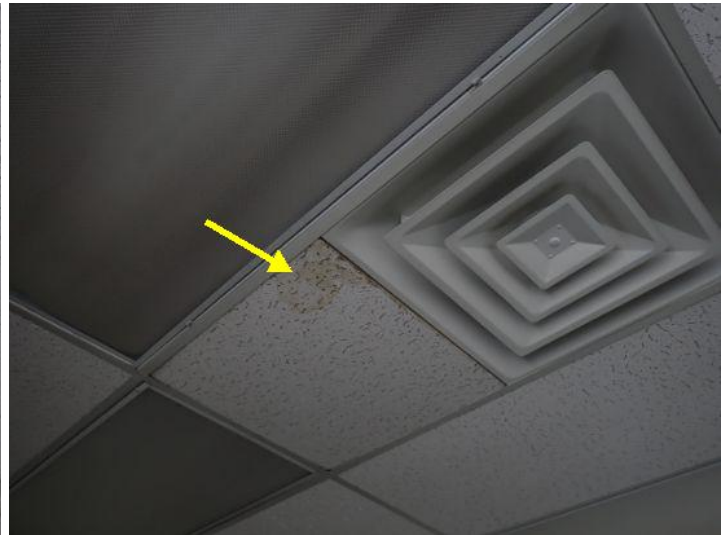
Moisture staining noted in areas of the acoustical tile ceilings throughout the building at the time of the inspection. Recommend repairs and monitoring

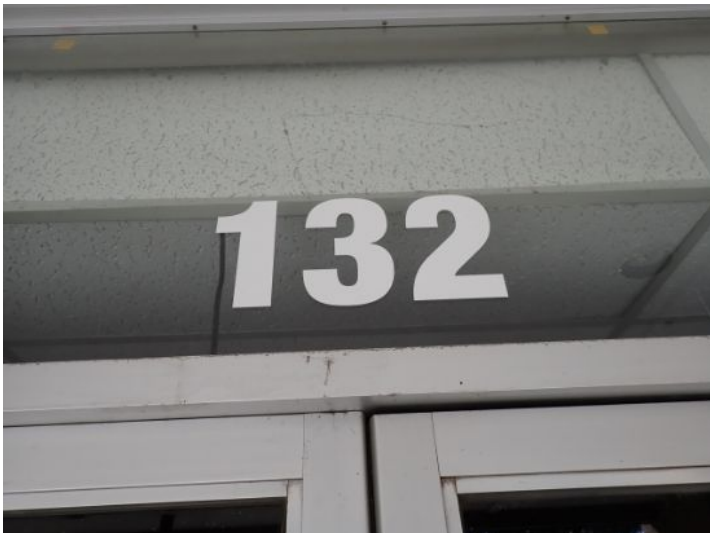
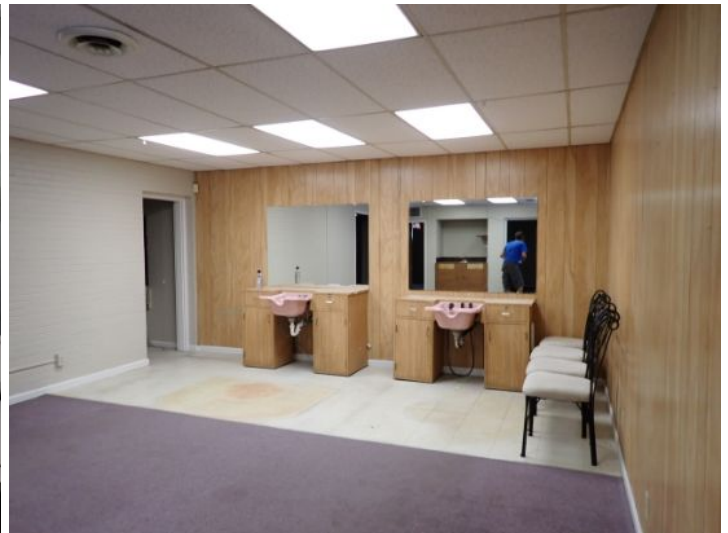
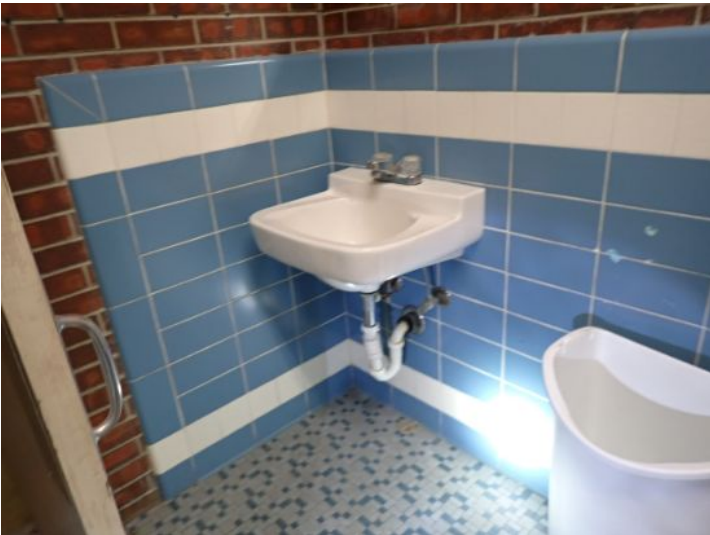
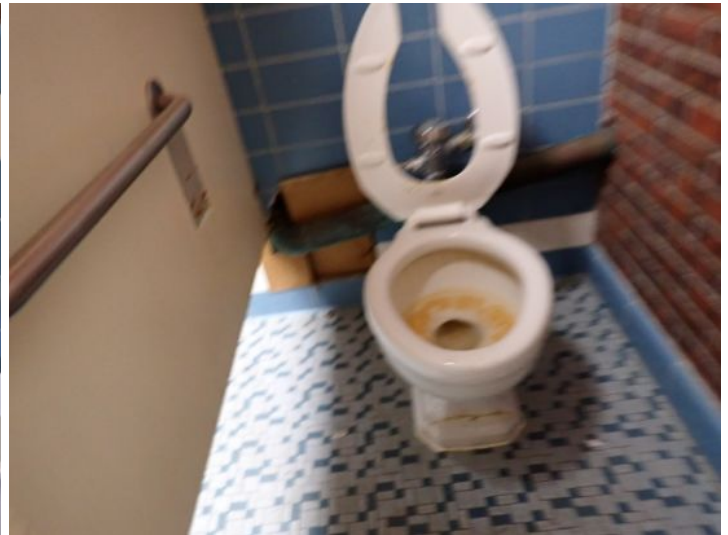
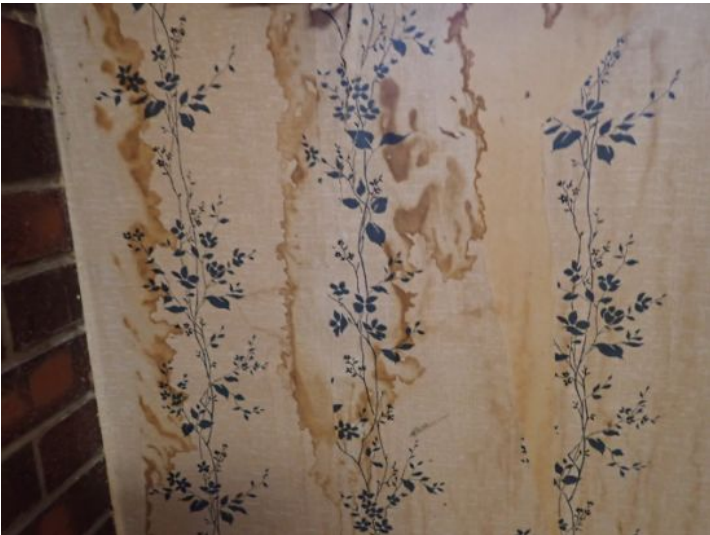
Unit 132: Unit was in poor condition and will require complete renovations prior to installing a new tenant.

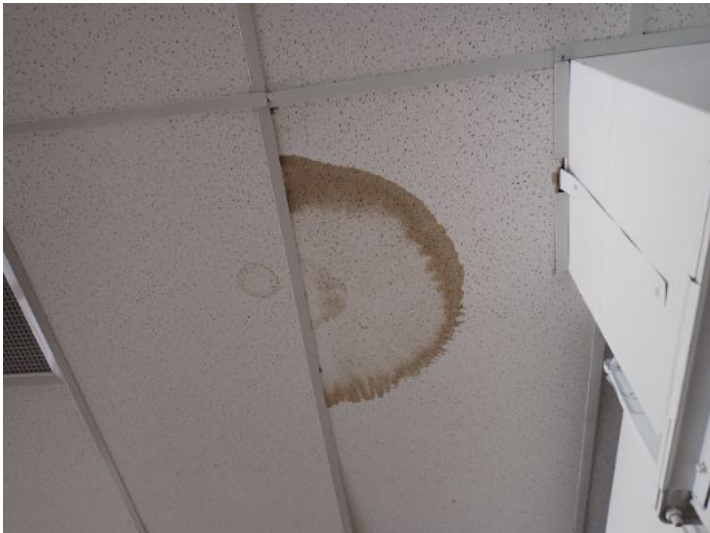
Unit 122: Moisture damage noted in ceiling tiles. Recommend repairs and monitoring.

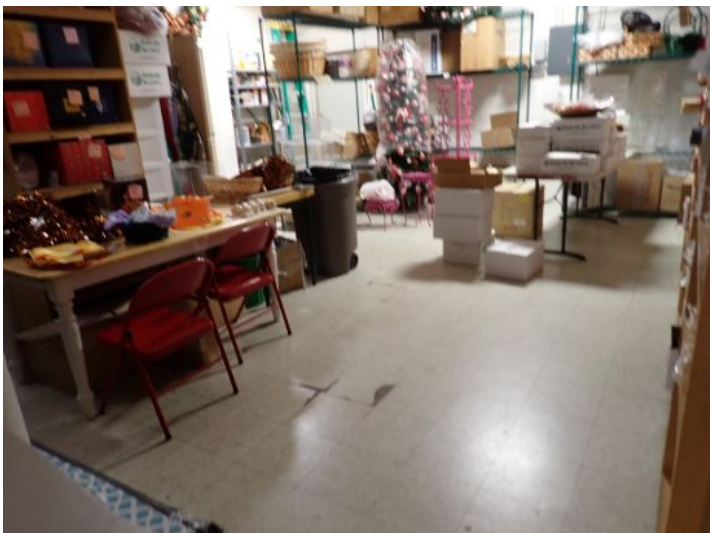
Unit 121: VCT flooring damage noted. Recommend repairs.

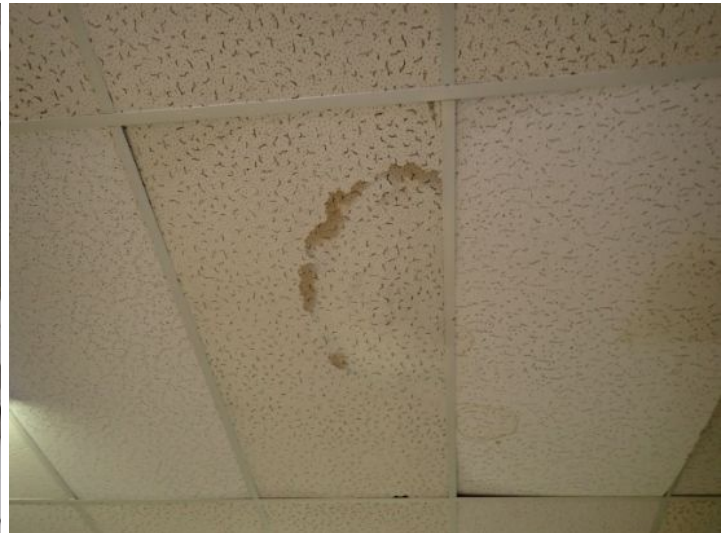
Unit 119: Moisture staining noted in ceiling tiles. Recommend repairs and monitoring

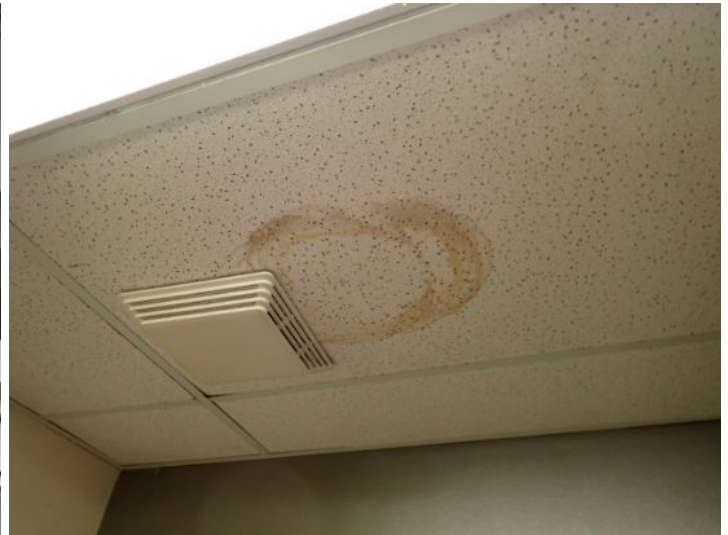
Unit 118: Moisture staining noted in ceiling.  
Moisture damage noted in drywall ceiling.  
Recommend repairs and monitoring.

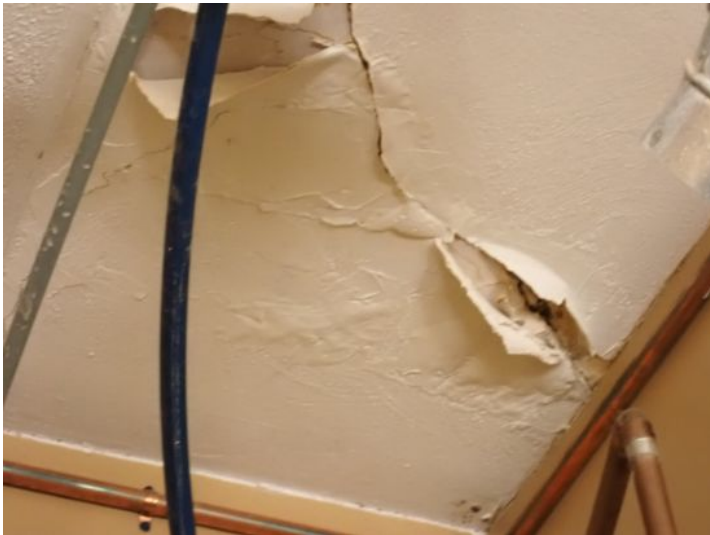
Unit 118: Moisture staining noted in ceiling.  
Moisture damage noted in drywall ceiling.  
Recommend repairs and monitoring.

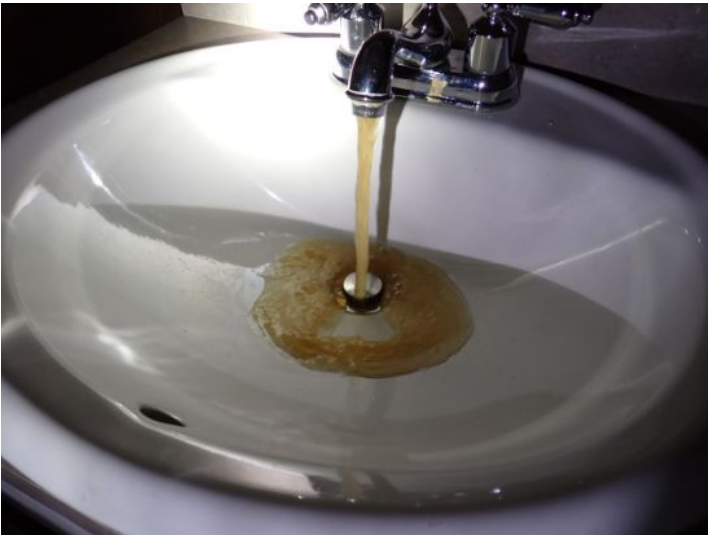
Unit 113: Unit was vacant and will require renovations prior to installing a new tenant.
