# *Forman Inspection Services, LLC*

## Property Inspection Report

1234 Retail St., Somewhere, CO 12345

Date of Inspection: 9/16/2022 Time: 10:00 Size: 93,886 sq. ft. per listing

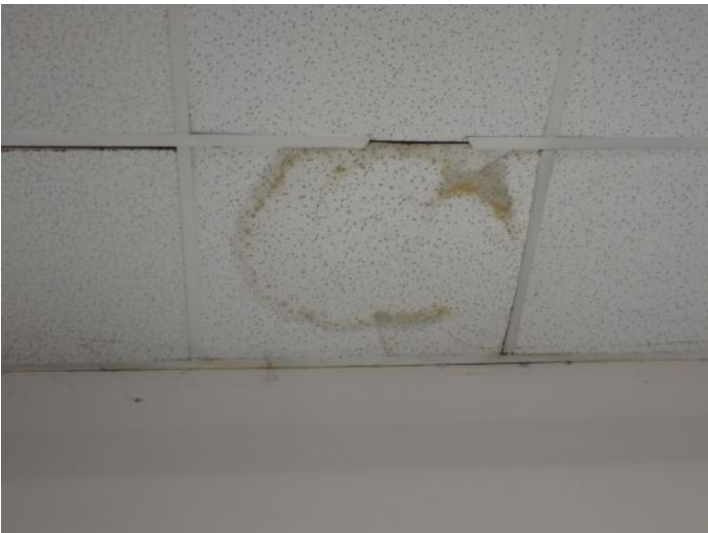
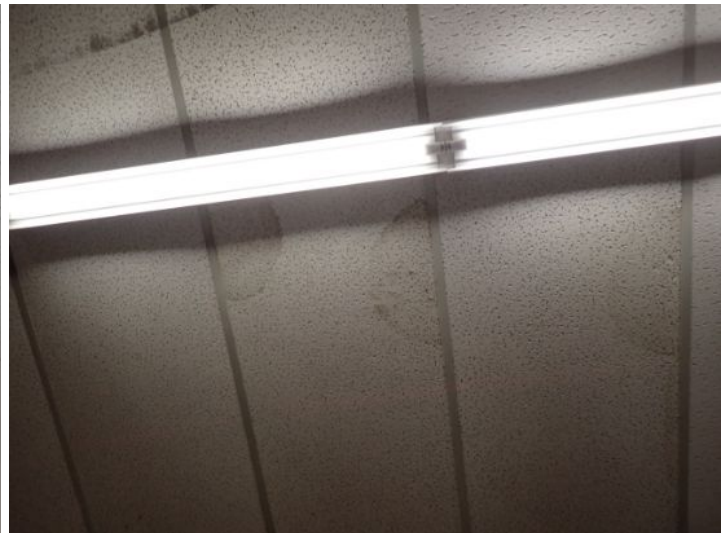
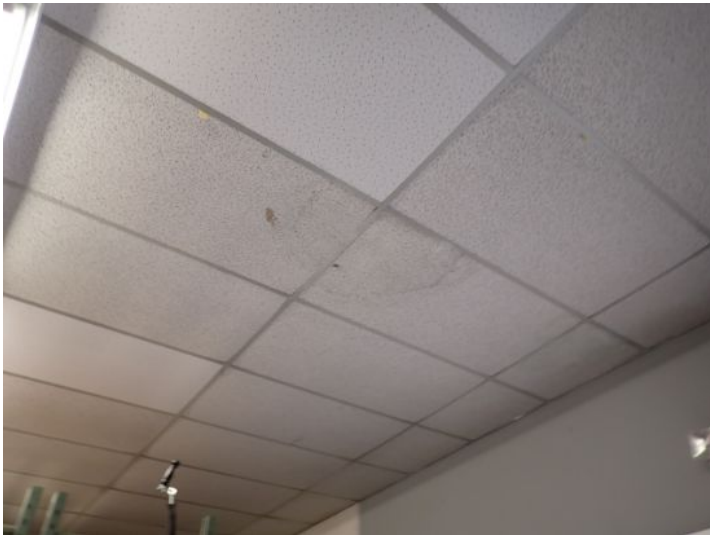
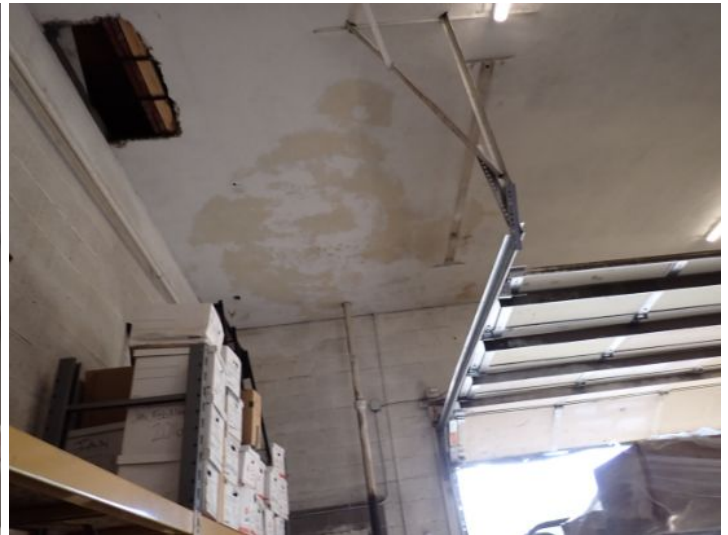
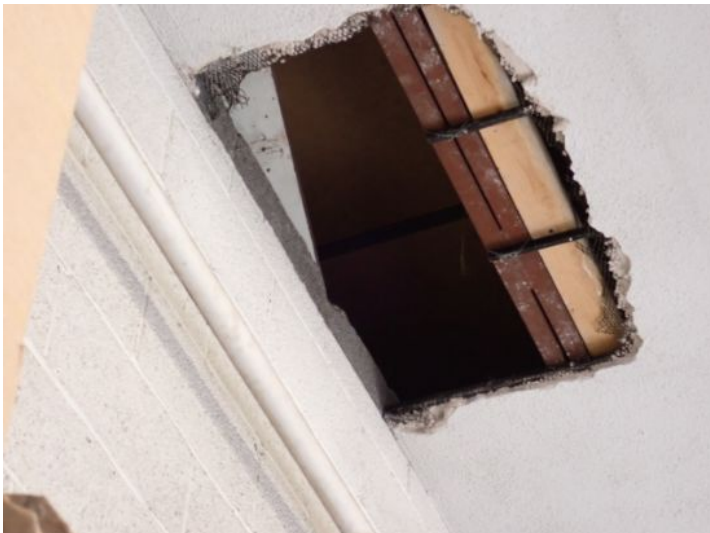
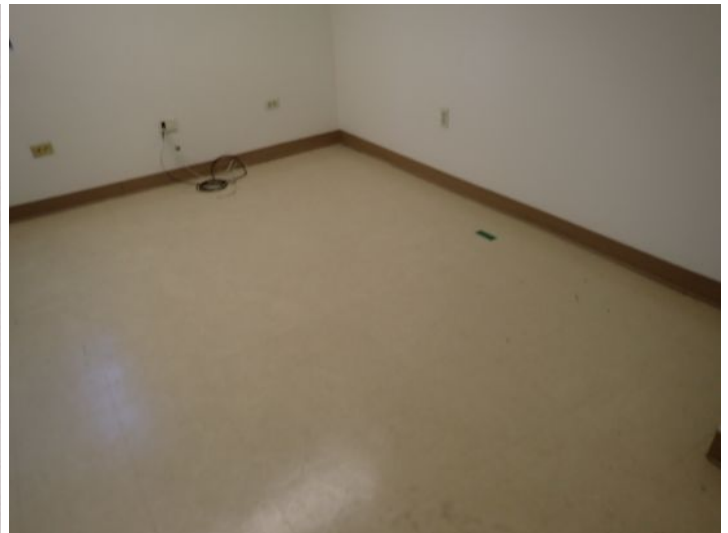
Unit 111-112: Moisture staining noted in ceiling tiles. Moisture damage noted in warehouse ceiling. Water heater not functional. Drywall ceiling damage noted. Recommend repairs.

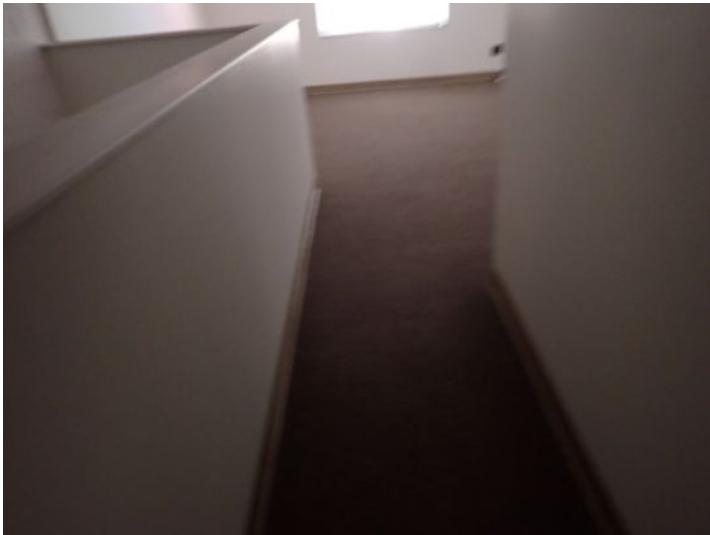
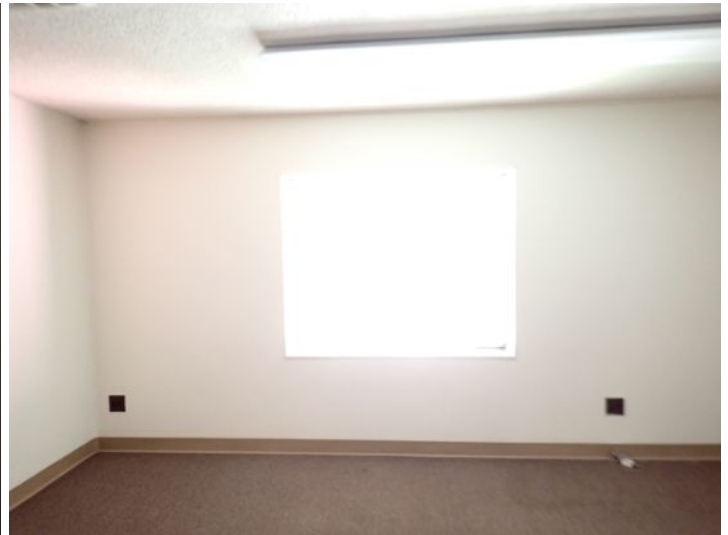
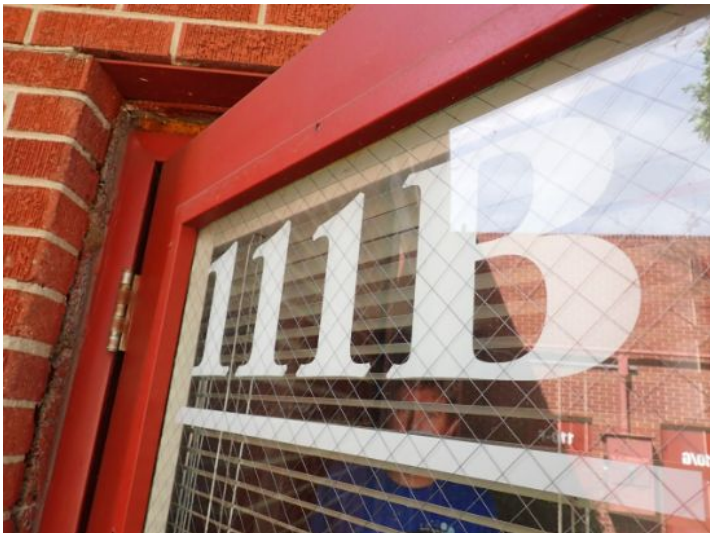
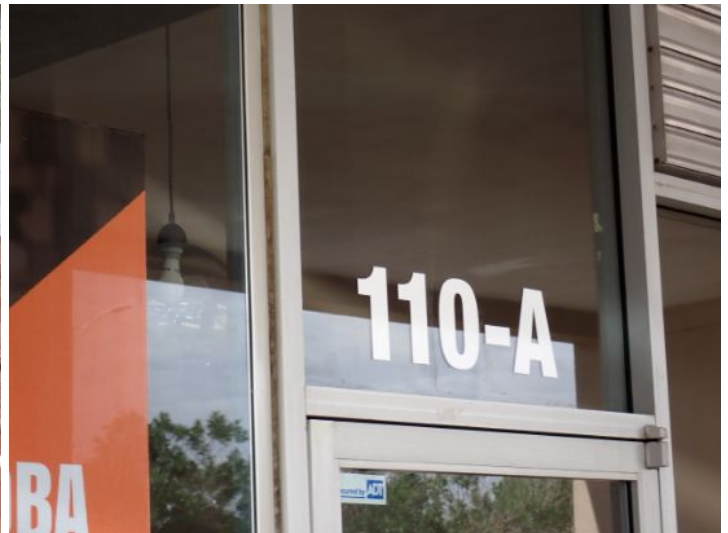
Unit 111B: Emergency egress goes through unit 111 which is locked at night. Recommend repairs by a licensed contractor prior to installing a new tenant.

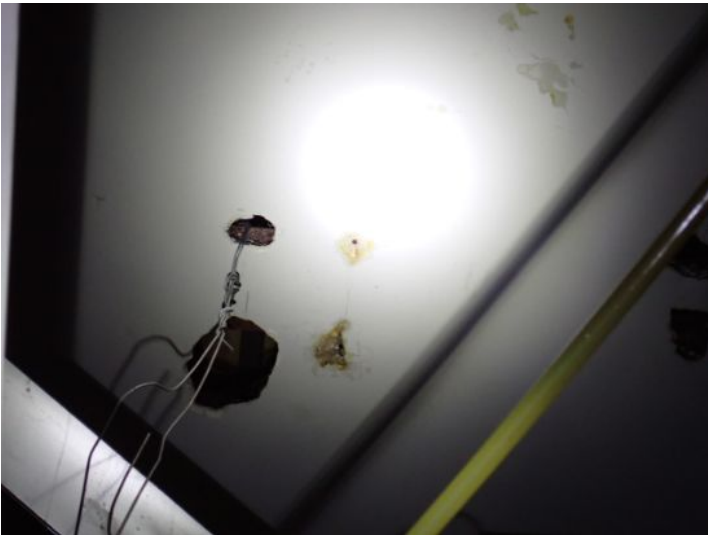
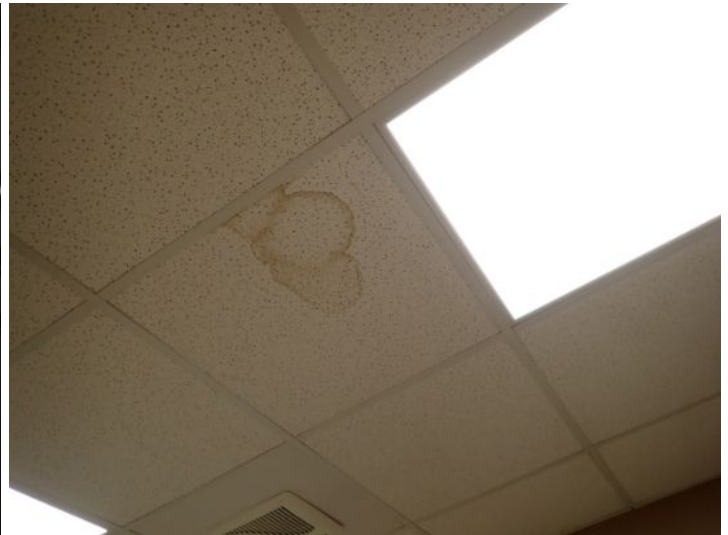
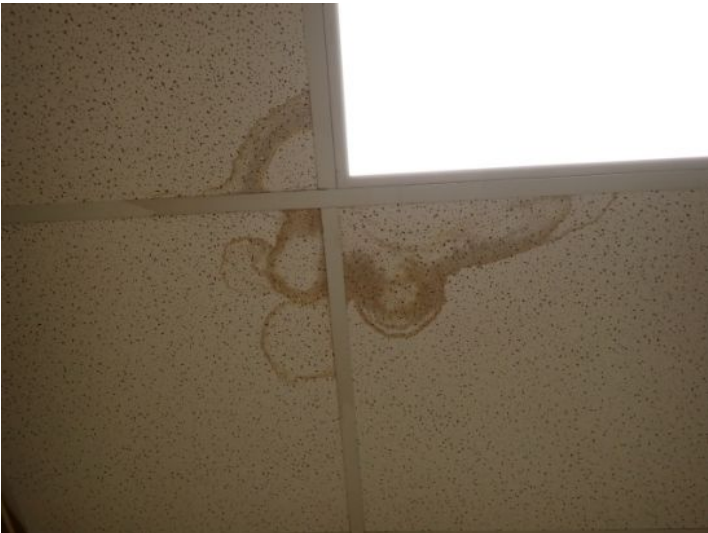
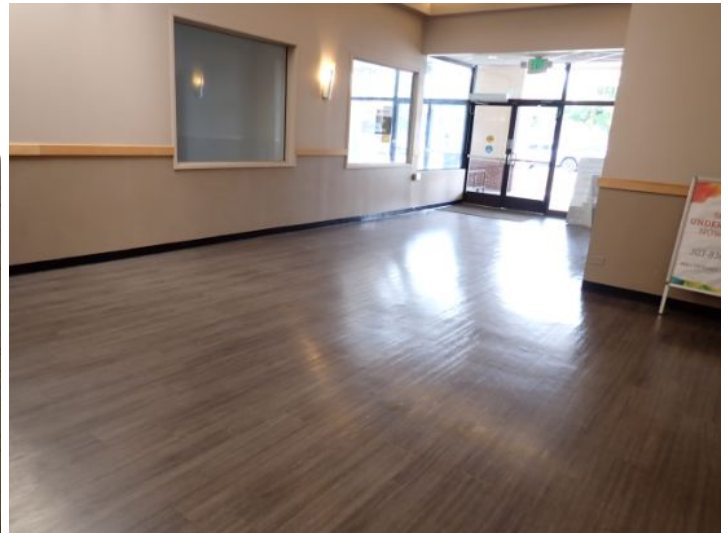
Unit 110A: Moisture staining noted in ceilings. Recommend repairs.

Unit 110A: Moisture staining noted in ceilings.  
Recommend repairs.

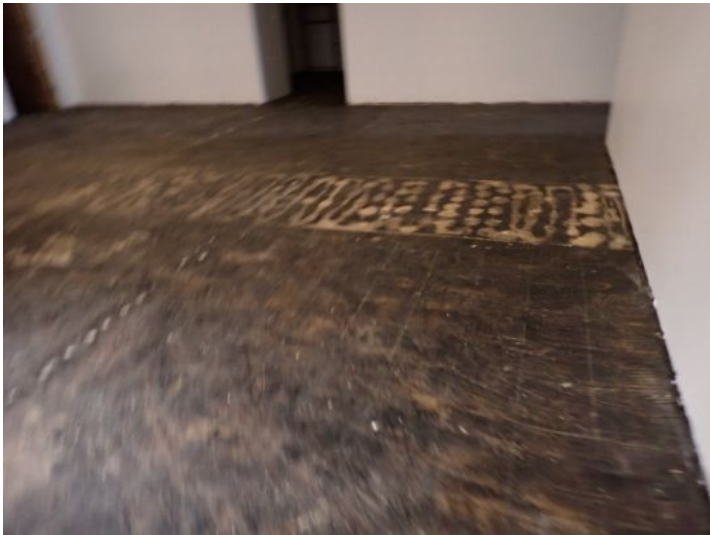
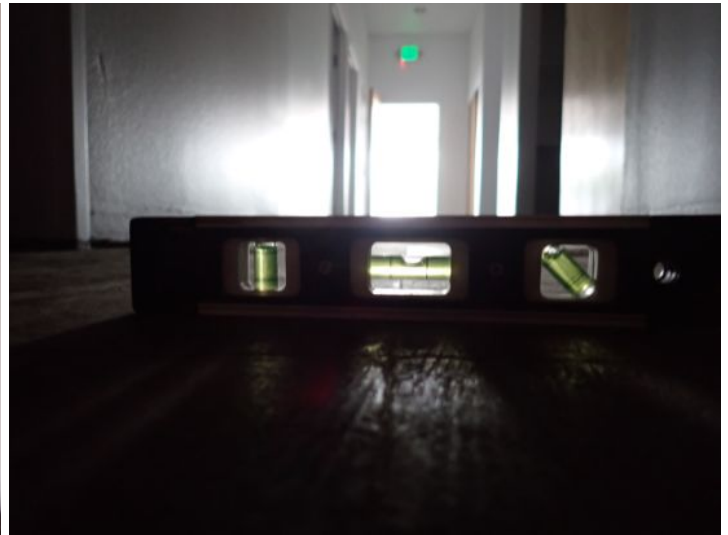
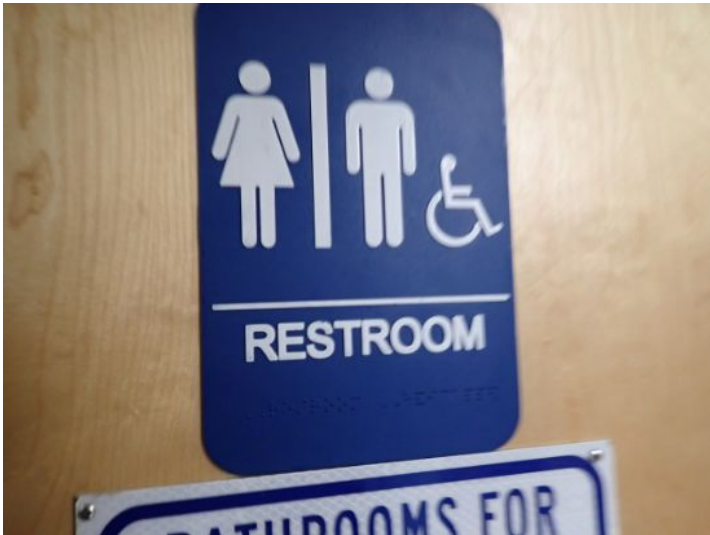
Unit 110C&D: Unit was vacant. Floor settling/deflection noted. Recommend repairs as needed by a licensed contractor.

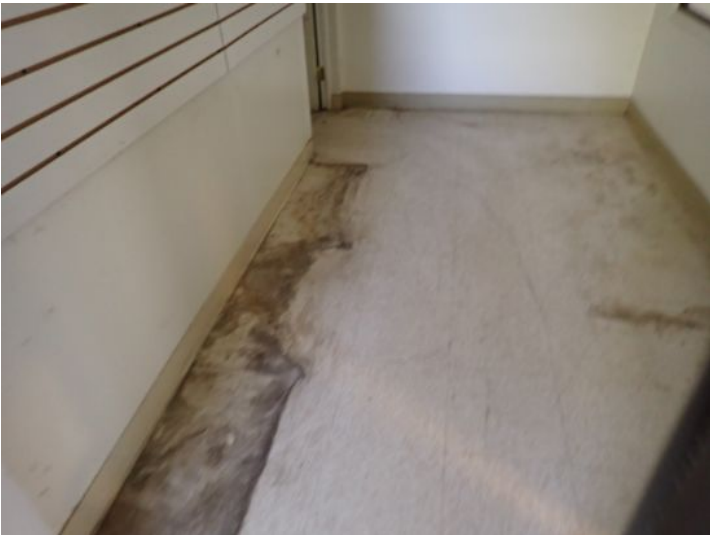
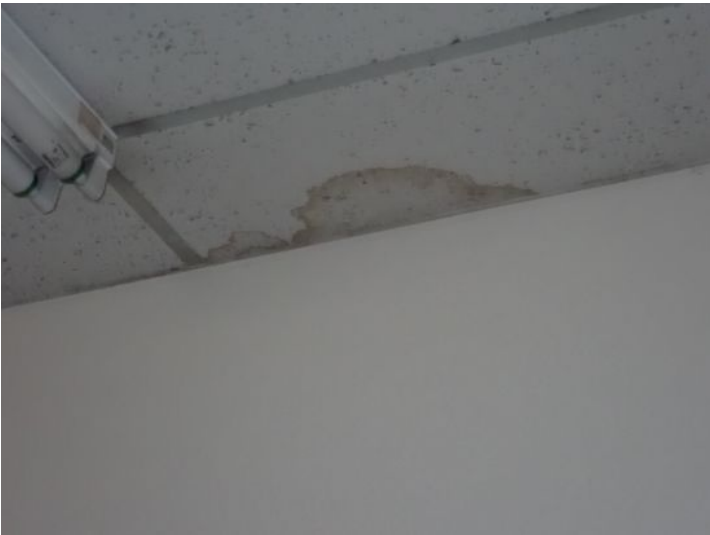
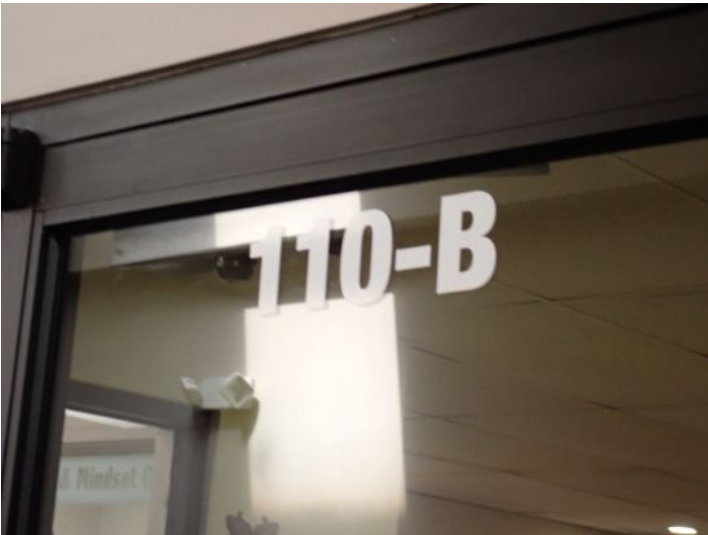
Unit 110E: Unit was vacant and will require renovations prior to placing a tenant. Recommend repairs by a licensed contractor.

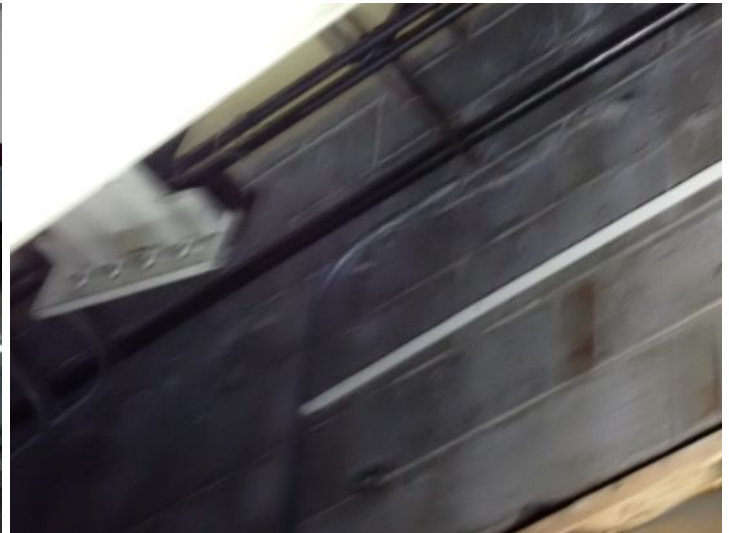
Unit 110G: Acoustical tile ceiling damage noted.  
Missing knockouts noted in electrical panel.  
Recommend repairs.

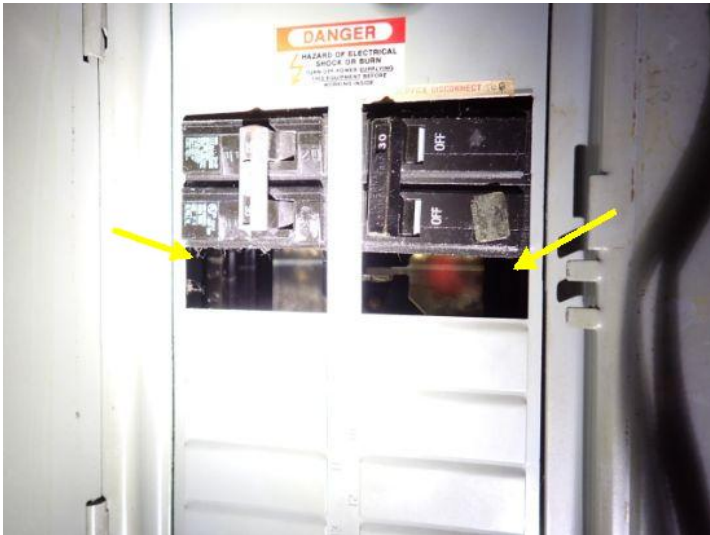
Unit 110G: Acoustical tile ceiling damage noted.  
Missing knockouts noted in electrical panel.  
Recommend repairs.

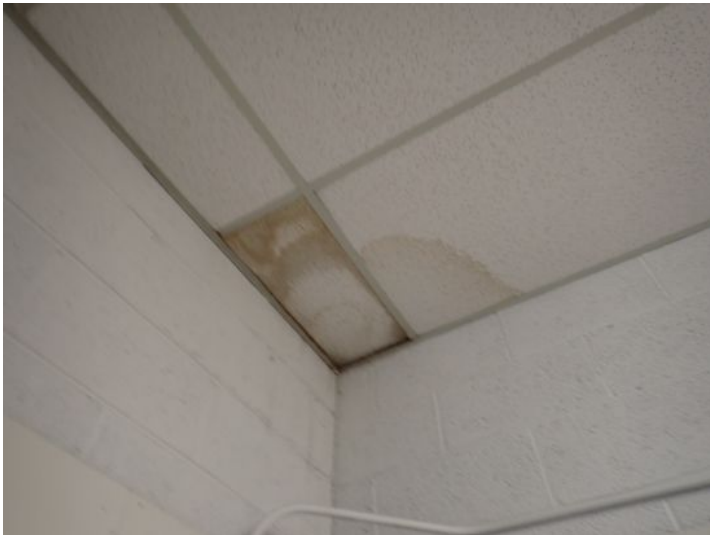
Unit 109: Past moisture staining noted in ceiling tiles. Recommend repairs.

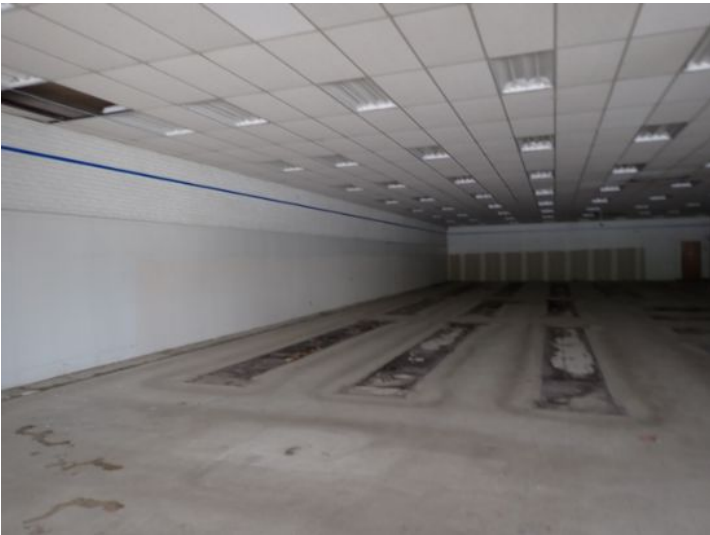
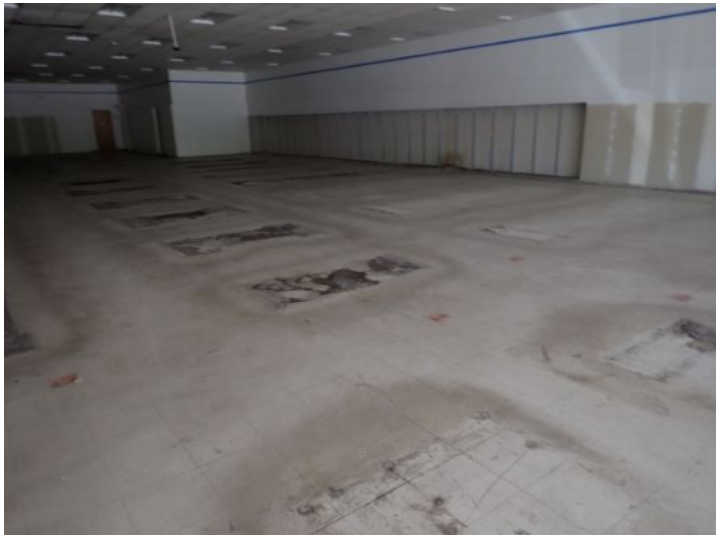
Unit 108-107: Vacant: Unit will require significant renovations prior to installing tenant. Active moisture noted in interior wall with possible microbial growth. Significant drywall damage noted in ceiling in loading dock area. Basement area in poor condition. Basement bathrooms in poor condition. Electrical not working at the time of the inspection. Moisture intrusion/damage noted in basement walls. Recommend repairs as needed by a licensed contractor.

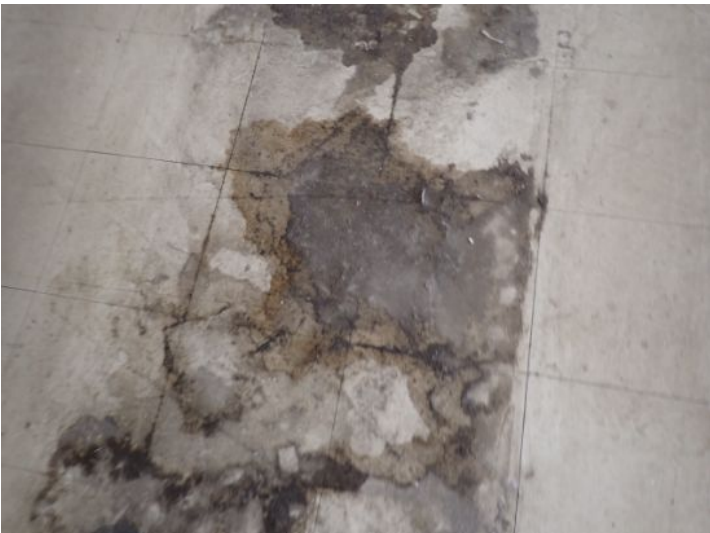
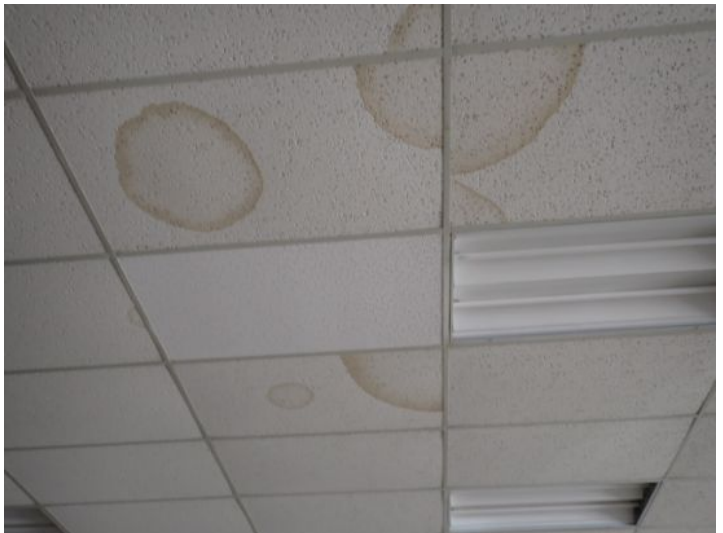
Unit 108-107: Vacant: Unit will require significant renovations prior to installing tenant. Active moisture noted in interior wall with possible microbial growth. Significant drywall damage noted in ceiling in loading dock area. Basement area in poor condition. Basement bathrooms in poor condition. Electrical not working at the time of the inspection. Moisture intrusion/damage noted in basement walls. Recommend repairs as needed by a licensed contractor.

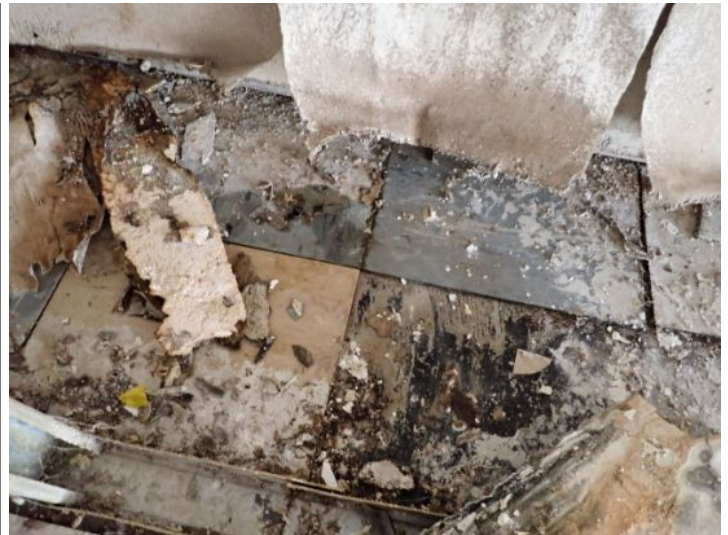
Unit 108-107: Vacant: Unit will require significant renovations prior to installing tenant. Active moisture noted in interior wall with possible microbial growth. Significant drywall damage noted in ceiling in loading dock area. Basement area in poor condition. Basement bathrooms in poor condition. Electrical not working at the time of the inspection. Moisture intrusion/damage noted in basement walls. Recommend repairs as needed by a licensed contractor.

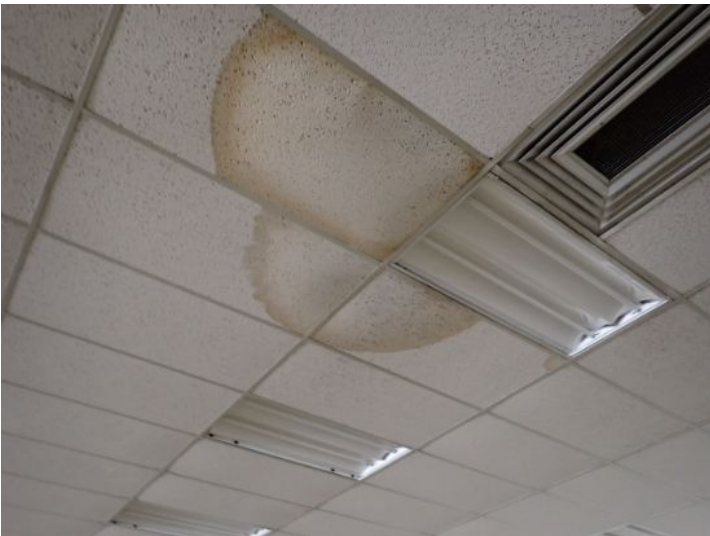
Unit 108-107: Vacant: Unit will require significant renovations prior to installing tenant. Active moisture noted in interior wall with possible microbial growth. Significant drywall damage noted in ceiling in loading dock area. Basement area in poor condition. Basement bathrooms in poor condition. Electrical not working at the time of the inspection. Moisture intrusion/damage noted in basement walls. Recommend repairs as needed by a licensed contractor.

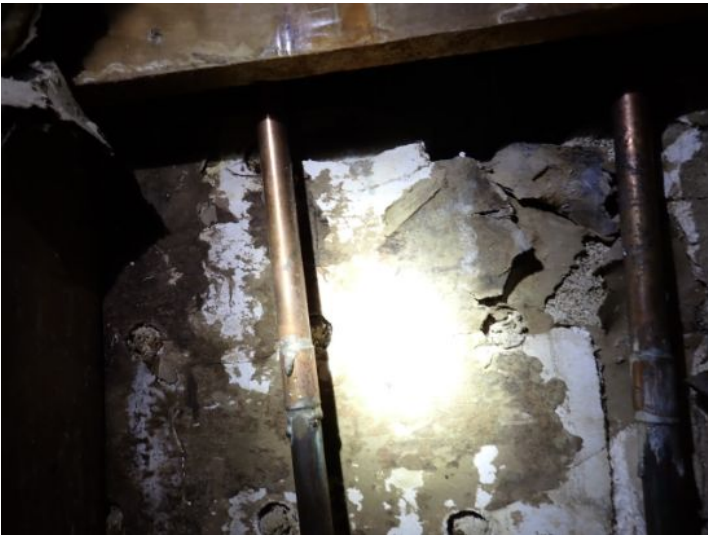
Unit 108-107: Vacant: Unit will require significant renovations prior to installing tenant. Active moisture noted in interior wall with possible microbial growth. Significant drywall damage noted in ceiling in loading dock area. Basement area in poor condition. Basement bathrooms in poor condition. Electrical not working at the time of the inspection. Moisture intrusion/damage noted in basement walls. Recommend repairs as needed by a licensed contractor.

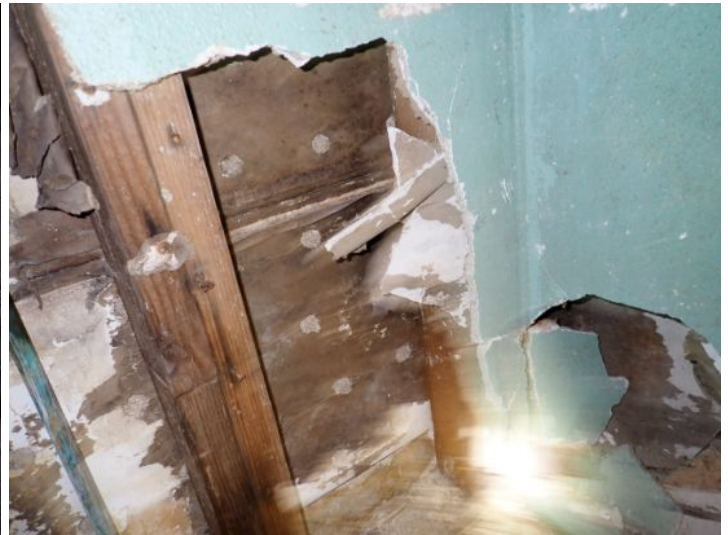
Unit 108-107: Vacant: Unit will require significant renovations prior to installing tenant. Active moisture noted in interior wall with possible microbial growth. Significant drywall damage noted in ceiling and walls in loading dock area. Basement area in poor condition. Basement bathrooms in poor condition. Electrical not working at the time of the inspection. Moisture intrusion/damage noted in basement walls. Recommend repairs as needed by a licensed contractor.

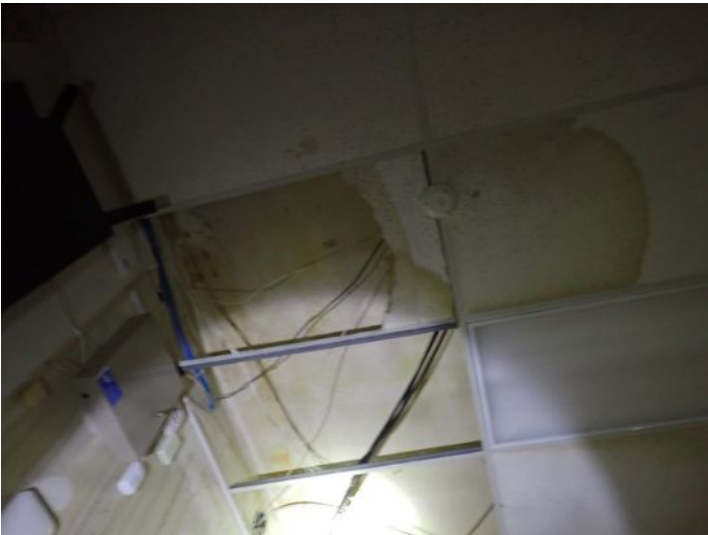
Unit 108-107: Vacant: Unit will require significant renovations prior to installing tenant. Active moisture noted in interior wall with possible microbial growth. Significant drywall damage noted in ceiling and walls in loading dock area. Basement area in poor condition. Basement bathrooms in poor condition. Electrical not working at the time of the inspection. Moisture intrusion/damage noted in basement walls. Recommend repairs as needed by a licensed contractor.

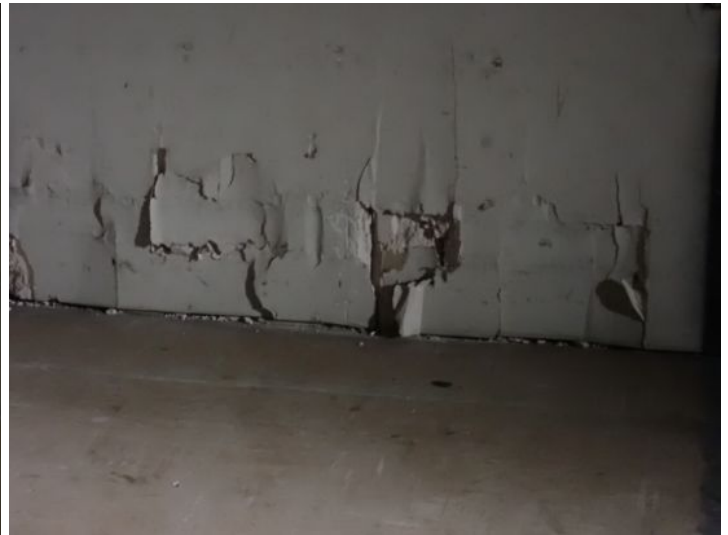
Unit 108-107: Vacant: Unit will require significant renovations prior to installing tenant. Active moisture noted in interior wall with possible microbial growth. Significant drywall damage noted in ceiling and walls in loading dock area. Basement area in poor condition. Basement bathrooms in poor condition. Electrical not working at the time of the inspection. Moisture intrusion/damage noted in basement walls. Recommend repairs as needed by a licensed contractor.

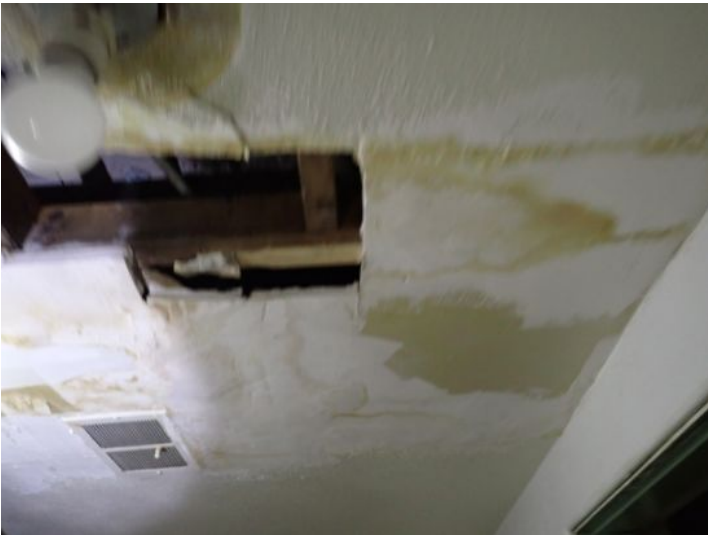
Unit 108-107: Vacant: Unit will require significant renovations prior to installing tenant. Active moisture noted in interior wall with possible microbial growth. Significant drywall damage noted in ceiling and walls in loading dock area. Basement area in poor condition. Basement bathrooms in poor condition. Electrical not working at the time of the inspection. Moisture intrusion/damage noted in basement walls. Recommend repairs as needed by a licensed contractor.

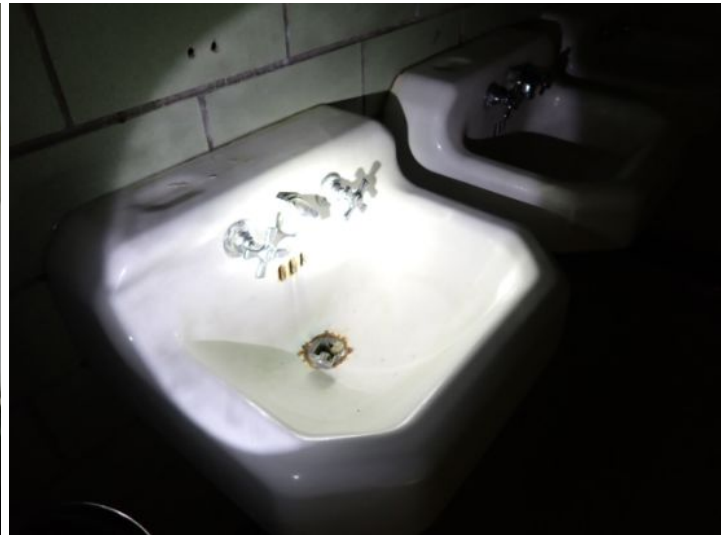
Unit 108-107: Vacant: Unit will require significant renovations prior to installing tenant. Active moisture noted in interior wall with possible microbial growth. Significant drywall damage noted in ceiling and walls in loading dock area. Basement area in poor condition. Basement bathrooms in poor condition. Electrical not working at the time of the inspection. Moisture intrusion/damage noted in basement walls. Recommend repairs as needed by a licensed contractor.

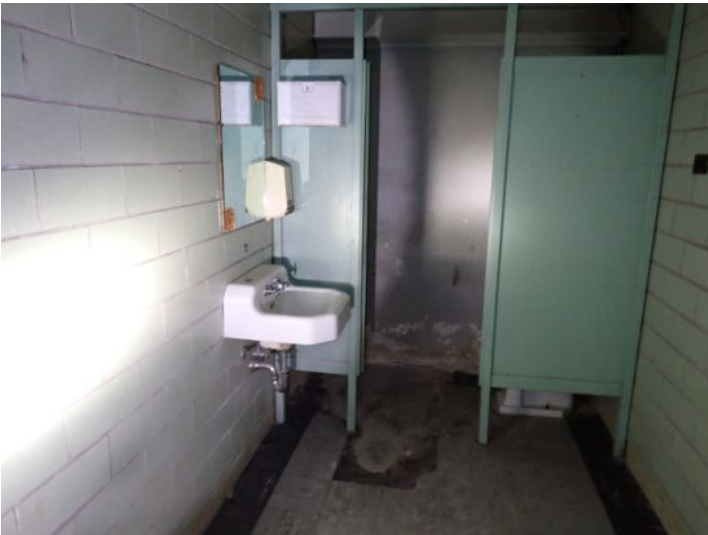
Unit 108-107: Vacant: Unit will require significant renovations prior to installing tenant. Active moisture noted in interior wall with possible microbial growth. Significant drywall damage noted in ceiling and walls in loading dock area. Basement area in poor condition. Basement bathrooms in poor condition. Electrical not working at the time of the inspection. Moisture intrusion/damage noted in basement walls. Recommend repairs as needed by a licensed contractor.

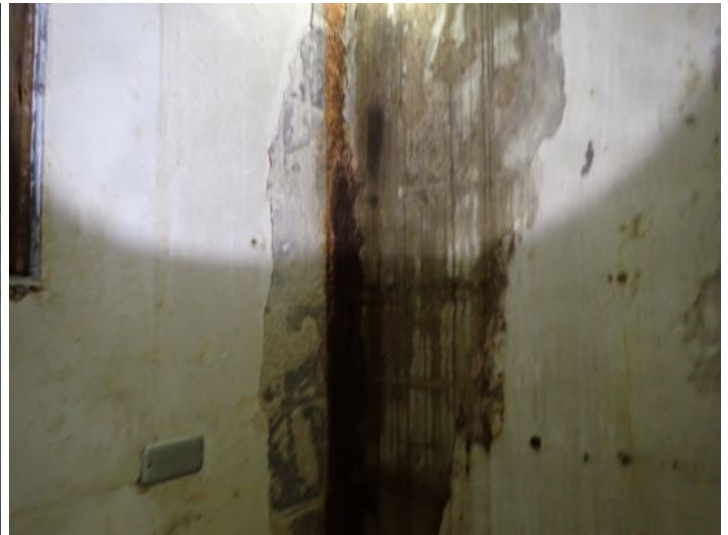
Unit 108-107: Vacant: Unit will require significant renovations prior to installing tenant. Active moisture noted in interior wall with possible microbial growth. Significant drywall damage noted in ceiling and walls in loading dock area. Basement area in poor condition. Basement bathrooms in poor condition. Electrical not working at the time of the inspection. Moisture intrusion/damage noted in basement walls. Recommend repairs as needed by a licensed contractor.

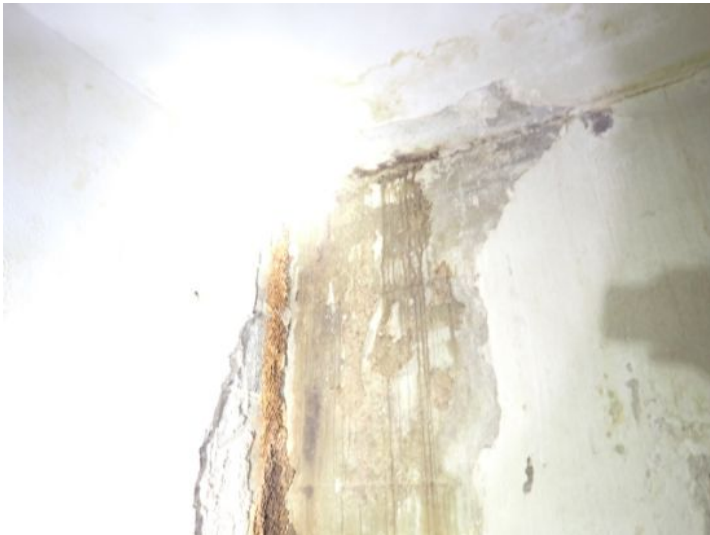
Unit 108-107: Vacant: Unit will require significant renovations prior to installing tenant. Active moisture noted in interior wall with possible microbial growth. Significant drywall damage noted in ceiling and walls in loading dock area. Basement area in poor condition. Basement bathrooms in poor condition. Electrical not working at the time of the inspection. Moisture intrusion/damage noted in basement walls. Recommend repairs as needed by a licensed contractor.

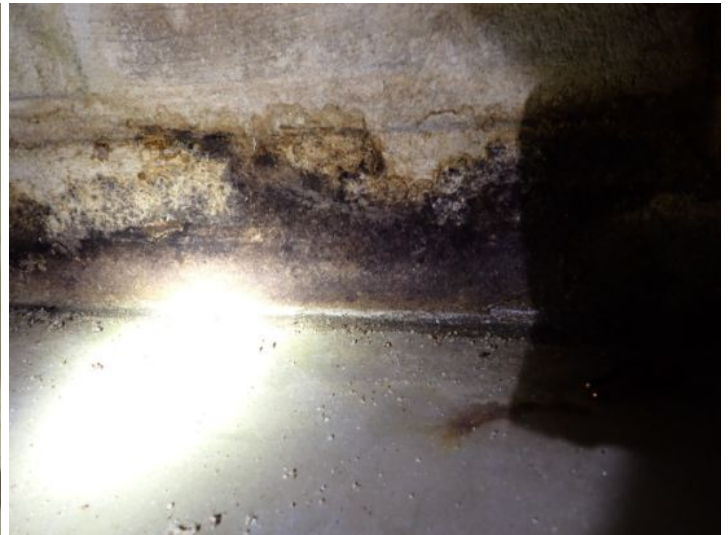
Unit 108-107: Vacant: Unit will require significant renovations prior to installing tenant. Active moisture noted in interior wall with possible microbial growth. Significant drywall damage noted in ceiling and walls in loading dock area. Basement area in poor condition. Basement bathrooms in poor condition. Electrical not working at the time of the inspection. Moisture intrusion/damage noted in basement walls. Recommend repairs as needed by a licensed contractor.

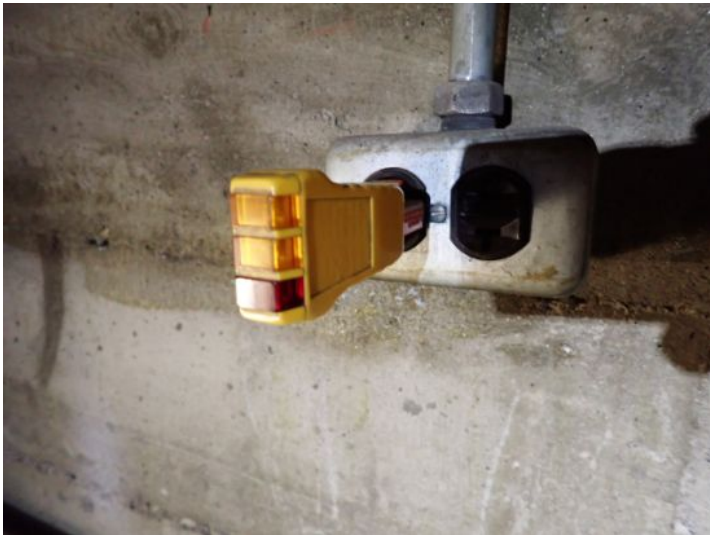
Unit 108-107: Vacant: Unit will require significant renovations prior to installing tenant. Active moisture noted in interior wall with possible microbial growth. Significant drywall damage noted in ceiling and walls in loading dock area. Basement area in poor condition. Basement bathrooms in poor condition. Electrical not working at the time of the inspection. Moisture intrusion/damage noted in basement walls. Recommend repairs as needed by a licensed contractor.

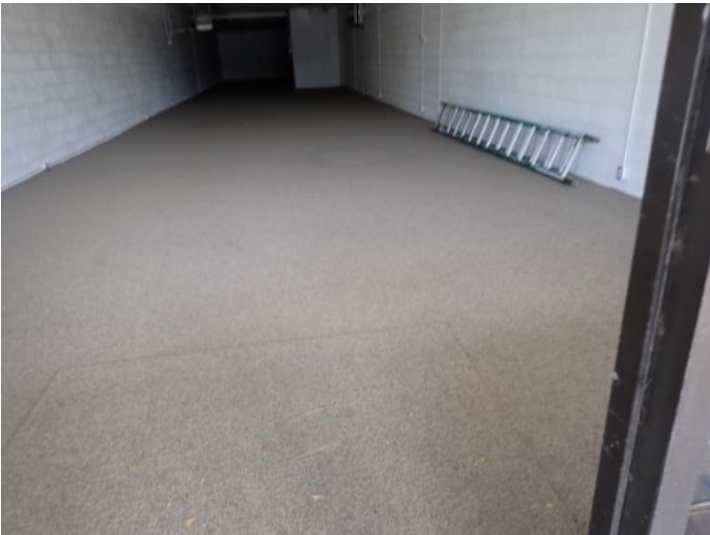
Unit 105: Vacant Unit: No significant findings noted at the time of the inspection

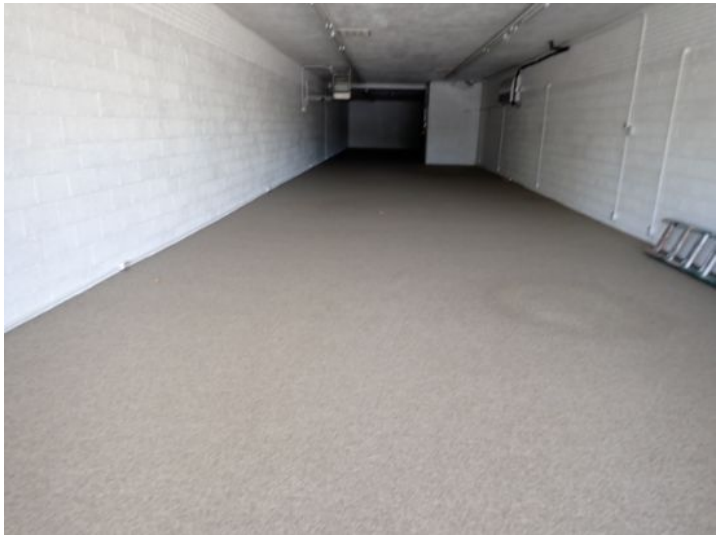
Unit 105: Vacant Unit: No significant findings noted at the time of the inspection

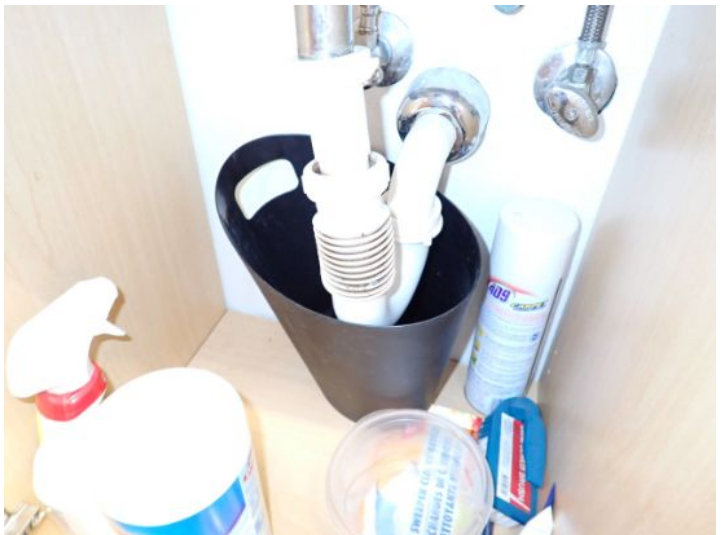
Unit 104: Sub standard plumbing noted below vanity sink. Past moisture staining noted in ceiling. Recommend repairs.

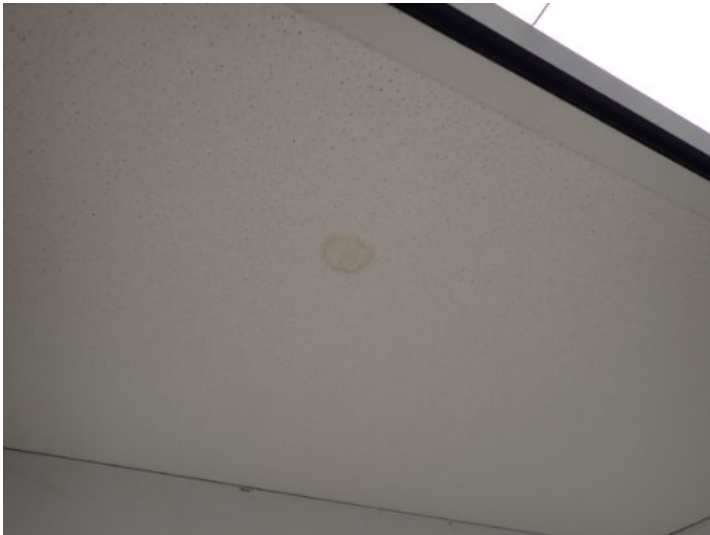
Unit 104: Sub standard plumbing noted below vanity sink. Past moisture staining noted in ceiling. Recommend repairs.

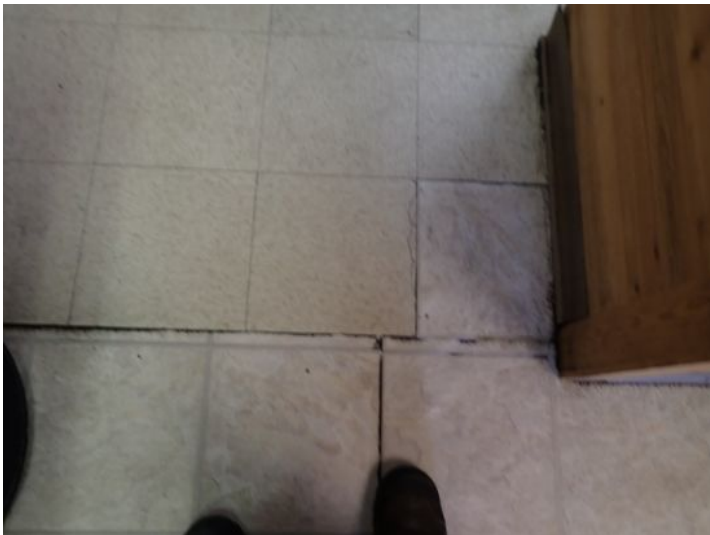
Unit 103: VCT flooring damage noted. Moisture staining noted in ceiling tiles. Moisture damage noted in rear ceiling. Active leak noted coming from roof drain. Restroom in poor condition. Recommend repairs.

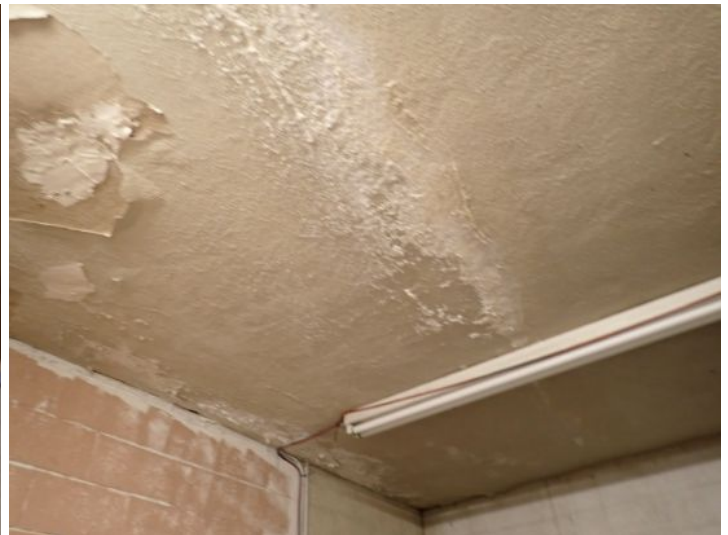
Unit 103: VCT flooring damage noted. Moisture staining noted in ceiling tiles. Moisture damage noted in rear ceiling. Recommend repairs.

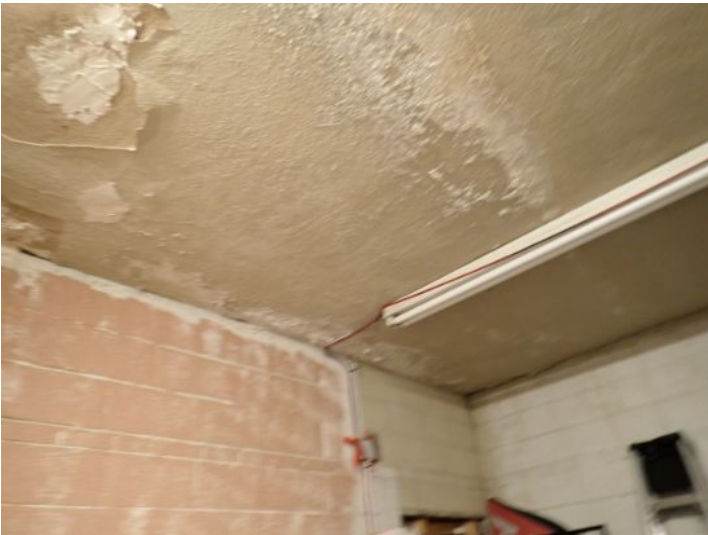
Unit 103: VCT flooring damage noted. Moisture staining noted in ceiling tiles. Moisture damage noted in rear ceiling. Recommend repairs.

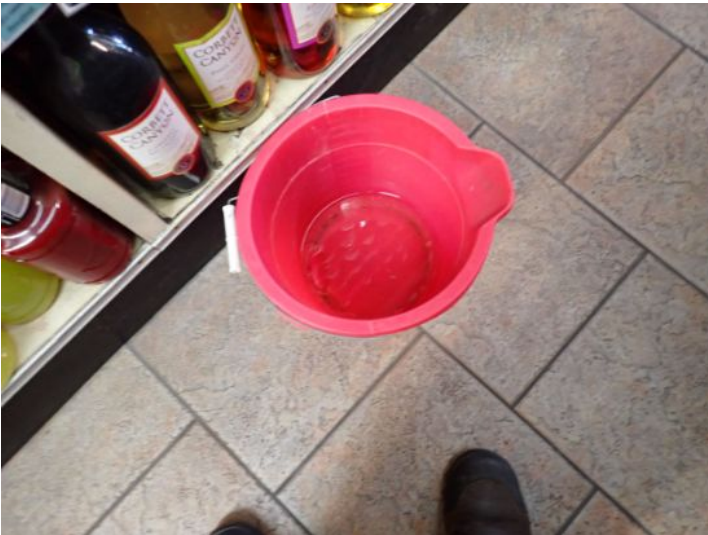
Unit 101: Active leak noted coming from roof drain. Restroom in poor condition. Recommend repairs.

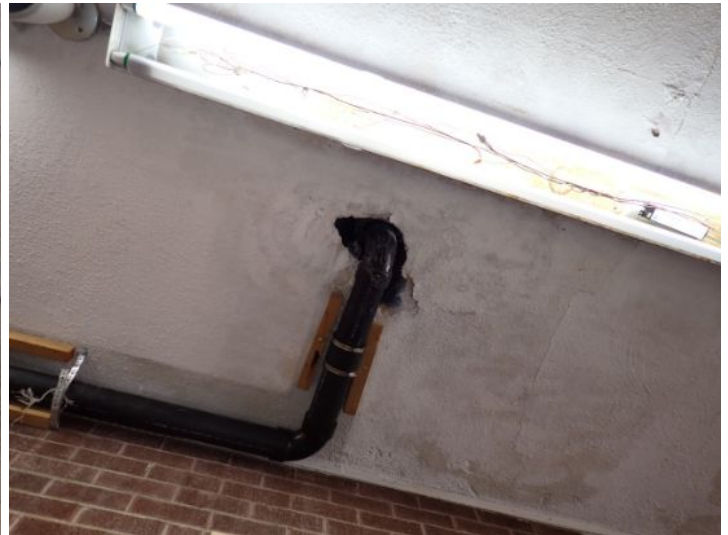
Unit 101: Active leak noted coming from roof drain. Restroom in poor condition. Recommend repairs.

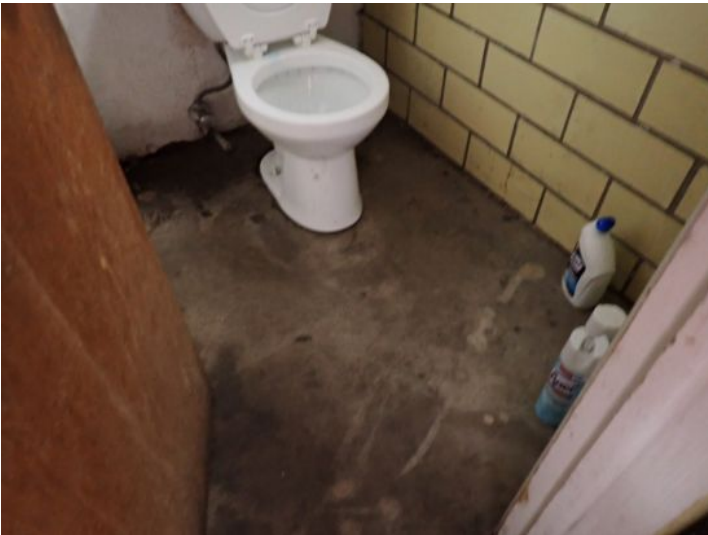
Unit 101: Active leak noted coming from roof drain. Restroom in poor condition. Recommend repairs.

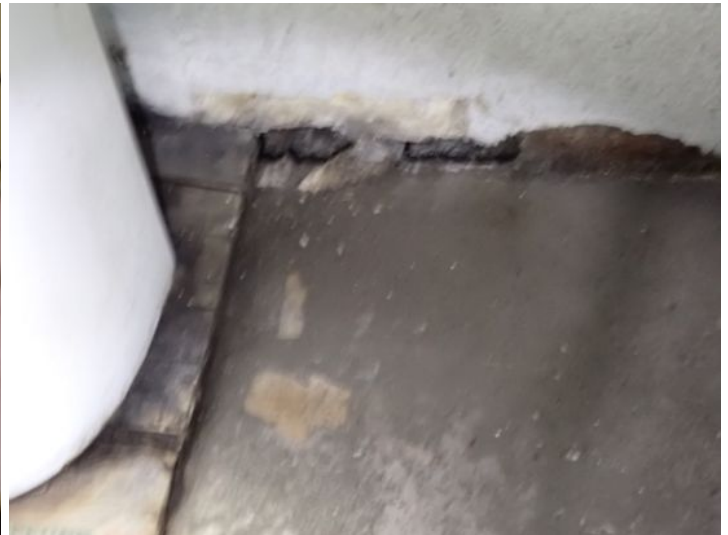
Unit 101: Active leak noted coming from roof drain. Restroom in poor condition. Recommend repairs.

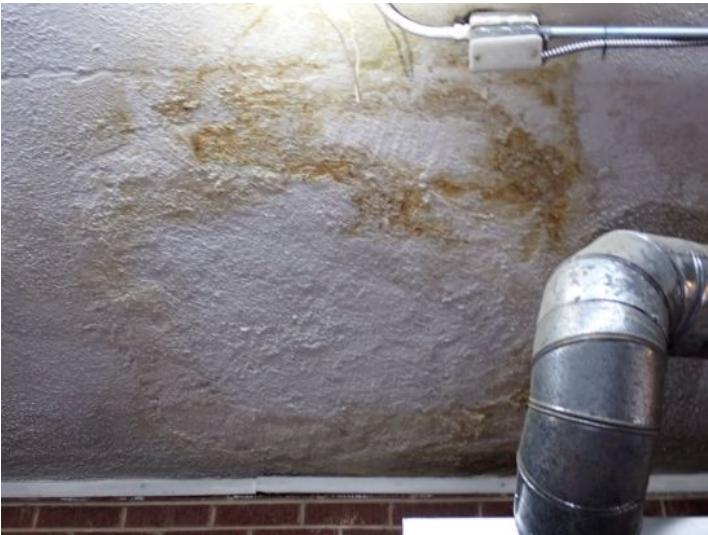
Unit 101: Active leak noted coming from roof drain. Restroom in poor condition. Recommend repairs.

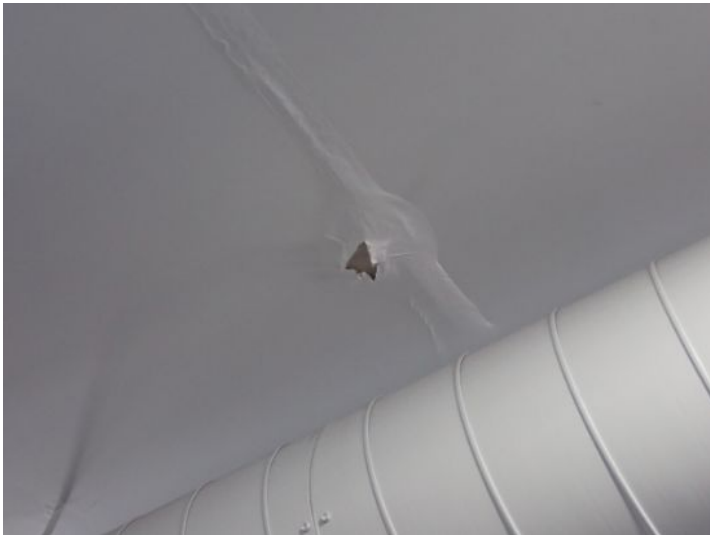
Unit 100: Active moisture damage and roof leaking noted. Recommend repairs.
