# *Forman Inspection Services, LLC*

## Property Inspection Report

1234 Retail St., Somewhere, CO 12345

Date of Inspection: 9/16/2022 Time: 10:00 Size: 93,886 sq. ft. per listing

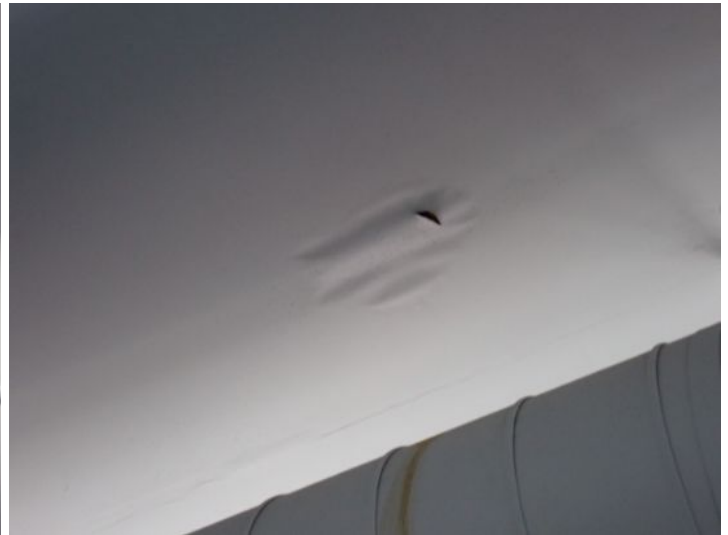
Unit 100: Active moisture damage and roof leaking noted. Recommend repairs.

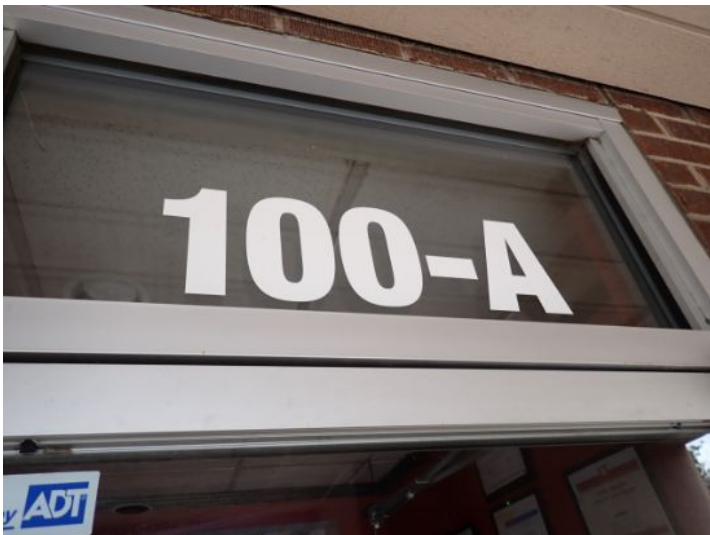
Unit 100: Active moisture damage and roof leaking noted. Recommend repairs.

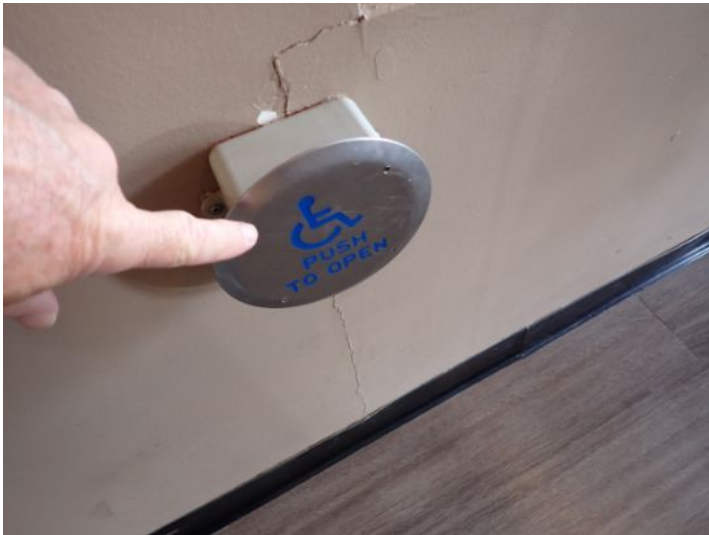
The ADA operator on the mall entrance was not working at the time of the inspection. Recommend repairs as needed by a licensed contractor.

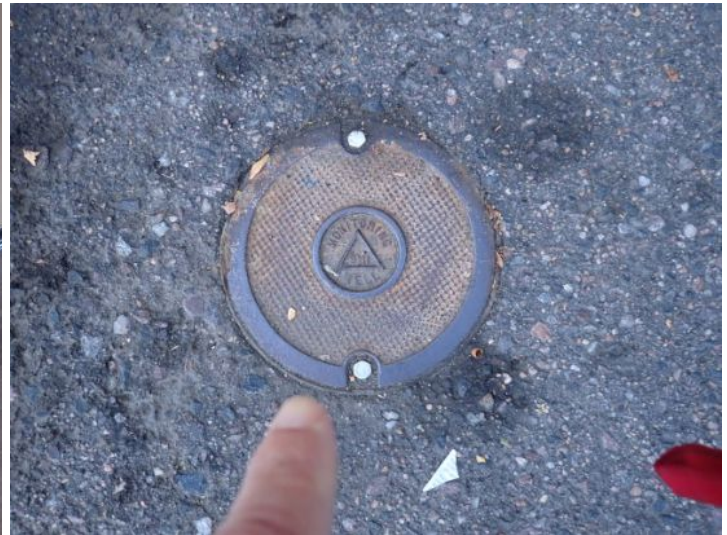
There is a ground watering monitoring well noted in the parking lot on the north side of the laundromat. Recommend finding out if this well is still in service or has been cleared by the state prior to taking possession of the property.
