# *Forman Inspection Services, LLC*

## Property Inspection Report

12345 Industrial Rd., Somewhere, CO 12345  
Inspection prepared for: John Smith  
Real Estate Agent: John Smith - Commercial Real Estate Company

Date of Inspection: 11/28/2022 Time: 10:00 Size: 10,400 sq. ft.  
Weather: Cloudy/Cool

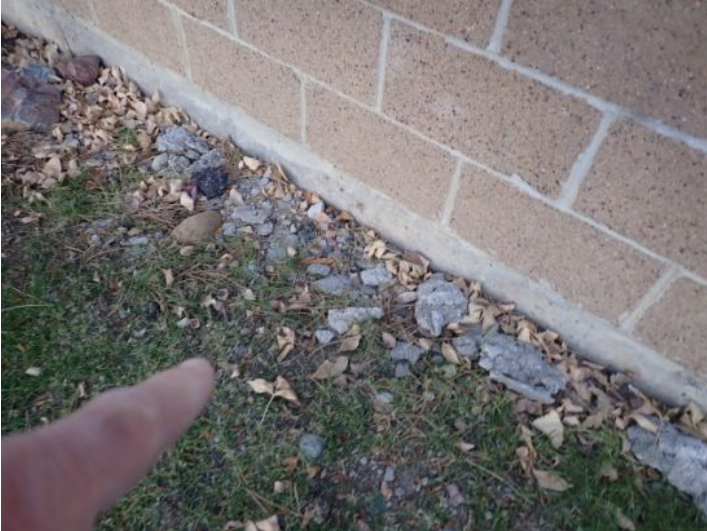
Signs of poor drainage noted along the rear of the structure at the time of the inspection. Recommend repairs by a licensed contractor.

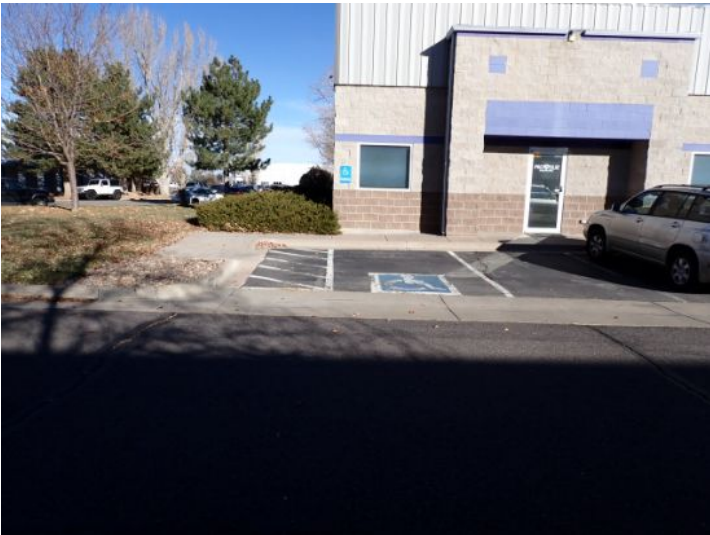
ADA parking was clearly marked at the time of the inspection.

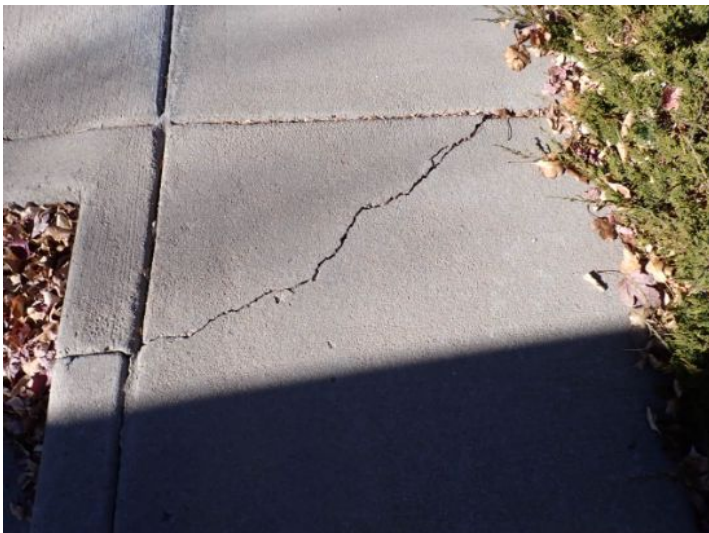
Minor cracking. Recommend monitoring for future repairs.

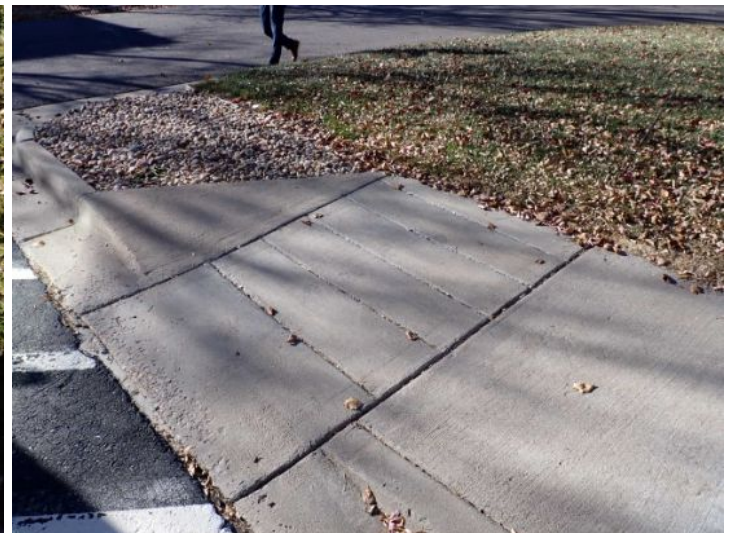
The ADA ramps were checked for proper grade and no significant issues were noted at the time of the inspection.

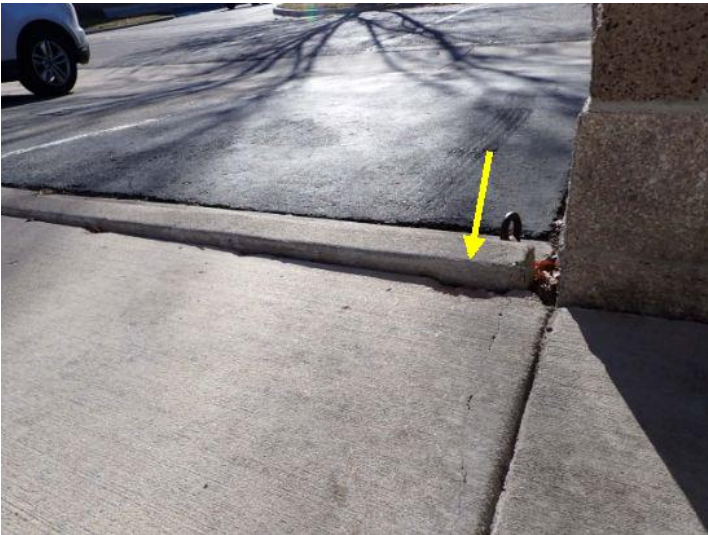
Trip hazards noted. Recommend repairs.

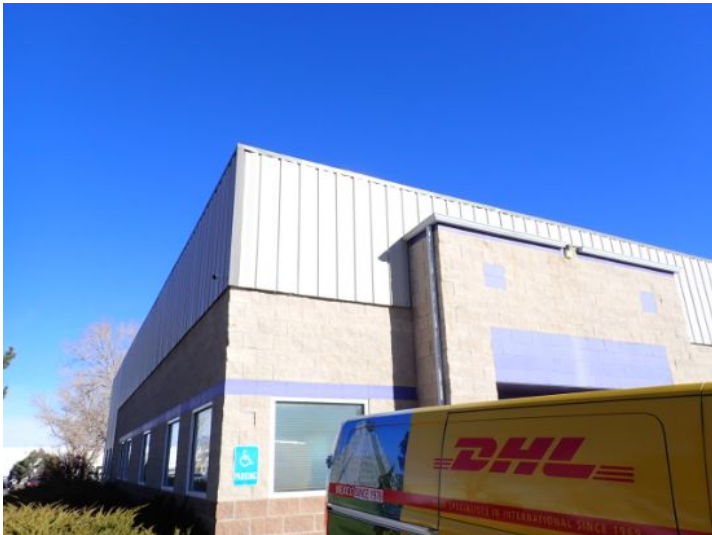
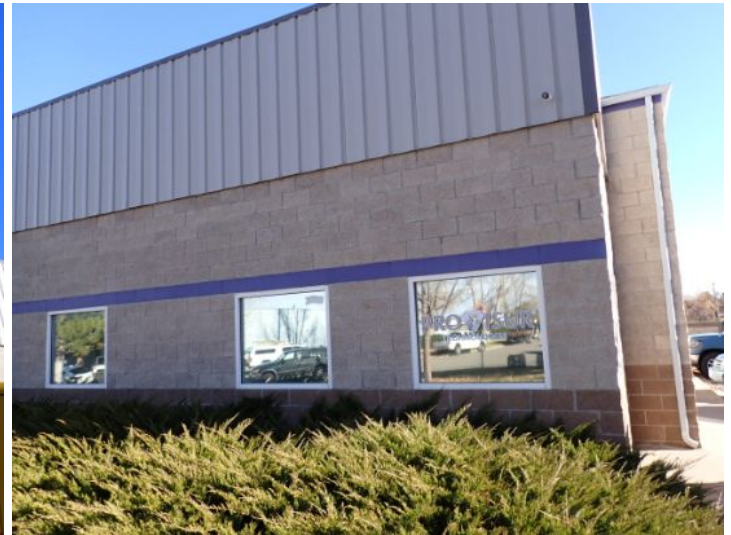
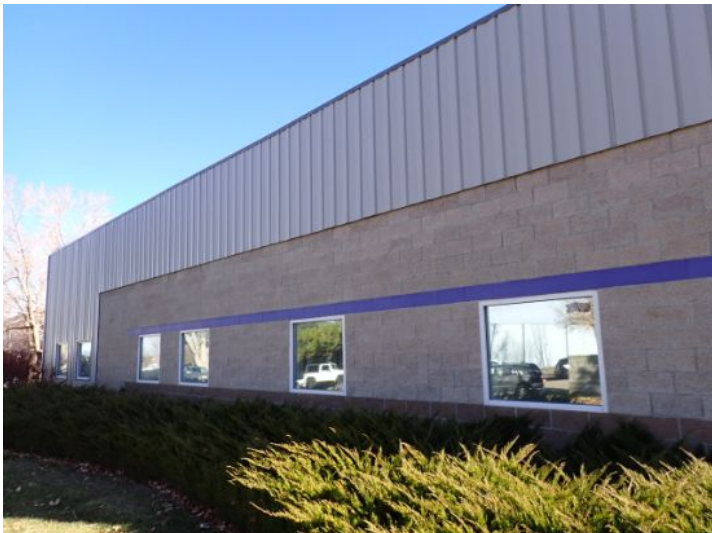
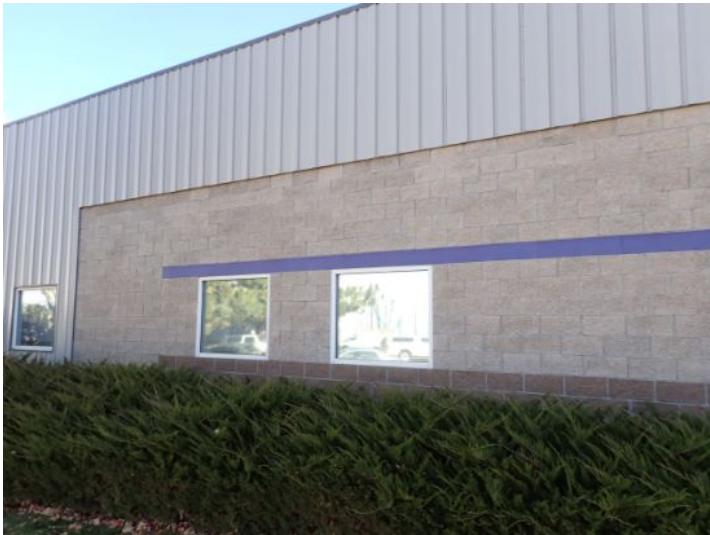
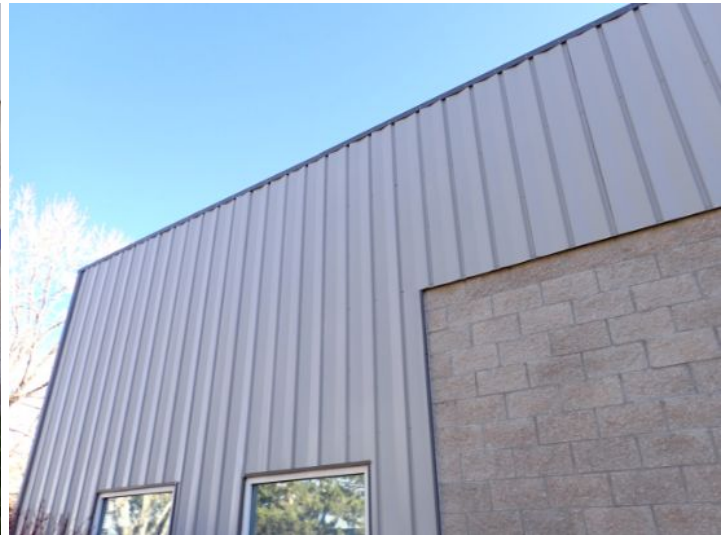
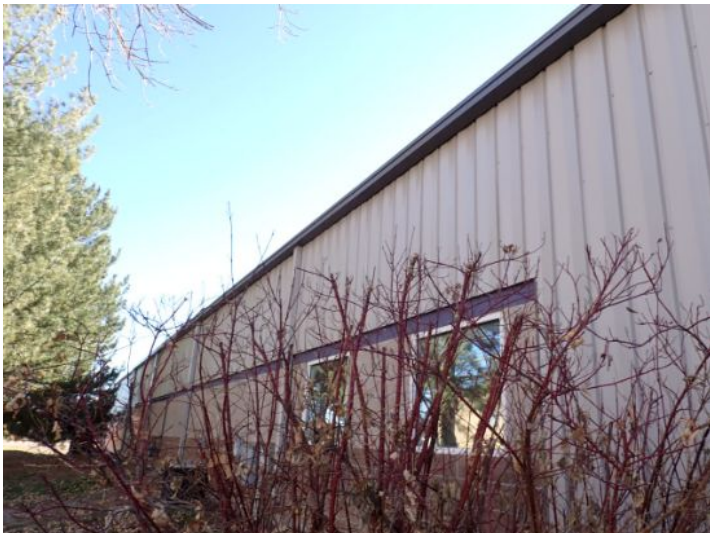
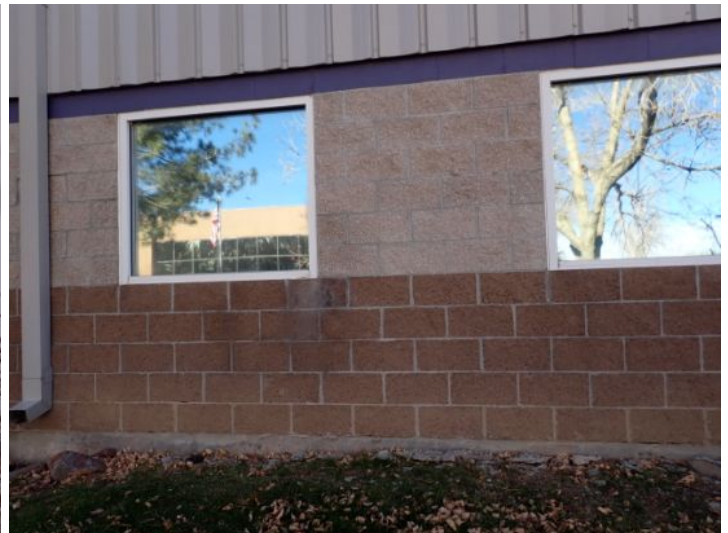
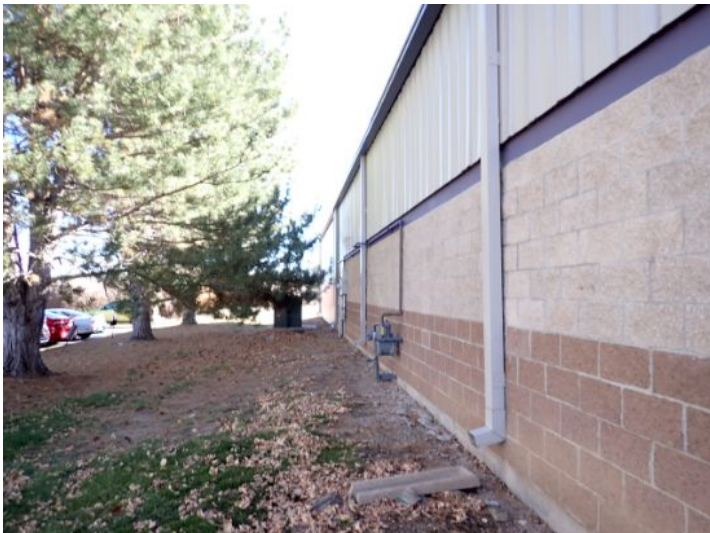
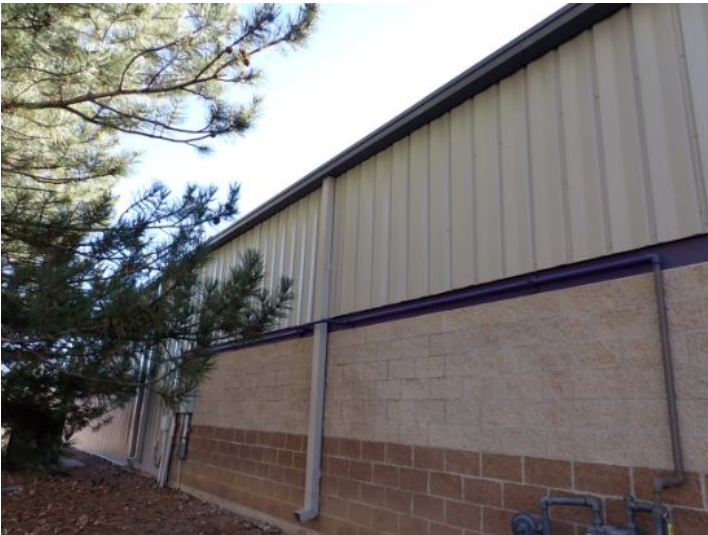
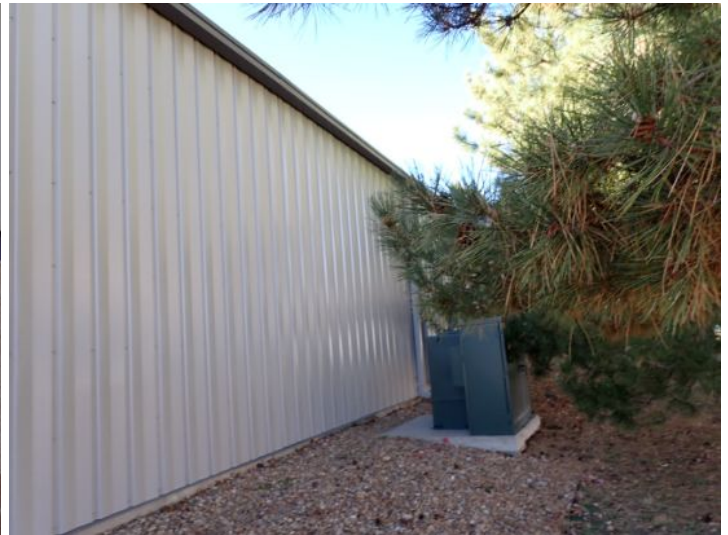
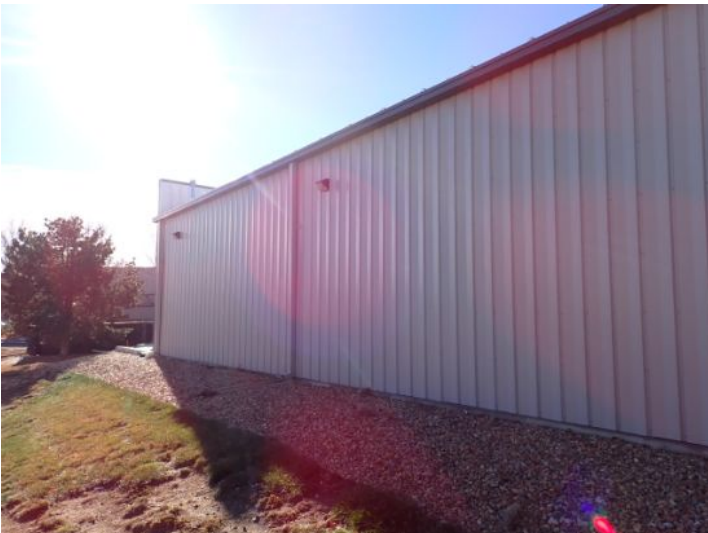
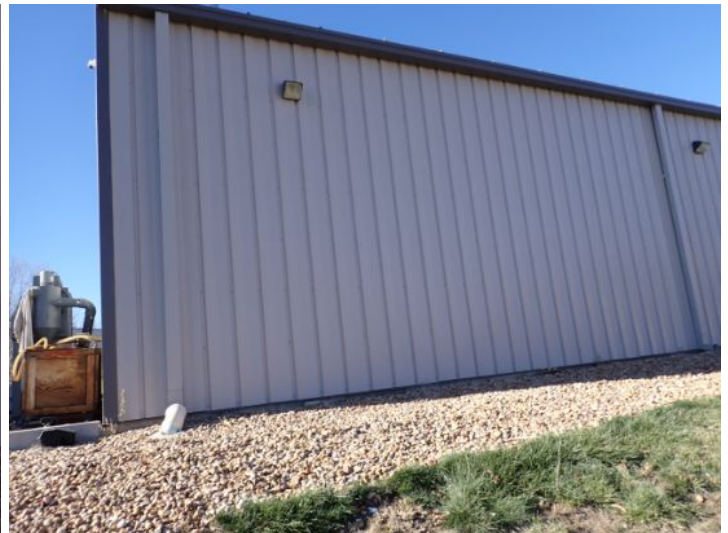
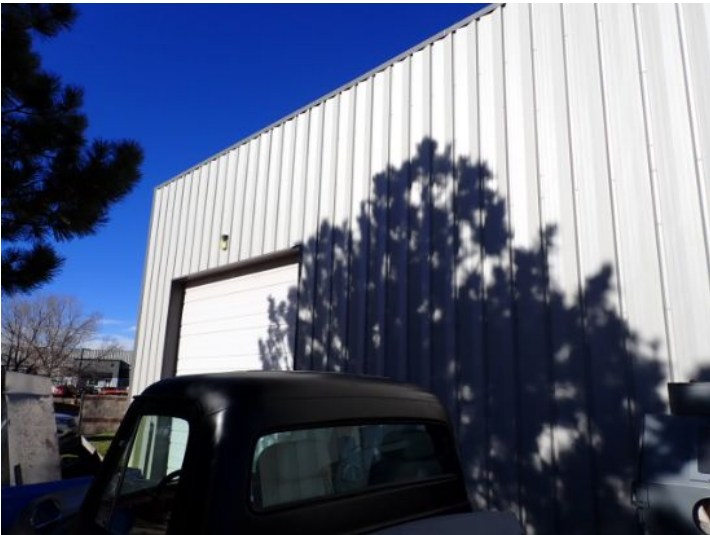
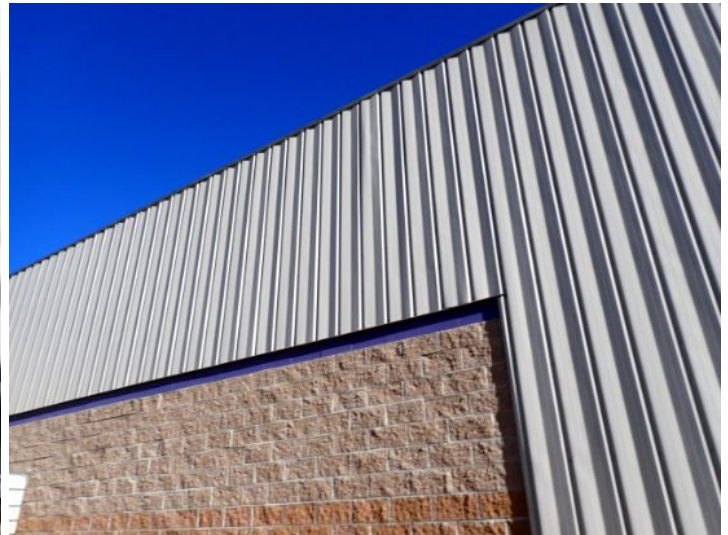
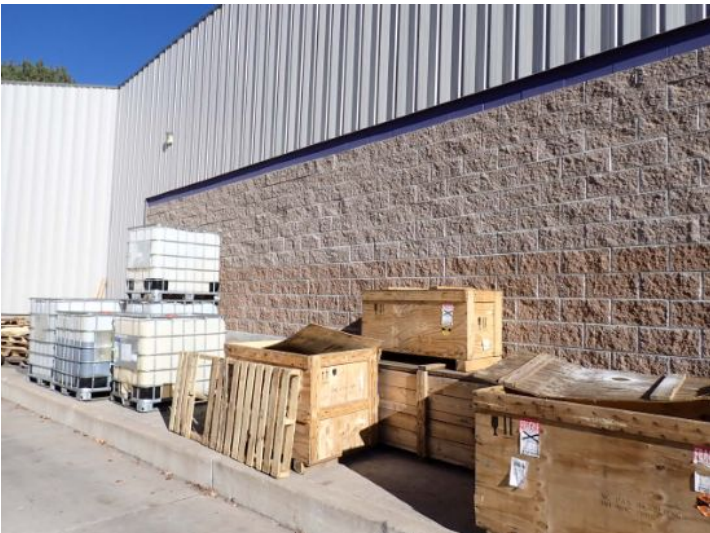
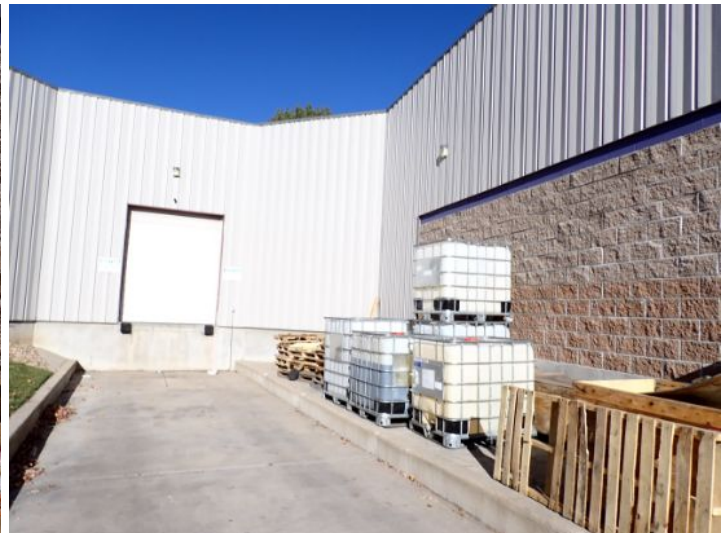
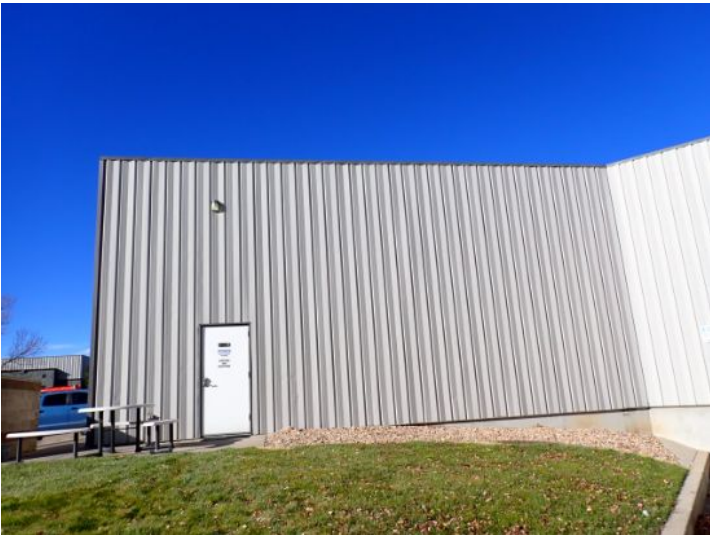
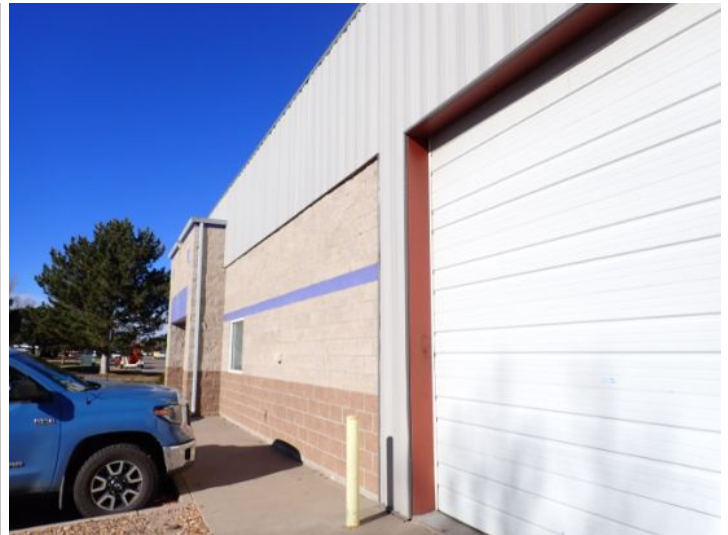
The majority of the exterior envelope of the structure appeared to be in fair condition with no significant movement noted at the time of the inspection.

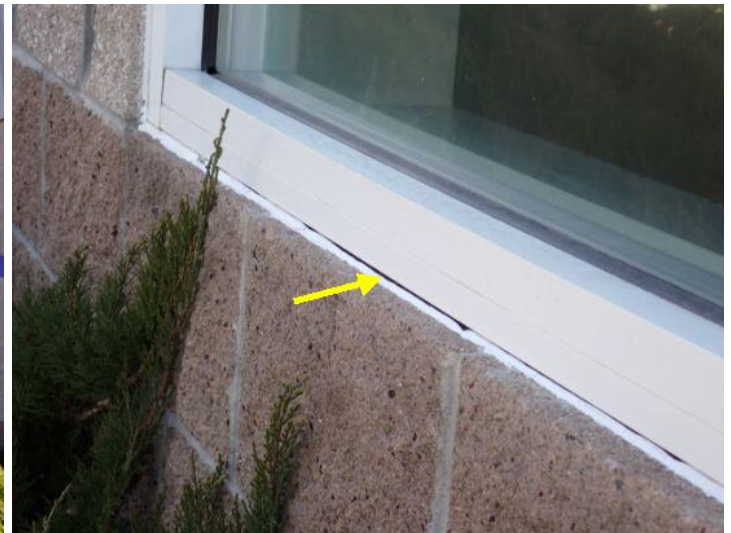
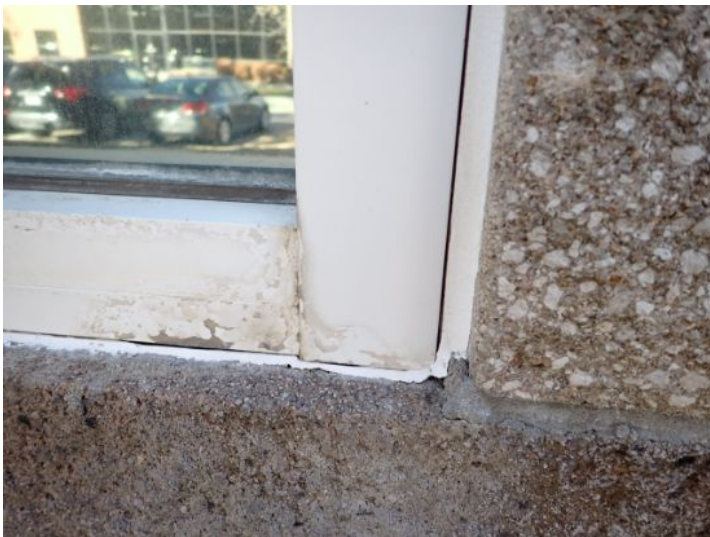
Recommend assuring that any area where two separate substrates meet be properly caulked/sealed. Recommend repairs by a licensed contractor.

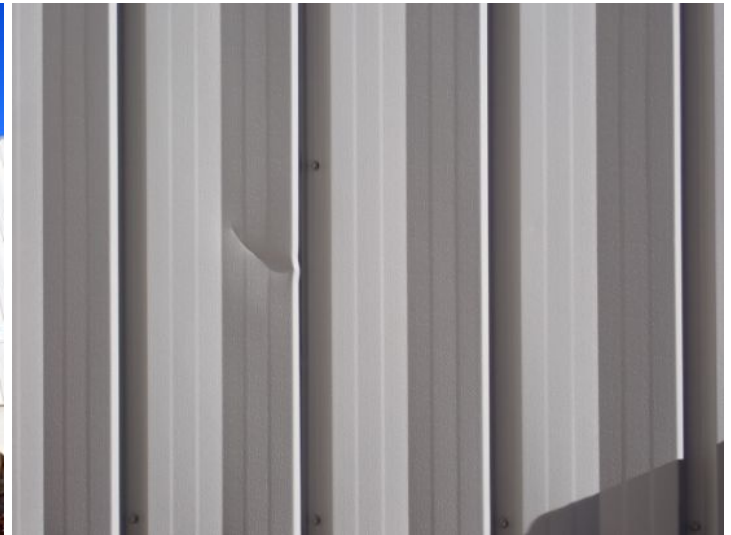
Minor steel siding damage noted in areas. Recommend repairs by a licensed contractor.

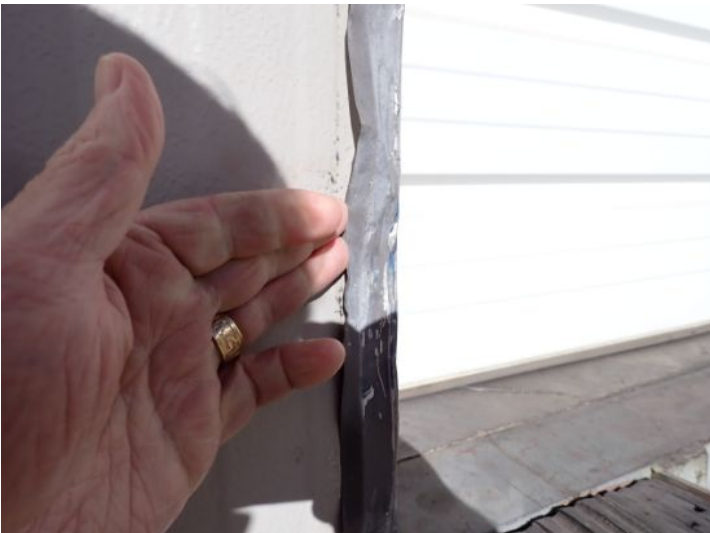
Minor steel trim damage noted around one or more of the overhead doors at the time of the inspection. Recommend repairs by a licensed contractor.

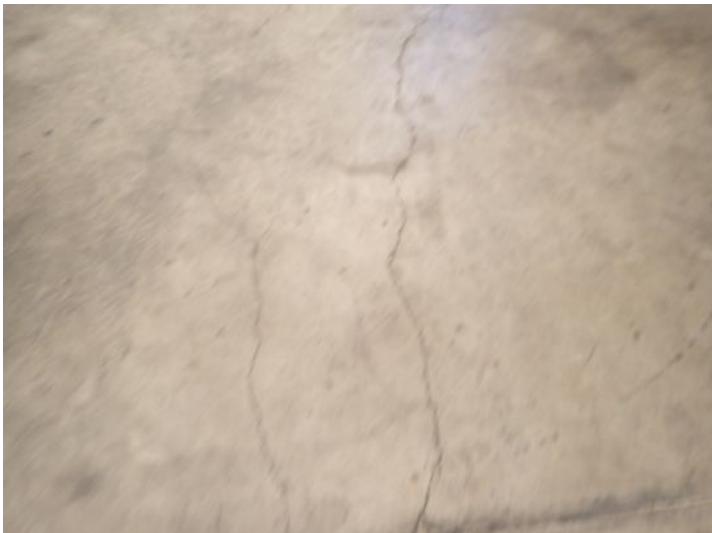
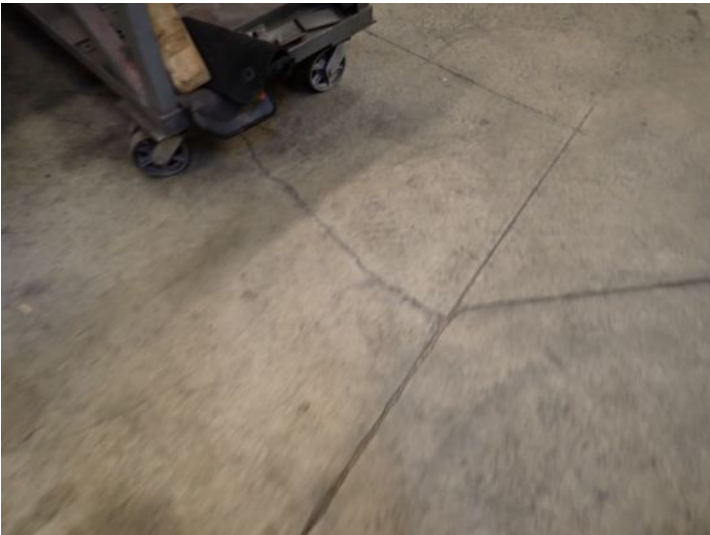
Minor slab cracking noted within the structure at the time of the inspection. Recommend monitoring for future movement/repairs.

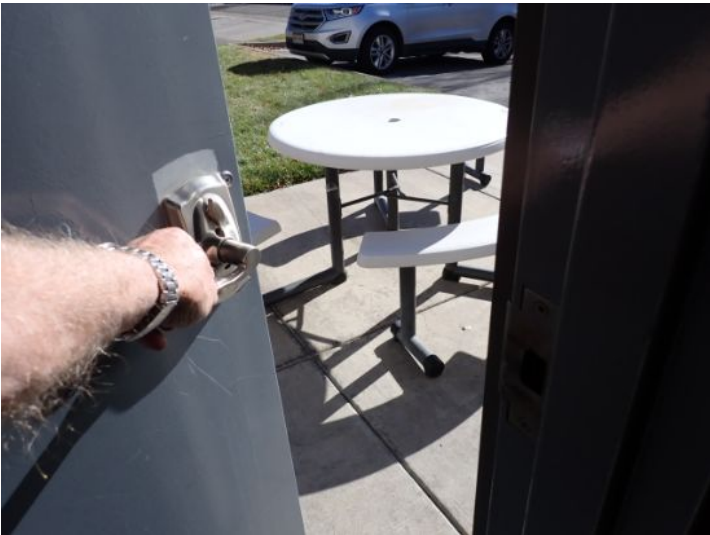
The overhead doors and personnel doors were tested and functional at the time of the inspection.

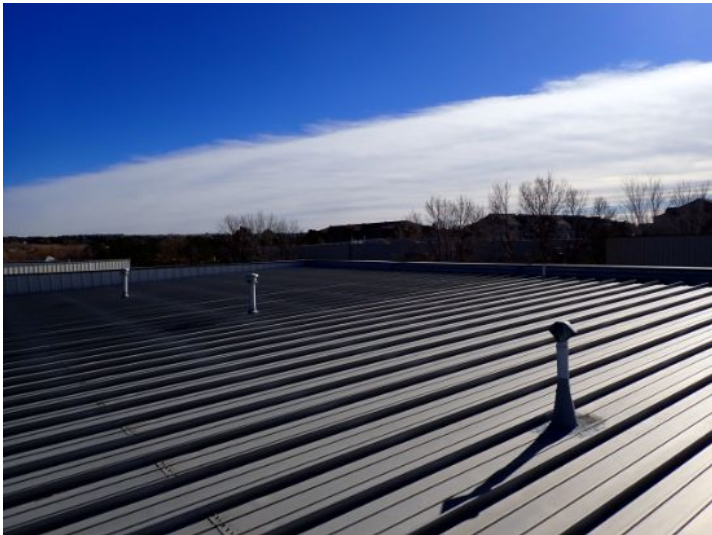
The sealant around the roof penetrations appeared to have reached its serviceable life expectancy and may begin leaking soon. Recommend repairs as needed by a licensed contractor.

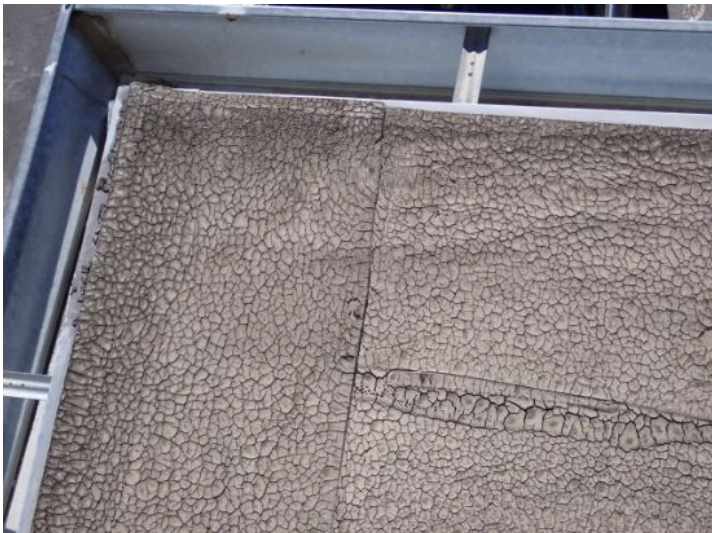
The roofing system located above the front entry was in poor condition and requires complete replacement. Recommend replacement by a licensed contractor.

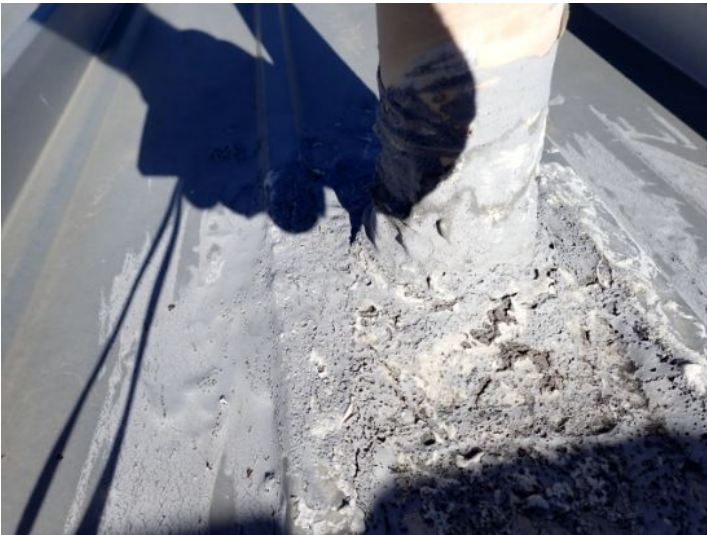
The roofing system located above the front entry was in poor condition and requires complete replacement. Recommend replacement by a licensed contractor.

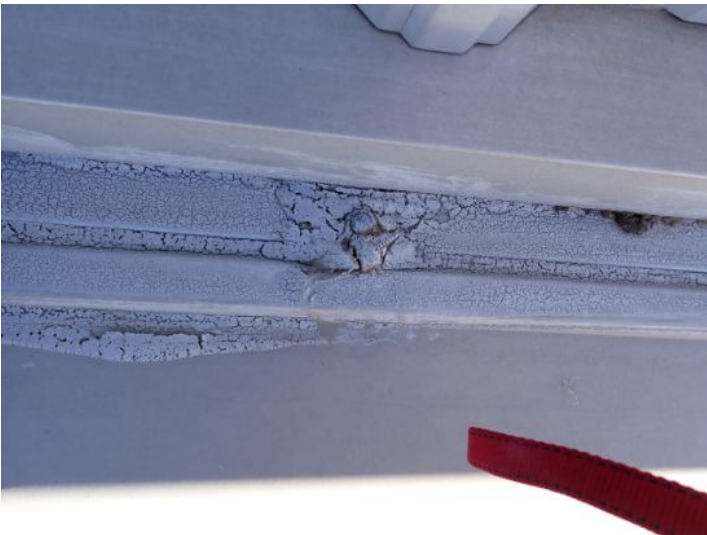
Sealant/repairs noted in areas along the parapet walls of the roofing system. At the time of the inspection the sealant appeared to have reached or be nearing its serviceable life expectancy. Recommend repairs as needed by a licensed contractor.

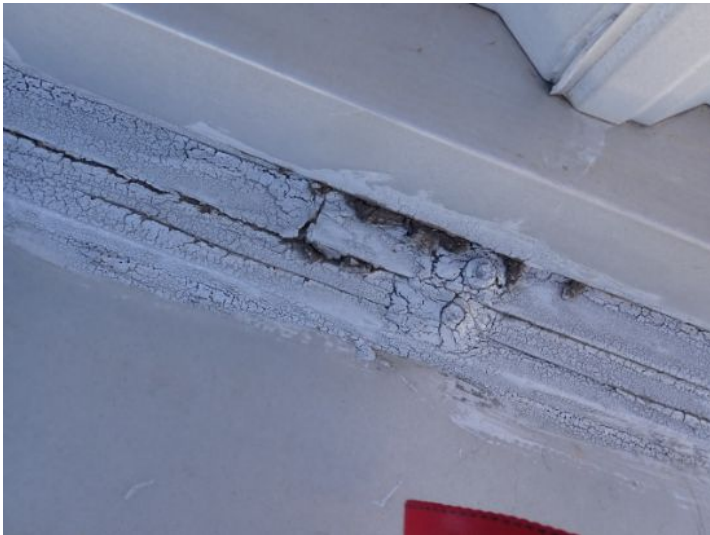
Sealant/repairs noted in areas along the parapet walls of the roofing system. At the time of the inspection the sealant appeared to have reached or be nearing its serviceable life expectancy. Recommend repairs as needed by a licensed contractor.

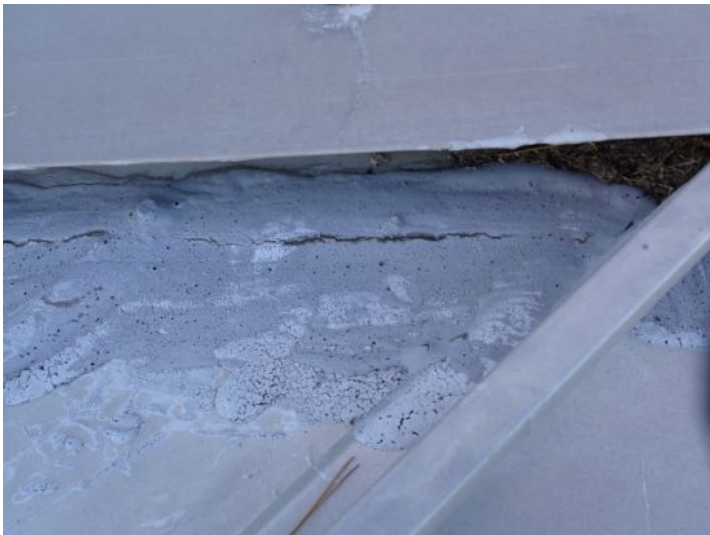
Past repairs/sealant noted in areas of the roofing system. At the time of the inspection the sealant appeared to be nearing failure. Recommend repairs as needed by a licensed contractor.

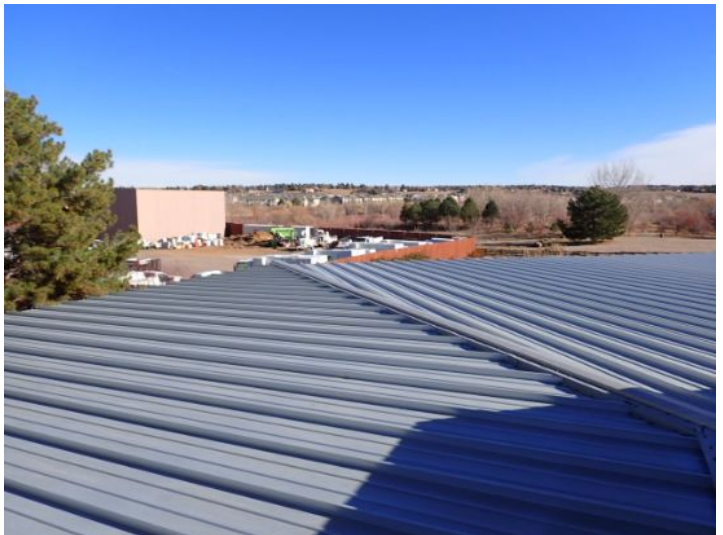
Past repairs/sealant noted in areas of the roofing system. At the time of the inspection the sealant appeared to be nearing failure. Recommend repairs as needed by a licensed contractor.

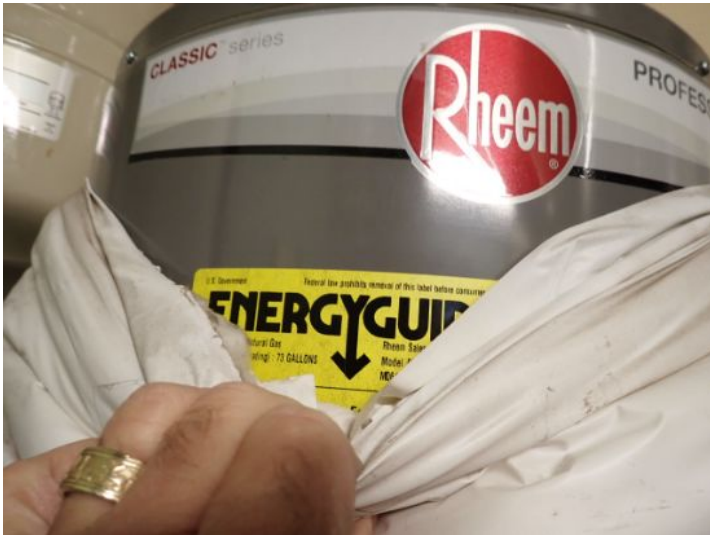
Age of water heater could not be determined as the unit was wrapped in an insulating blanket at the time of the inspection.

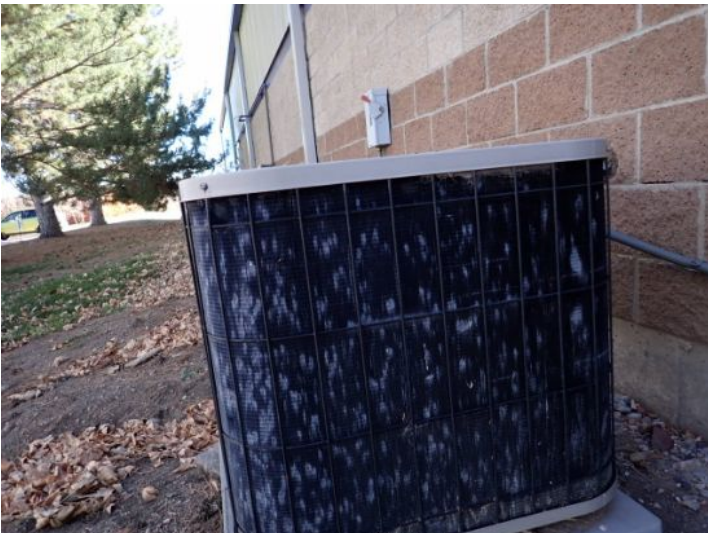
Hail damage noted on the external cooling fins of CU 1 at the time of the inspection.

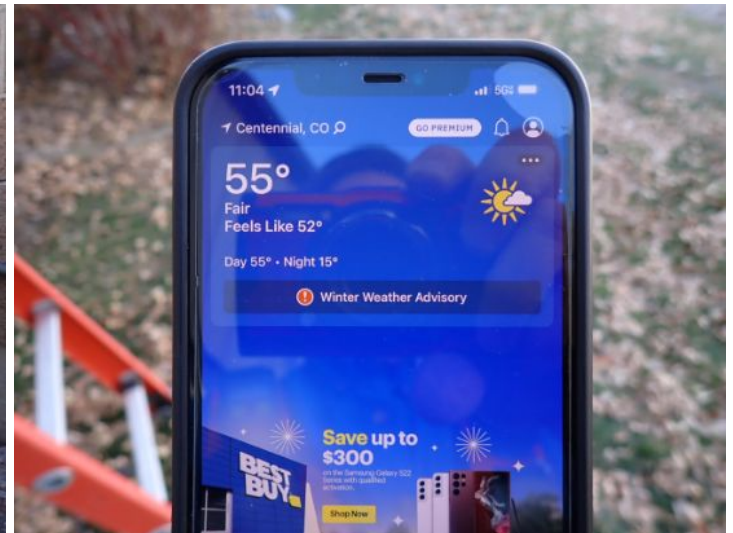
The air conditioning system could not be tested due to the exterior temperature at the time of the inspection.

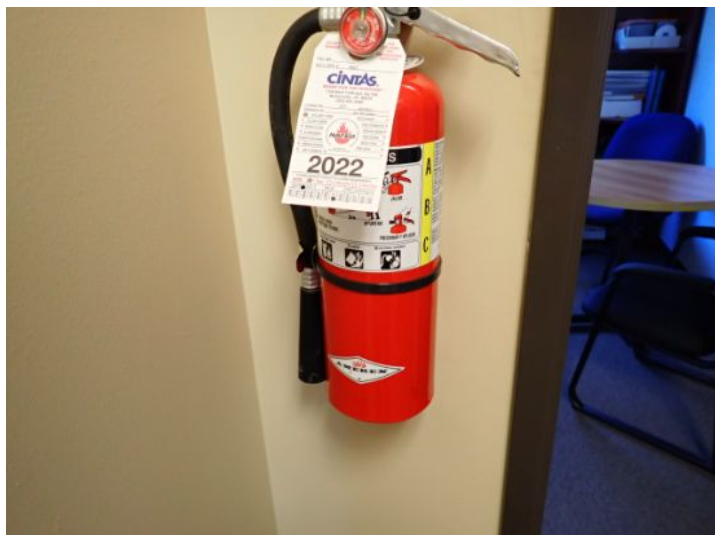
There were fire extinguishers located within the structure

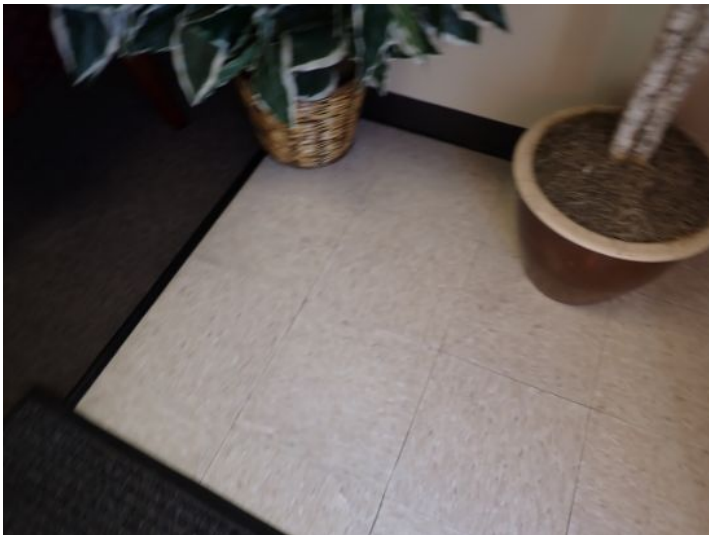
VCT flooring damage noted in the main entry area. Recommend repairs as needed by a licensed contractor.

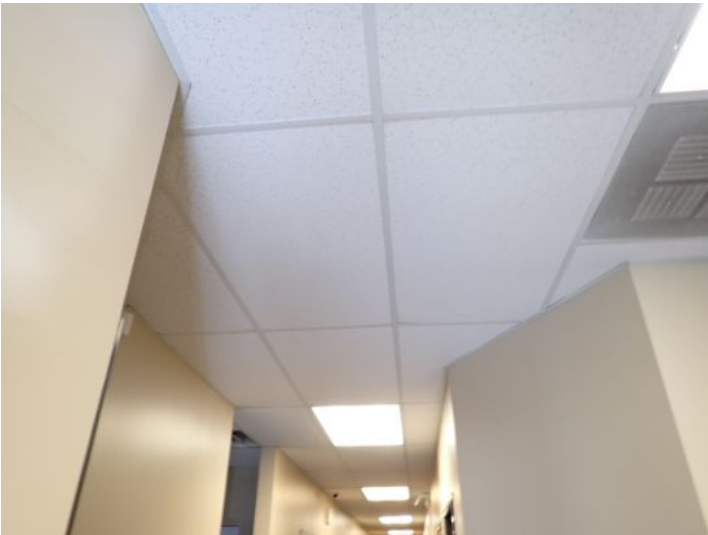
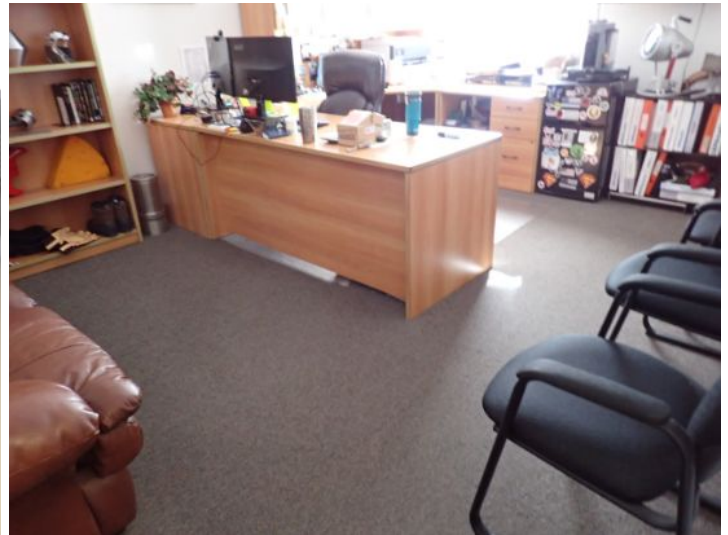
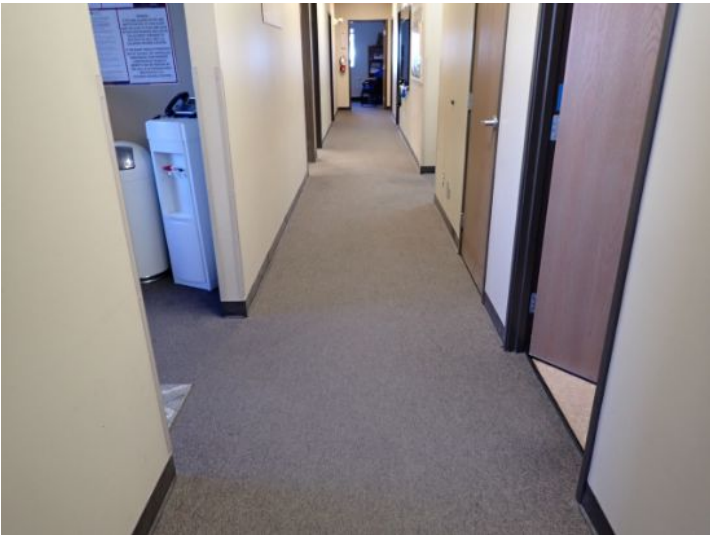
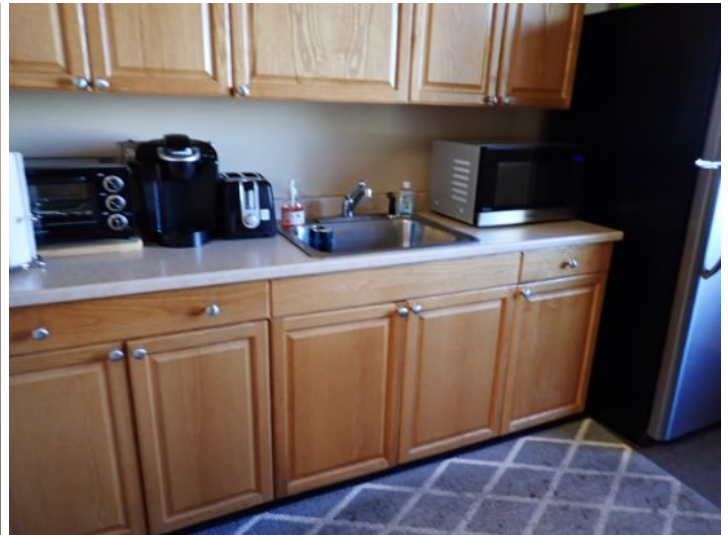
The majority of the interior of the office area appeared to be in fair condition at the time of the inspection.

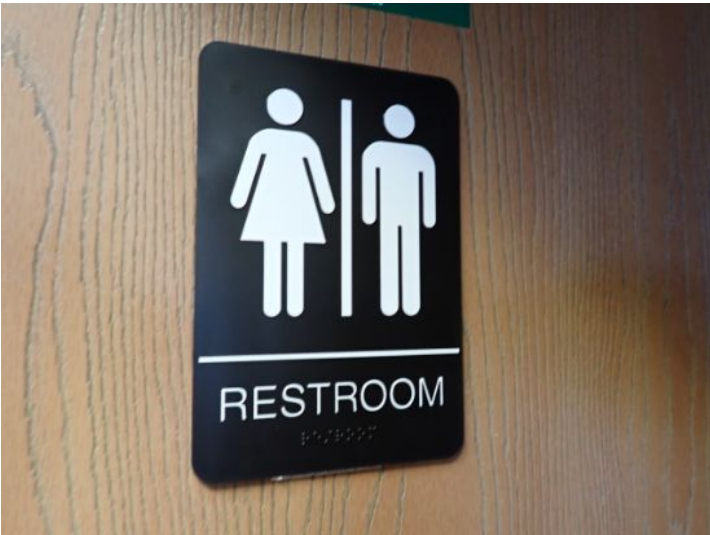
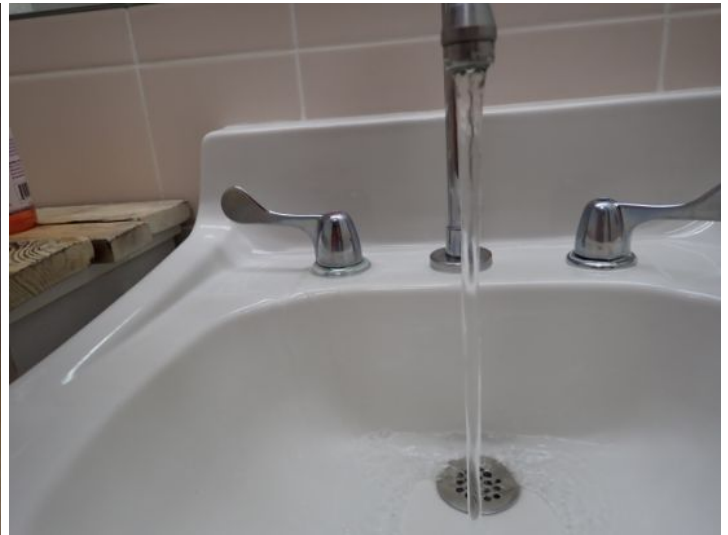
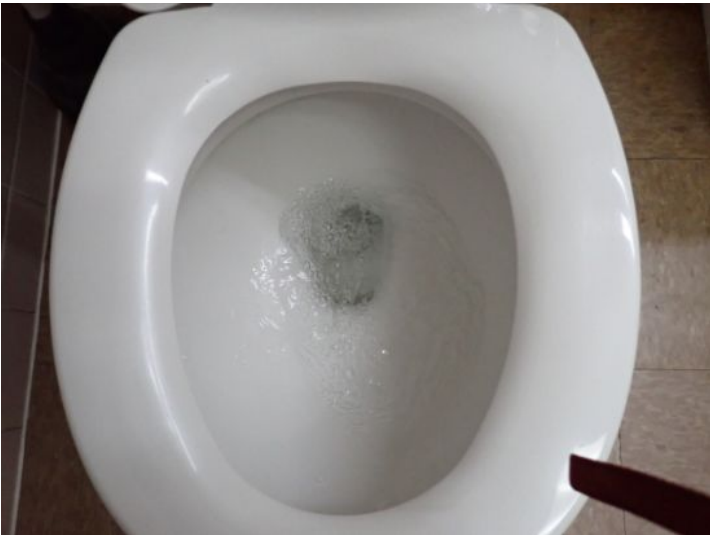
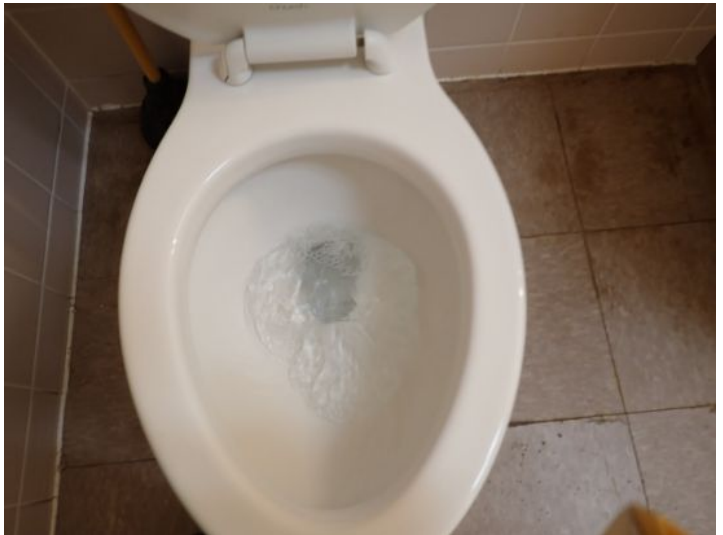
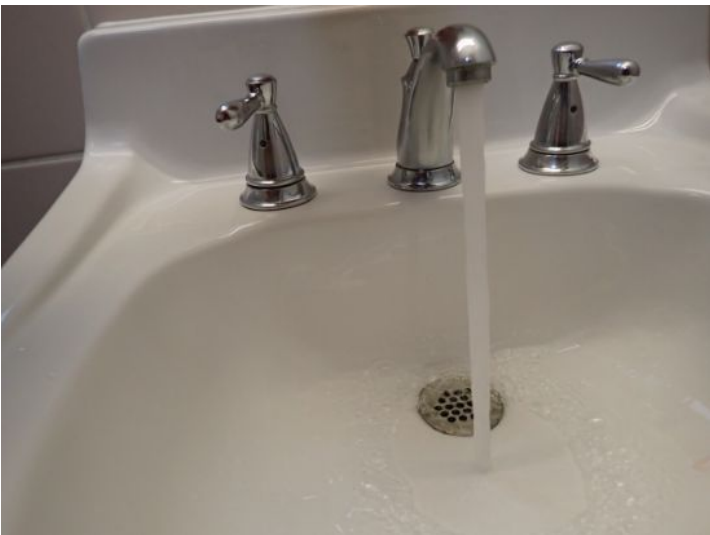
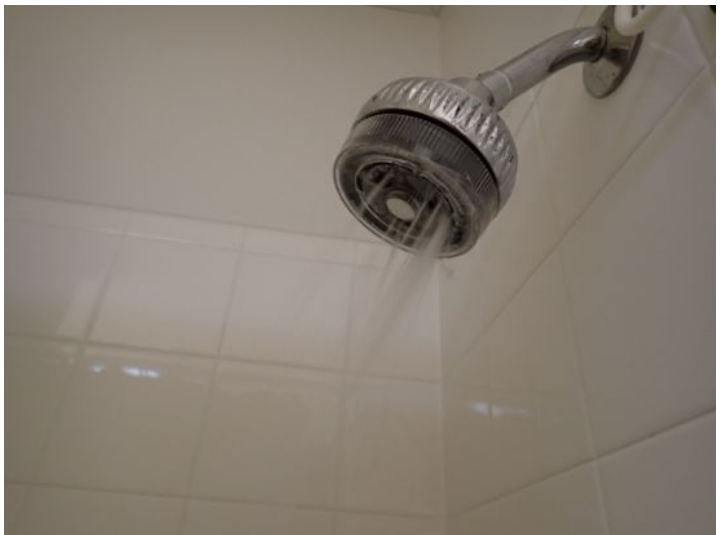
The restroom facilities were tested and functional at the time of the inspection.

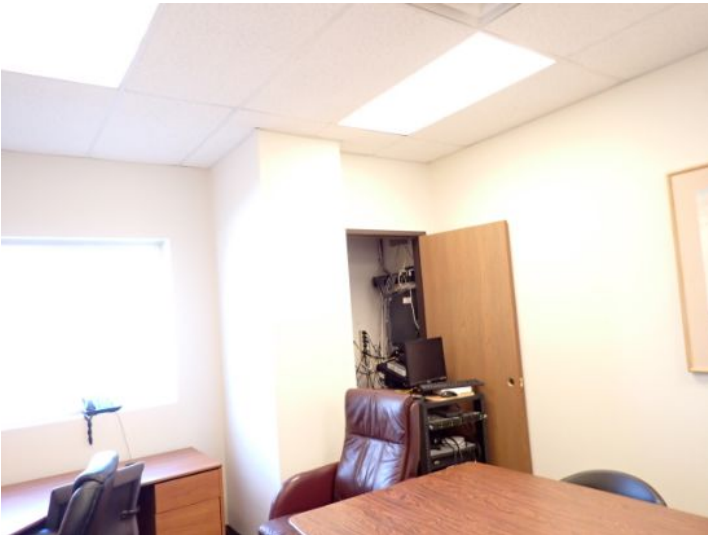
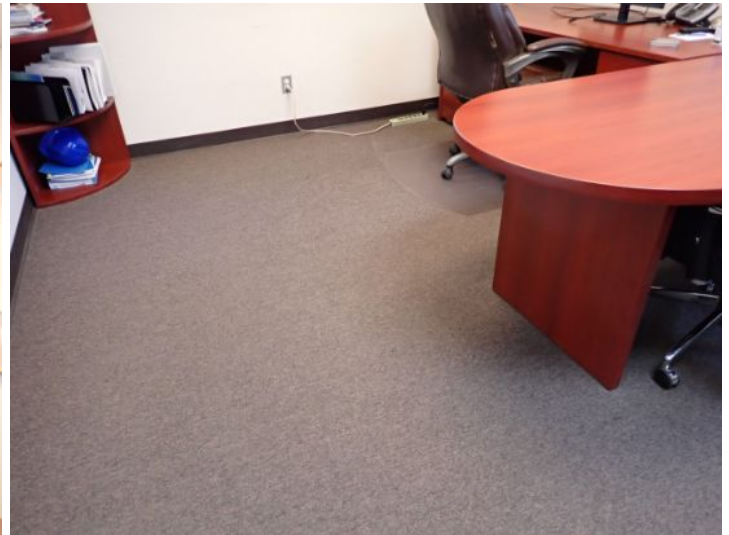
The majority of the interior of the office area appeared to be in fair condition at the time of the inspection.

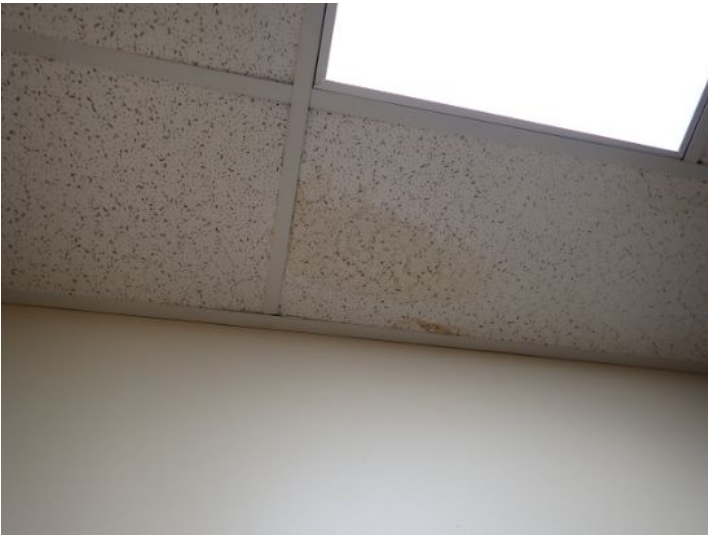
Minor past moisture staining noted in one or more of the acoustical ceiling tiles but no moisture present at the time of the inspection. Recommend repairs and monitoring for any future issues.
