# *Forman Inspection Services, LLC*

## Property Inspection Report

12345 Industrial Rd., Somewhere, CO 12345  
Inspection prepared for: John Smith  
Real Estate Agent: John Smith - Commercial Real Estate Company

Date of Inspection: 11/28/2022 Time: 10:00 Size: 10,400 sq. ft.  
Weather: Cloudy/Cool

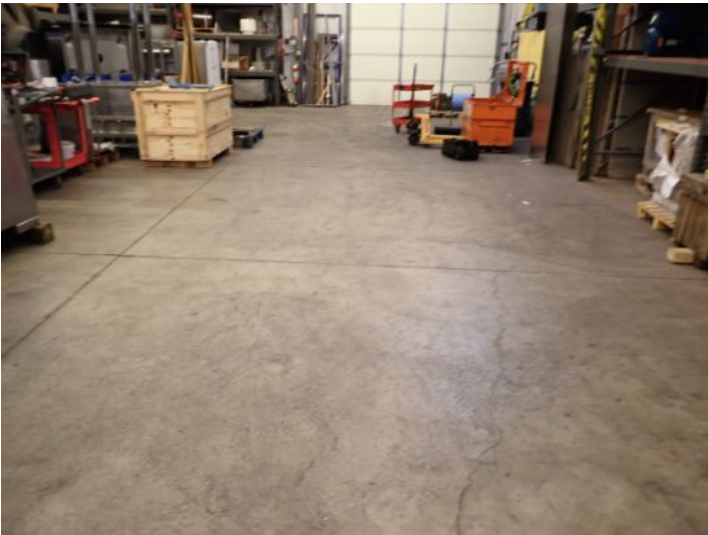
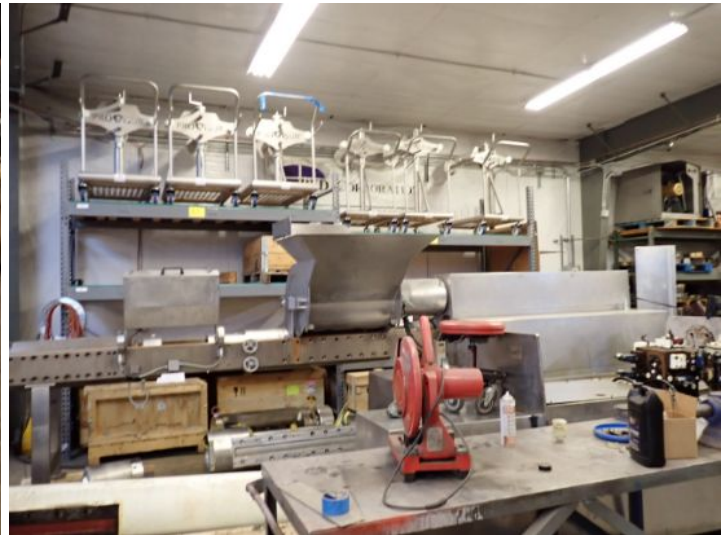
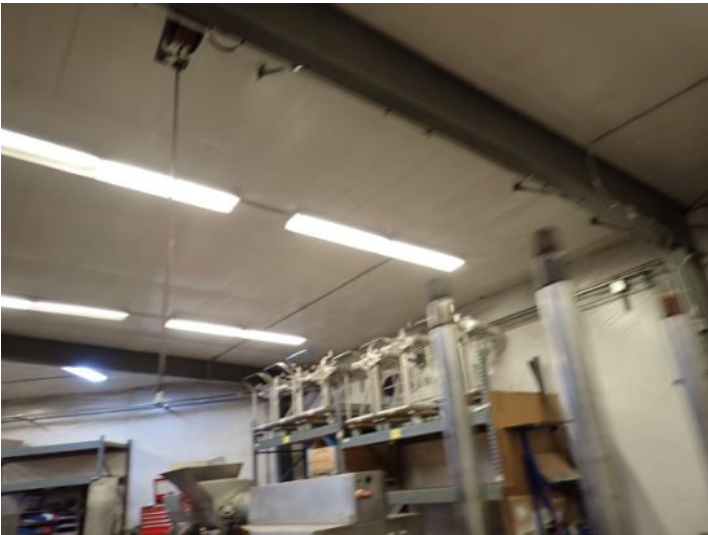
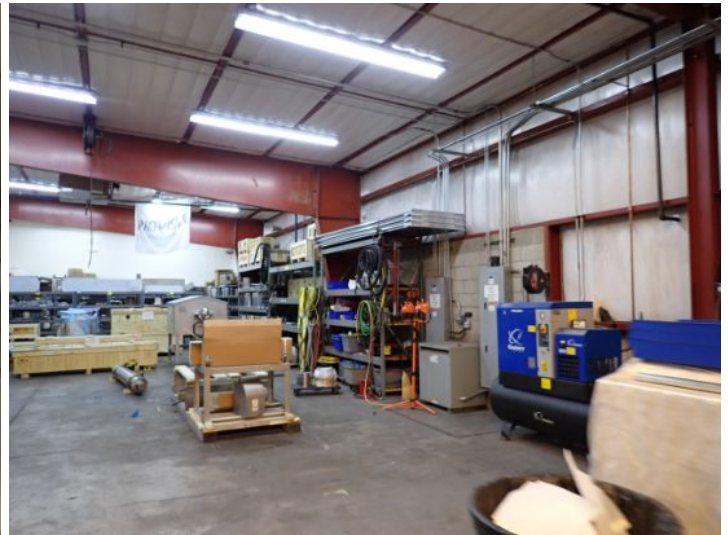
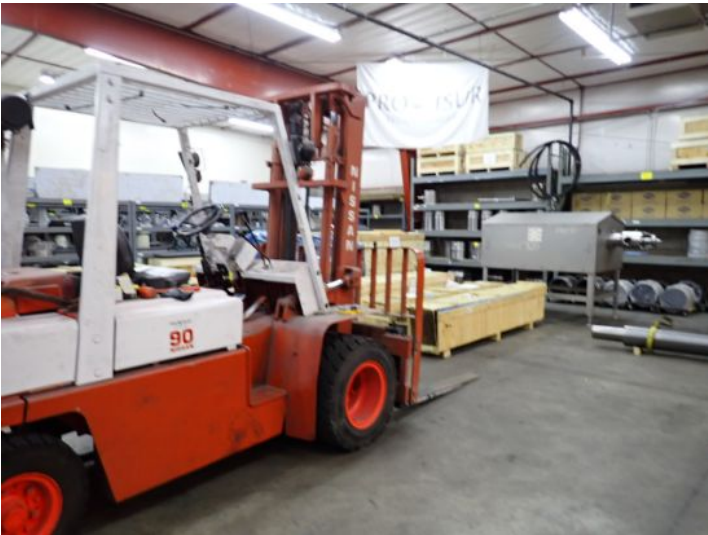
The majority of the interior of the warehouse area appeared to be in fair condition at the time of the inspection.

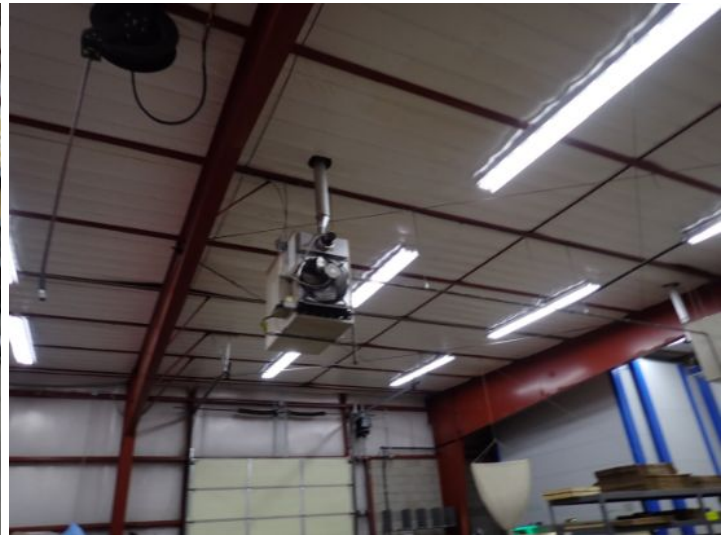
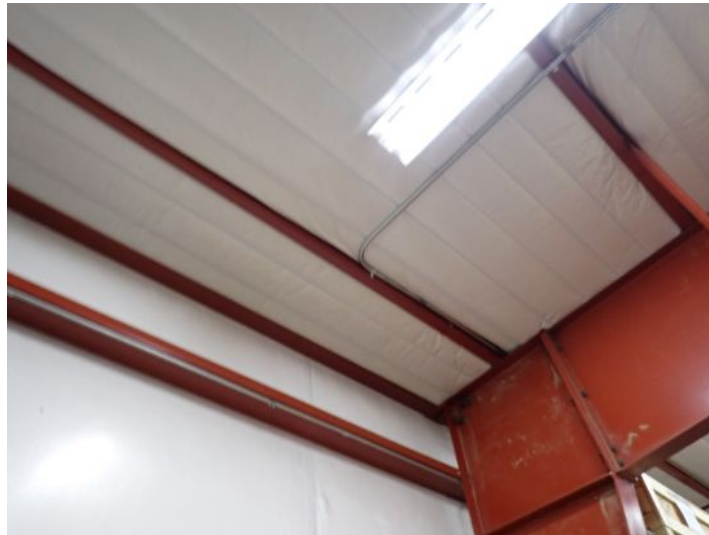
The majority of the interior of the warehouse area appeared to be in fair condition at the time of the inspection.
