# *Forman Inspection Services, LLC*

## Property Inspection Report

12345 Industrial Rd., Somewhere, CO 12345  
Inspection prepared for: John Smith  
Real Estate Agent: John Smith - Commercial Real Estate Company

Date of Inspection: 11/28/2022 Time: 10:00 Size: 10,400 sq. ft.  
Weather: Cloudy/Cool

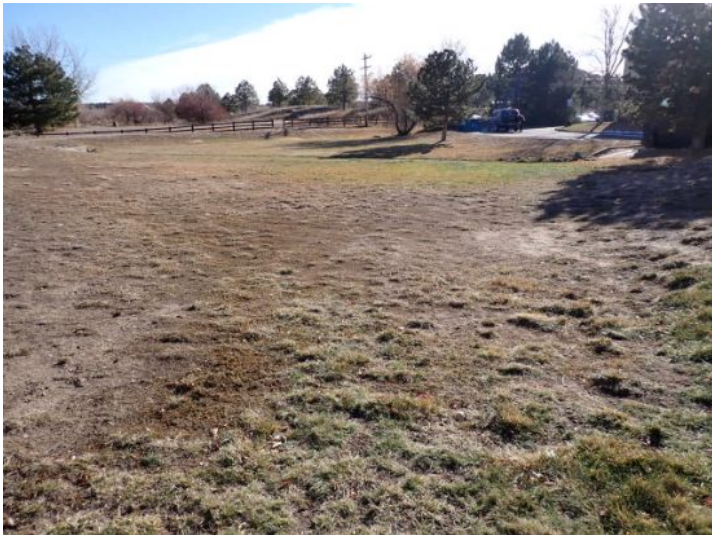
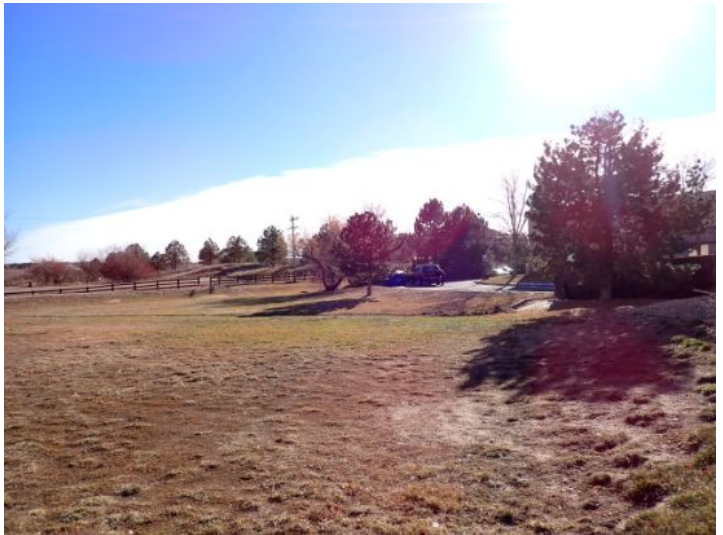
There was a retention pond/area located on the east side of the property at the time of the inspection.

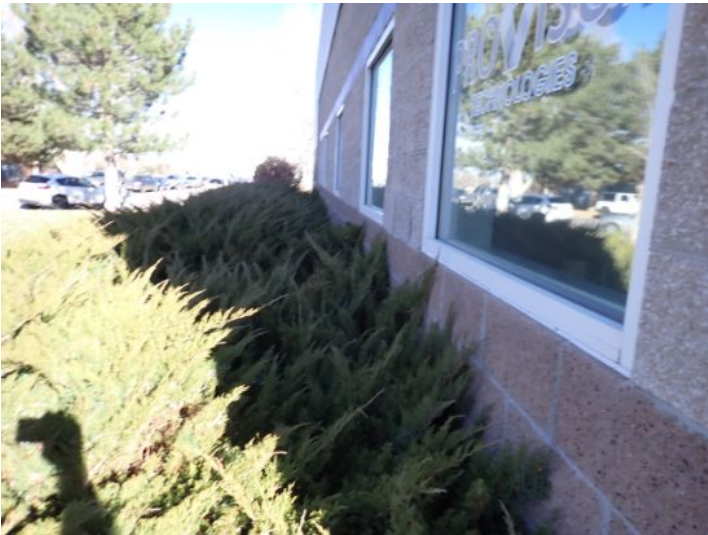
Foliage in contact with structure at time of inspection. Recommend trimming/removal.

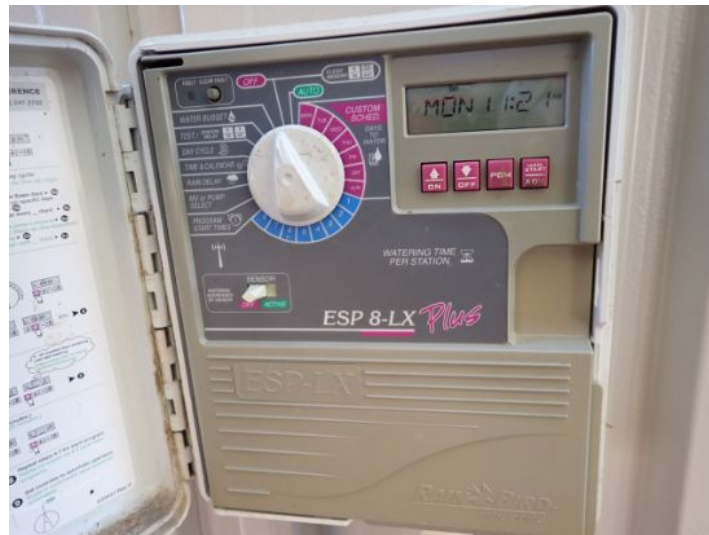
The property had an irrigation system at the time of the inspection.

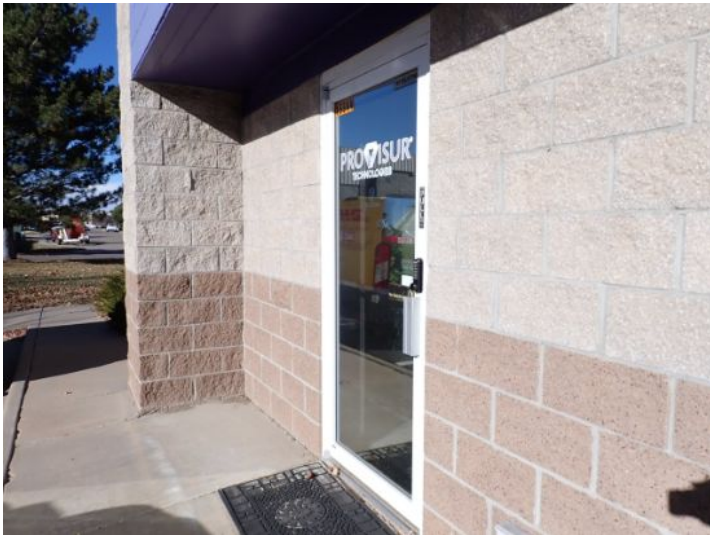
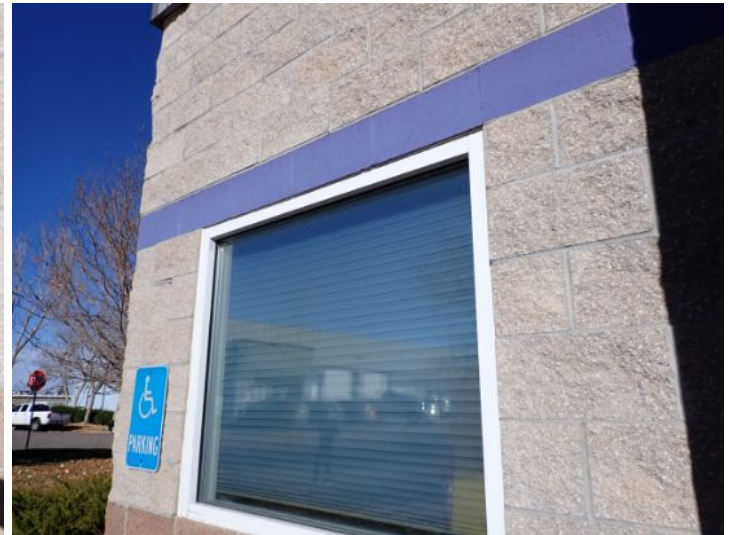
The majority of the exterior envelope of the structure appeared to be in fair condition with no significant movement noted at the time of the inspection.

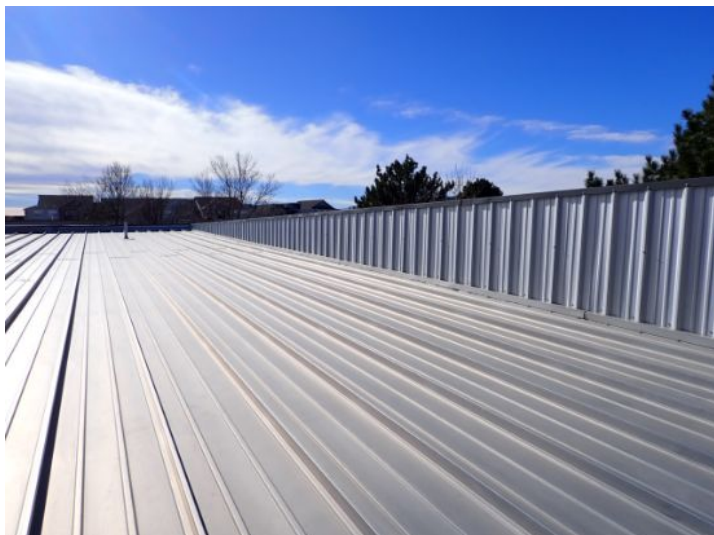
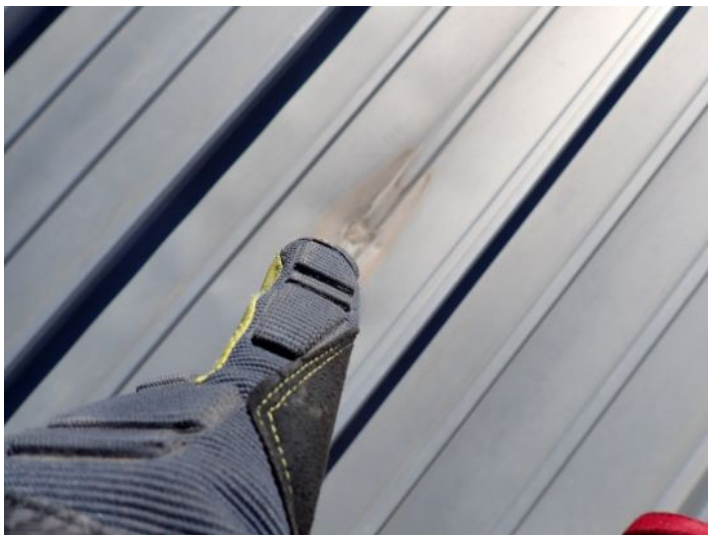
The majority of the standing seam metal roofing system appeared to be in fair condition at the time of the inspection.

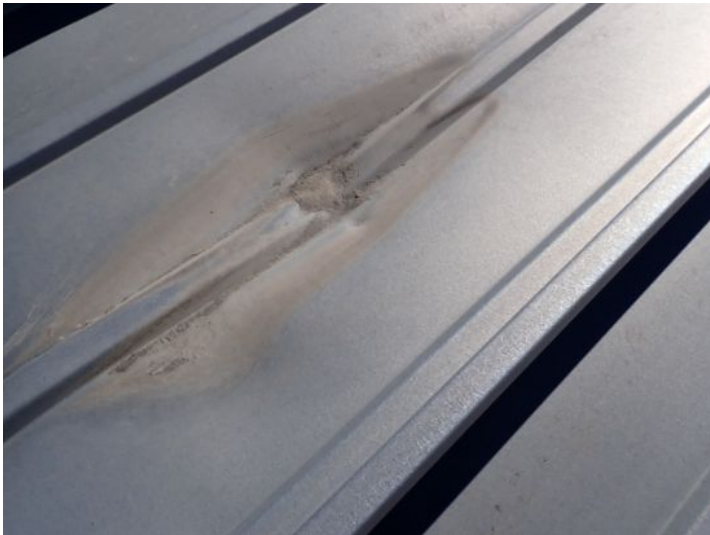
There were a couple of areas noted on the roof top where there were fairly large indentation's noted in the steel roofing system causing ponding. Recommend repairs by a licensed contractor.

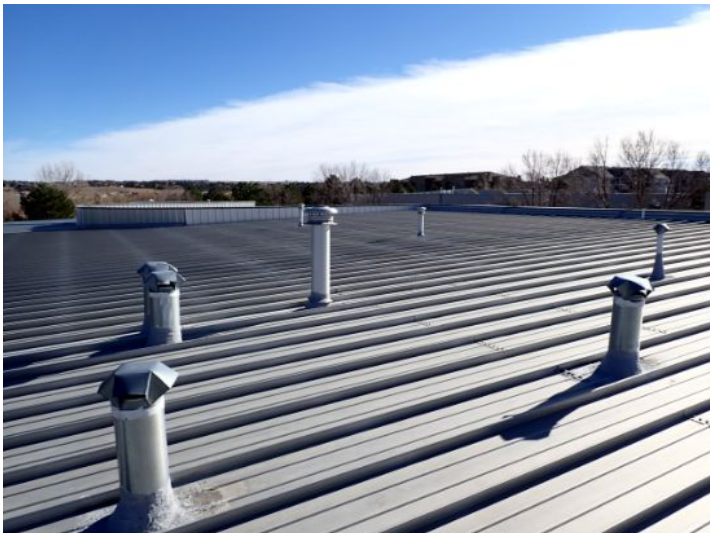
There were a couple of areas noted on the roof top where there were fairly large indentation's noted in the steel roofing system causing ponding. Recommend repairs by a licensed contractor.

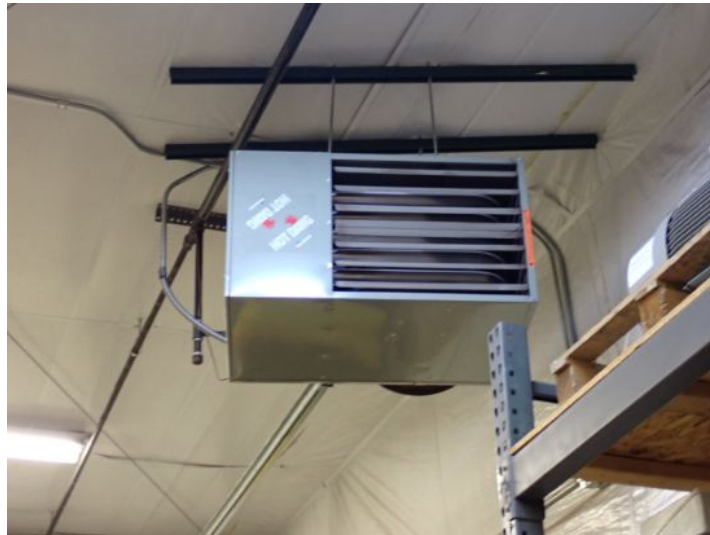
The shop heaters located in the east side of the warehouse were not functional at the time of the inspection. Recommend repairs as needed by a licensed contractor.

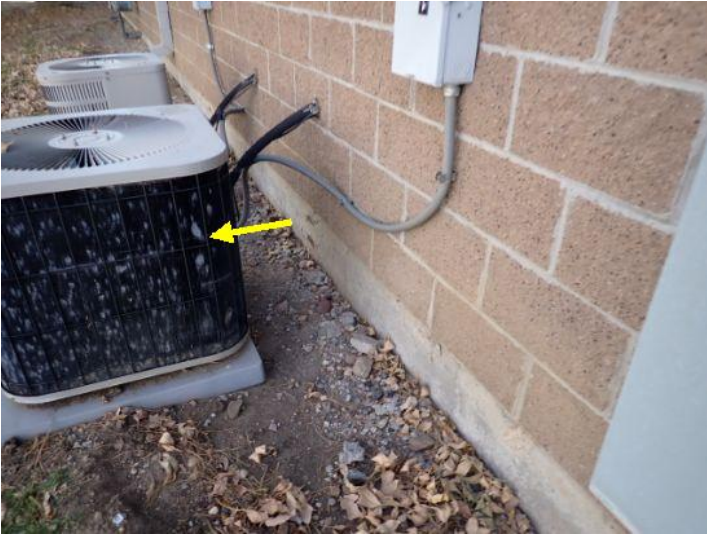
Hail damage noted on the external cooling fins of CU 1 at the time of the inspection. CU 1: Goodman: M/N CK49-18 S/N 0102523880. Manufacture year 2001.

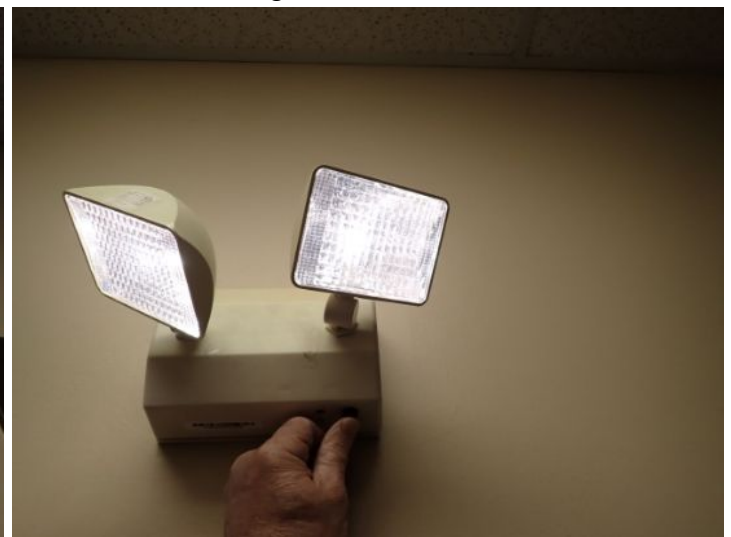
The emergency lighting was tested and functional at the time of the inspection.

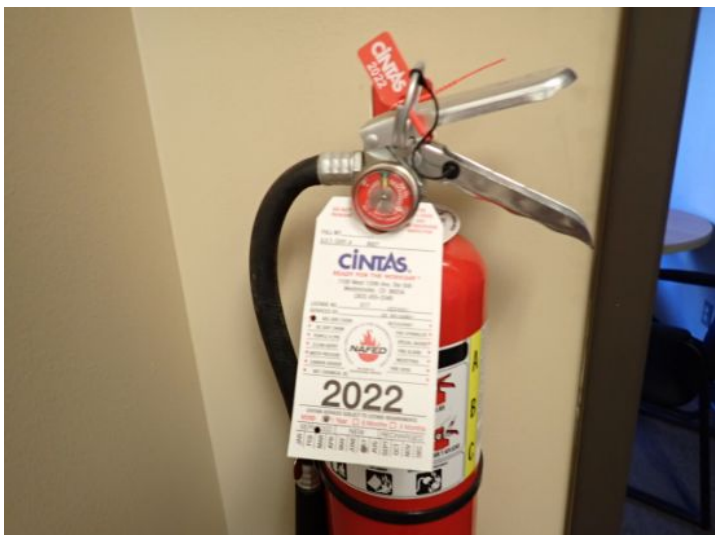
Last date of inspection/certification for the fire extinguishers was 7/22.
